REPORT NO.: MGA-93-21402
NHTSA NO: MP0208

OFFICE OF MARKET INCENTIVES
SIDE IMPACT PROTECTION STUDY

1993 Ford Probe 2-Door Coupe

FINAL REPORT

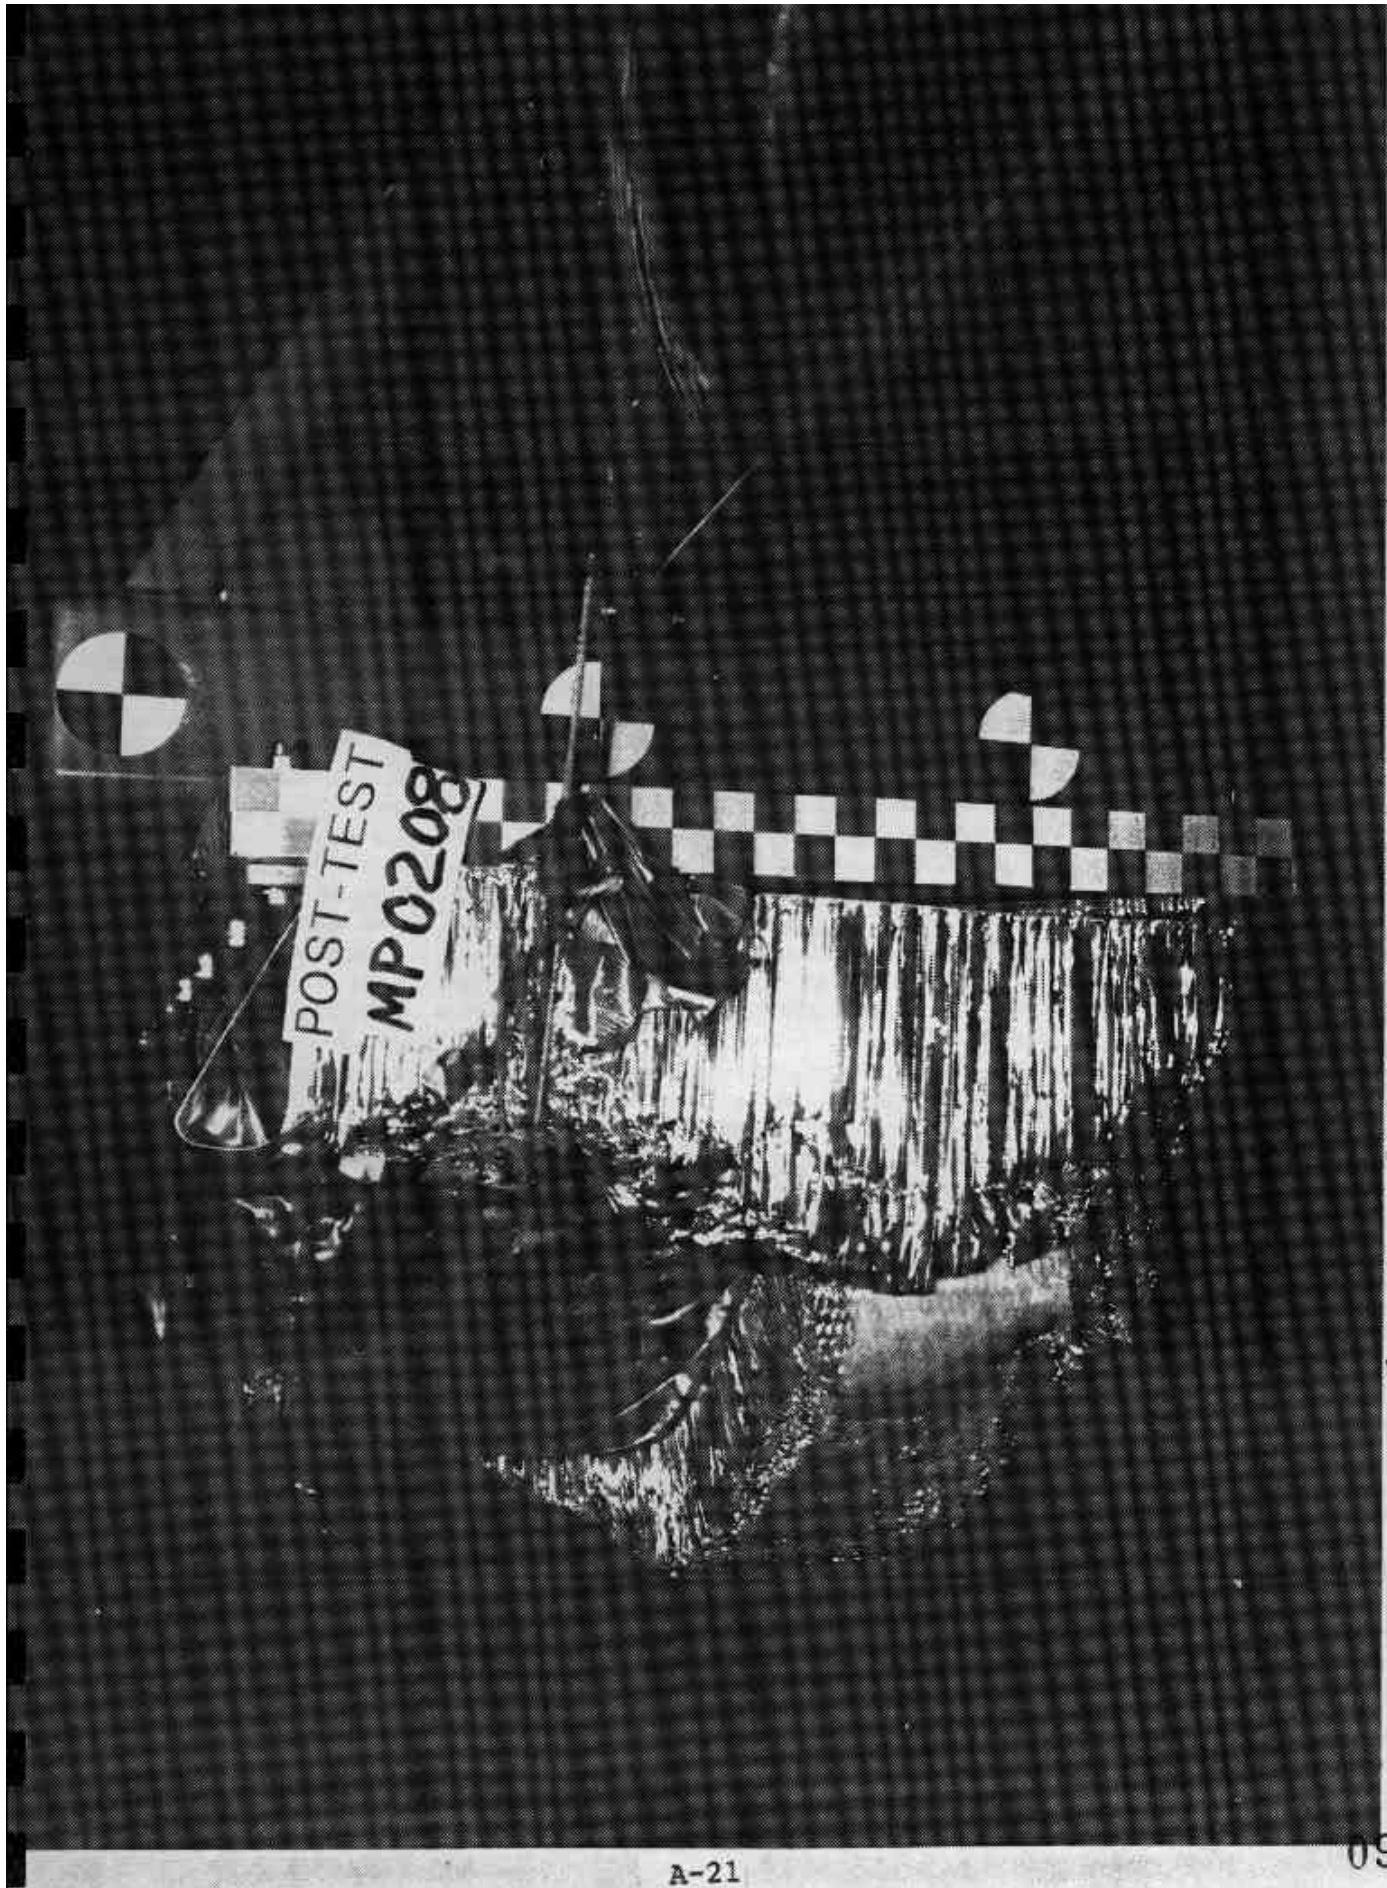
Photo No. A-21 - Post-Test MDB Left Side View
