REPORT NO.: MGA-93-21406
NHTSA NO: MP0105

OFFICE OF MARKET INCENTIVES
SIDE IMPACT PROTECTION STUDY

1993 OLDSMOBILE ACHIEVA
2-Door

FINAL REPORT

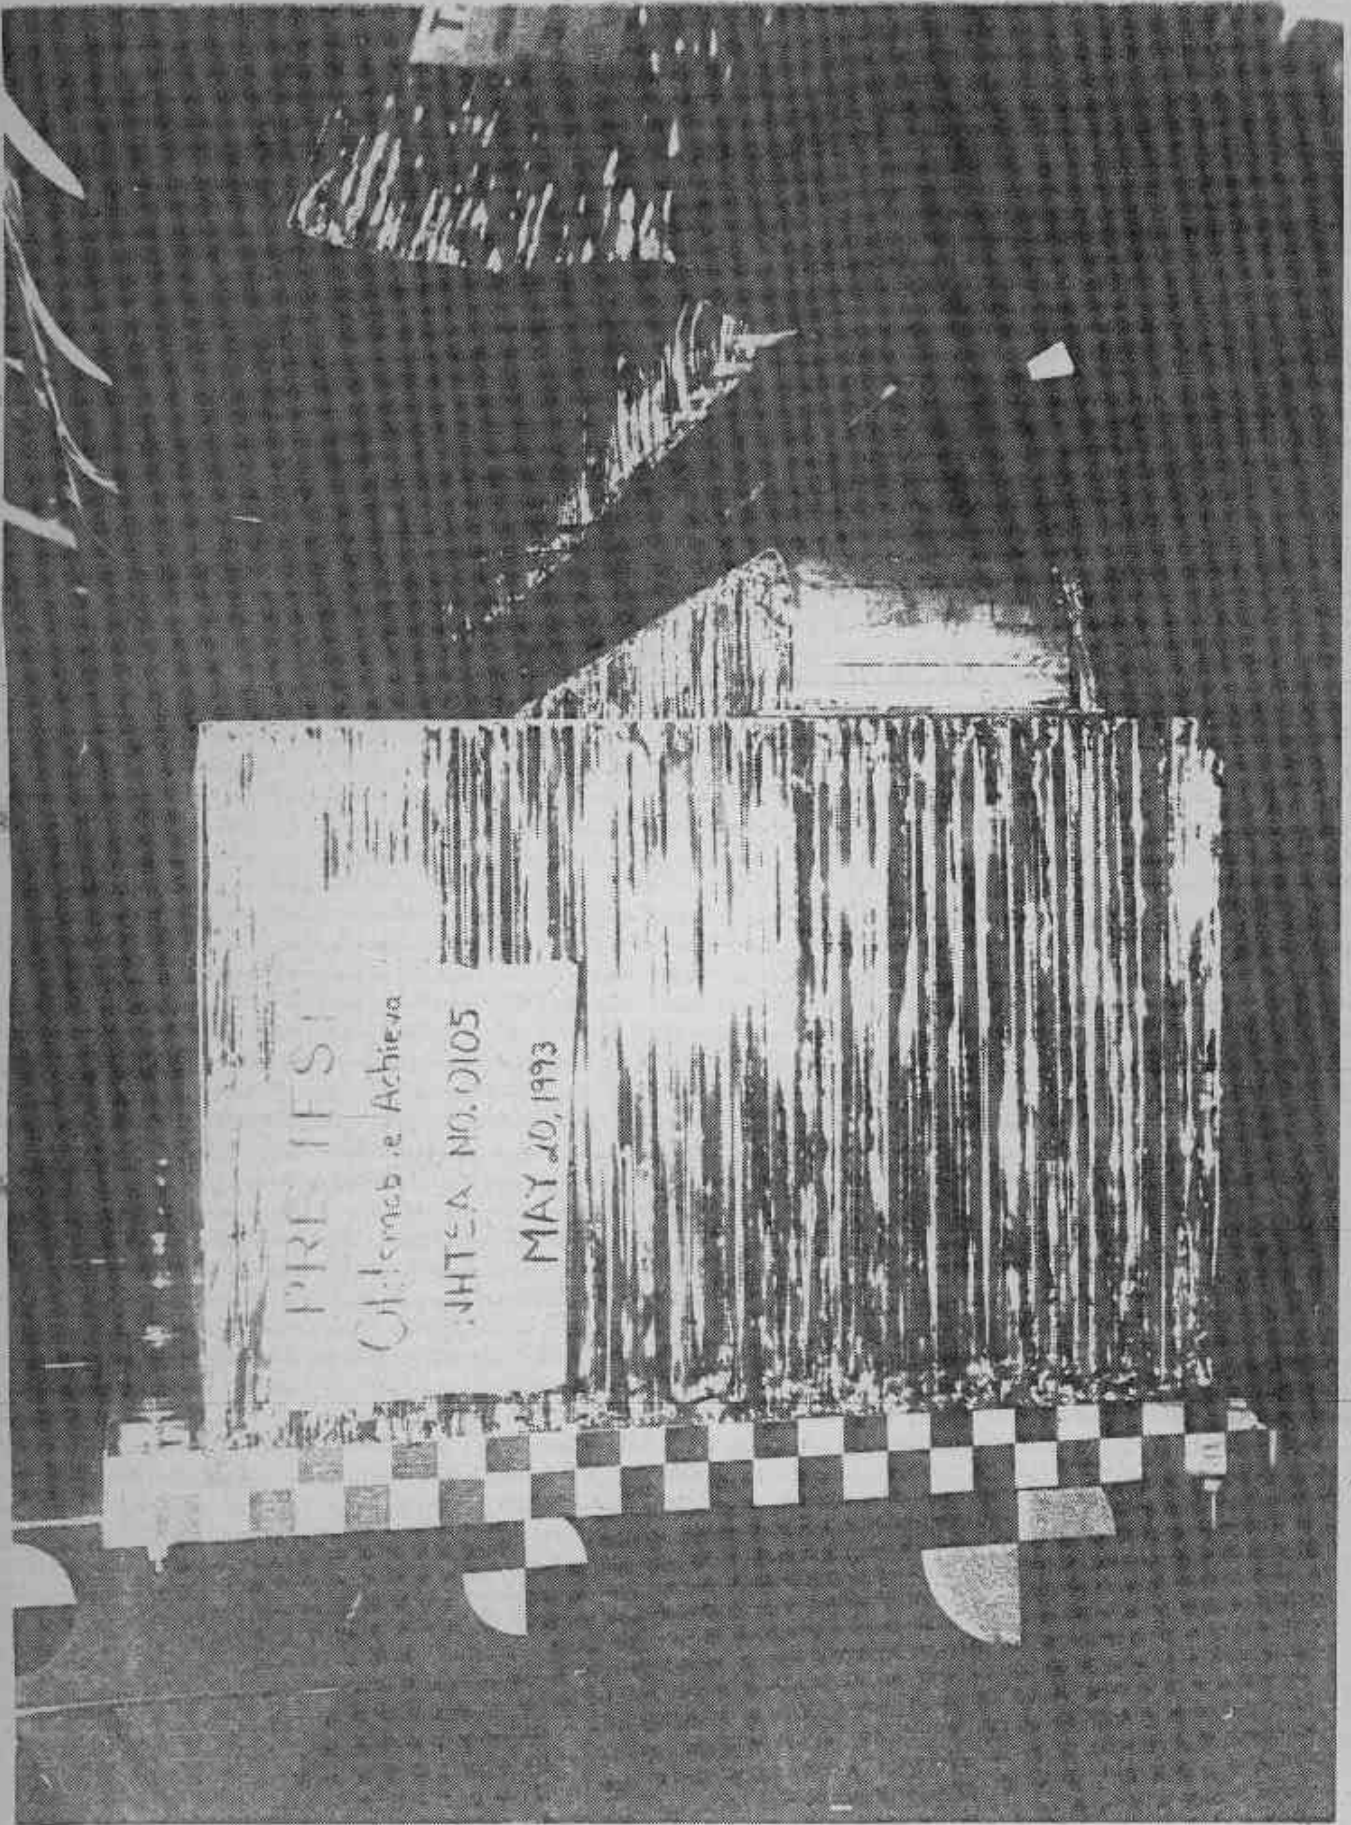
Photo No. A-8 - Pre-Test MDH and Vehicle Left Side Rear View

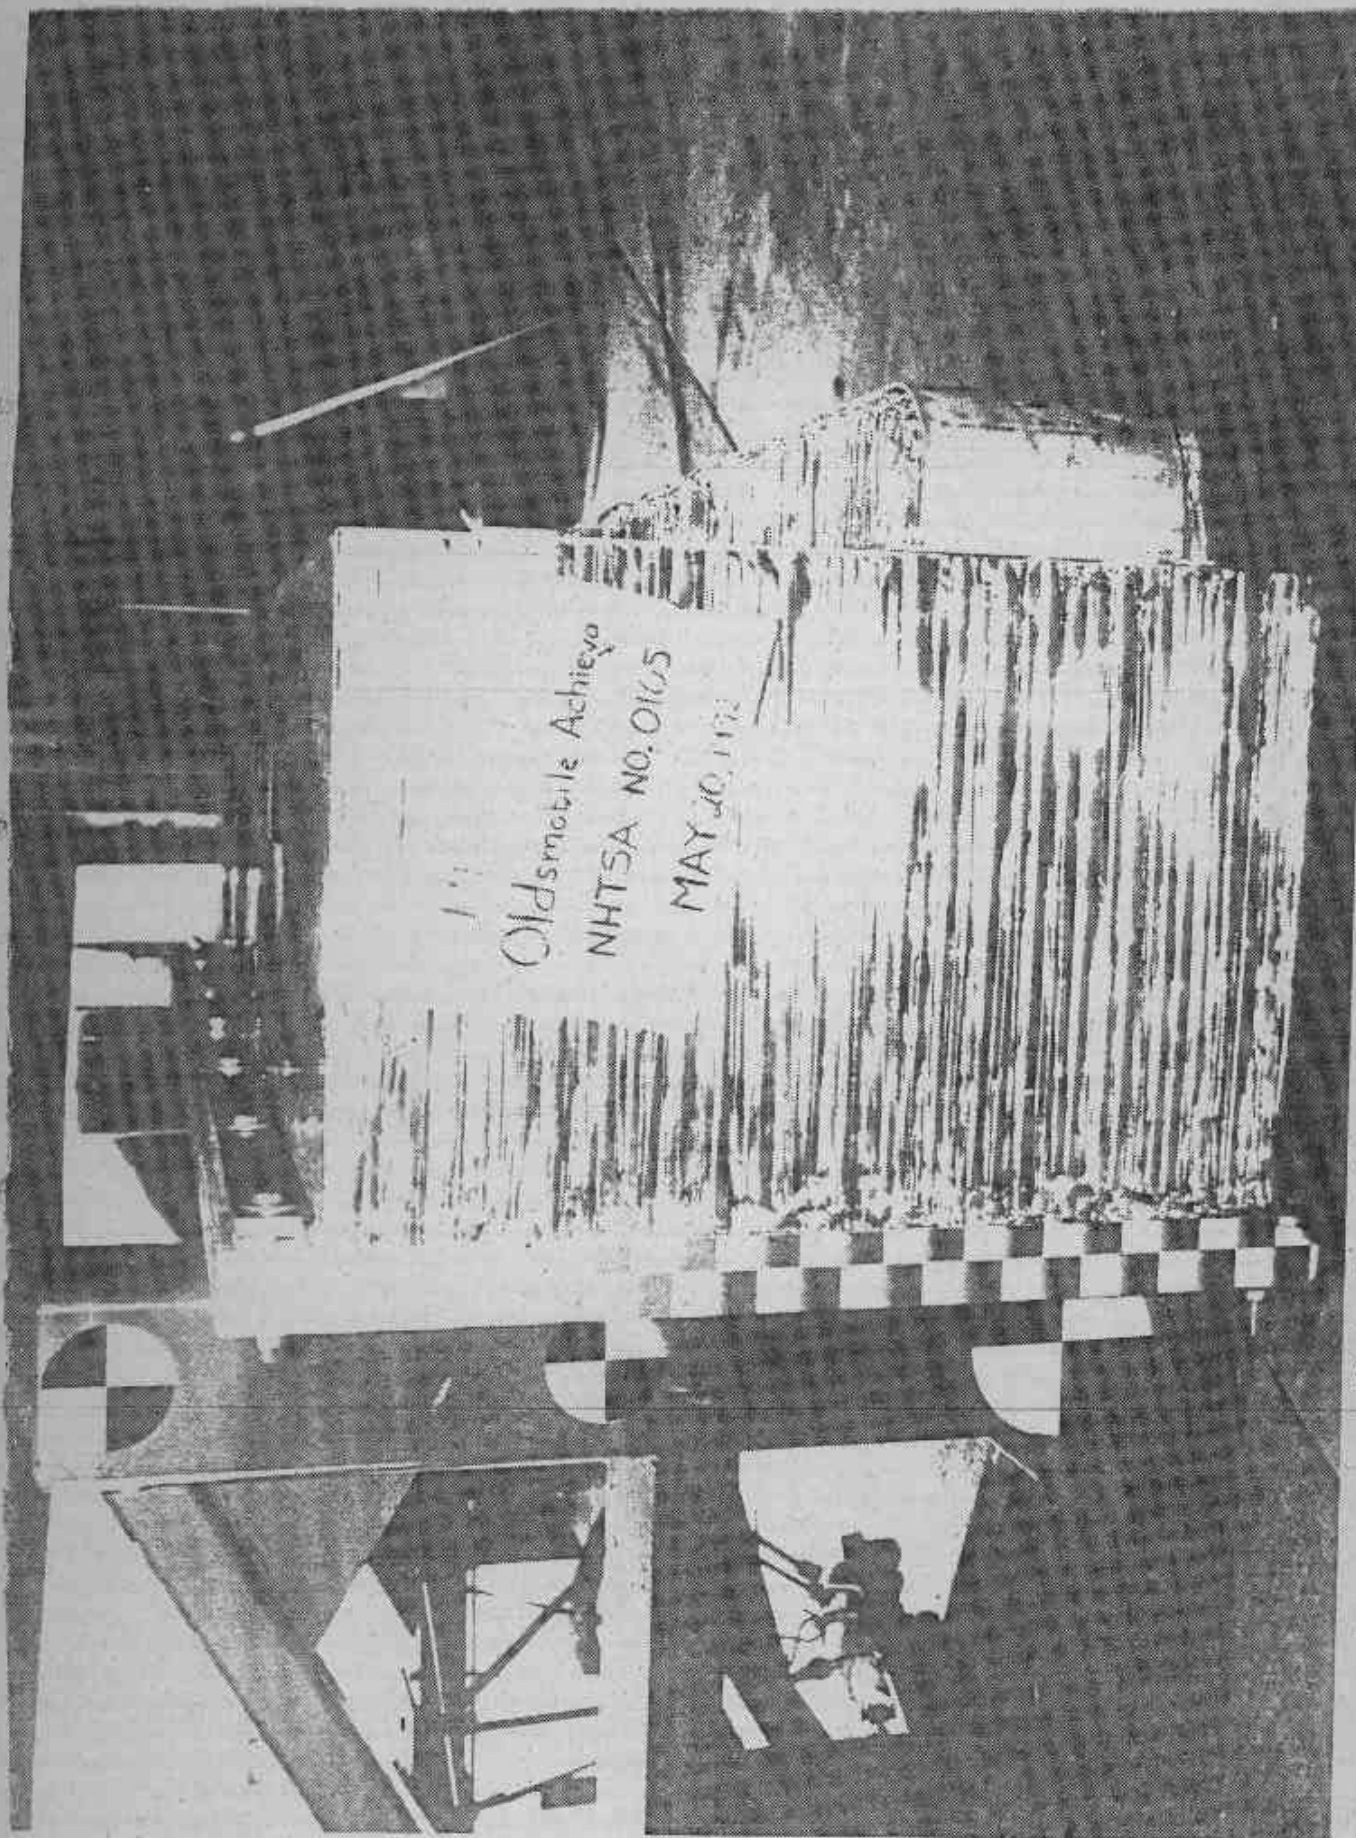
Photo No. A-15 - Pre-Test MDB Right Side View

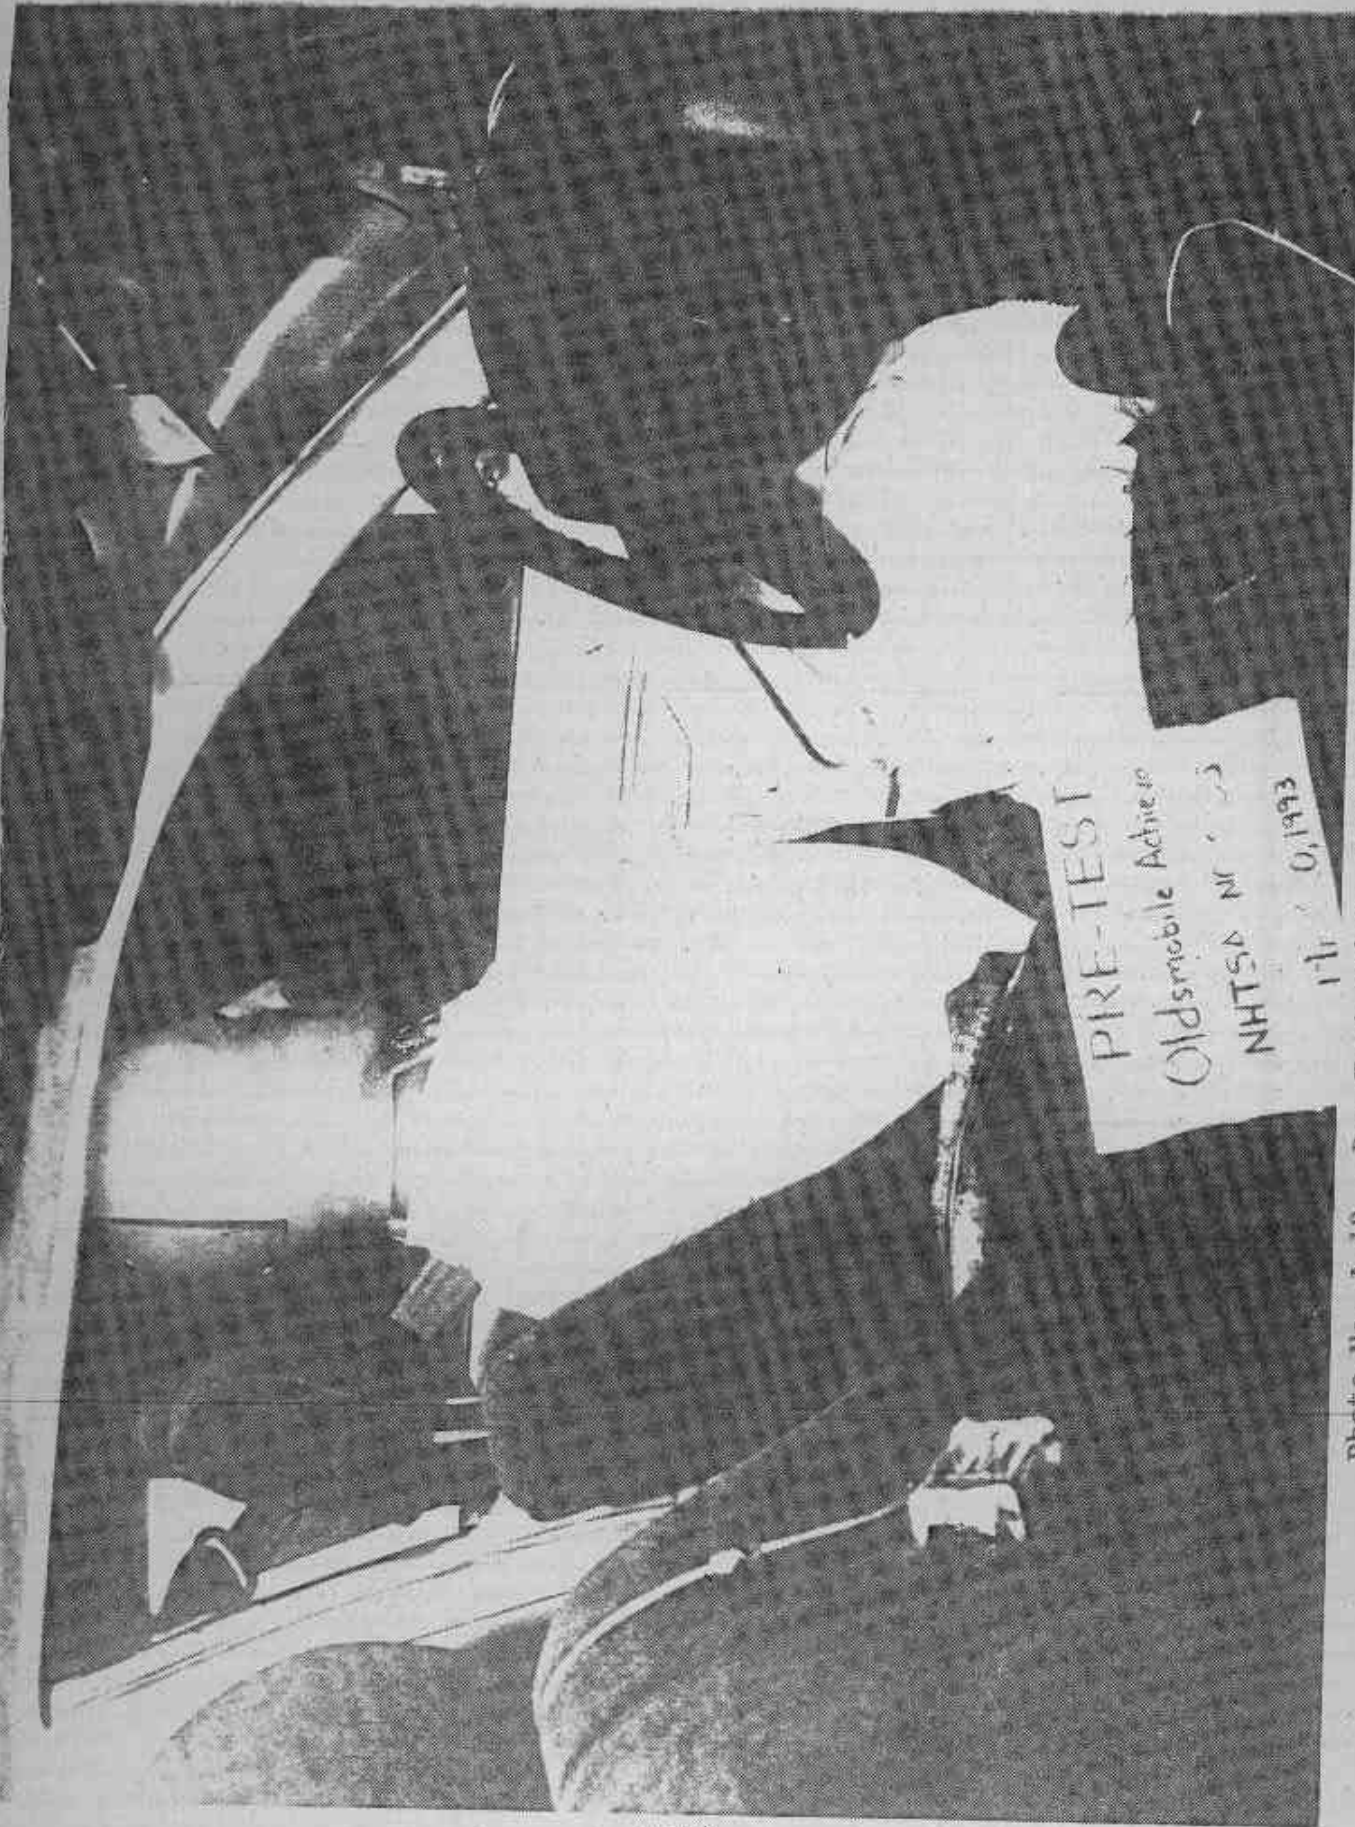
Photo No. A-19 - Pre-Test Driver Dummy Right Side View

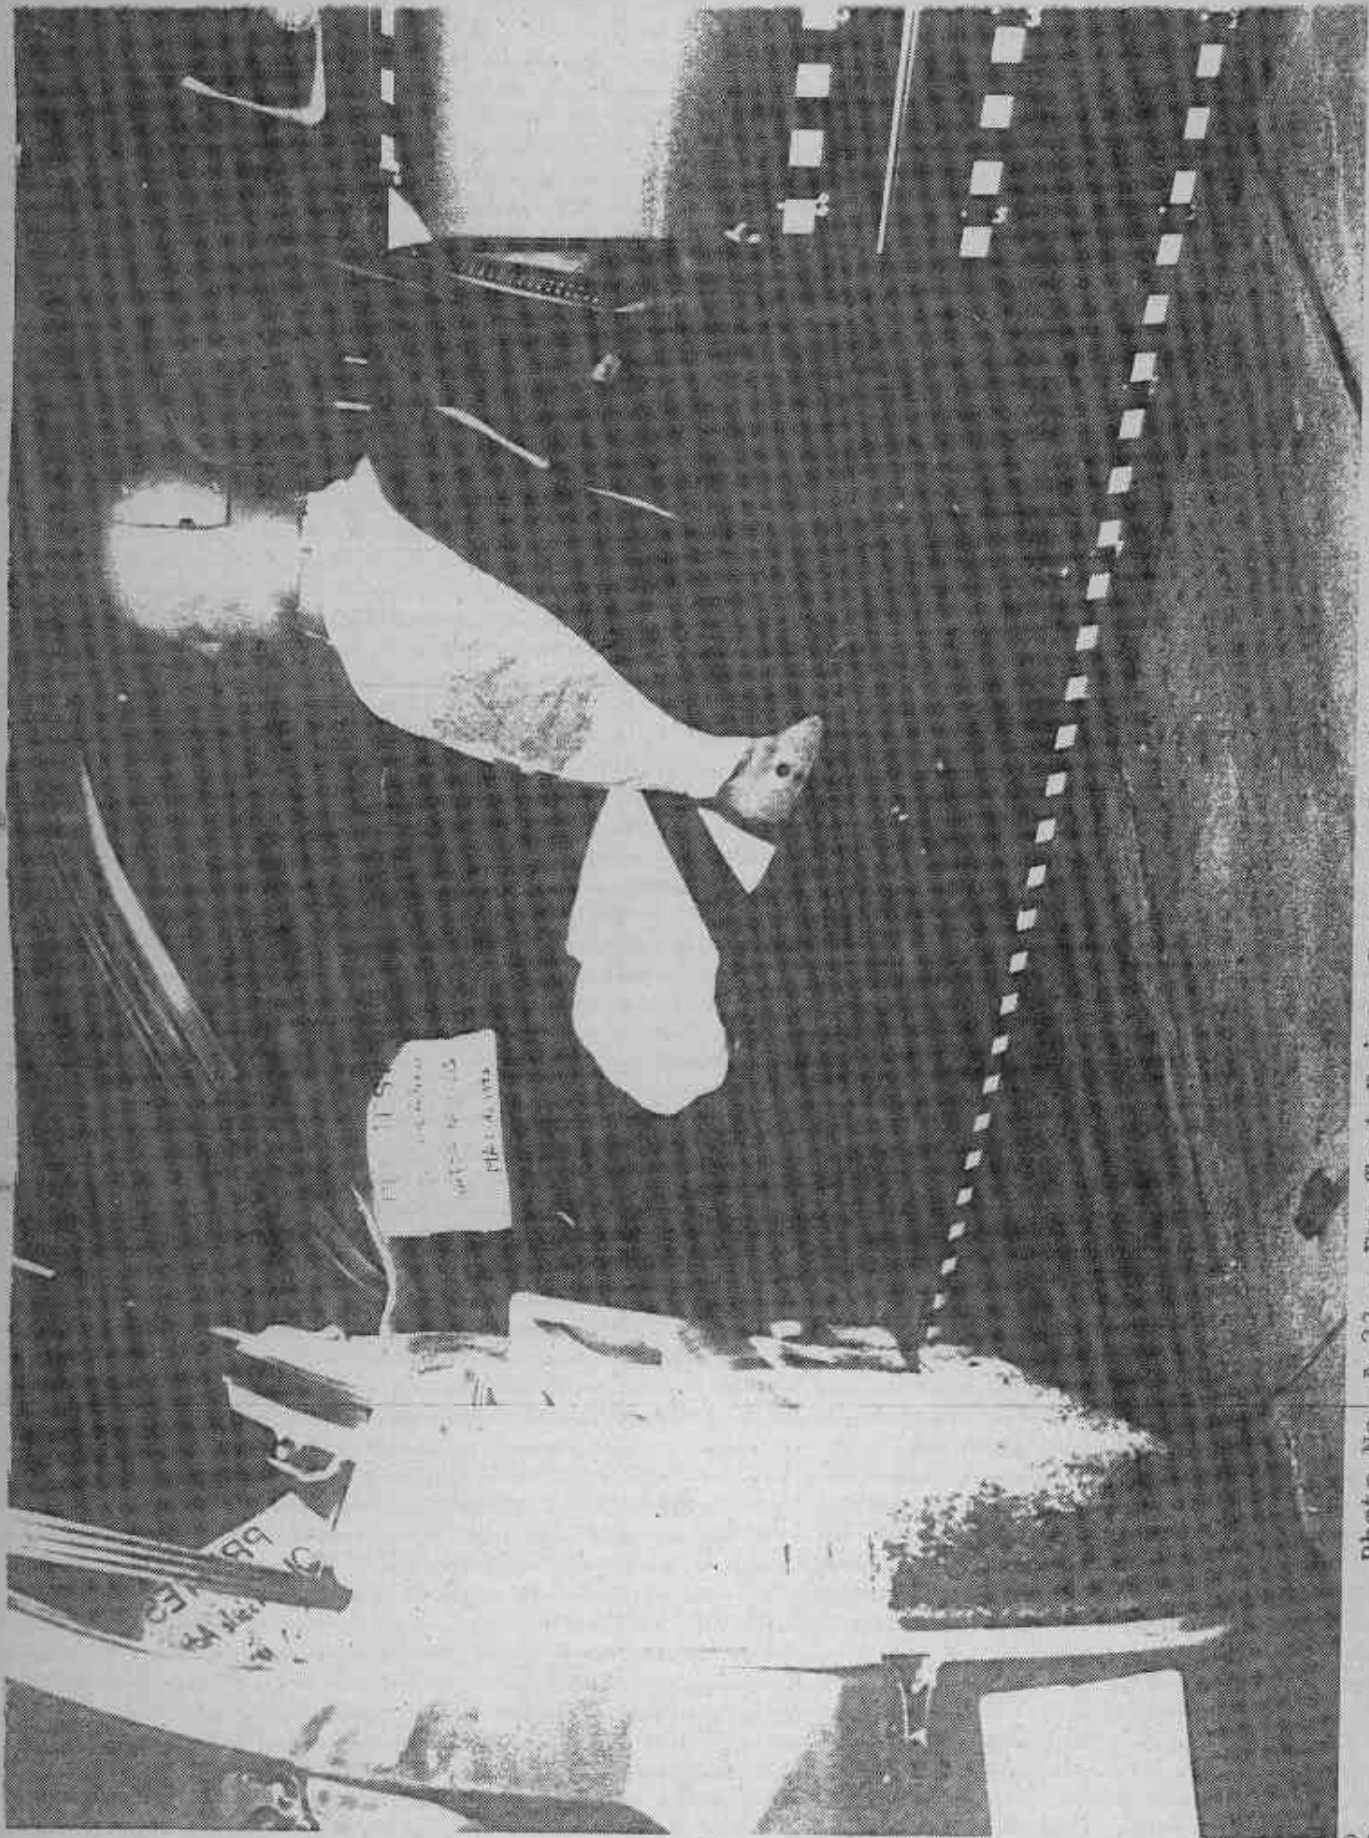
Photo No. A-23 - Pre-Test Driver Dummy Left Side View (Door Open)
