## **SAFETY COMPLIANCE TEST FOR**

**FMVSS 301-75R**

## **FUEL SYSTEM INTEGRITY**

**1993 PLYMOUTH COLT 2 DOOR COUPE**

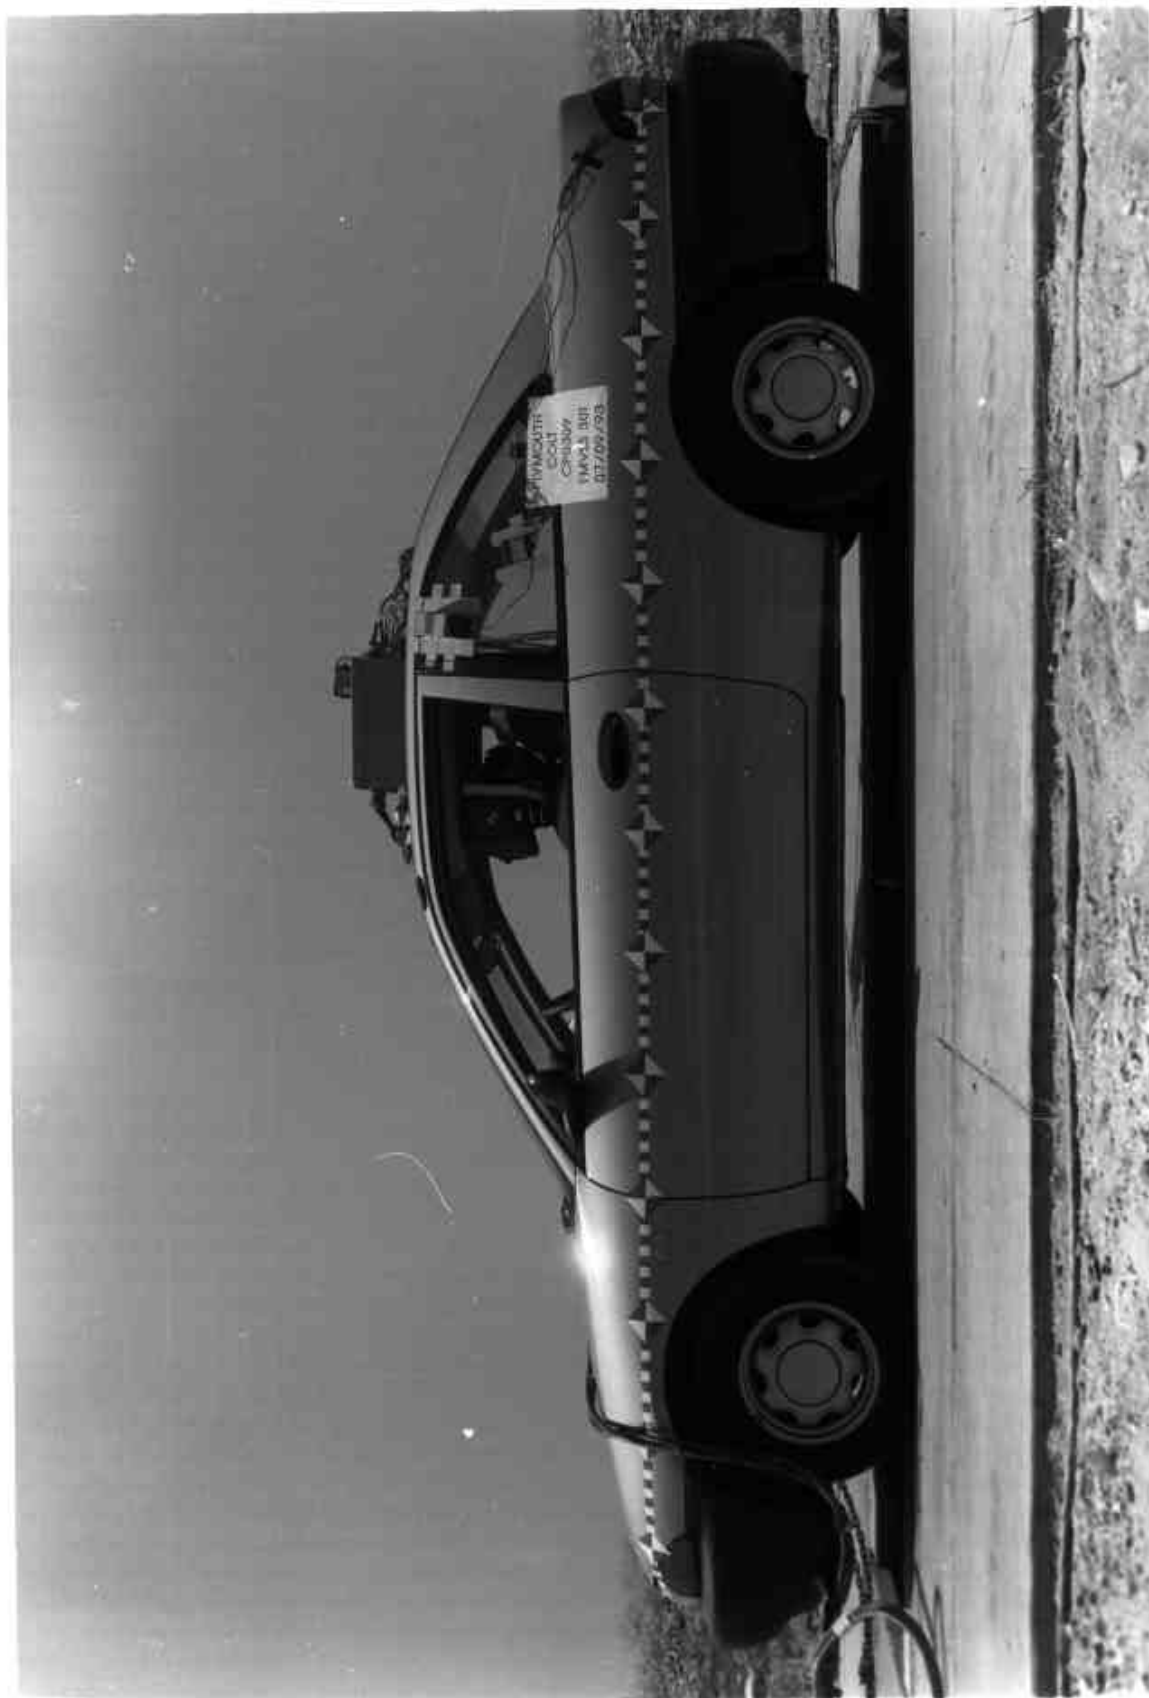
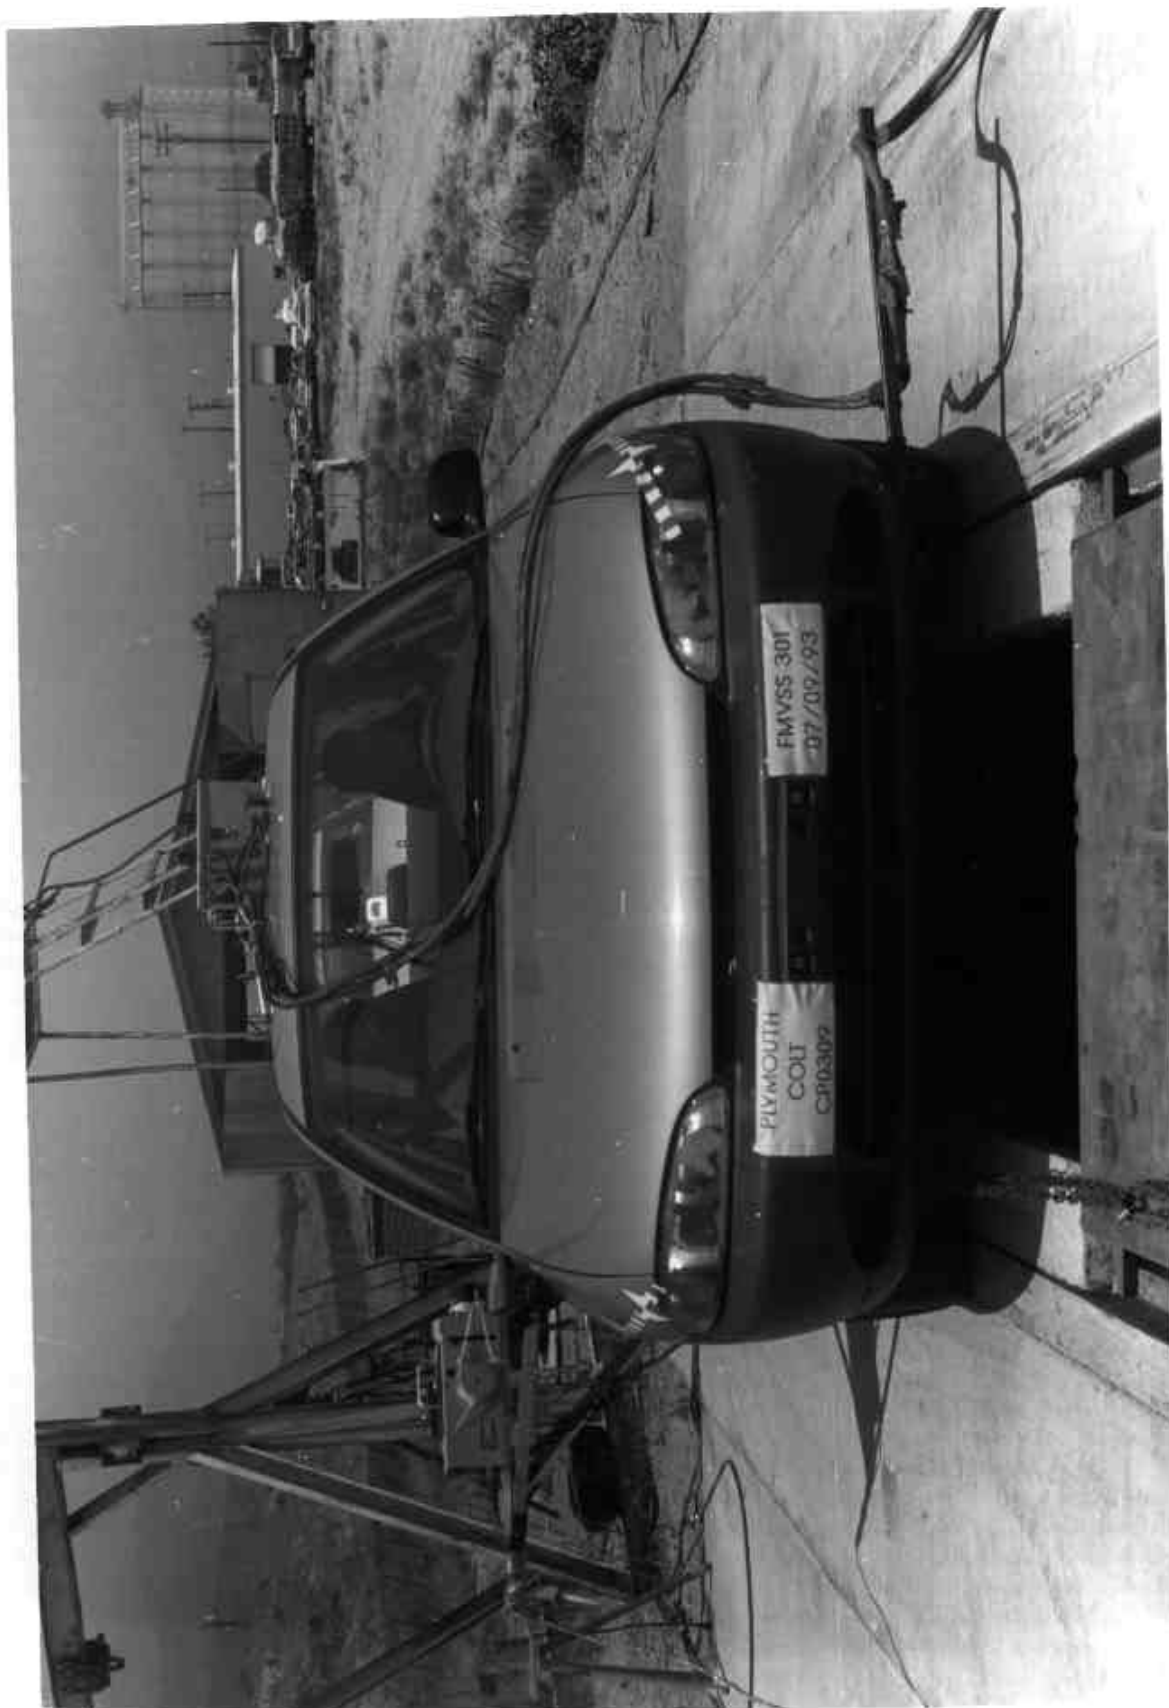
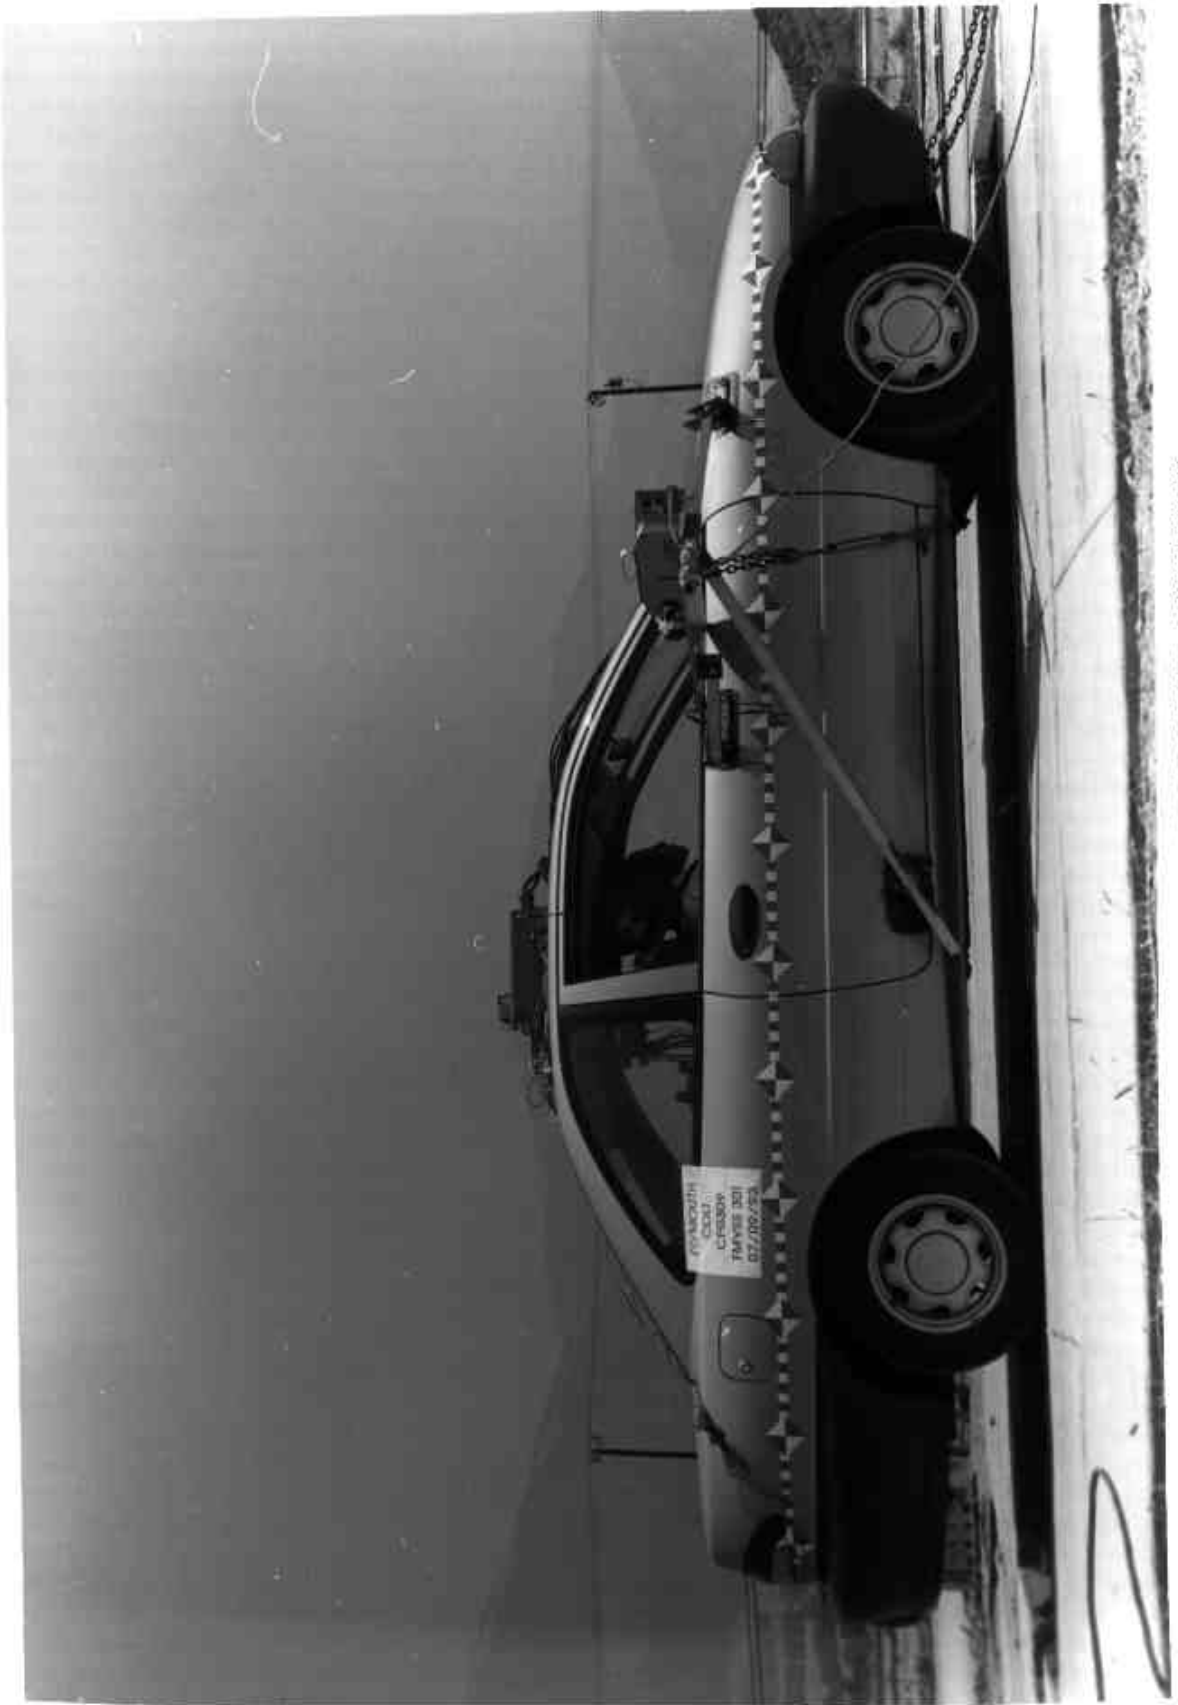
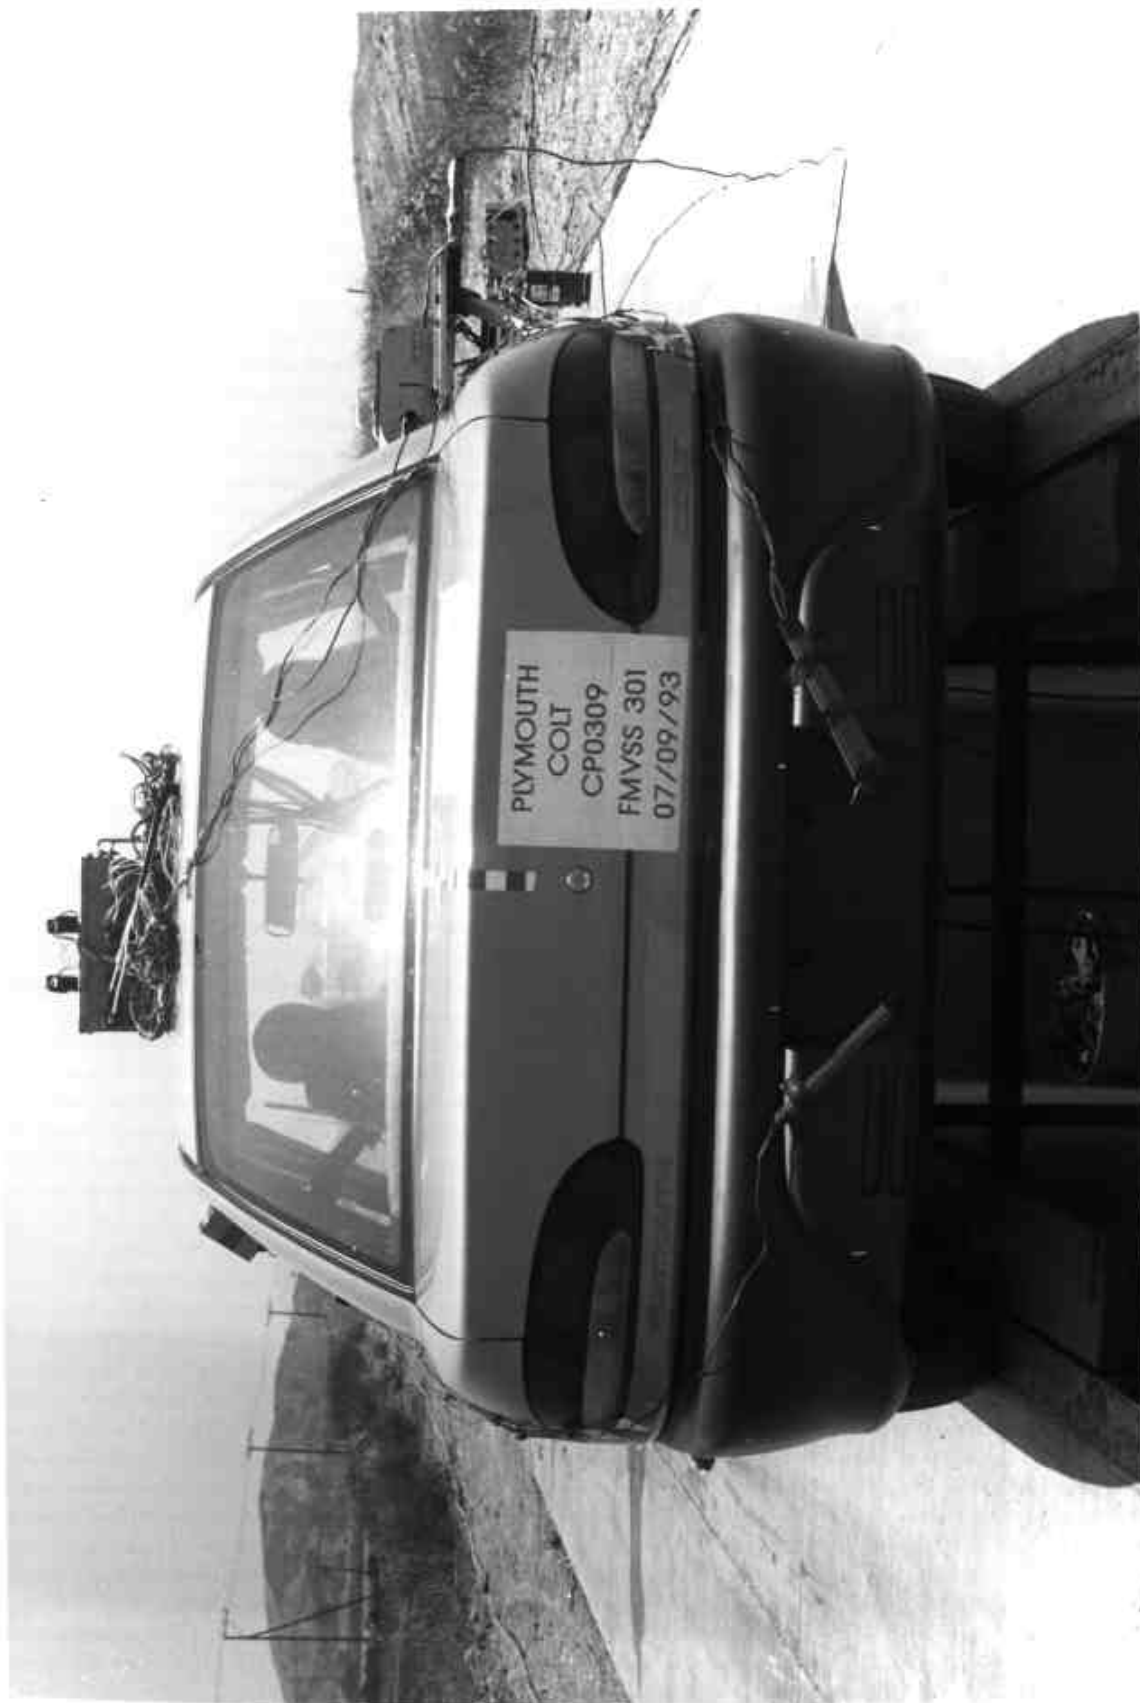
The 1993 Plymouth Colt 2 Door Coupe, NHTSA No. CP0309, was subjected to FMVSS 301-75 Rear testing on July 9, 1993. The vehicle is shown in pretest condition in Figures 5-1 to 5-4. The manufacturer's certification label is shown in Figure 5-5 and the tire placard is shown in Figure 5-6.

FIGURE 5-1 PRETEST LEFT SIDE VIEW

FIGURE 5-2 PRETEST FRONT VIEW

FIGURE 5-3 PRETEST RIGHT SIDE VIEW

FIGURE 5-4 PRETEST REAR VIEW

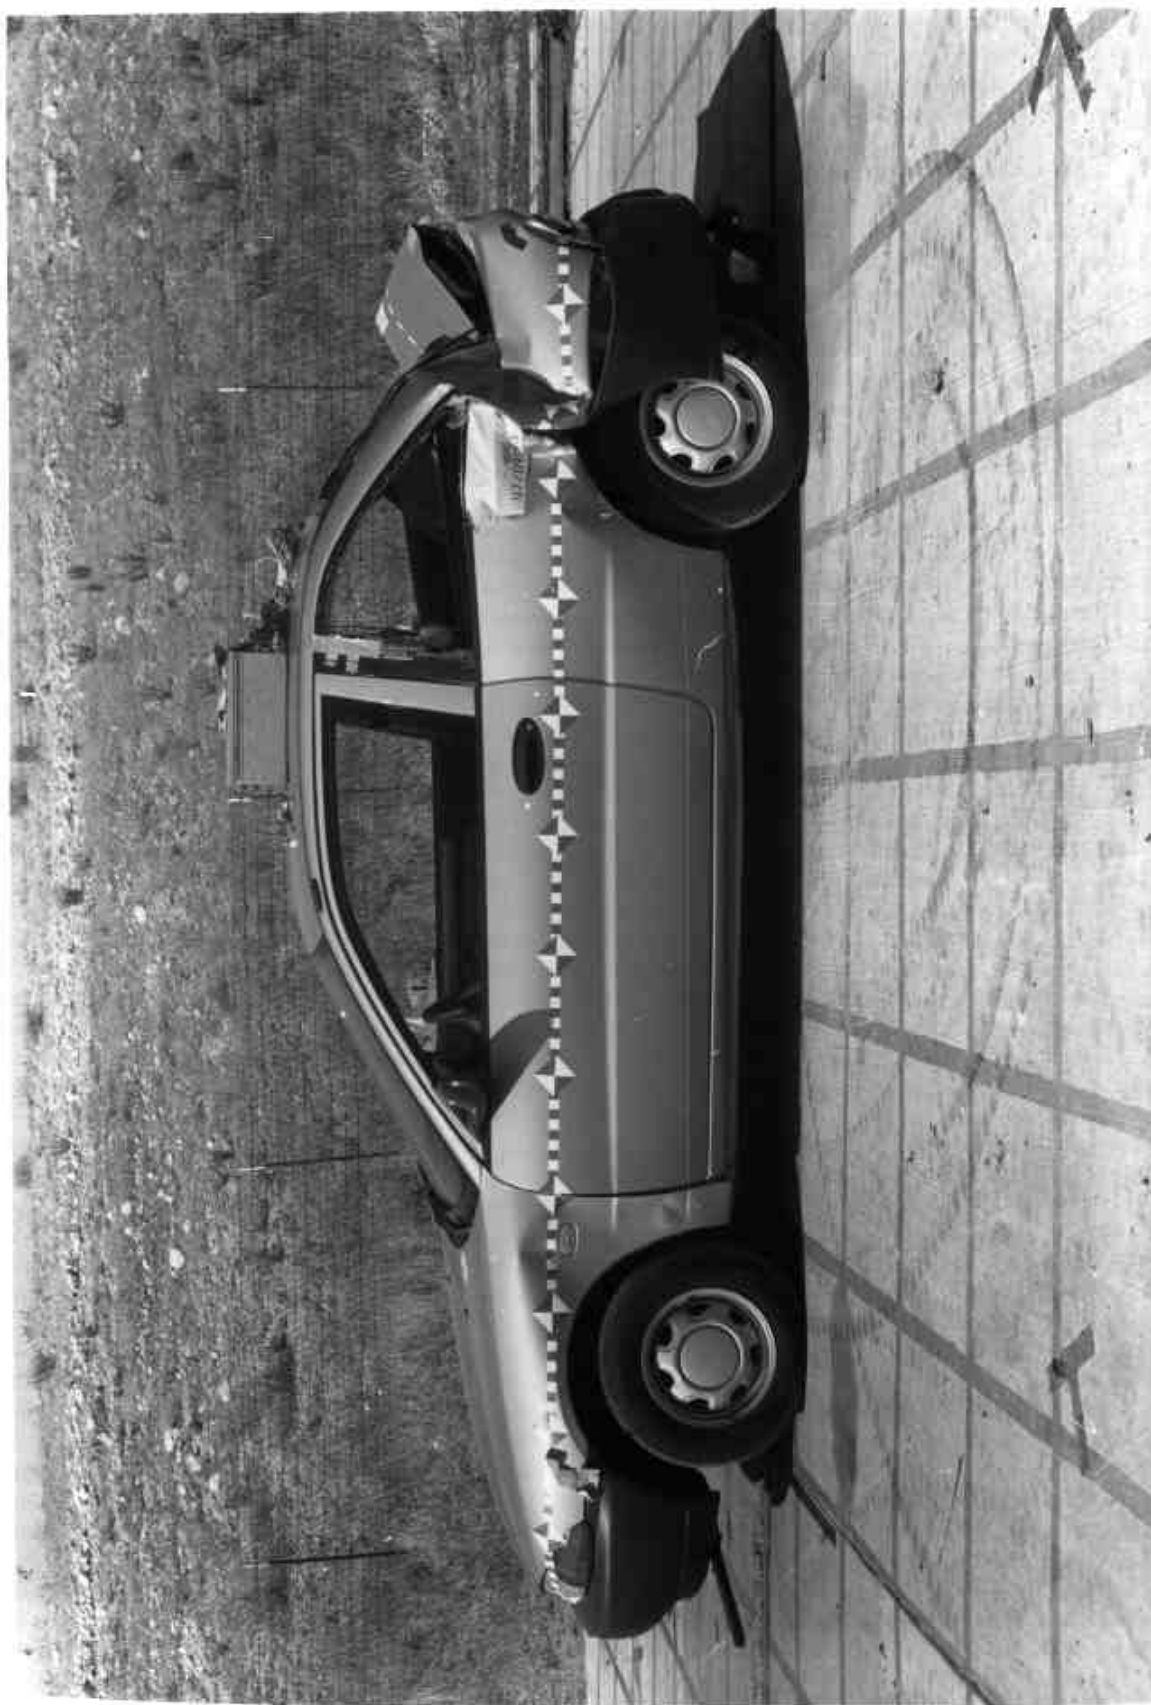
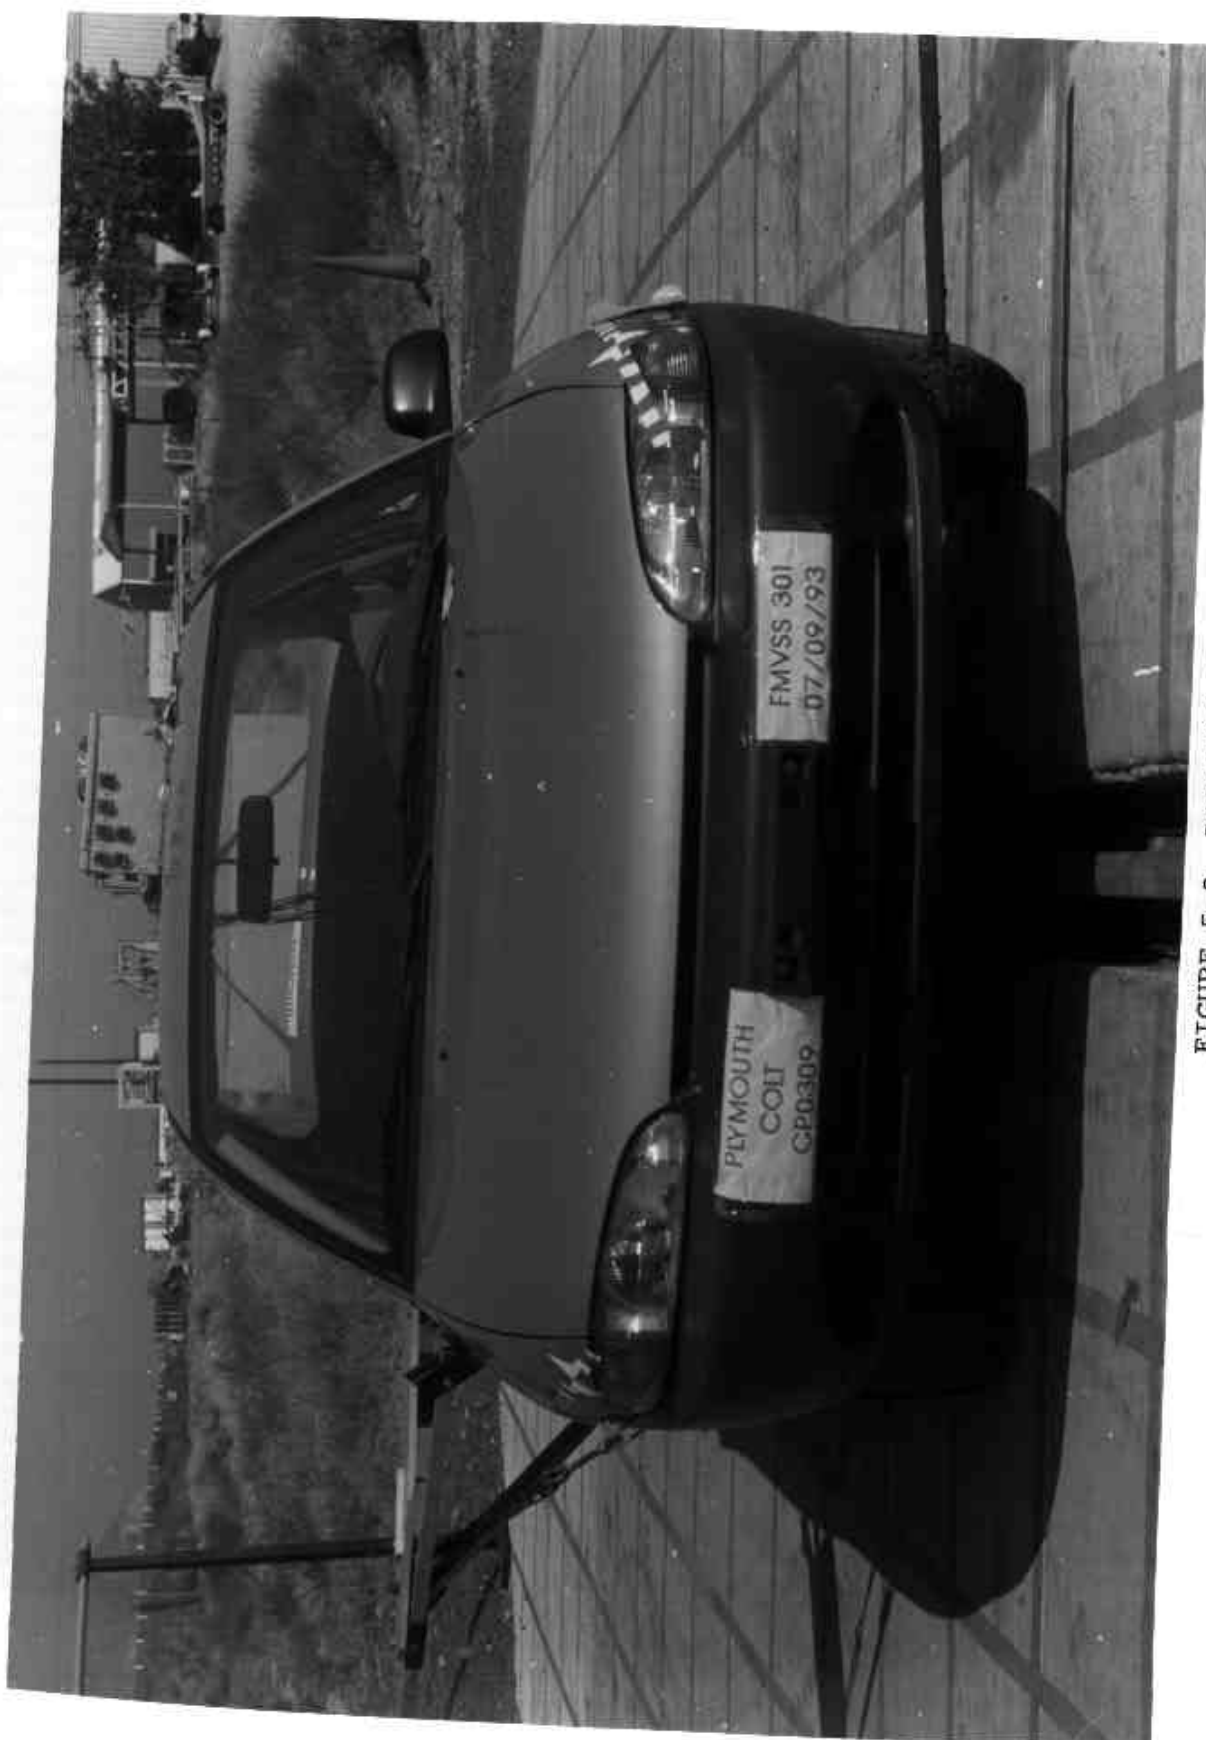
The velocity of the rear impact sled was 29.33 mph. Test velocity information and posttest crush details are given in Table 3-2. Posttest left side, front, right side and rear views of the test vehicle are given in Figures 5-7 to 5-10.

FIGURE 5-7 POSTTEST LEFT SIDE VIEW

FIGURE 5-8 POSTTEST FRONT VIEW

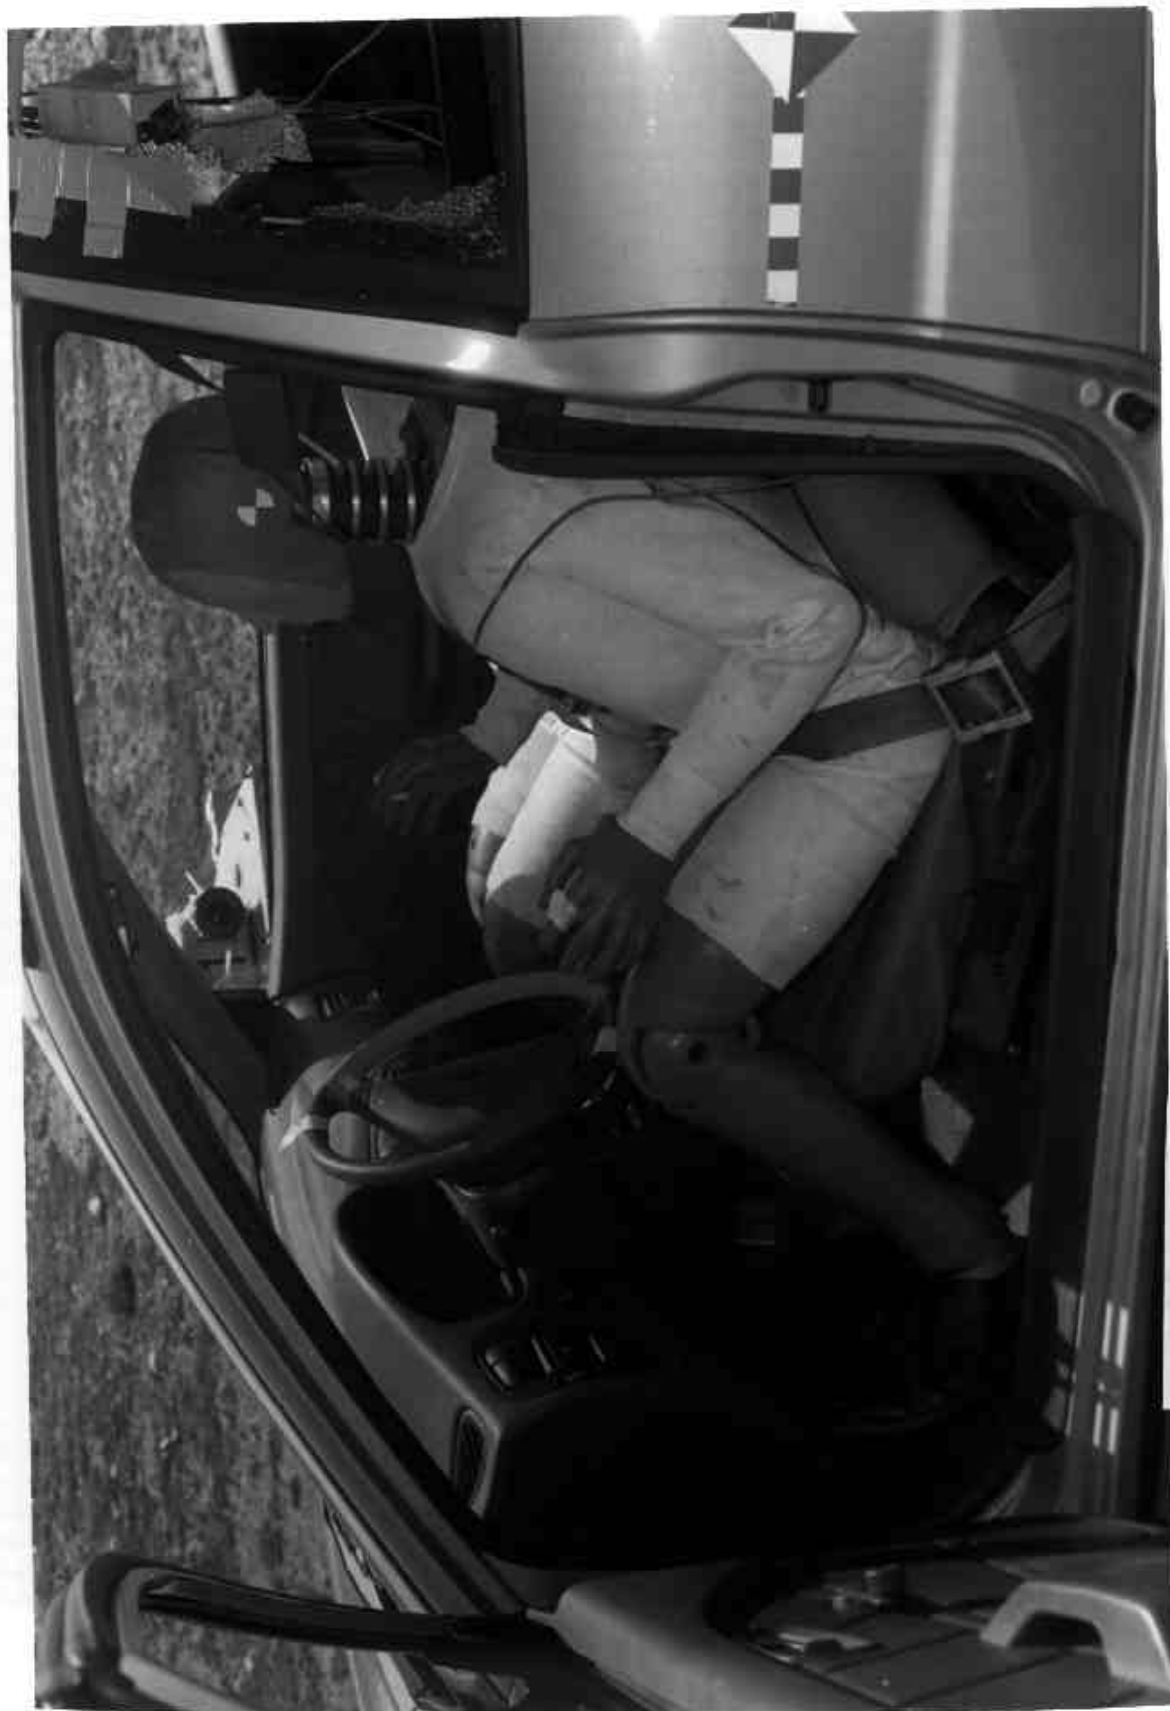
FIGURE 5-15 POSTTEST DRIVER ATD POSITION

Upon impact the driver ATD moved rearward as the seatback gave way. The ATD made no contact except for the head restraint. The Head Injury Criteria (HIC) for the driver ATD was 134.6. The chest resultant (3 msec clip) was 13.0 g's. All driver ATD instrumentation results are presented in Table 3-4. Pretest measurements are shown in Tables 3-5 and 3-6. Pretest and posttest views of the Driver ATD position are shown in Figures 5-14 and 5-15. Figures 5-16 and 5-17 show the vehicle sensor locations.

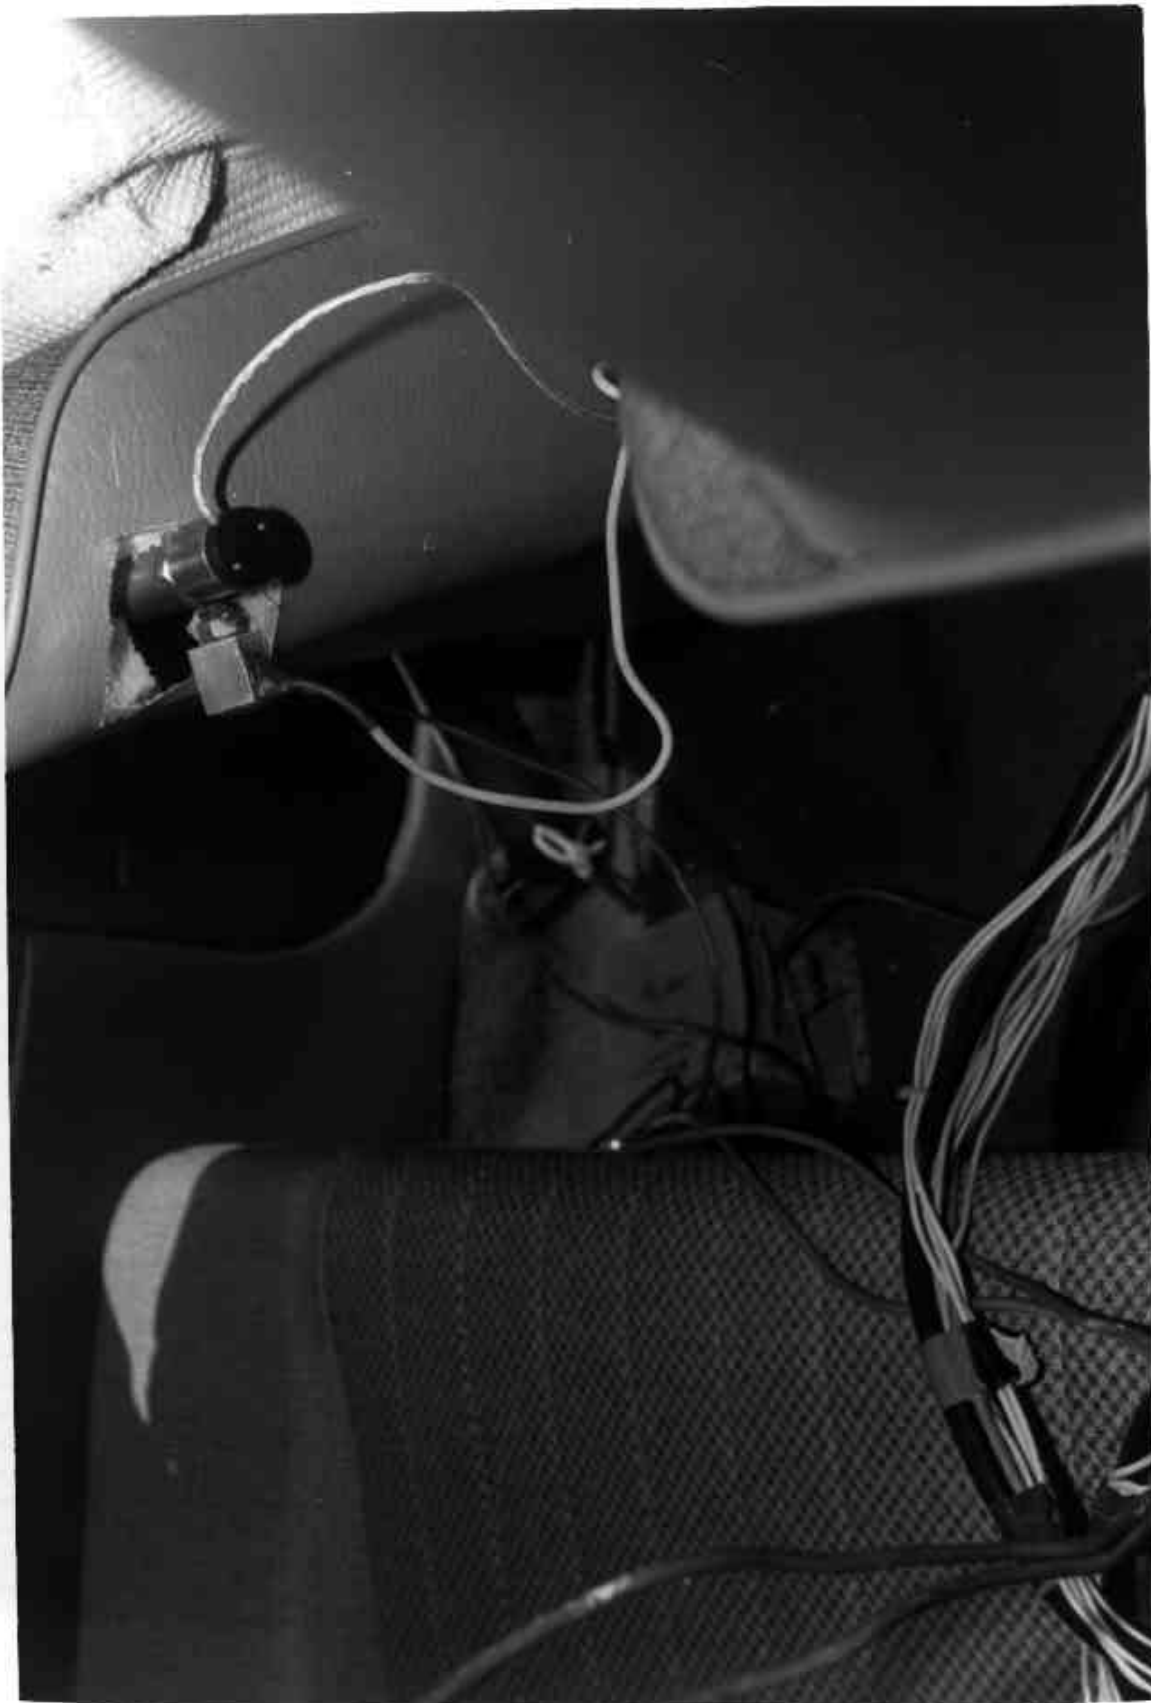
FIGURE 5-17 SEAT FRAME MOUNTED ACCELEROMETERS AND MHD SENSOR

Rate sensor mounted 19.5 inches above seatback pivot point, on inboard edge. Seatback accel 19.5 inches above pivot point on inboard edge.
