**SAFETY COMPLIANCE TEST FOR  
FMVSS 301-75R  
FUEL SYSTEM INTEGRITY**

1993 FORD ESCORT 2 DOOR COUPE

NHTSA No. CP0209

FINAL REPORT

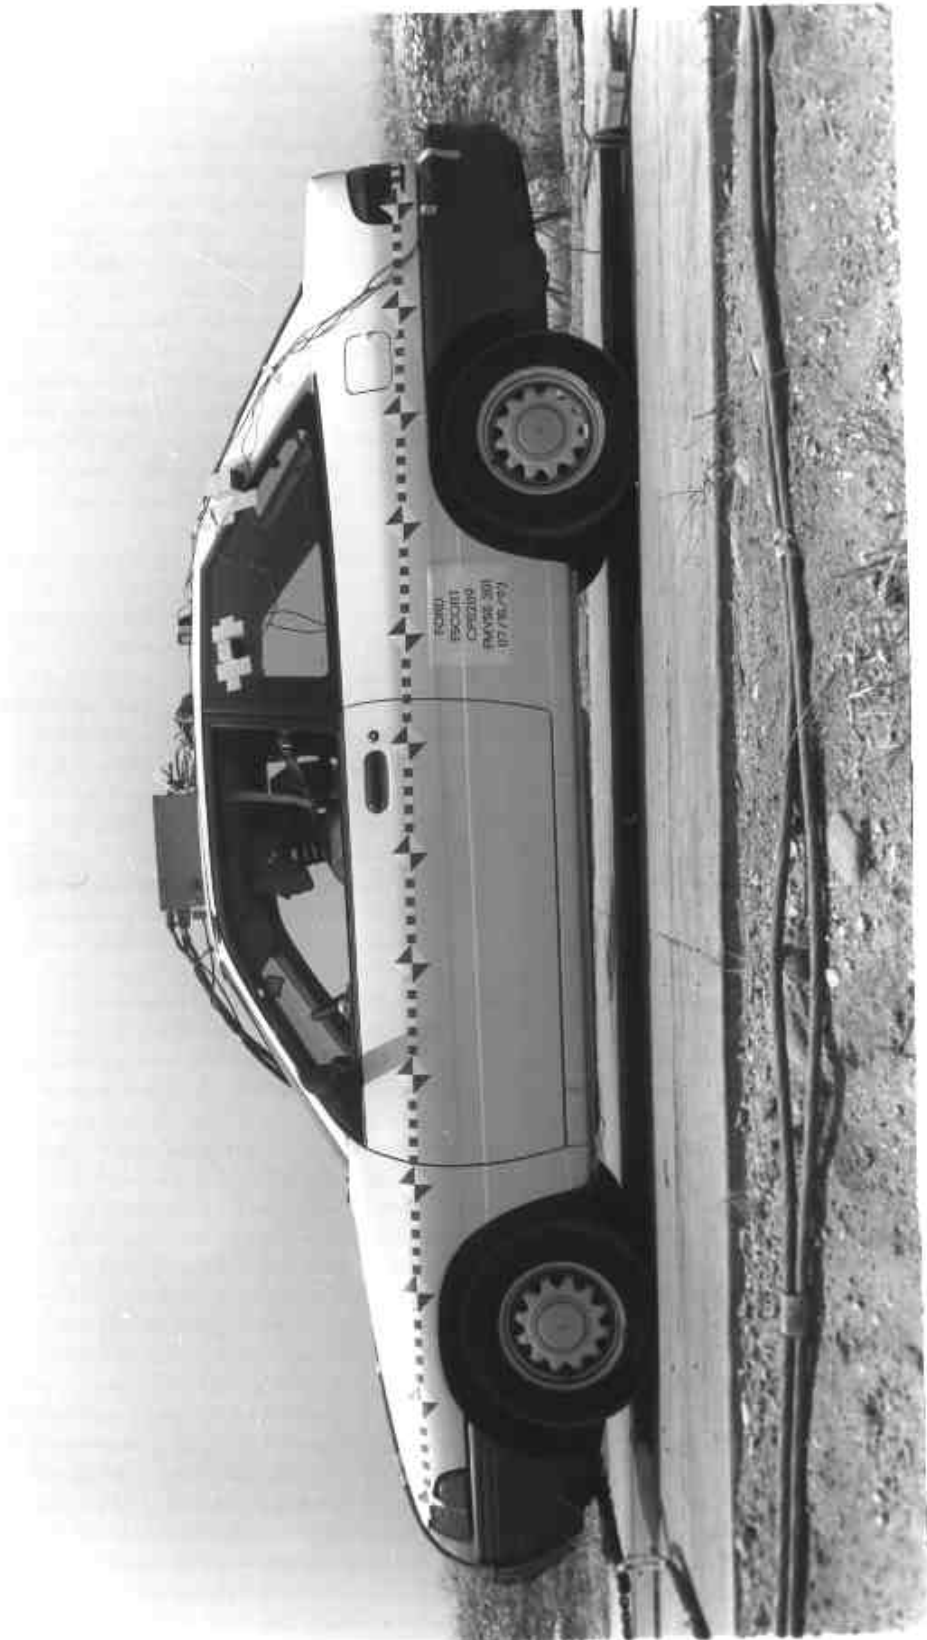
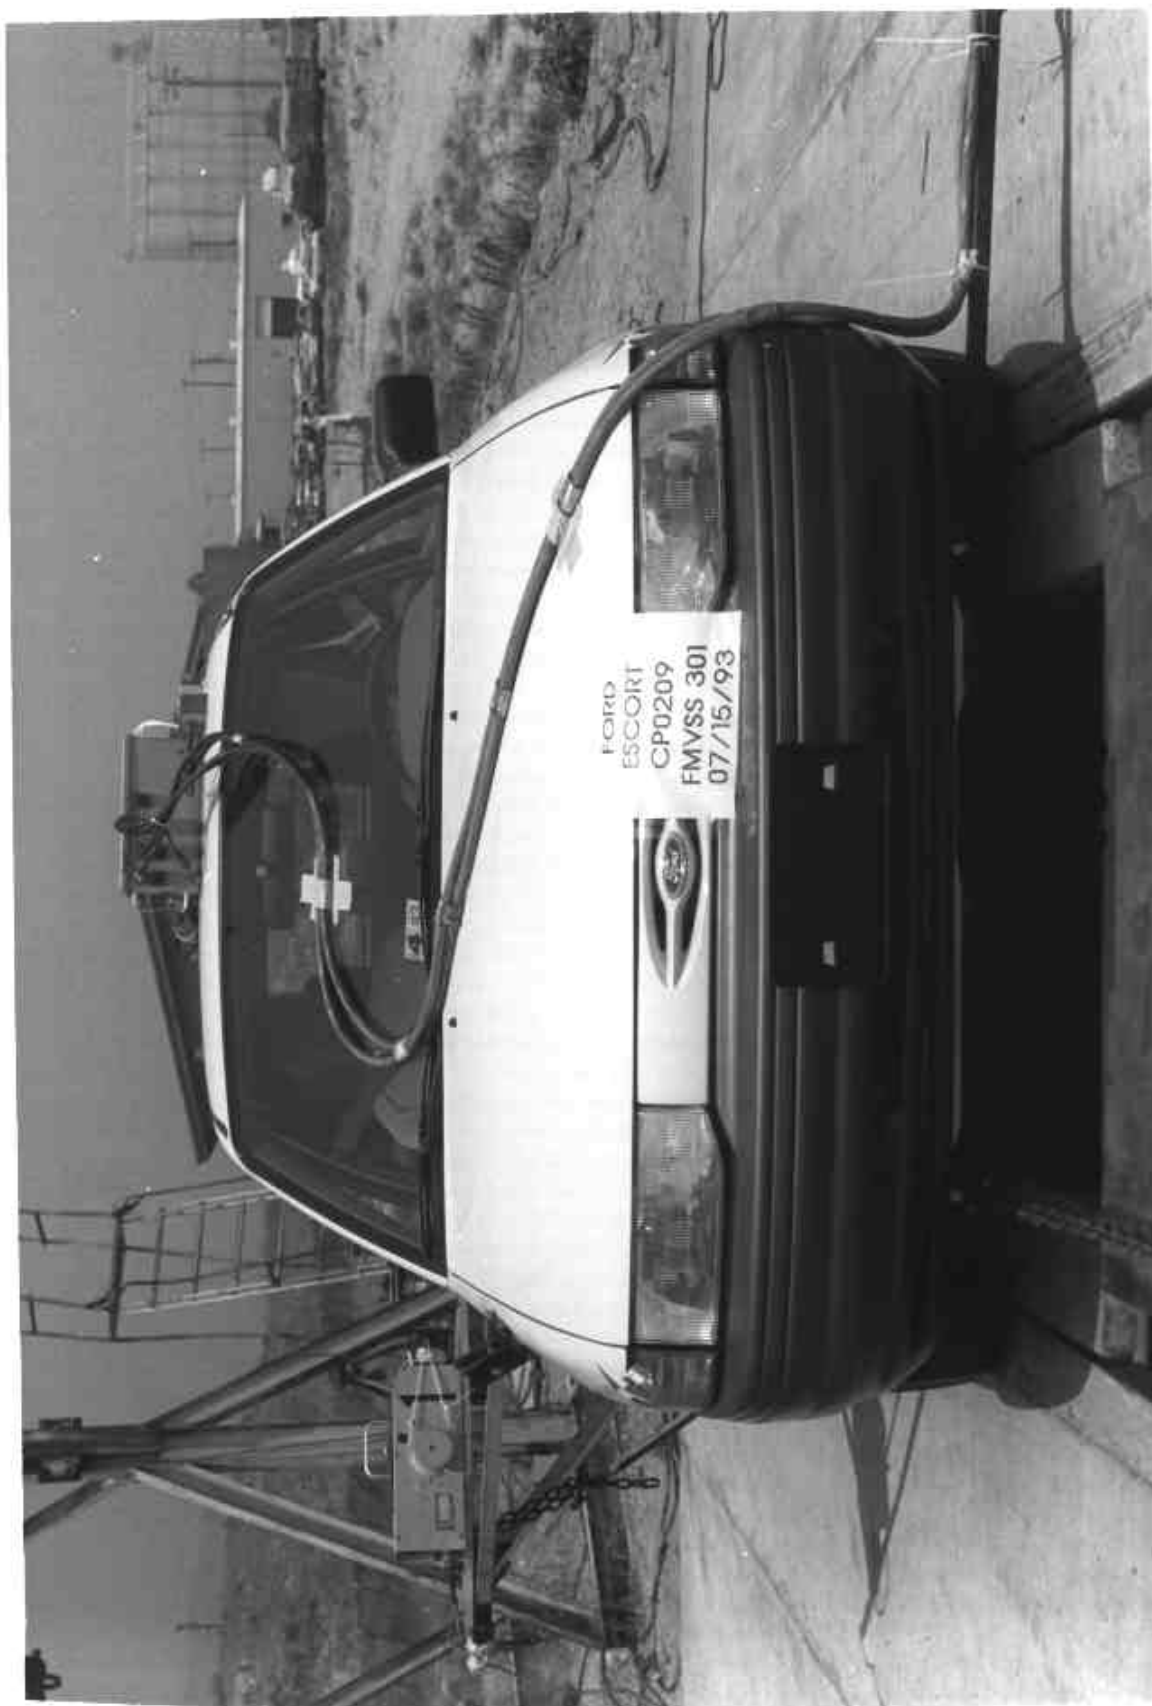
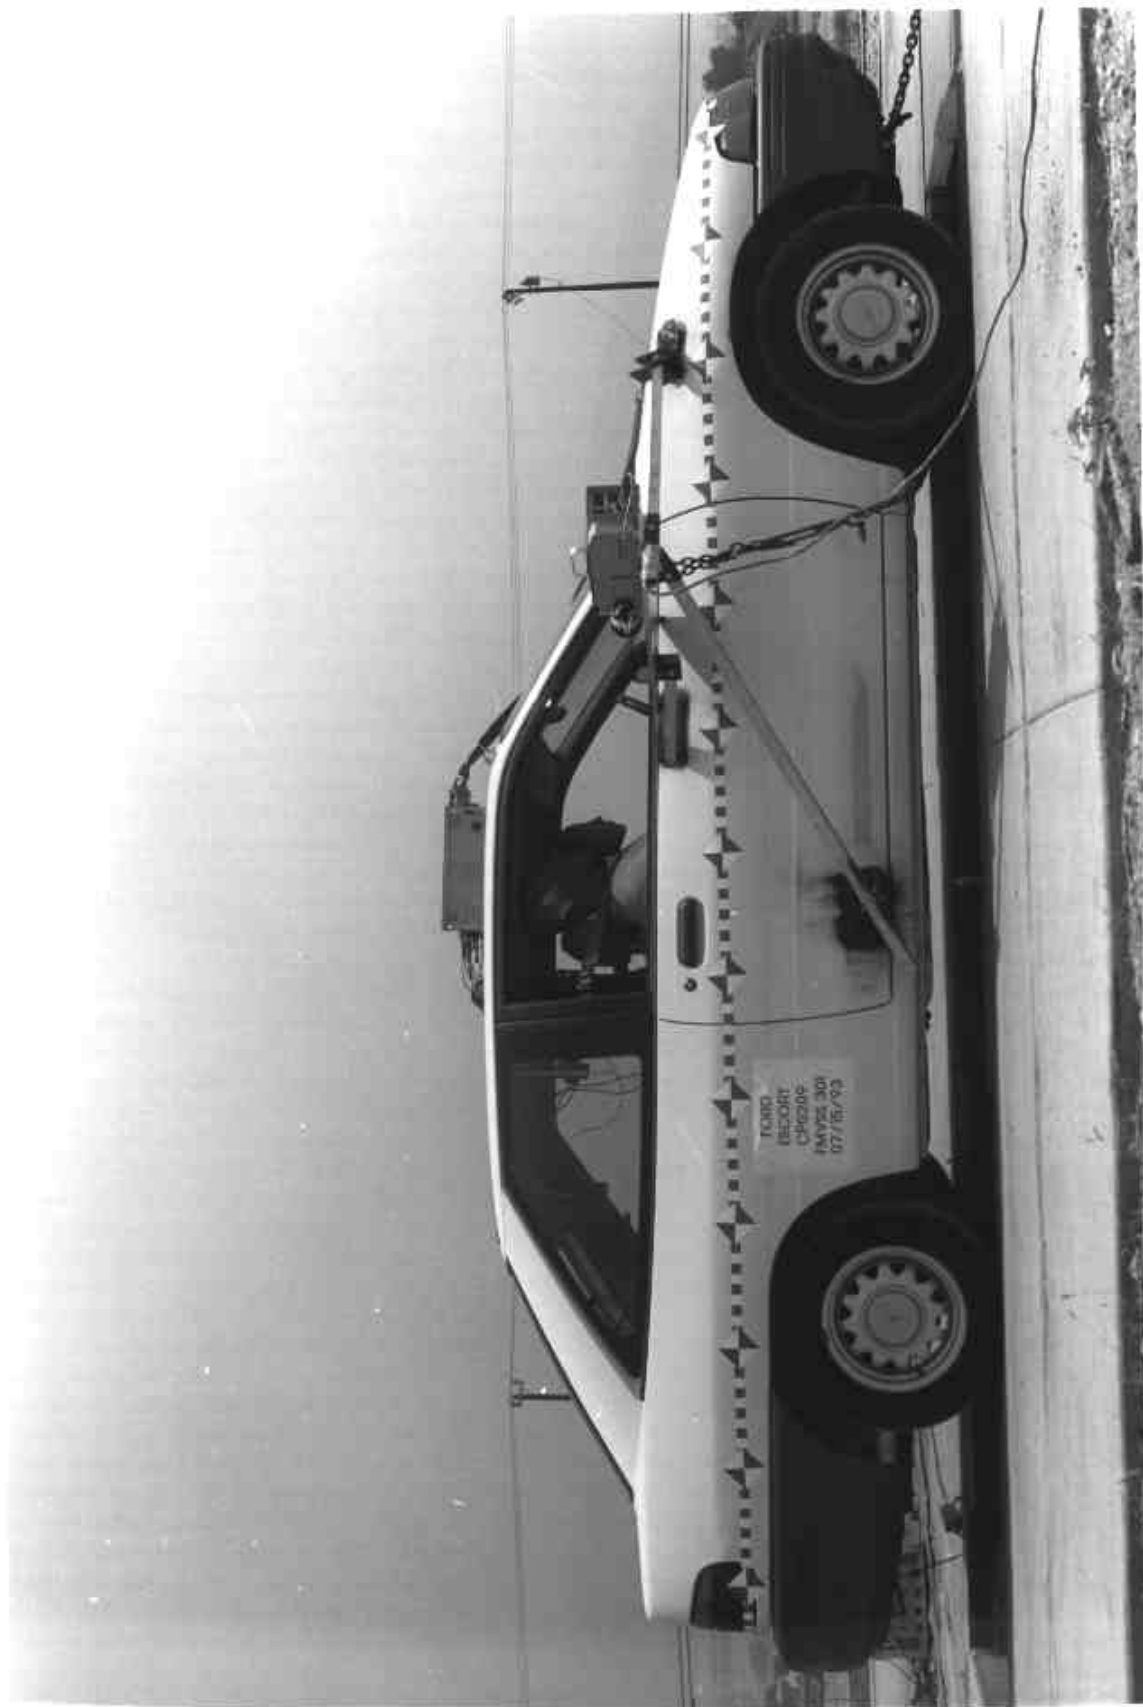
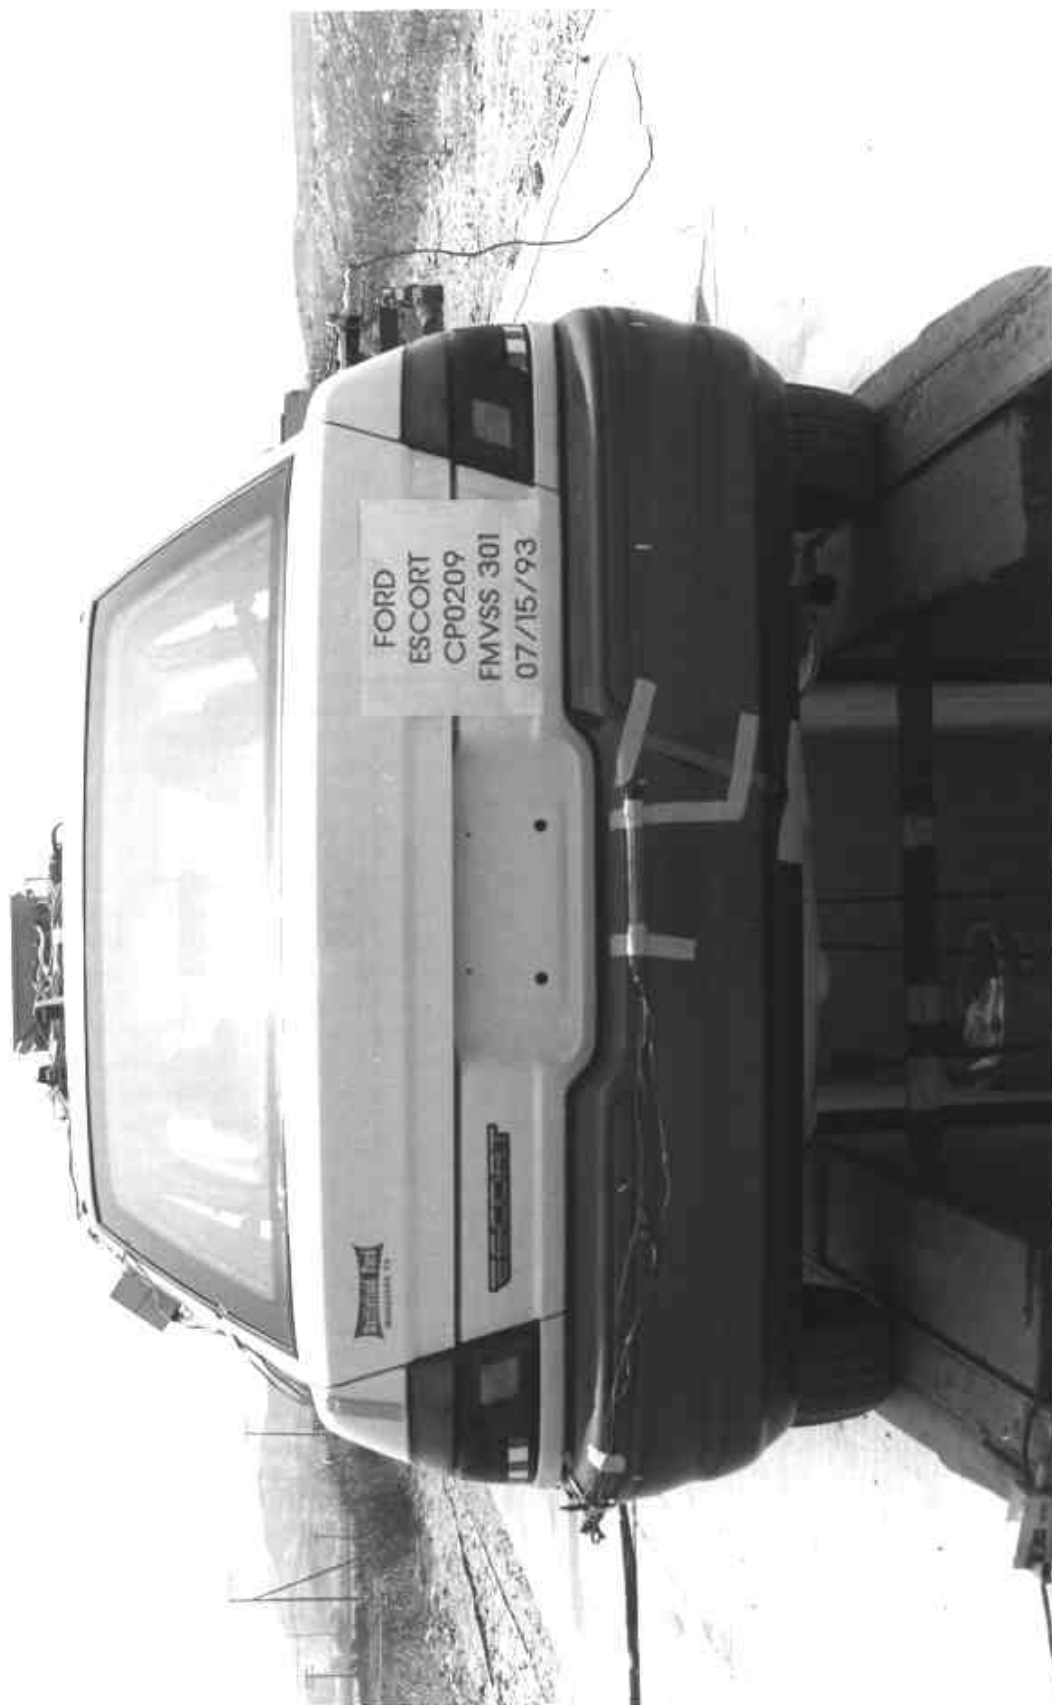
The 1993 Ford Escort 2 Door Coupe, NHTSA No. CP0209, was subjected to FMVSS 301-75 Rear testing on July 15, 1993. The vehicle is shown in pretest condition in Figures 5-1 to 5-4. The manufacturer's certification label is shown in Figure 5-5 and the tire placard is shown in Figure 5-6.

FIGURE 5-1 PRETEST LEFT SIDE VIEW

FIGURE 5-2 PRETEST FRONT VIEW

FIGURE 5-3 PRETEST RIGHT SIDE VIEW

FIGURE 5-4 PRETEST REAR VIEW

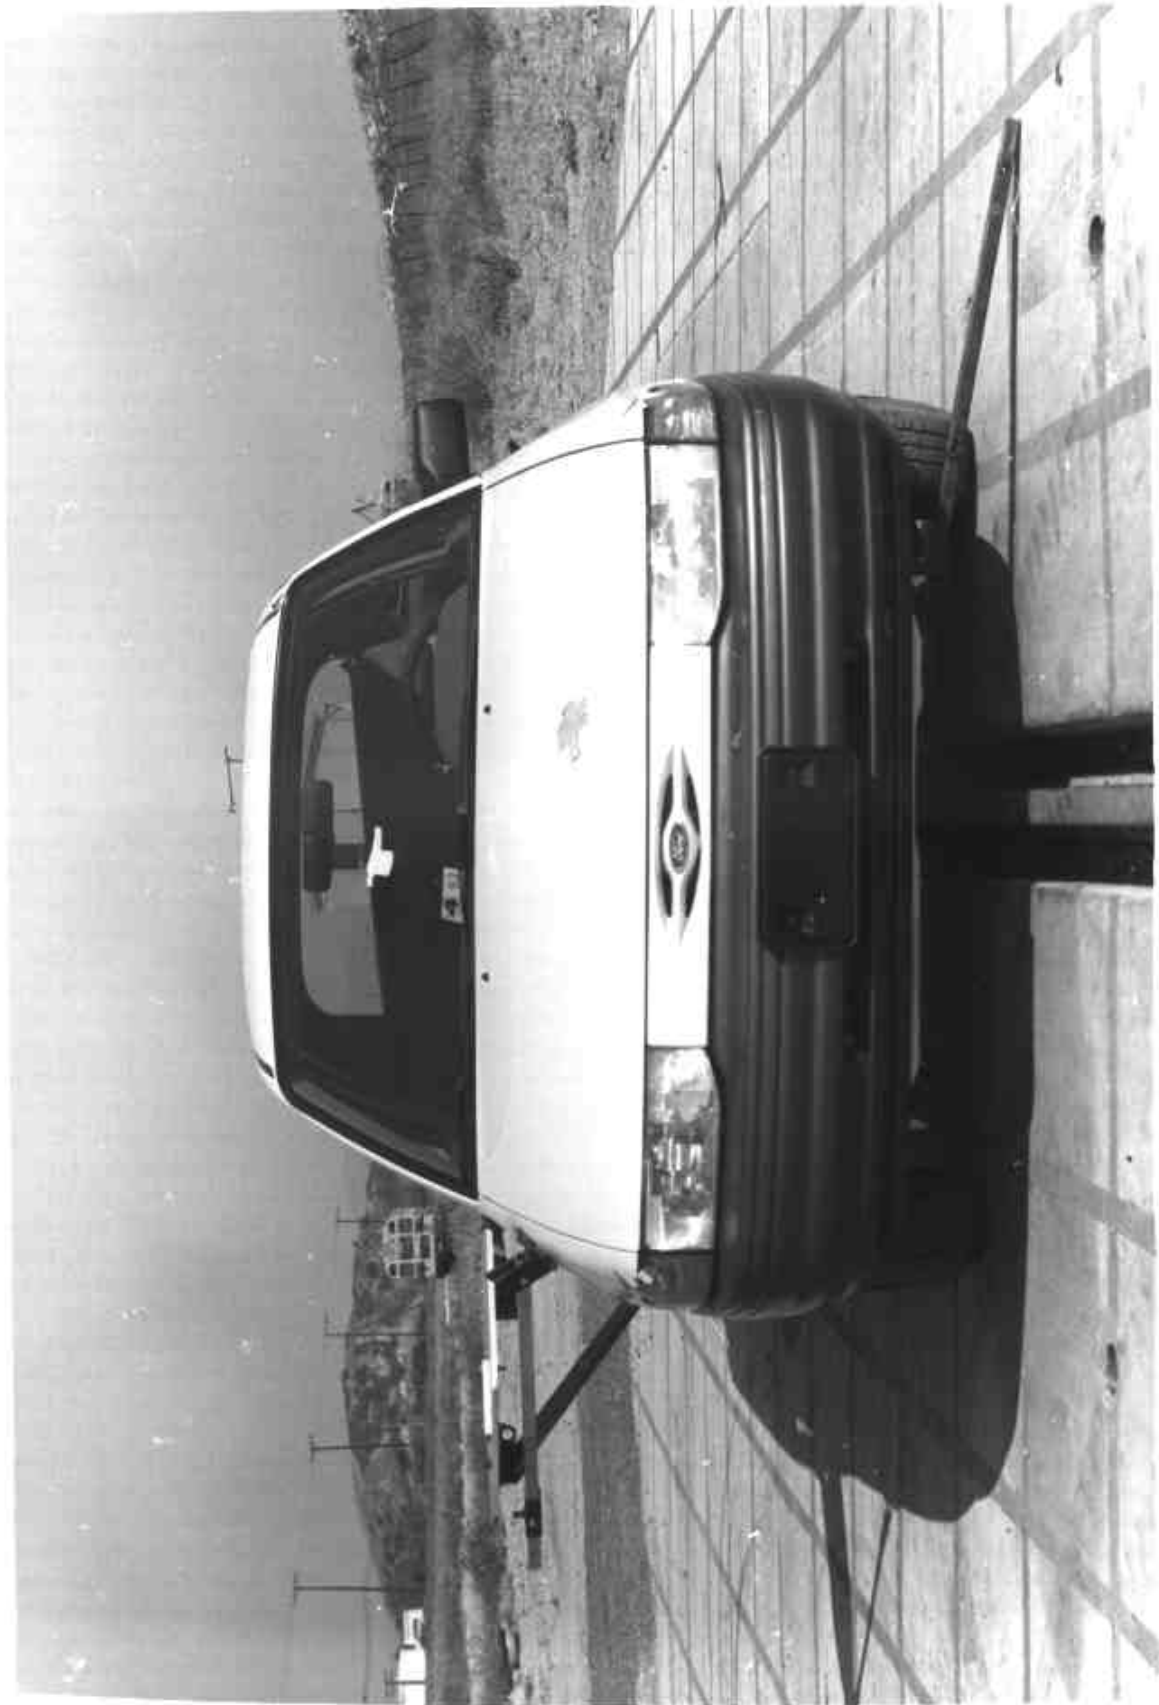
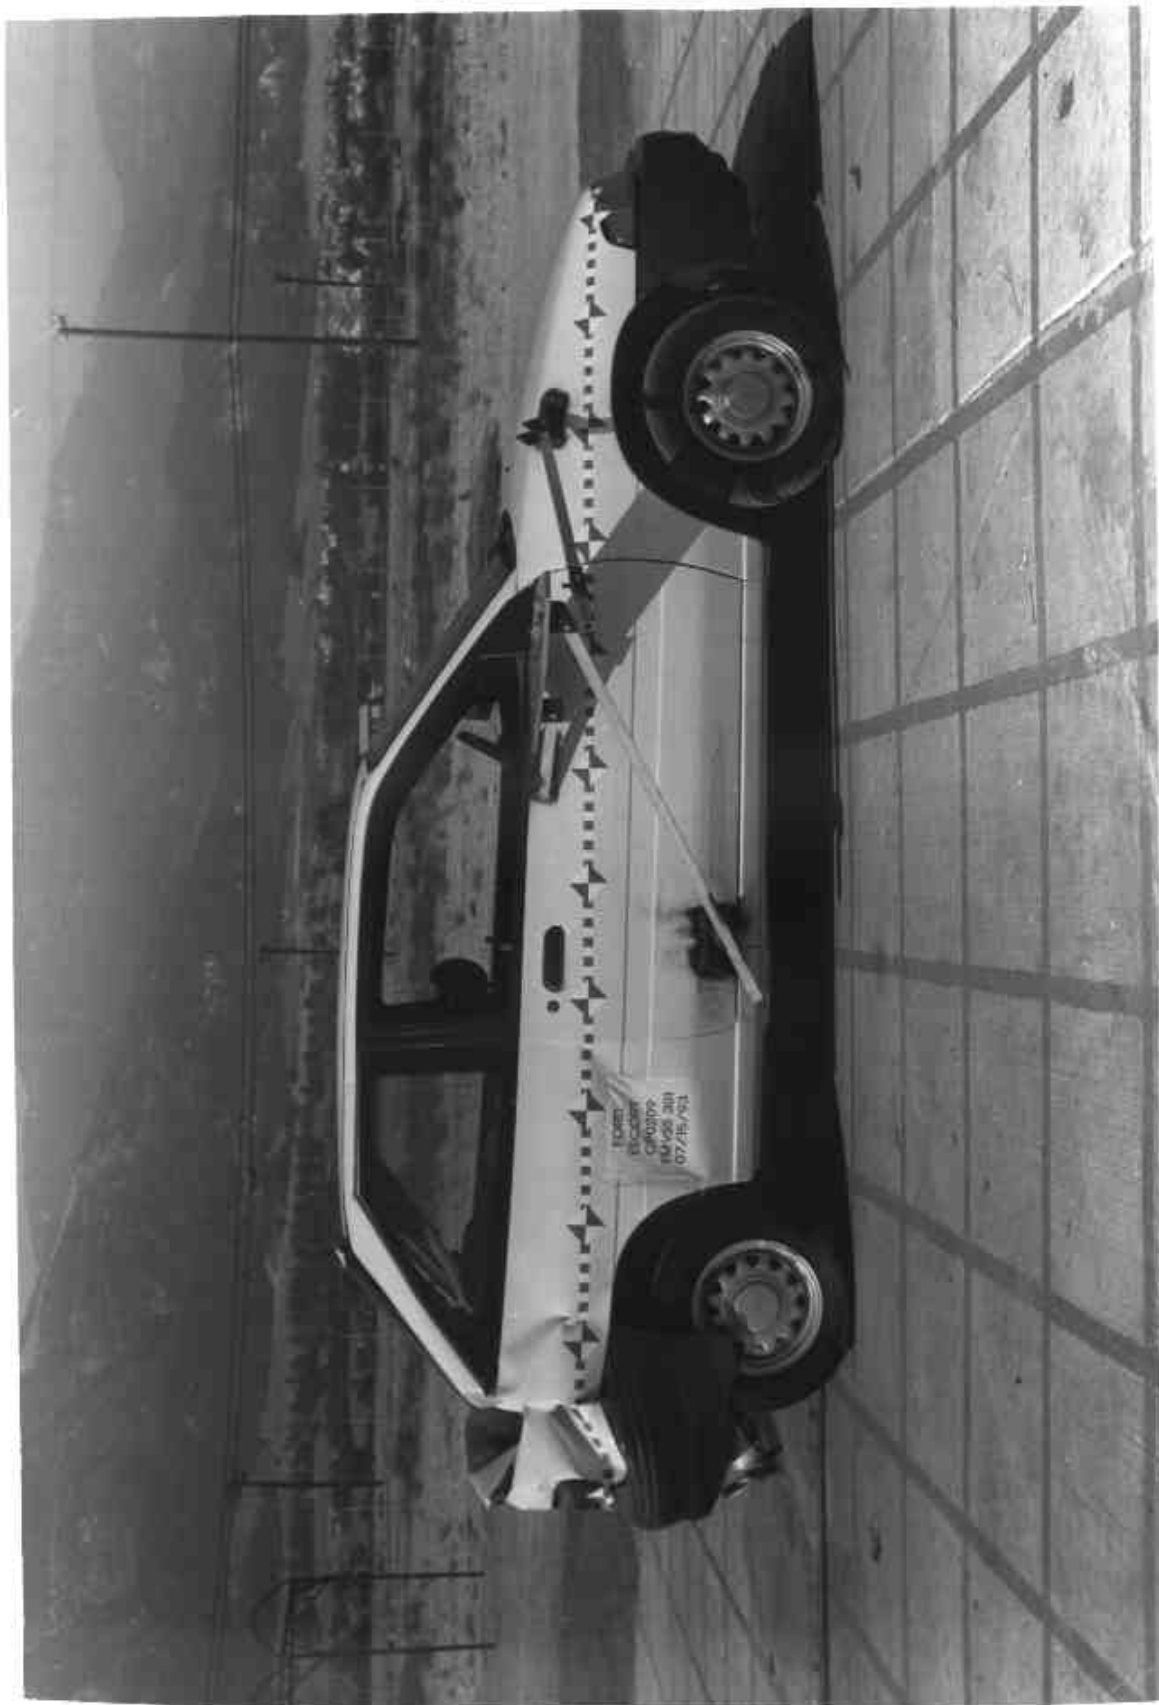
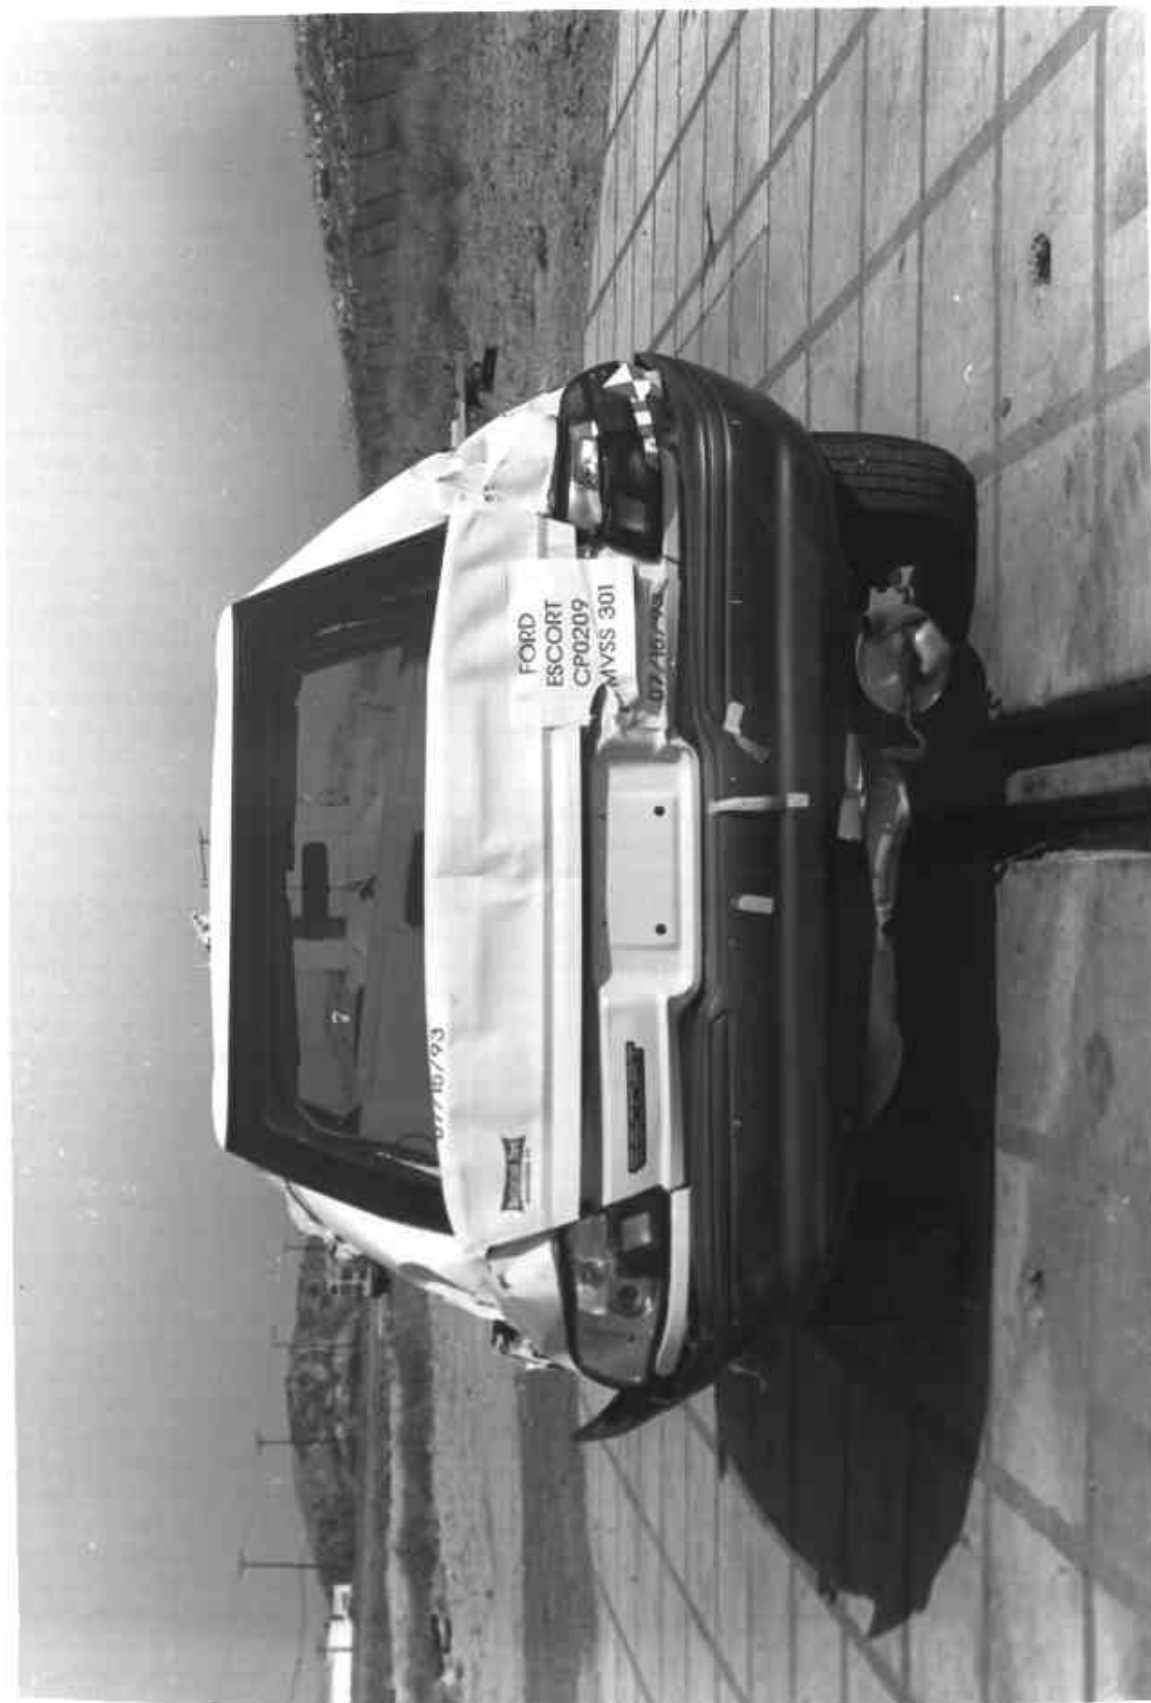
The velocity of the rear impact sled was 29.48 mph. Test velocity information and posttest crush details are given in Table 3-2. Posttest left side, front, right side and rear views of the test vehicle are given in Figures 5-7 to 5-10.

FIGURE 5-7 POSTTEST LEFT SIDE VIEW

FIGURE 5-8 POSTTEST FRONT VIEW

FIGURE 5-9 POSTTEST RIGHT SIDE VIEW

FIGURE 5-10 POSTTEST REAR VIEW

STATIC CRUSH: Left Side = 12.1 in

Right Side = 13.5 in

Centerline = 14.9 in

AVERAGE CRUSH: 13.5 in

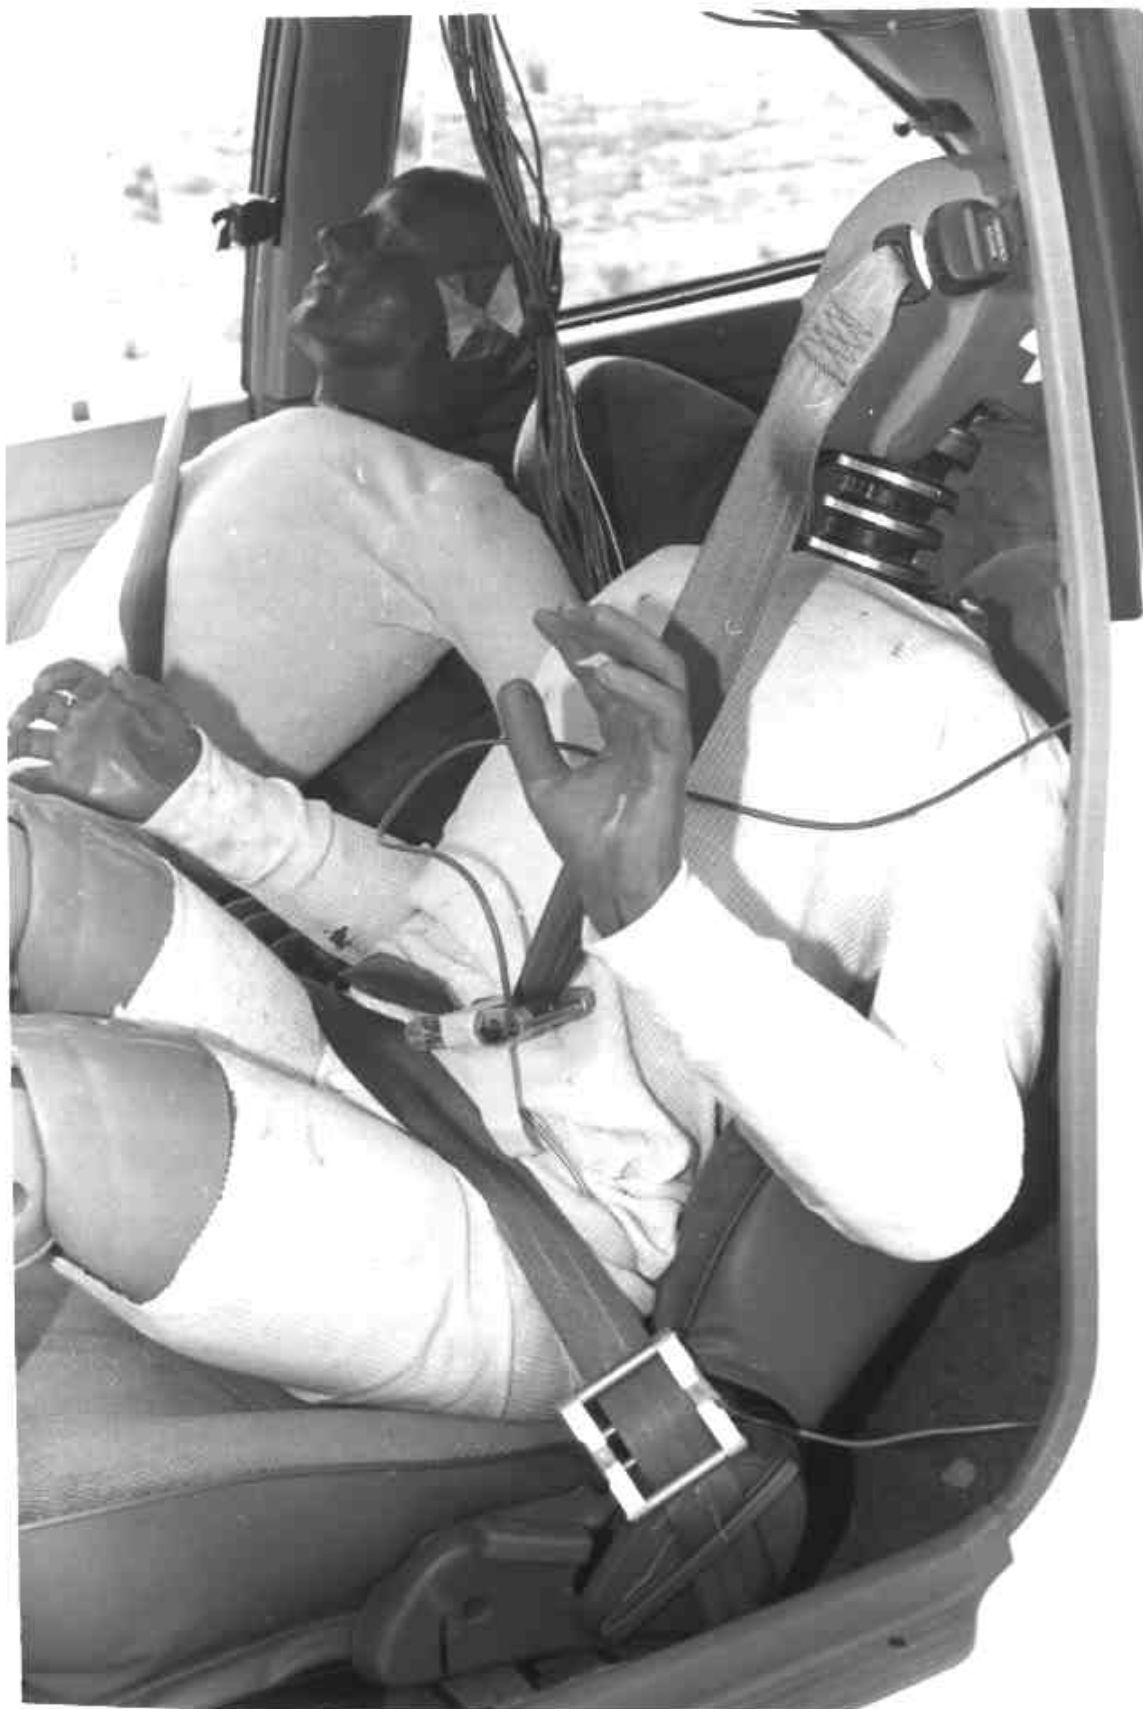
Driver ATD: Top of head contacted rear seat seatback

Upon impact the driver ATD moved rearward as the seatback gave way. The ATD's head contacted the rear seat seatback. The Head Injury Criteria (HIC) for the driver ATD was 67.8. The chest resultant (3 msec clip) was 12.8 g's. All driver ATD instrumentation results are presented in Table 3-4. Pretest measurements are shown in Tables 3-5 and 3-6. Pretest and posttest views of the Driver ATD position are shown in Figures 5-14 and 5-15. Figures 5-16 and 5-17 show the vehicle sensor locations.

FIGURE 5-15 POSTTEST DRIVER ATD POSITION

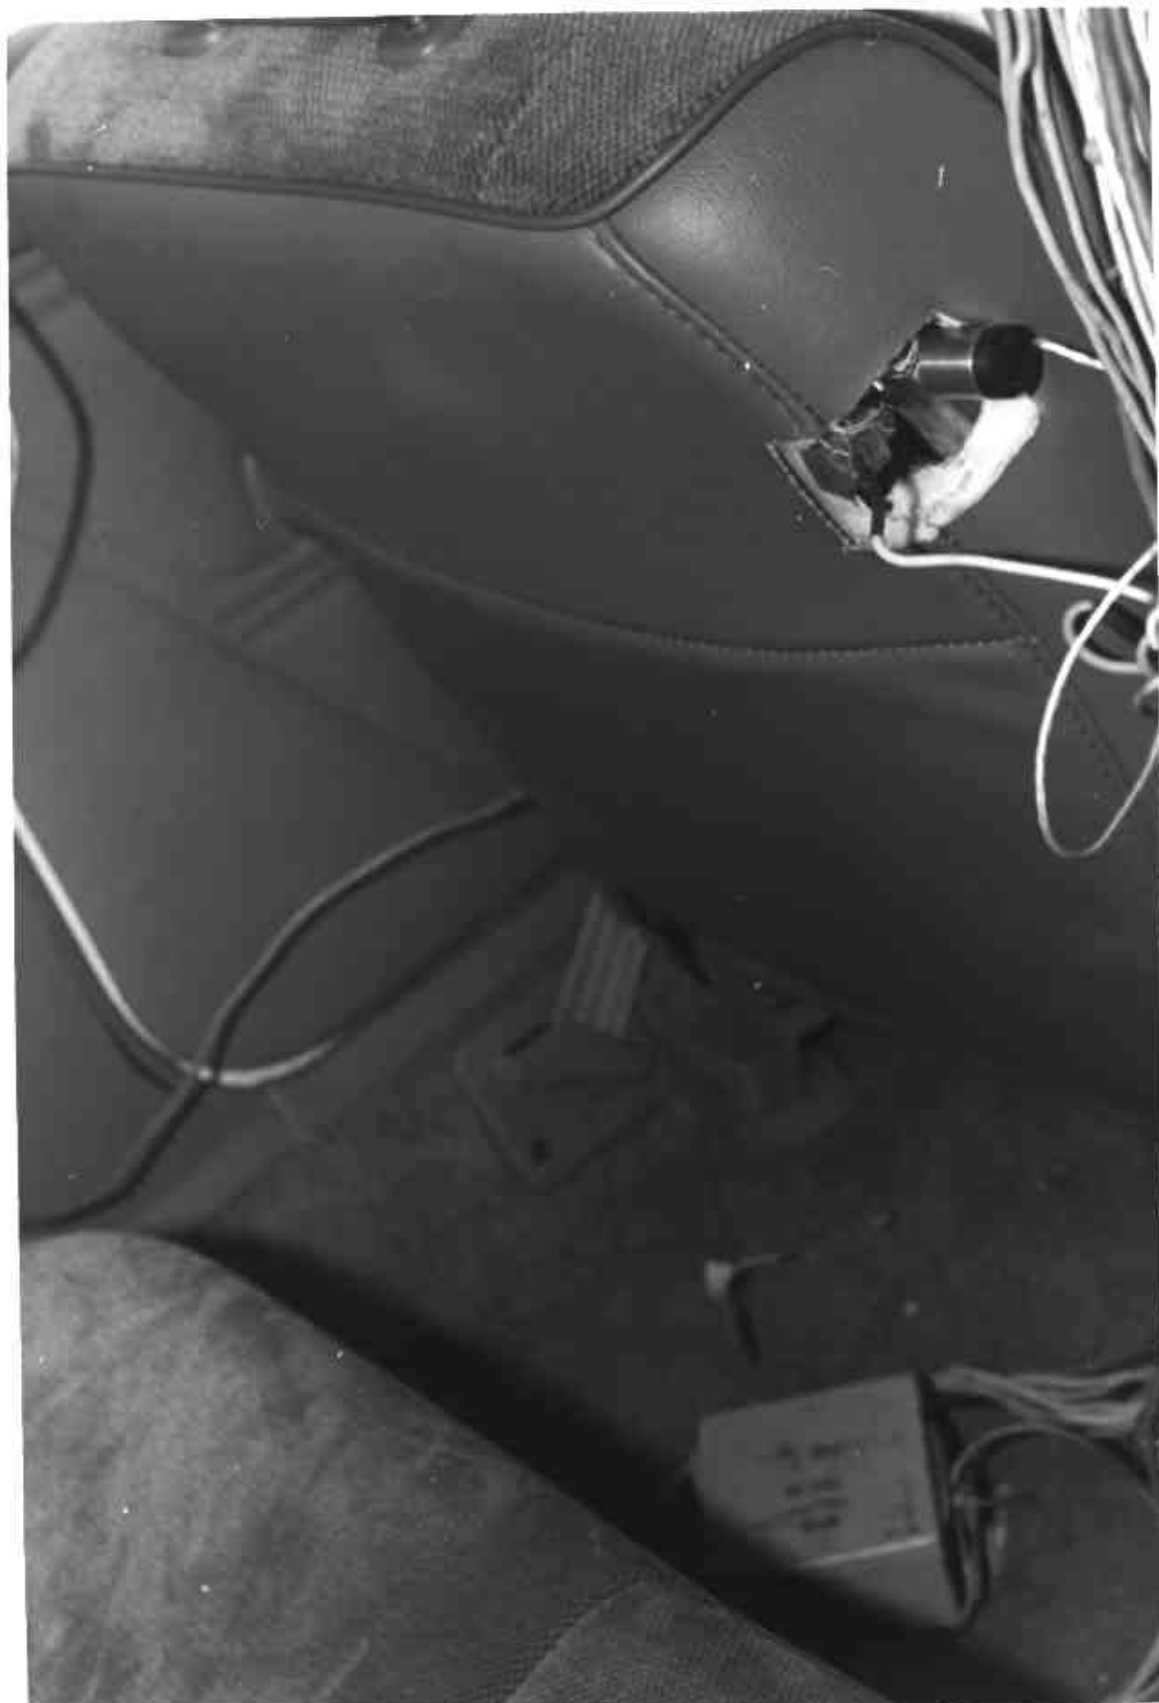
FIGURE 5-17 SEAT MOUNTED ACCELEROMETER AND MHD SENSOR

Rate sensor mounted 18.0 inches above seatback pivot point, on inboard edge. Seatback accel 18.0 inches above pivot point on inboard edge.
