**SAFETY COMPLIANCE TEST FOR  
FMVSS 301-75R**

**FUEL SYSTEM INTEGRITY**

1993 CHEVROLET BLAZER MPV

NHTSA No. CP0116

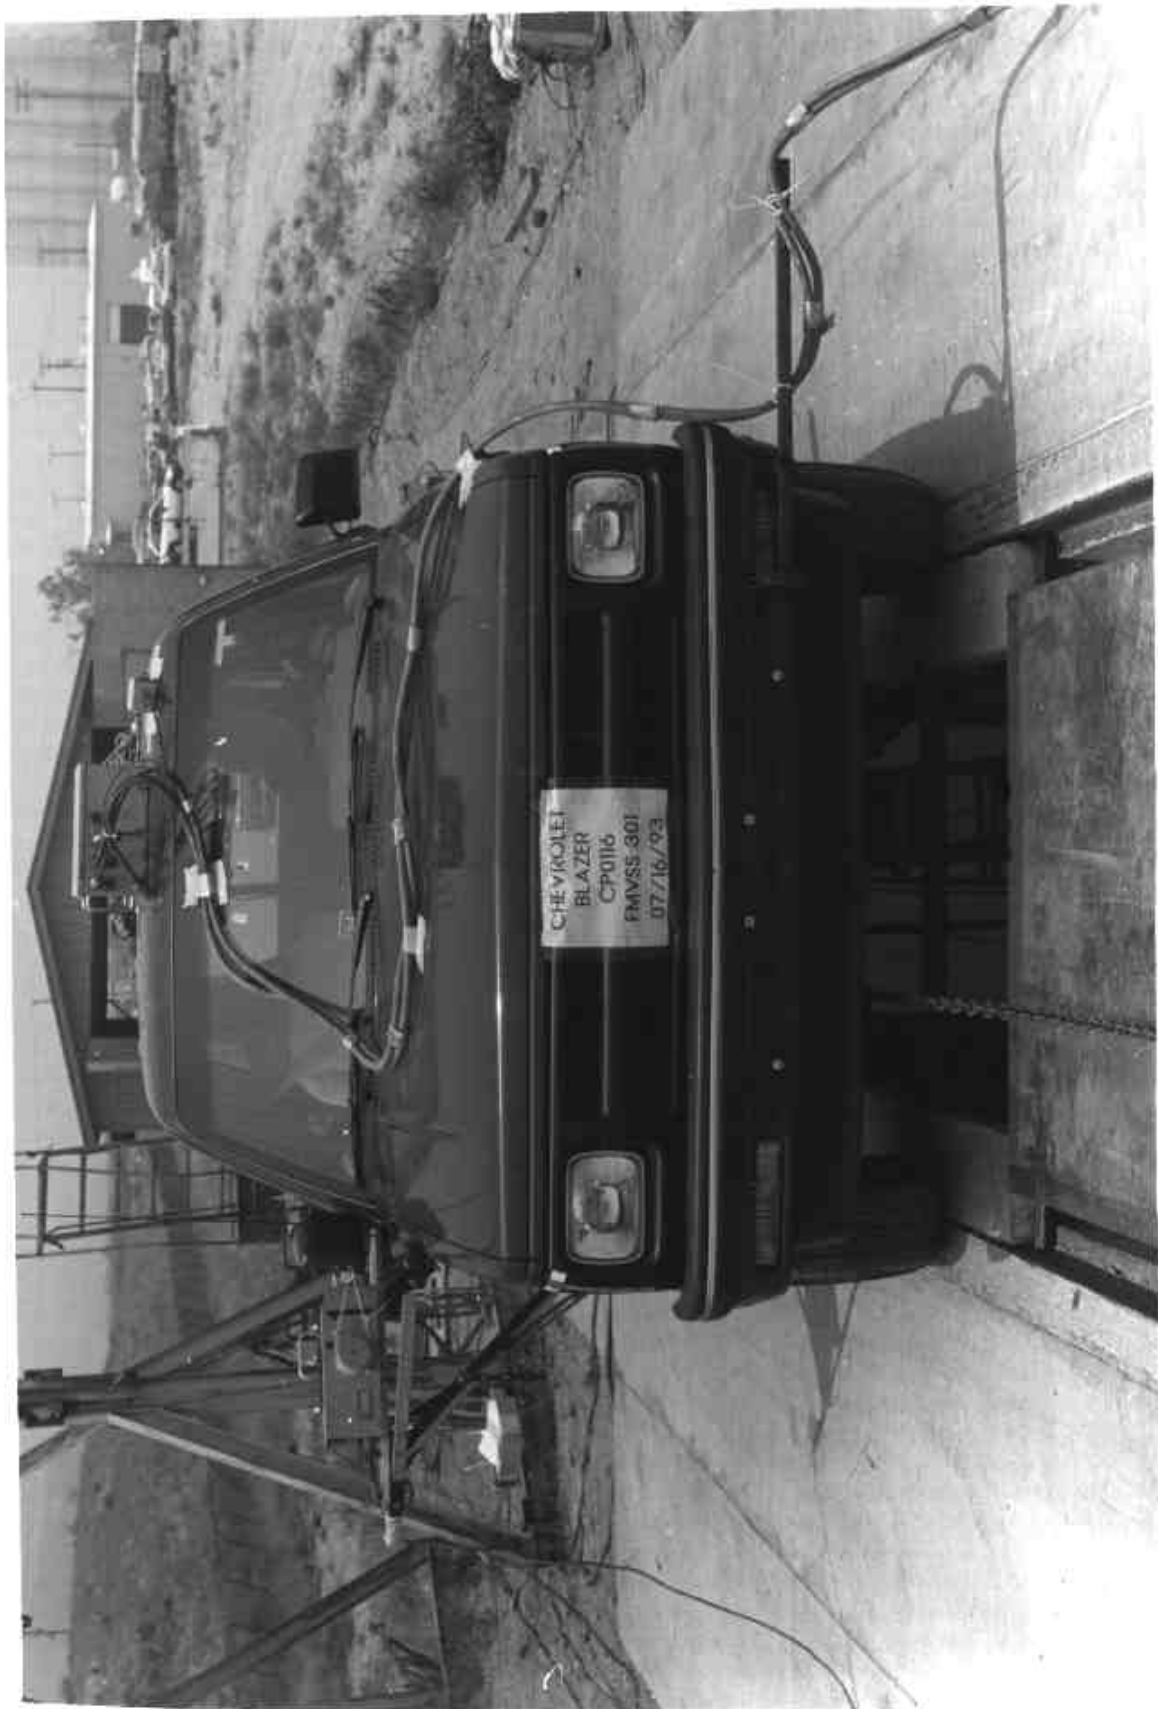
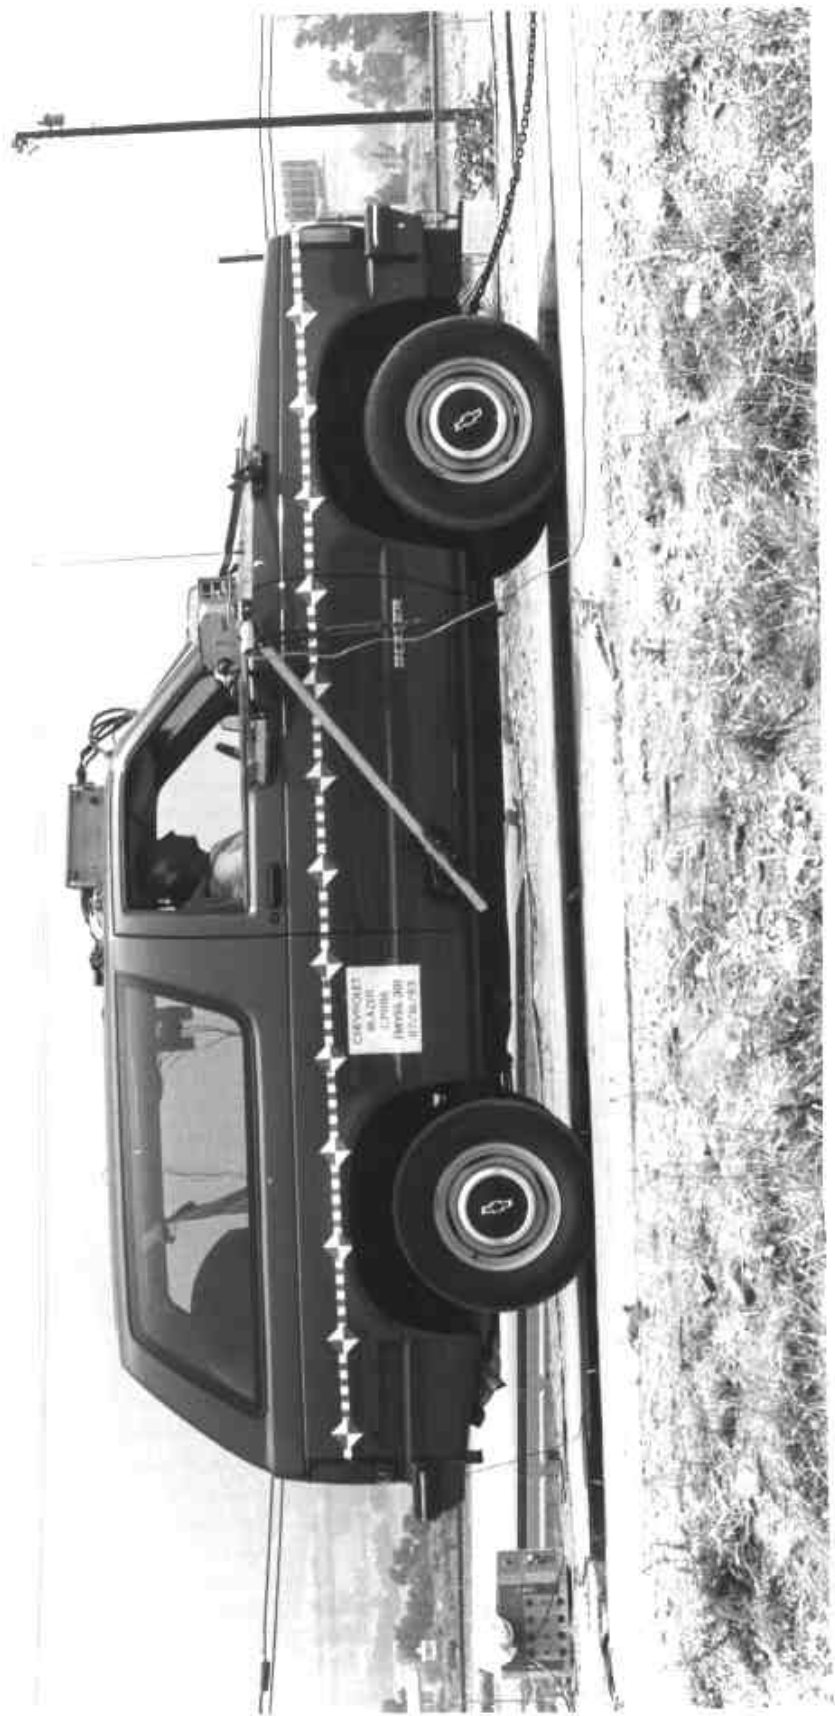
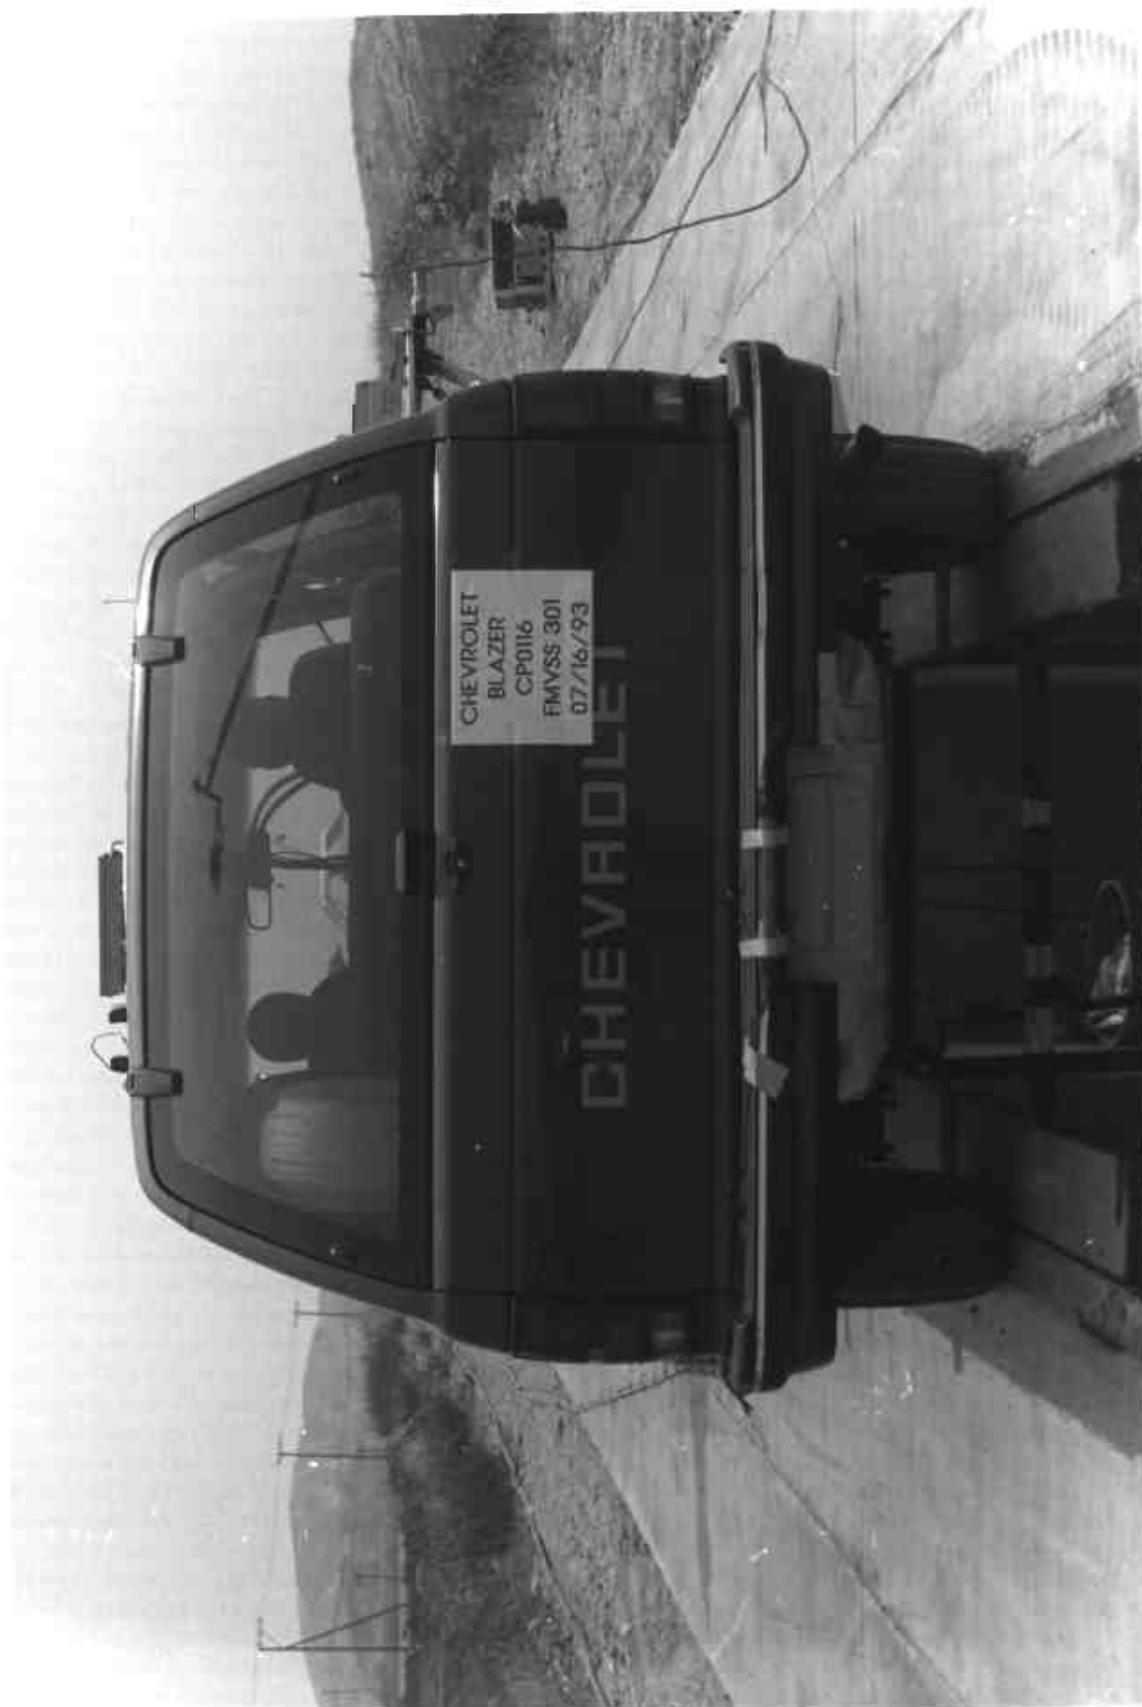
FIGURE 5-1 PRETEST LEFT SIDE VIEW

The 1993 Chevrolet Blazer MPV, NHTSA No. CP0116, was subjected to FMVSS 301-75 Rear testing on July 19, 1993. The vehicle is shown in pretest condition in Figures 5-1 to 5-4. The manufacturer's certification label is shown in Figure 5-5 and the tire placard is shown in Figure 5-6.

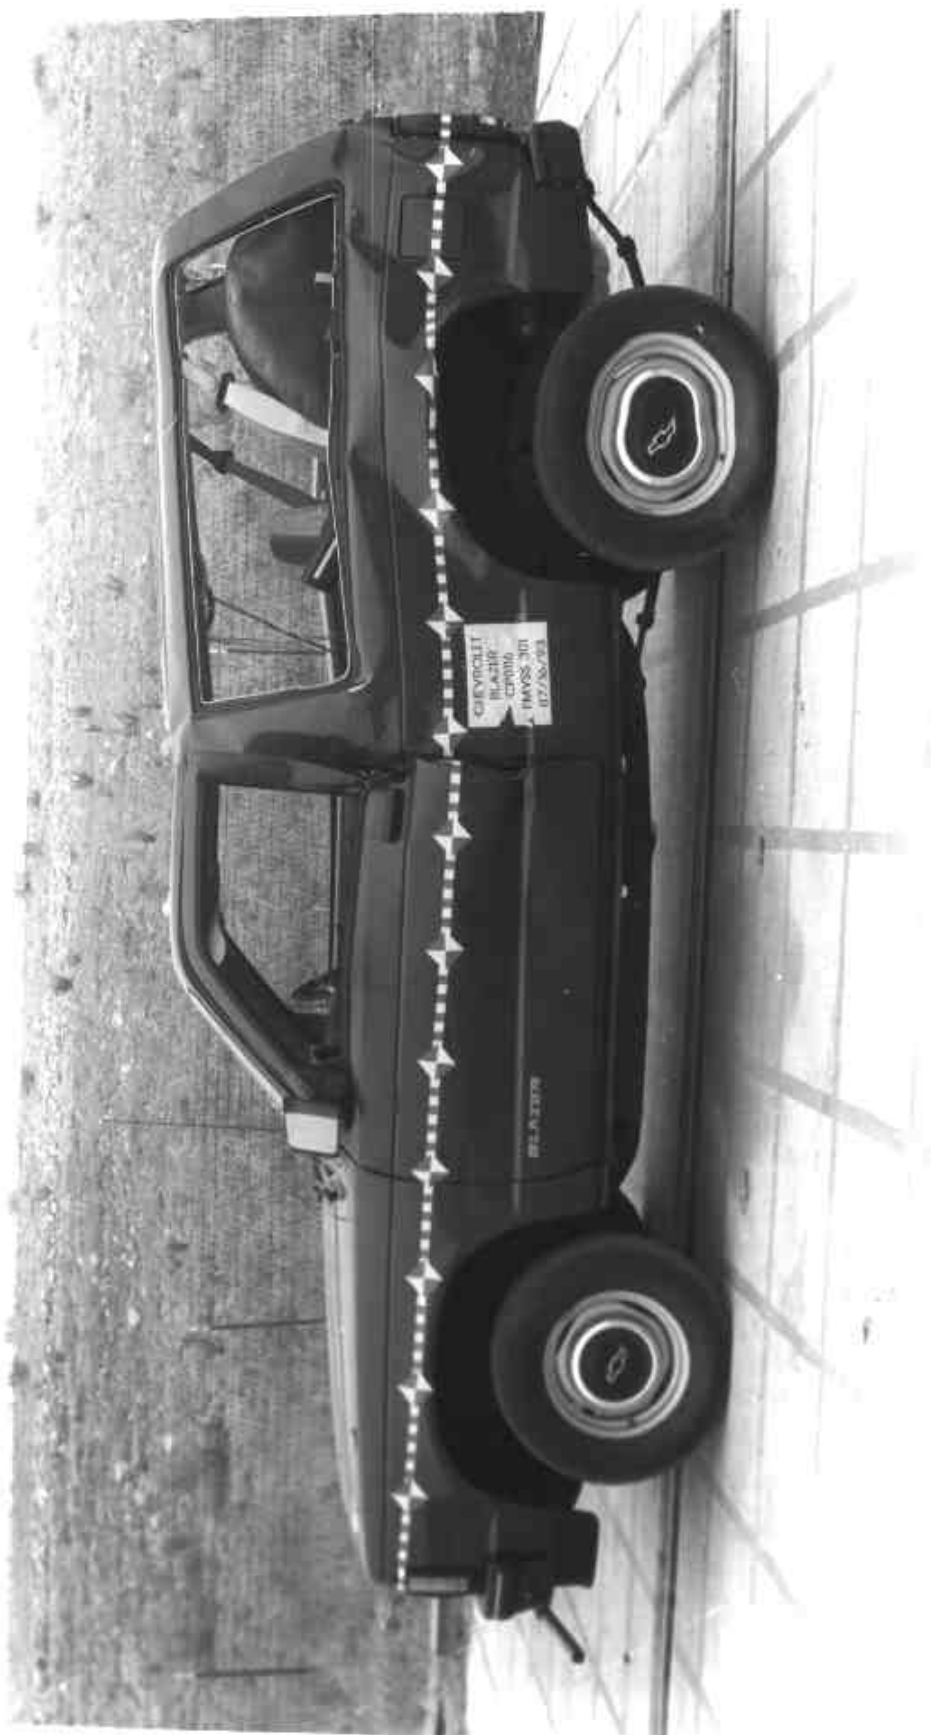
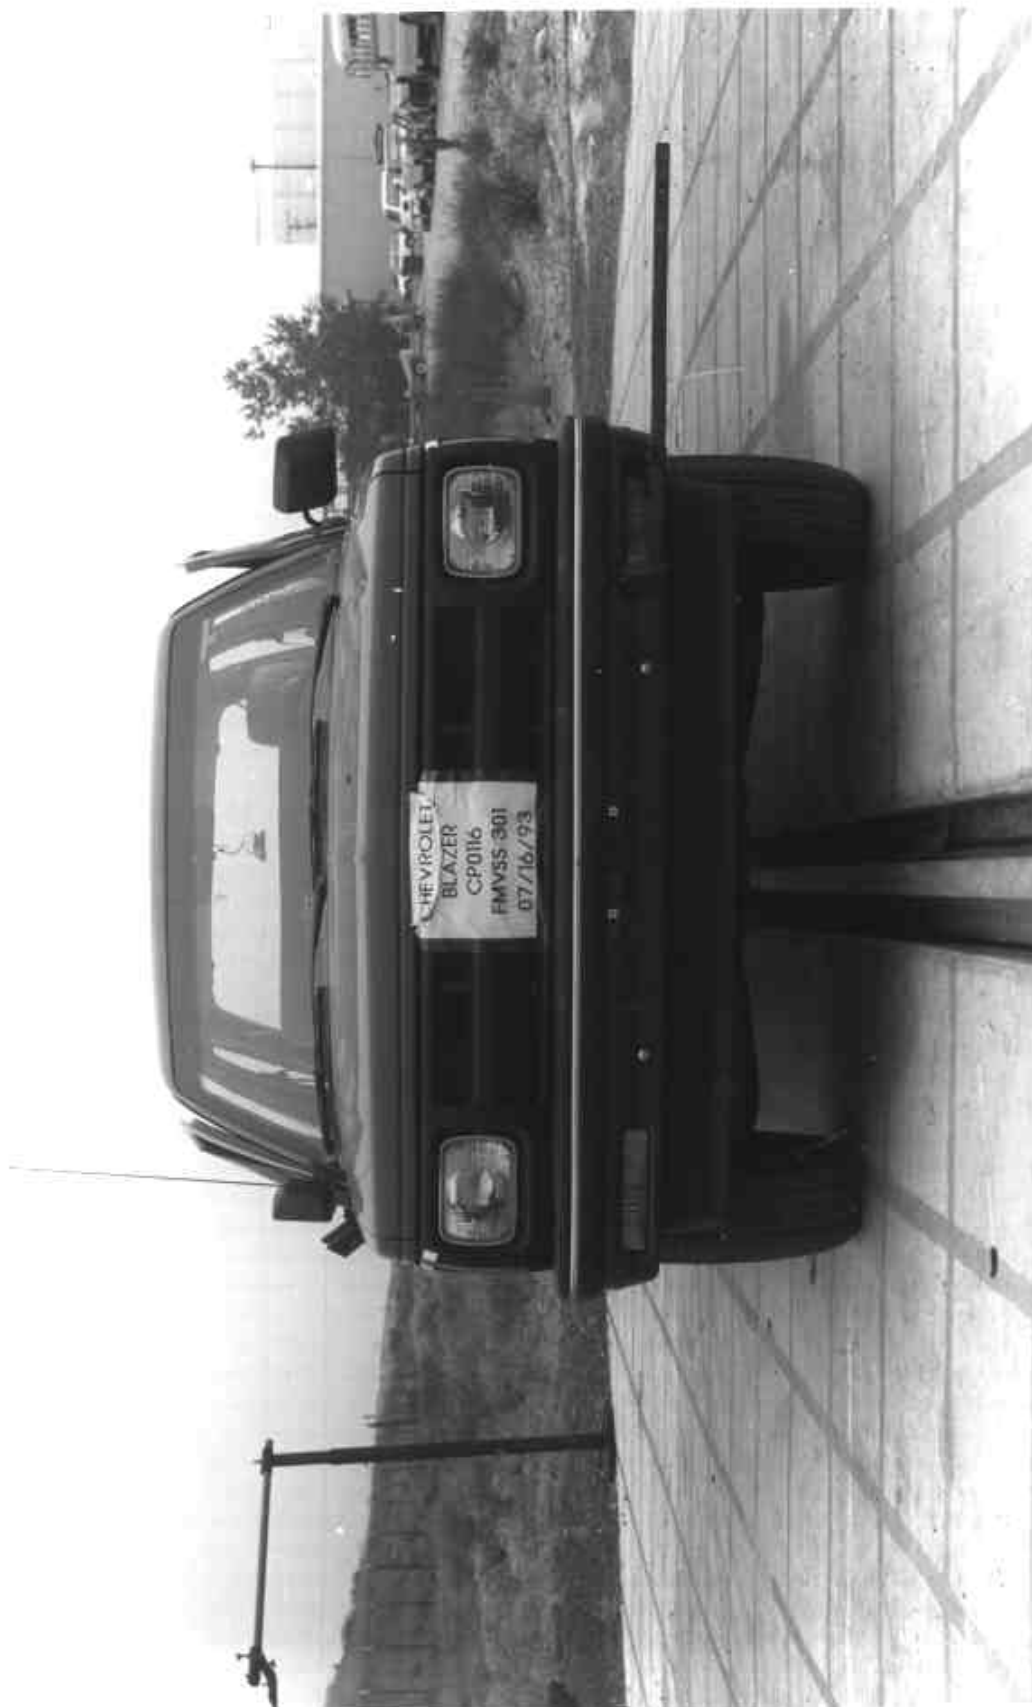
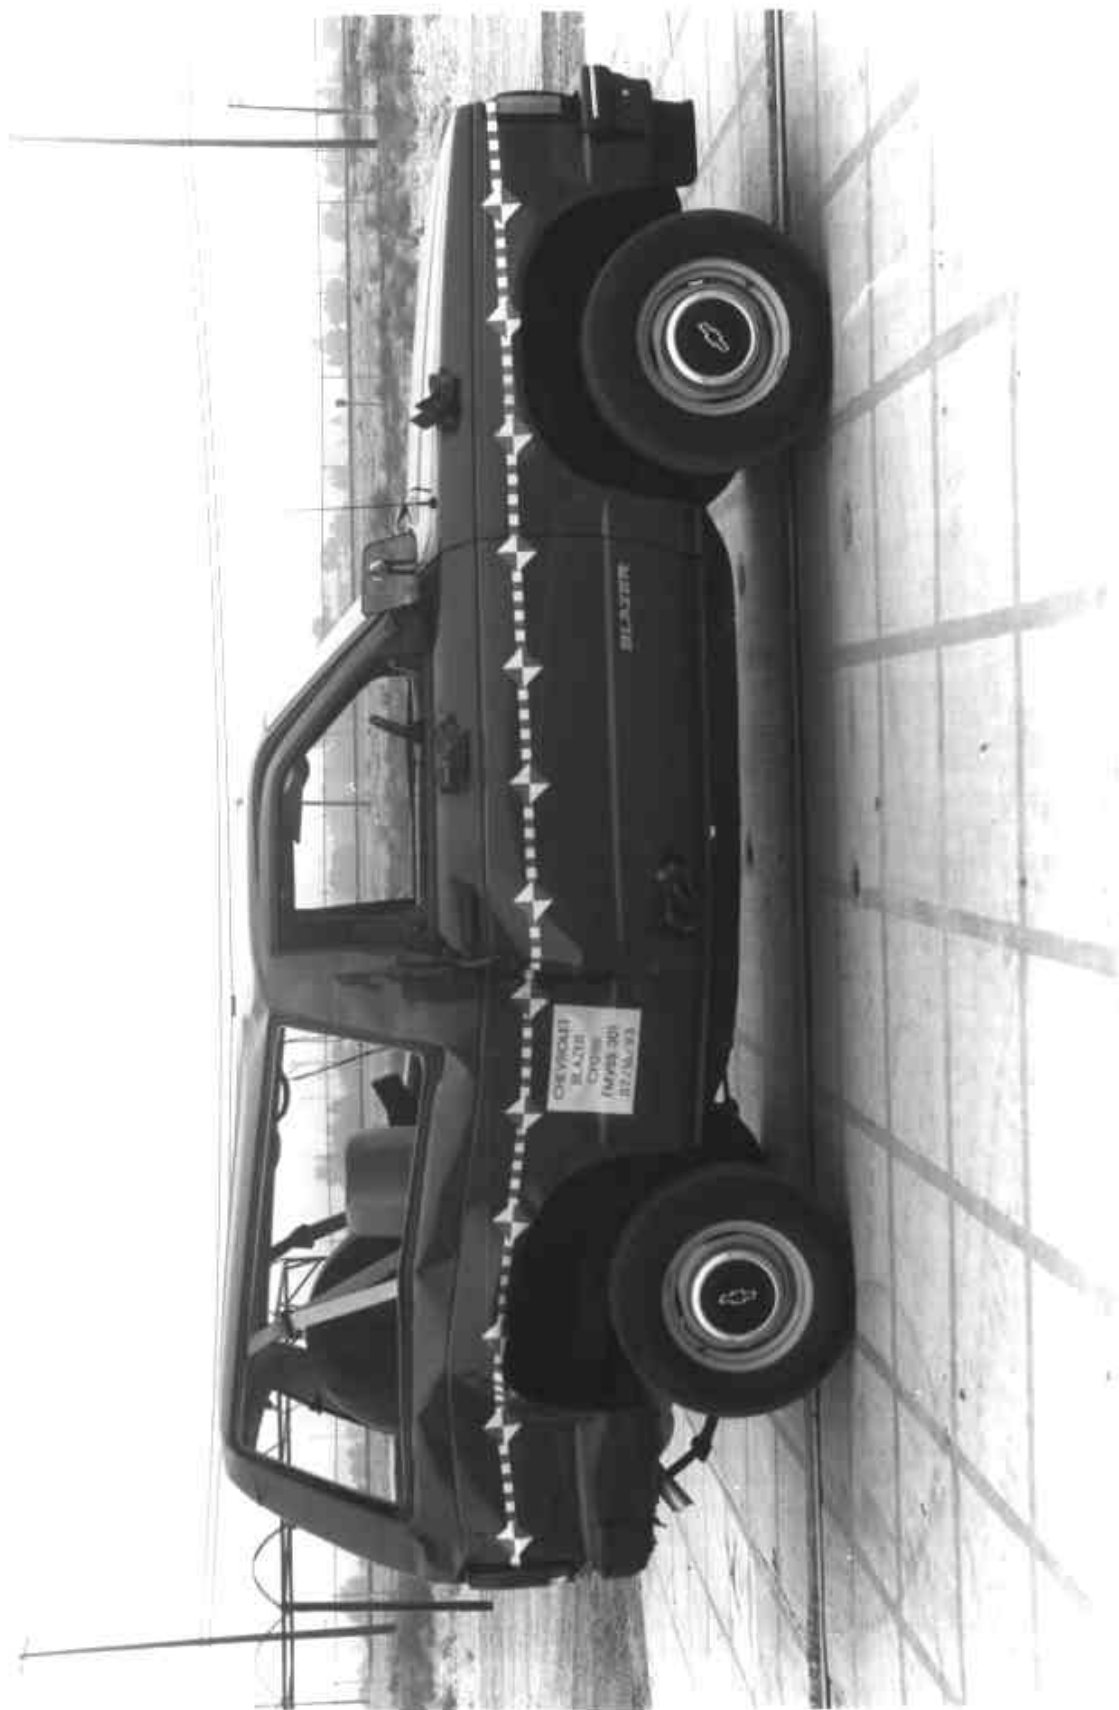
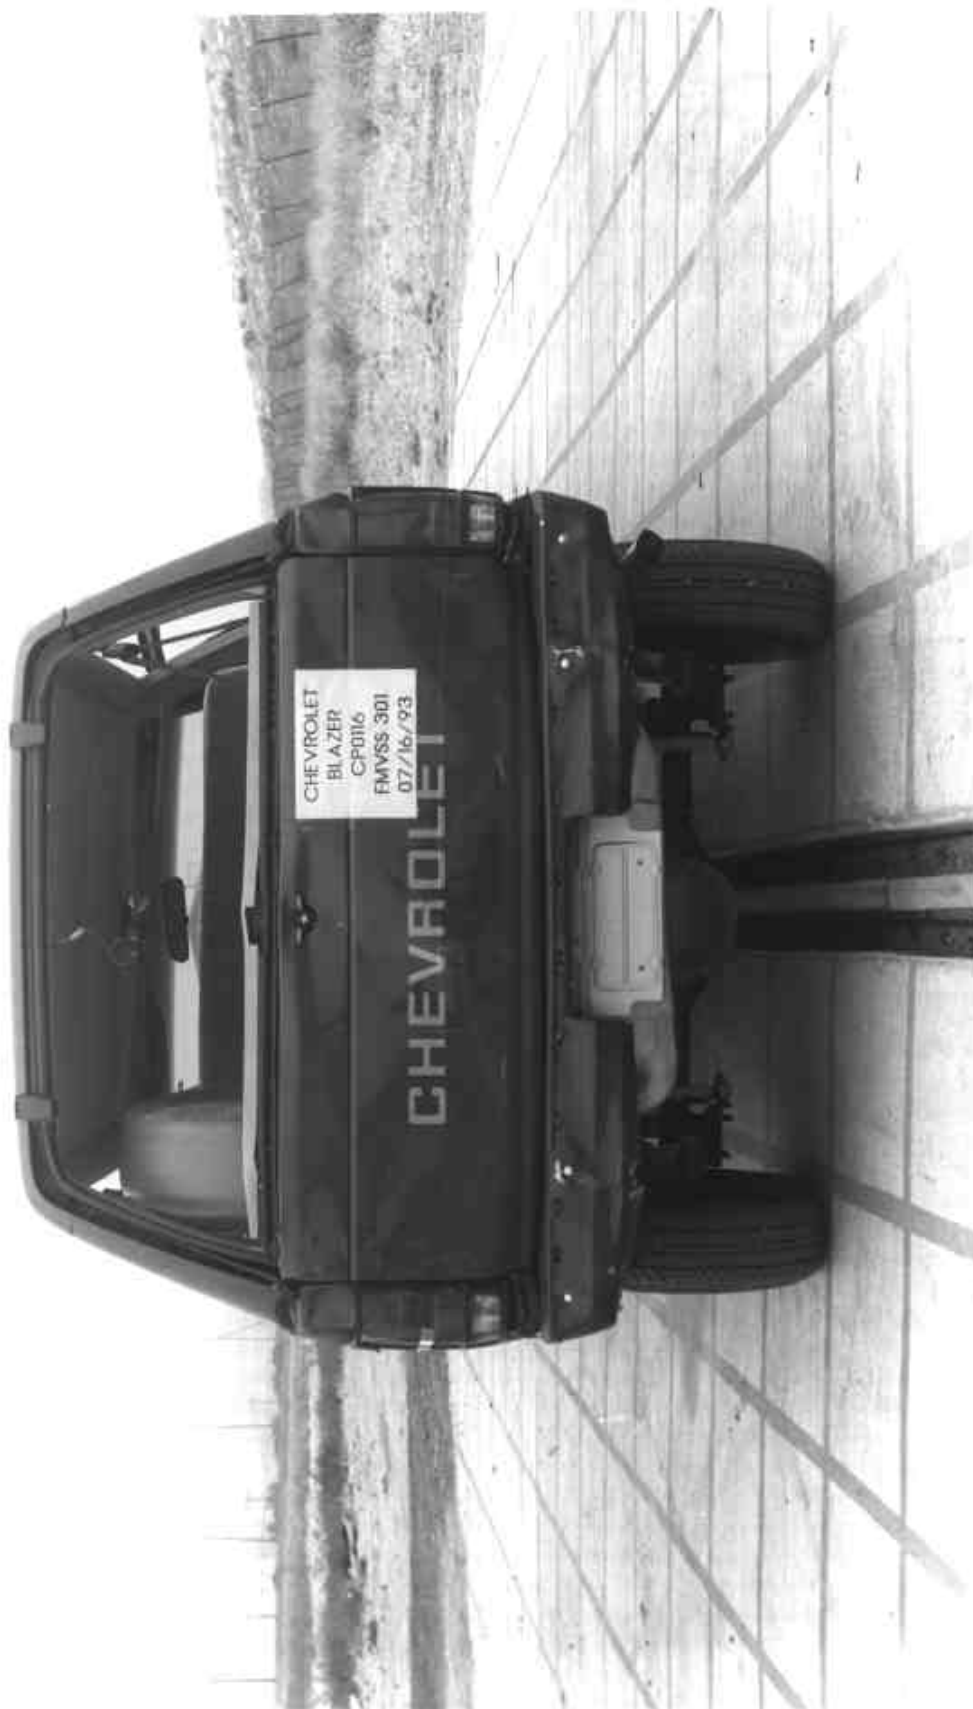
FIGURE 5-7 POSTTEST LEFT SIDE VIEW

The velocity of the rear impact sled was 29.12 mph. Test velocity information and posttest crush details are given in Table 3-2. Posttest left side, front, right side and rear views of the test vehicle are given in Figures 5-7 to 5-10.

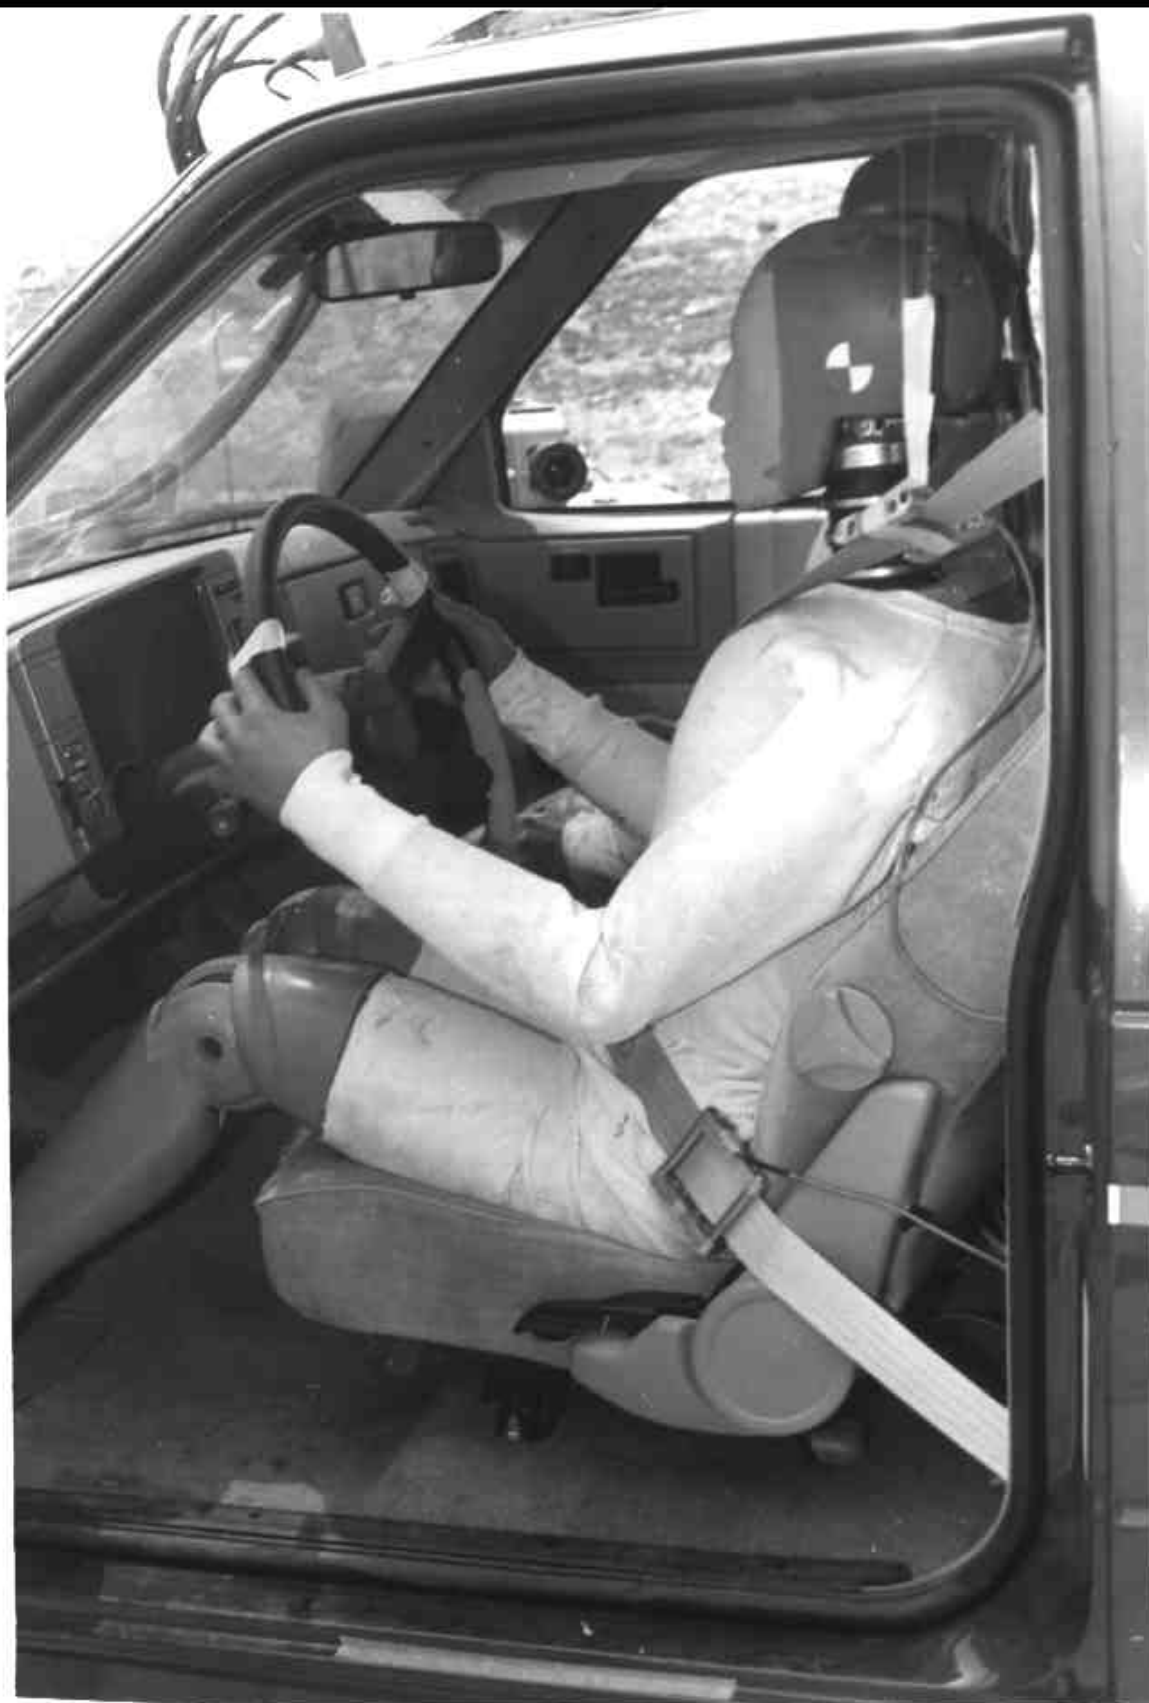
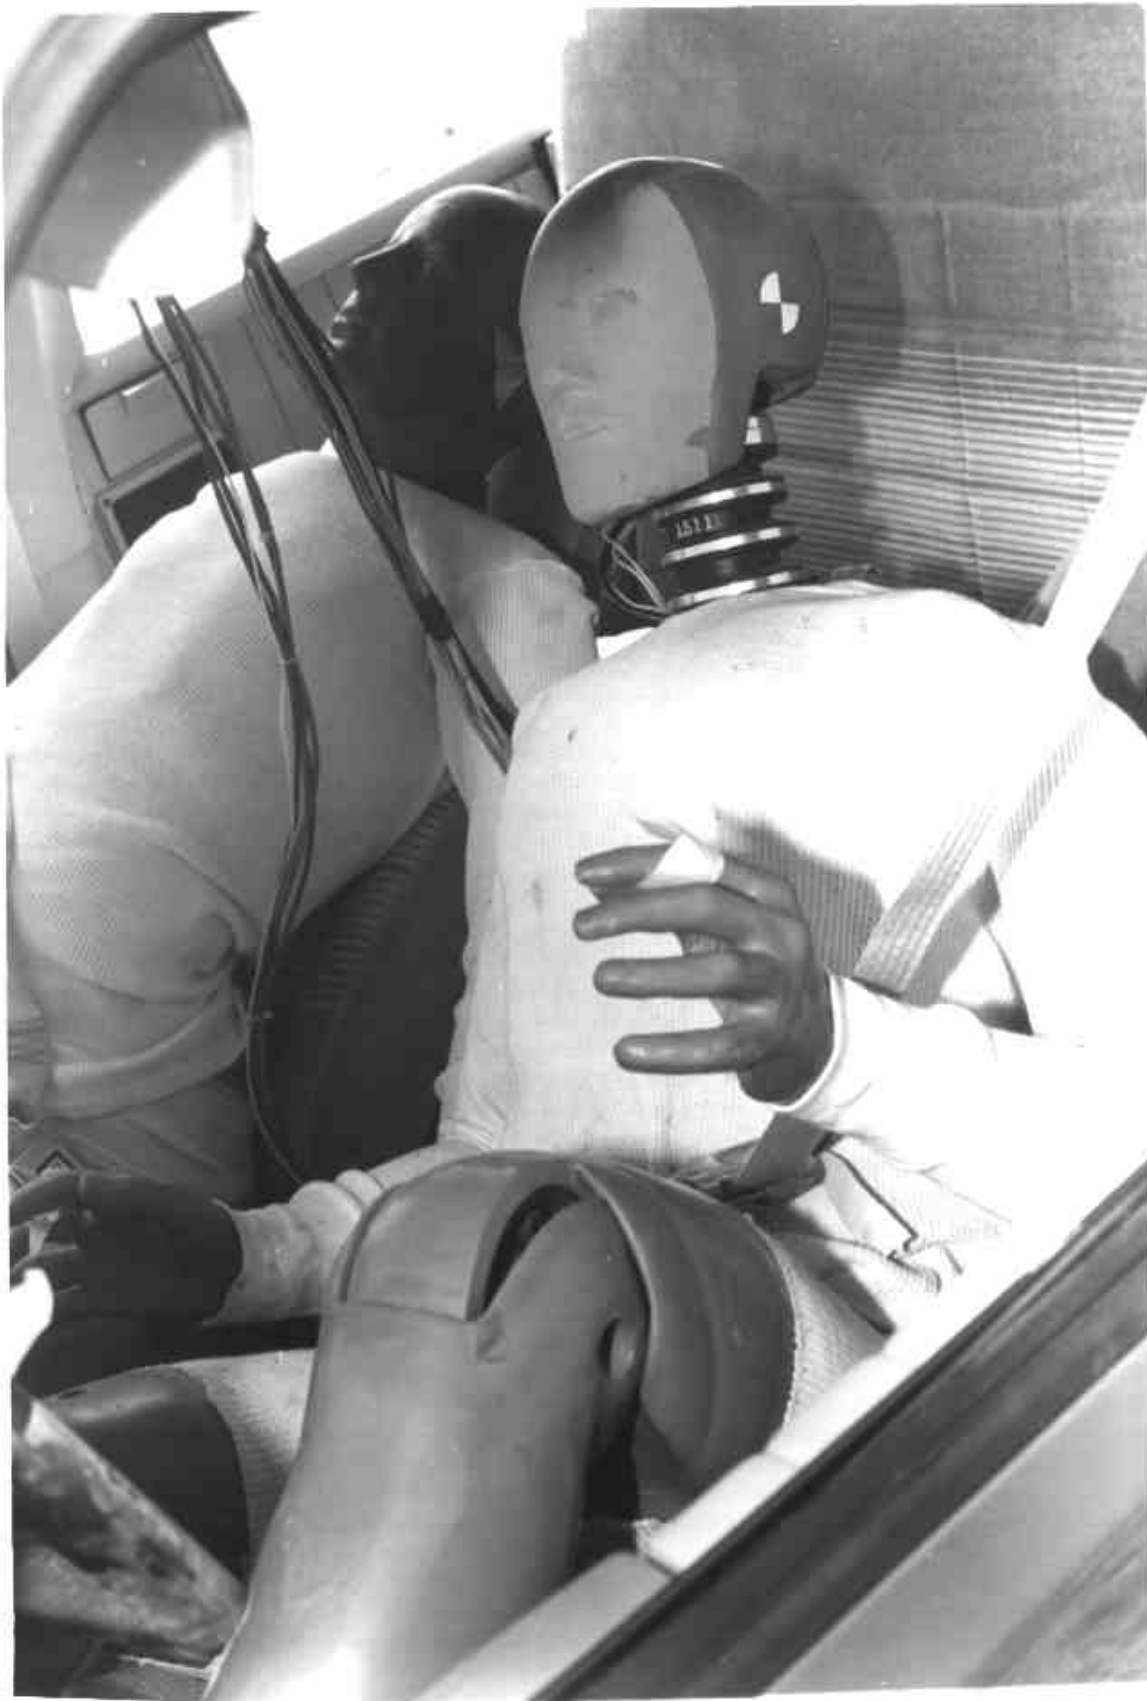
FIGURE 5-14 PRETEST DRIVER ATD POSITION

Driver ATD: Top of head contacted rear seat seatback

Upon impact the driver ATD moved rearward as the seatback gave way. The ATD's head contacted the rear seat seatback. The Head Injury Criteria (HIC) for the driver ATD was 222.8. The chest resultant (3 msec clip) was 14.2 g's. All driver ATD instrumentation results are presented in Table 3-4. Pretest measurements are shown in Tables 3-5 and 3-6. Pretest and posttest views of the Driver ATD position are shown in Figures 5-14 and 5-15. Figures 5-16 and 5-17 show the vehicle sensor locations.

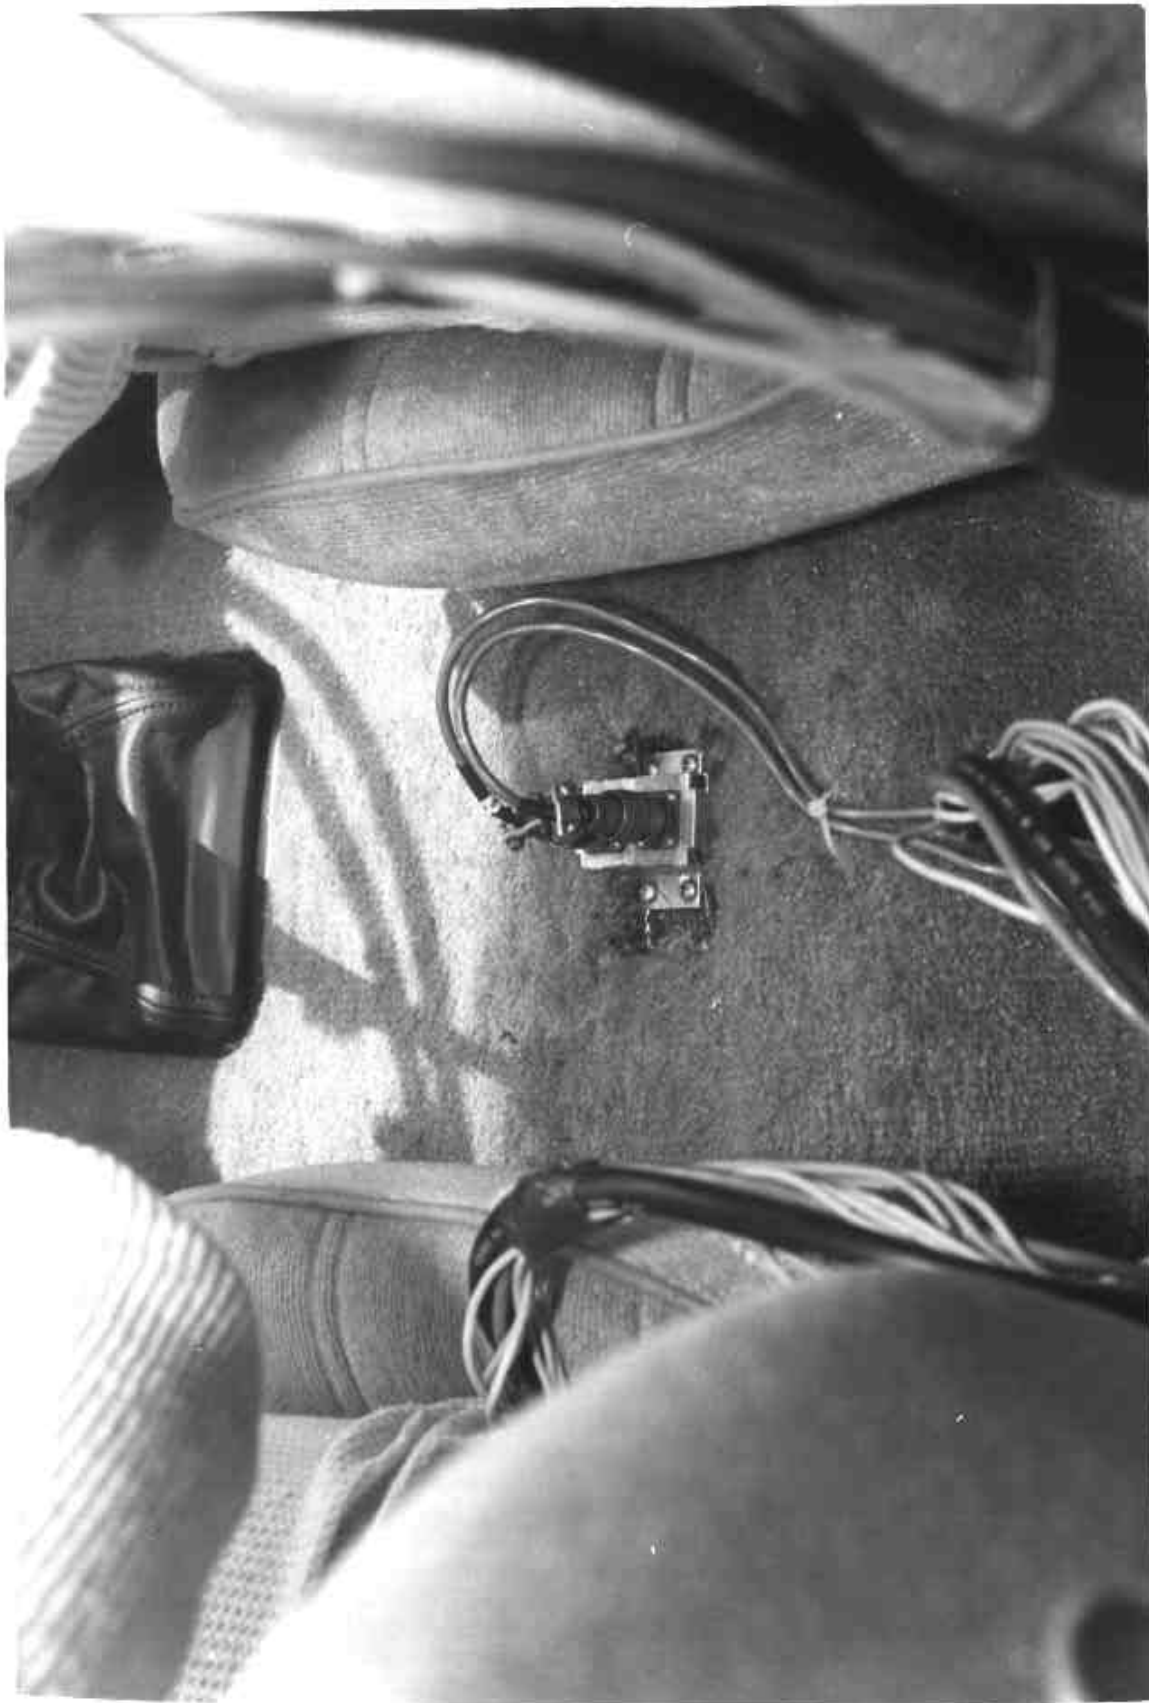
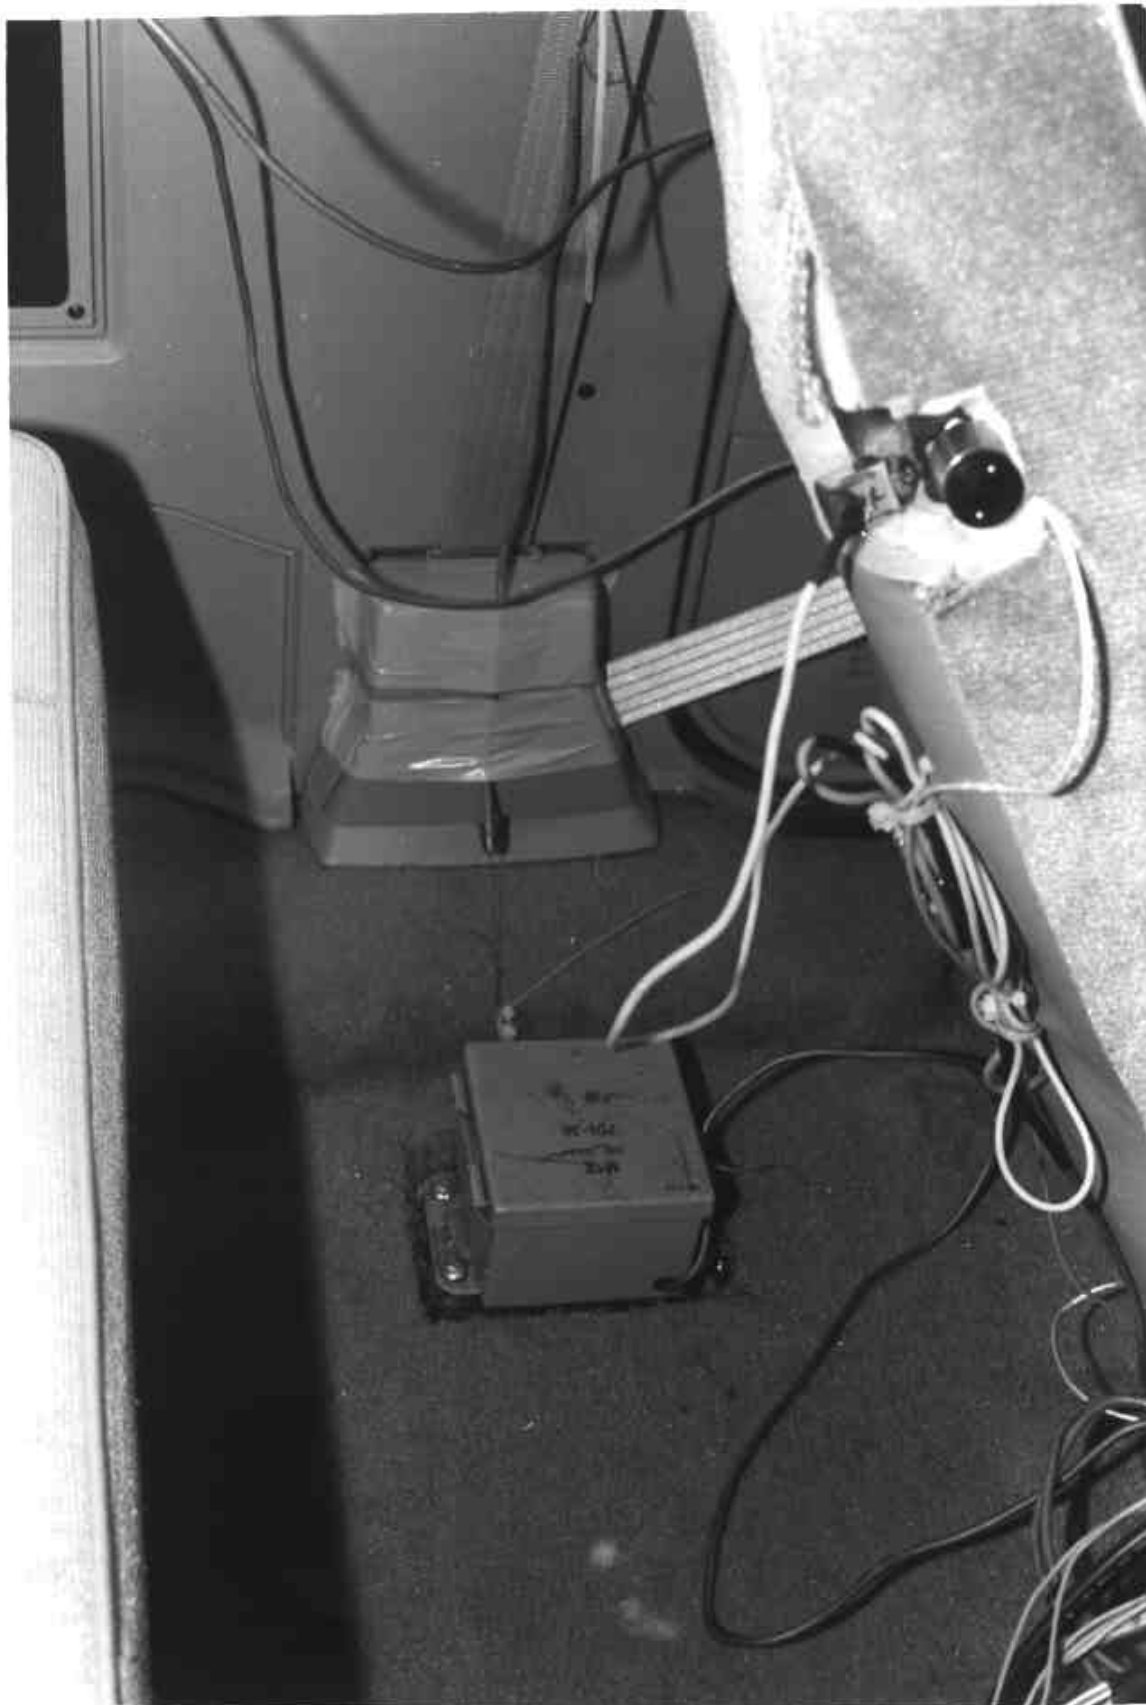
FIGURE 5-16 VEHICLE ACCELEROMETERS

Rate sensor mounted 19.0 inches above seatback pivot point, on inboard edge. Seatback accel 19.0 inches above pivot point on inboard edge.
