# NEW CAR ASSESSMENT PROGRAM

## FRONTAL BARRIER IMPACT TEST

TOYOTA MOTOR CORPORATION  
1994 TOYOTA COROLLA  
4 DOOR SEDAN  
NHTSA No. MR5101

FINAL REPORT

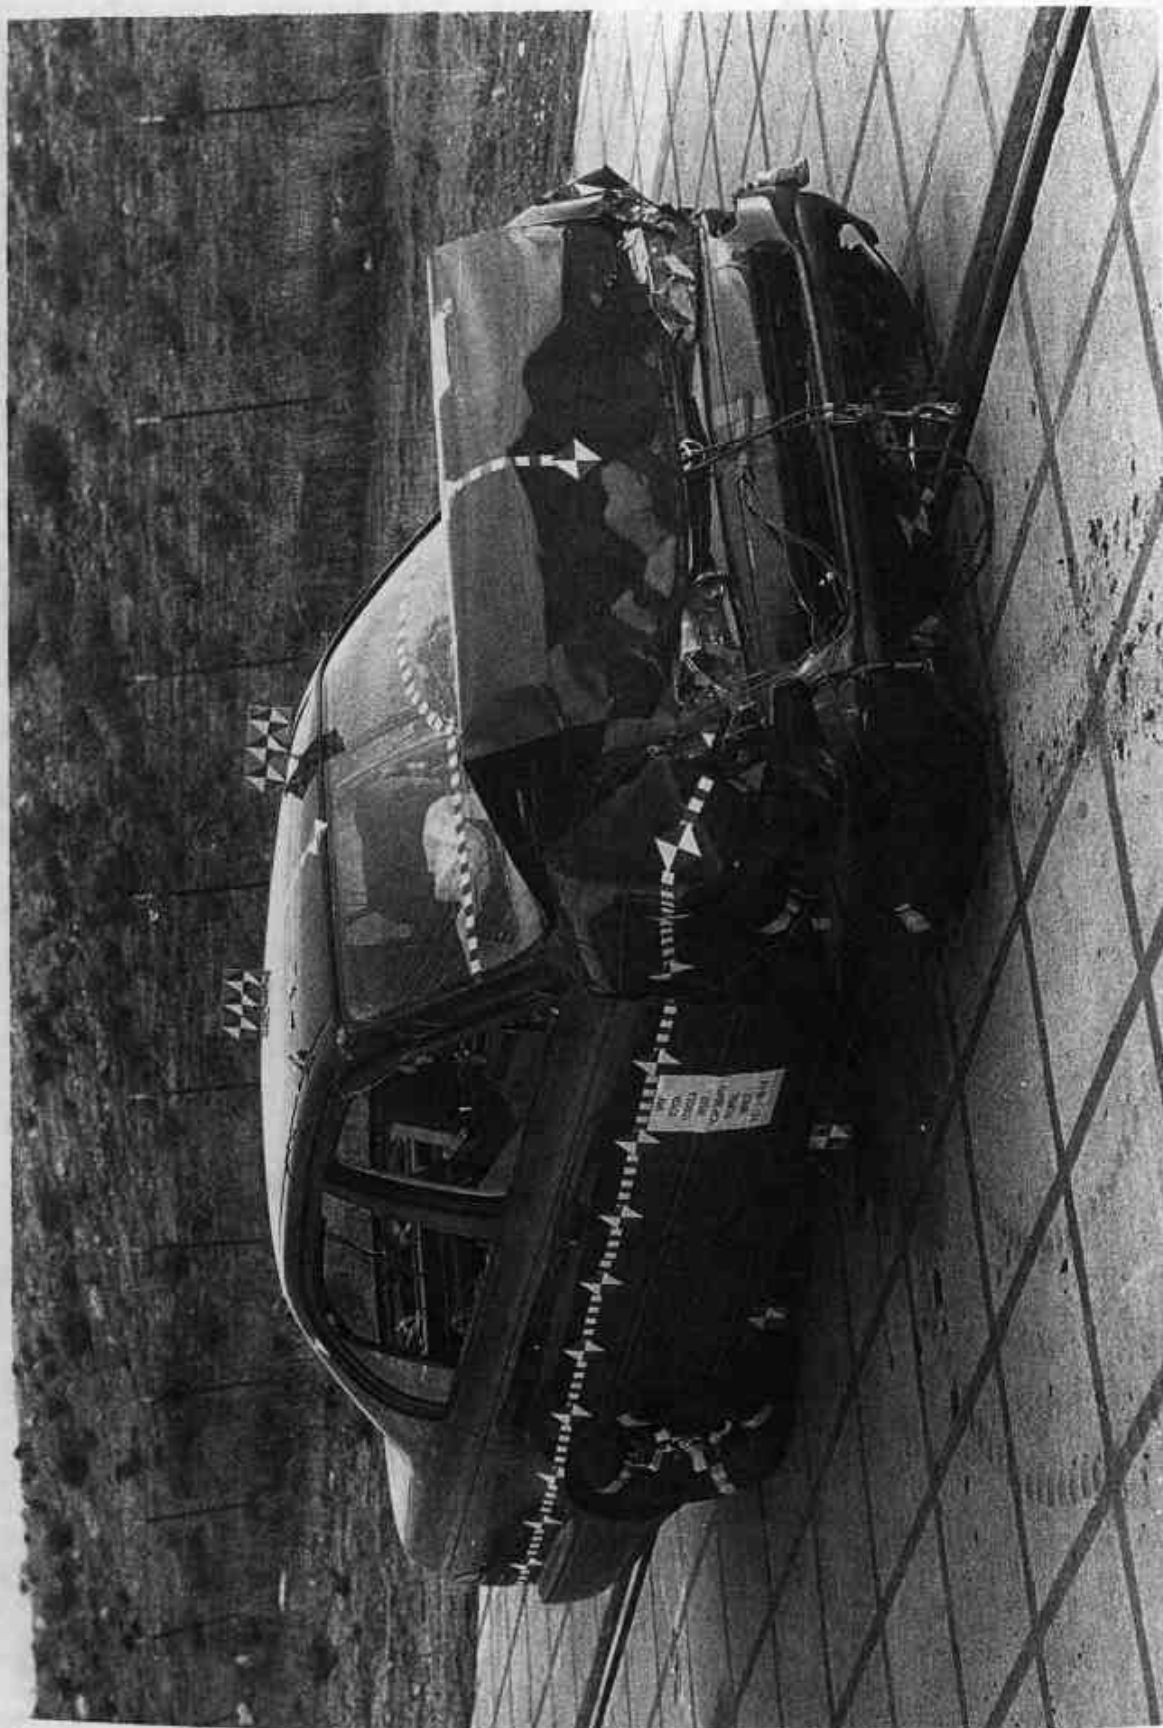
POSTTEST RIGHT FRONT 3/4 VIEW

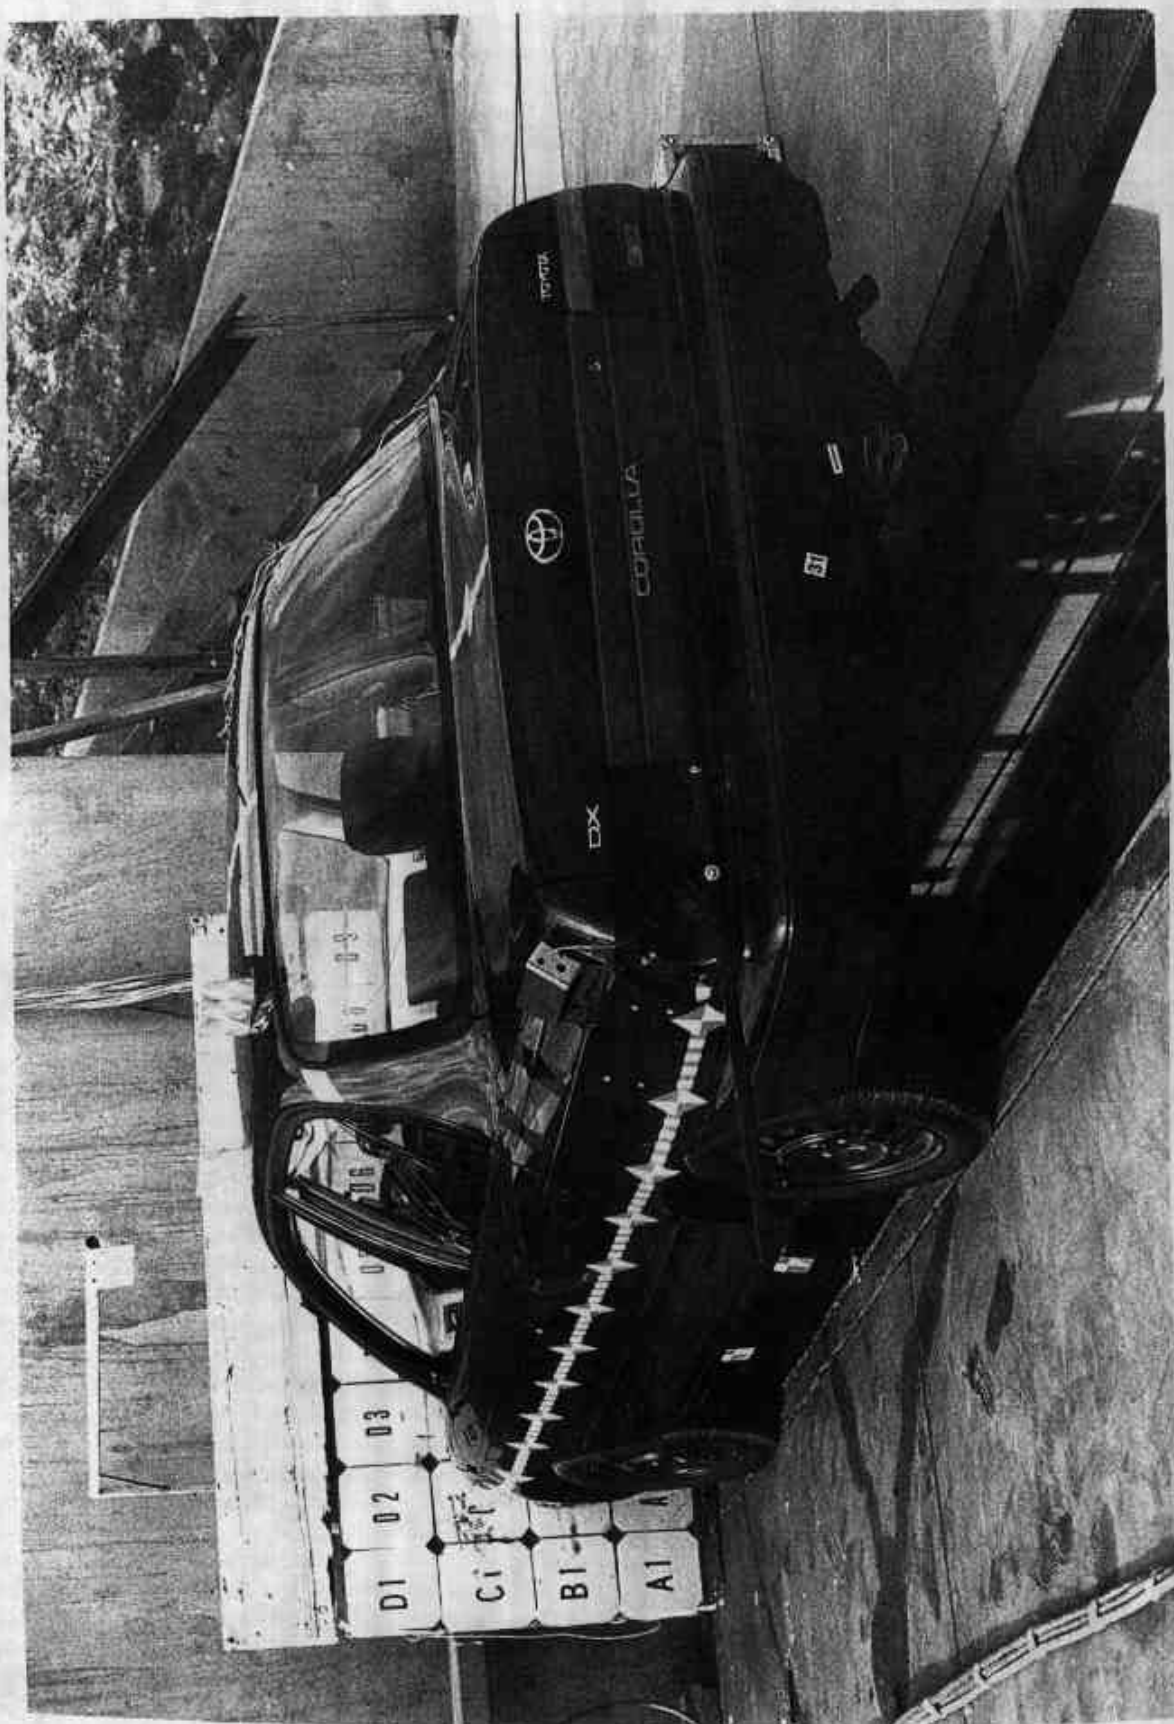
PRETEST LEFT REAR 3/4 VIEW

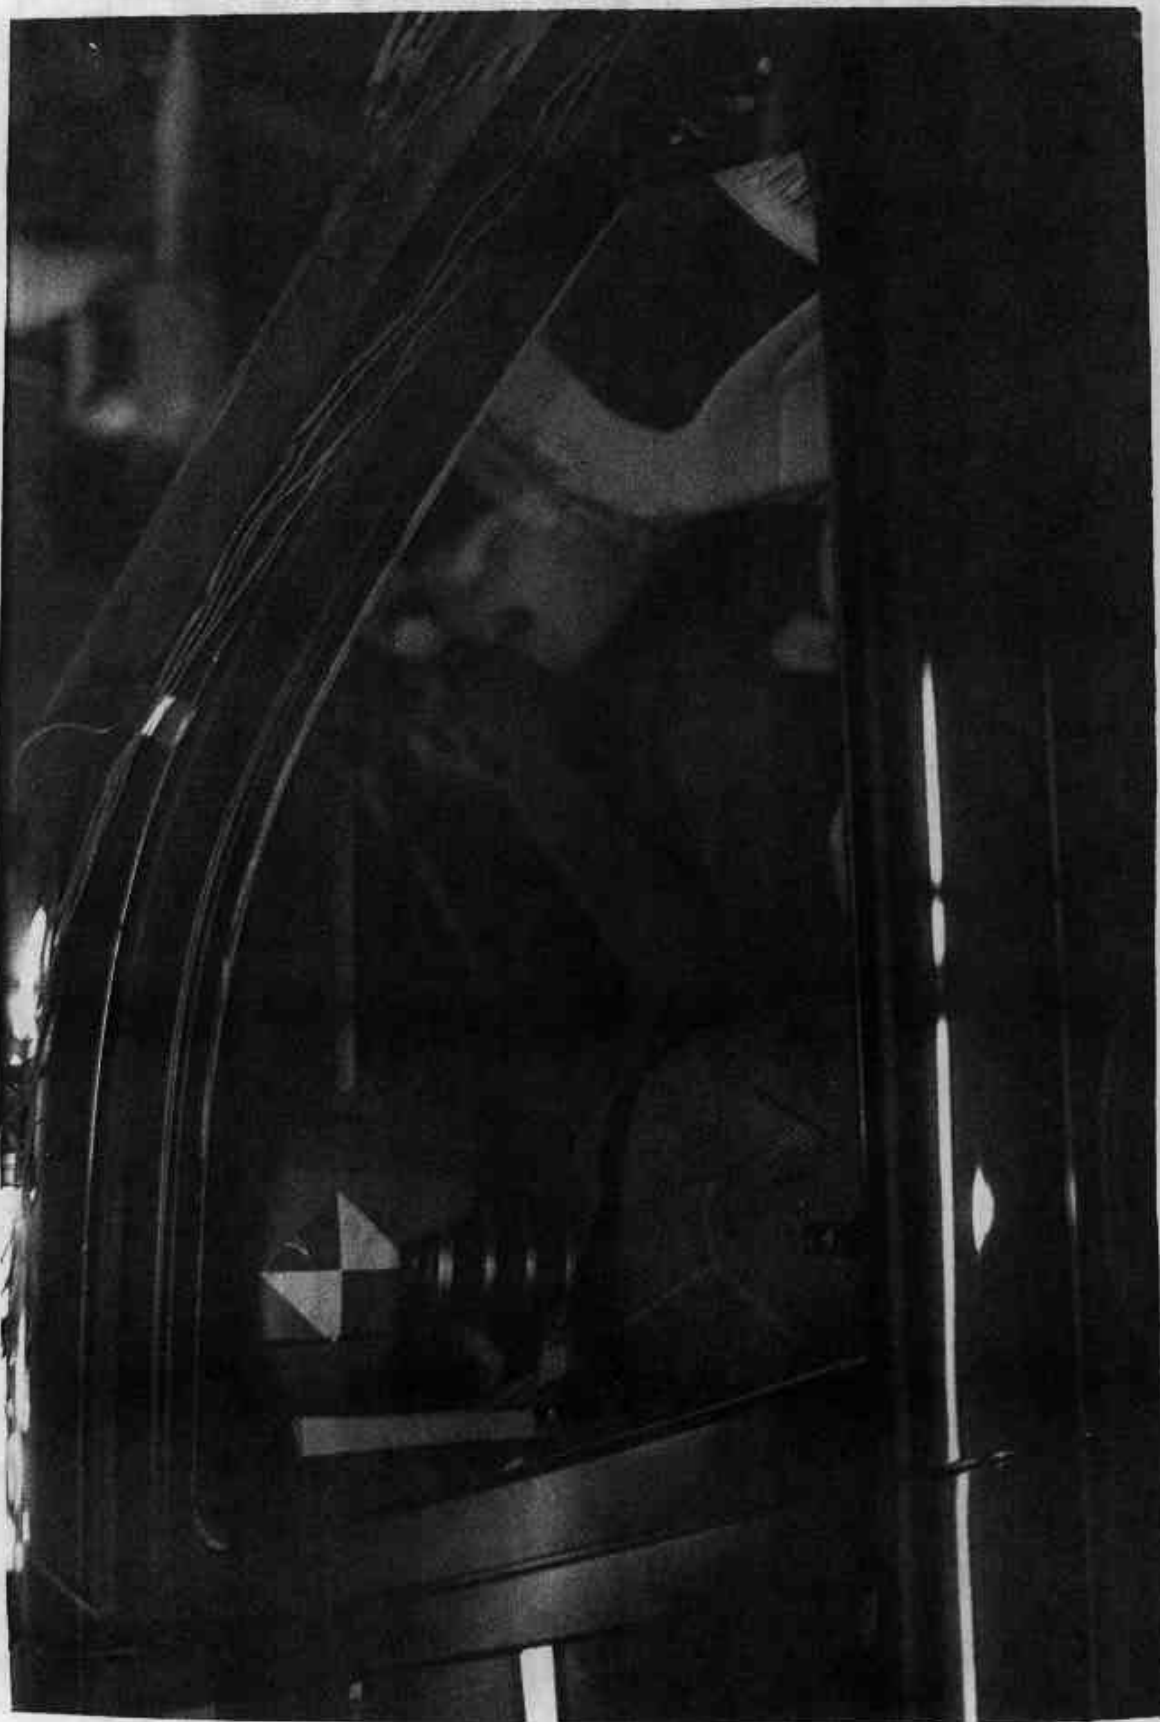
PRETEST PASSENGER DUMMY POSITION VIEW

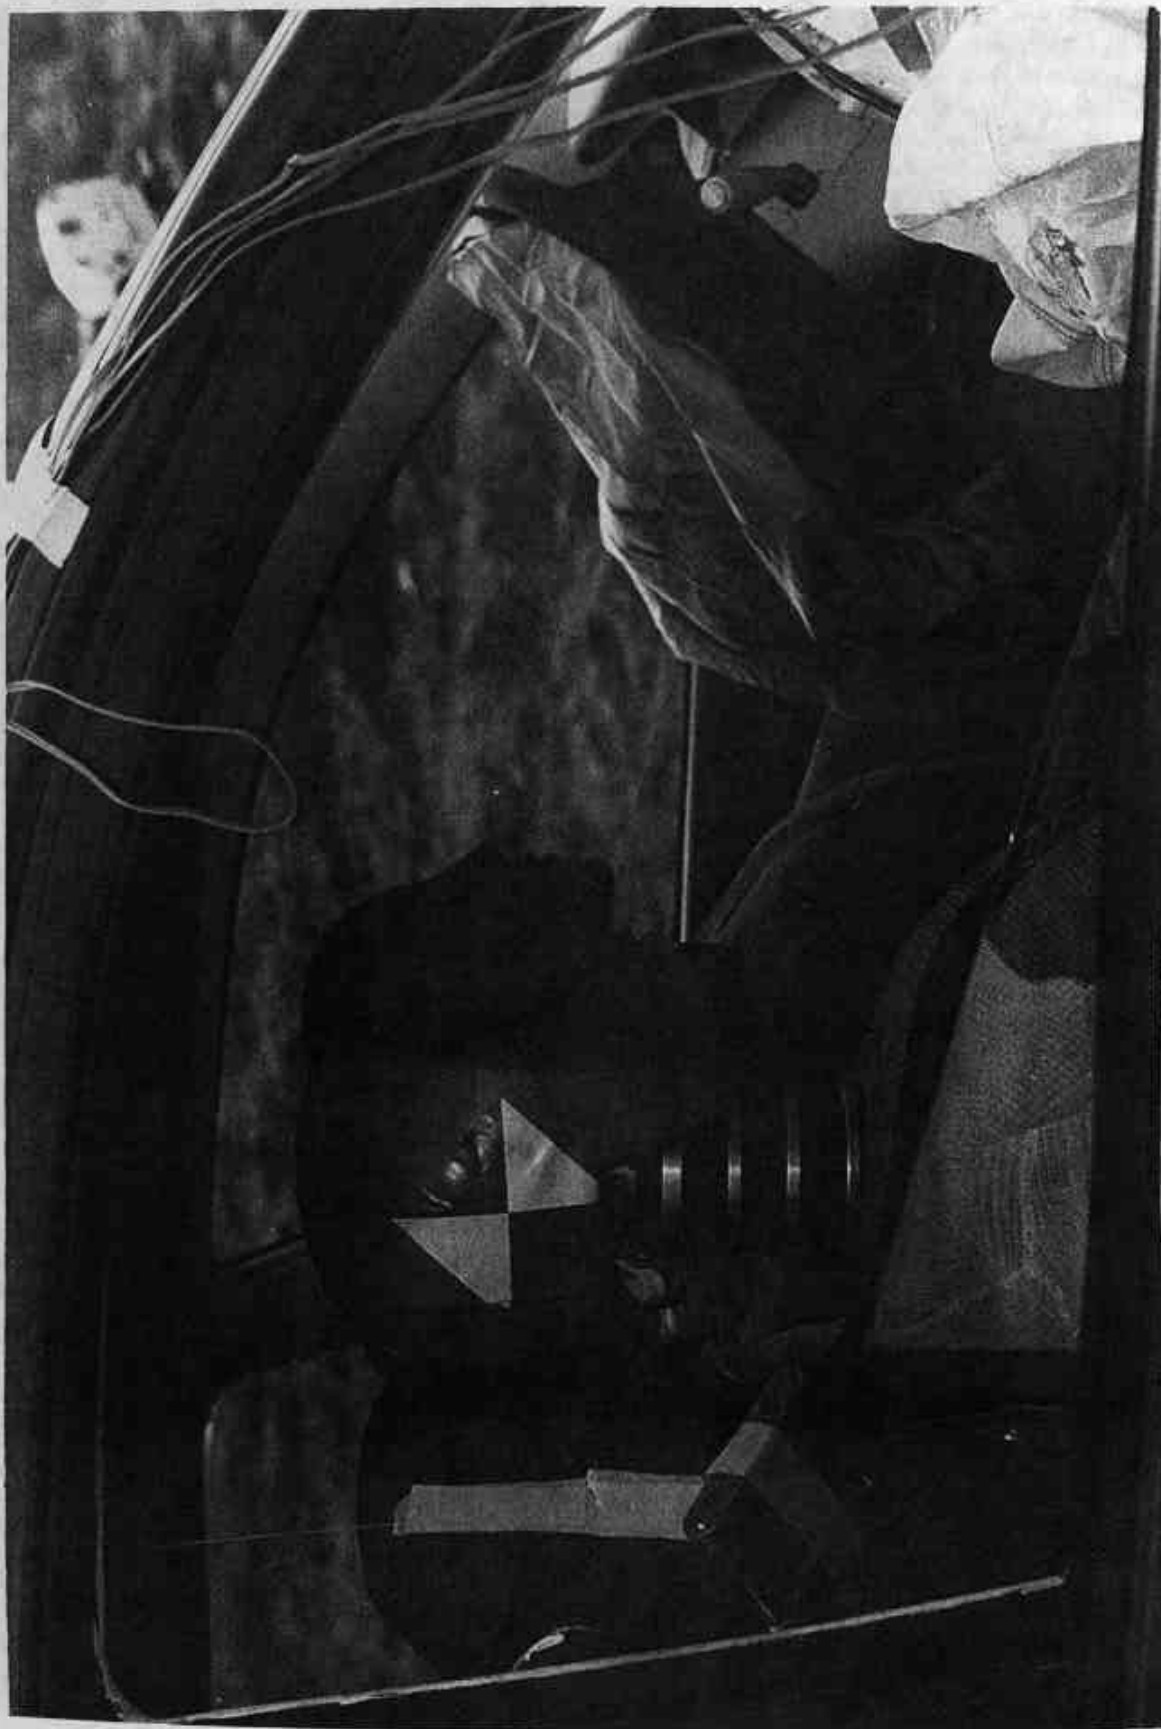
POSTTEST PASSENGER DUMMY POSITION VIEW

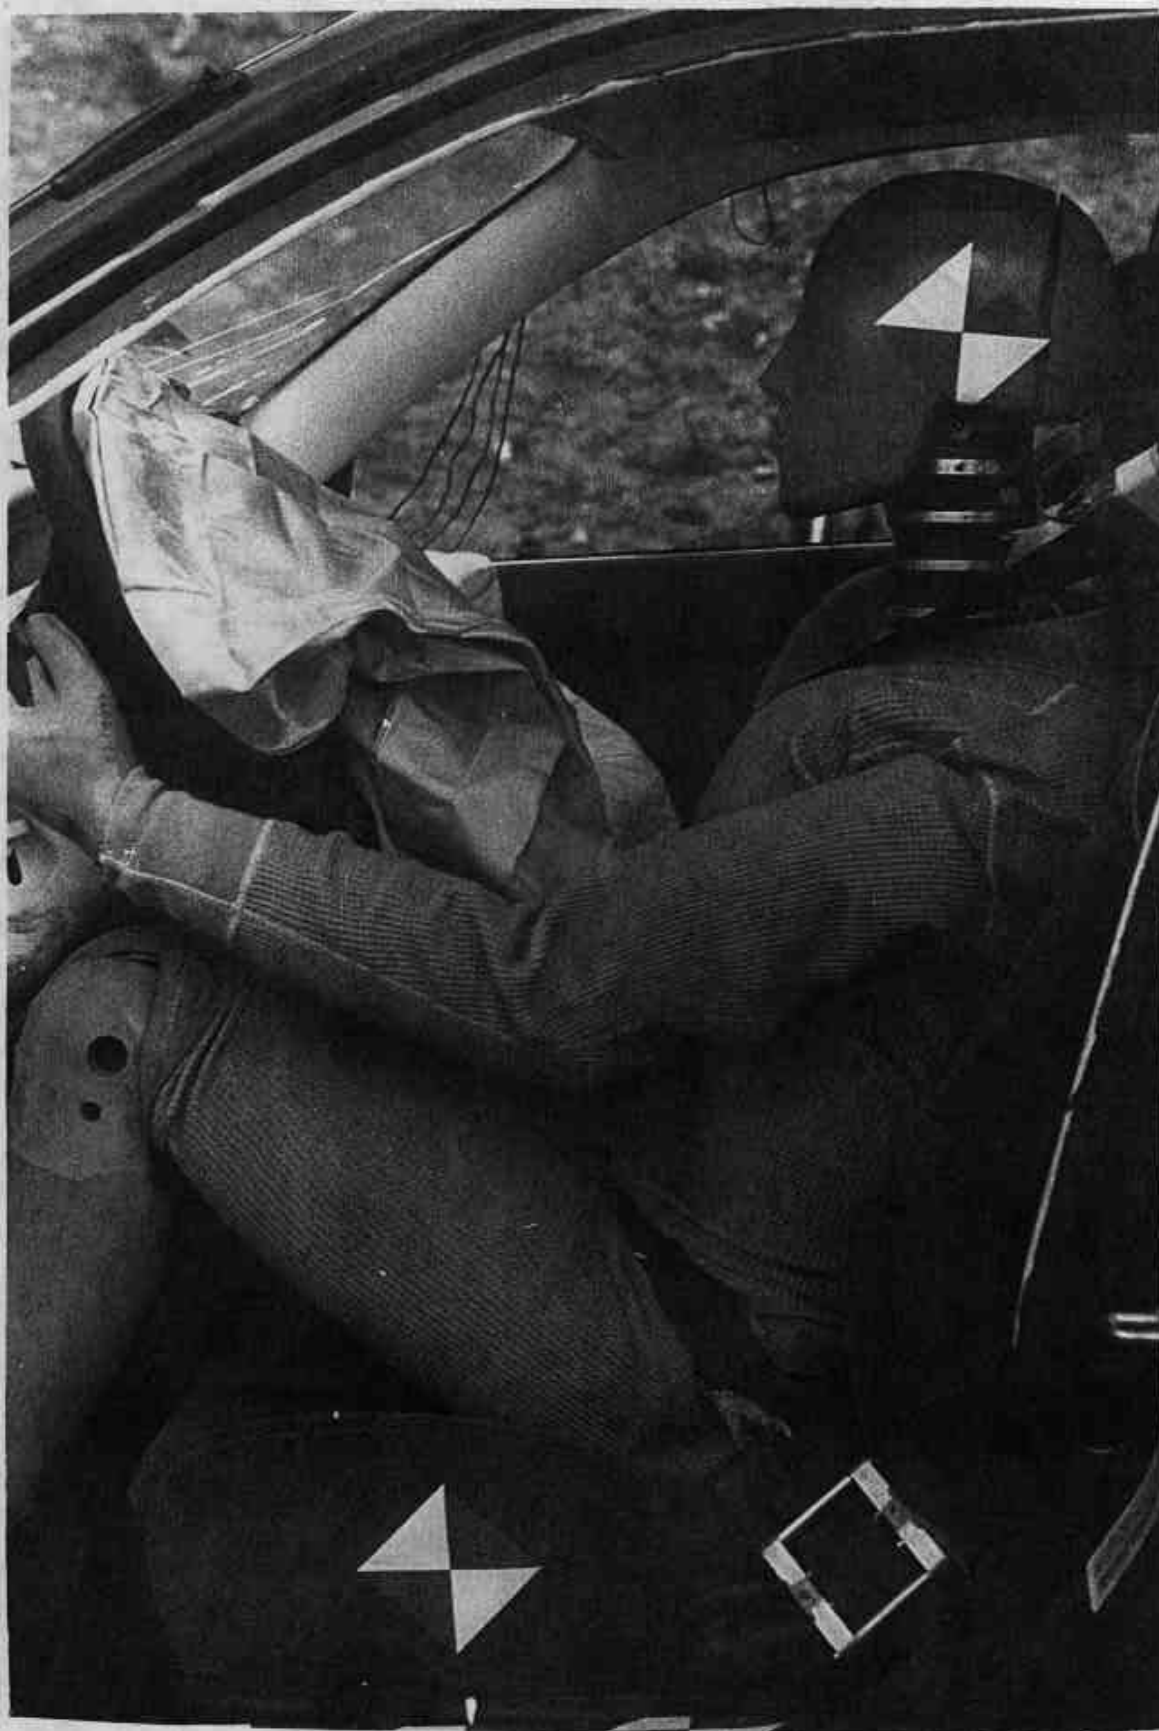
POSTTEST DRIVER DUMMY AND VEHICLE  
INTERIOR VIEW (DOOR OPEN)

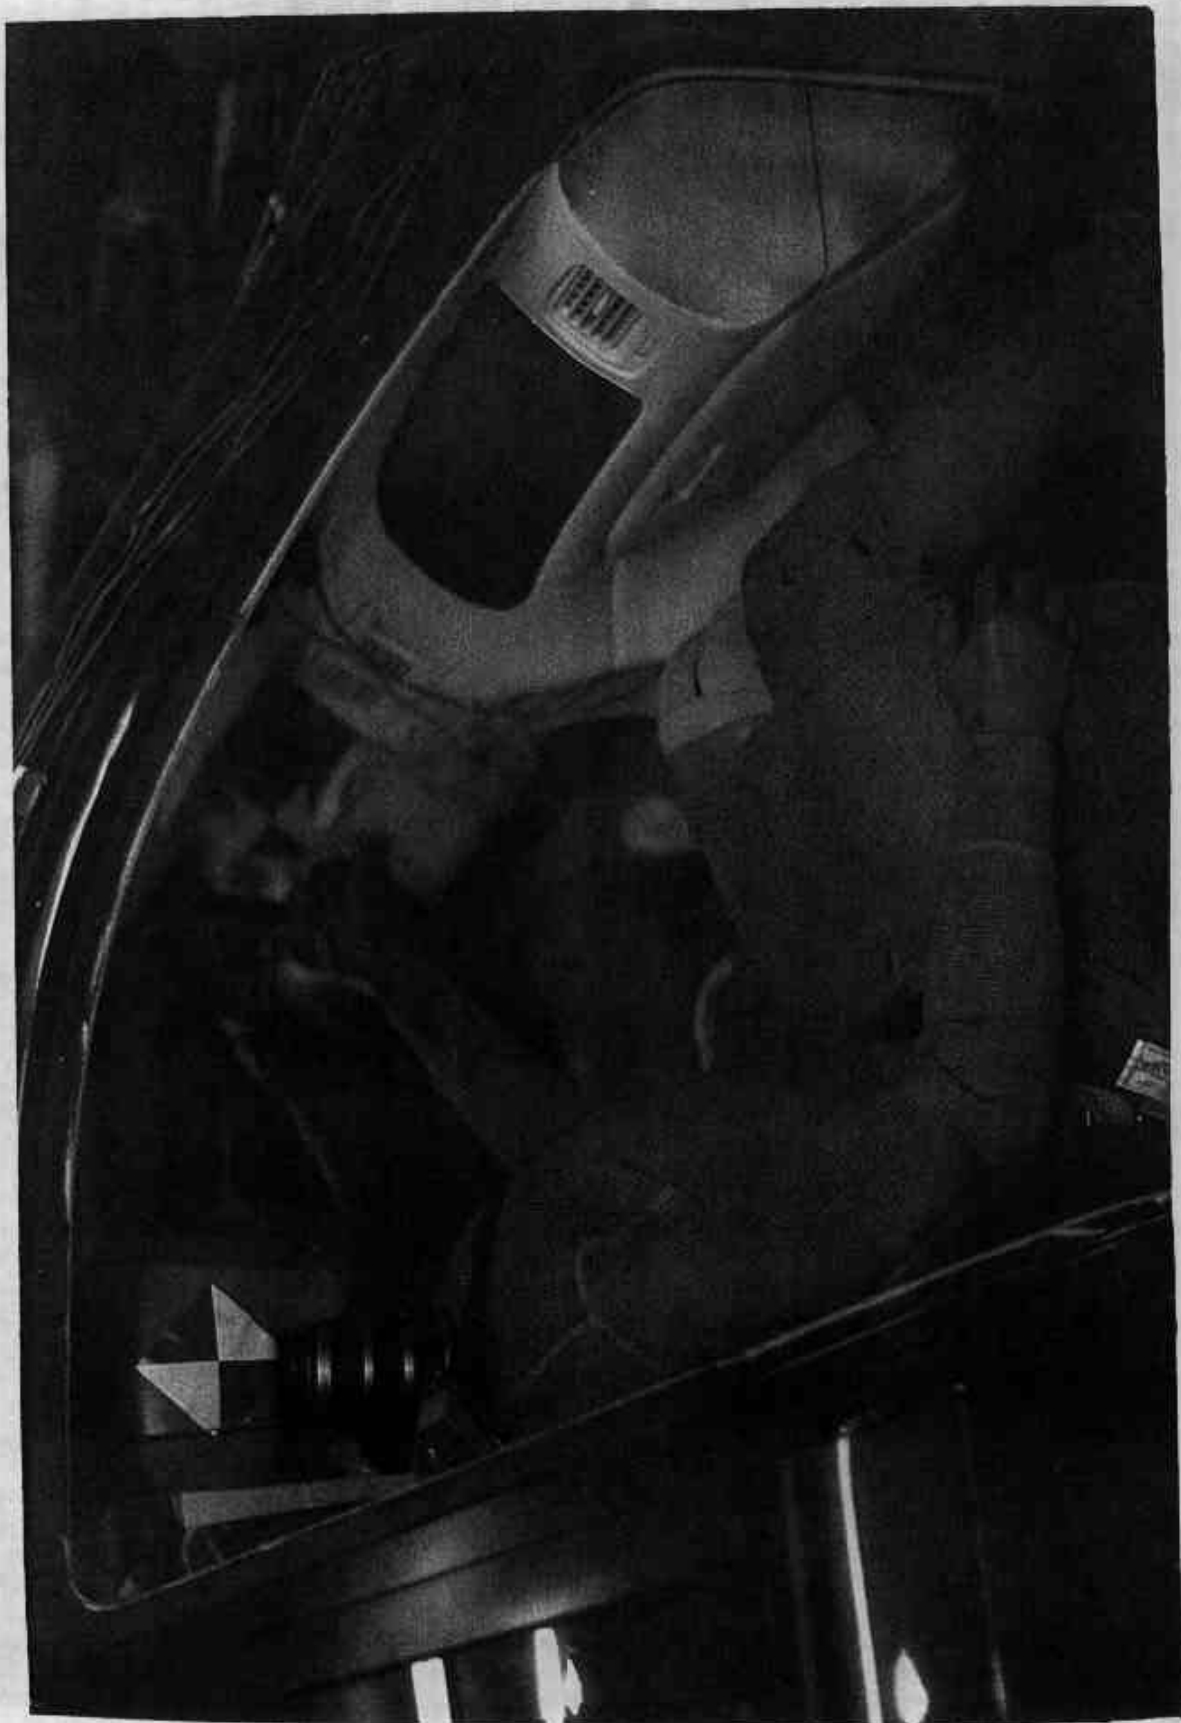
A25

PRETEST PASSENGER DUMMY AND  
VEHICLE INTERIOR VIEW (DOOR OPEN)

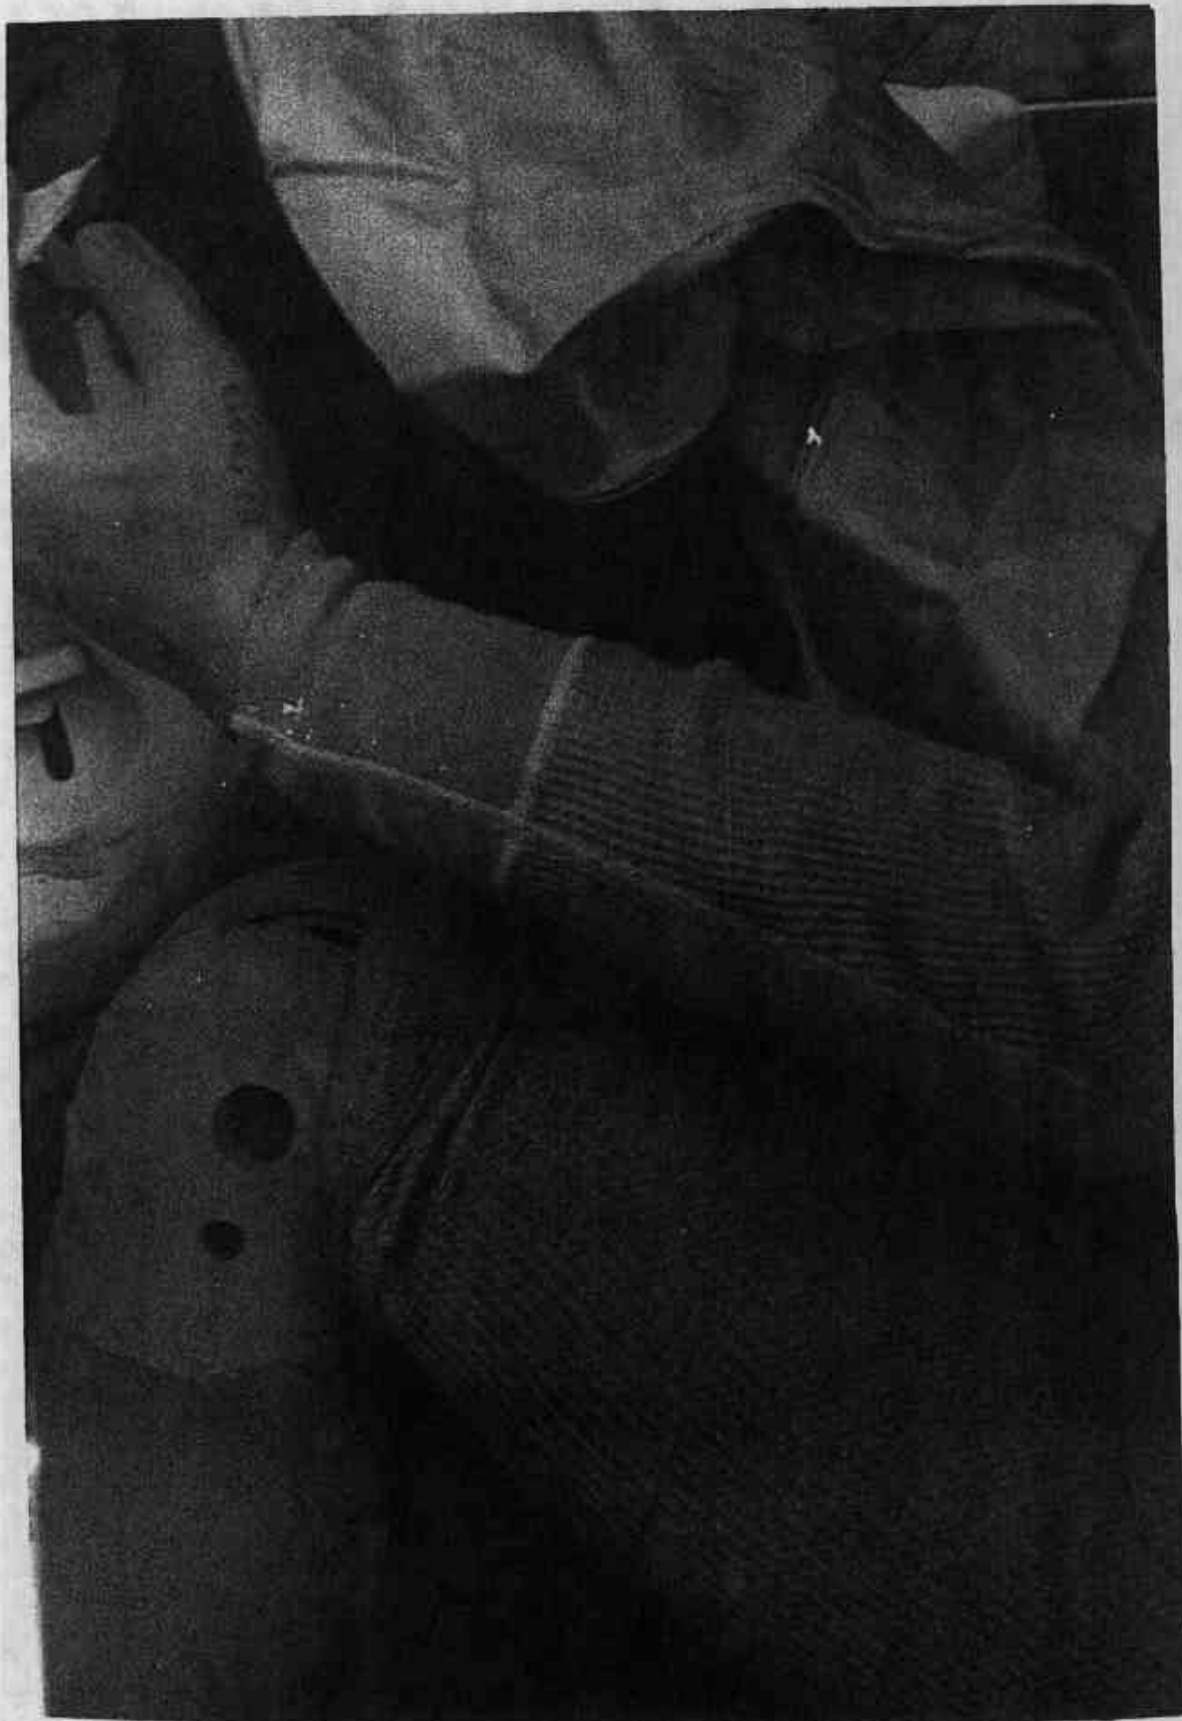
POSTTEST DRIVER DUMMY KNEE CONTACT AREA

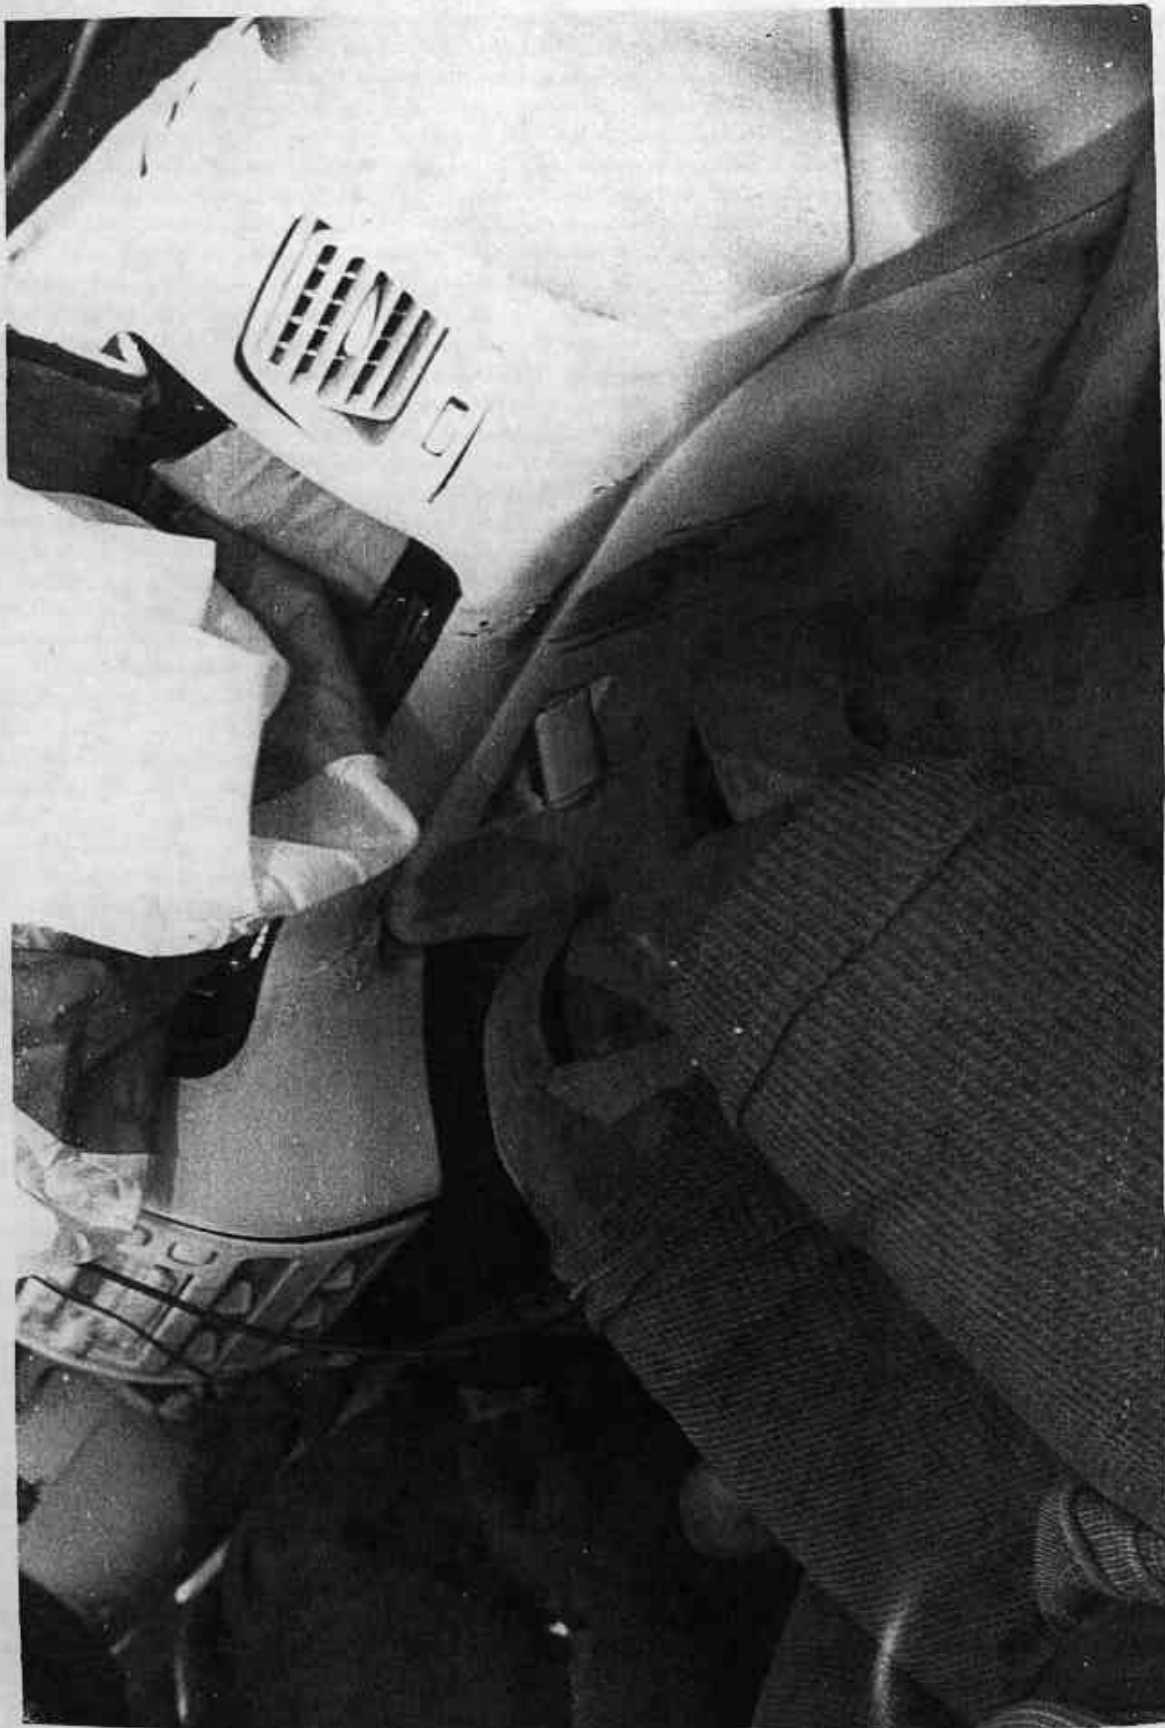
POSTTEST PASSENGER DUMMY KNEE CONTACT AREA
