Report Numbers: 208-TRC-94-012
212-TRC-94-012
301-TRC-94-012

Vehicle Safety Compliance Testing
for Occupant Crash Protection,
Windshield Mounting, Windshield Zone Intrusion (partial),
and Fuel System Integrity

Ford Motor Company
1994 Ford Probe
3-door hatchback
NHTSA Number: CR0210
TRC Test Number: 940302

Final Report

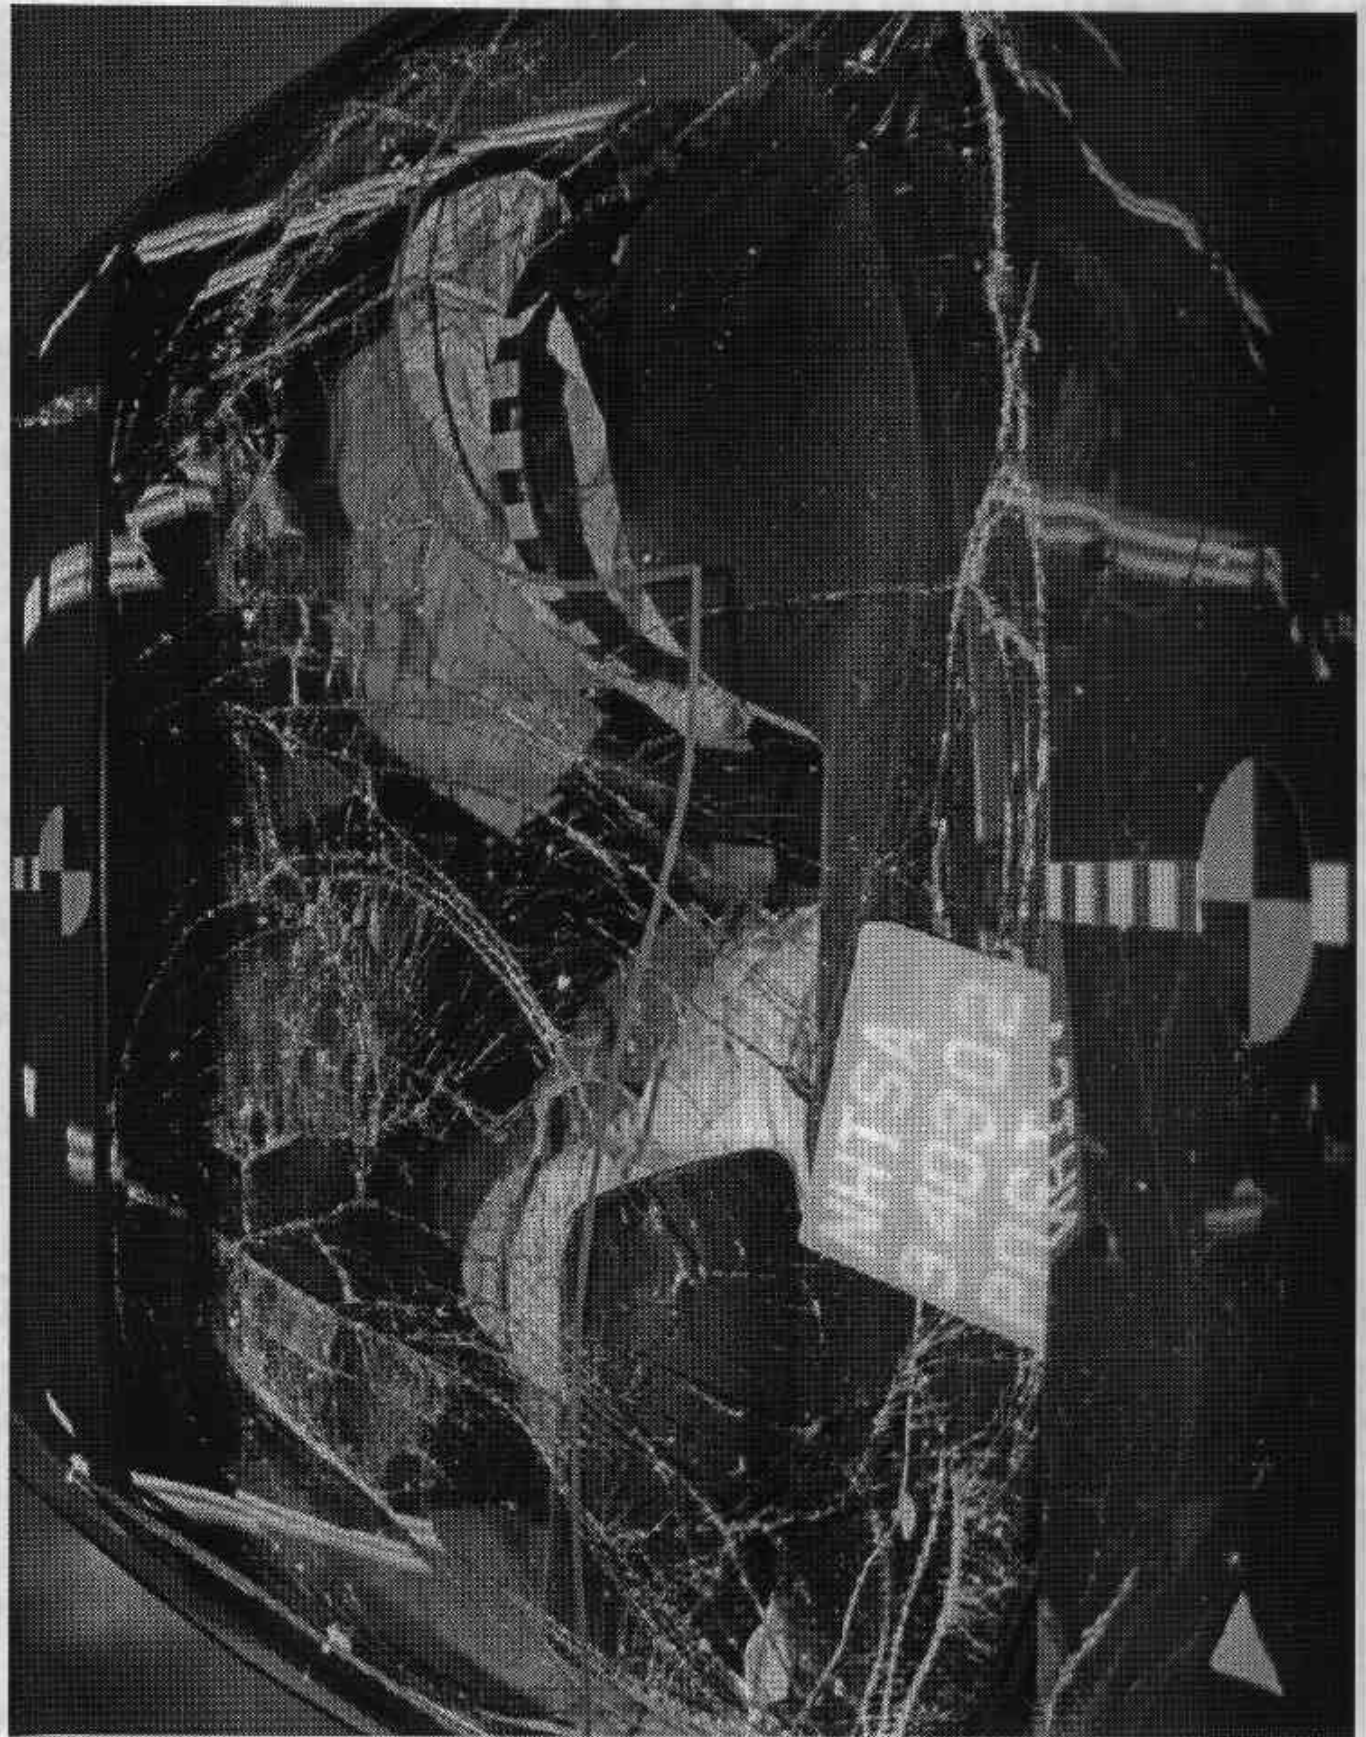
Figure A-14. Post-test Windshield View
A-15

There was no loss of windshield periphery retention.

There was no penetration through the windshield.

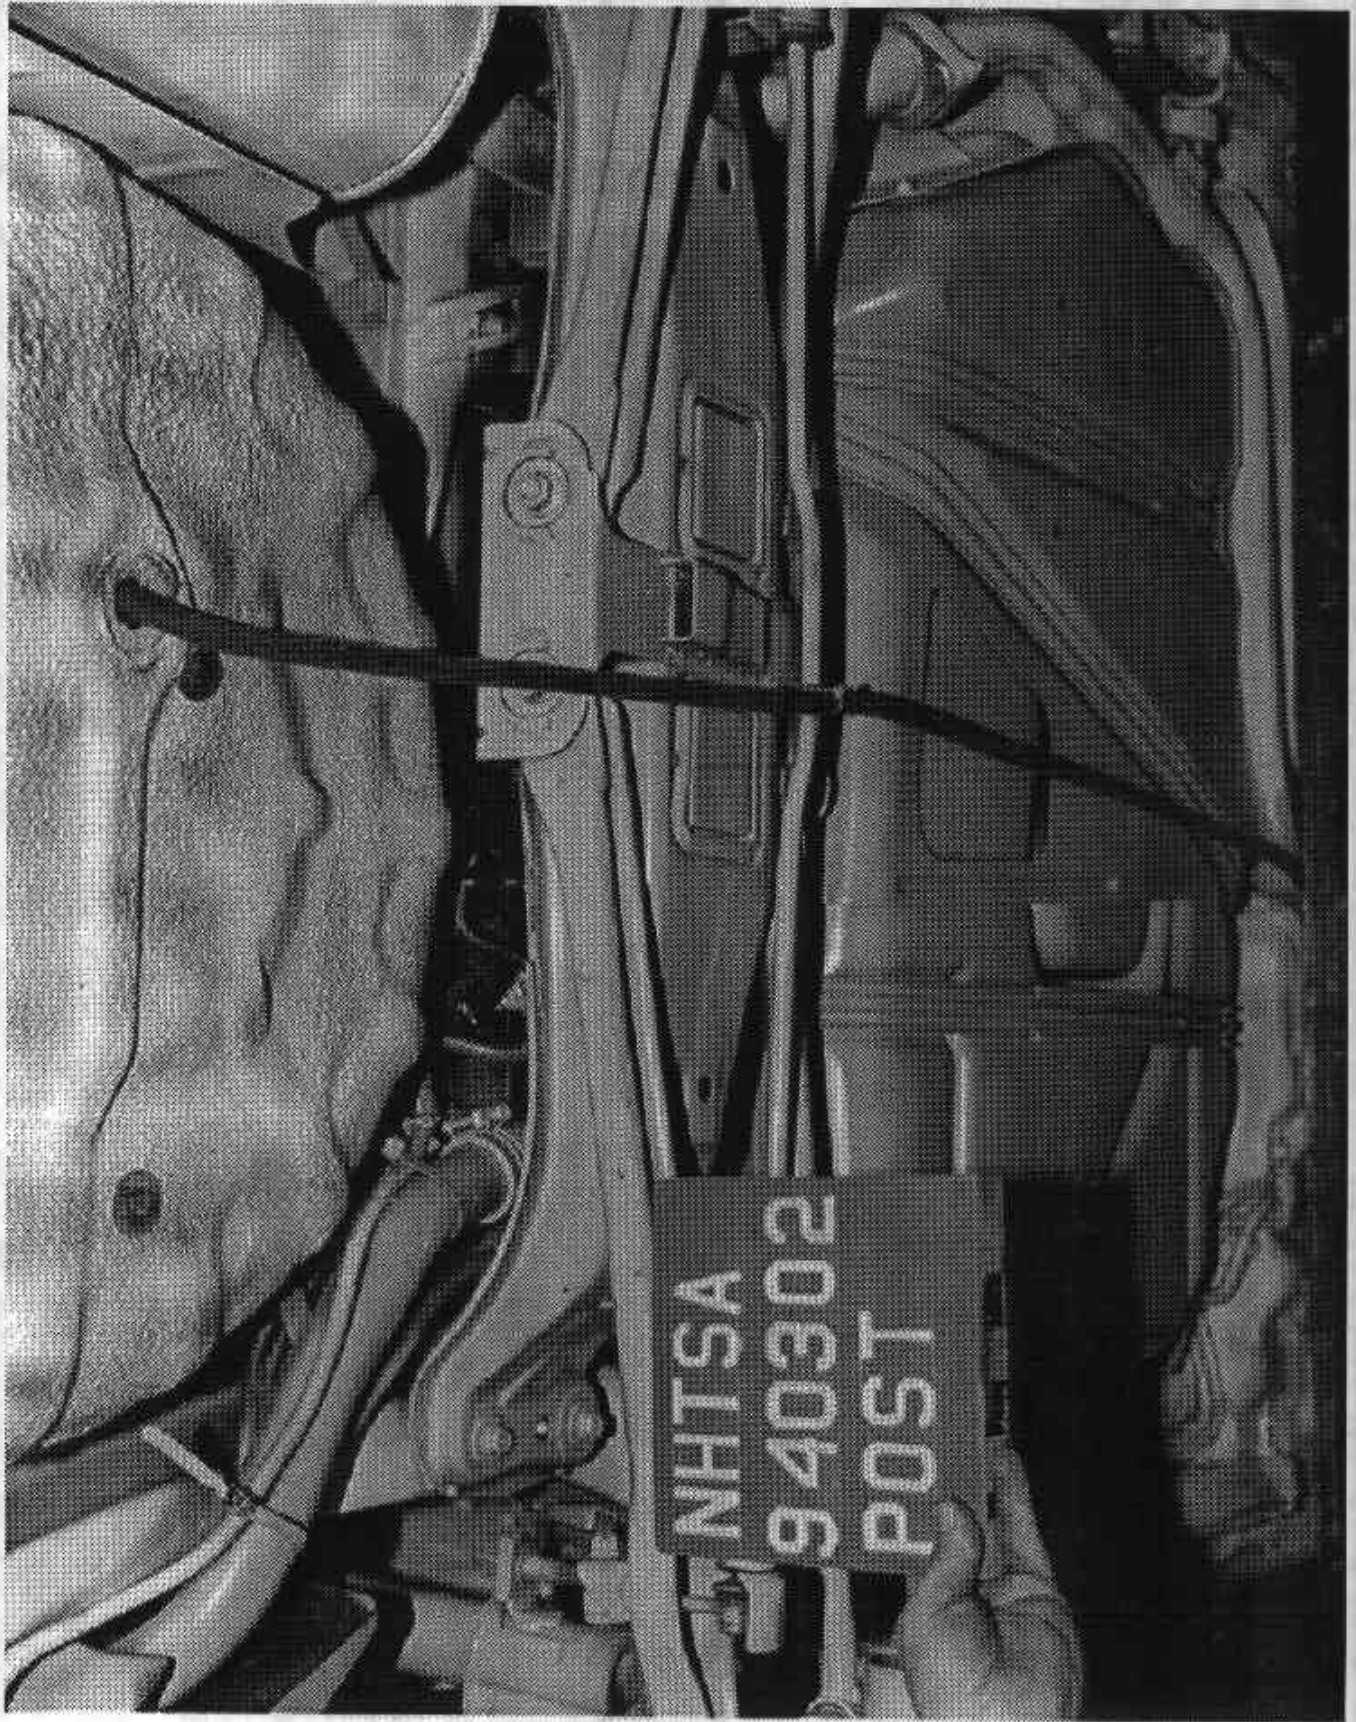
Figure A-22. Post-test Fuel Filler Neck and Fuel Tank View
A-23

Following the impact, no fluid spilled from the vehicle's fuel system prior to the static rollover test or during any portion of the static rollover test.

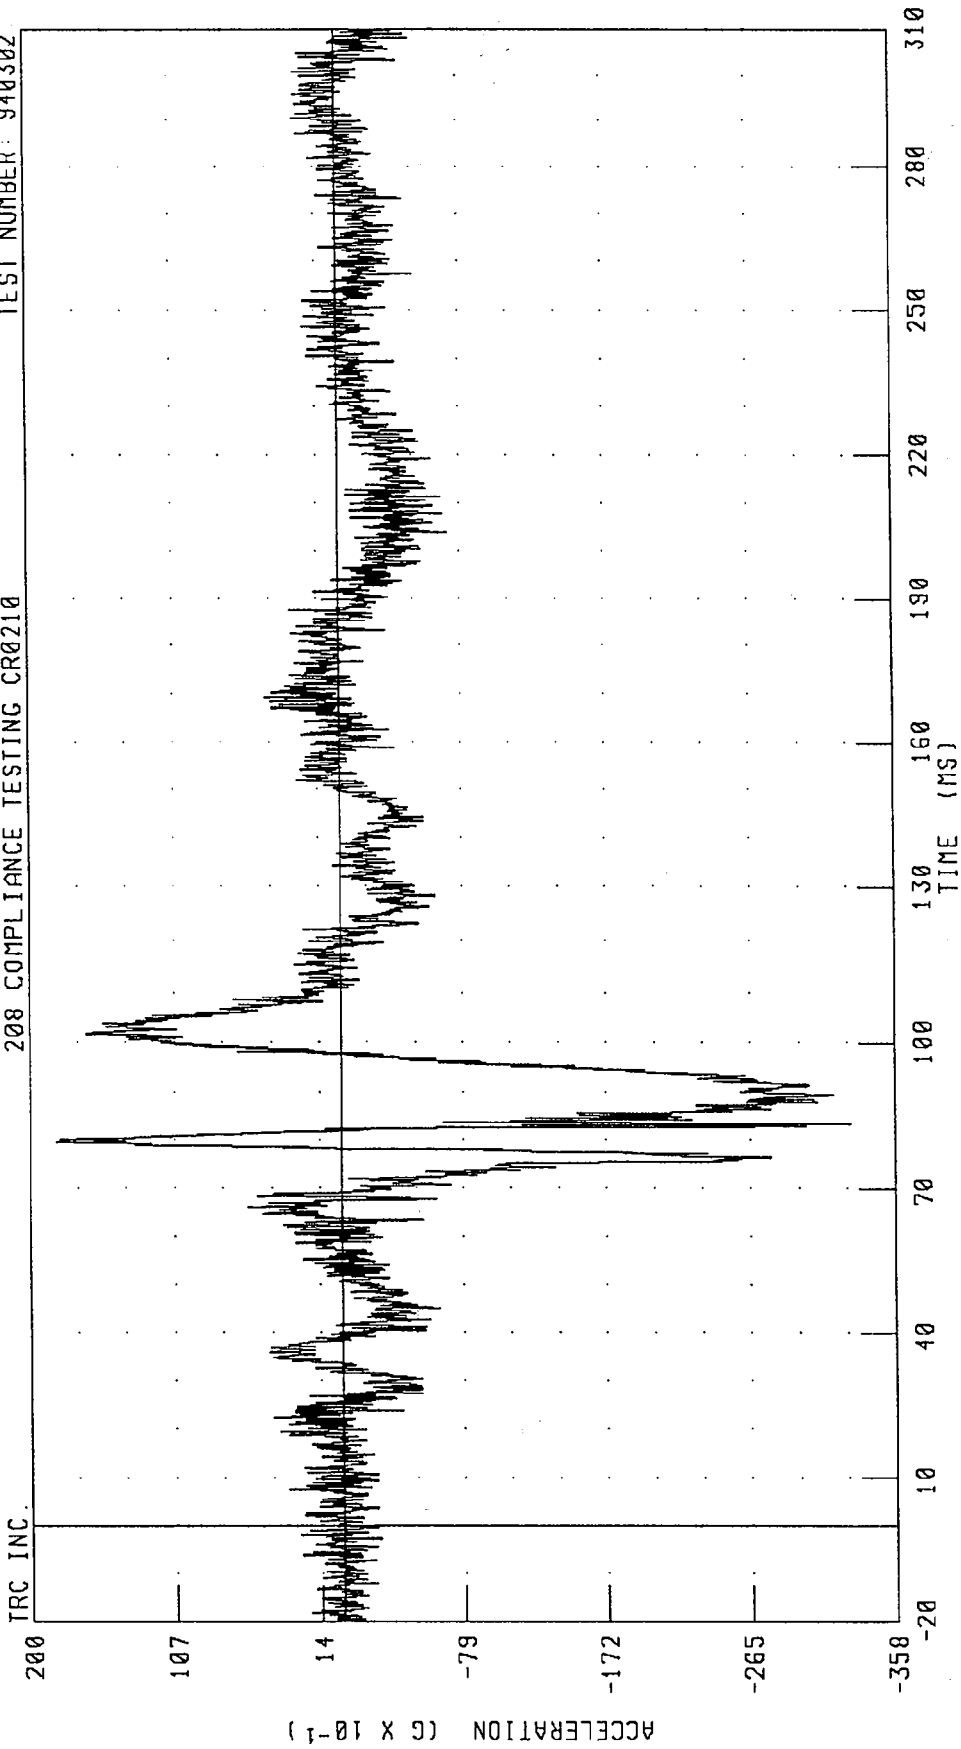
1994 FORD PROBE INTO FLAT FRONTAL BARRIER
DRIVER HEAD Z-AXIS ACCELERATION
208 COMPLIANCE TESTING CR0210

PEAK DATA: 18.30 G @ 79.60 MS; -32.97 G @ 83.36 MS

CHANNEL: HEDZG1 FILTER: CH. CLASS 1000

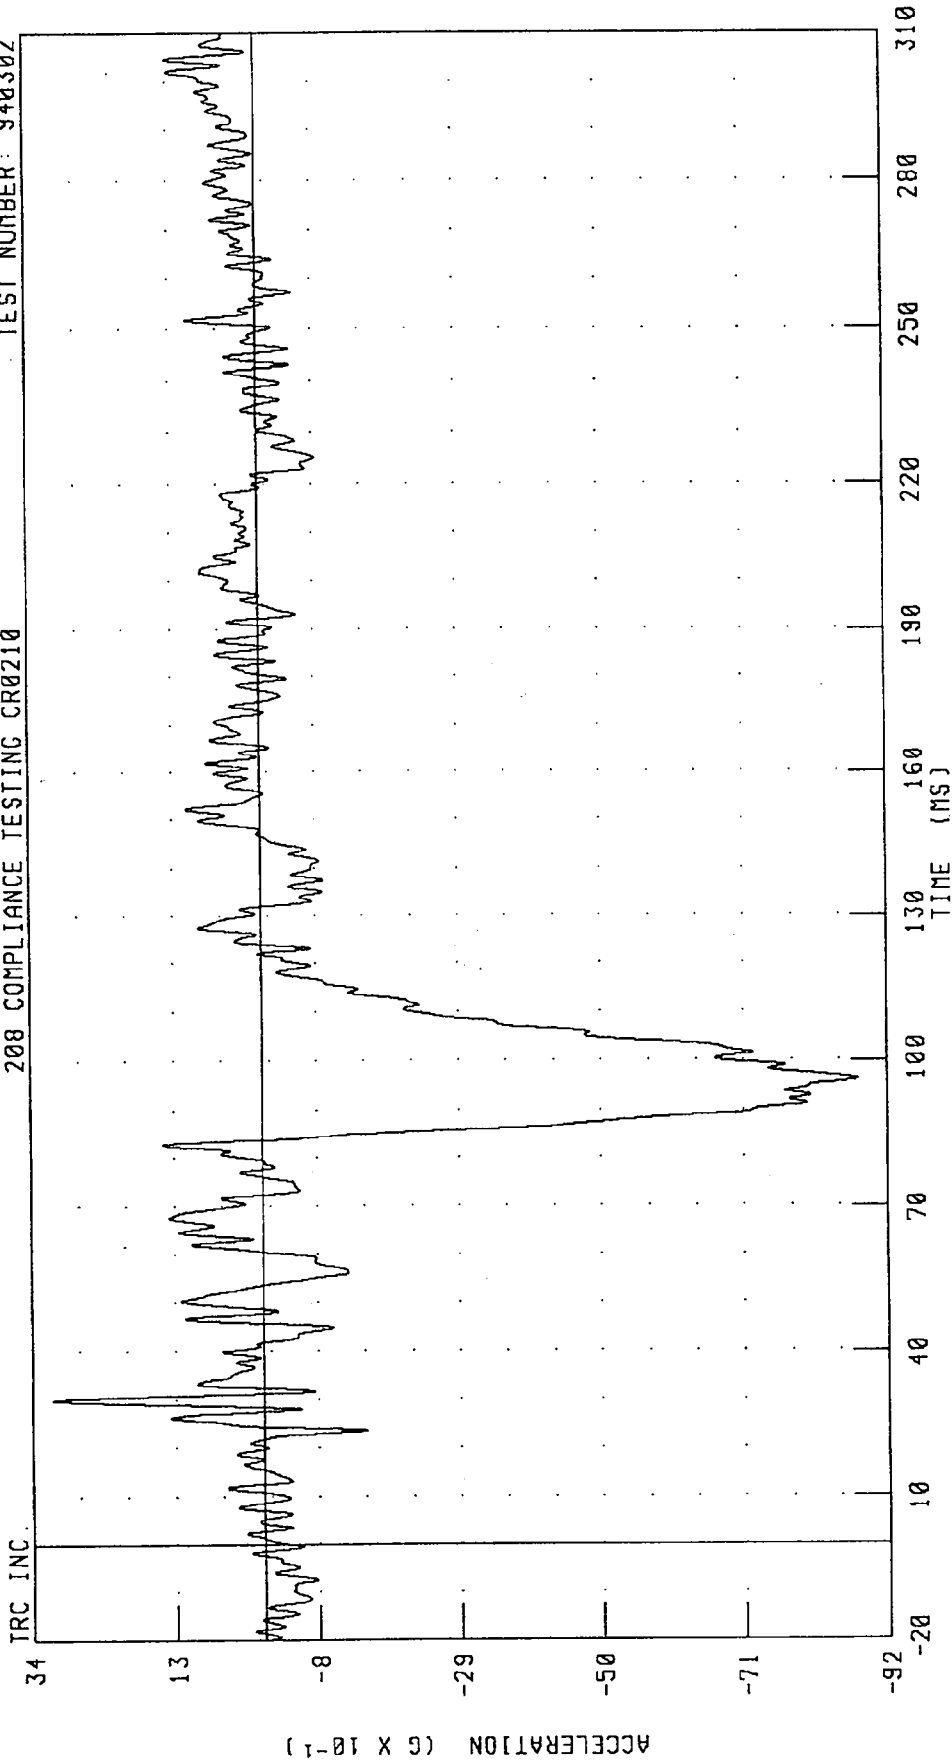
1994 FORD PROBE INTO FLAT FRONTAL BARRIER
DRIVER CHEST Y-AXIS ACCELERATION
208 COMPLIANCE TESTING CR0210

PEAK DATA: 3.10 G @ 30.00 MS; -8.77 G @ 96.16 MS

CHANNEL: CSTYG1 FILTER: CH. CLASS 180

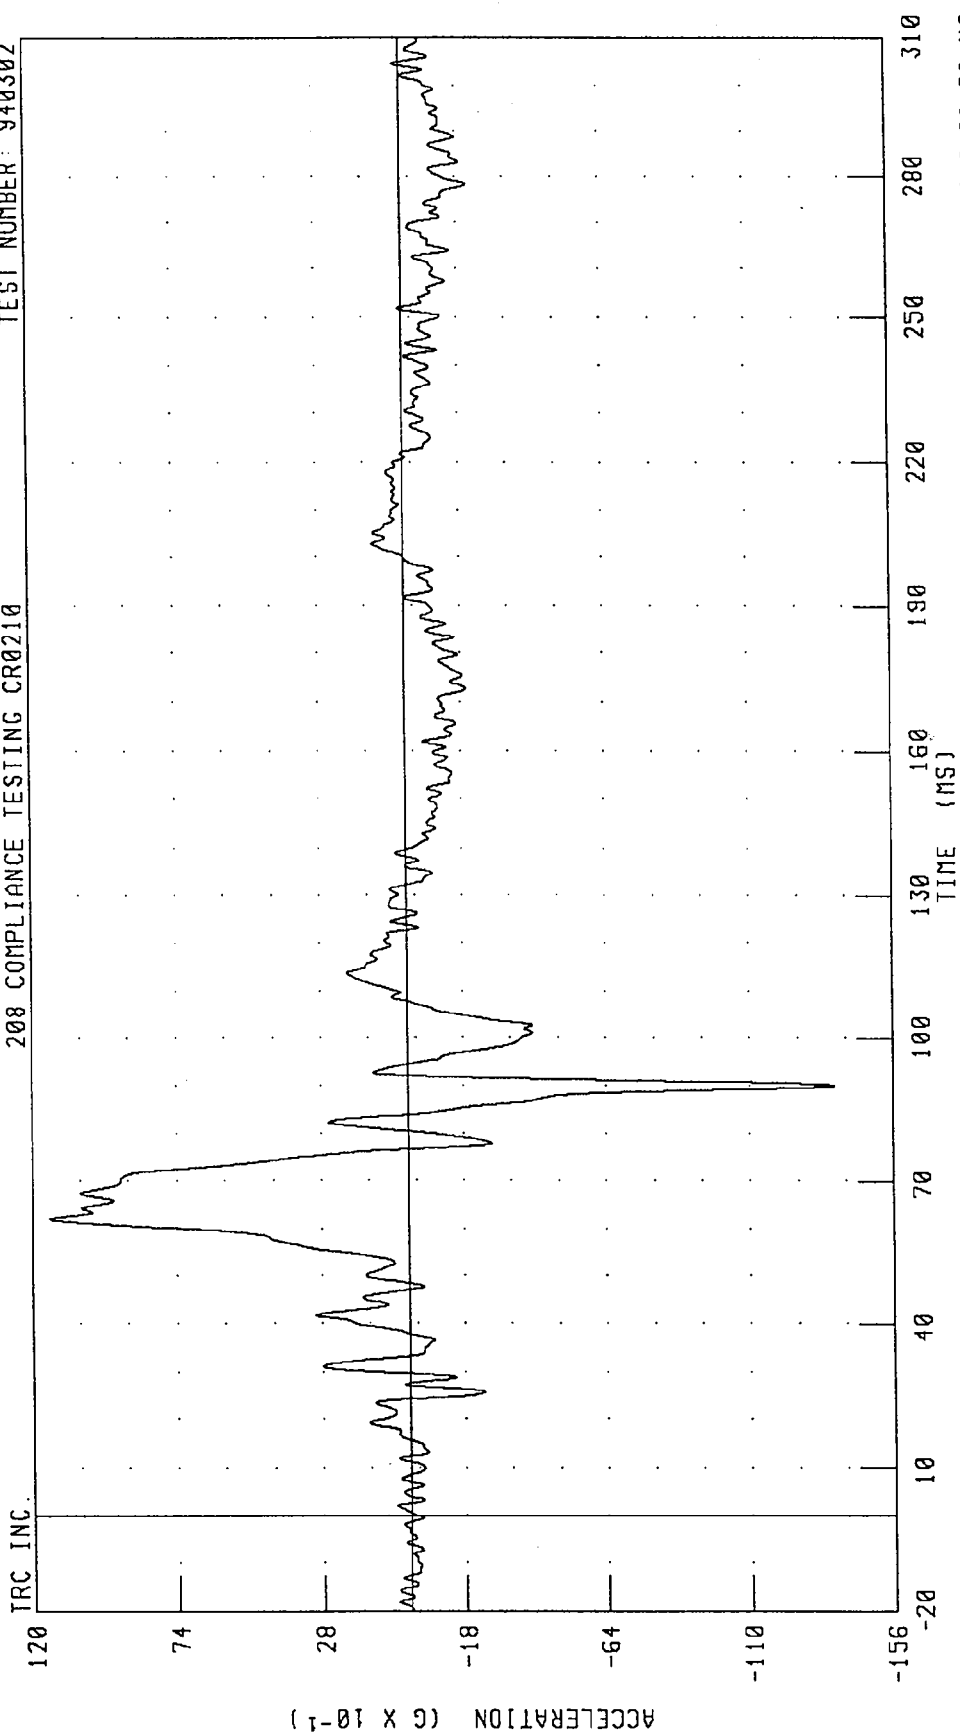
1994 FORD PROBE INTO FLAT FRONTAL BARRIER
DRIVER CHEST Z-AXIS ACCELERATION
208 COMPLIANCE TESTING CR0210

CHANNEL: CSTZG1 FILTER: CH. CLASS 180

PEAK DATA: 11.46 G @ 62.16 MS; -13.70 G @ 90.00 MS

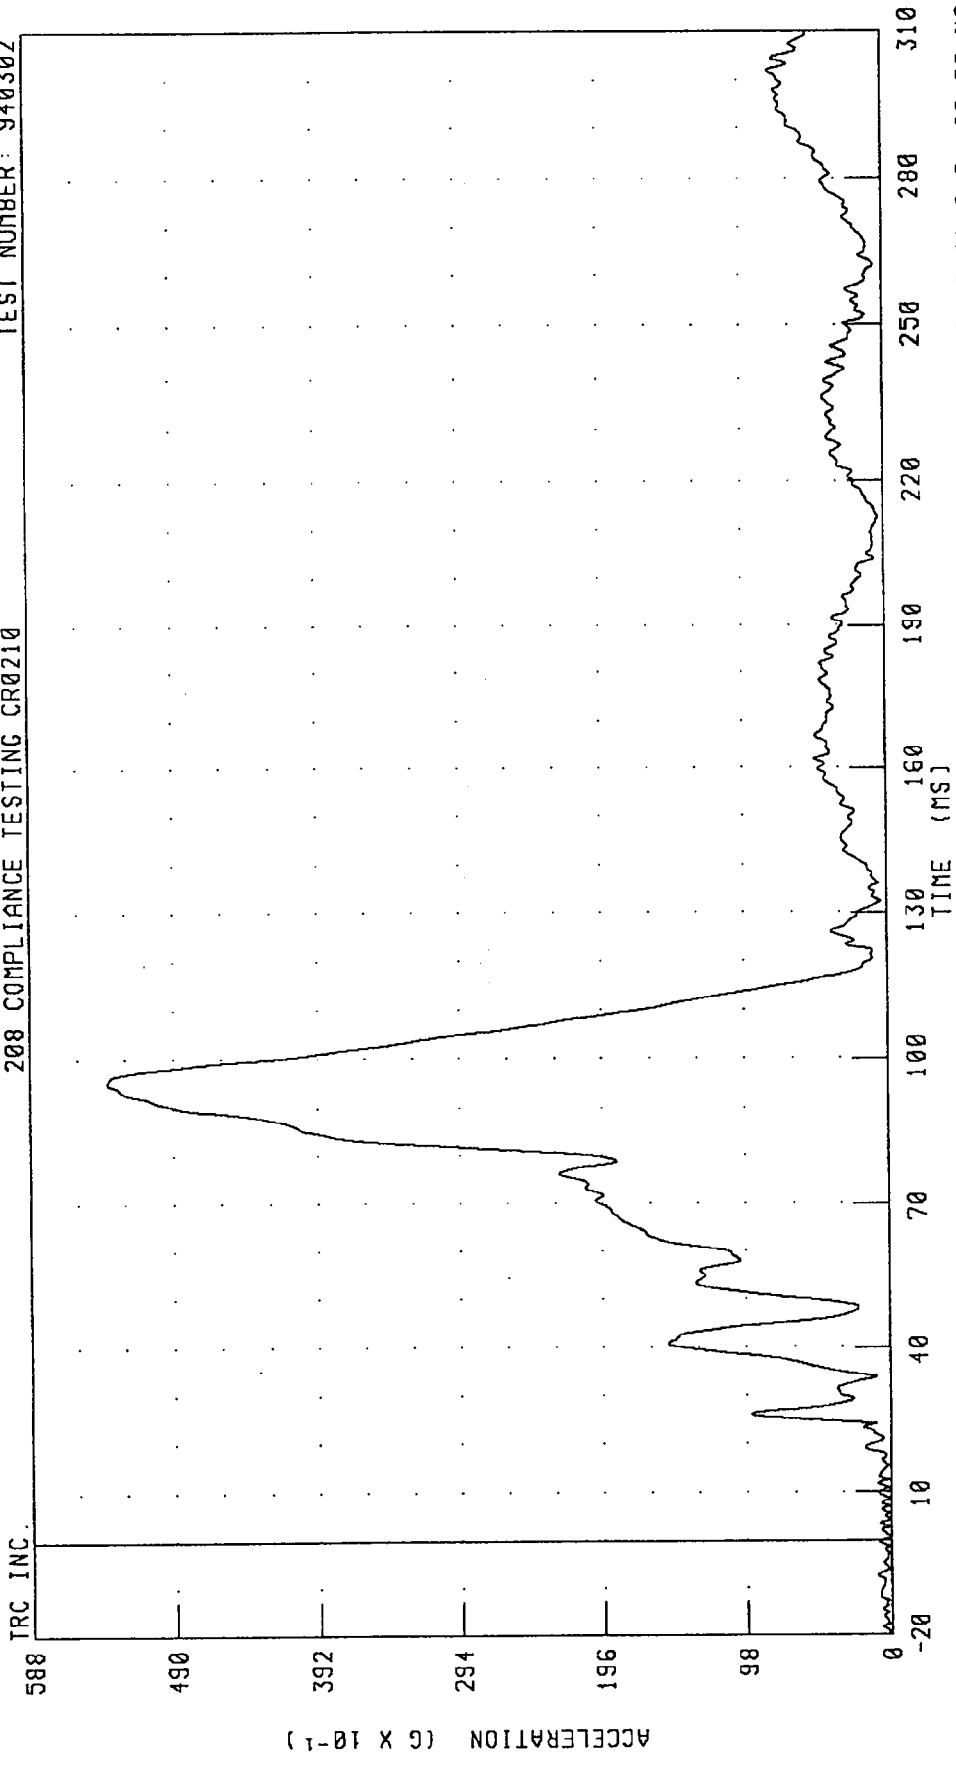
1984 FORD PROBE INTO FLAT FRONTAL BARRIER
DRIVER CHEST RESULTANT ACCELERATION
208 COMPLIANCE TESTING CR0210

The driver's HIC was 341. The driver's chest maximum resultant acceleration with three (3) milliseconds minimum duration was 52.7 g. The driver's left and right femur maximum compressive forces were 1248 pounds and 1349 pounds, respectively.

PEAK DATA: 53.46 G @ 95.12 MS; 0.01 G @ -20.00 MS

CHANNEL: CSTRG1 FILTER: CH. CLASS 180

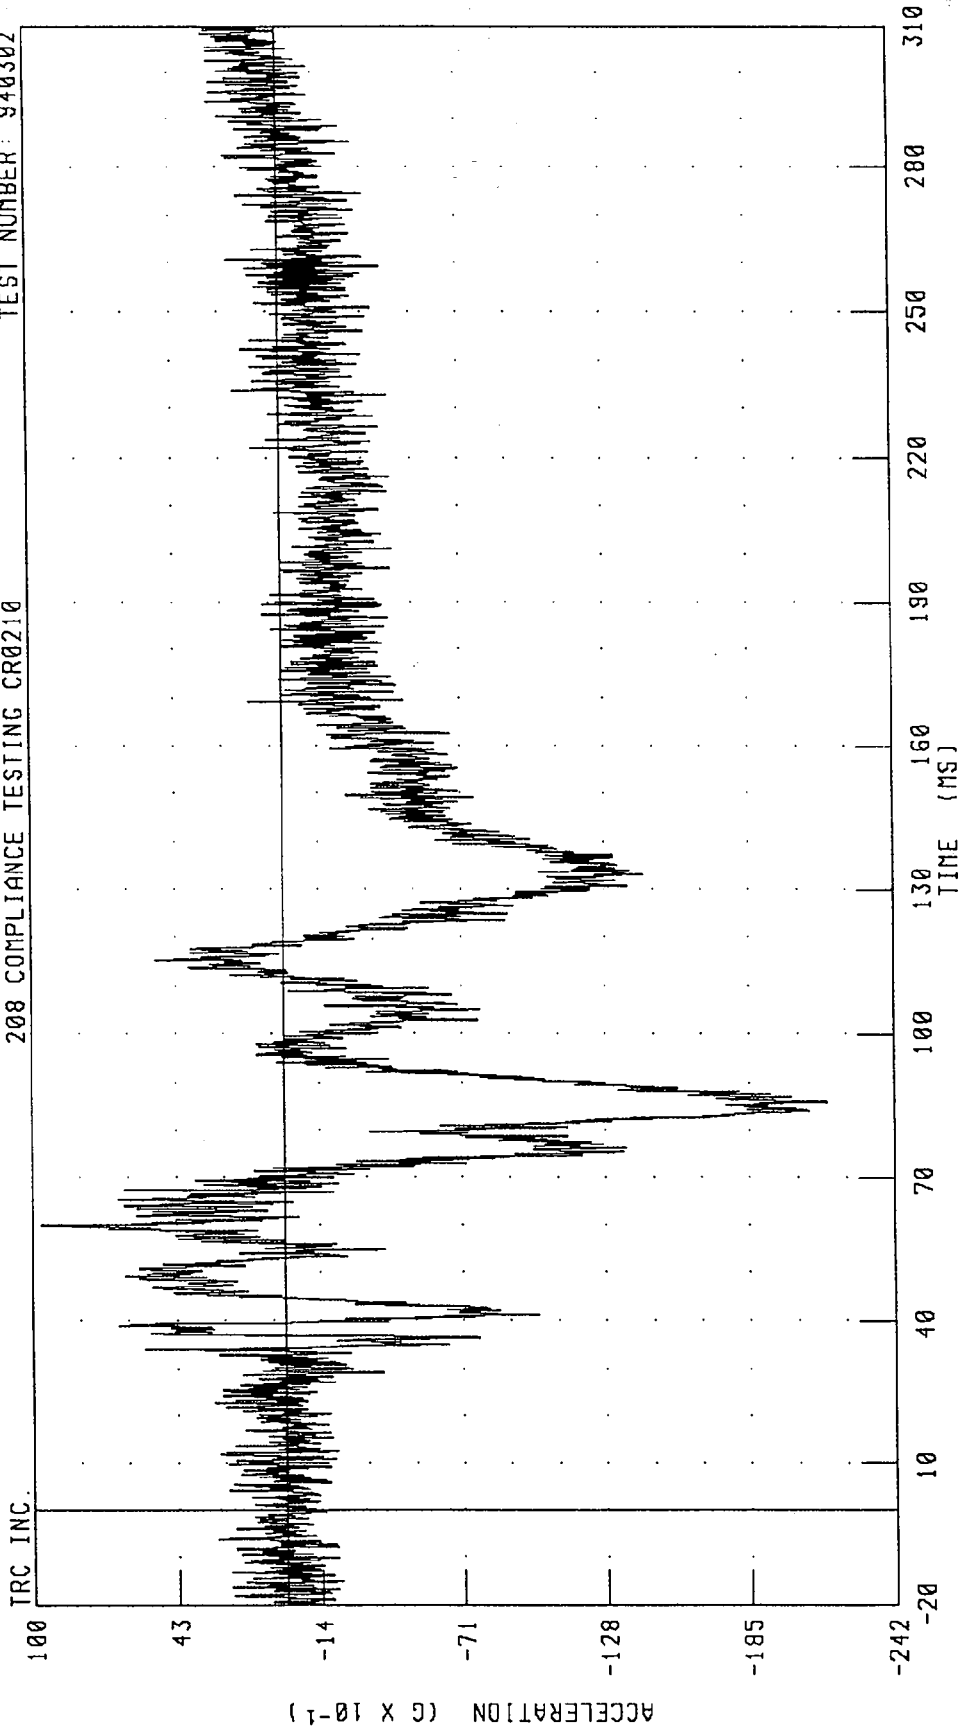
1984 FORD PROBE INTO FLAT FRONTAL BARRIER
RIGHT FRONT PASSENGER HEAD Z-AXIS ACCELERATION
208 COMPLIANCE TESTING CR0210

CHANNEL: HEDZG2 FILTER: CH. CLASS 1000 PEAK DATA: 9.64 G @ 59.92 MS; -21.55 G @ 86.08 MS

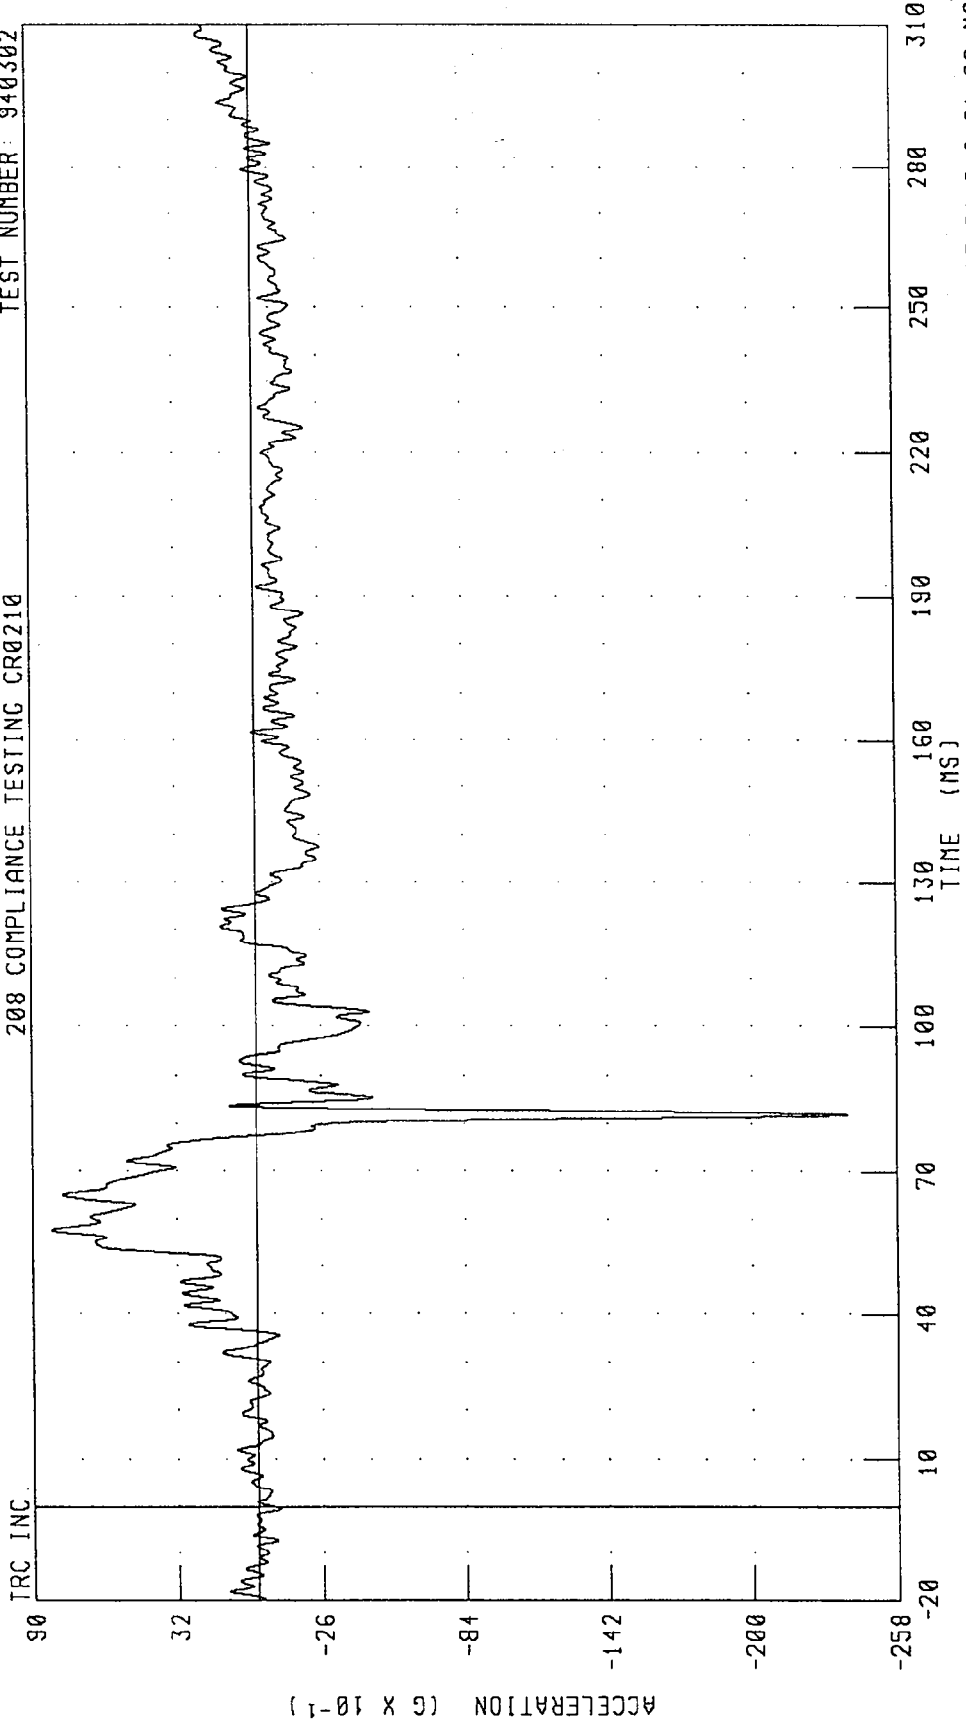
1994 FORD PROBE INTO FLAT FRONTAL BARRIER
RIGHT FRONT PASSENGER CHEST Z-AXIS ACCELERATION
208 COMPLIANCE TESTING CR0210

PEAK DATA: 8.27 G @ 57.68 MS, -23.81 G @ 81.92 MS

CHANNEL: CSTZG2 FILTER: CH. CLASS 180

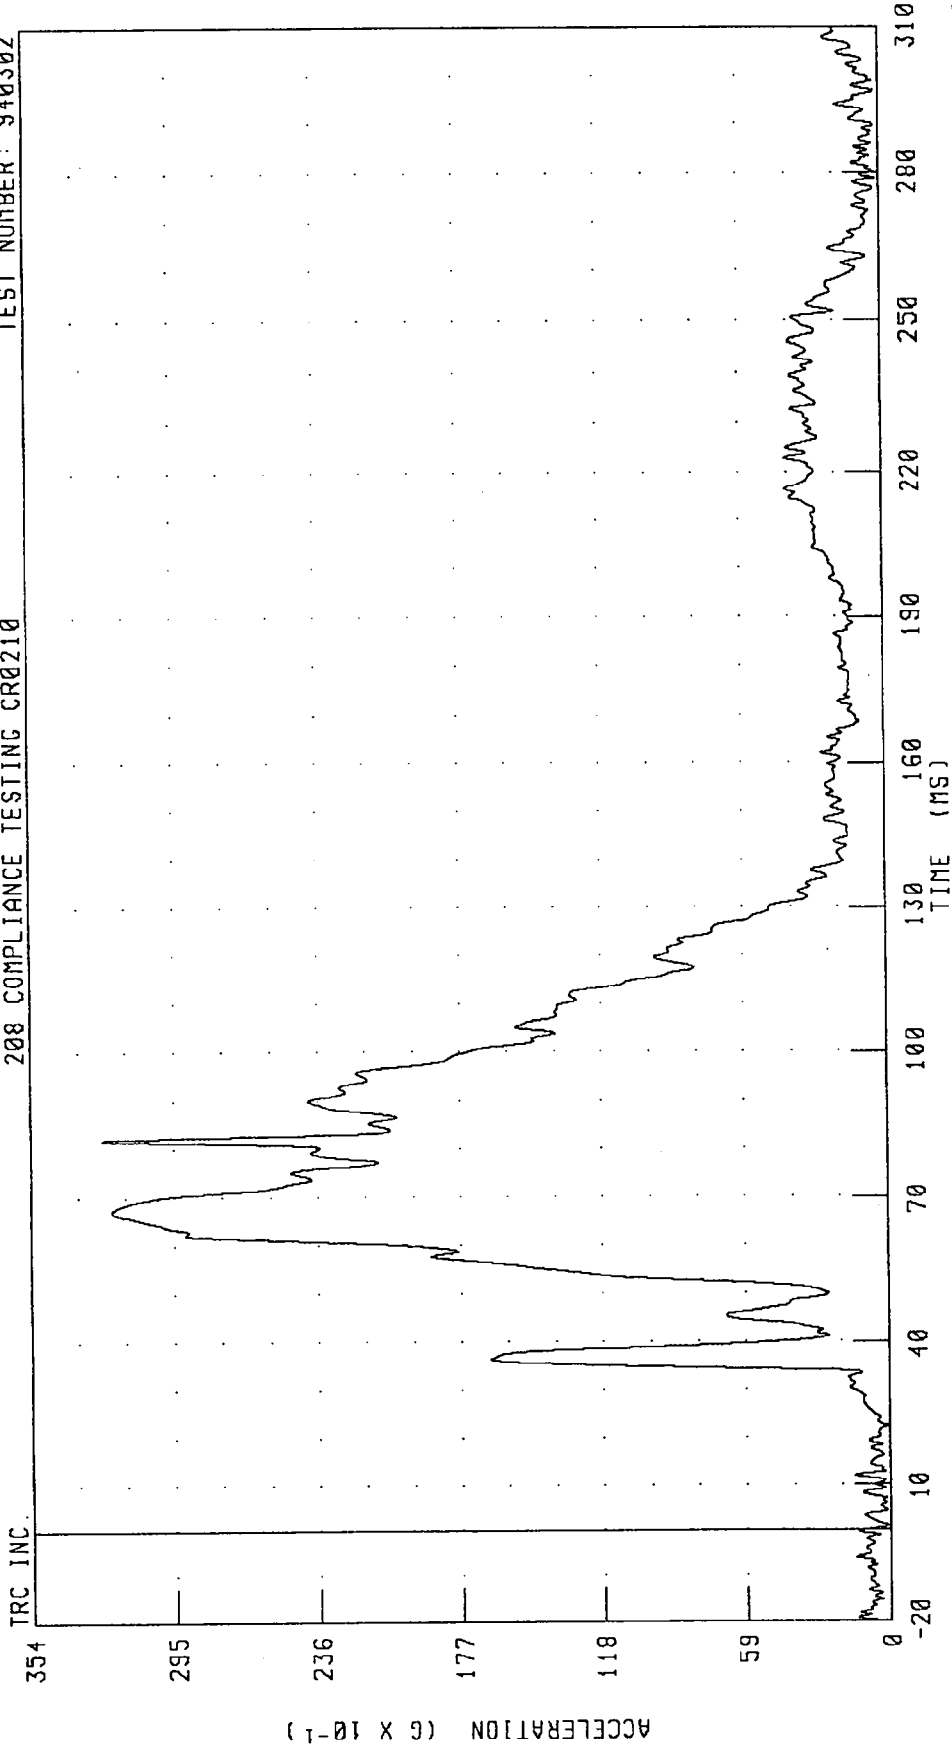
1994 FORD PROBE INTO FLAT FRONTAL BARRIER
RIGHT FRONT PASSENGER CHEST RESULTANT ACCELERATION
208 COMPLIANCE TESTING CR0210

The right front passenger's HIC was 107. The right front passenger's chest maximum resultant acceleration with three (3) milliseconds minimum duration was 31.4 g. The right front passenger's left and right femur maximum compressive forces were 1407 pounds and 1641 pounds, respectively.

PEAK DATA: 32.44 G @ 81.92 MS; 0.09 G @ 22.48 MS

CHANNEL: CSTRG2 FILTER: CH. CLASS 180

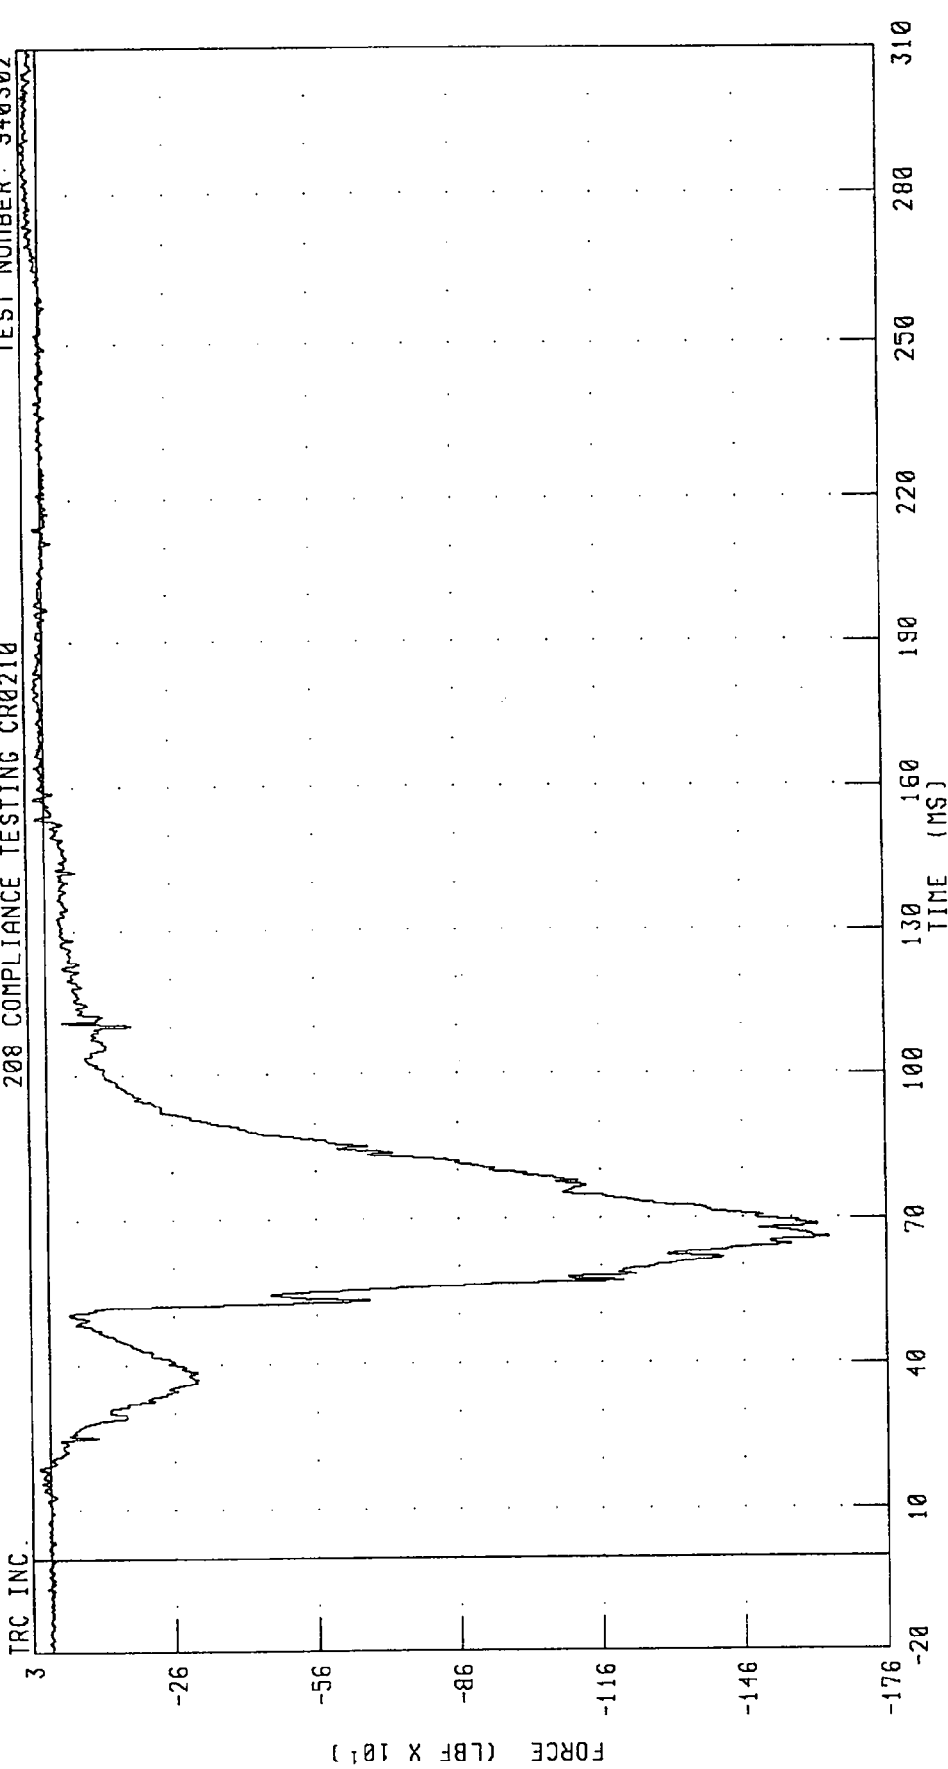
PEAK DATA: 35.06 LBF @ 288.72 MS, -1641.30 LBF @ 65.92 MS

CHANNEL: RFMF2 FILTER: CH. CLASS 600

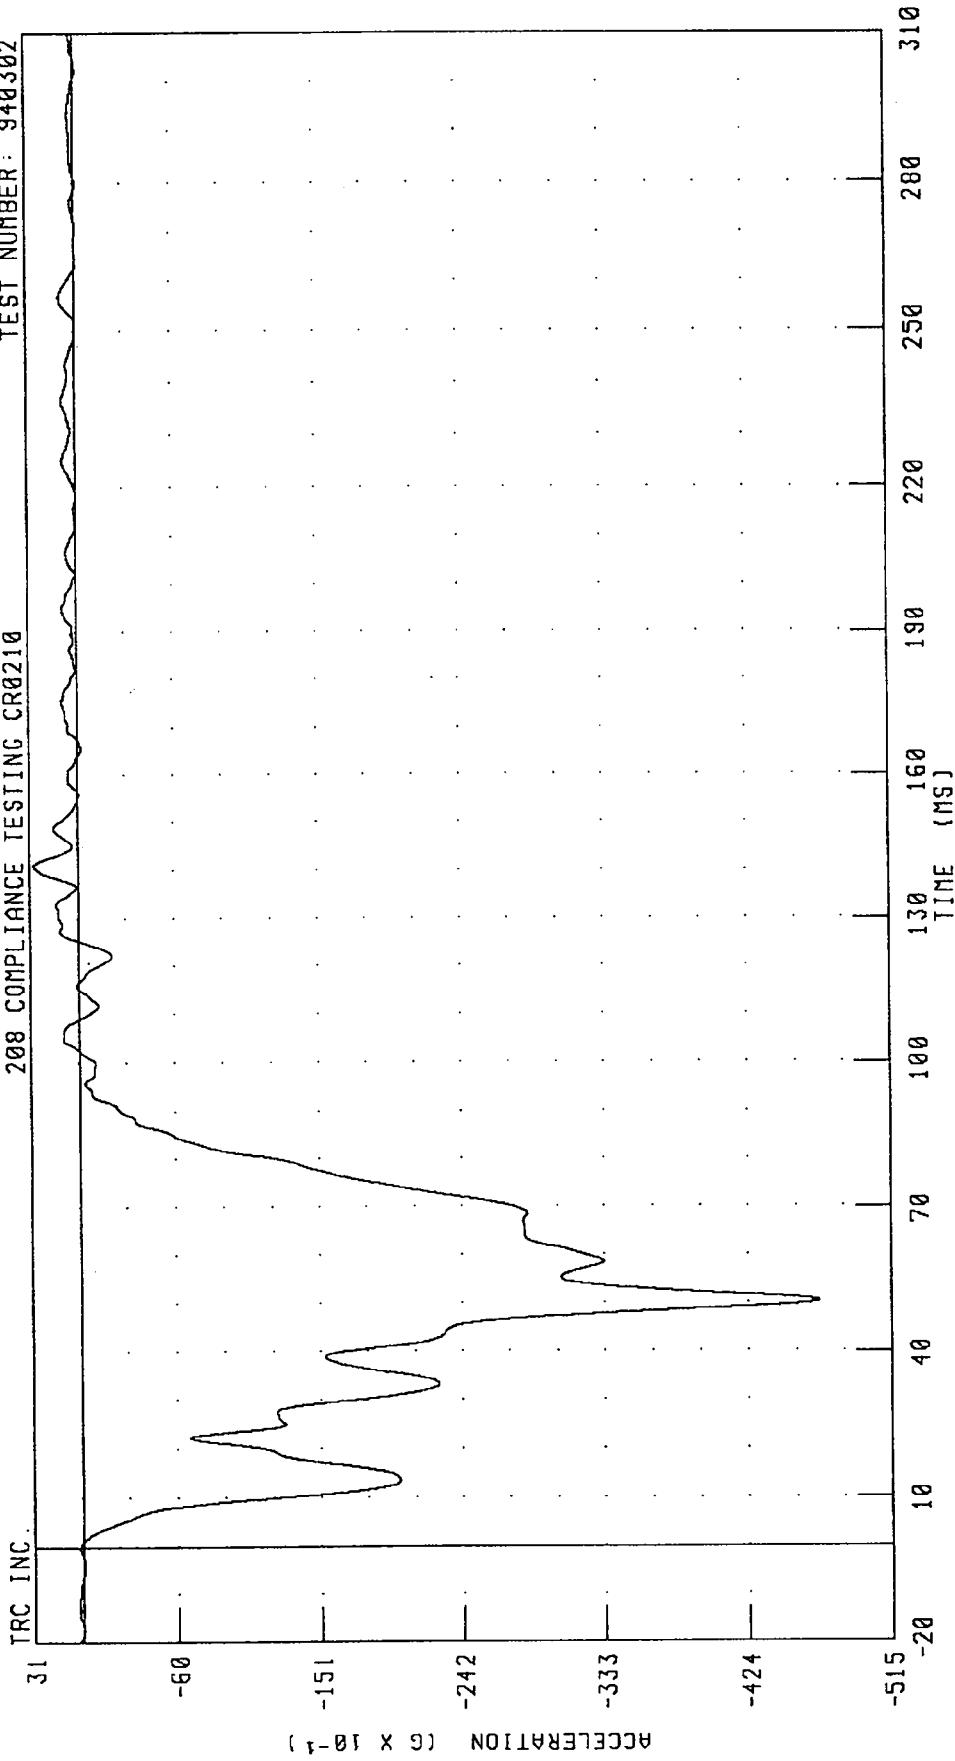
1994 FORD PROBE INTO FLAT FRONTAL BARRIER
RIGHT REAR SEAT X-AXIS ACCELERATION
208 COMPLIANCE TESTING CR0210

PEAK DATA: 2.83 G @ 141.28 MS; -46.89 G @ 50.40 MS

CHANNEL: TRRXG1 FILTER: CH. CLASS 60

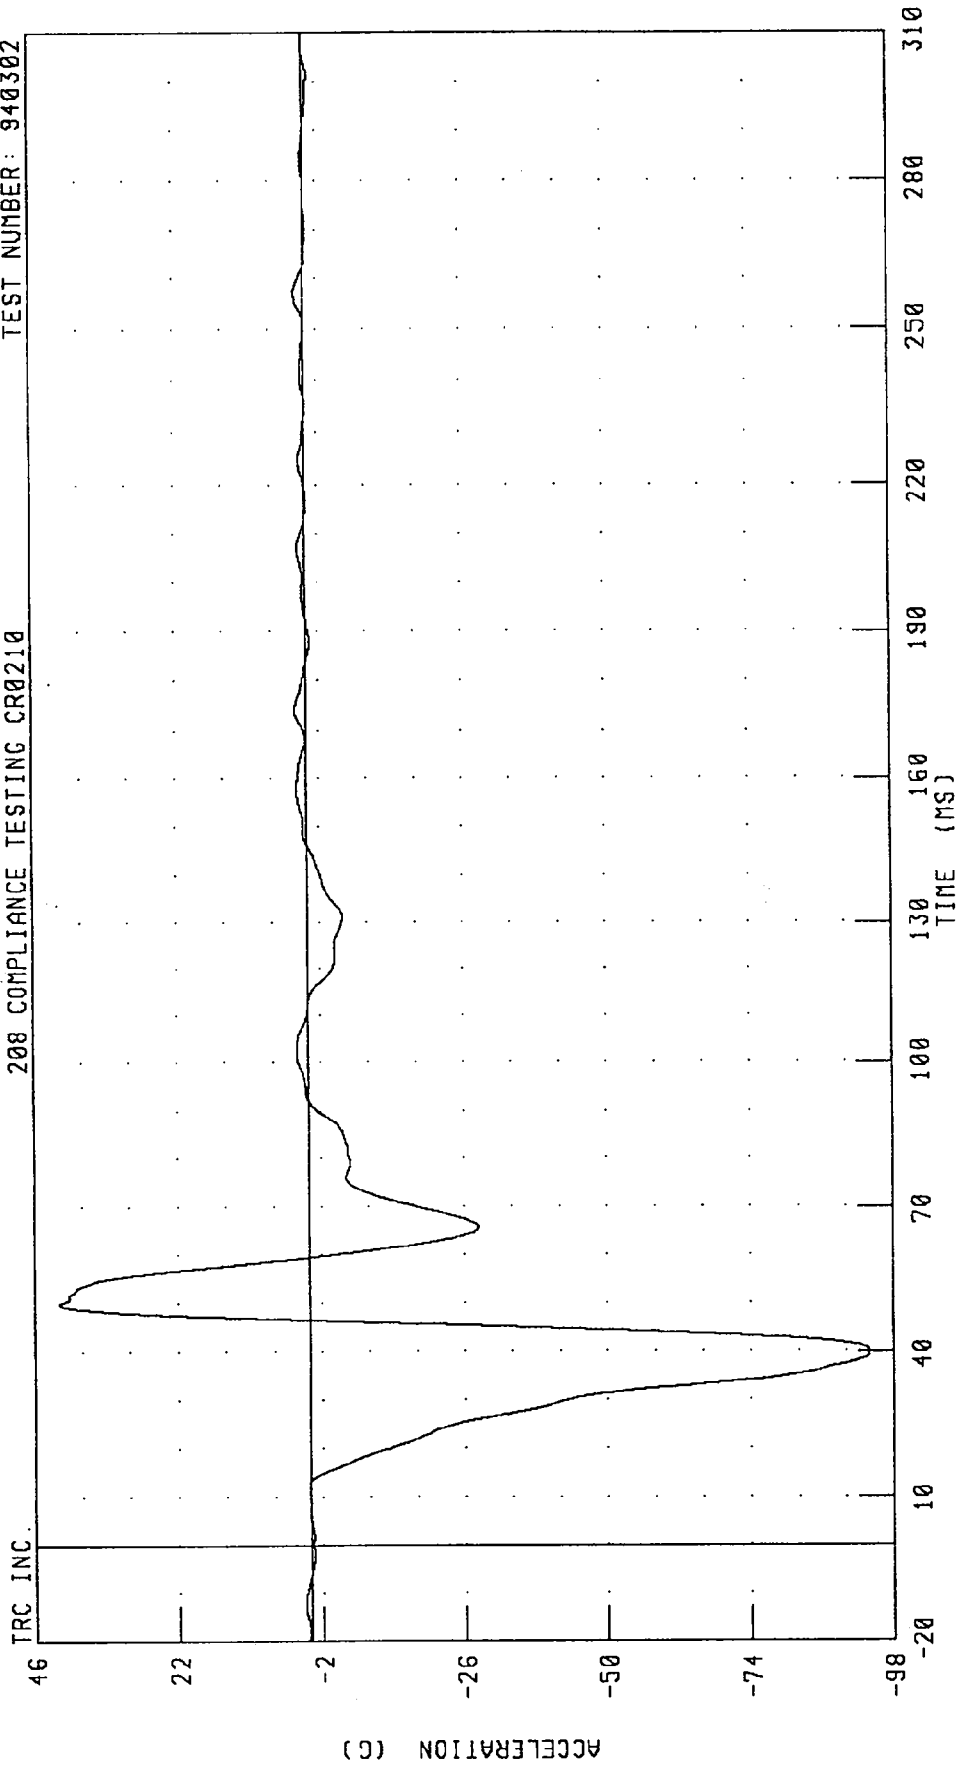
1994 FORD PROBE INTO FLAT FRONTAL BARRIER
ENGINE BOTTOM BLOCK X-AXIS ACCELERATION
208 COMPLIANCE TESTING CR0210

CHANNEL: ENXG2 FILTER: CH. CLASS 60

PEAK DATA: 41.93 G @ 50.00 MS; -93.95 G @ 39.60 MS
