REPORT NO. MSE-94-06

NEW CAR ASSESSMENT PROGRAM
FRONTAL BARRIER IMPACT TEST

FORD MOTOR COMPANY
1994 FORD PROBE 2 DOOR COUPE
NHTSA No. MR0201

FINAL REPORT

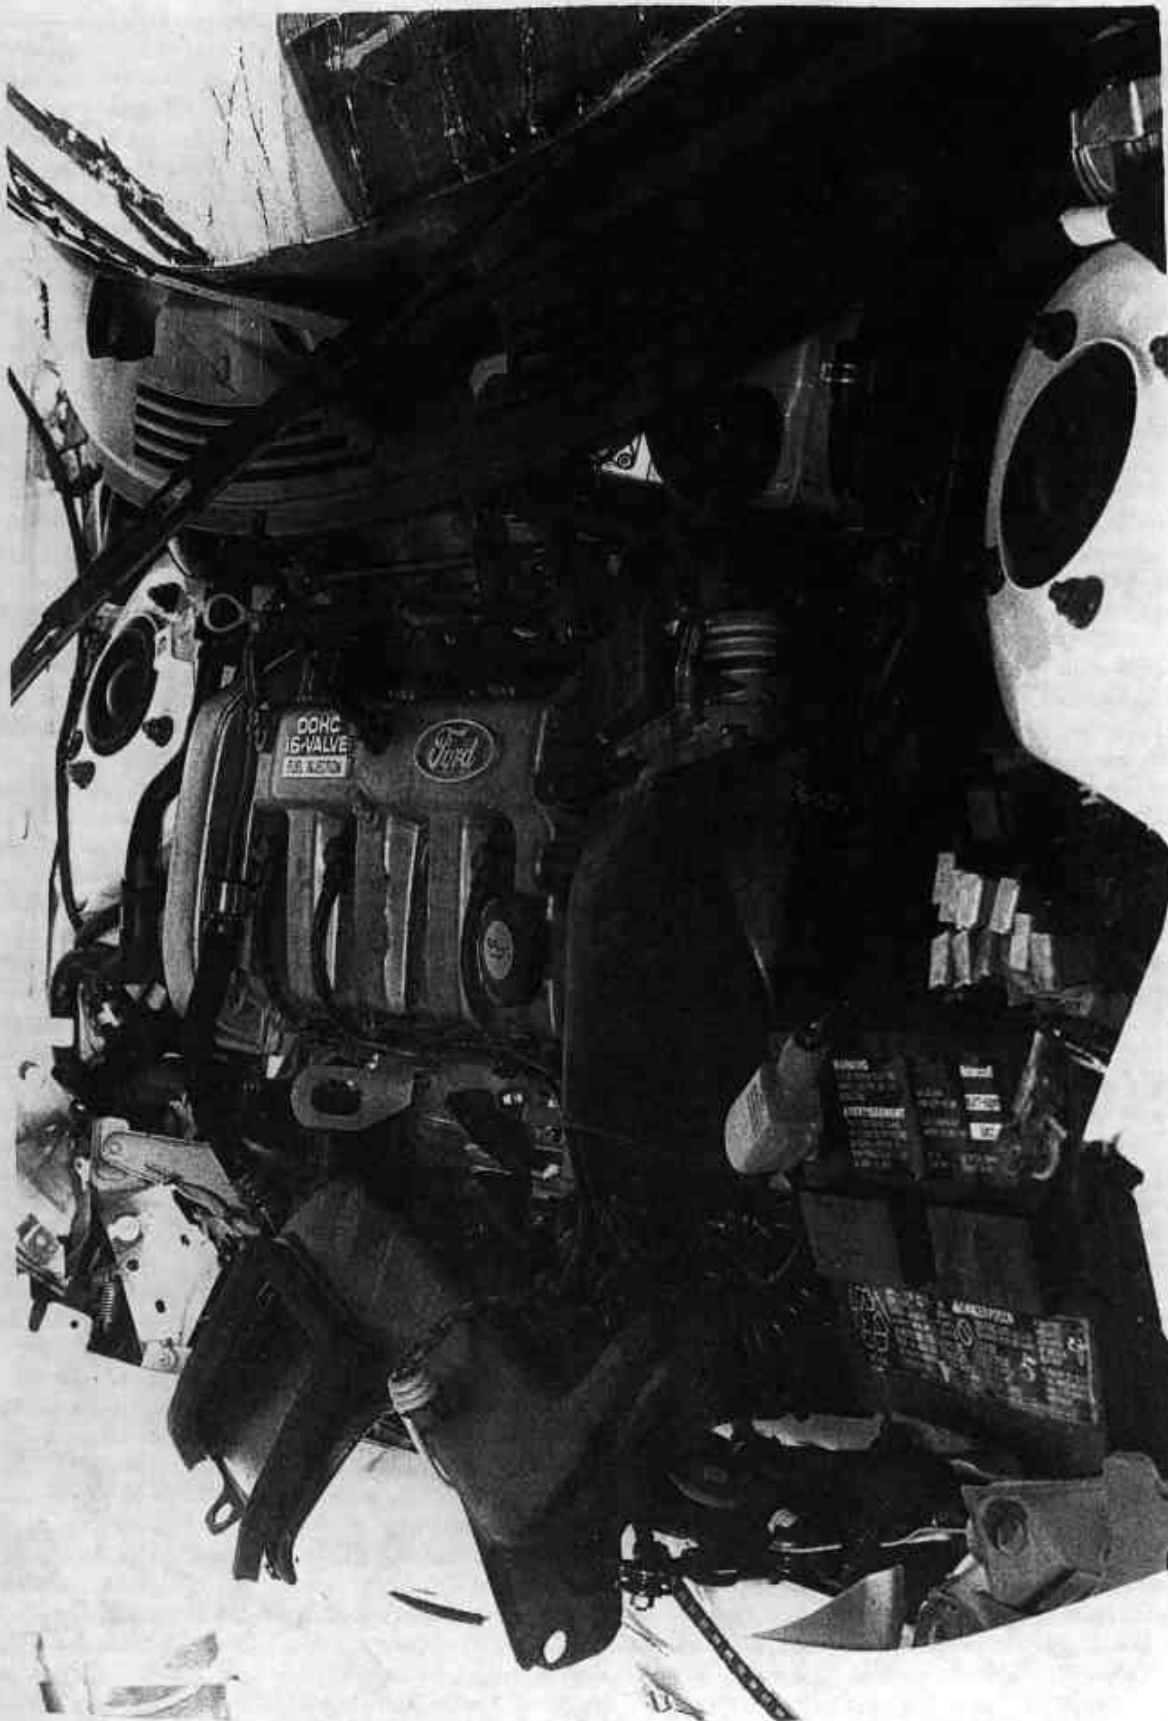
POSTTEST ENGINE COMPARTMENT VIEW

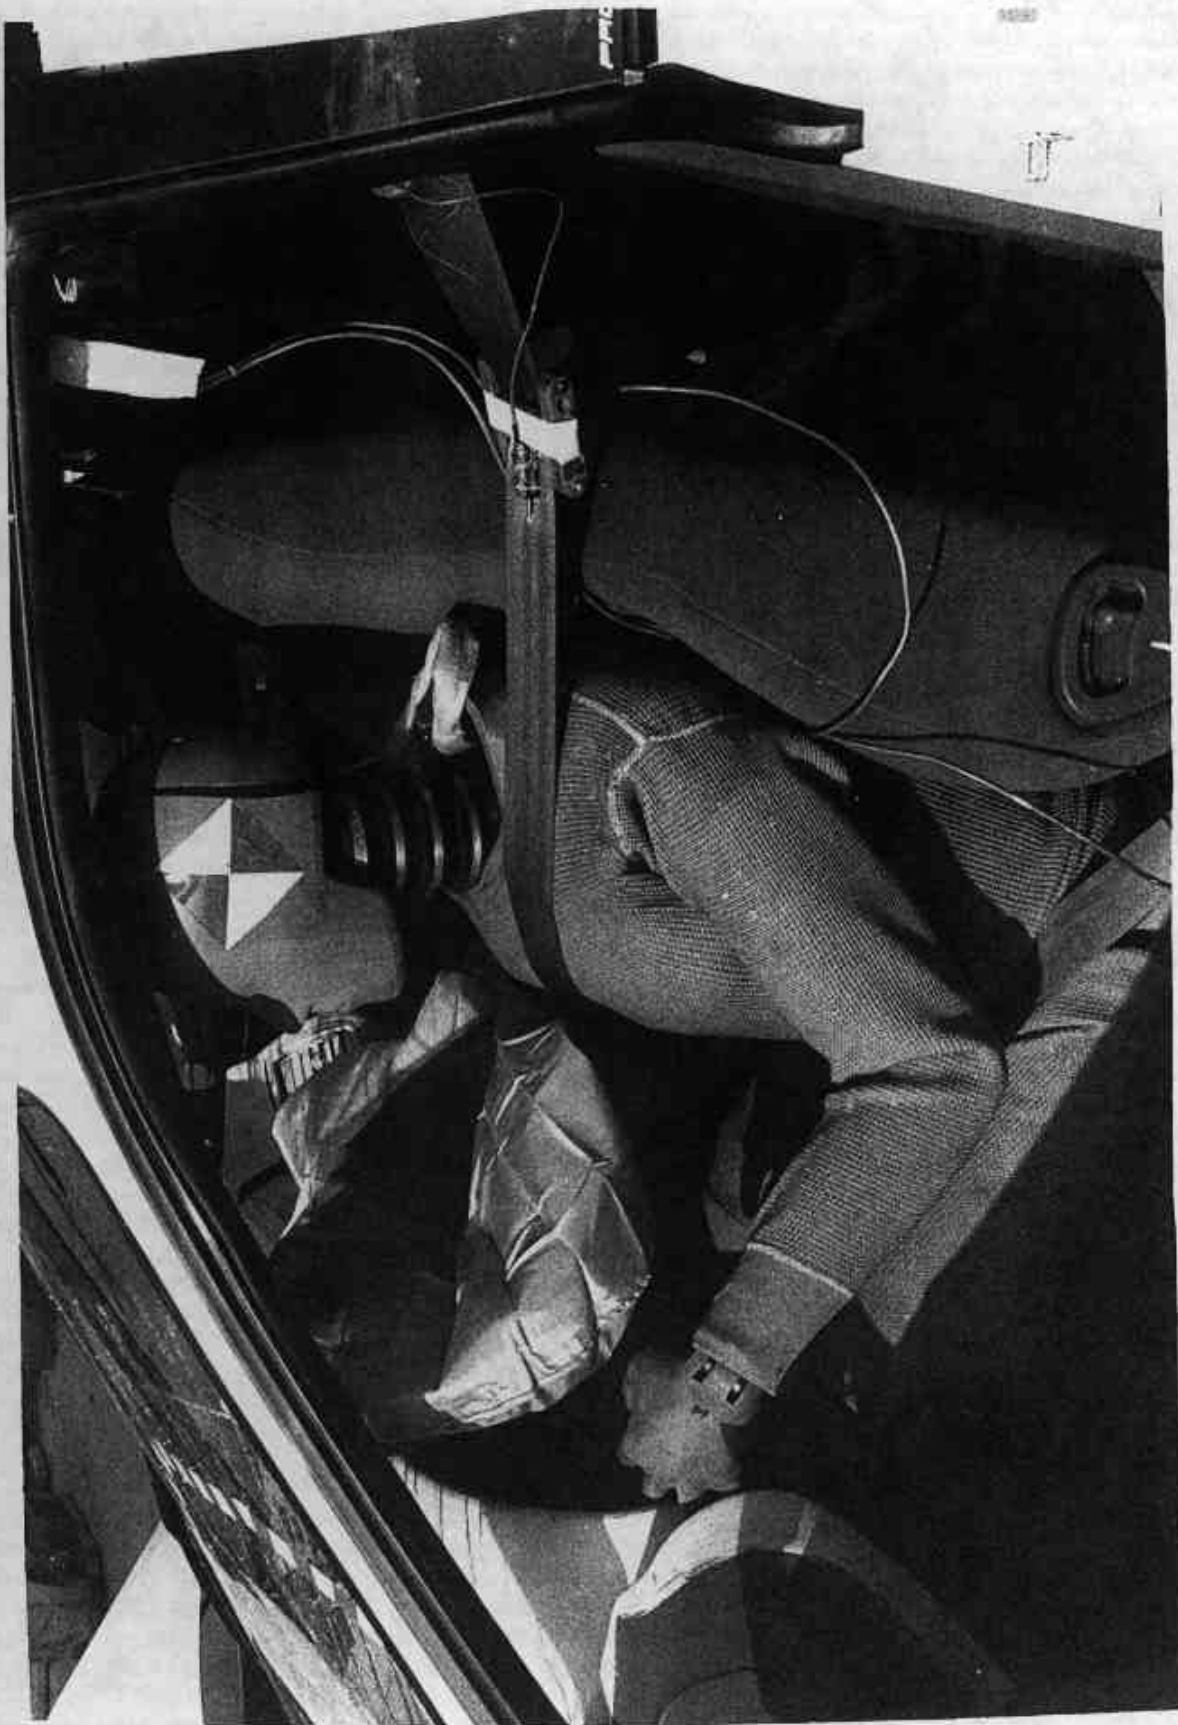
POSTTEST DRIVER ATD & VEHICLE INTERIOR
VIEW (DOOR OPEN)

* Lap Belt stitching tore loose at mount, Driver seat broke loose from mounting on right side.

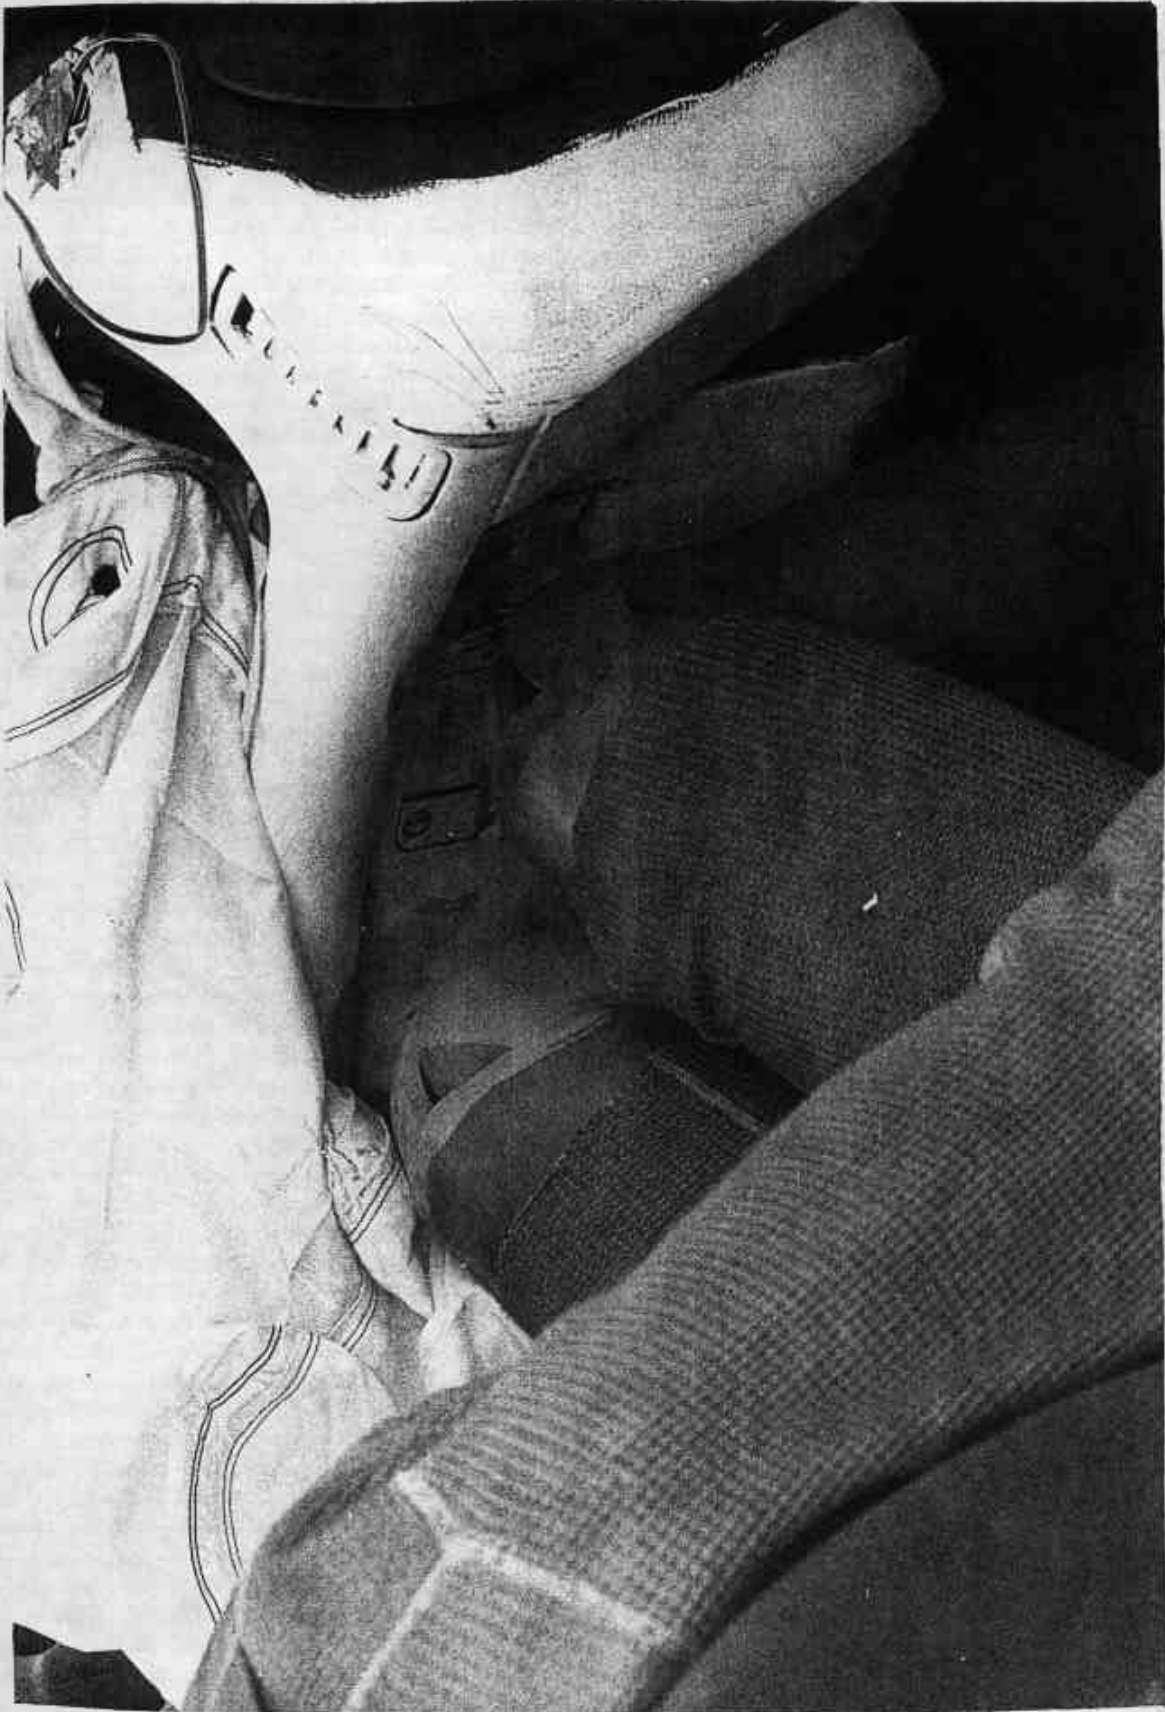
POSTEST PASSENGER ATD KNEE CONTACT AREA
