**National Highway
Traffic Safety
Administration**

DOT HS 808 300

October 1993

Final Report of a 1992 Dodge Ram B250 Van Rear Impact CNG Fuel Tank Integrity

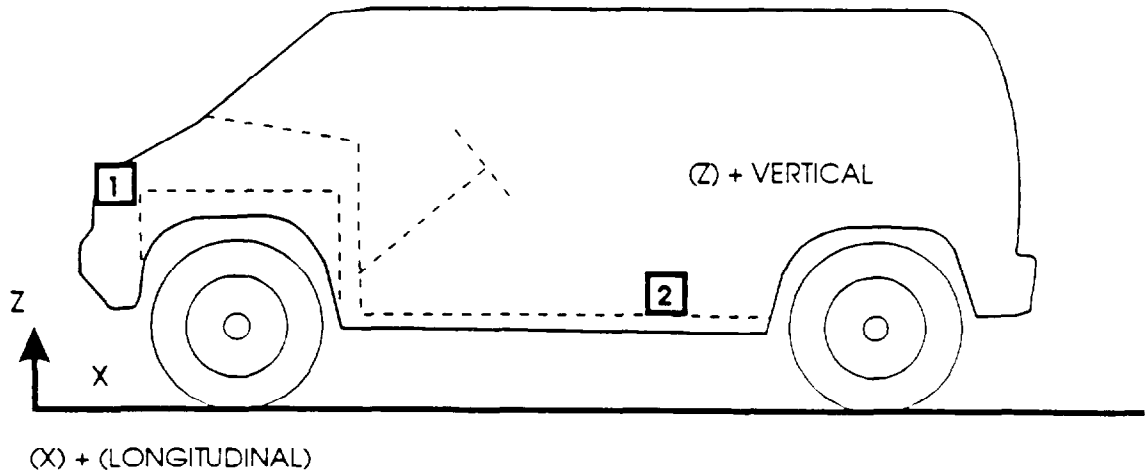
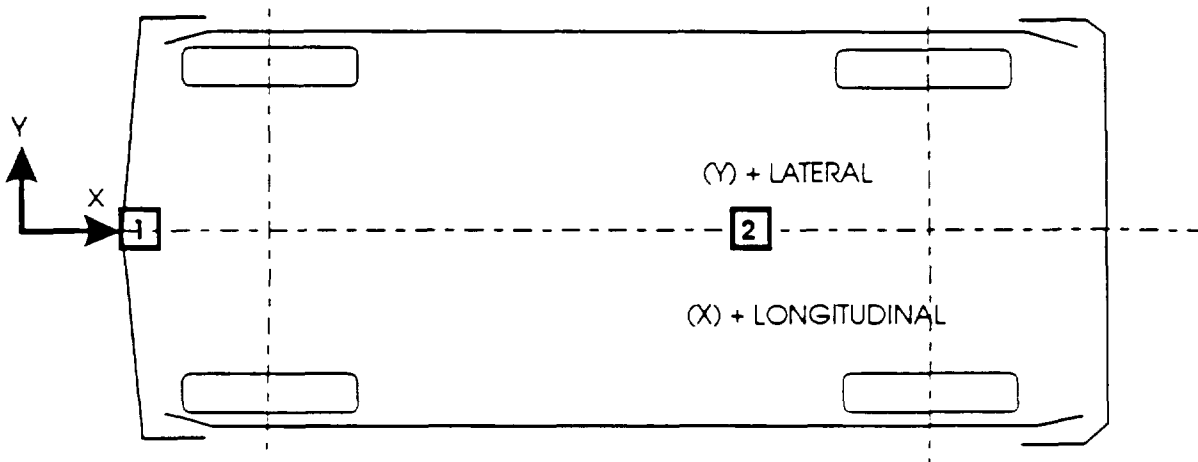
FIGURE 3 VEHICLE ACCELEROMETER PLACEMENT

SIDE VIEW

BOTTOM VIEW

No. LOCATION	X*	Y*	Z*	POSITIVE DIRECTION MAX G MSEC	NEGATIVE DIRECTION MAX G MSEC
1 FRONT FRAME CROSSMEMBER	190.6	0.0	39.0		
LONGITUDINAL				41.2 34.8	23.4 57.0
LATERAL				4.9 32.8	5.3 75.0
VERTICAL				22.9 26.6	17.5 34.1
RESULTANT				44.5 34.5	
2 VEHICLE CENTER OF GRAVITY	136.0	0.0	23.9		
LONGITUDINAL ¹				---	---
LATERAL ¹				4.8 1.0	112.6 6.9
VERTICAL ¹				214.7 7.5	9.7 92.3
RESULTANT ¹				---	---

REFERENCE: X: + FORWARD FROM REAR BUMPER
 Y: + LEFTWARD FROM VEHICLE CENTERLINE
 Z: + UPWARD FROM GROUND LEVEL

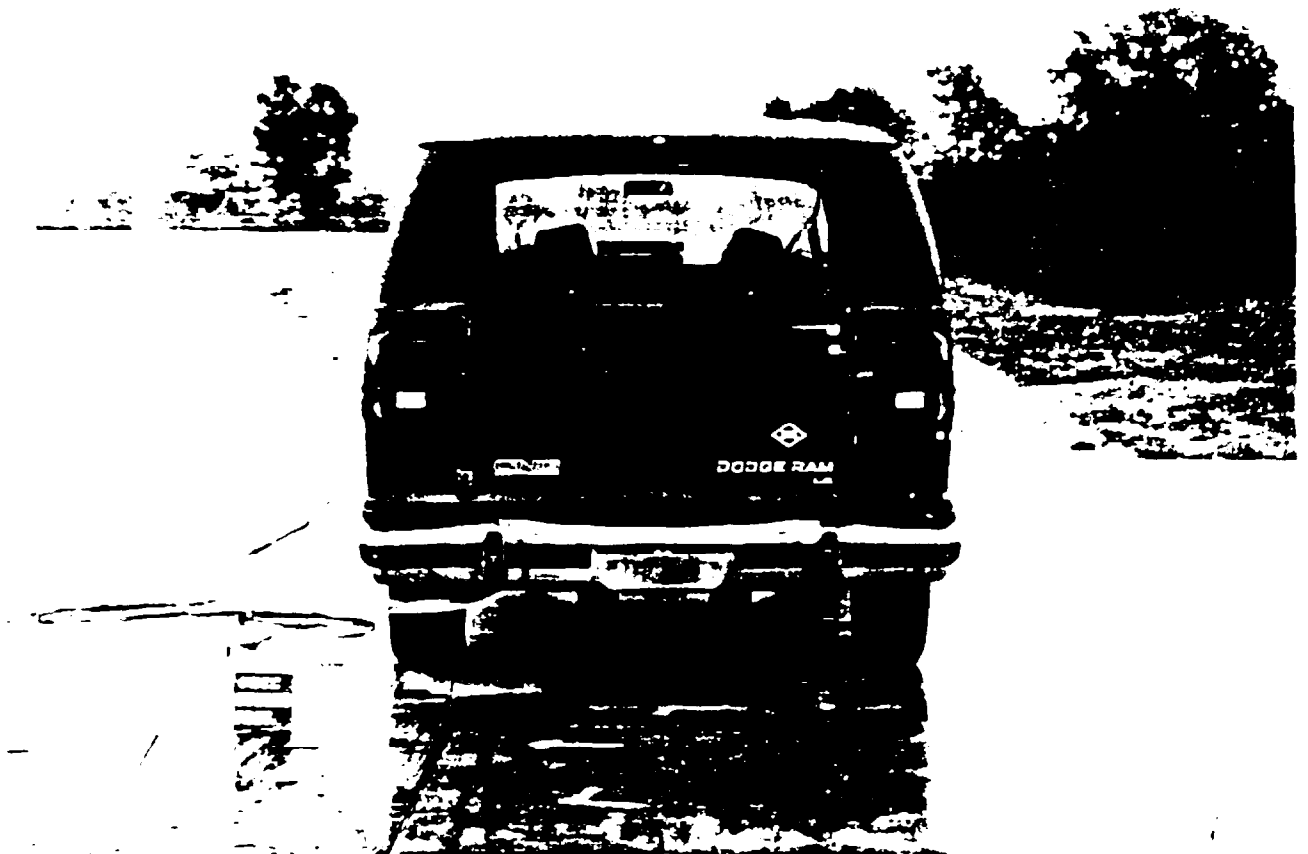
Figure A-6. POST-TEST REAR VIEW

The rear window and two side windows broke during
the crash.

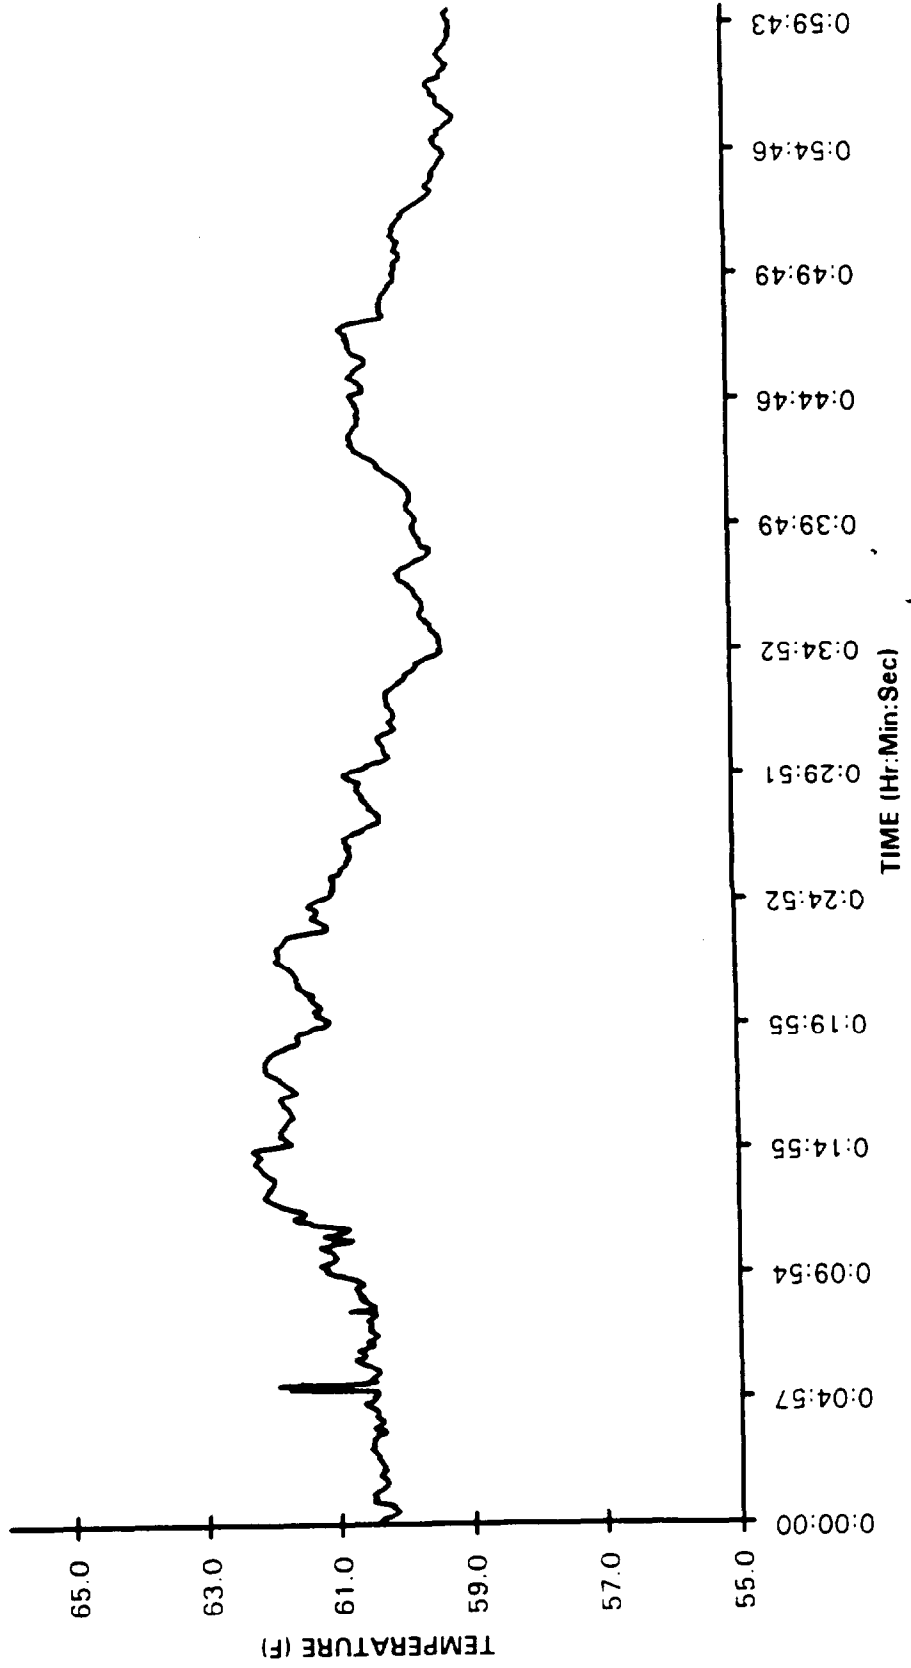
1992 DODGE B250 VAN REAR IMPACT
OUTSIDE AMBIENT TEMPERATURE
CNG FUEL TANK INTEGRITY

See DATA ACQUISITION EXPLANATIONS

All of the temperature channels recorded anomalous spikes at 5 minutes and at 8 minutes after impact.
