MOVING BARRIER
INTO THE LEFT SIDE OF A
1985 FORD F150 PICKUP TRUCK
TRC TEST NO. 921217-1

FINAL REPORT
DECEMBER 1992 - JANUARY 1993

1. Report No. 921217-1	2. Government Accession No.	3. Recipient's Catalog No. VRTC-73-0282 (EA92-041)	
4. Title and Subtitle FINAL REPORT OF FMVSS 301 COMPLIANCE TESTING OF A 1985 FORD F150 PICKUP TRUCK		5. Report Date JANUARY 1993

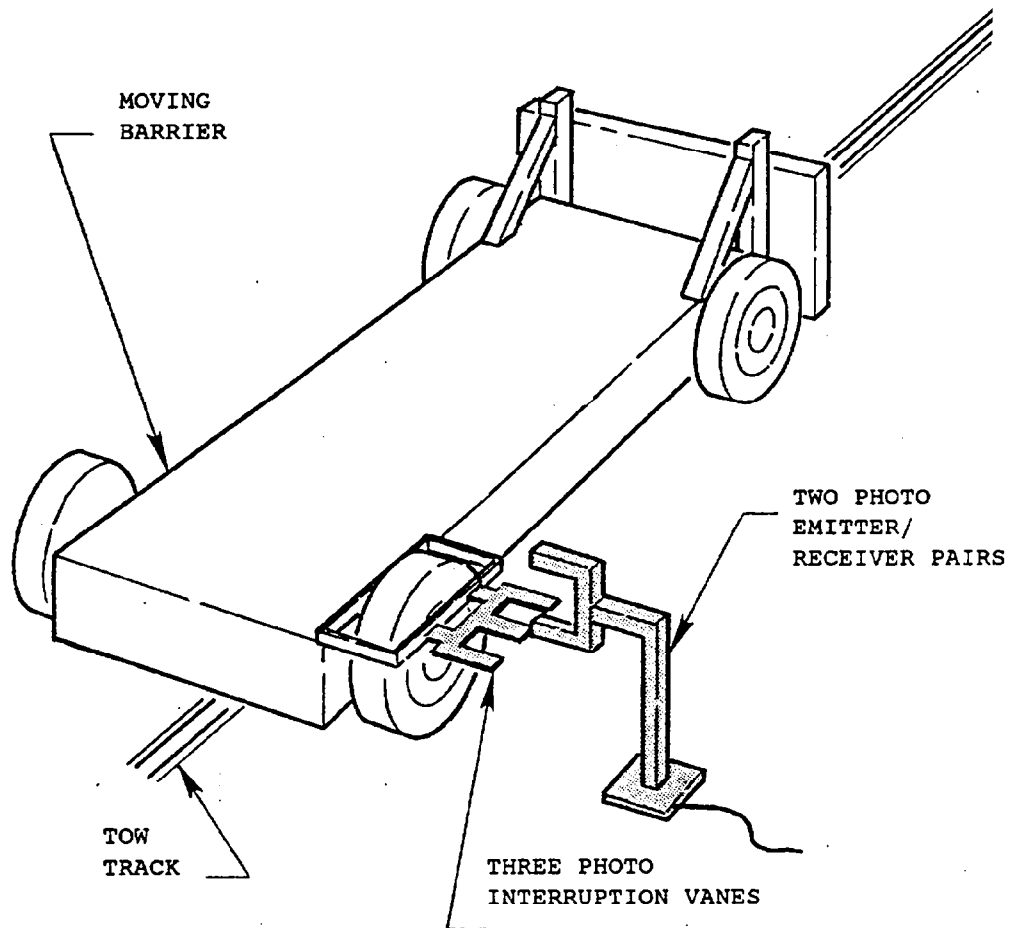
FIGURE 1 IMPACT VELOCITY MEASUREMENT SYSTEM

The final vane clears the final emitter/receiver pair two inches before impact.

The vanes have one foot spacing.

**Speed trap measurement ($\pm .05$ mph accuracy). The velocity measurement system contains two (2) independent photo emitter/receiver pairs (See Figure 1) which each measure the impact velocity.

*The velocity measurement system contains two (2) independent photo emitter/receiver pairs (See Figure 1) which each measure the impact velocity.

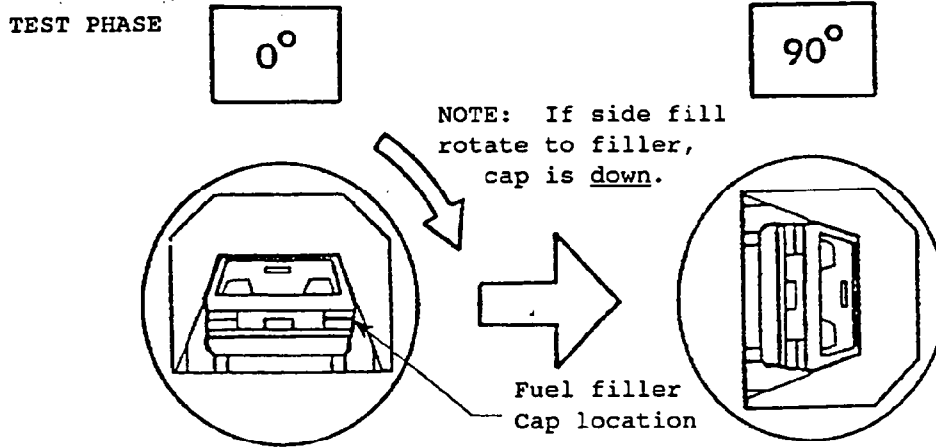
FIGURE 2 FMVSS 301 STATIC ROLLOVER TEST DATA

STATIC ROLLOVER MACHINE ROTATION TIME INFORMATION: (Spec. Range = 1-3 min.)

TIME REQ. FOR MACHINE TO ROTATE 90° = 2 minutes, 00 seconds
 FMVSS 301 POSITION HOLD TIME = 5 minutes, 00 seconds
 TOTAL - - - - - = 7 minutes, 00 seconds
 NEXT WHOLE MINUTE INTERVAL - - - - = 7 minutes

<u>0° TO 90° ROTATION (FUEL FILLER CAP DOWN)</u>	<u>TEST RESULTS</u>	<u>MAXIMUM ALLOWABLE</u>
1. FIRST 5 MINUTES FROM ONSET OF ROTATION - - - - -	0 oz.	5 oz.
2. 6TH MINUTE FROM ONSET OF ROTATION - - - - -	0 oz.	1 oz.
3. 7TH MINUTE FROM ONSET OF ROTATION - - - - -	0 oz.	1 oz.

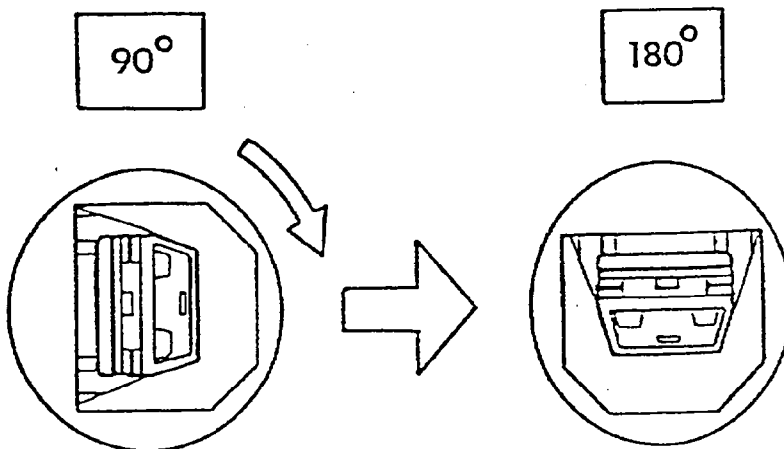
FIGURE 2 FMVSS 301 STATIC ROLLOVER TEST DATA, CONT'D.

TIME REQ. FOR MACHINE TO ROTATE 90° = 2 minutes, 00 seconds
 FMVSS 301 POSITION HOLD TIME = 5 minutes, 00 seconds
 TOTAL - - - - - = 7 minutes, 00 seconds
 NEXT WHOLE MINUTE INTERVAL - - - - - = 14 minutes

<u>90° TO 180° ROTATION</u>	<u>TEST RESULTS</u>	<u>MAXIMUM ALLOWABLE</u>
1. FIRST 5 MINUTES FROM ONSET OF ROTATION - - - - -	0 oz.	5 oz.
2. 6TH MINUTE FROM ONSET OF ROTATION - - - - -	0 oz.	1 oz.
3. 7TH MINUTE FROM ONSET OF ROTATION - - - - -	0 oz.	1 oz.

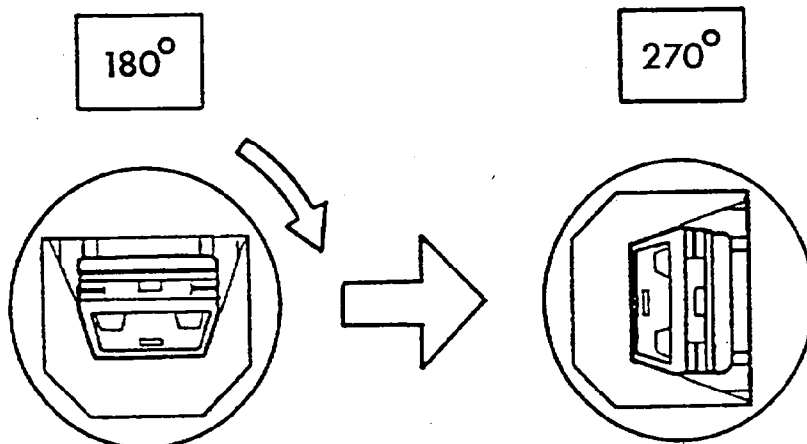
FIGURE 2 FMVSS 301 STATIC ROLLOVER TEST DATA, CONT'D.

TIME REQ. FOR MACHINE TO ROTATE 90° = 2 minutes, 00 seconds
 FMVSS 301 POSITION HOLD TIME = 5 minutes, 00 seconds
 TOTAL - - - - - = 7 minutes, 00 seconds
 NEXT WHOLE MINUTE INTERVAL - - - - - = 21 minutes

<u>180° TO 270° ROTATION</u>	<u>TEST RESULTS</u>	<u>MAXIMUM ALLOWABLE</u>
1. FIRST 5 MINUTES FROM ONSET OF ROTATION - - - - -	0 oz.	5 oz.
2. 6TH MINUTE FROM ONSET OF ROTATION - - - - -	0 oz.	1 oz.
3. 7TH MINUTE FROM ONSET OF ROTATION - - - - -	0 oz.	1 oz.

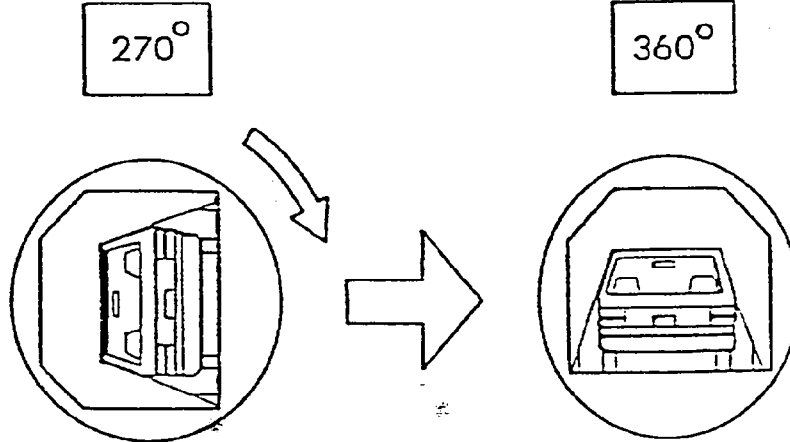
FIGURE 2 FMVSS 301 STATIC ROLLOVER TEST DATA, CONT'D.

TIME REQ. FOR MACHINE TO ROTATE 90° = 2 minutes, 00 seconds
 FMVSS 301 POSITION HOLD TIME = 5 minutes, 00 seconds
 TOTAL - - - - - = 7 minutes, 00 seconds
 NEXT WHOLE MINUTE INTERVAL - - - - = 28 minutes

<u>270° TO 360° ROTATION</u>	<u>TEST RESULTS</u>	<u>MAXIMUM ALLOWABLE</u>
1. FIRST 5 MINUTES FROM ONSET OF ROTATION - - - - -	0 oz.	5 oz.
2. 6TH MINUTE FROM ONSET OF ROTATION - - - - -	0 oz.	1 oz.
3. 7TH MINUTE FROM ONSET OF ROTATION - - - - -	0 oz.	1 oz.

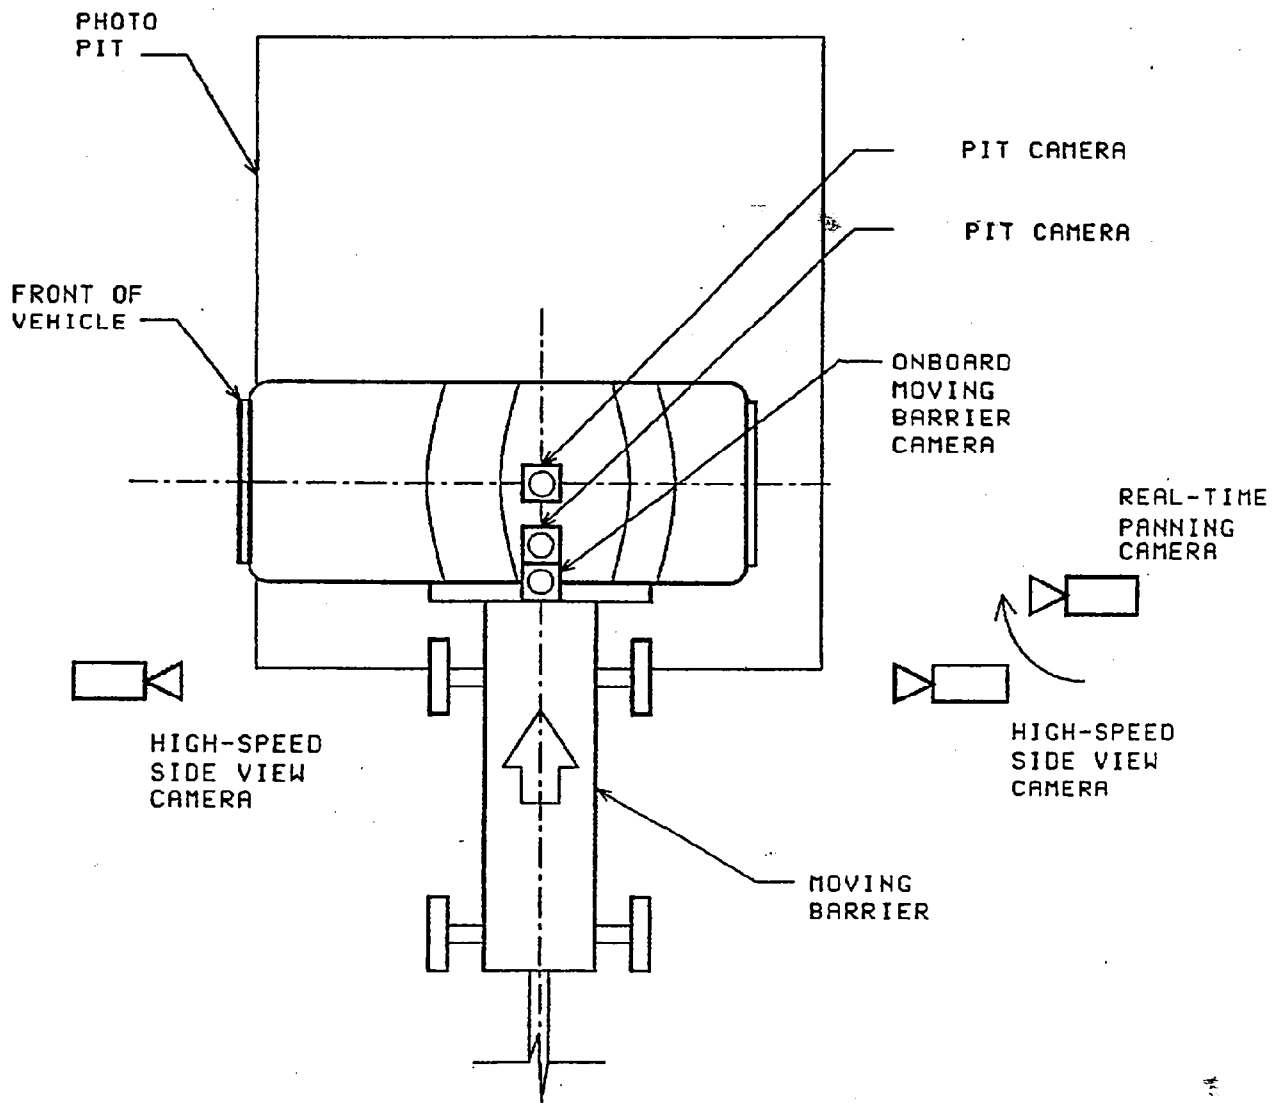
FIGURE 3

CAMERA POSITIONS

TEST NO.:	921217-1	VEHICLE:	1985 Ford F150 pickup truck			CAMERA POSITIONS (IN)*			ANGLE** (DEG)	LENS (MM)	FILM SPEED (FPS)
						X	Y	Z			
CAMERA NO.	VIEW										
1	Left Overall		48.0	204.0	37.0	0	25	500			
2	Right Overall		38.0	-338.0	37.0	0	25	498			
3	Onboard Moving Barrier		NA	NA	NA	-90	13	508			
4	Pit Left Position		-12.0	0.0	-148.0	90	17	805			
5	Pit Right Position		-12.0	-36.0	-148.0	90	25	800			
6	Real-Time Panning		-156.0	-504.0	61.0	NA	16	24			
7	Real-Time Documentation		NA	NA	NA	NA	12-120	24

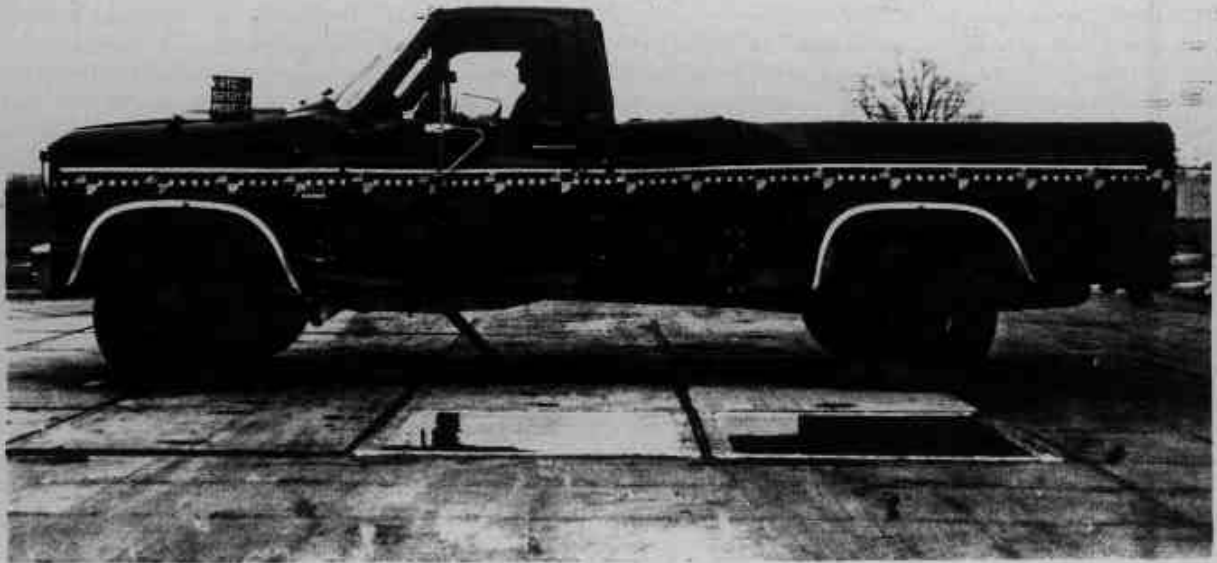
Figure A-3. POST-TEST LEFT SIDE VIEW

Roof Height	69.0	X	X	X	X	4.7	4.9	5.0	4.9	4.8	X	X	X	X	X	X
Upper Door	47.0	5.2	5.6	6.4	7.0	8.3	8.0	8.0	7.7	7.4	7.7	7.2	7.0	8.1	7.4	5.9
Mid Door	31.9	6.9	7.6	7.7	8.6	9.8	9.4	8.9	9.0	9.0	9.6	9.4	10.2	10.7	10.0	7.6
Axle Height	14.2	6.2	6.6	7.0	7.2	7.4	7.4	7.7	7.9	8.1	8.3	10.9	10.0	9.6	10.1	6.8

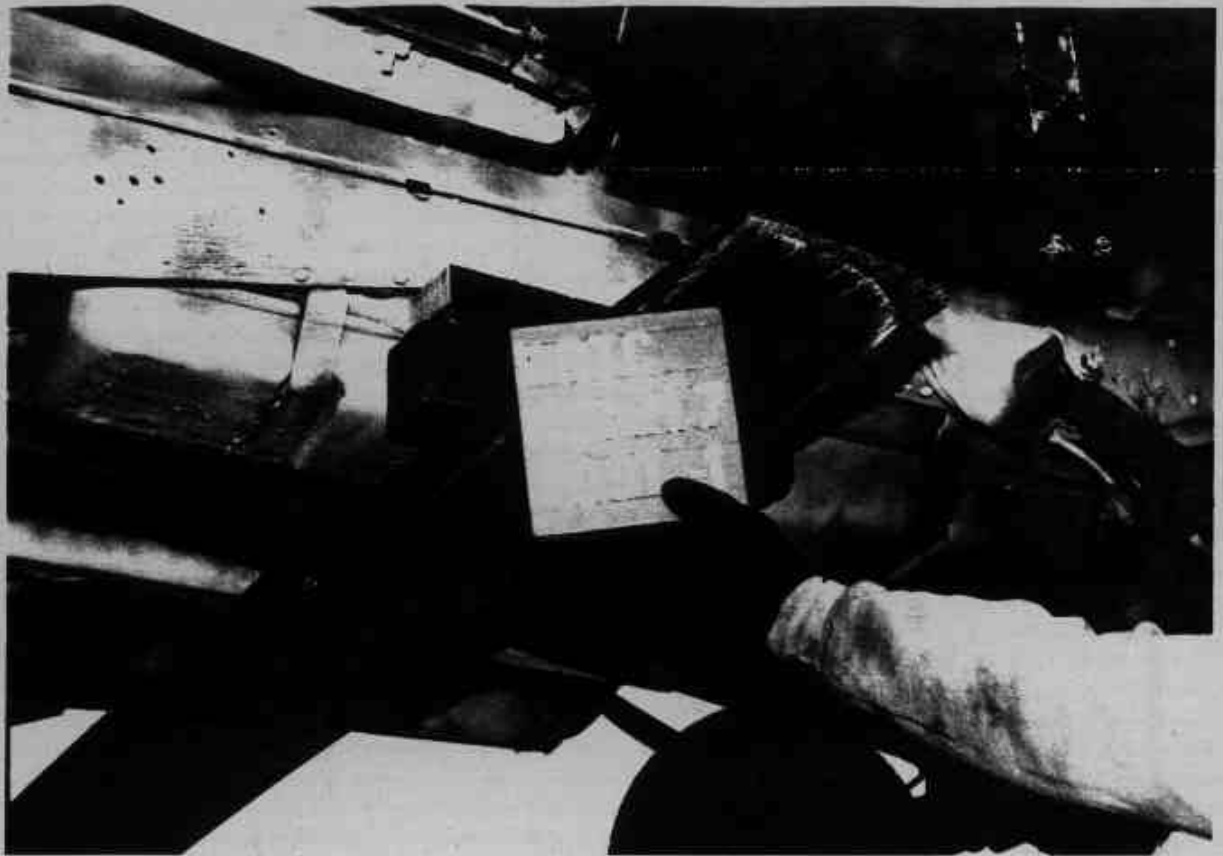
Figure A-17. POST-TEST FUEL TANK - VIEW 1

DETAILS OF FUEL SYSTEM: The fuel filler neck was on the left side. The fuel tank was in front of the rear axle and inside the left frame rail. The fuel lines run along the left frame rail to the front.
