Report Numbers: 208-TRC-95-003  
212-TRC-95-003  
301-TRC-95-003

Vehicle Safety Compliance Testing  
for Occupant Crash Protection,  
Windshield Mounting, Windshield Zone Intrusion,  
and Fuel System Integrity

General Motors Corporation  
1995 Pontiac Grand Am  
NHTSA Number: CS0103  
TRC Test Number: 941123

Final Report

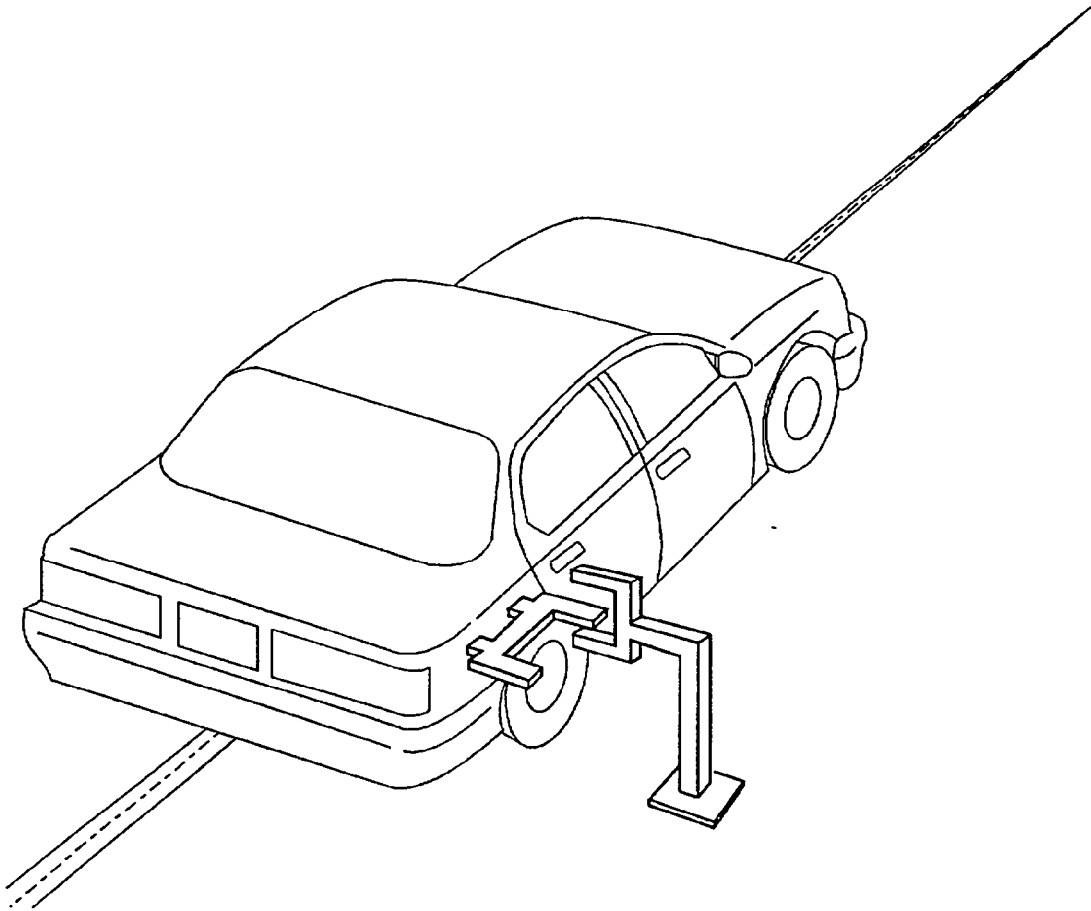
Figure 1 Impact Velocity Measurement System

The final vane clears emitter/receiver two inches before impact.  
The vanes have a one-foot spacing.

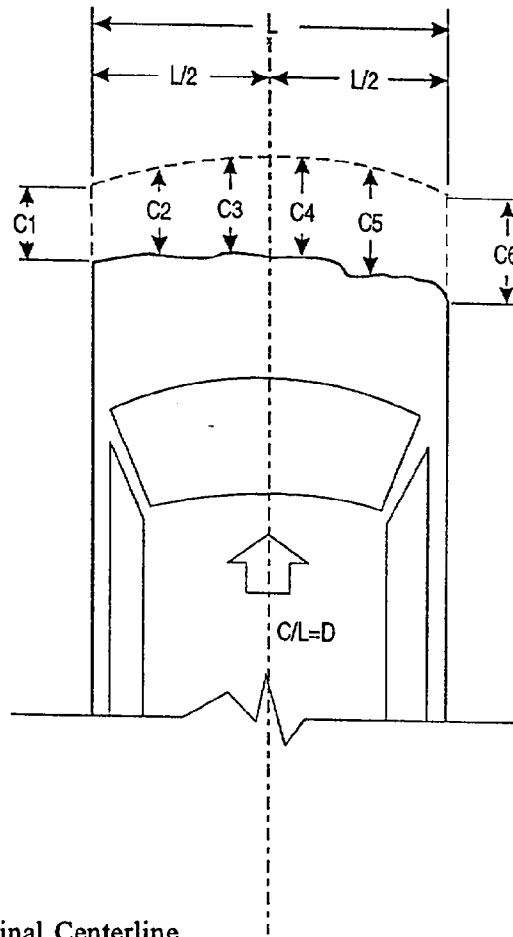
**Figure 2 Accident Investigation Division Data for 30 mph Frontal Barrier Impact**

Midpoint of damage: D: Vehicle Longitudinal Centerline

Length of damaged region: L: 56.0 in

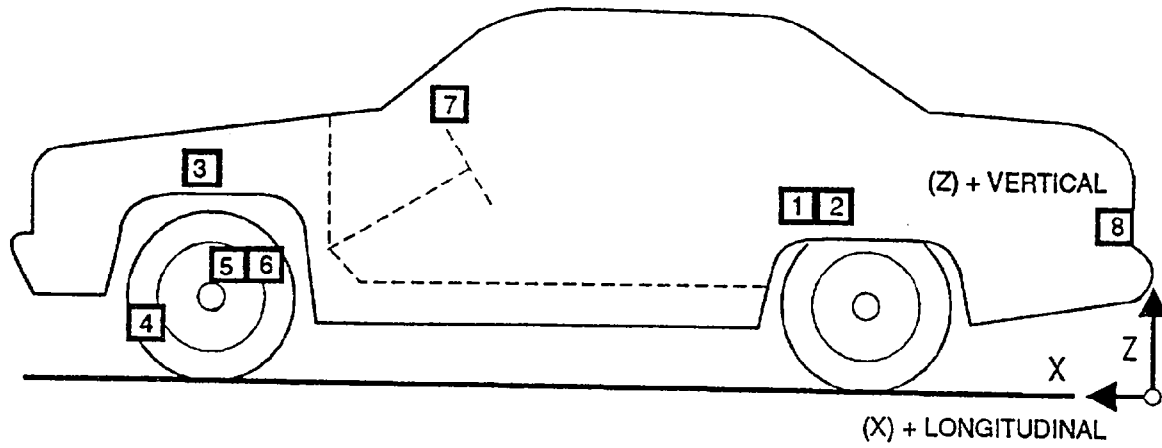
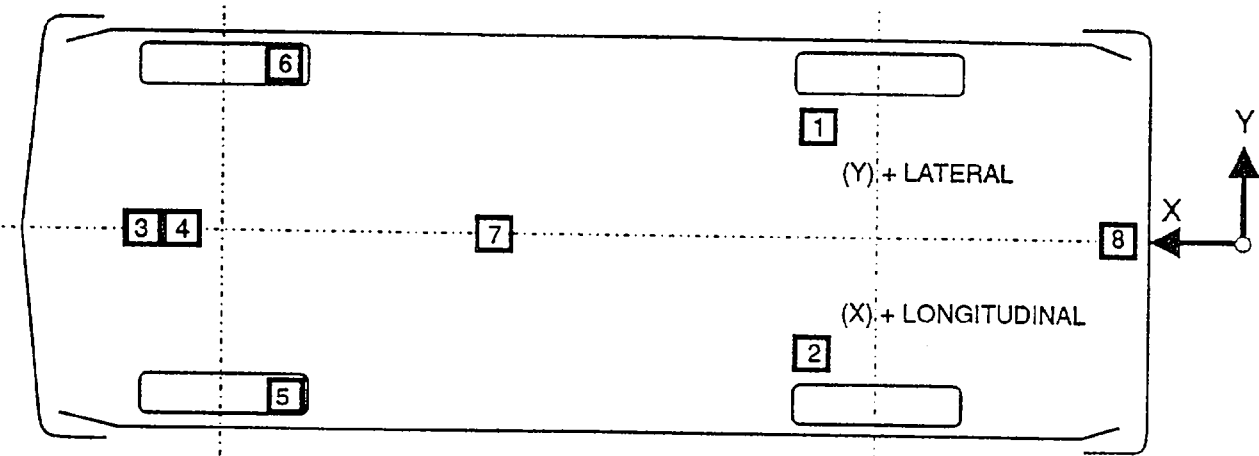
Figure 3 Vehicle Accelerometer Placement

SIDE VIEW

BOTTOM VIEW

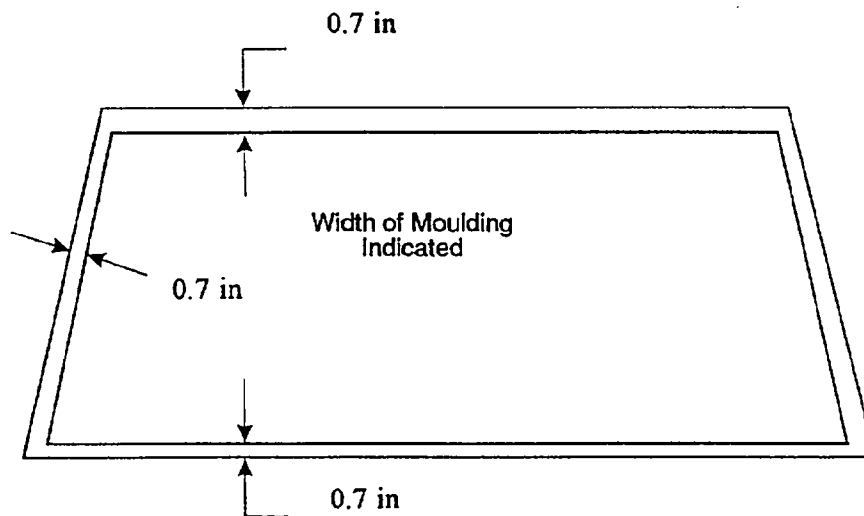
Front view of windshield<sup>1</sup>

Pre-test	Post-test	Percent Retention
Right side	79.0 in	79.0 in	100.0
Left side	79.0 in	79.0 in	100.0
Total	158.0 in	158.0 in	100.0

Loss of windshield retention lengths: None

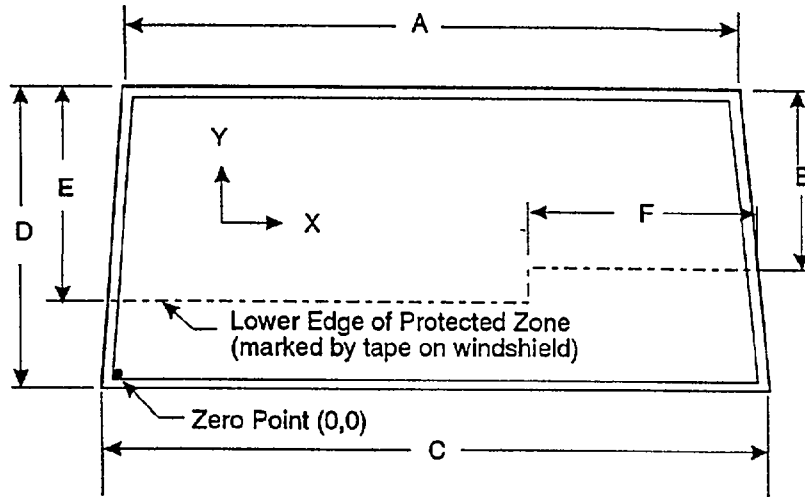
FRONT VIEW

- A: 42.5 in
- B: 17.9 in
- C: 61.1 in
- D: 31.3 in
- E: 20.8 in
- F: 25.5 in

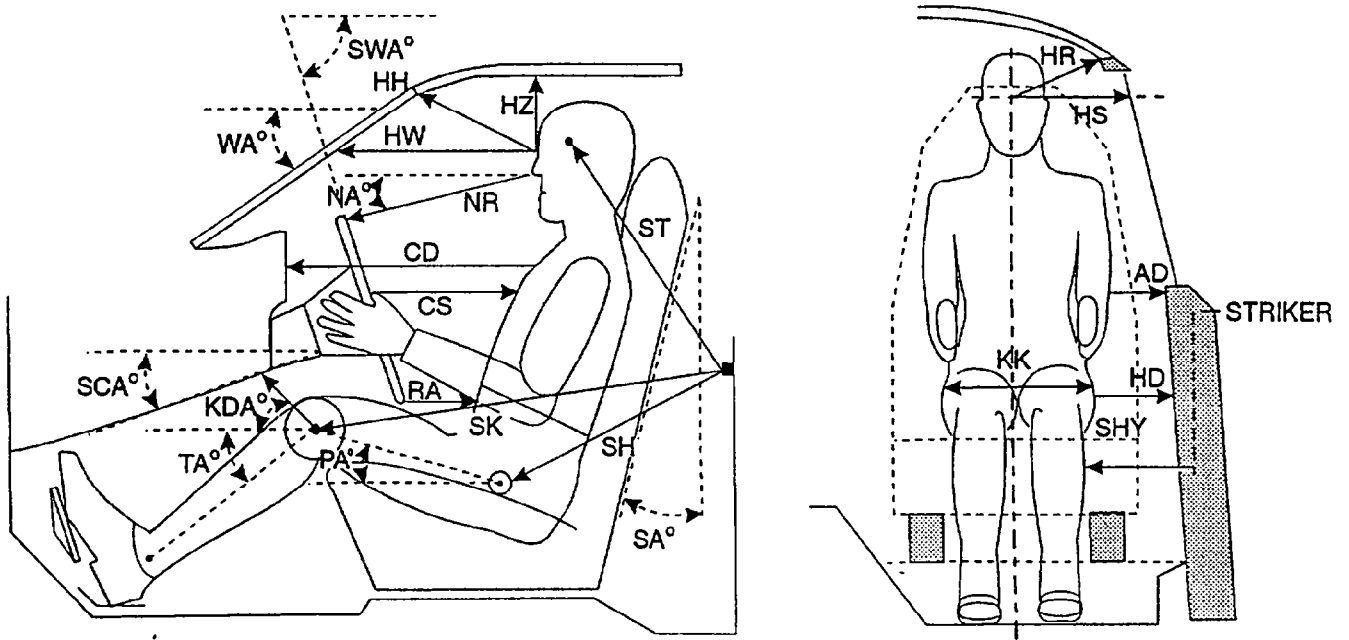
**Figure 9 Dummy Measurement Locations for Front Seat Occupants**

**VERTICAL LONGITUDINAL PLANE**

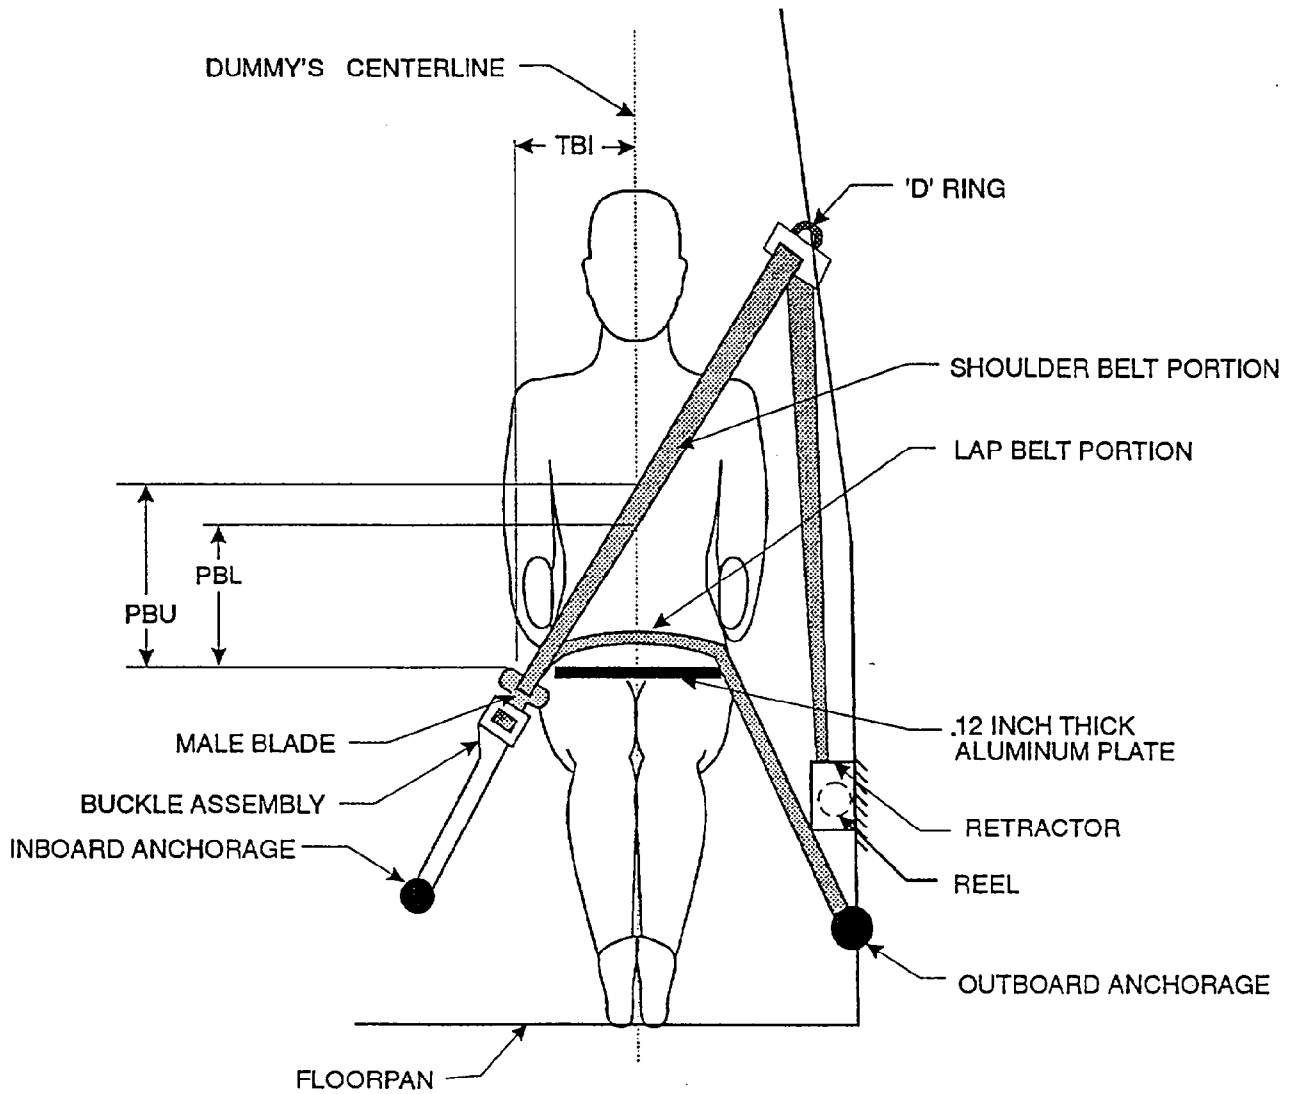
**Figure 10 Seat Belt Positioning Data**

Driver	Passenger
PBU - Top surface of aluminum plate to belt upper edge	12.5 in	13.7 in
PBL - Top surface of aluminum plate to belt lower edge	9.0 in	10.7 in
TBI - Dummy centerline to intersection of upper torso belt and lap belt	8.8 in	11.0 in

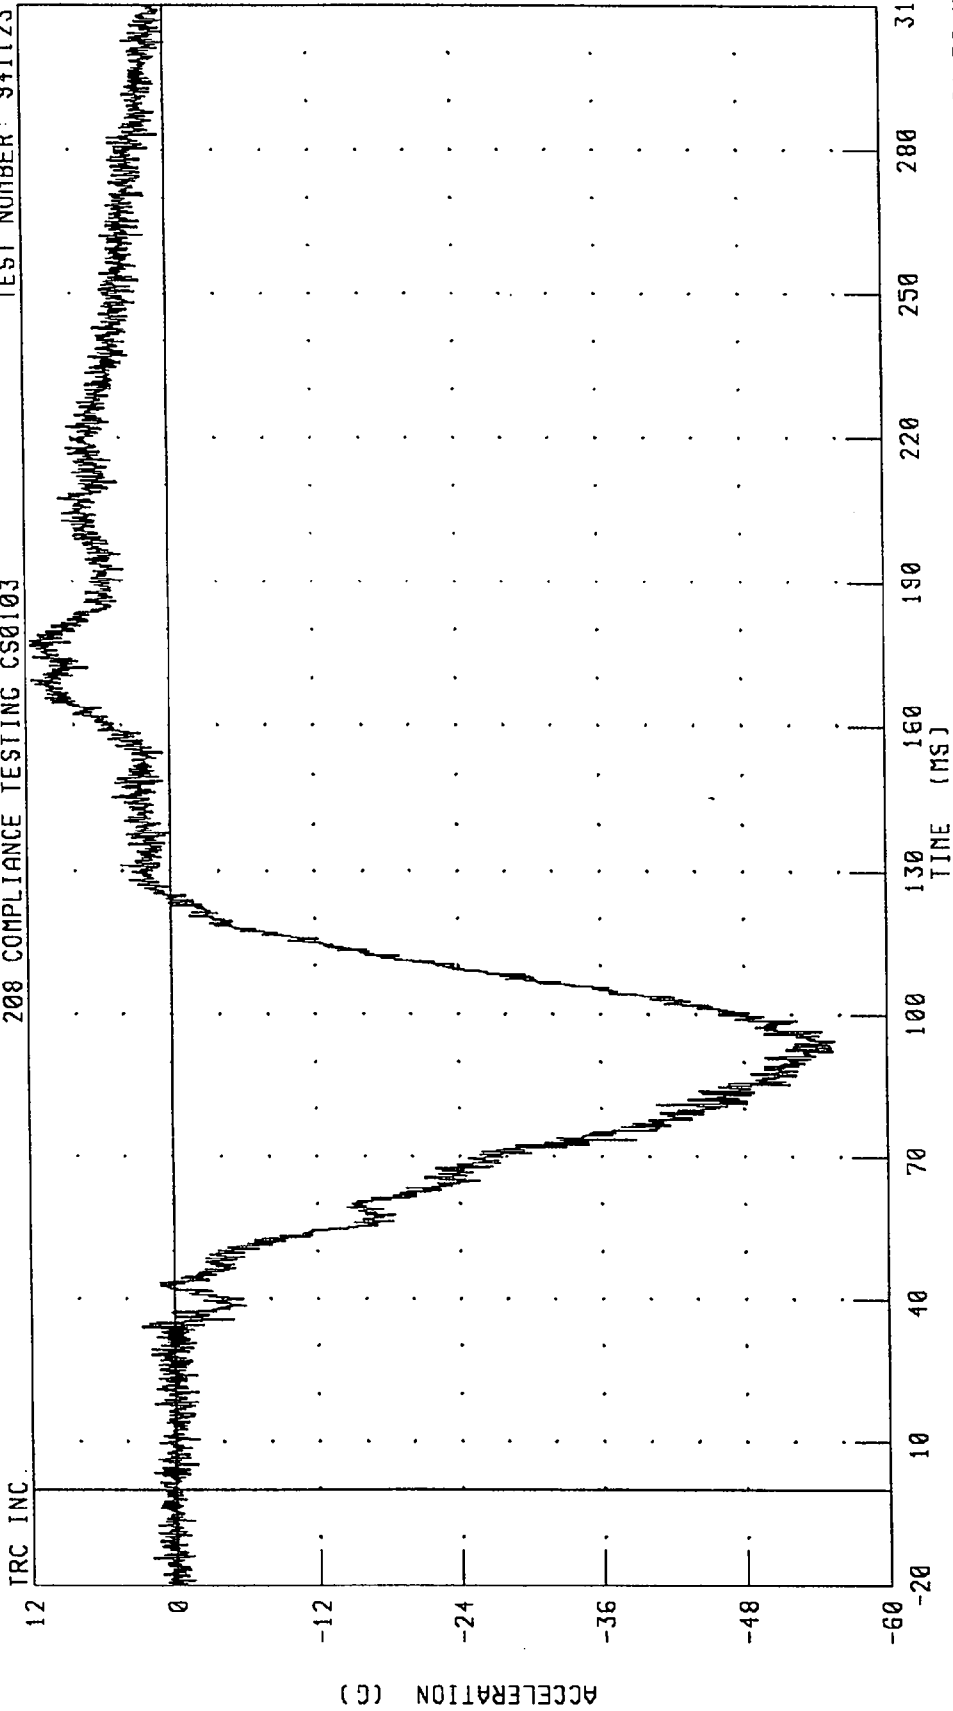
1995 PONTIAC GRAND AM INTO FLAT FRONTAL BARRIER  
DRIVER HEAD X-AXIS ACCELERATION  
208 COMPLIANCE TESTING CS0103

CHANNEL: HEDXG1 FILTER: CH. CLASS 1000

PEAK DATA: 11.54 G @ 176.80 MS; -55.61 G @ 94.56 MS

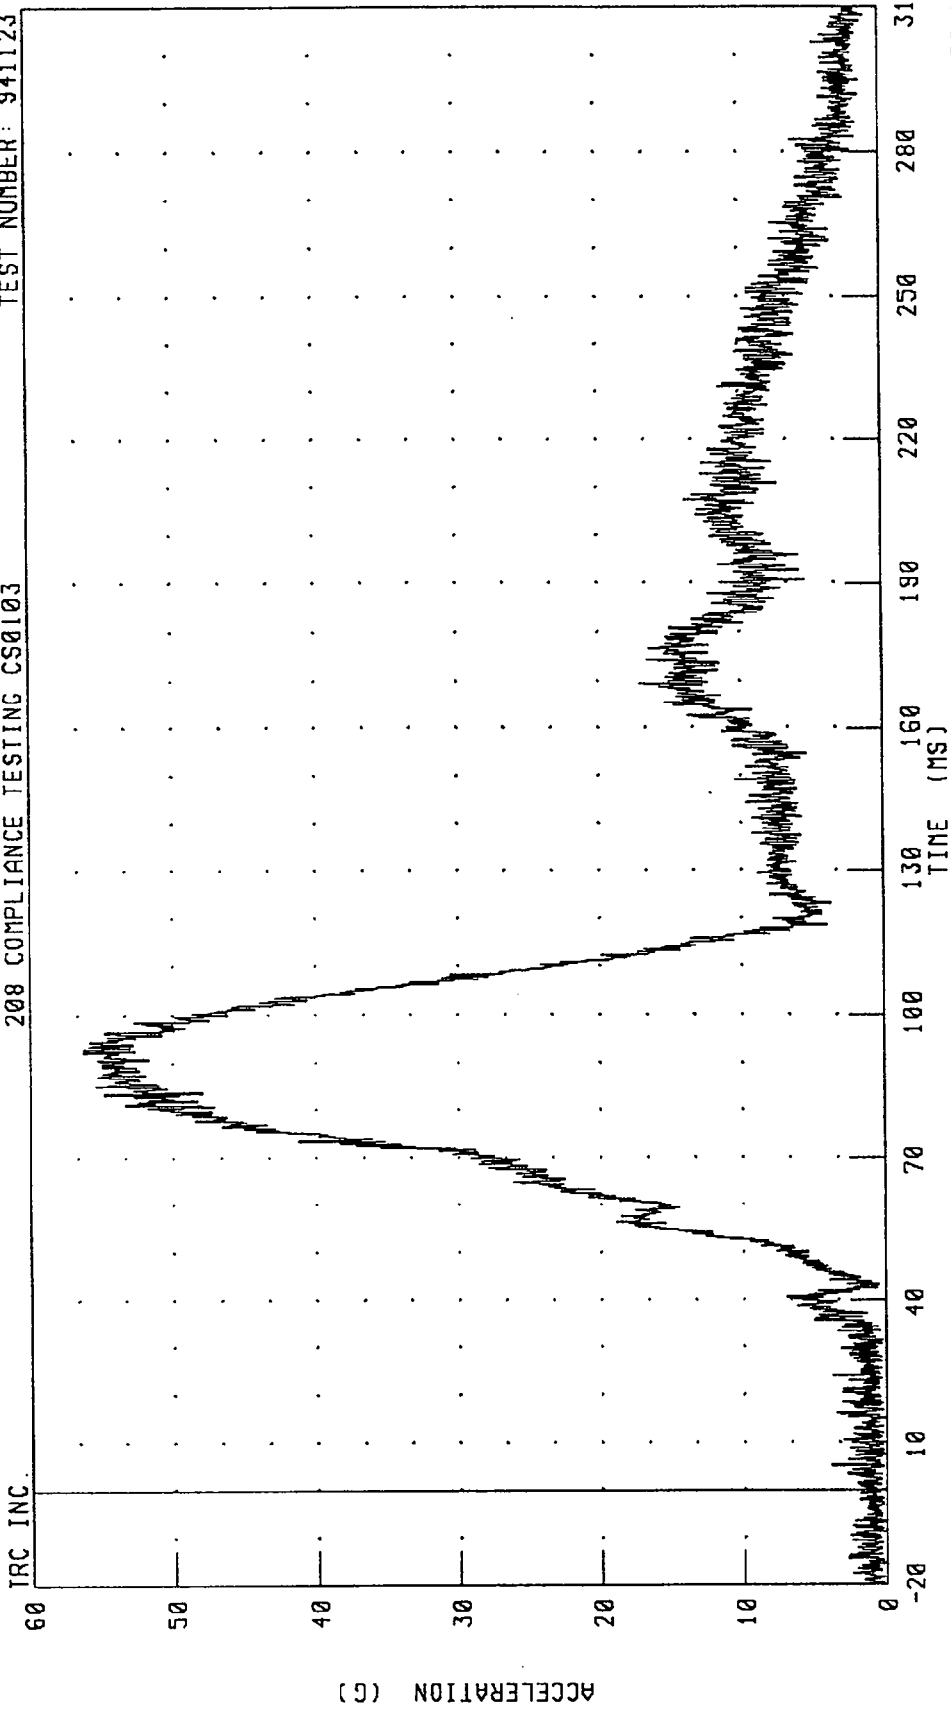
1985 PONTIAC GRAND AM INTO FLAT FRONTAL BARRIER  
DRIVER HEAD RESULTANT ACCELERATION  
208 COMPLIANCE TESTING CS0103

PEAK DATA: 56.25 G @ 92.48 MS; 0.16 G @ 7.52 MS

CHANNEL: HEDRG1 FILTER: CH. CLASS 1000

The driver's HIC was 554. The driver's chest maximum resultant acceleration with three (3) milliseconds minimum duration was 45.2 g. The driver's chest maximum deflection was 1.6 inches. The driver's left and right femur maximum compressive forces were 1550 pounds and 1314 pounds, respectively.

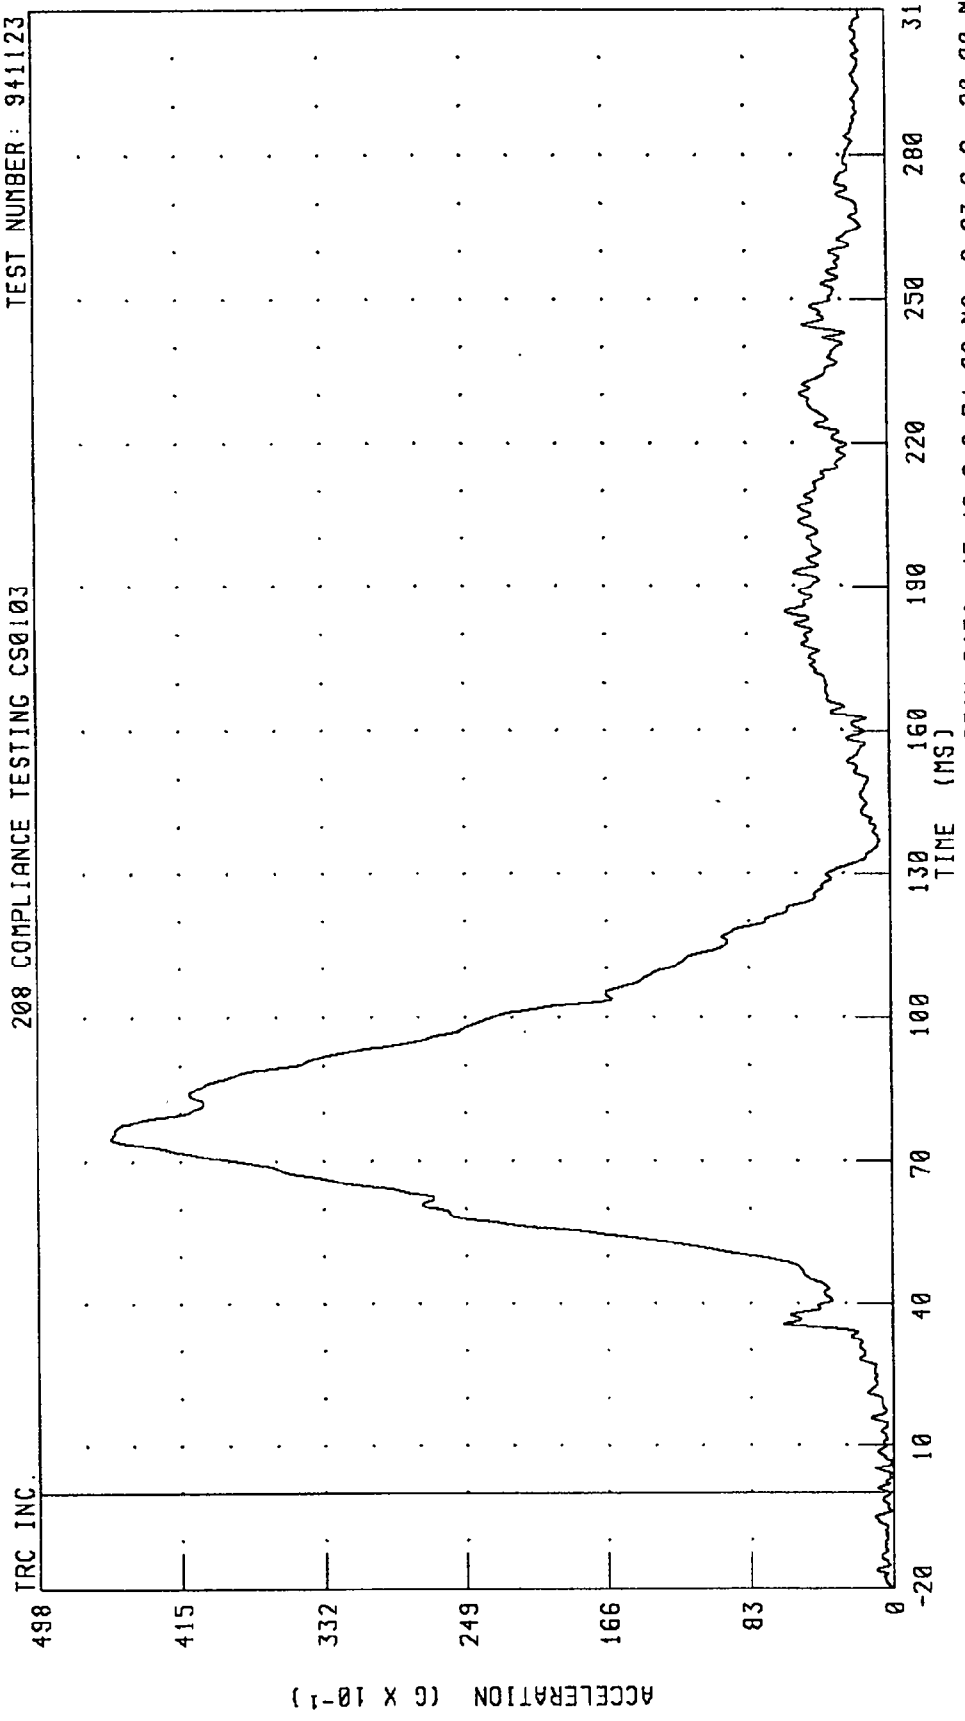
1995 PONTIAC GRAND AM INTO FLAT FRONTAL BARRIER  
DRIVER CHEST RESULTANT ACCELERATION  
208 COMPLIANCE TESTING CS0103

CHANNEL: CSTRG1 FILTER: CH. CLASS 180

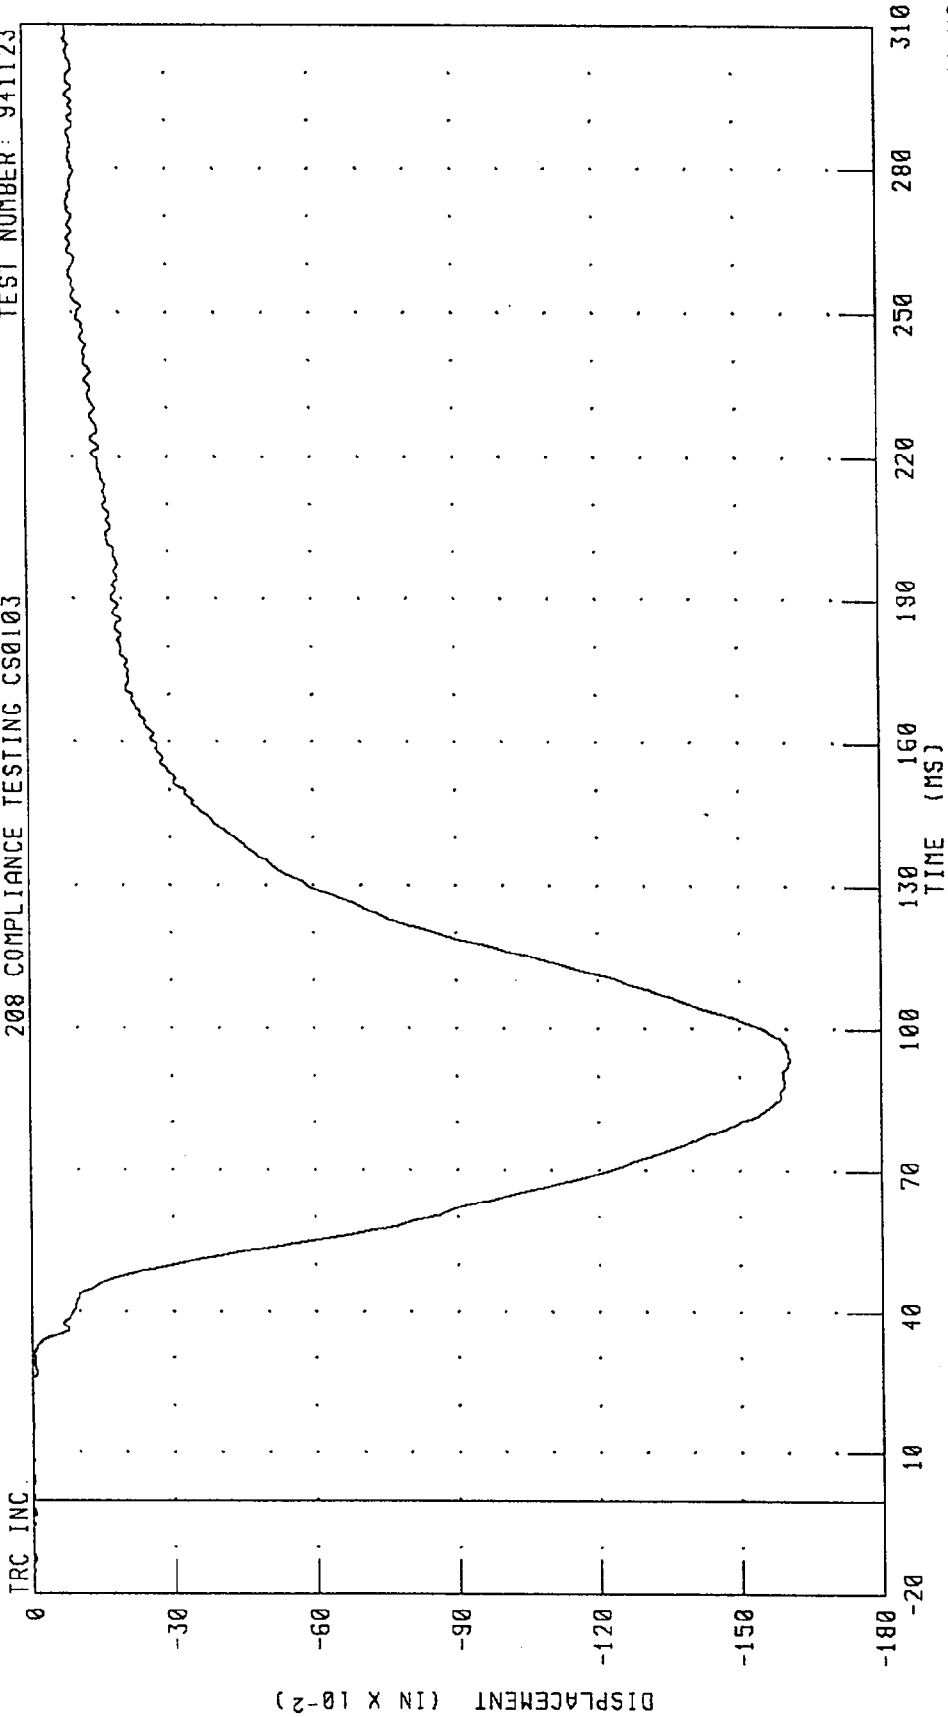
1995 PONTIAC GRAND AM INTO FLAT FRONTAL BARRIER  
DRIVER CHEST DEFLECTION  
208 COMPLIANCE TESTING CS0103

CHANNEL: CSTXD1 FILTER: CH. CLASS 180

PEAK DATA: 0.01 IN @ -18.88 MS, -1.61 IN @ 93.60 MS

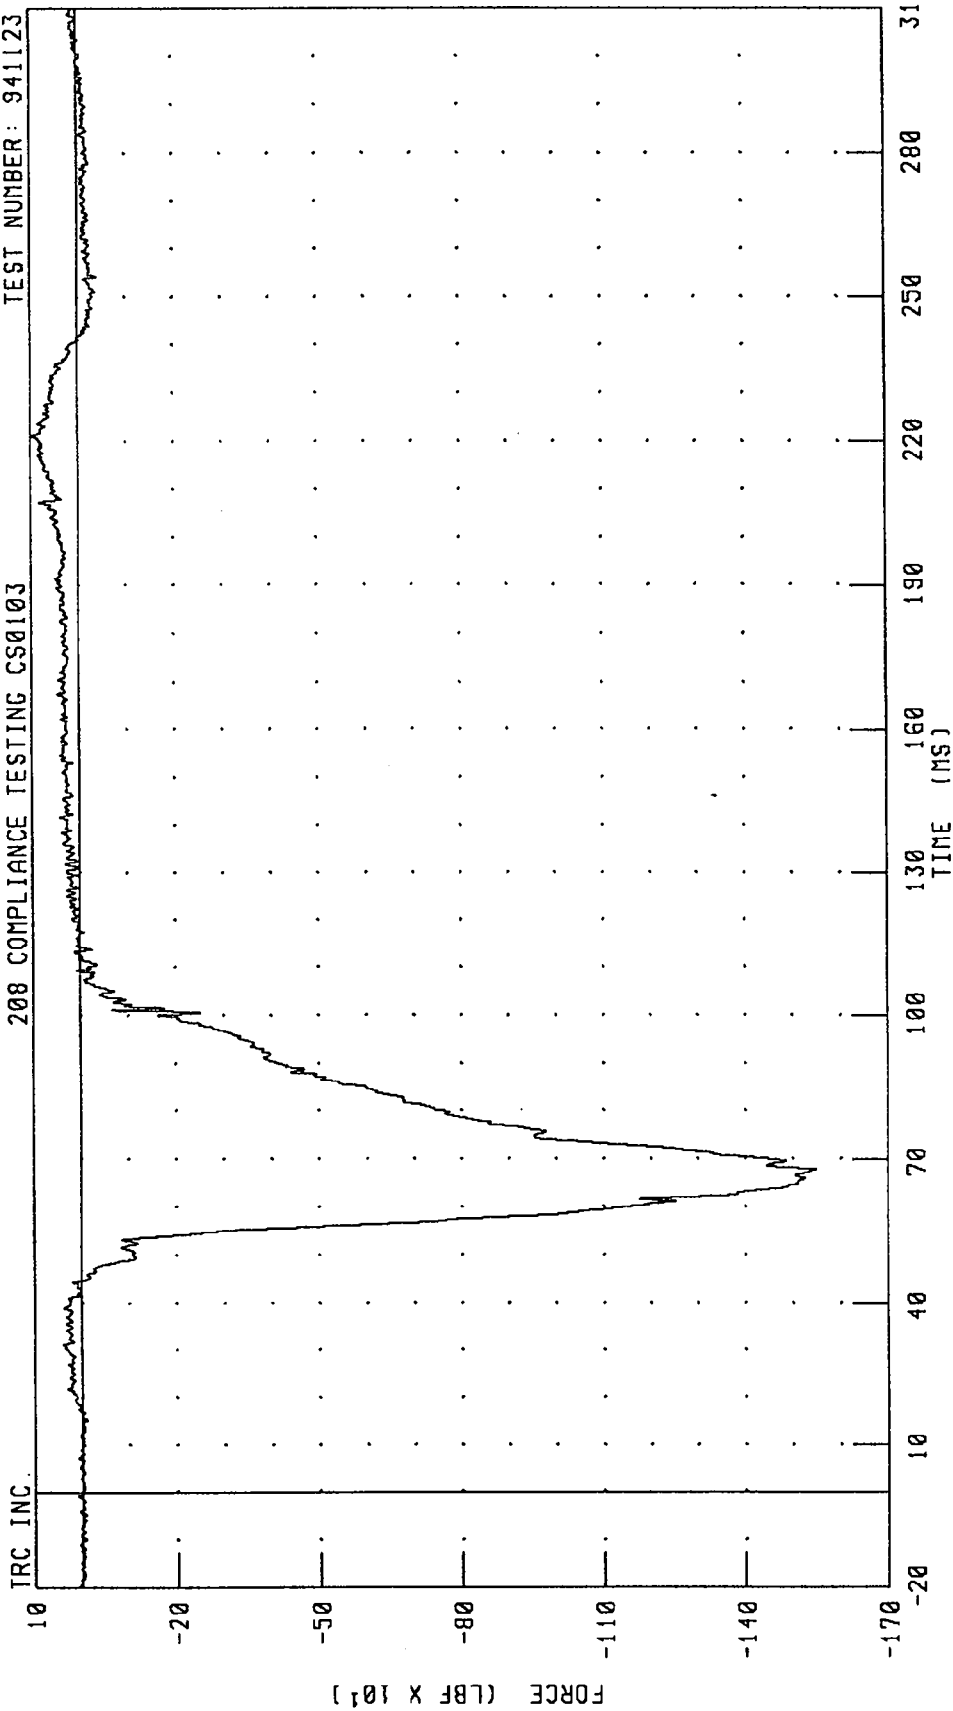
1995 PONTIAC GRAND AM INTO FLAT FRONTAL BARRIER  
DRIVER LEFT FEMUR FORCE  
208 COMPLIANCE TESTING CS0103

CHANNEL: LFMF1 FILTER: CH. CLASS 600  
PEAK DATA: 96.77 LBF @ 221.28 MS; -1550.40 LBF @ 67.76 MS

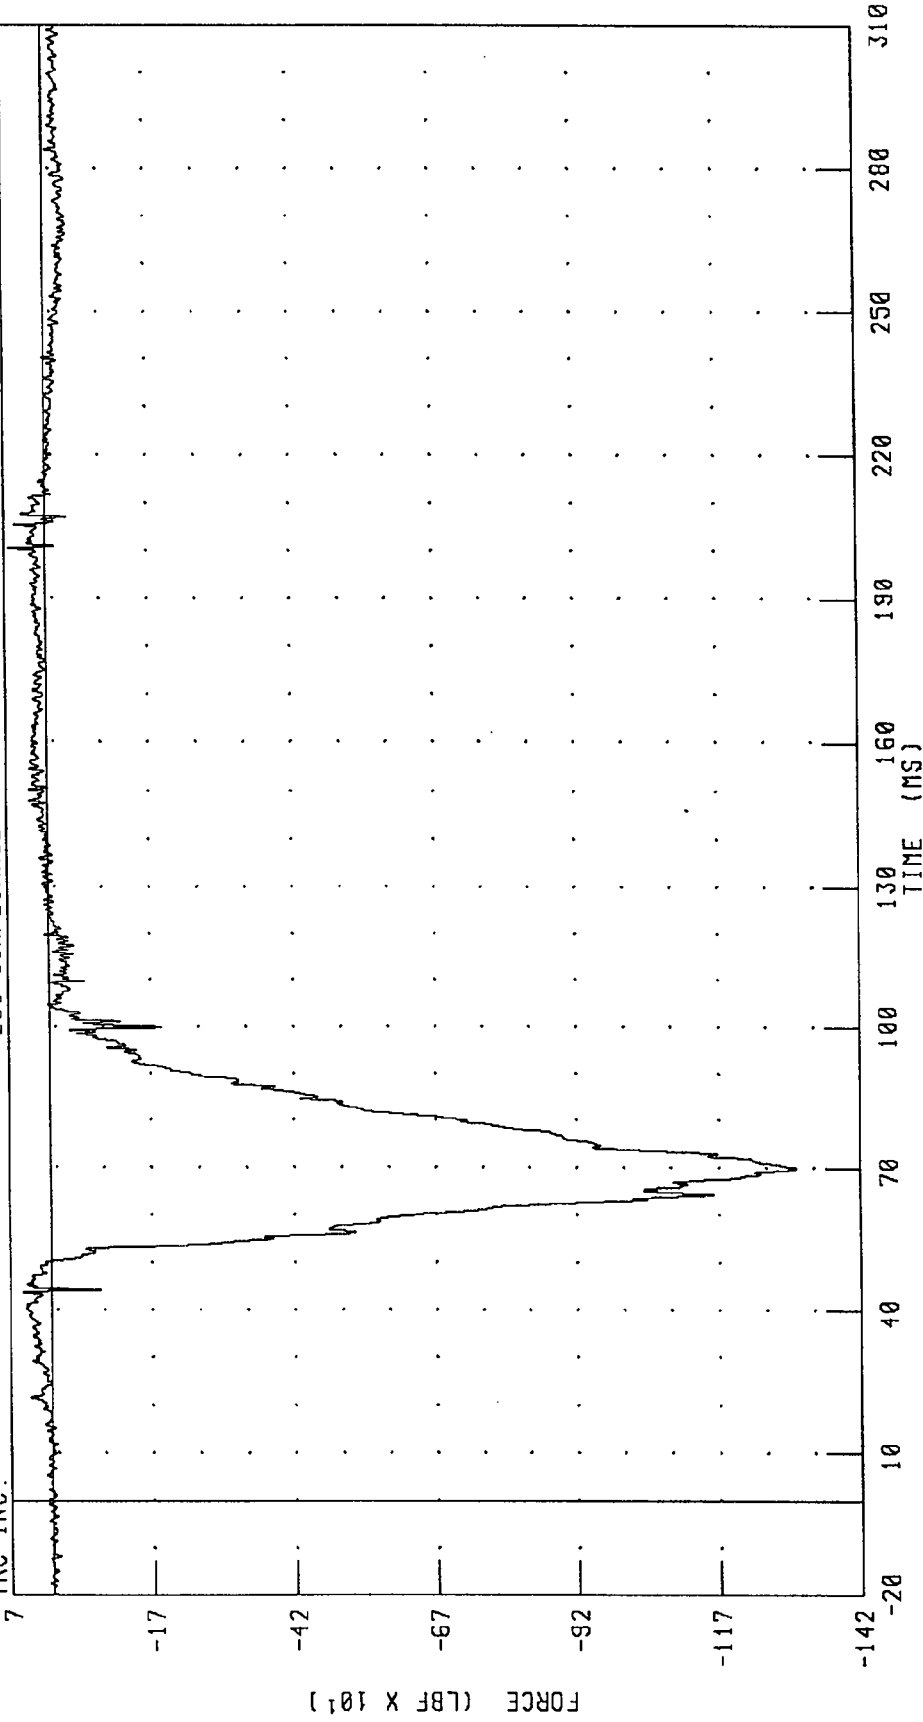
1995 PONTIAC GRAND AM INTO FLAT FRONTAL BARRIER  
DRIVER RIGHT FEMUR FORCE  
208 COMPLIANCE TESTING CS0103

CHANNEL: RFMF1 FILTER: CH. CLASS 600  
PEAK DATA: 66.53 LBF @ 200.56 MS; -1313.85 LBF @ 70.00 MS

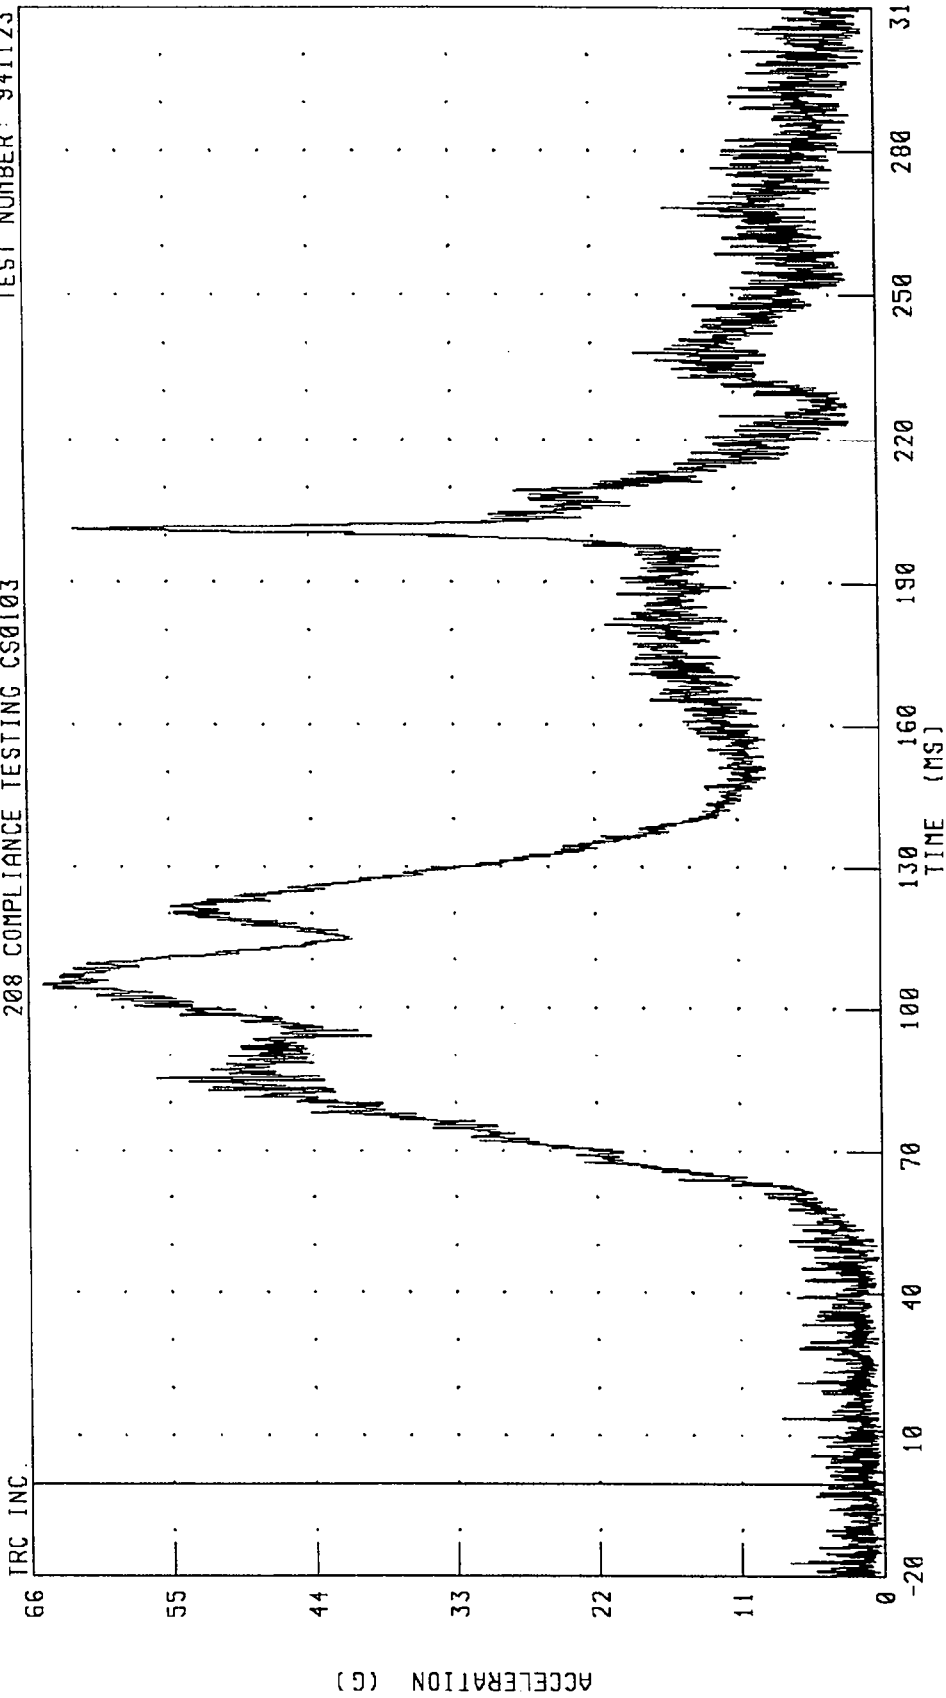
CHANNEL: HEDRG2 FILTER: CH. CLASS 1000

PEAK DATA: 64.89 G @ 104.72 MS; 0.07 G @ 11.12 MS

The right front passenger's HIC was 672. The right front passenger's chest maximum resultant acceleration with three (3) milliseconds minimum duration was 42.2 g. The right front passenger's chest maximum deflection was 1.9 inches. The right front passenger's left and right femur maximum compressive forces were 792 pounds and 1091 pounds, respectively.

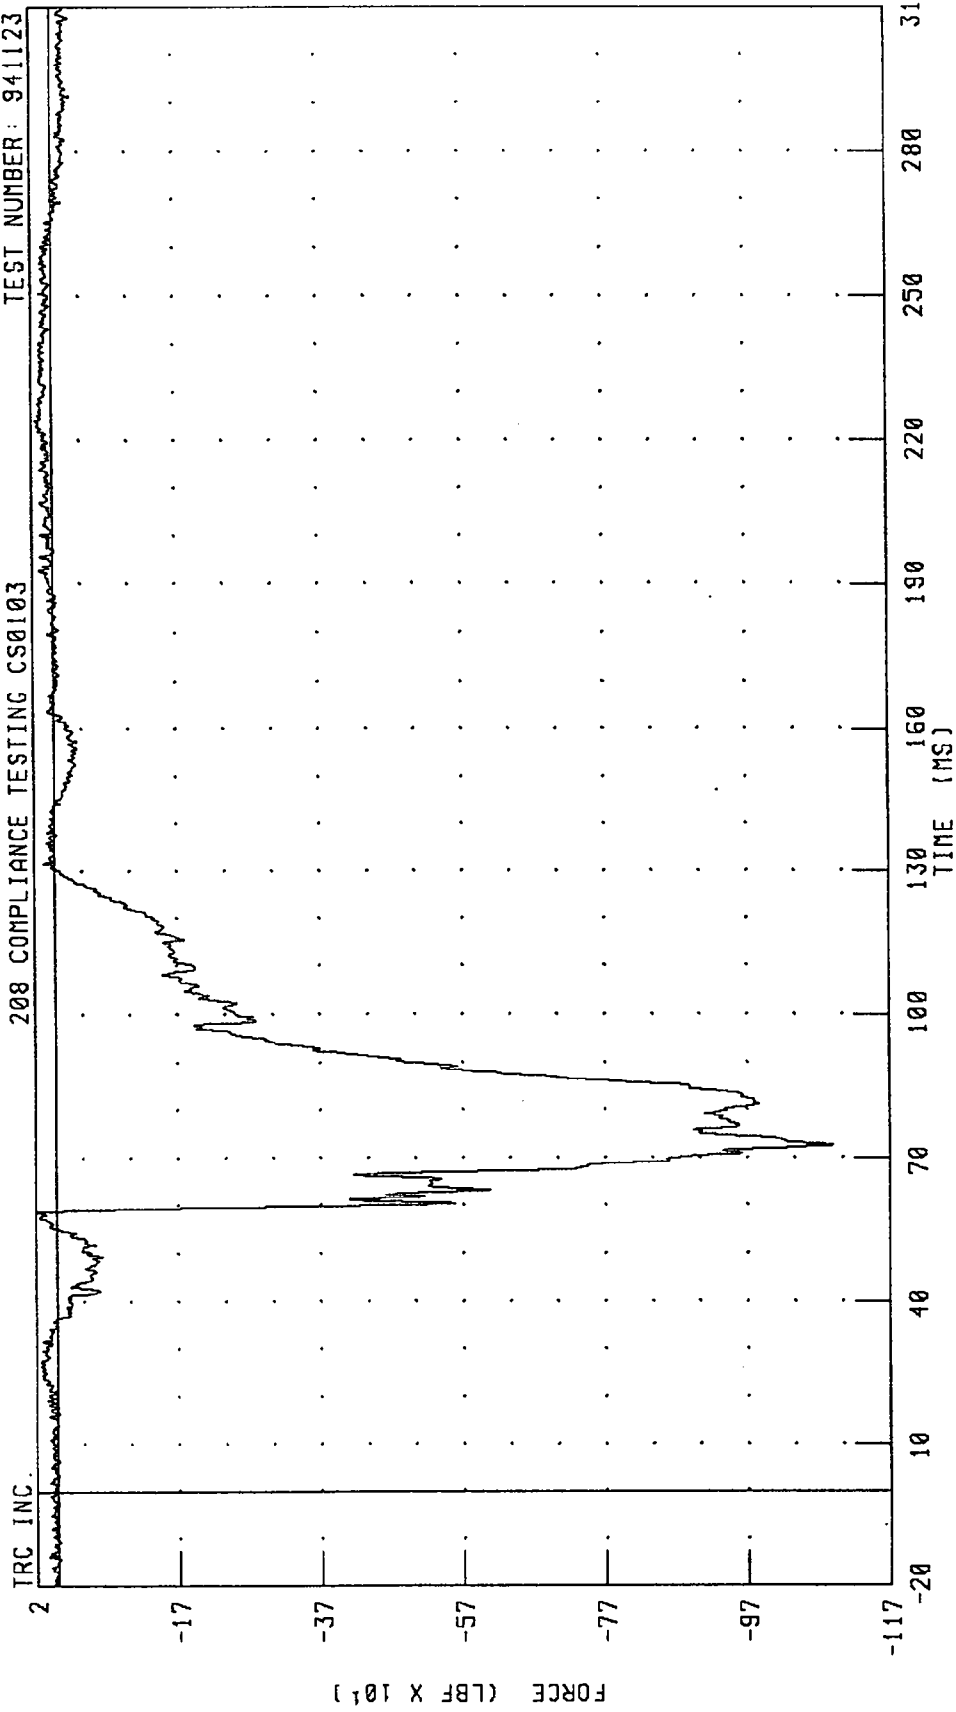
1995 PONTIAC GRAND AM INTO FLAT FRONTAL BARRIER  
RIGHT FRONT PASSENGER RIGHT FEMUR FORCE  
208 COMPLIANCE TESTING CS0103

CHANNEL: RFMF2 FILTER: CH. CLASS 600  
PEAK DATA: 27.19 LBF @ 58.64 MS; -1091.32 LBF @ 72.72 MS
