REPORT NO.: 208-MGA-95-007
212-MGA-95-007
301-MGA-95-007

VEHICLE SAFETY COMPLIANCE TESTING
FOR
FMVSS 208, OCCUPANT CRASH PROTECTION
FMVSS 212, WINDSHIELD MOUNTING
FMVSS 219, WINDSHIELD INTRUSION (PARTIAL)
FMVSS 301, FUEL SYSTEM INTEGRITY

CHRYSLER CORPORATION
1995 Dodge Ram 2500 Van
NHTSA NO. CS0308

FINAL REPORT

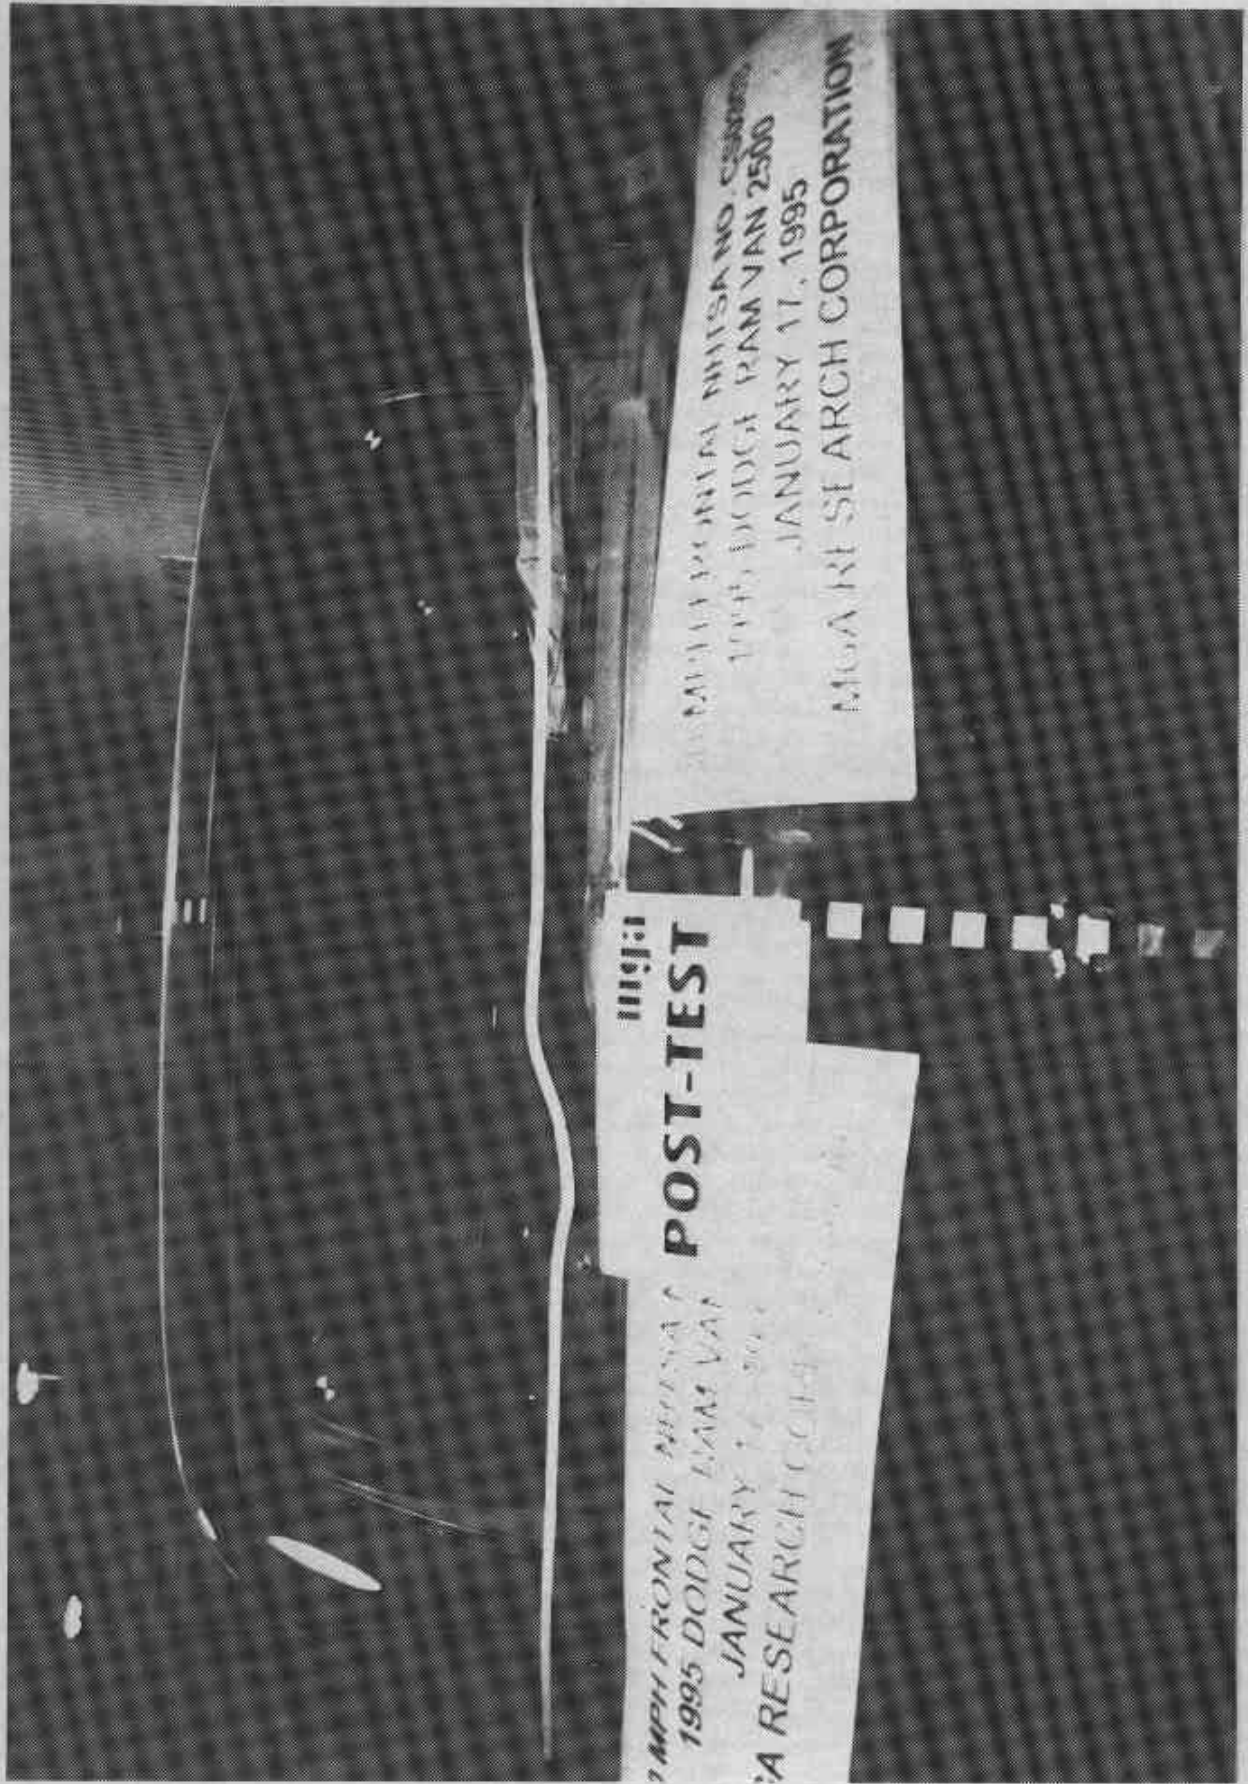
Photo No. A-19 - Post-Test Front Windshield View

There was no loss of windshield periphery retention and no penetration through the windshield.

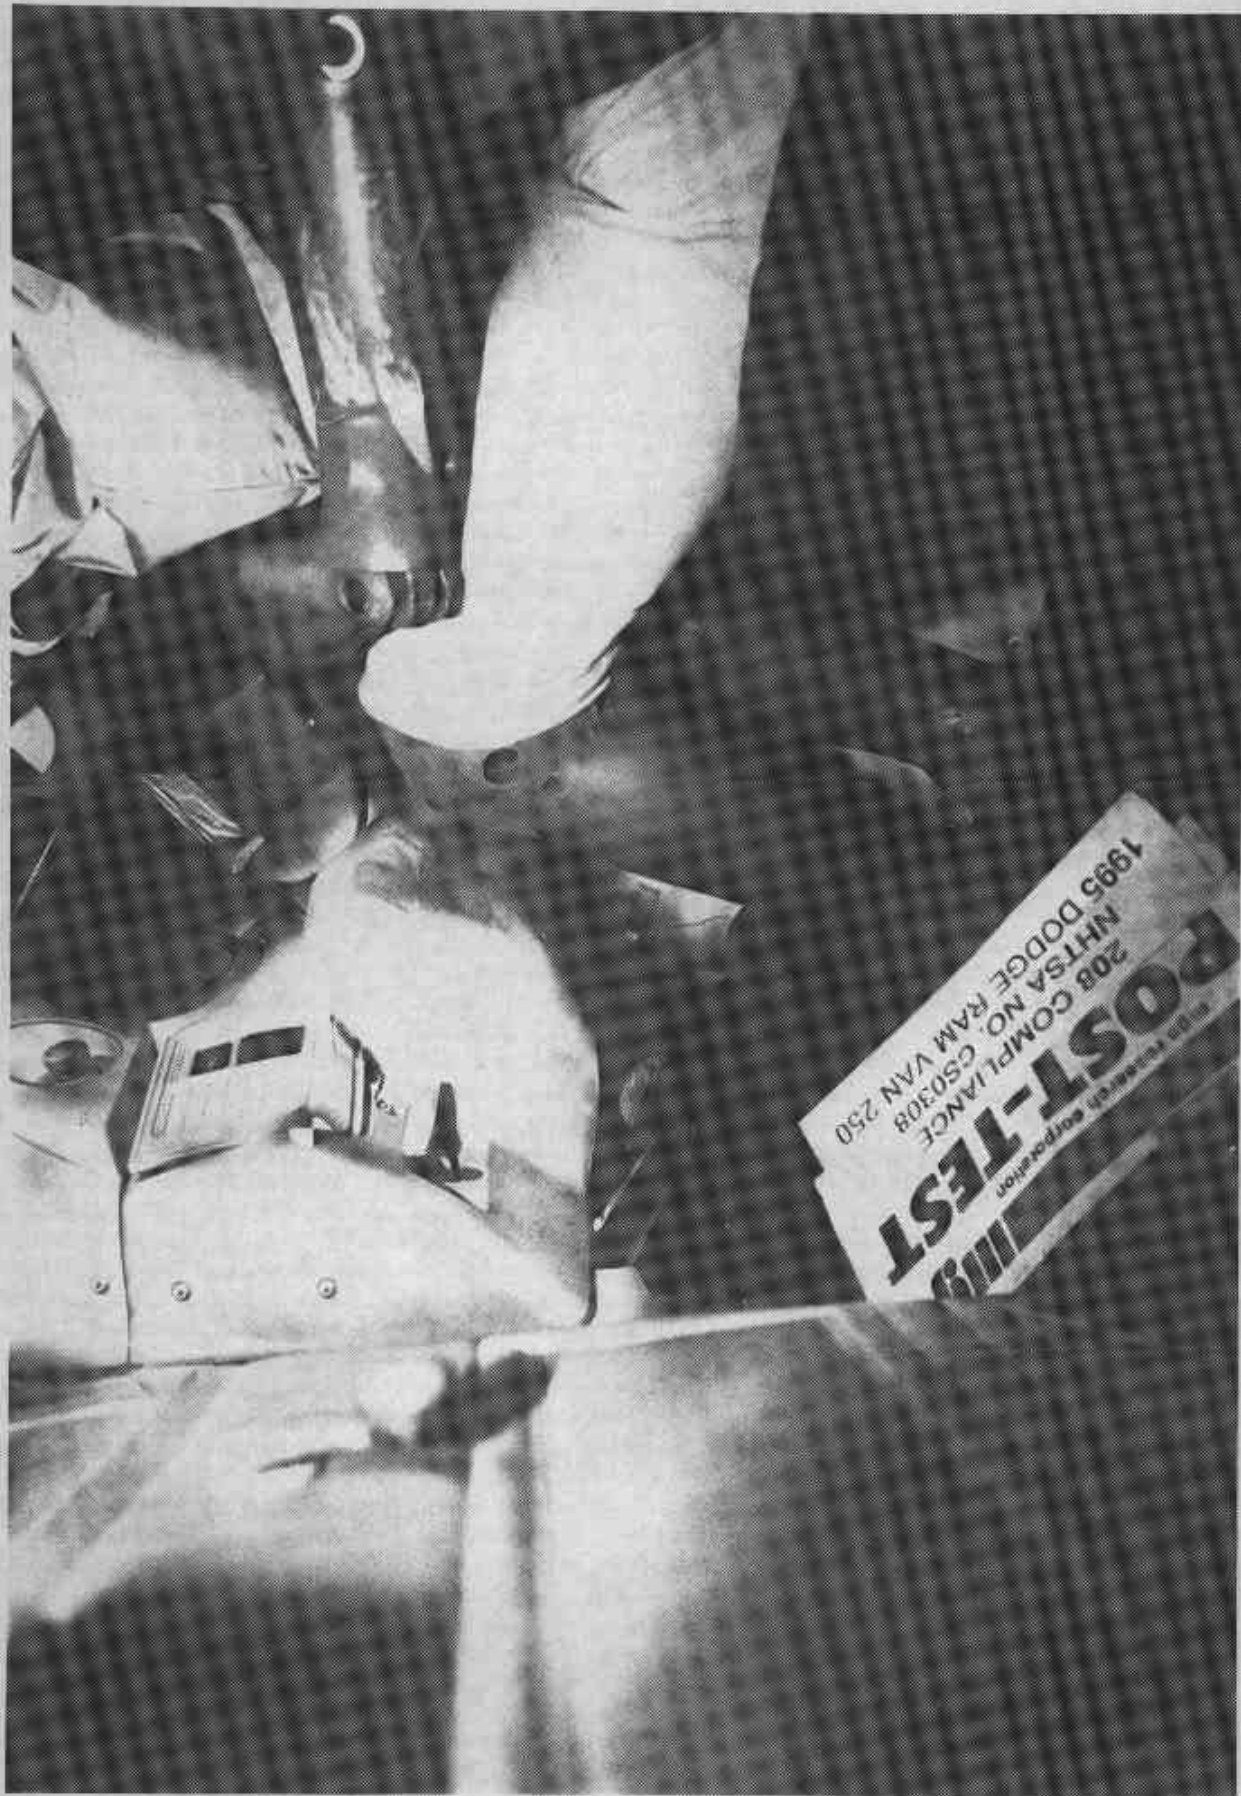
Photo No. A-29 - Post-Test Driver Dummy Knee Bolster View

| Visible Dummy Contact Points: | Driver | Passenger |
|---|---|---|
| Left Knee | <u>Knee Bolster</u> | <u>Lower Dash</u> |

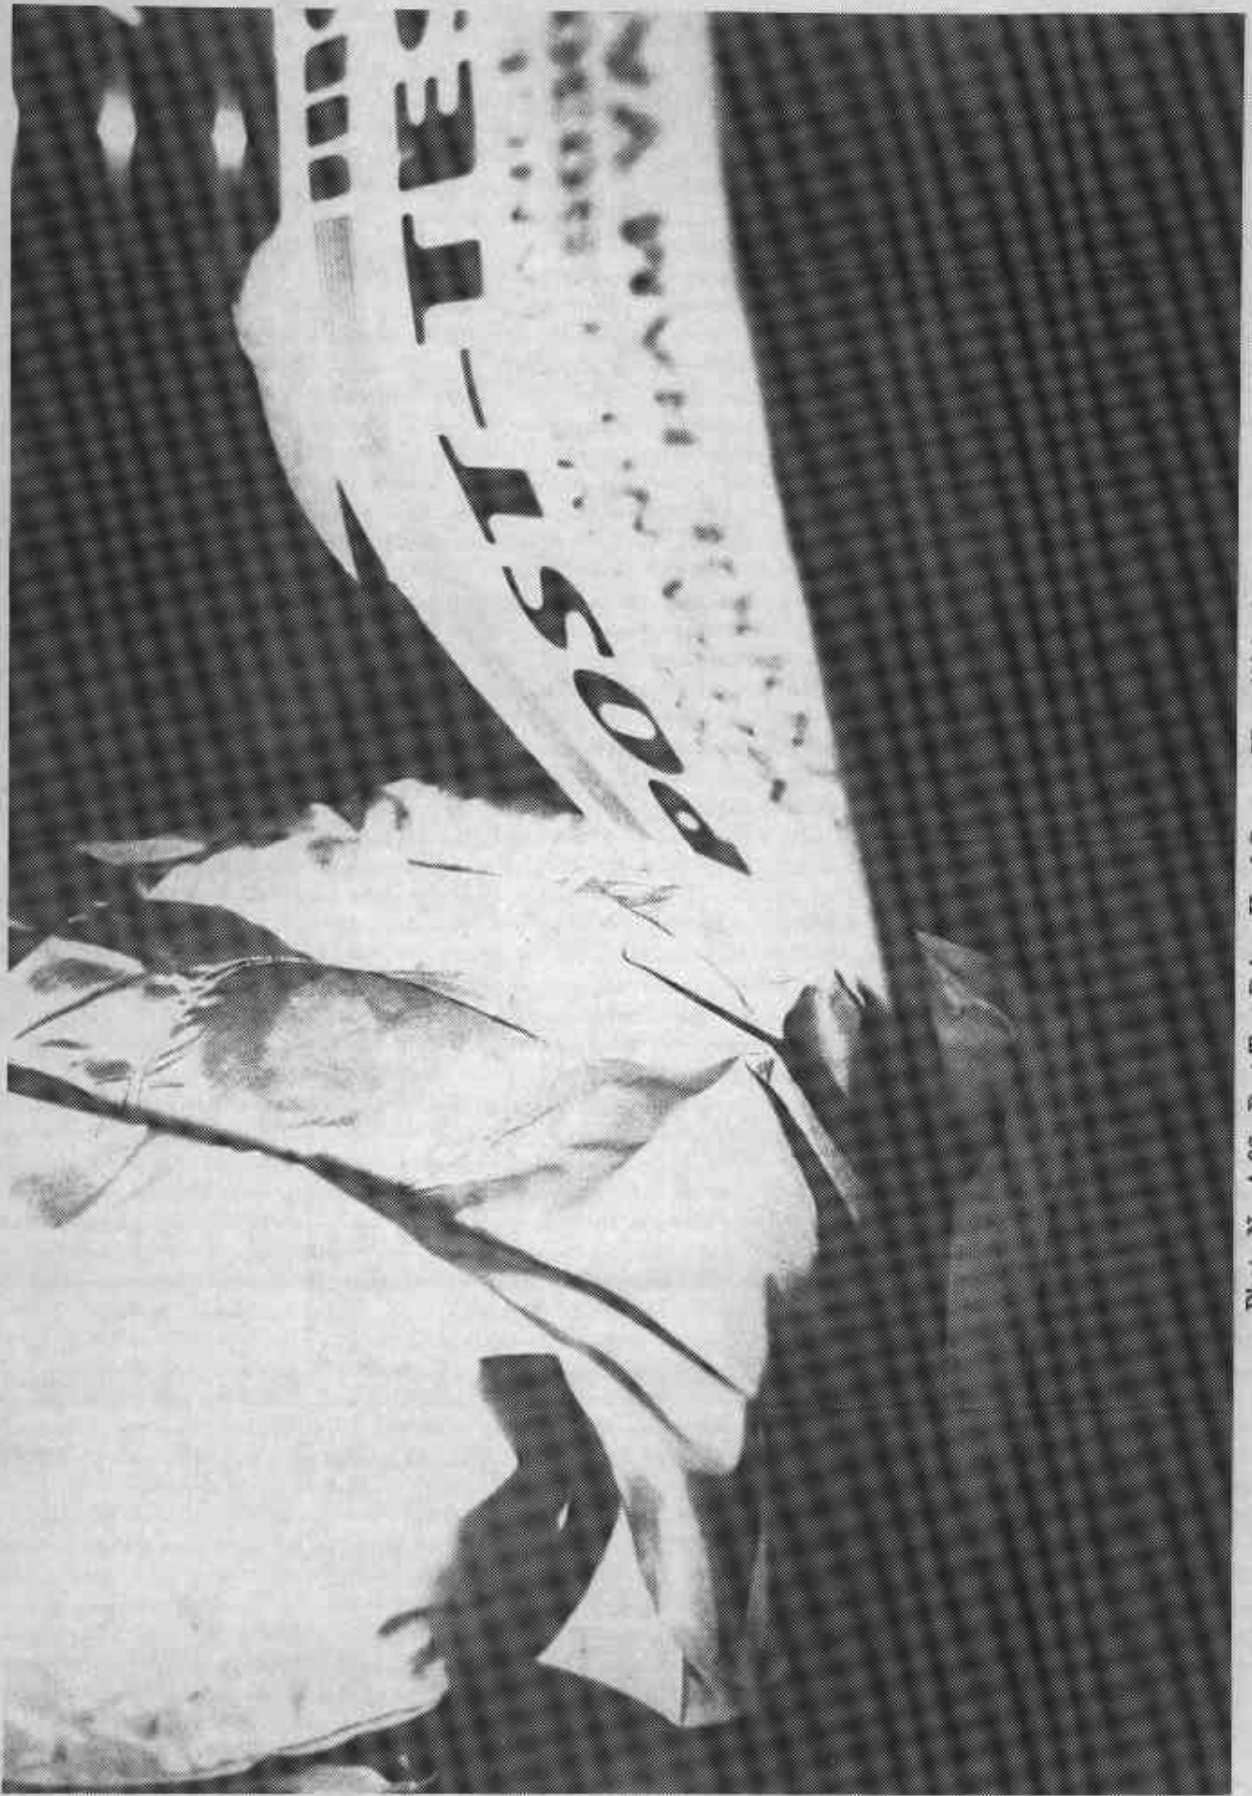
Photo No. A-30 - Post-Test Driver Head Contact View (Airbag)

| Visible Dummy Contact Points: | Driver | Passenger |
|---|---|---|
| Head | <u>Airbag, headrest</u> | <u>Headrest</u> |
