REPORT NO.: 208-MGA-95-003  
212-MGA-95-003  
301-MGA-95-003

VEHICLE SAFETY COMPLIANCE TESTING  
FOR  
FMVSS 208, OCCUPANT CRASH PROTECTION  
FMVSS 212, WINDSHIELD MOUNTING  
FMVSS 219, WINDSHIELD INTRUSION (PARTIAL)  
FMVSS 301, FUEL SYSTEM INTEGRITY

HONDA MOTOR CO., LTD.  
1995 Acura Integra 3 Door  
NHTSA NO. CS5301

FINAL REPORT

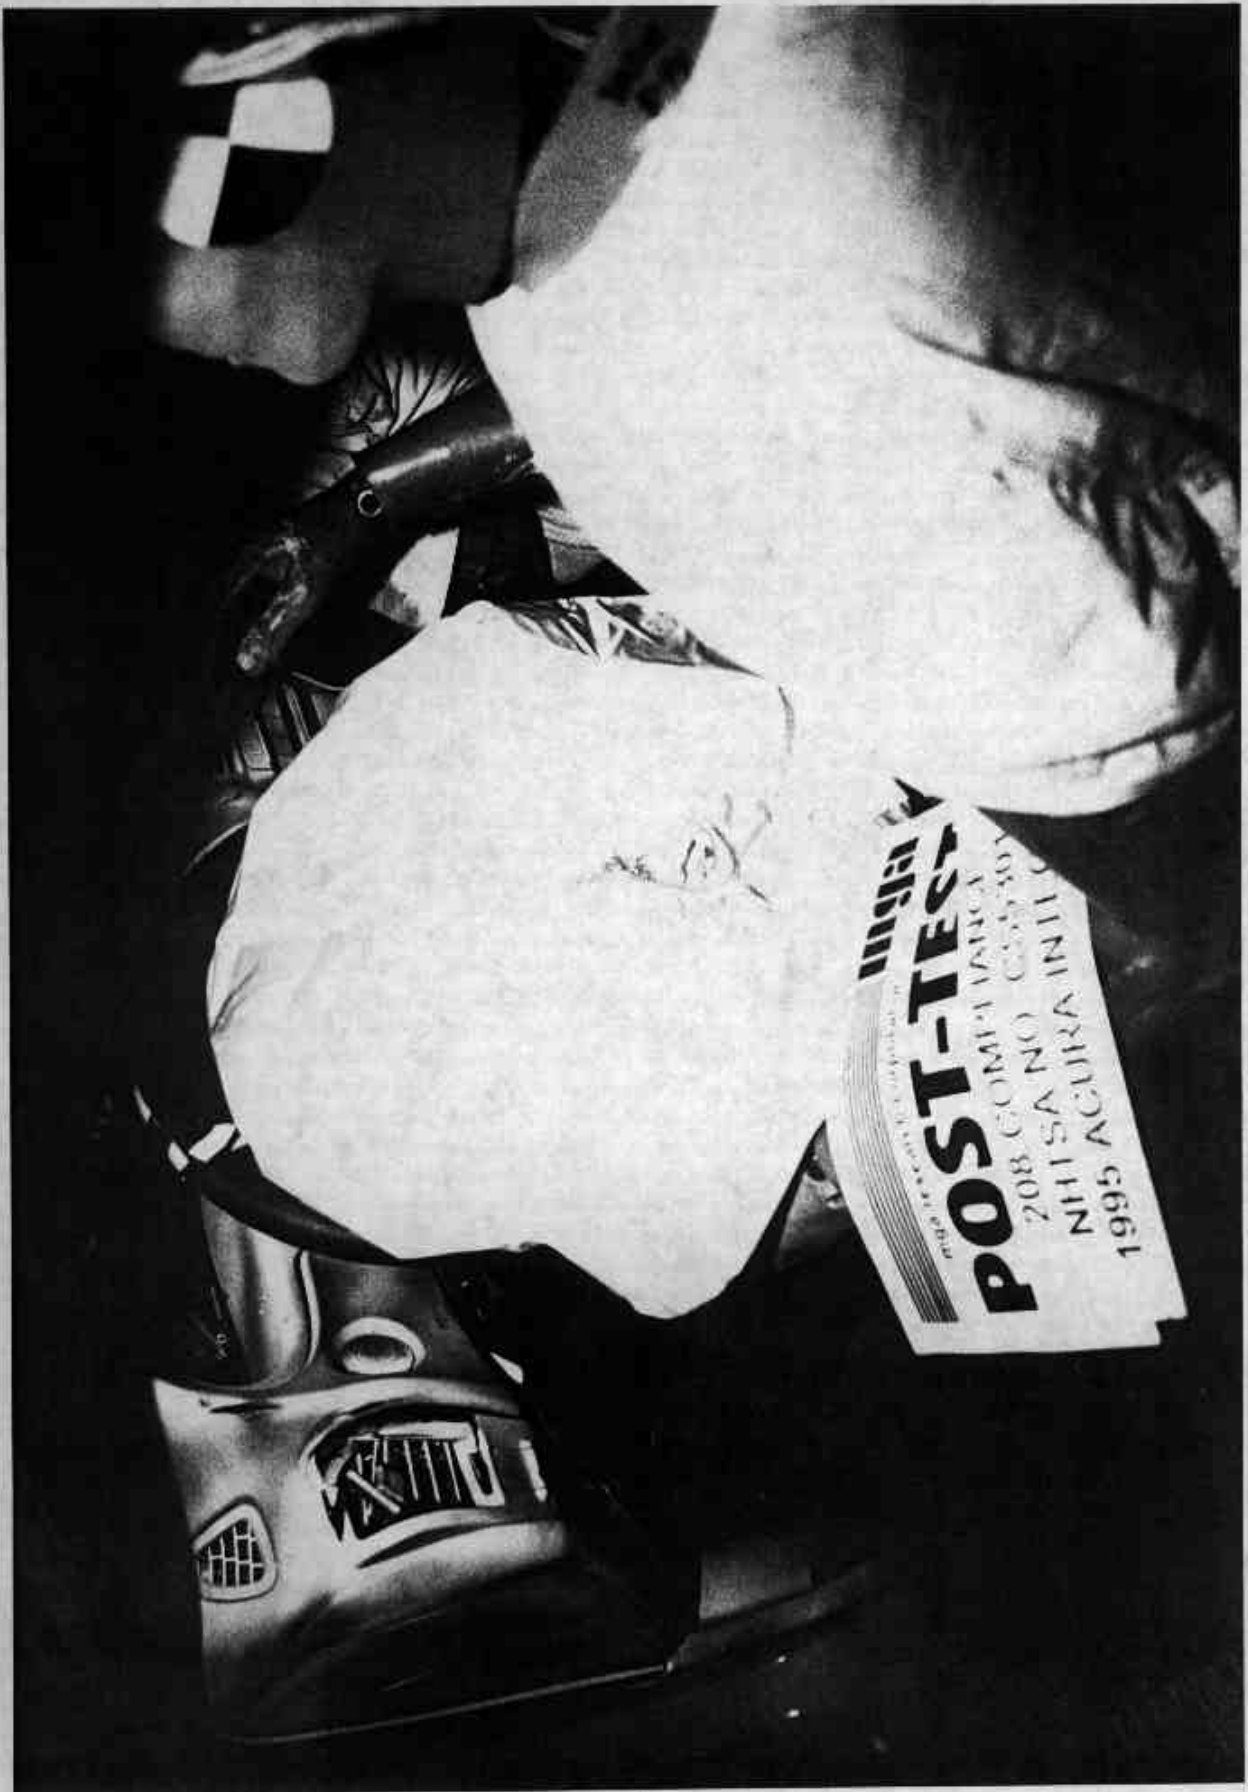
| Head | <u>Airbag and Windshield</u> | <u>Airbag and Windshield</u> |

Photo No. A-25 - Post-Test Driver Head Contact View (Airbag)
