REPORT NO.: MGA-95-21411

SAFETY COMPLIANCE TESTING FOR FMVSS 214  
"SIDE IMPACT PROTECTION - PASSENGER CARS"

VOLVO  
1995 VOLVO 850 4 DOOR STATION WAGON  
NHTSA NO: CS5900

FINAL REPORT

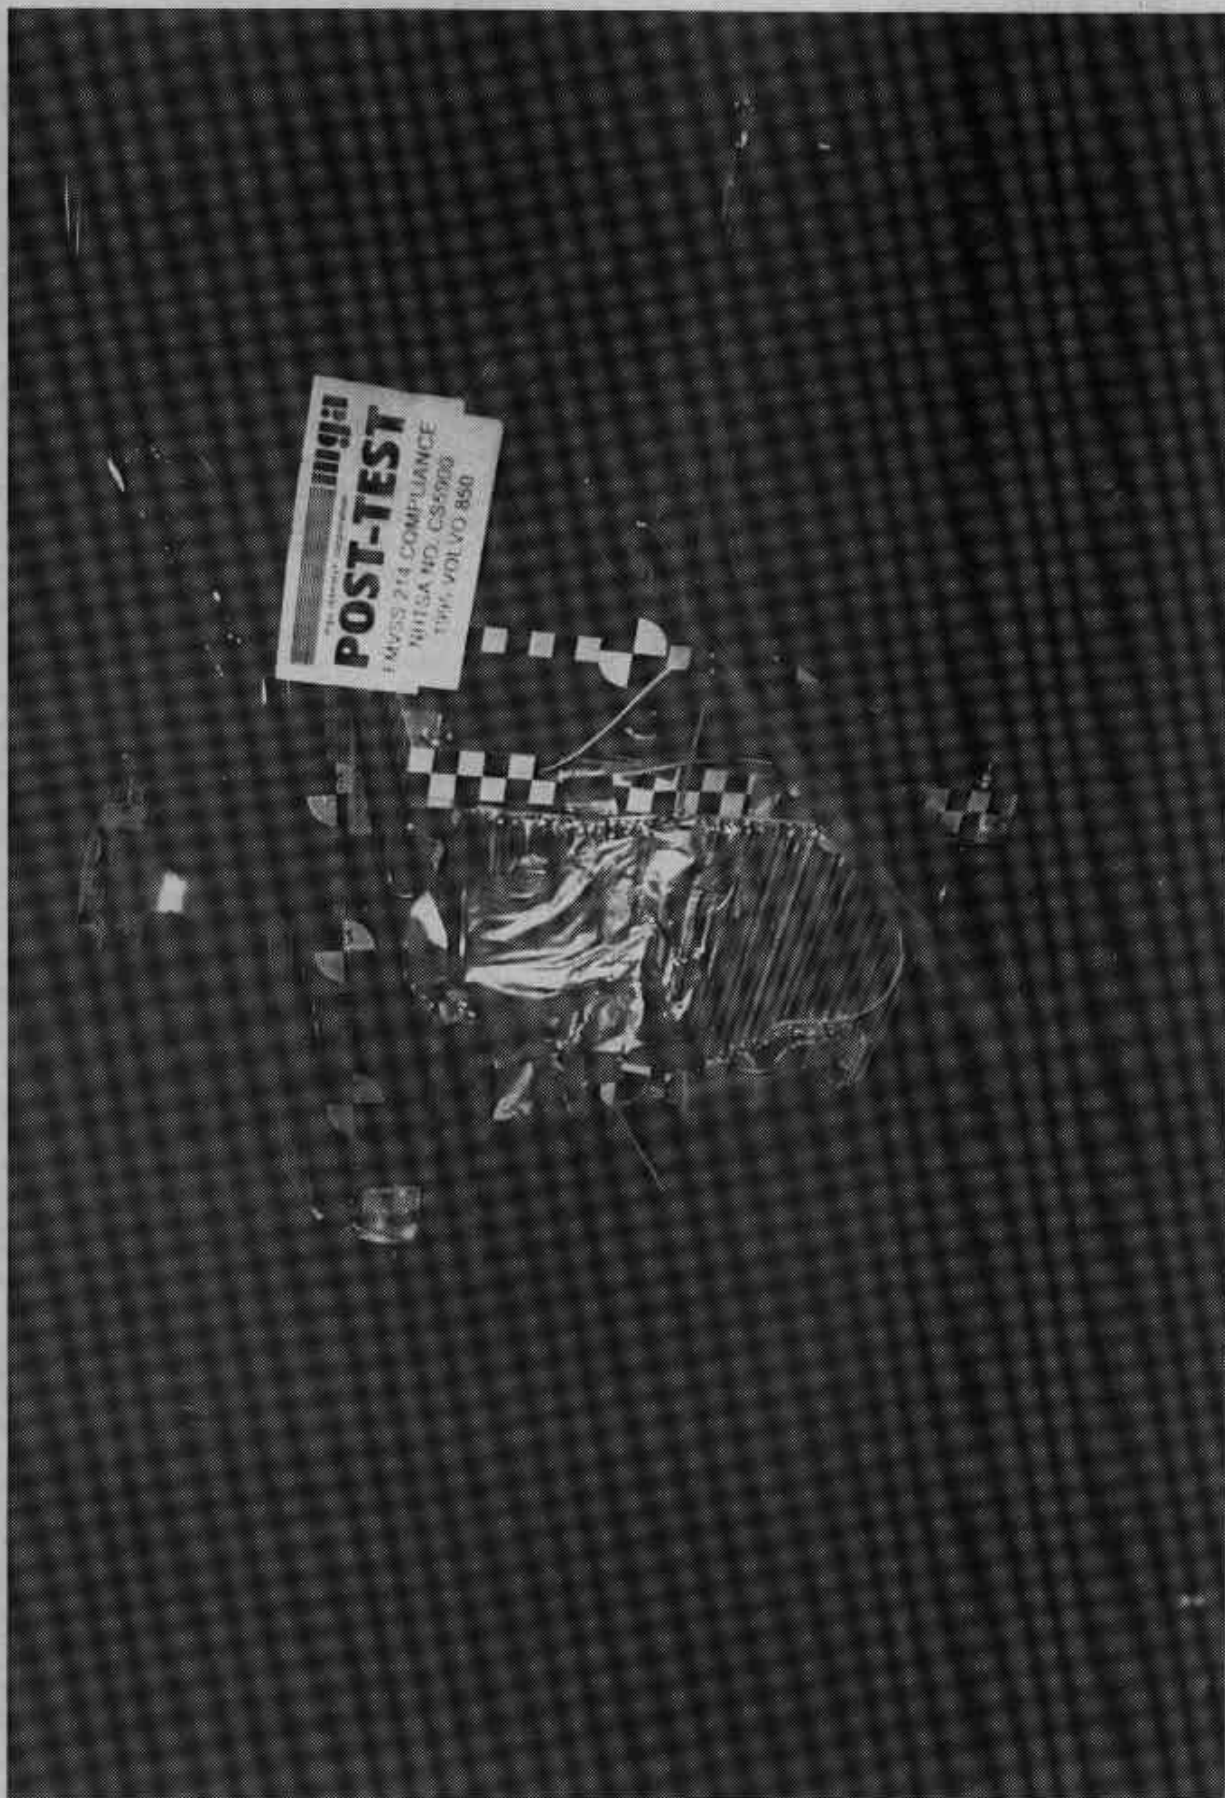
Photo No. A-10 - Post-Test MDB Position Against Vehicle (left side)

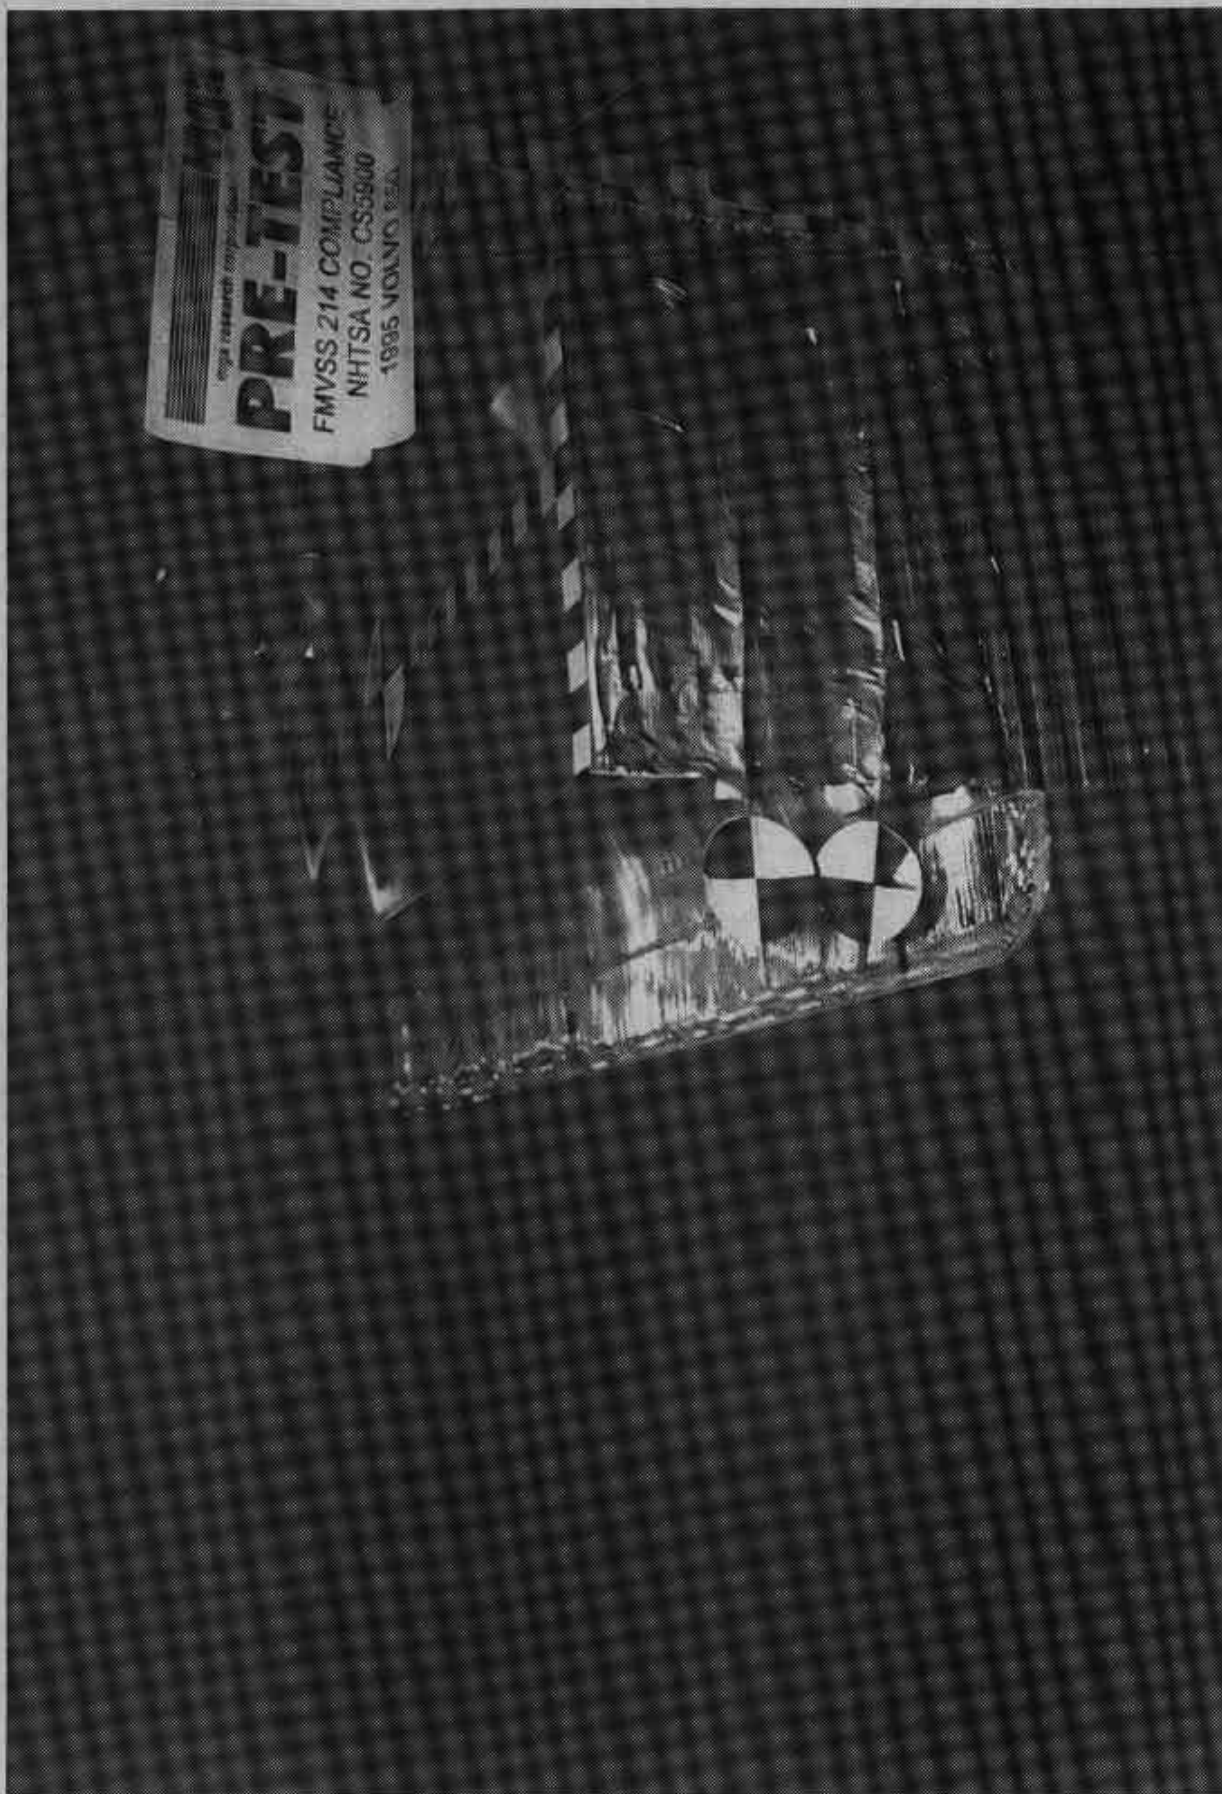
Photo No. A-16 - Pre-Test MDB Left Side View
