Vehicle Safety Compliance Testing  
for Occupant Crash Protection,  
Windshield Mounting, Windshield Zone Intrusion,  
and Fuel System Integrity

1995 Pontiac Sunfire

NHTSA Number: CS0114

TRC Test Number: 950201

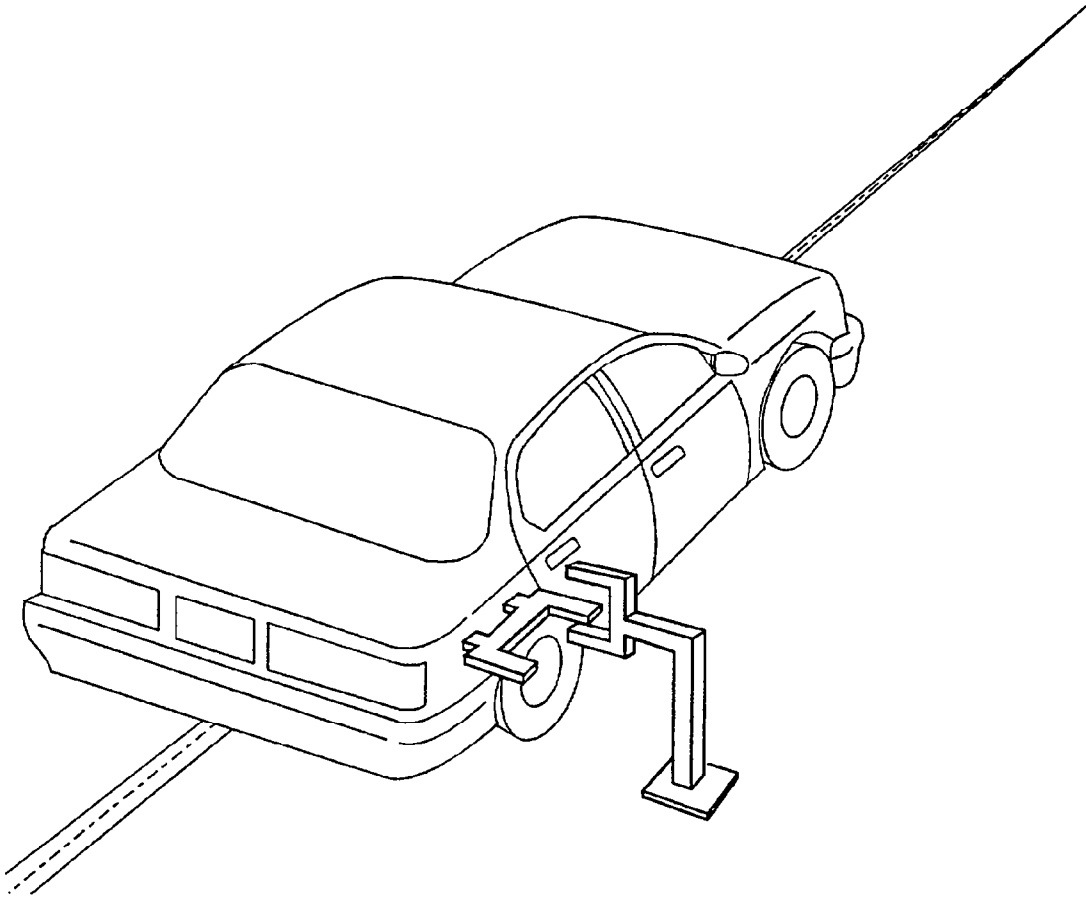
Figure 1 Impact Velocity Measurement System

The final vane clears the final emitter/receiver pair two inches before impact.  
The vanes have a one-foot spacing.

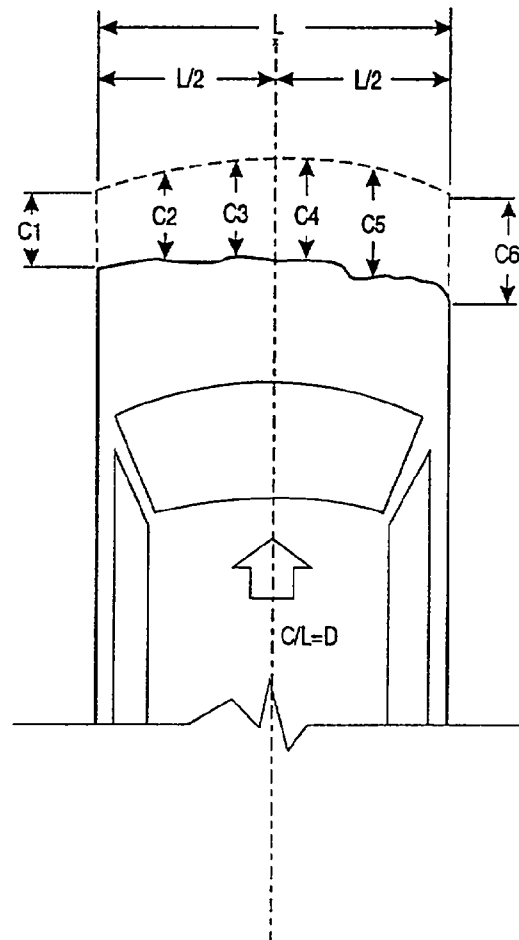
Figure 2 Accident Investigation Division Data for 30 mph Frontal Barrier Impact

Midpoint of damage: D: Vehicle Longitudinal Centerline

Length of damaged region: L: 48.0 in

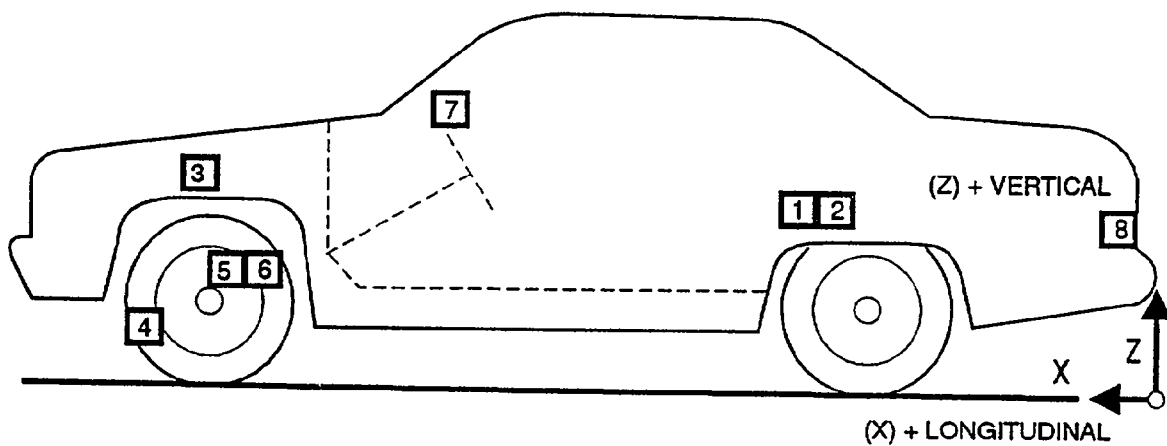
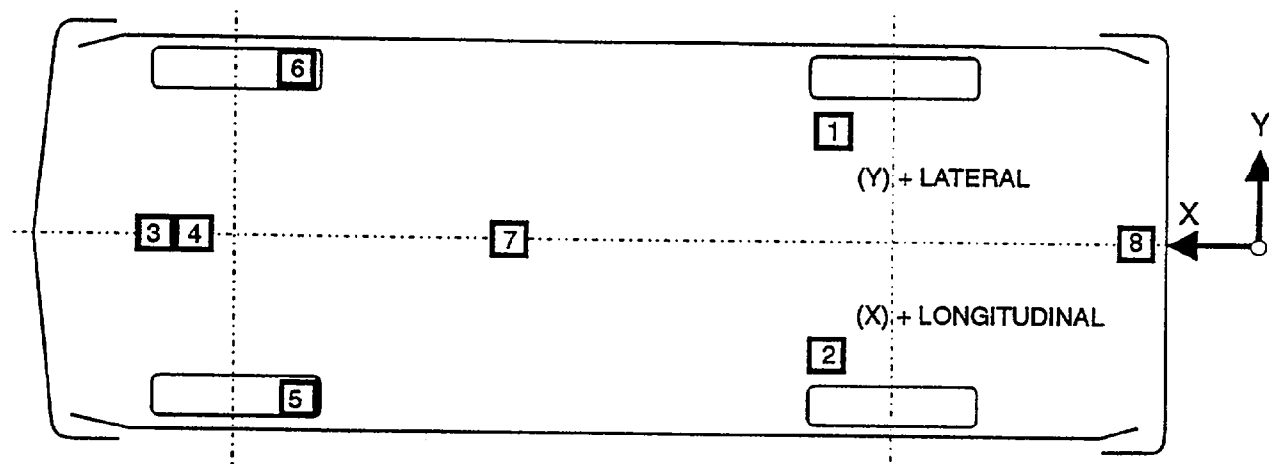
Figure 3 Vehicle Accelerometer Placement

SIDE VIEW

BOTTOM VIEW

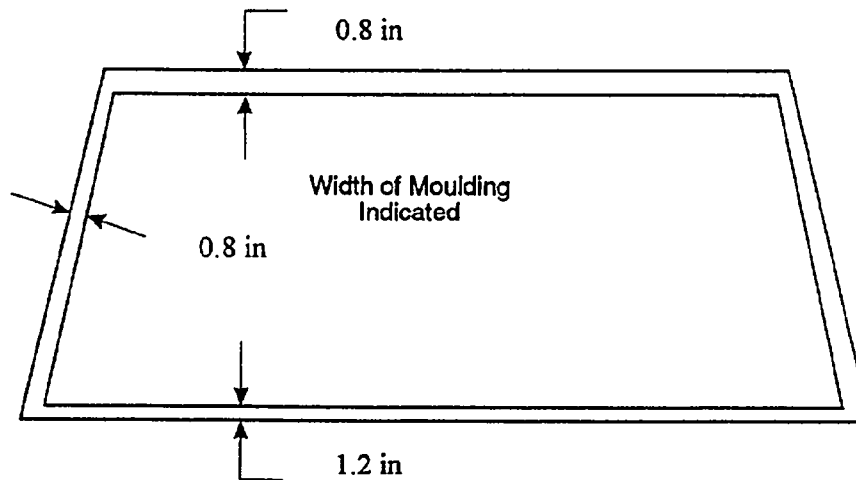
Front view of windshield<sup>1</sup>

Loss of windshield retention lengths: None
