**REPORT NO.: MGA-95-21407**

**SAFETY COMPLIANCE TESTING FOR FMVSS 214**  
**"SIDE IMPACT PROTECTION - PASSENGER CARS"**

**MITSUBISHI MOTORS**  
1995 **MITSUBISHI GALANT 4 DOOR**  
NHTSA NO: CS5601

**FINAL REPORT**

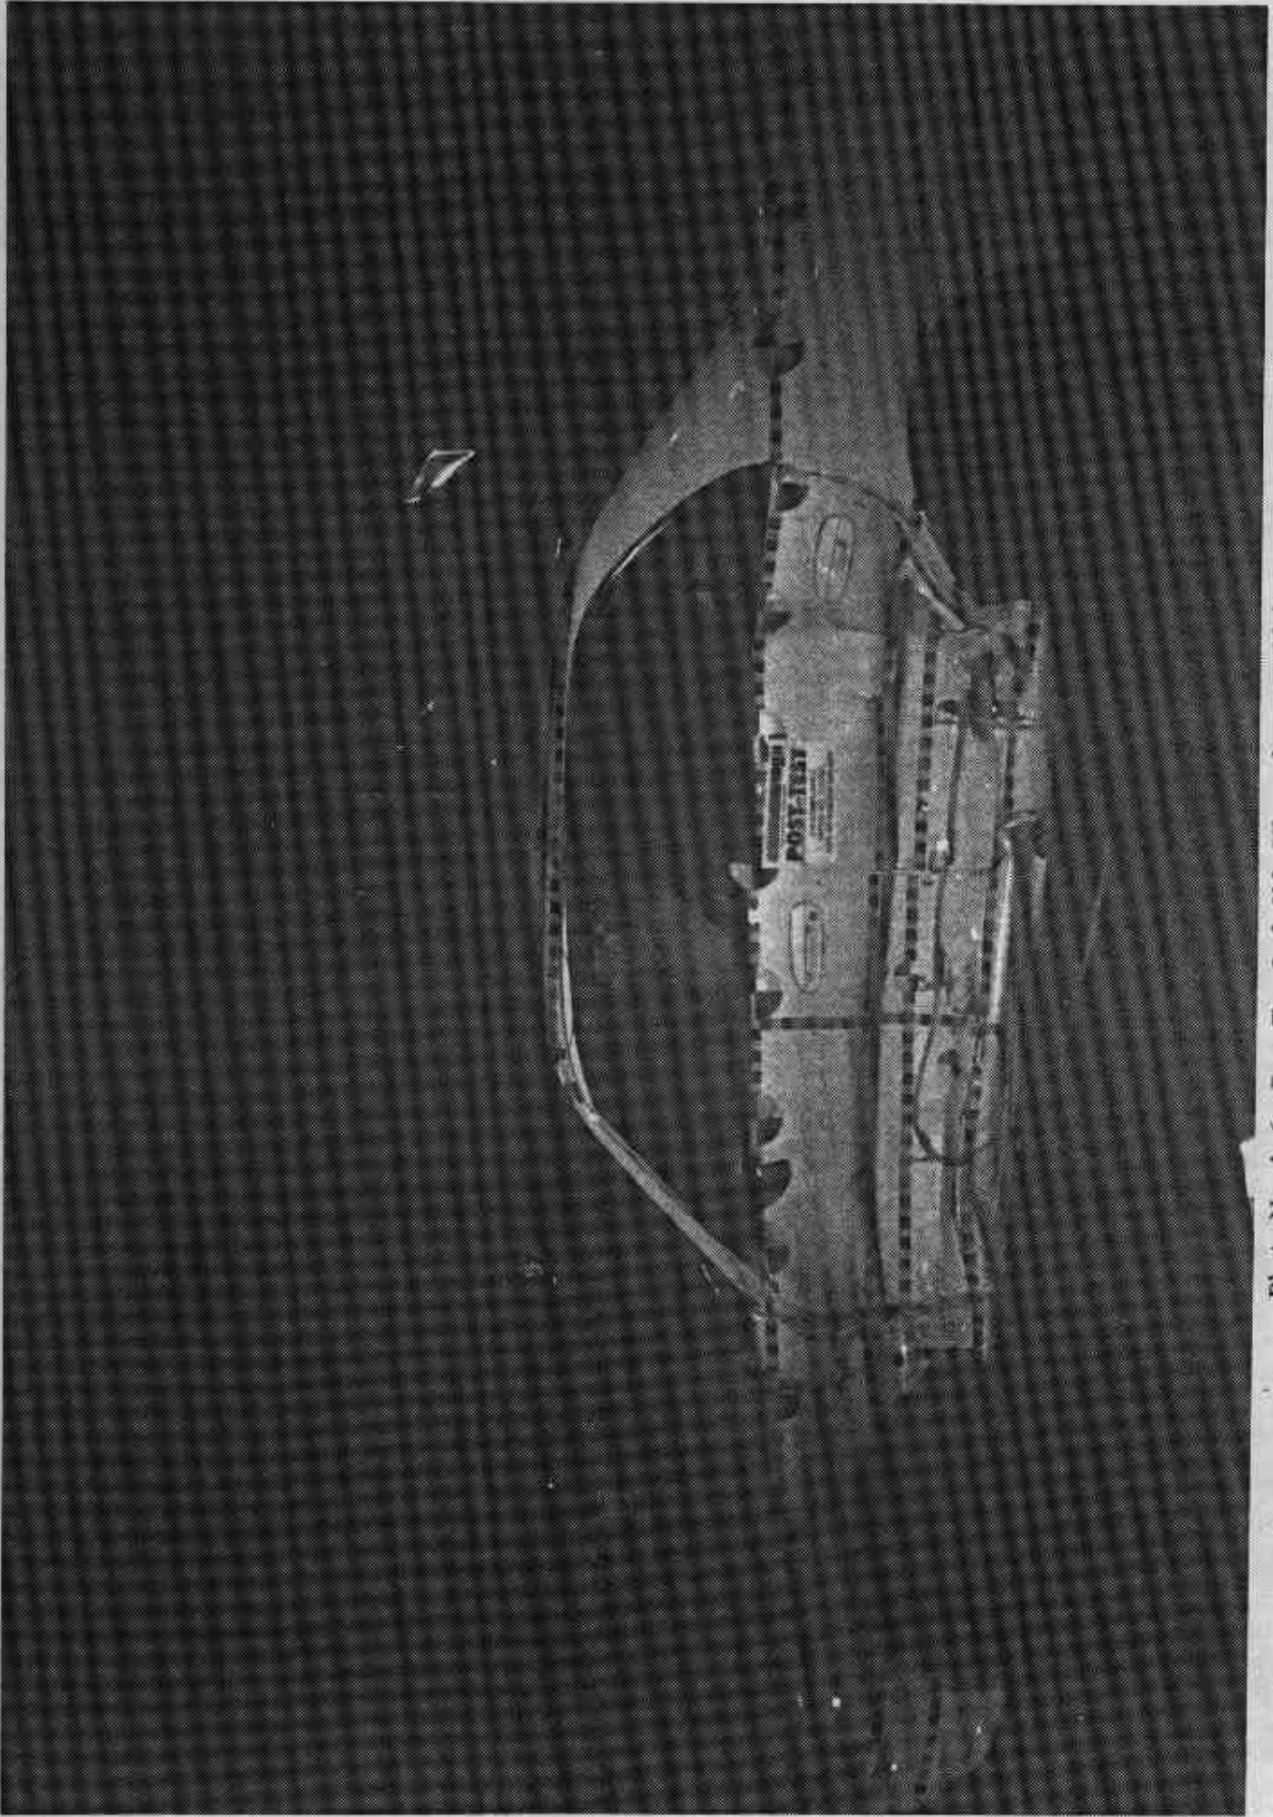
Photo No. A-6 - Post-Test Left Side View of Test Vehicle

Left side windows broken & windshield cracked

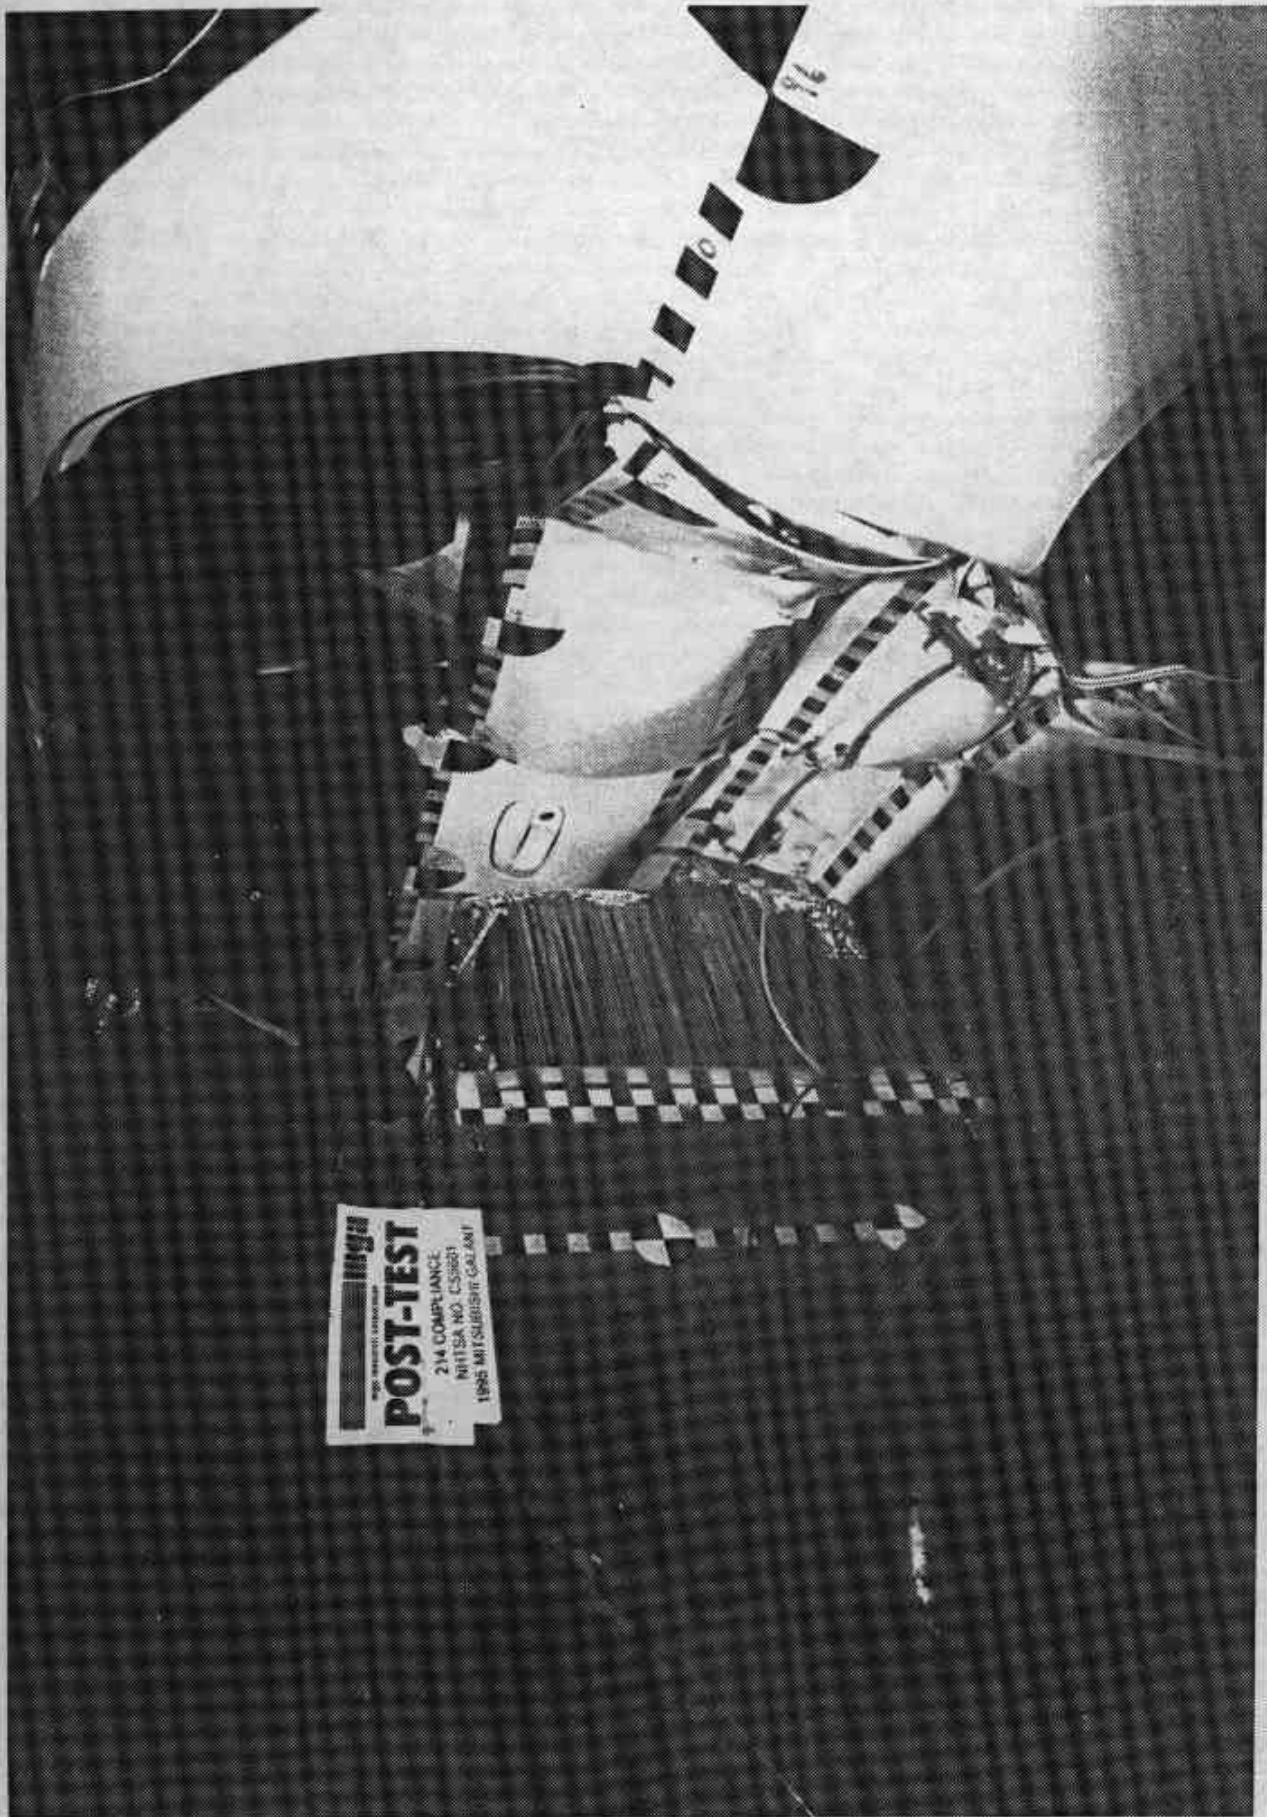
Photo No. A-11 - Post-Test MDB and Vehicle Right Side Rear View

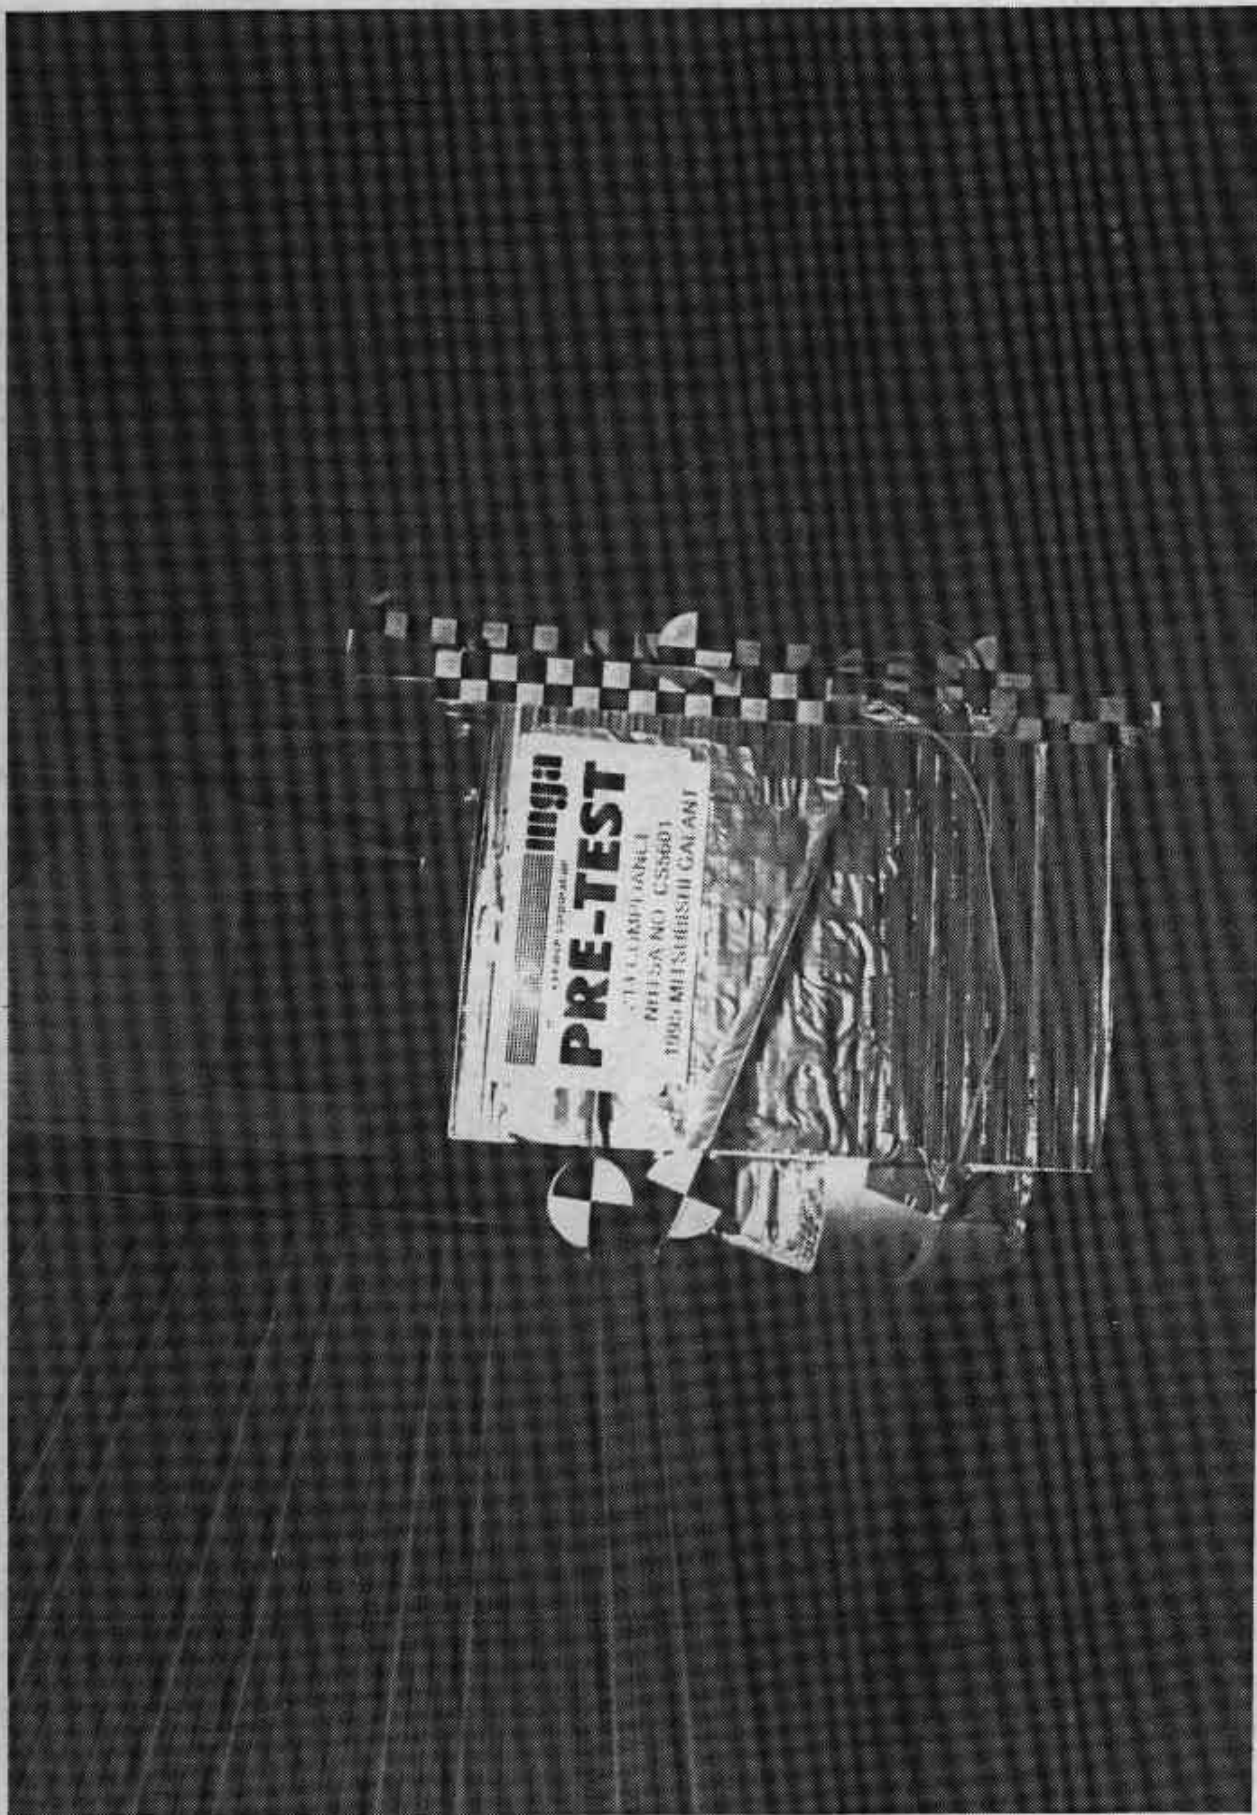
Photo No. A-16 - Pre-Test MDB Left Side View

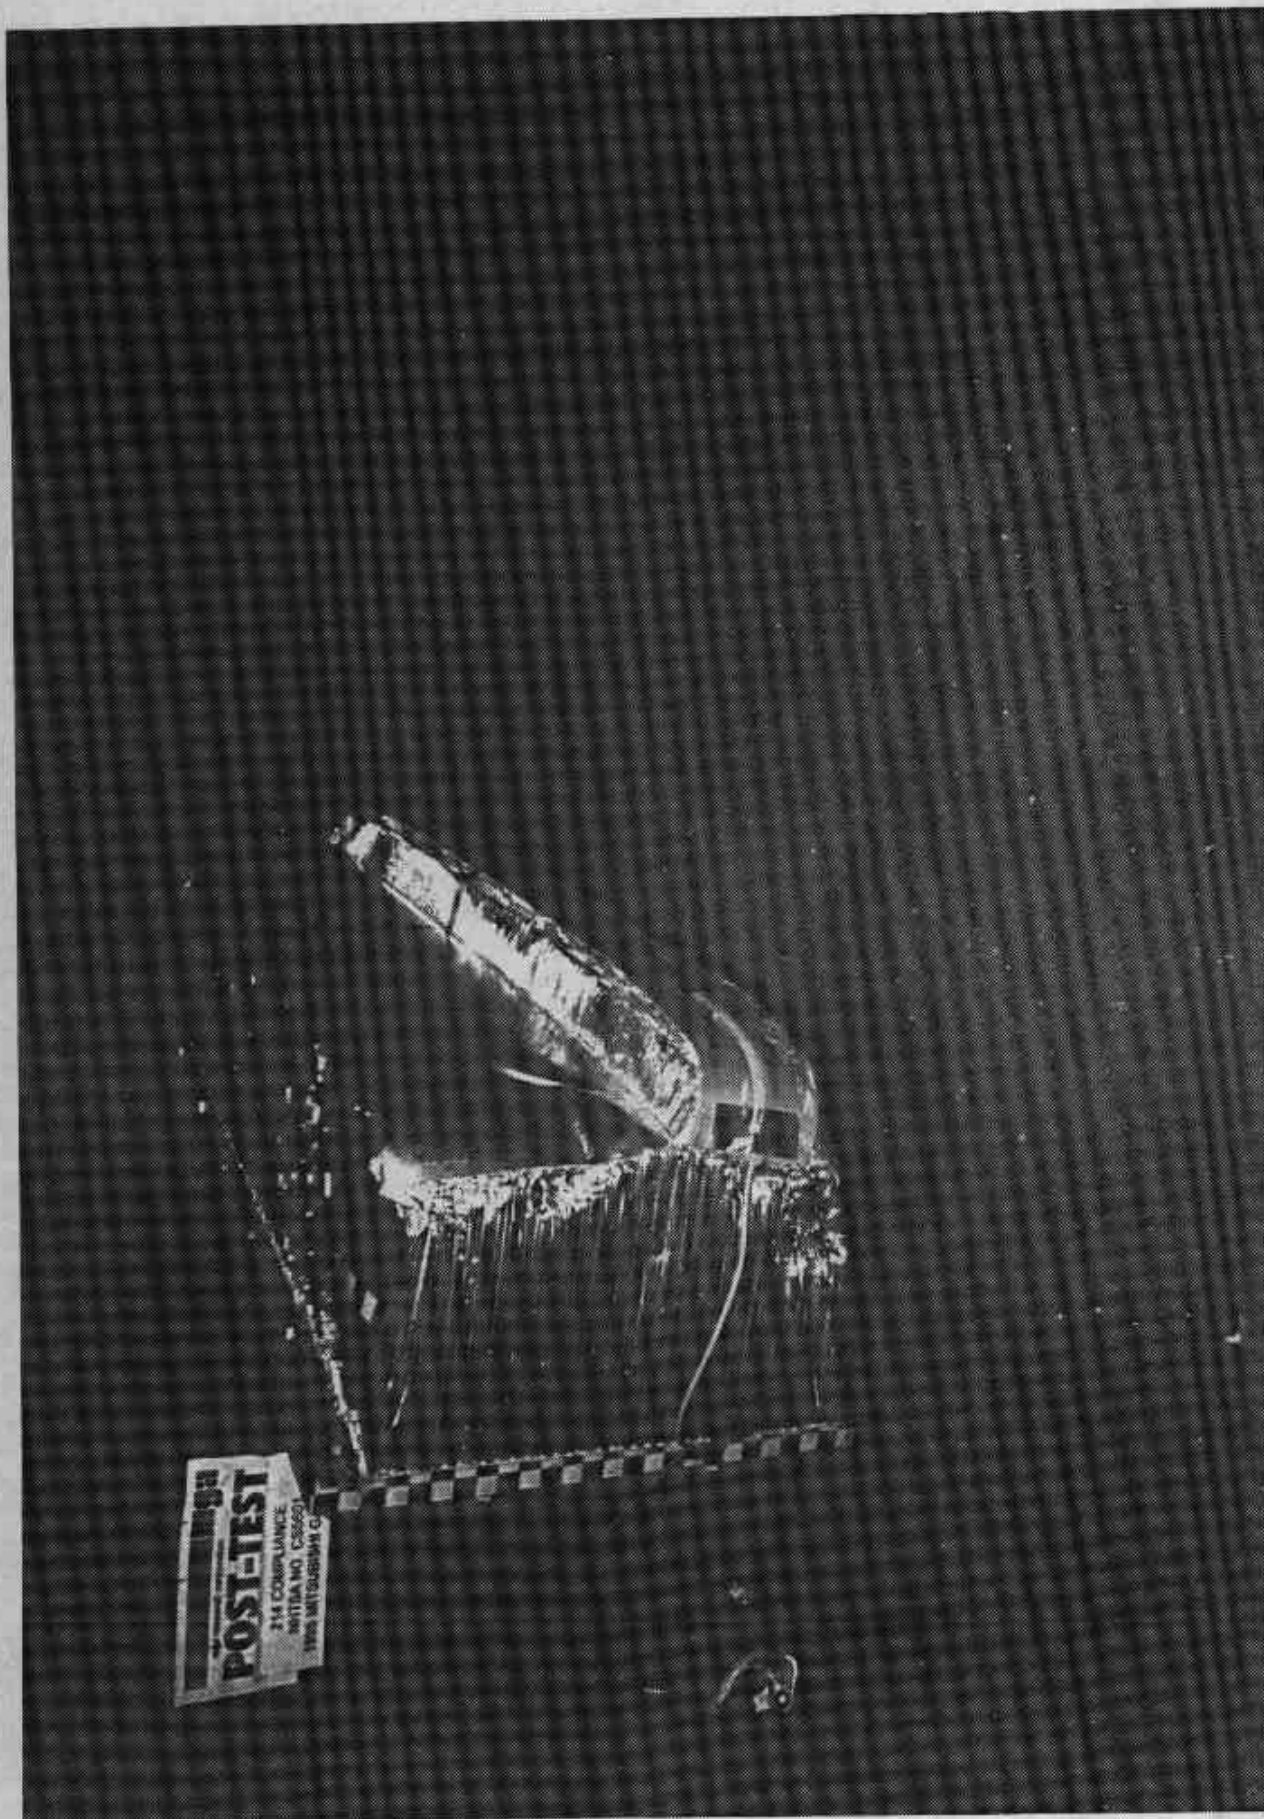
Photo No. A-19 - Post-Test MDB Right Side View

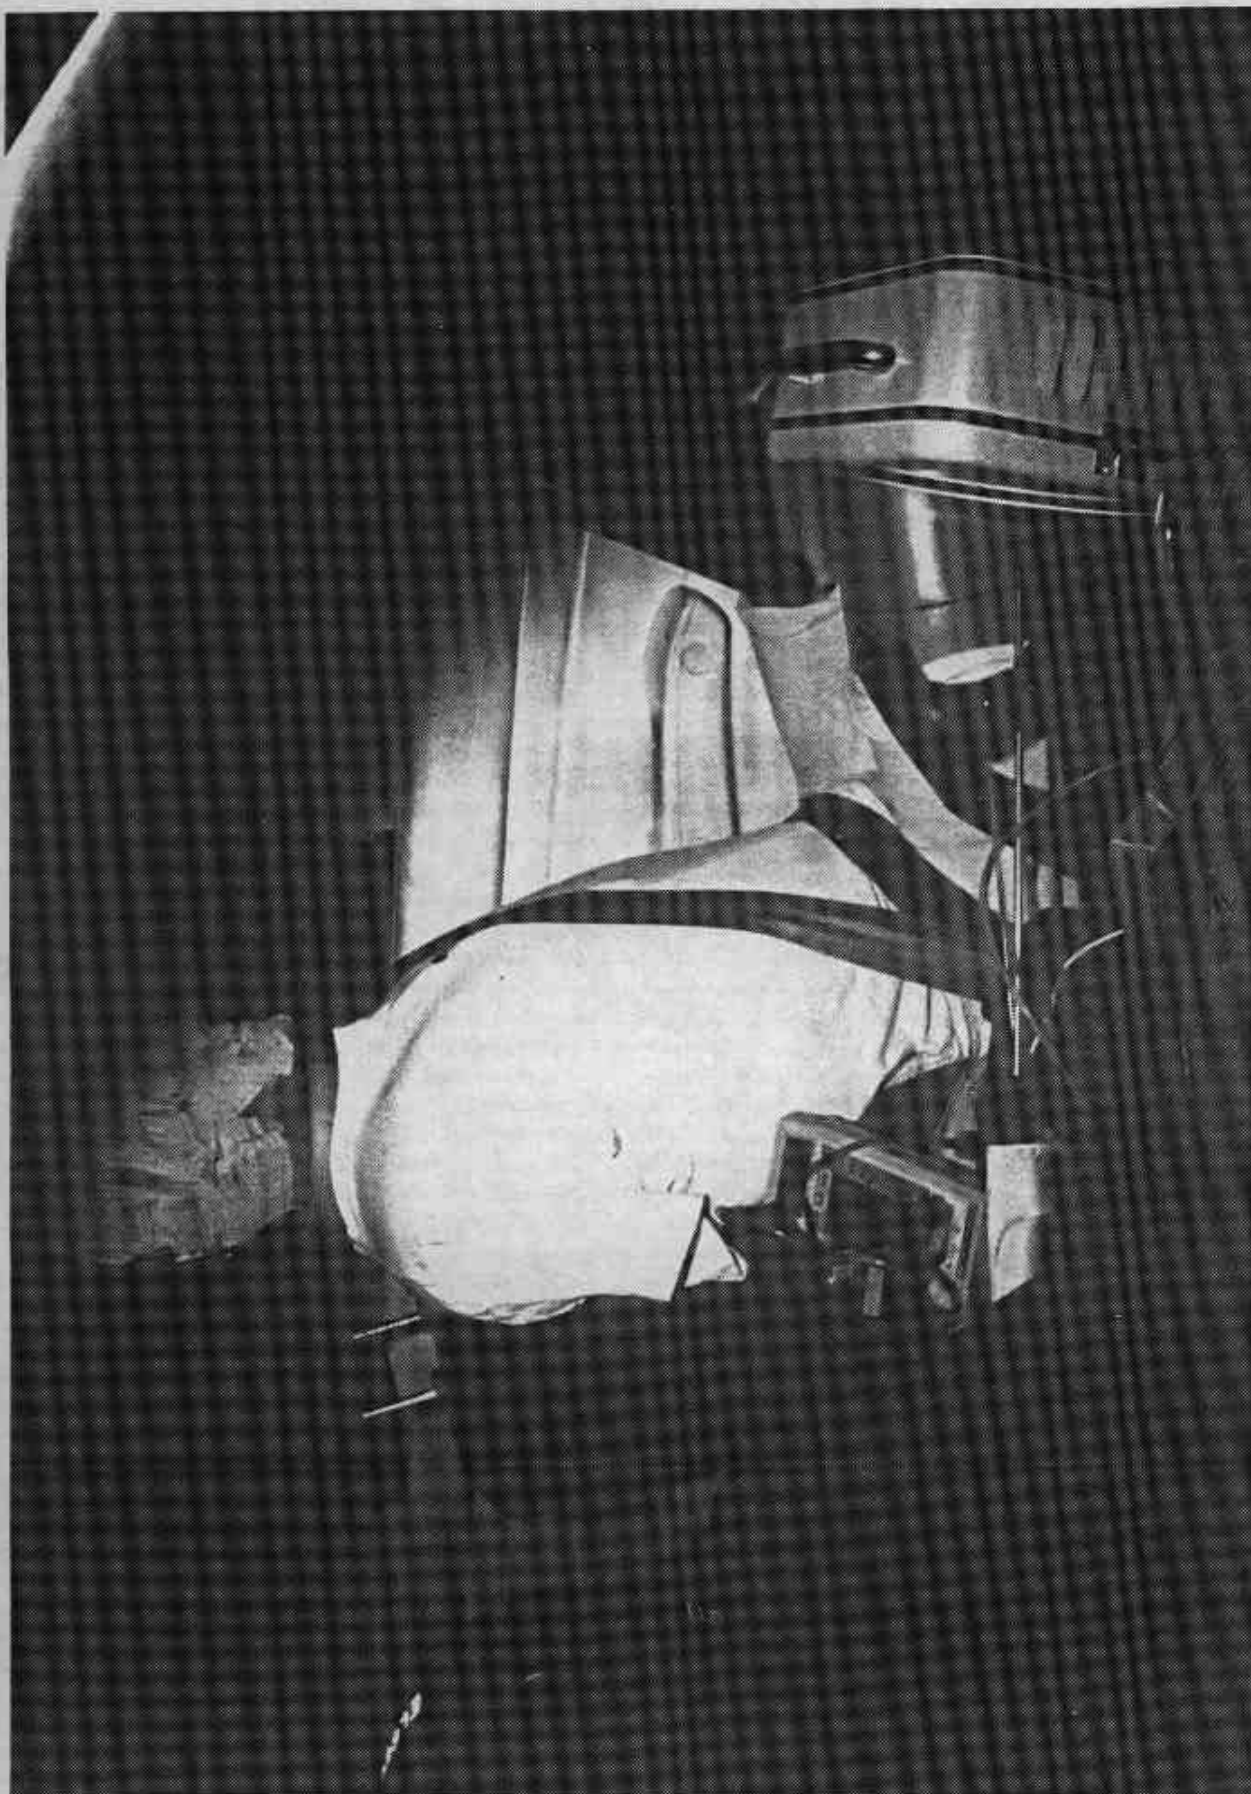
Photo No. A-21 - Pre-Test Driver Dummy Right Side View

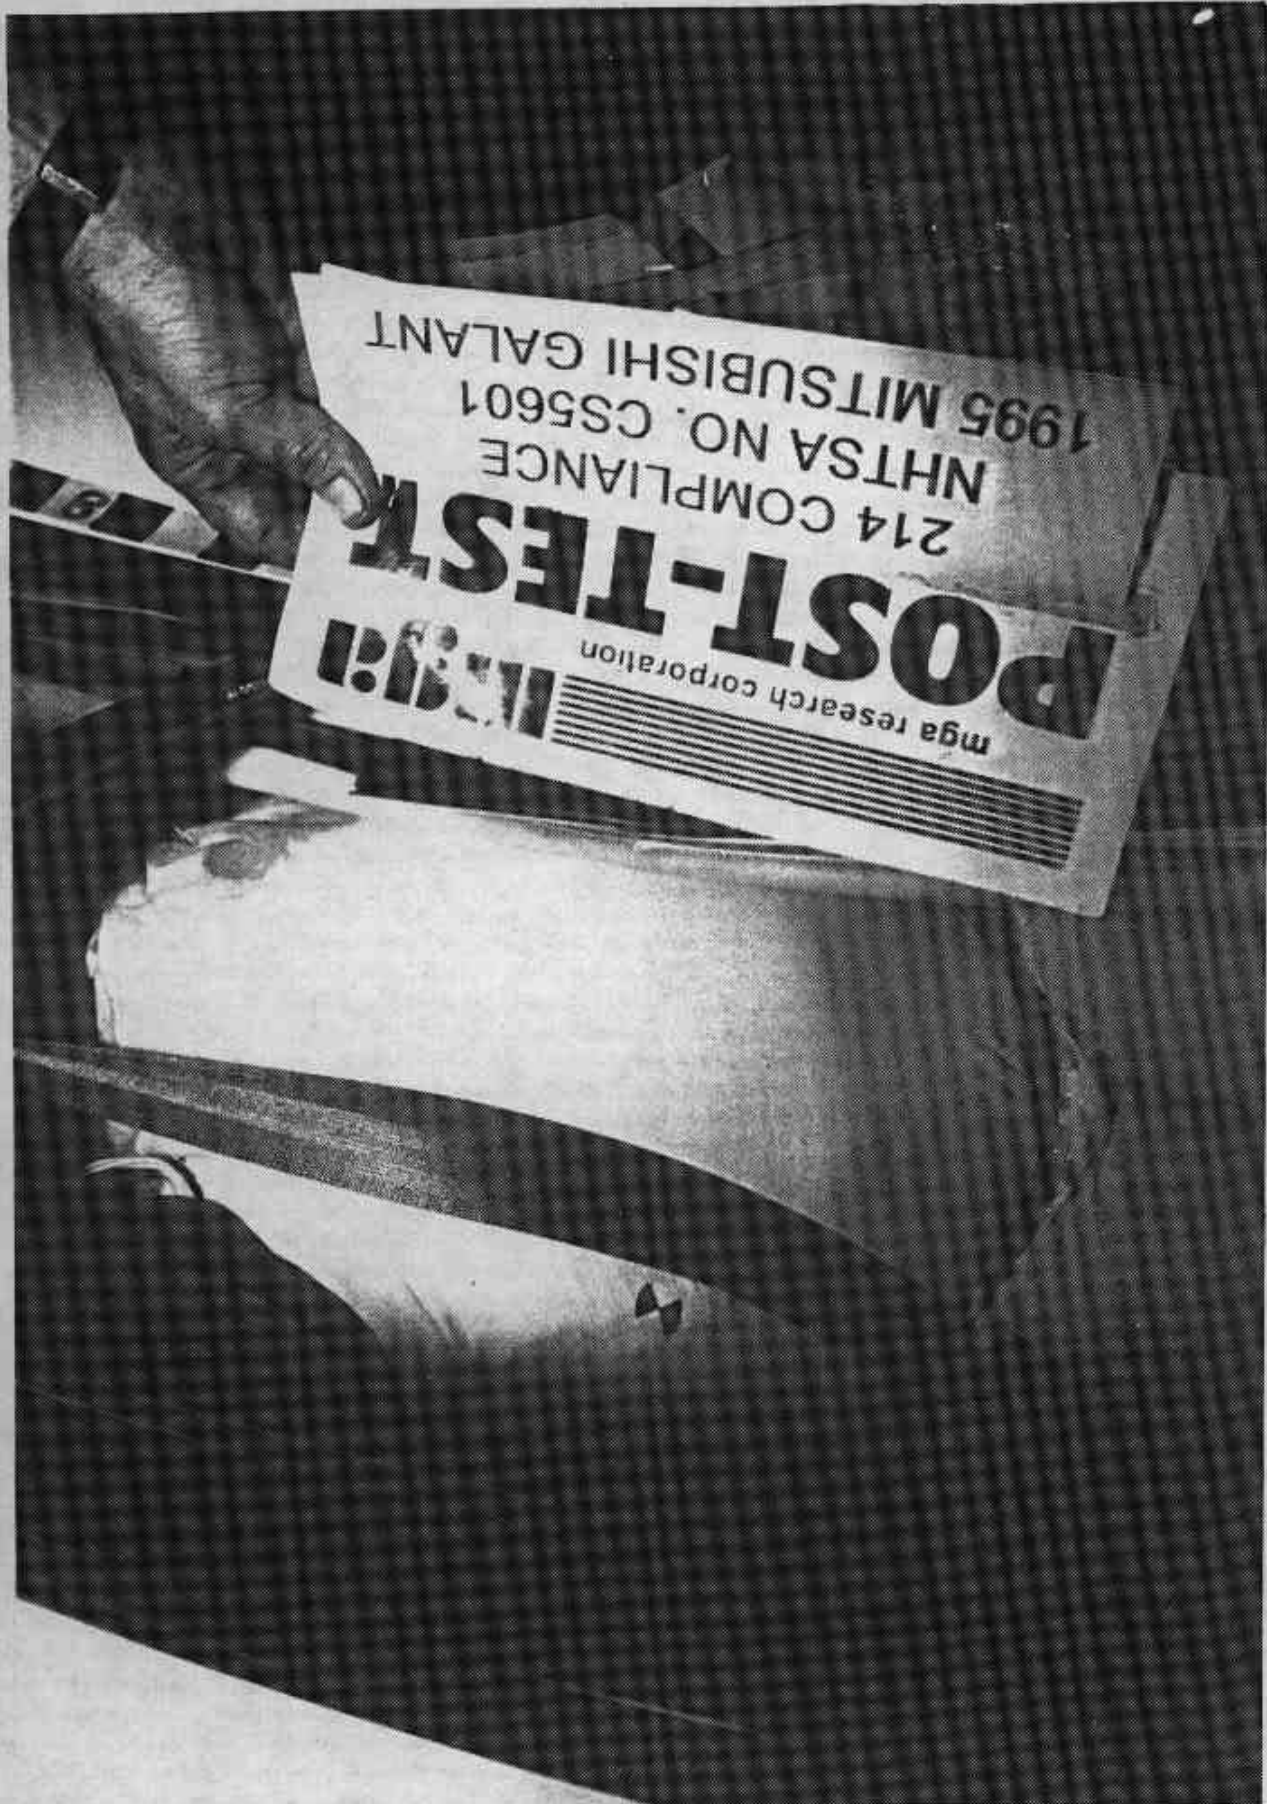
Photo No. A-26 - Post-Test Driver Dummy Shoulder and Door Top View

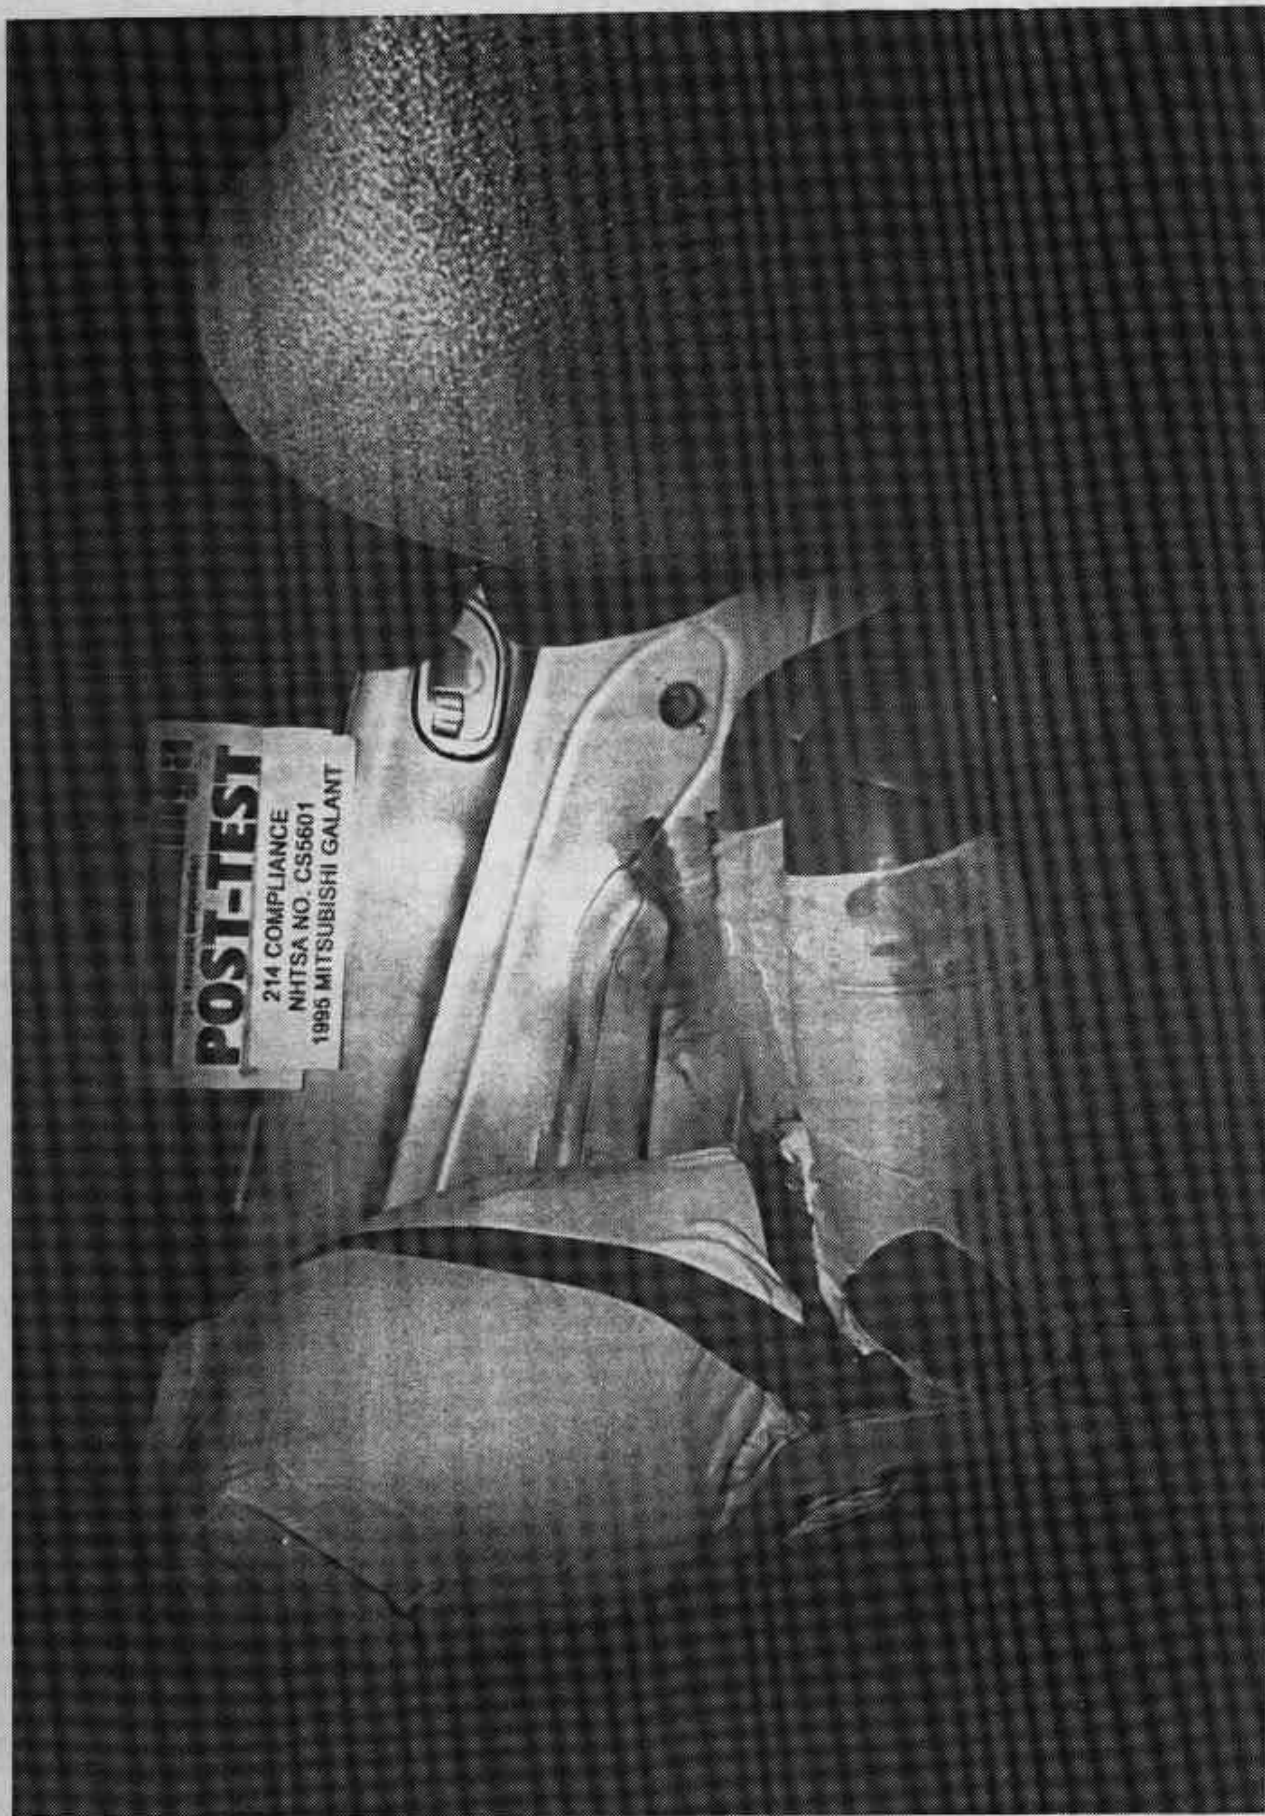
Photo No. A-29 - Post-Test Passenger Dummy Right Side View

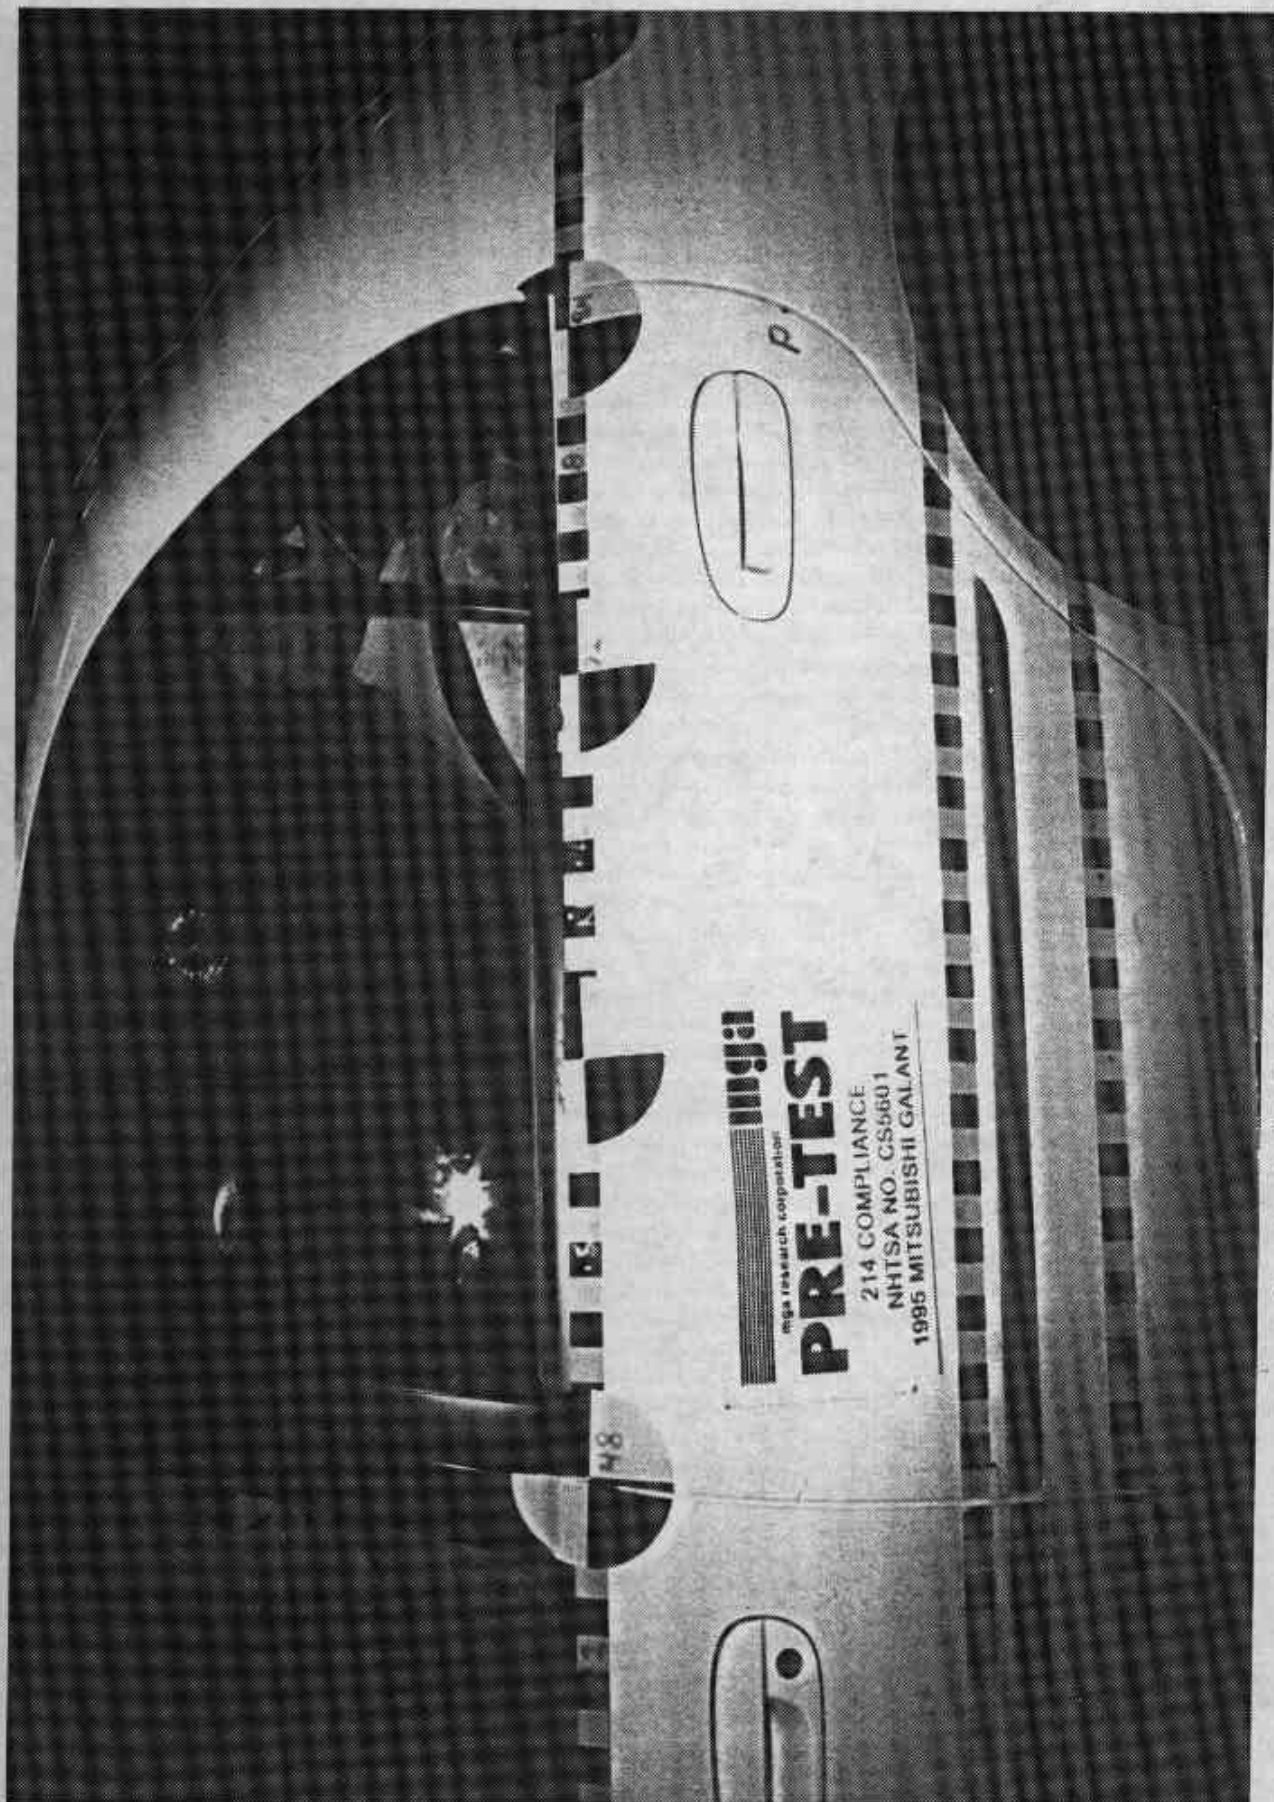
Photo No. A-30 - Pre-Test Passenger Dummy Left Side View

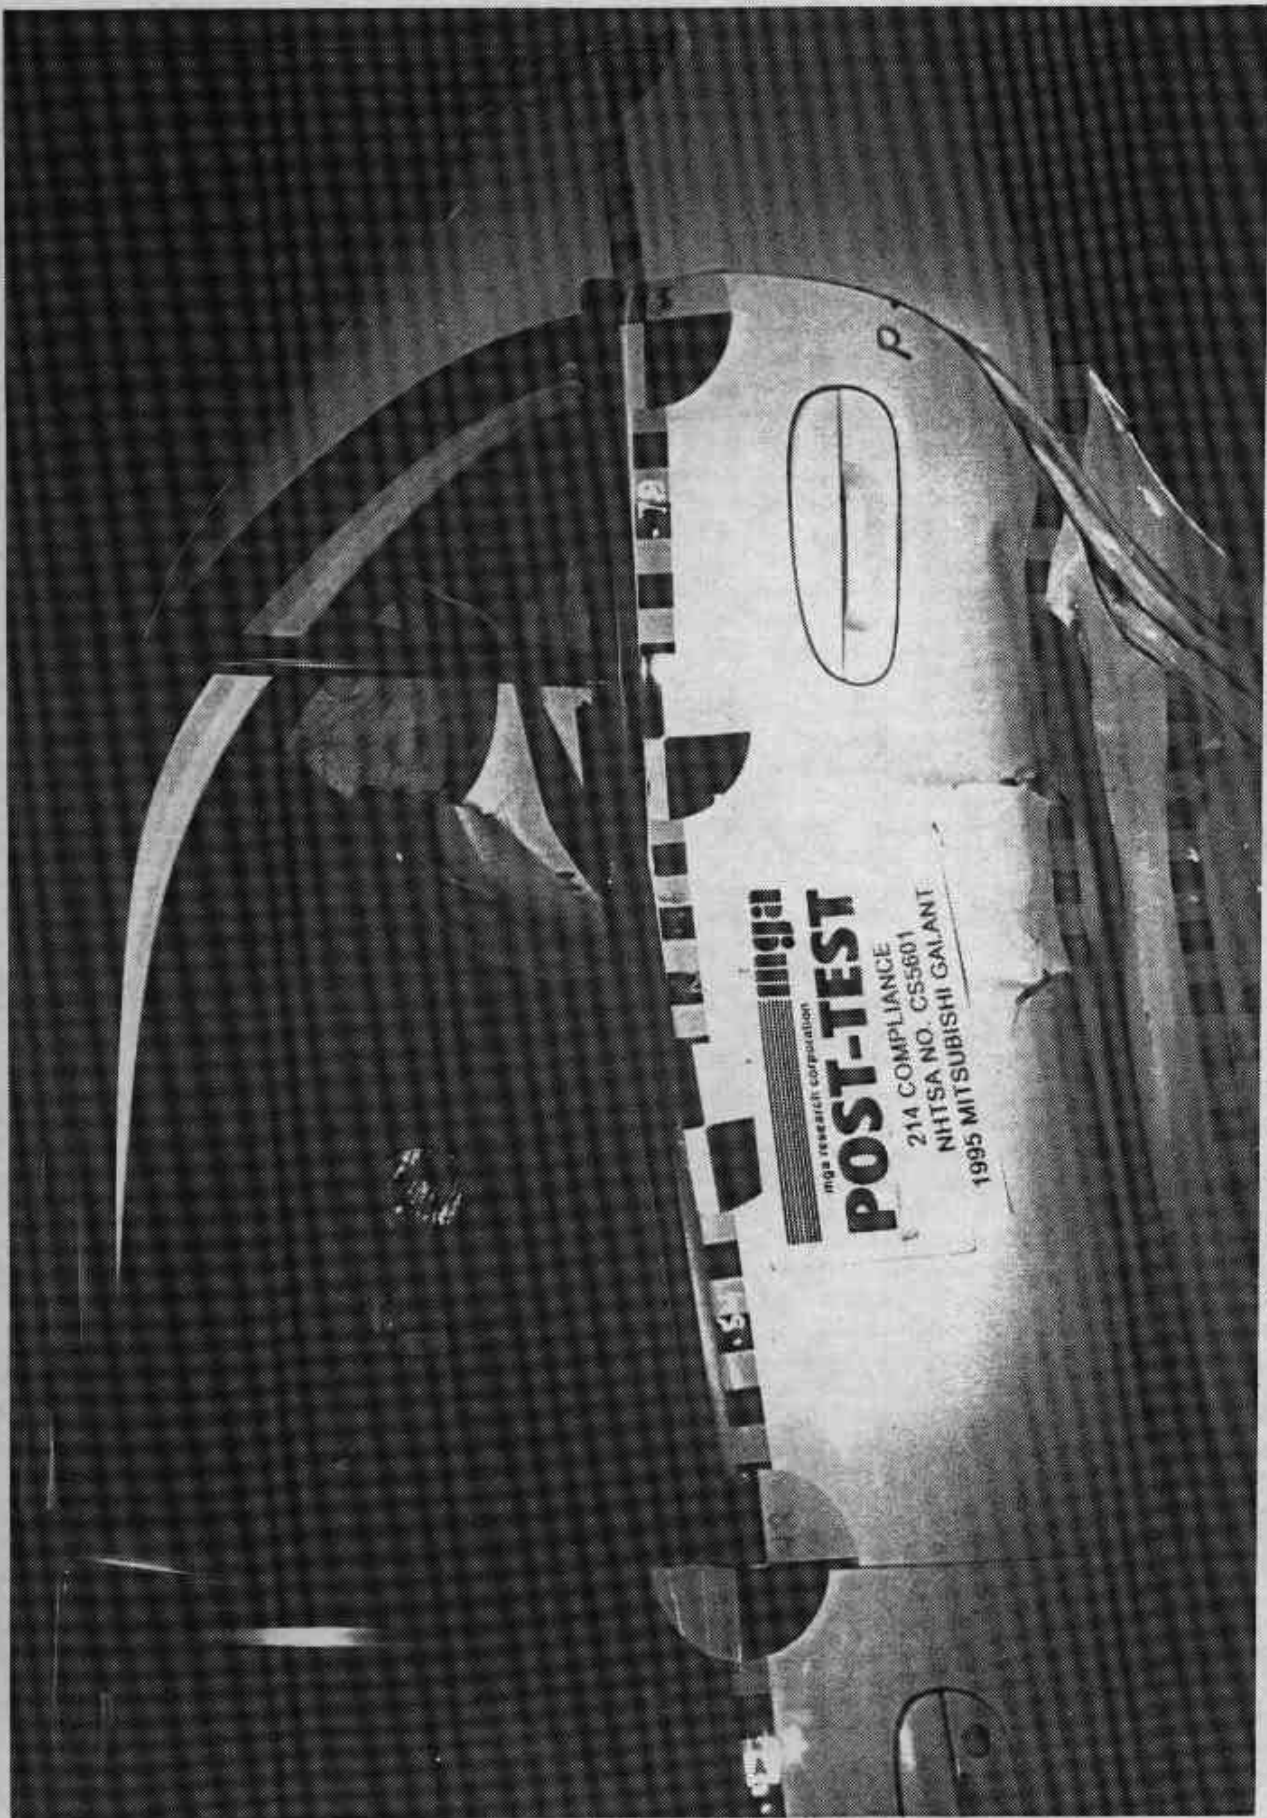
Photo No. A-31 - Post-Test Passenger Dummy Left Side View

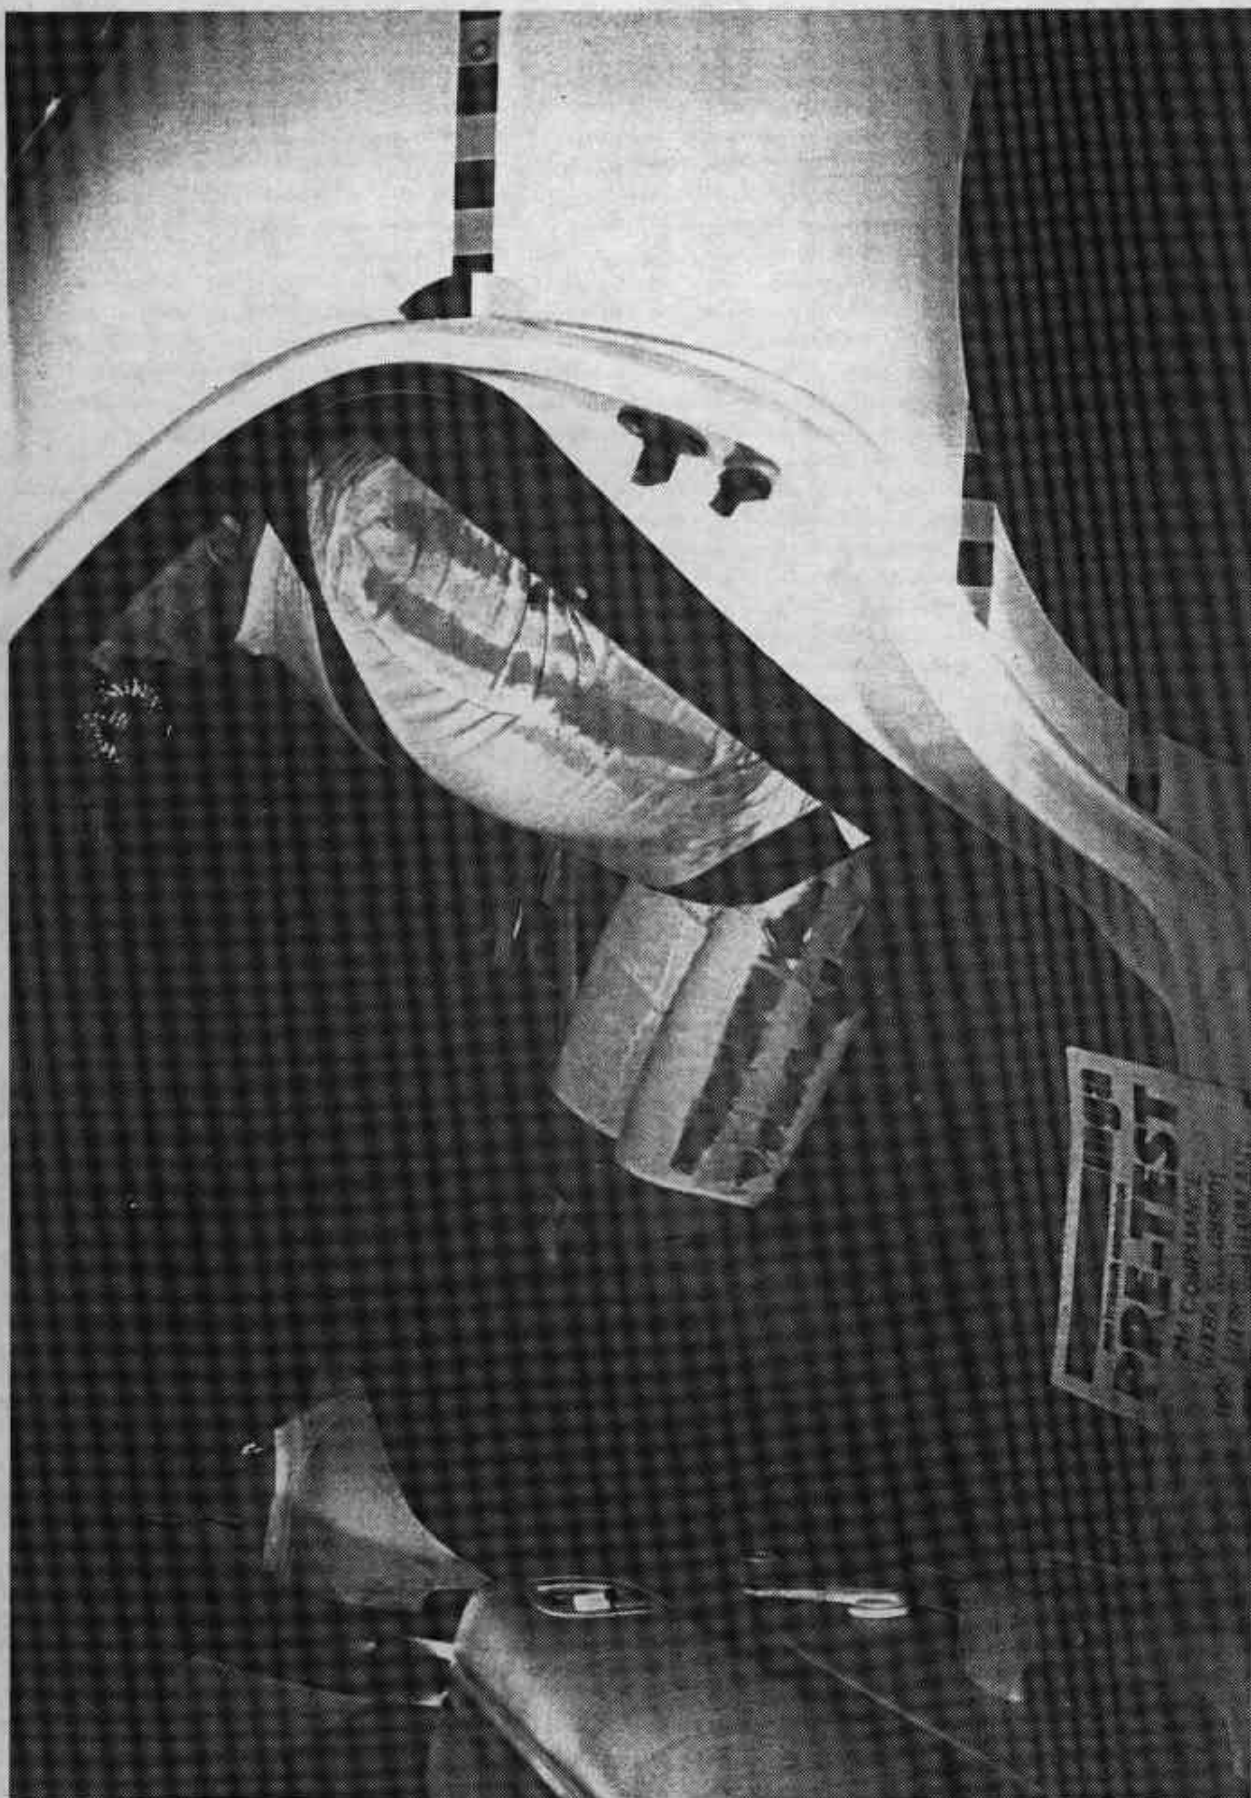
Photo No. A-32 - Pre-Test Passenger Dummy Left Side View (Door Open)
