**REPORT NO.: MGA-95-21407**

**SAFETY COMPLIANCE TESTING FOR FMVSS 214**  
**"SIDE IMPACT PROTECTION - PASSENGER CARS"**

**MITSUBISHI MOTORS**  
1995 **MITSUBISHI GALANT 4 DOOR**  
NHTSA NO: CS5601

**FINAL REPORT**

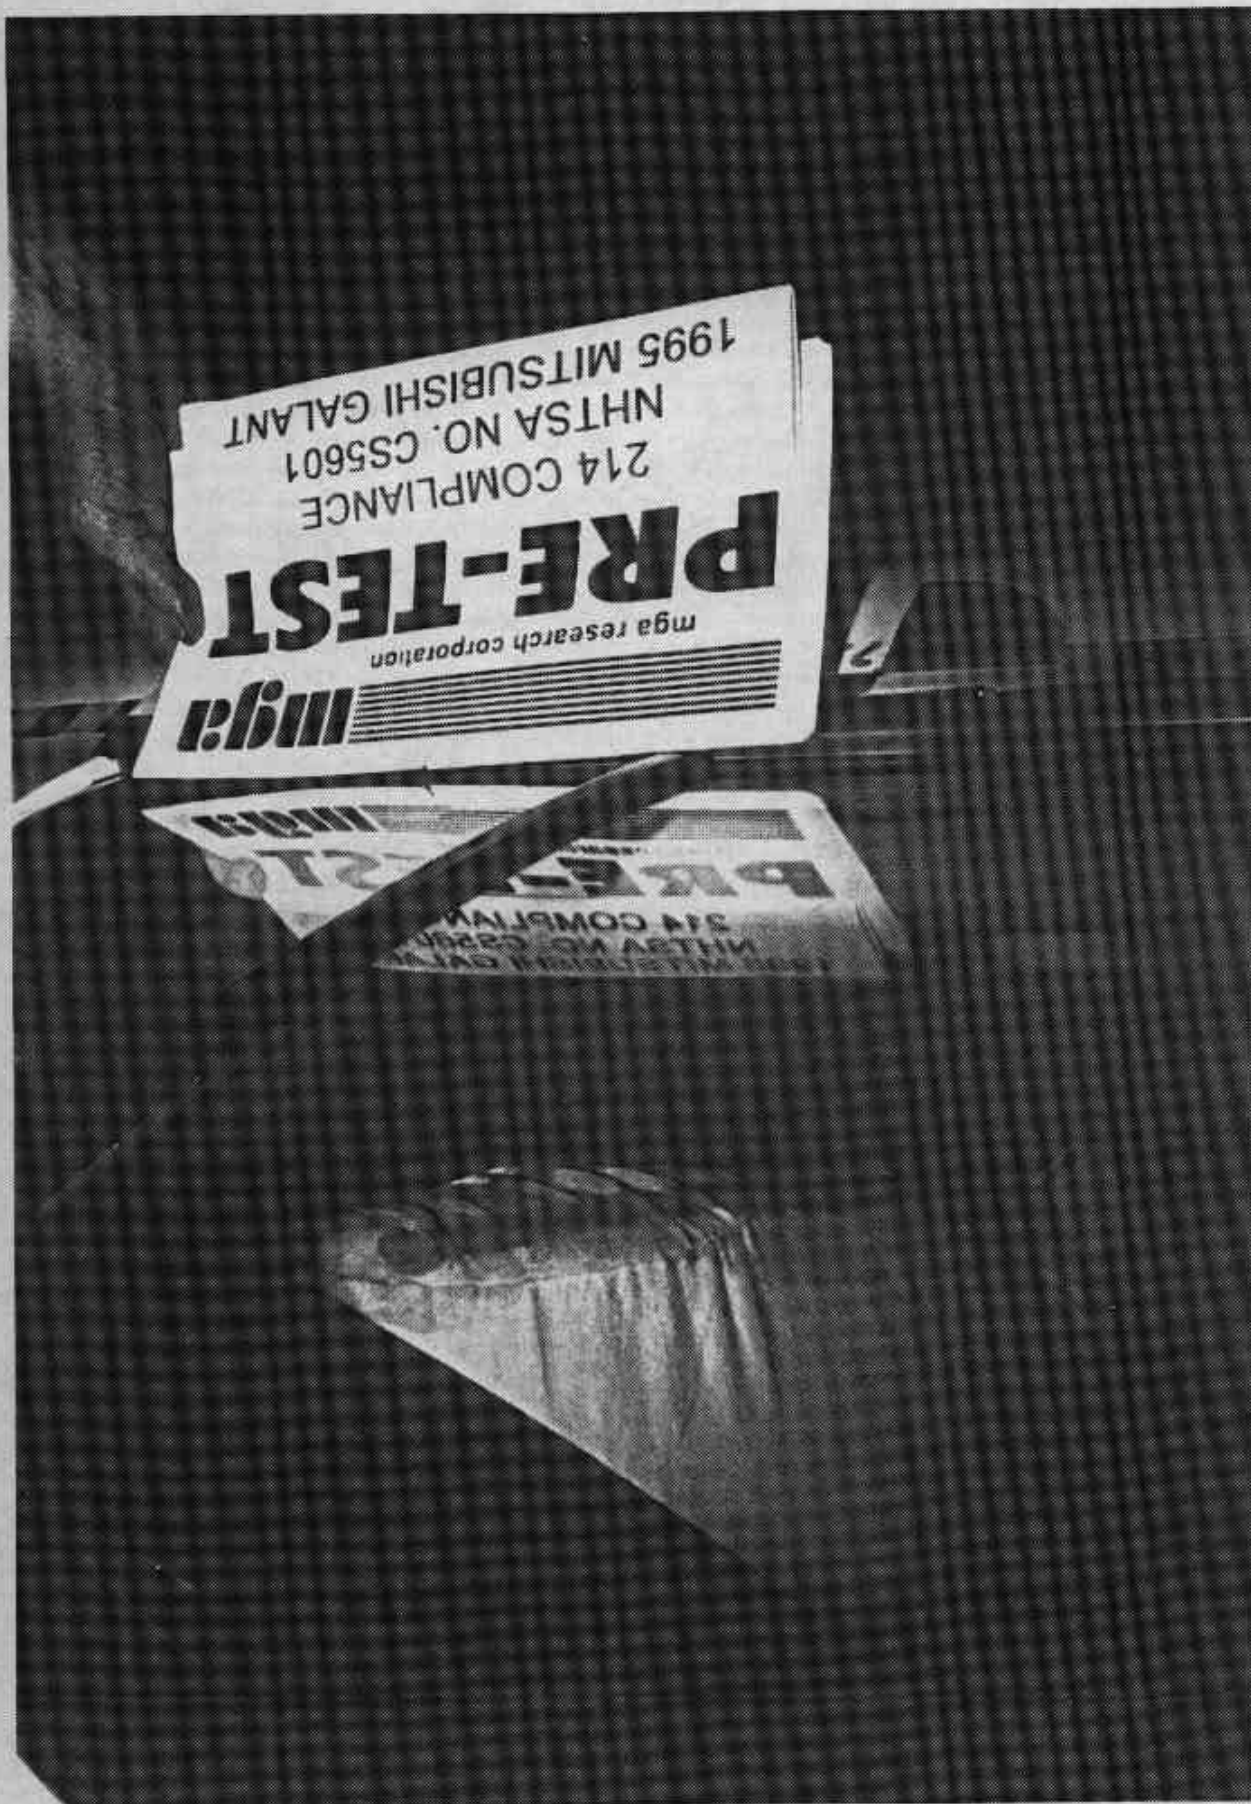
Photo No. A-33 - Pre-Test Passenger Dummy Shoulder and Door Top View

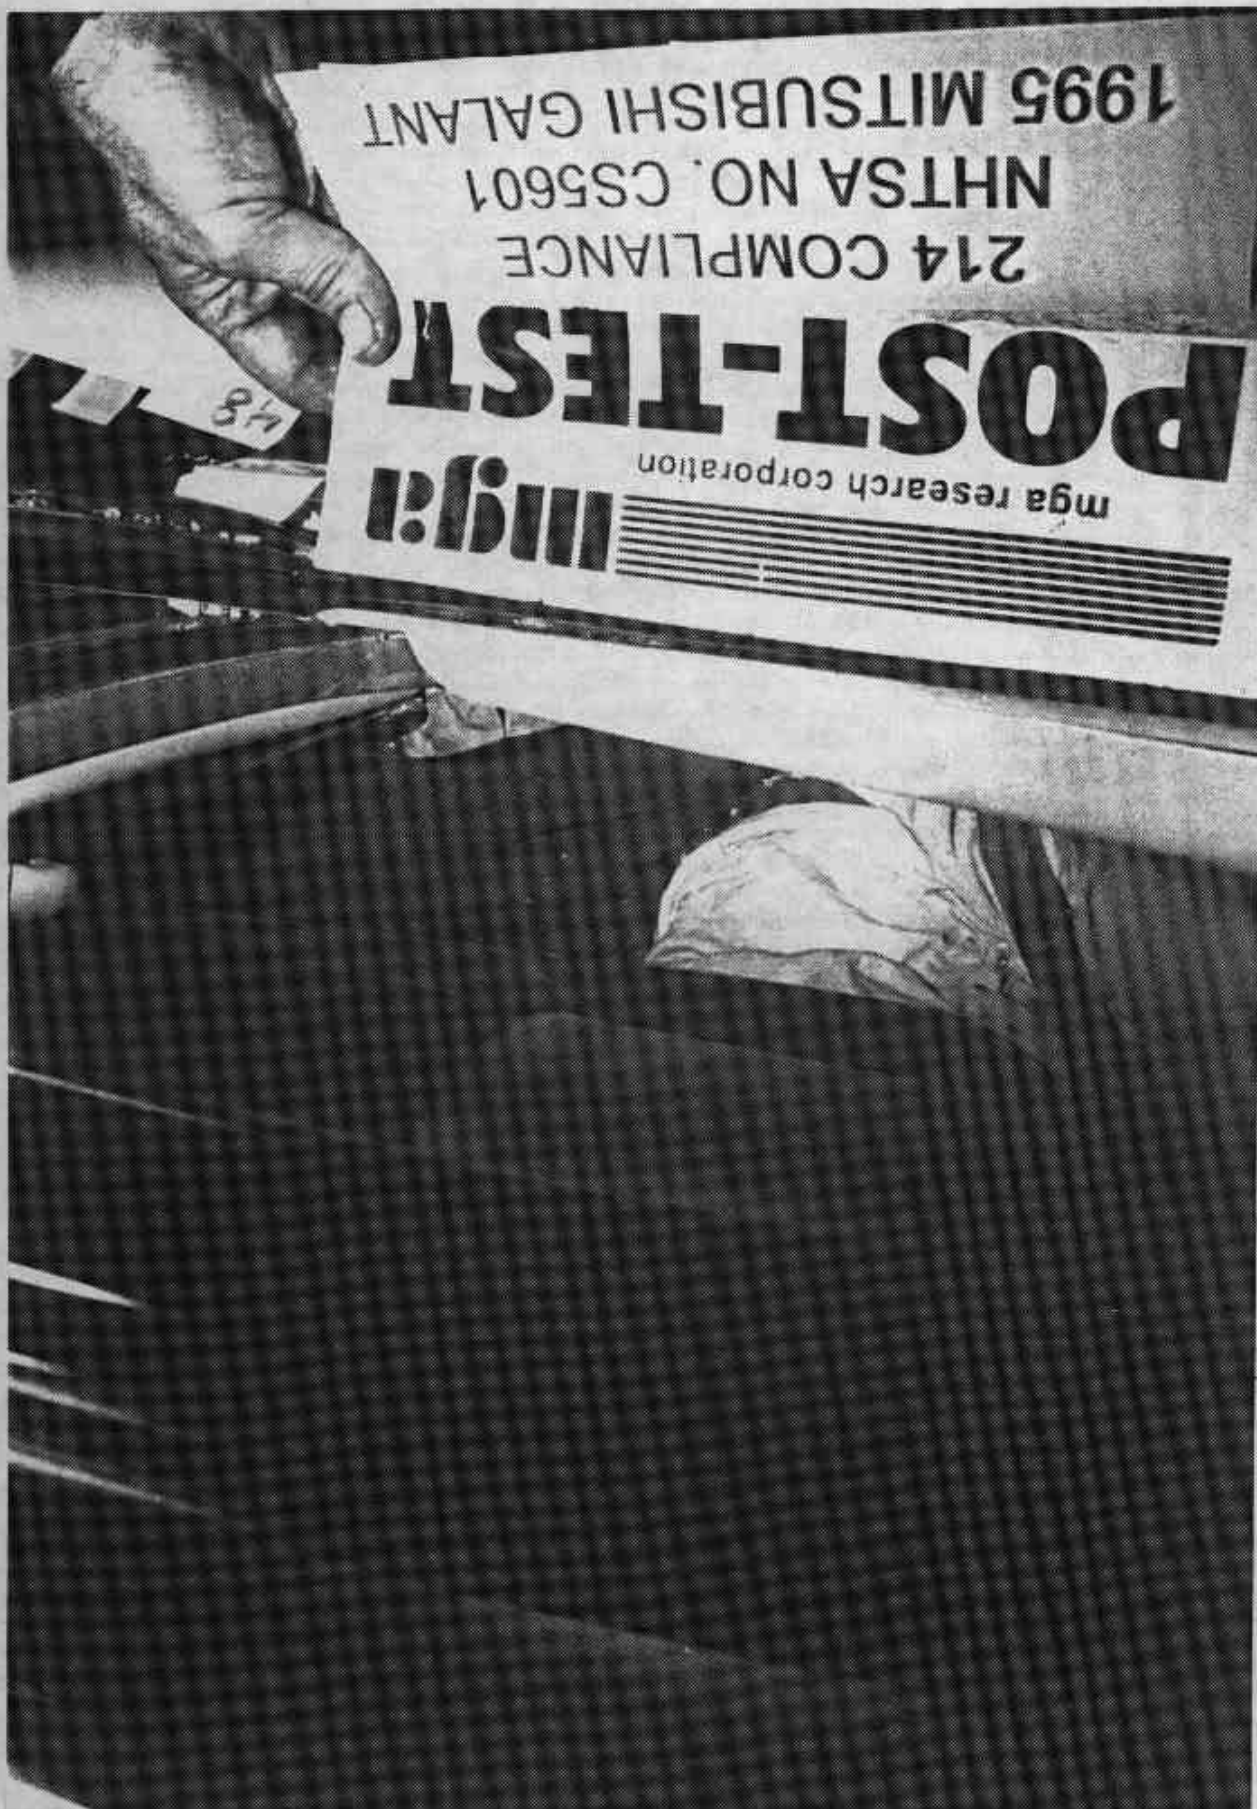
Photo No. A-34 - Post-Test Passenger Dummy Shoulder and Door Top View

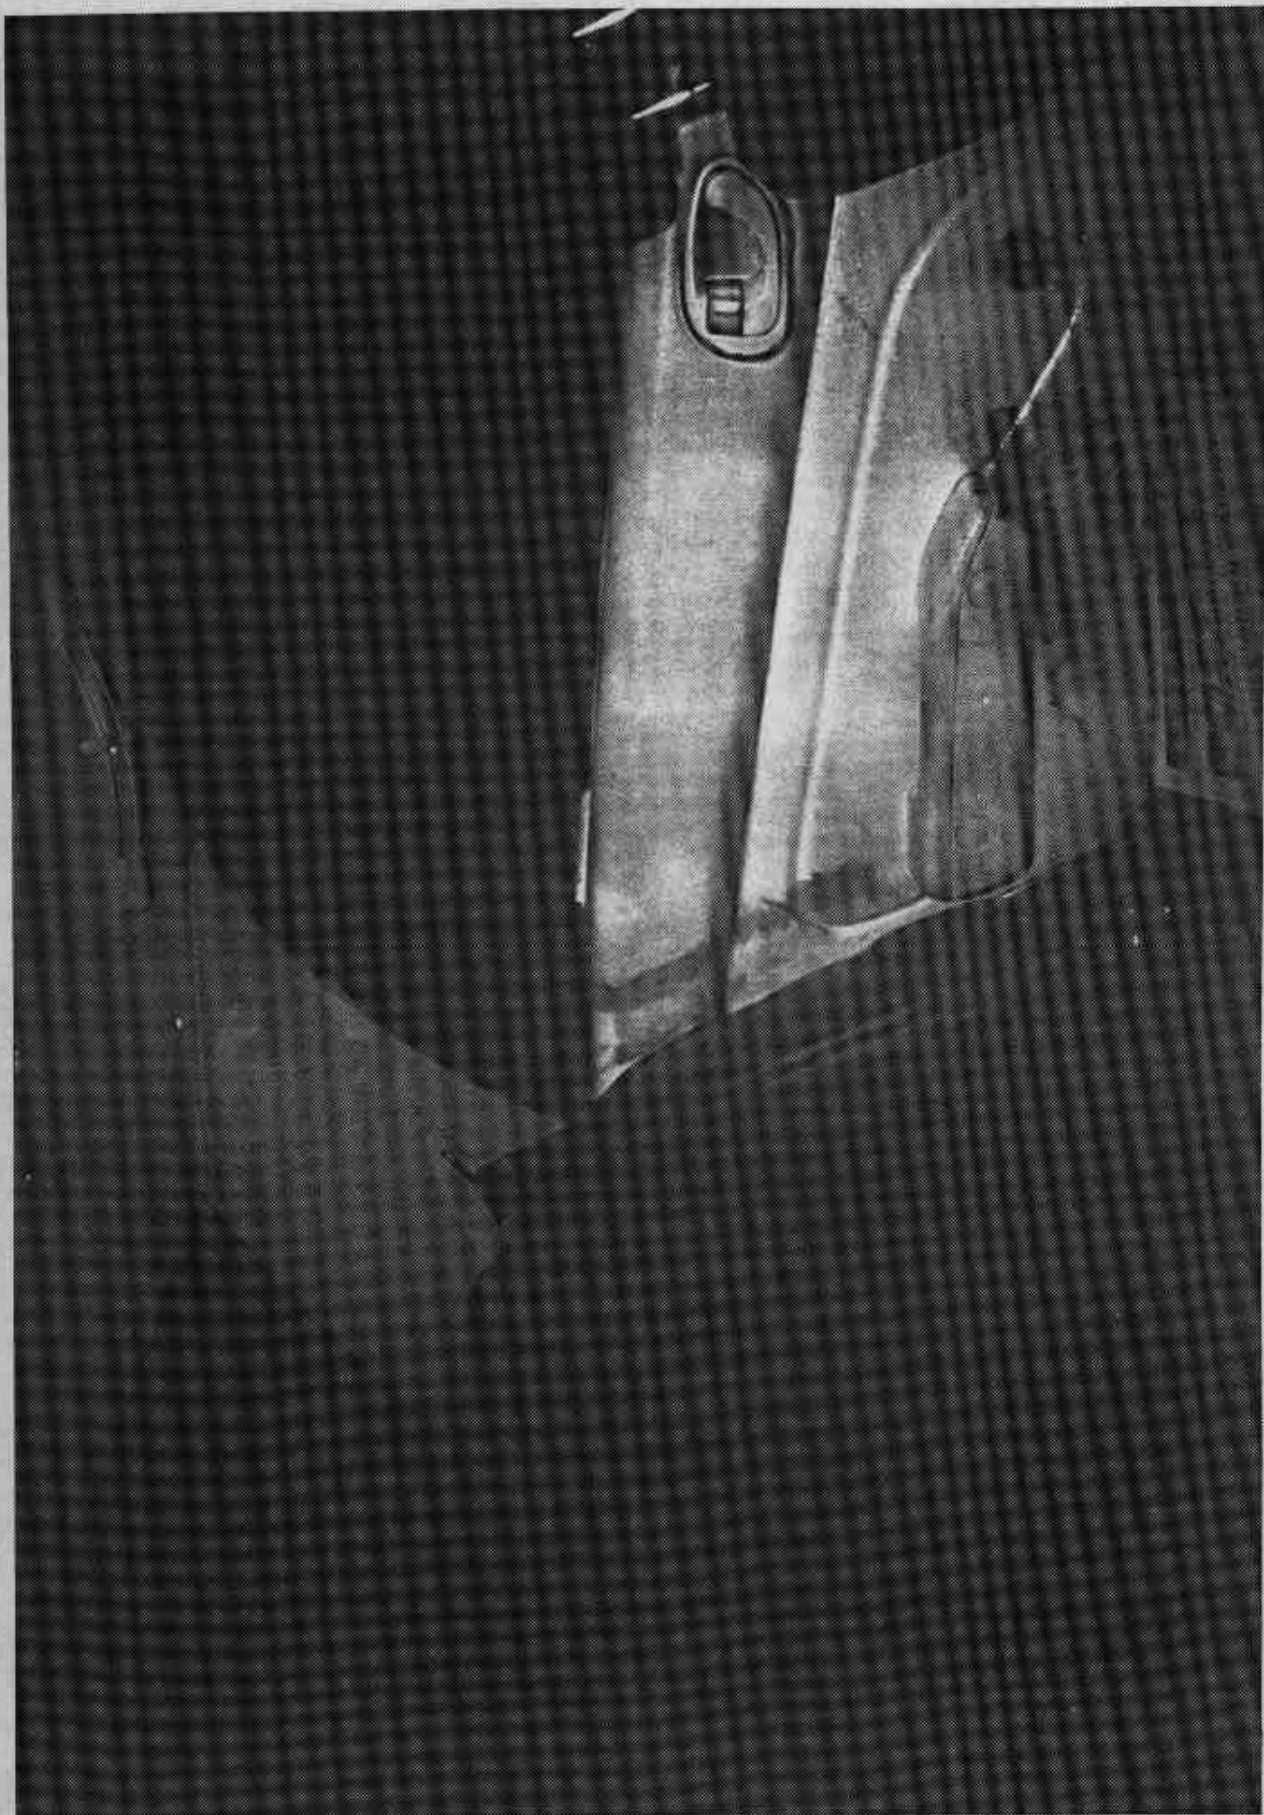
Photo No. A-35 - Post-Test Passenger Dummy Contact

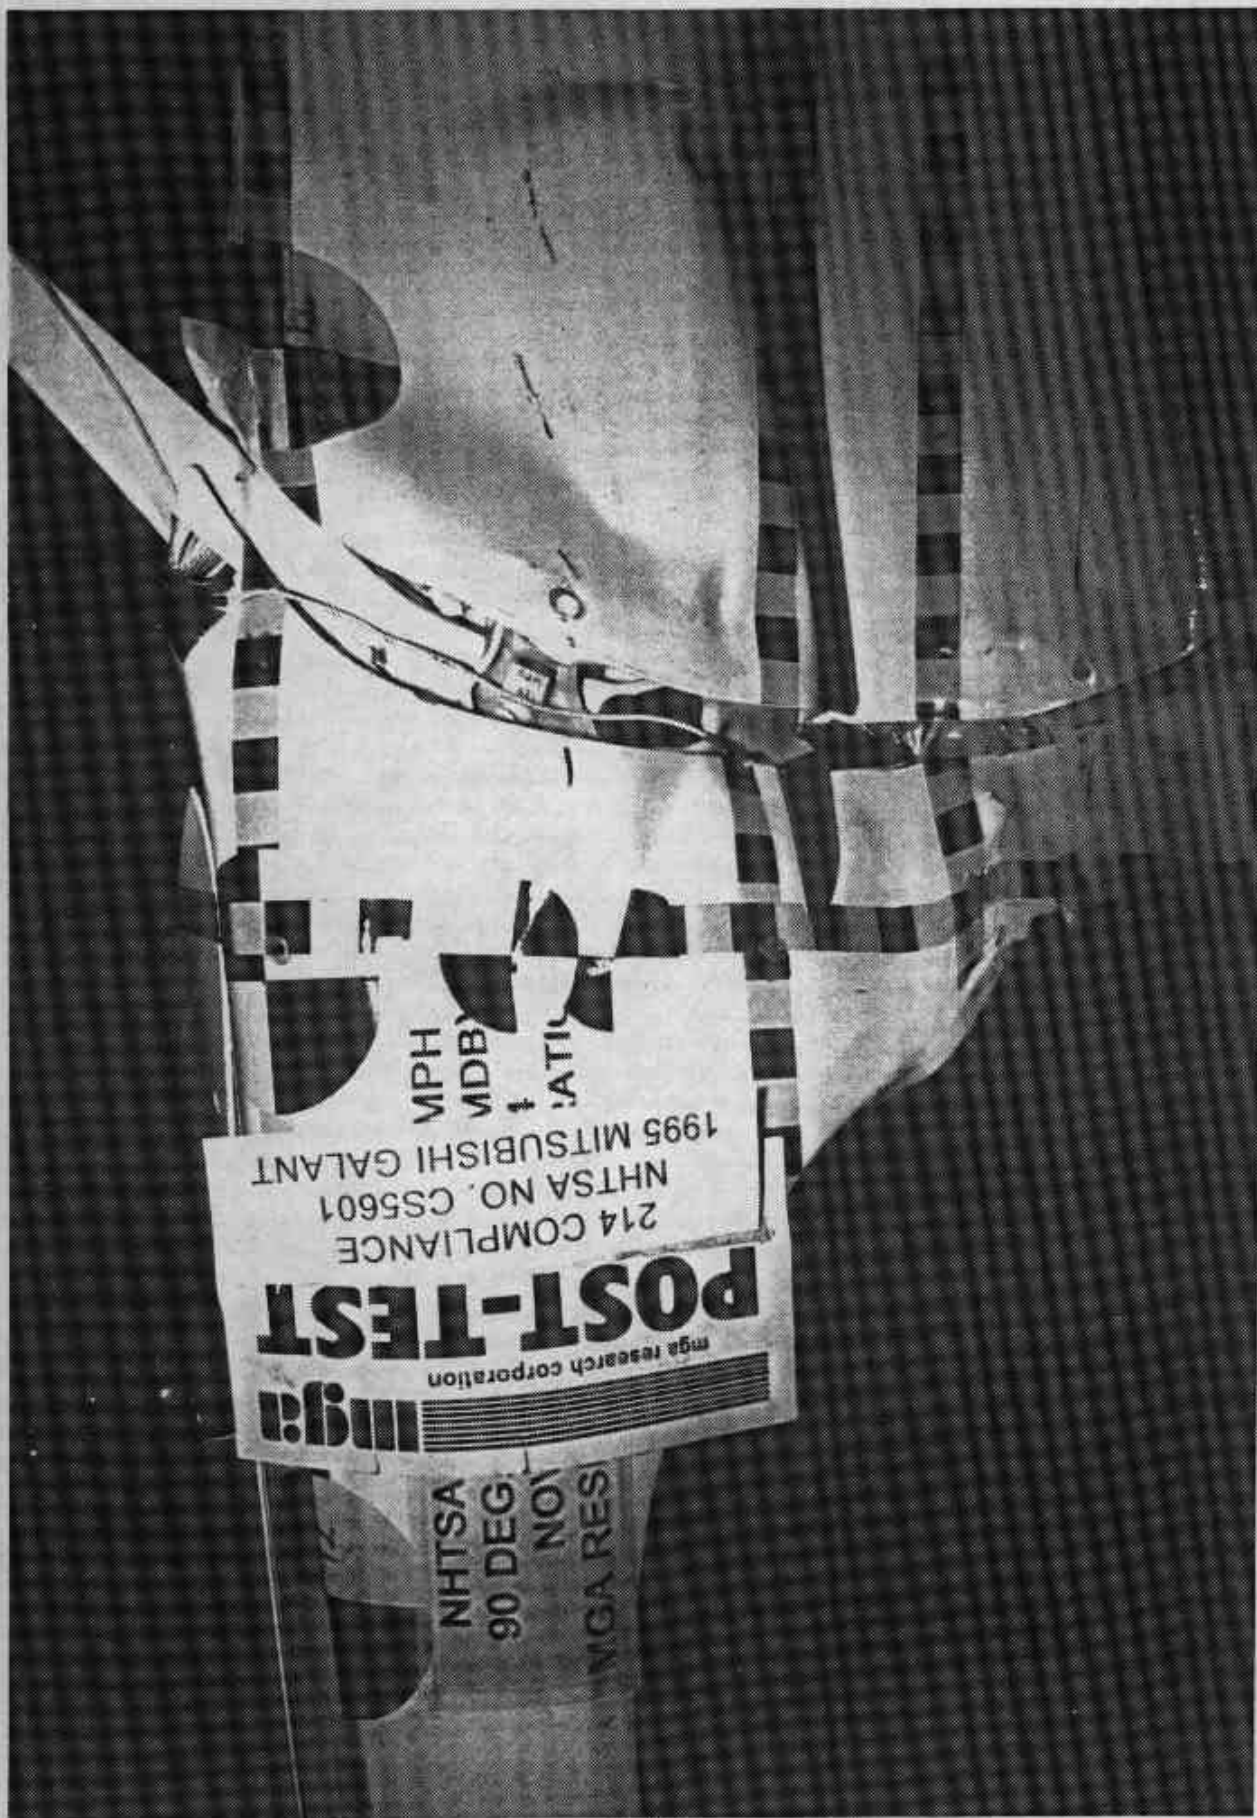
Photo No. A-36 - Left Front Impact Point on Vehicle

Wheelbase: = 103.8 in (2635 mm)  
Impact Point is 14.9 in (378 mm) rearward of front axle centerline

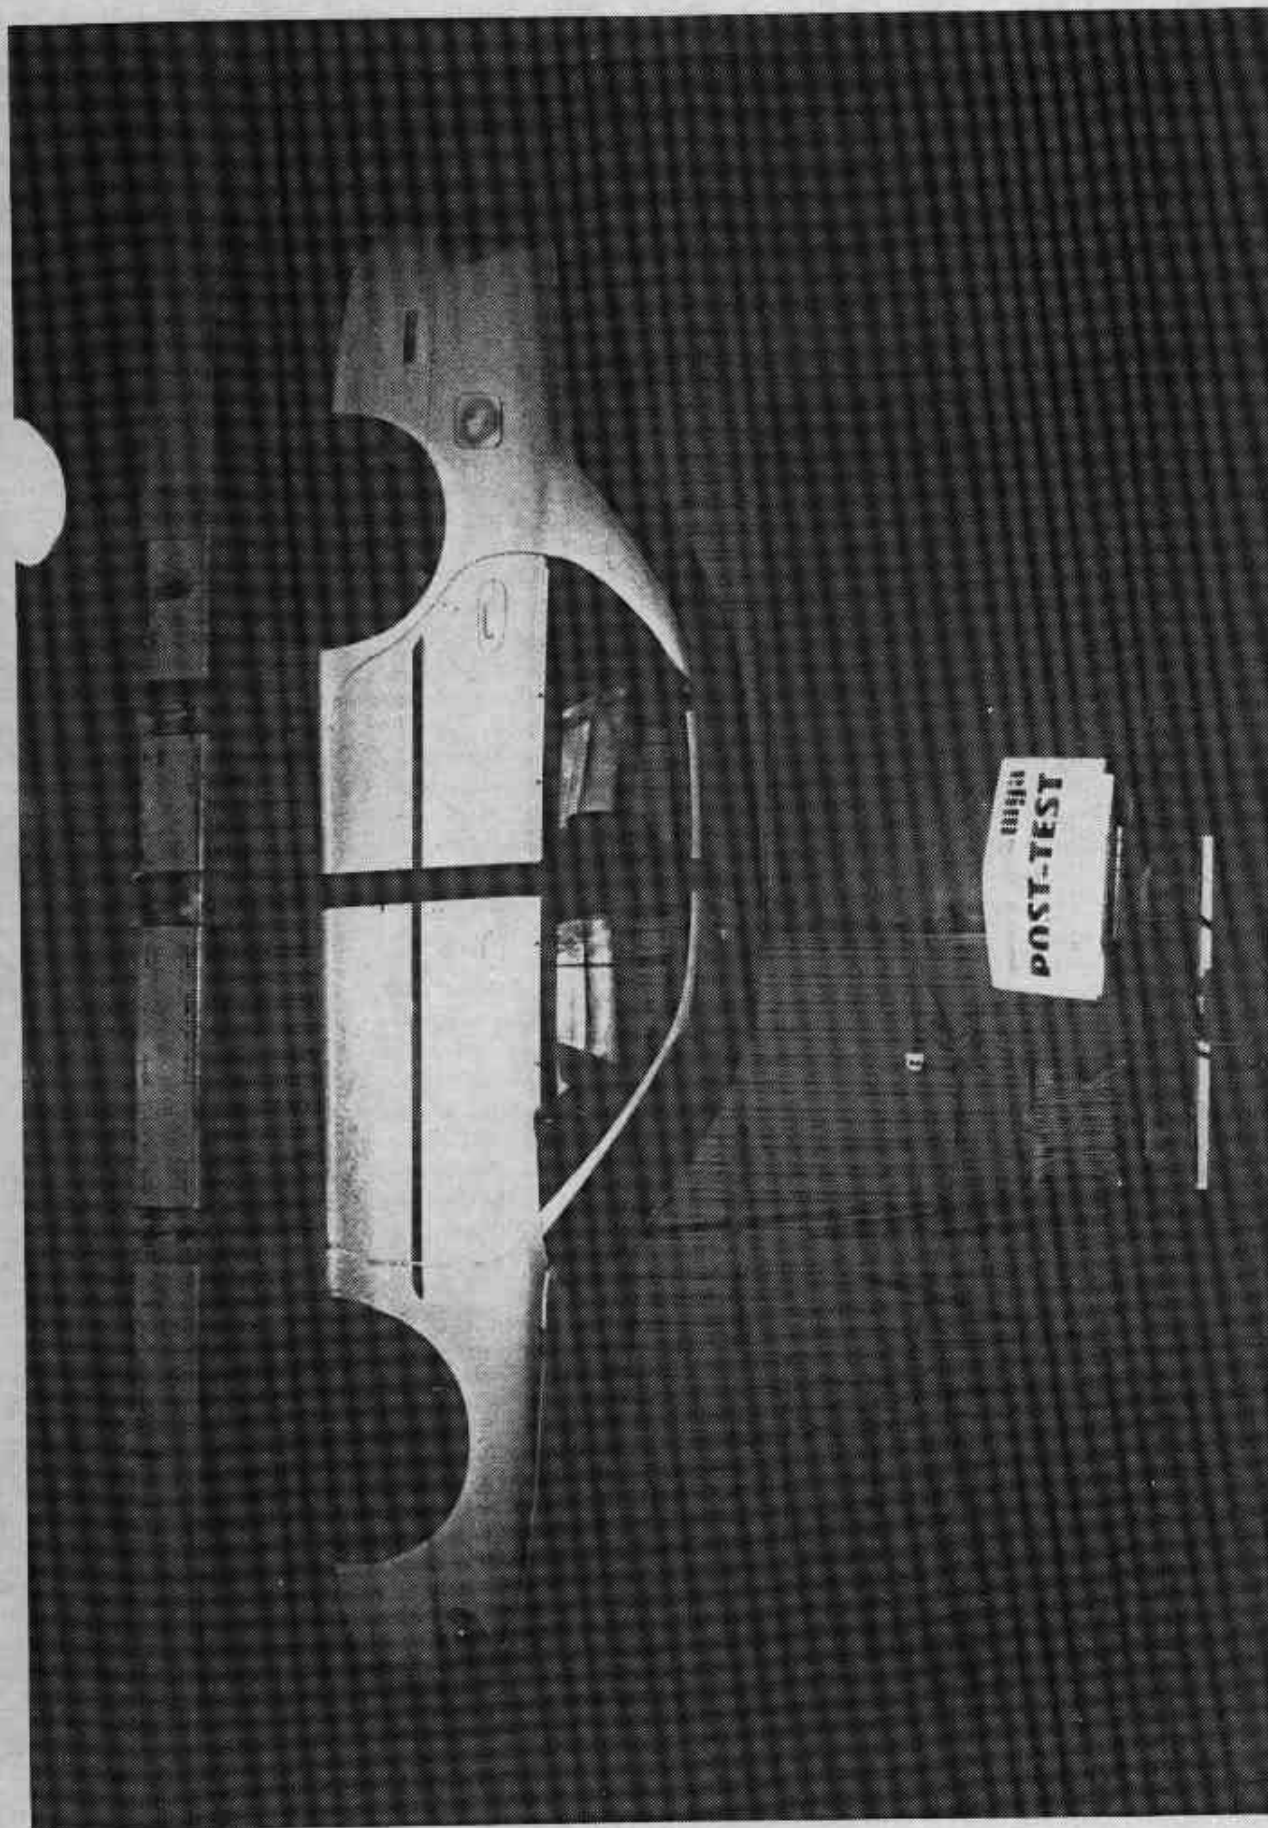
Photo No. A-41 - Rollover 180°
