**REPORT NO.: MGA-95-21415**

**SAFETY COMPLIANCE TESTING FOR FMVSS 214**  
**"SIDE IMPACT PROTECTION - PASSENGER CARS"**

**CHRYSLER CORPORATION**  
1995 CHRYSLER CIRRUS 4 DOOR SEDAN  
NHTSA NO: CS0309

**FINAL REPORT**

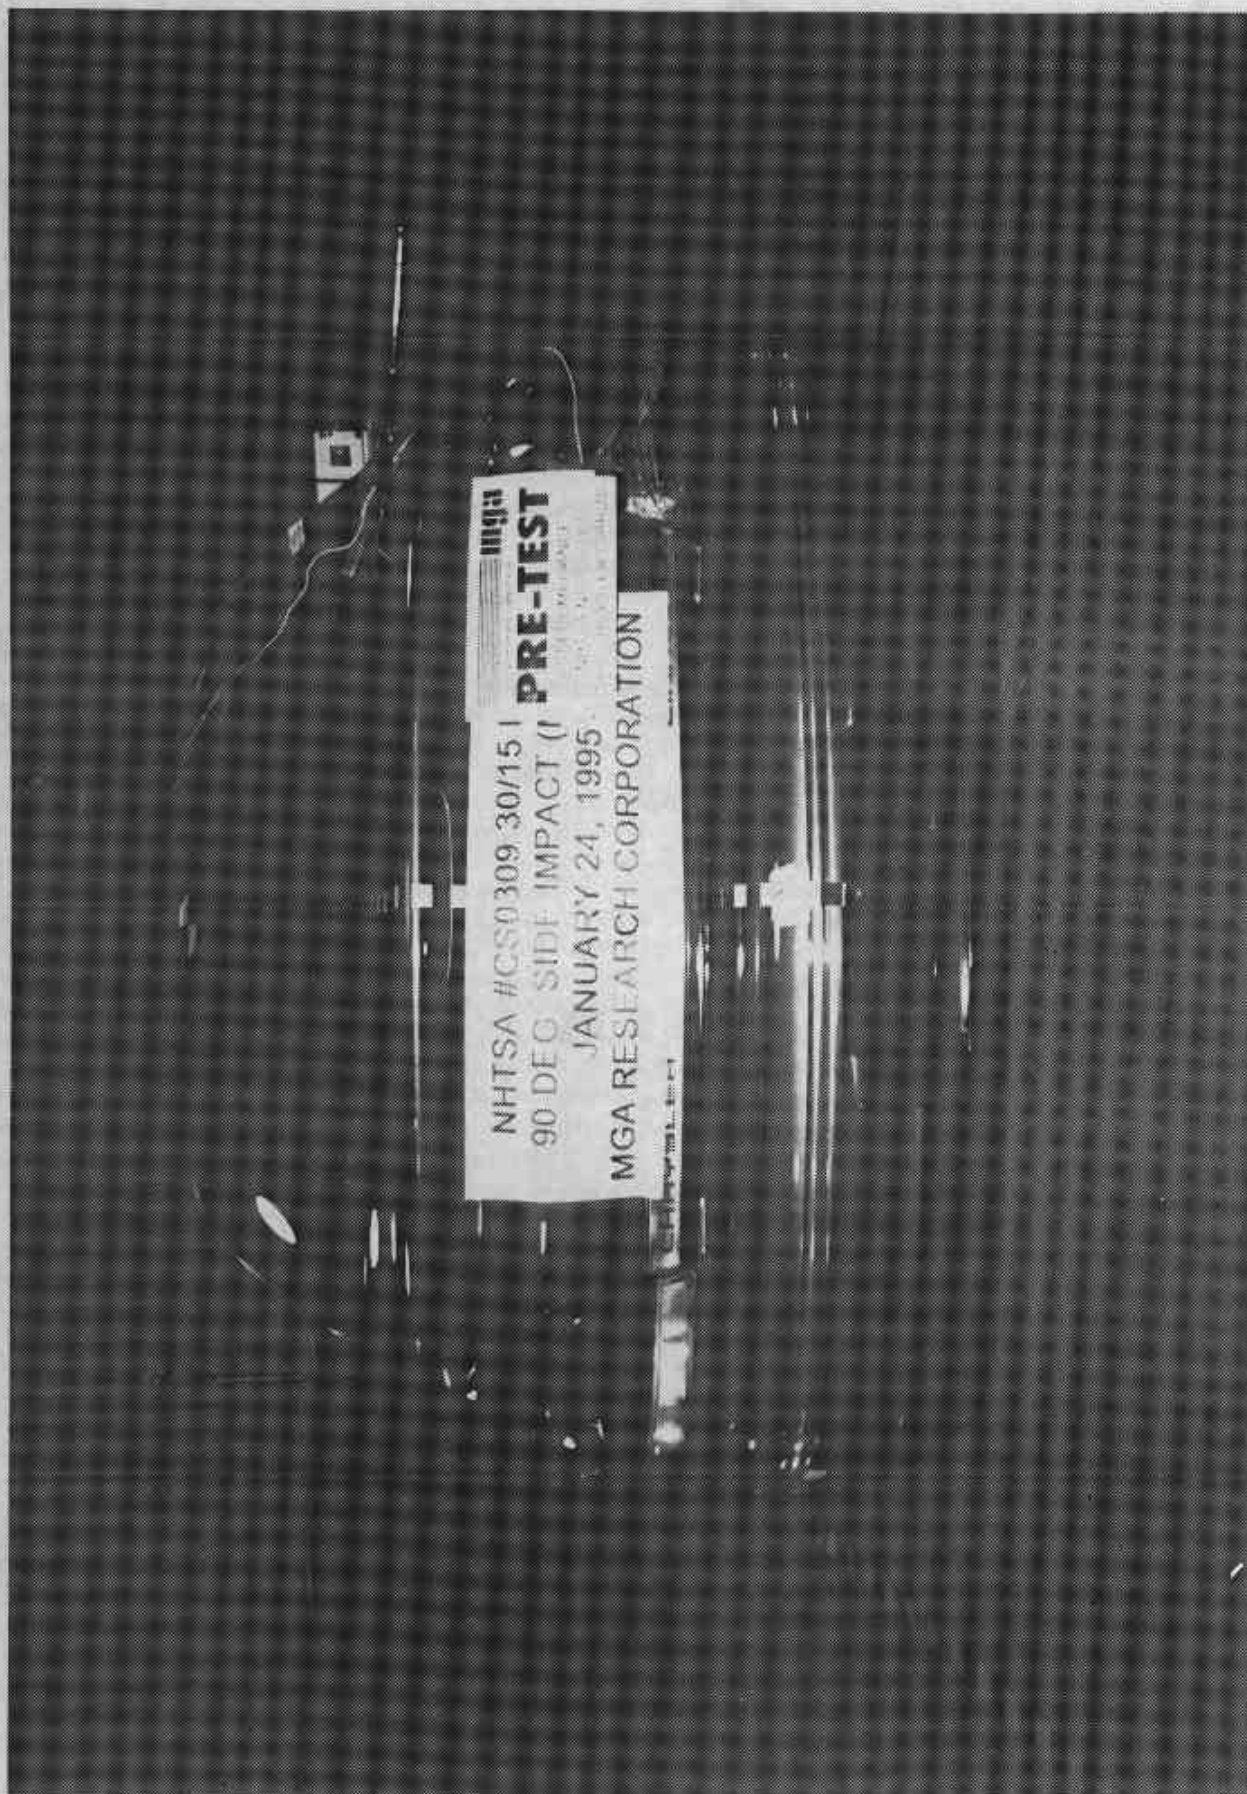
Photo No. A-3 - Pre-Test Rear View of Test Vehicle

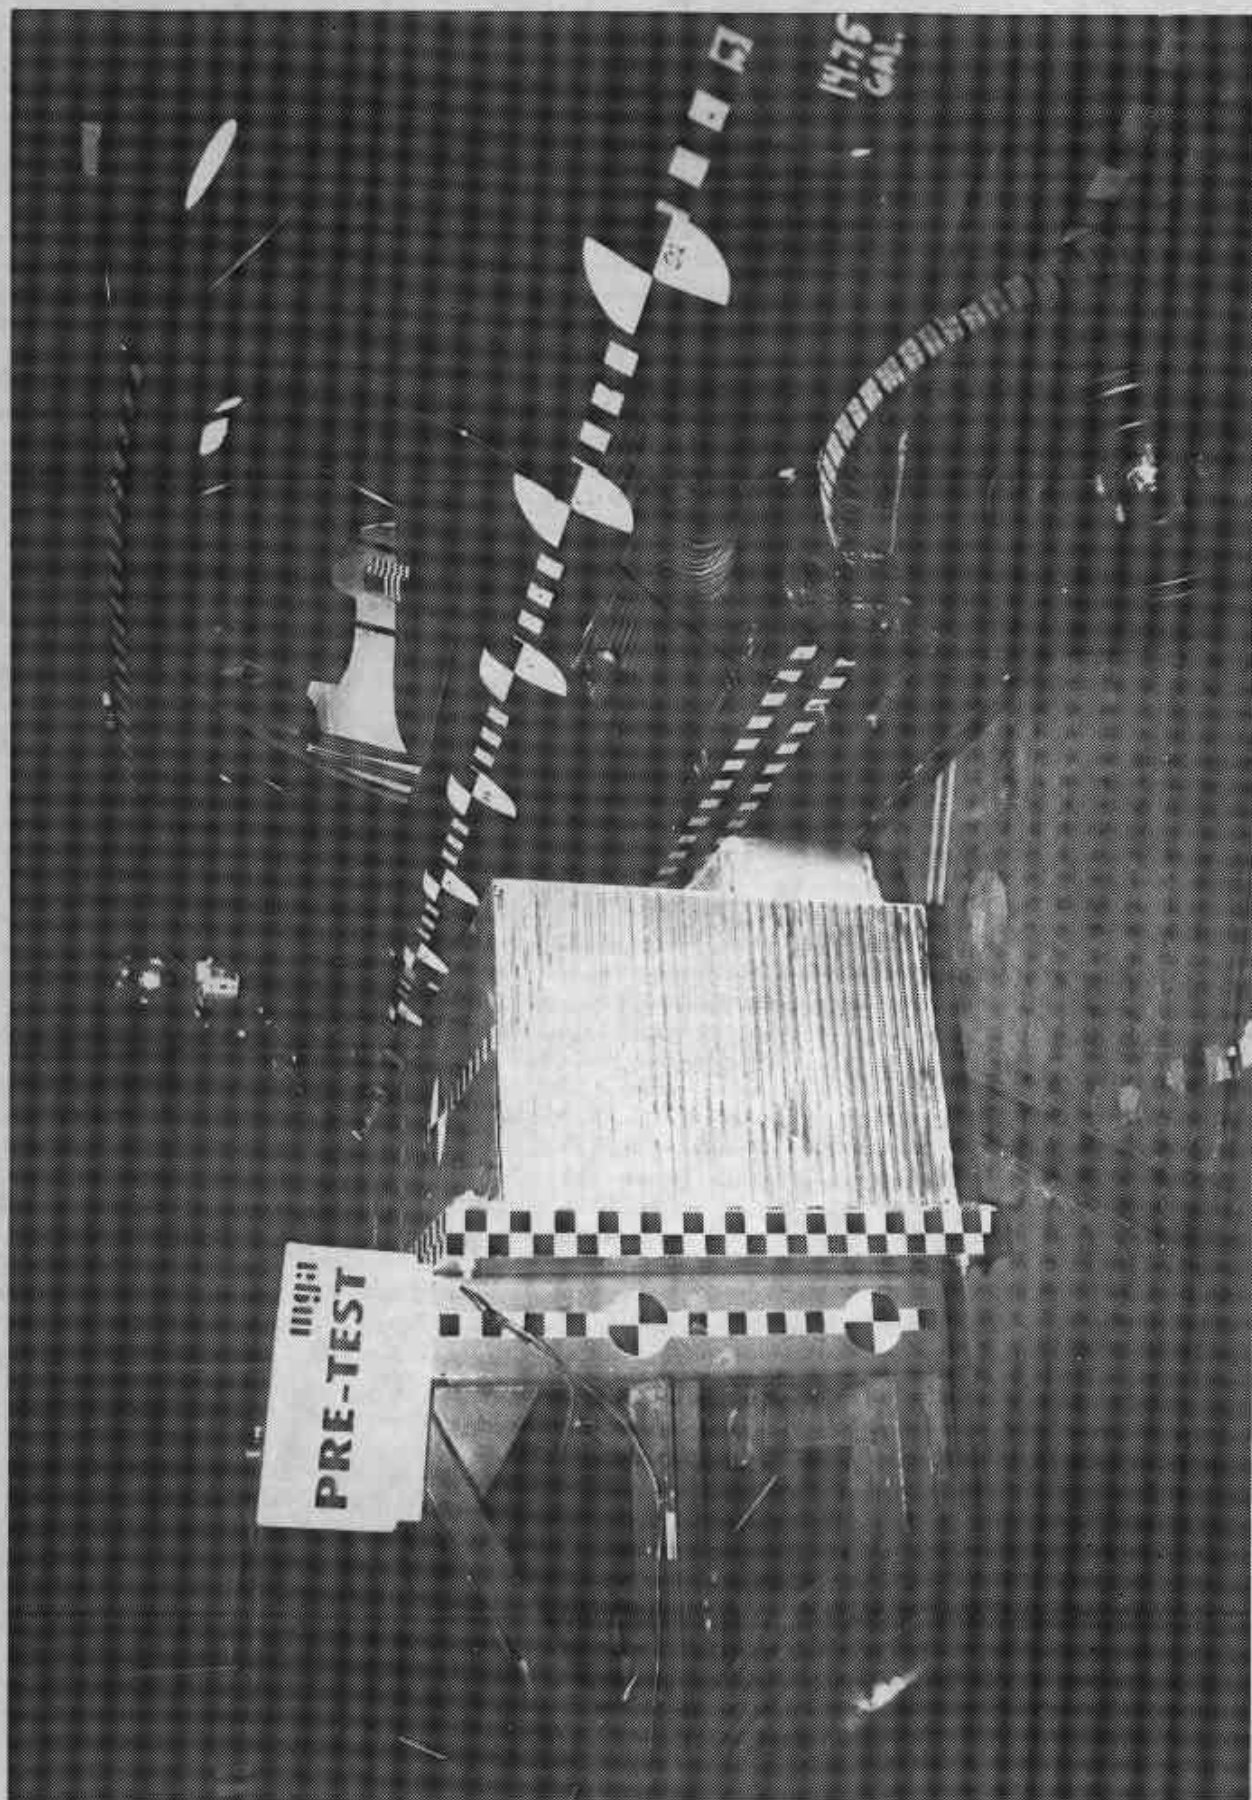
Photo No. A-8 - Pre-Test MDB Positioned Against Vehicle (right side)

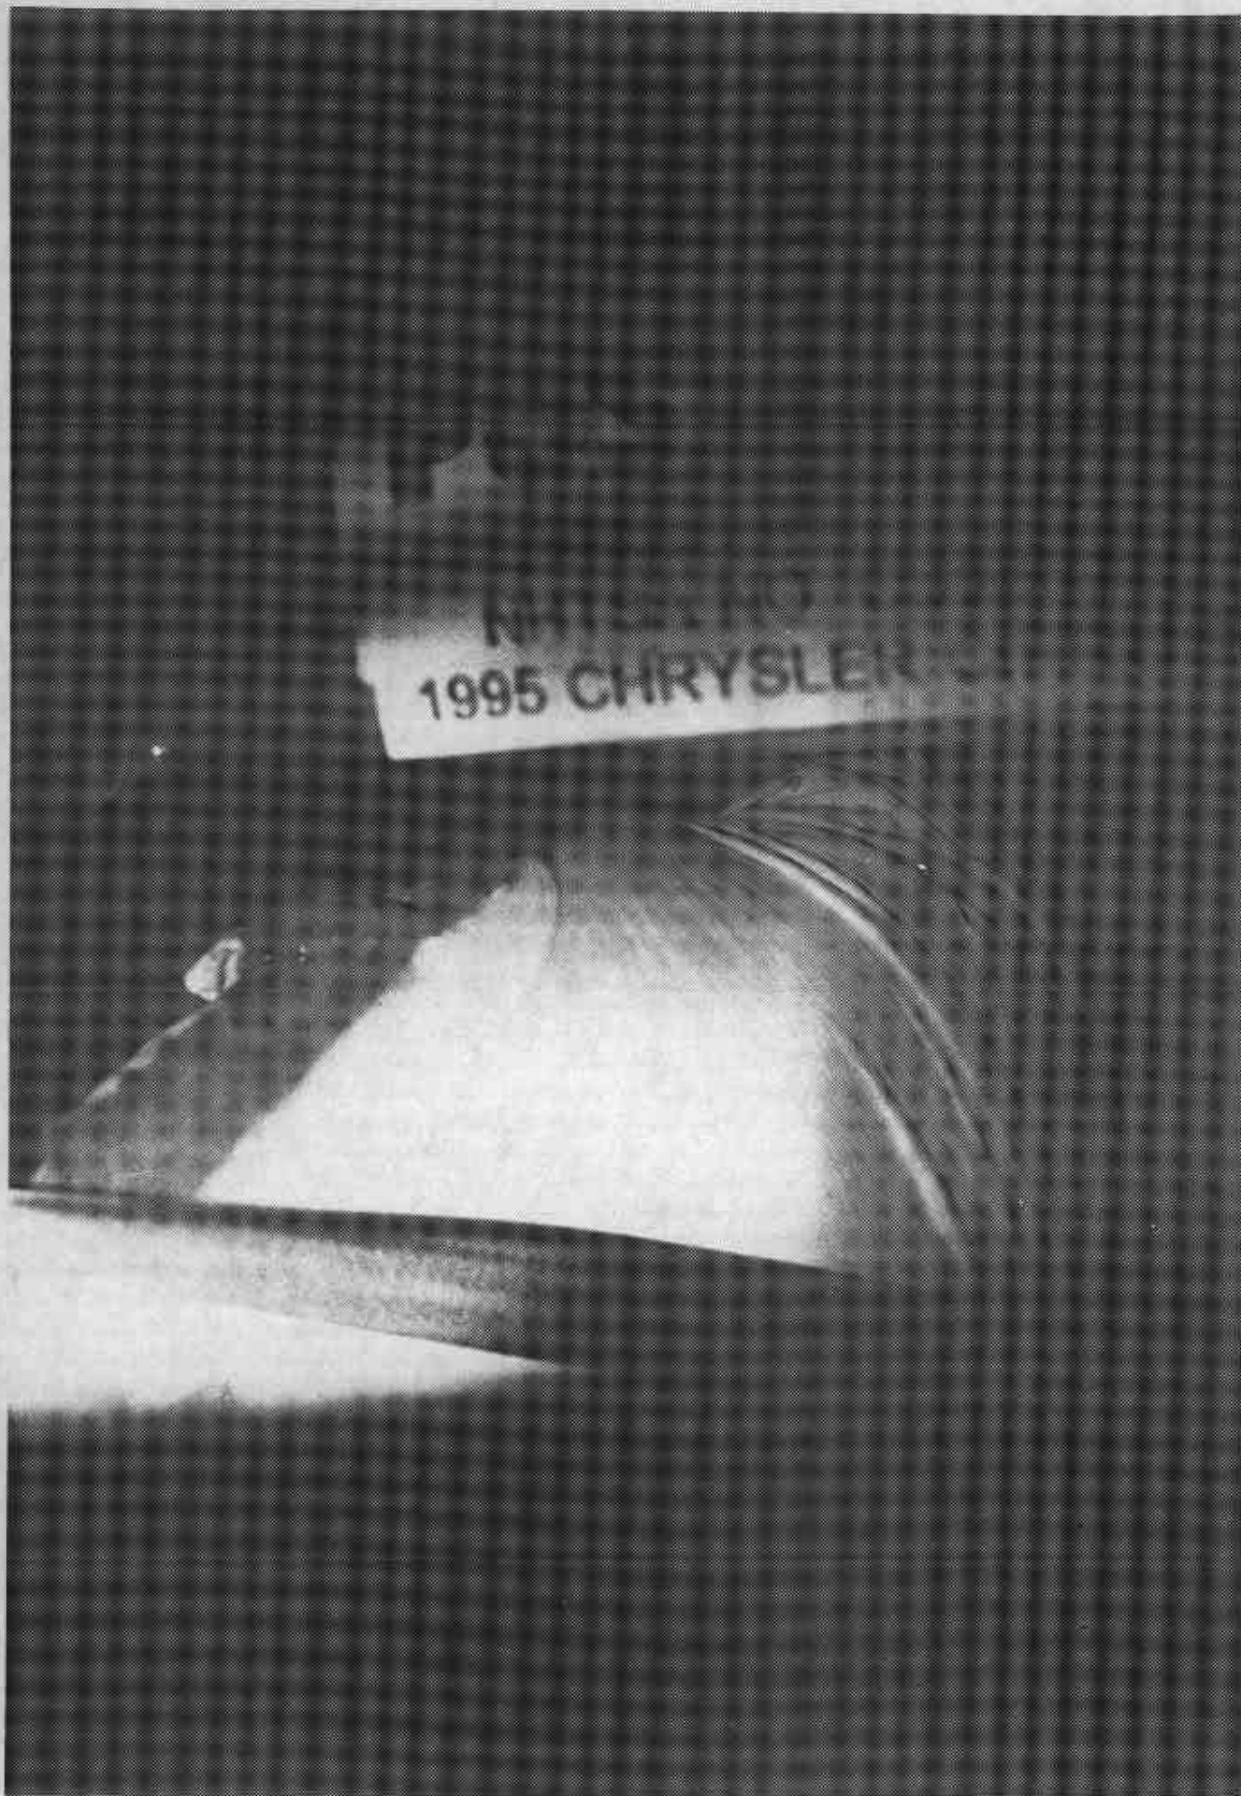
Photo No. A-27 - Post-Test Driver Dummy Shoulder and Door Top View

| | <u>LEFT FRONT SID</u> | <u>LEFT REAR SID</u> |
|---|---|---|
| Head | <u>to shoulder</u> | <u>to C Post</u> |
| Arm | <u>to door, door lock</u> | <u>to door</u> |

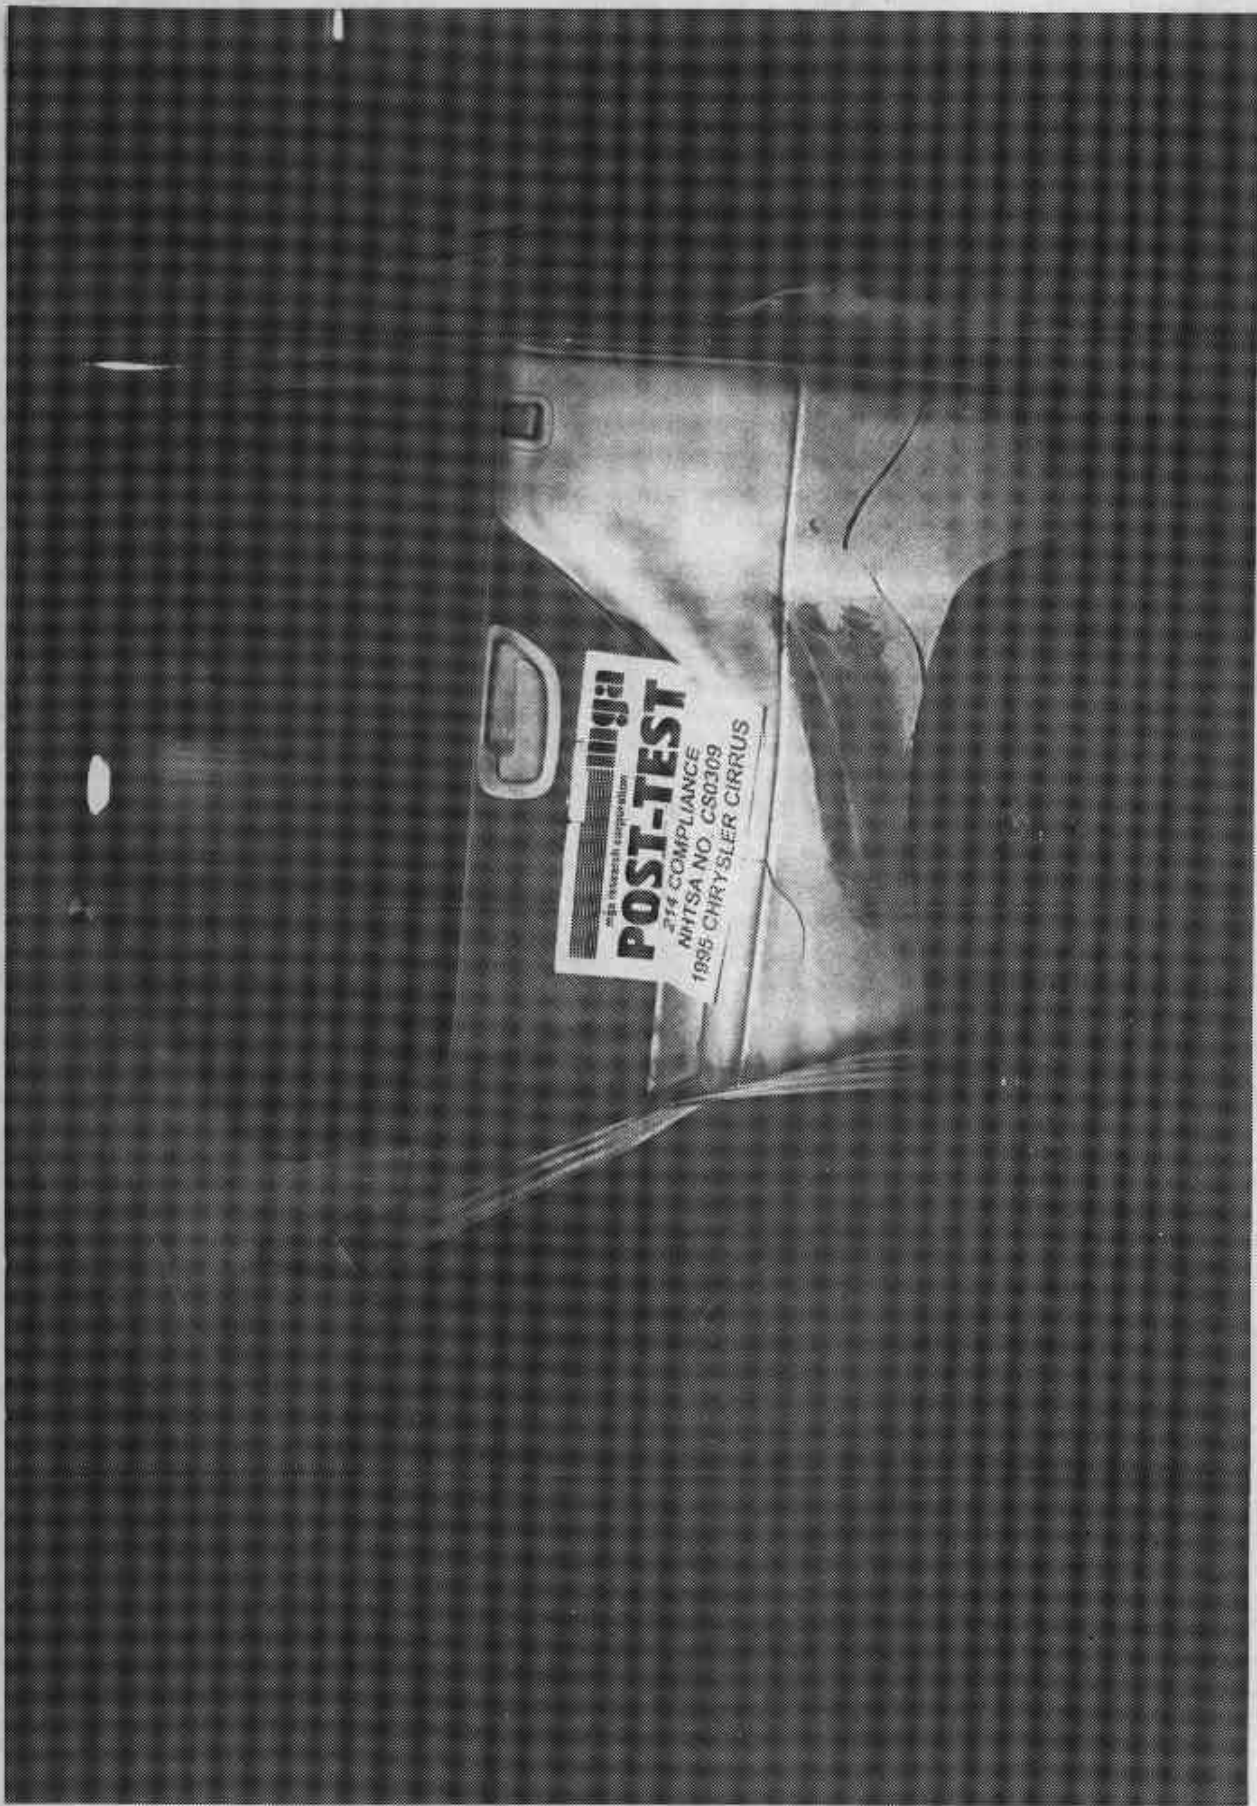
Photo No. A-36 - Post-Test Passenger Dummy Contact

VISIBLE DUMMY CONTACT POINTS:

| | <u>LEFT FRONT SID</u> | <u>LEFT REAR SID</u> |
| Pelvis | <u>to armrest</u> | <u>to armrest</u> |

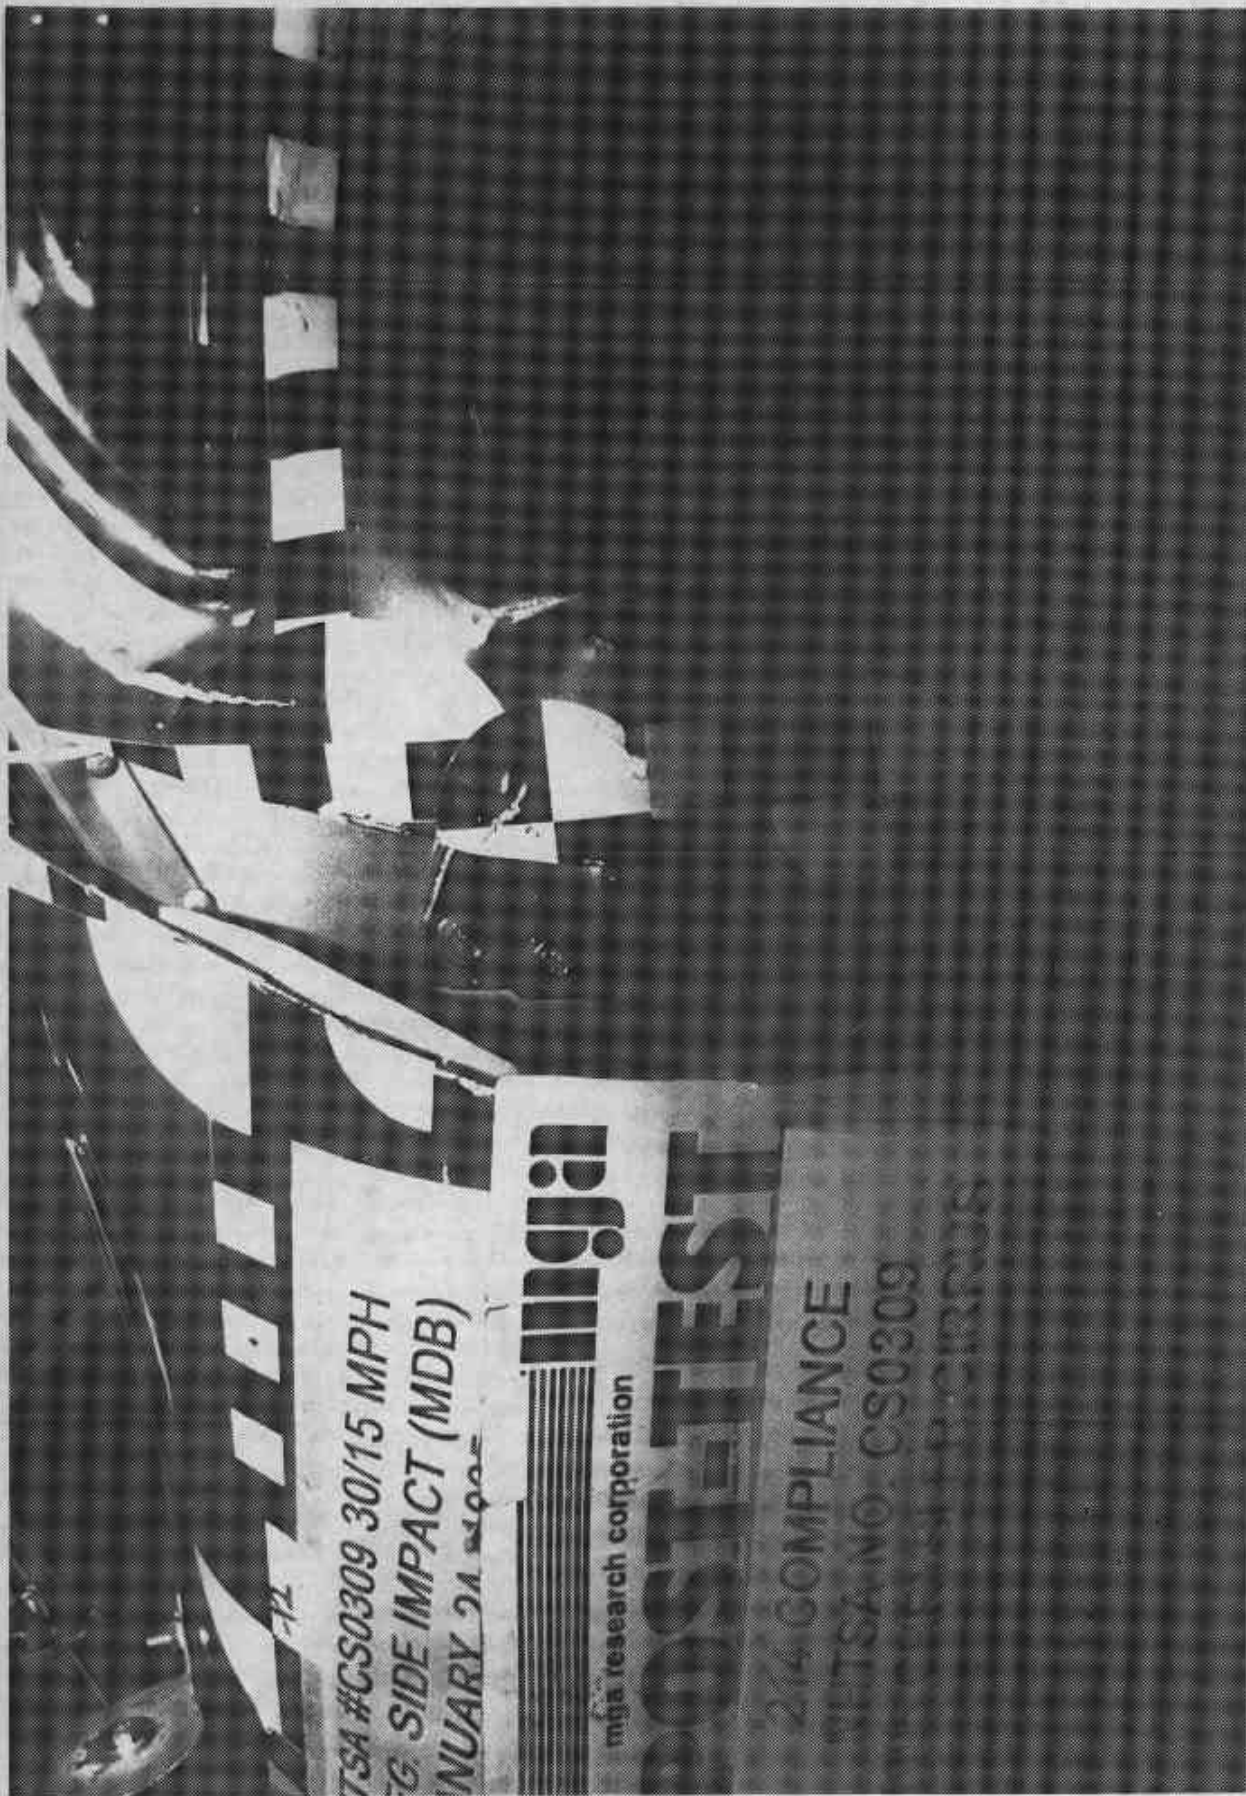
Photo No. A-37 - Left Front Impact Point on Vehicle

Impact Point is 16.9 in (430 mm) rearward of front axle centerline
