**REPORT NO.: MGA-95-21416**

**SAFETY COMPLIANCE TESTING FOR FMVSS 214**  
**"SIDE IMPACT PROTECTION - PASSENGER CARS"**

**SUBARU MOTORS**  
1995 SUBARU IMPREZA 4 DOOR SEDAN  
NHTSA NO: CS5503

**FINAL REPORT**

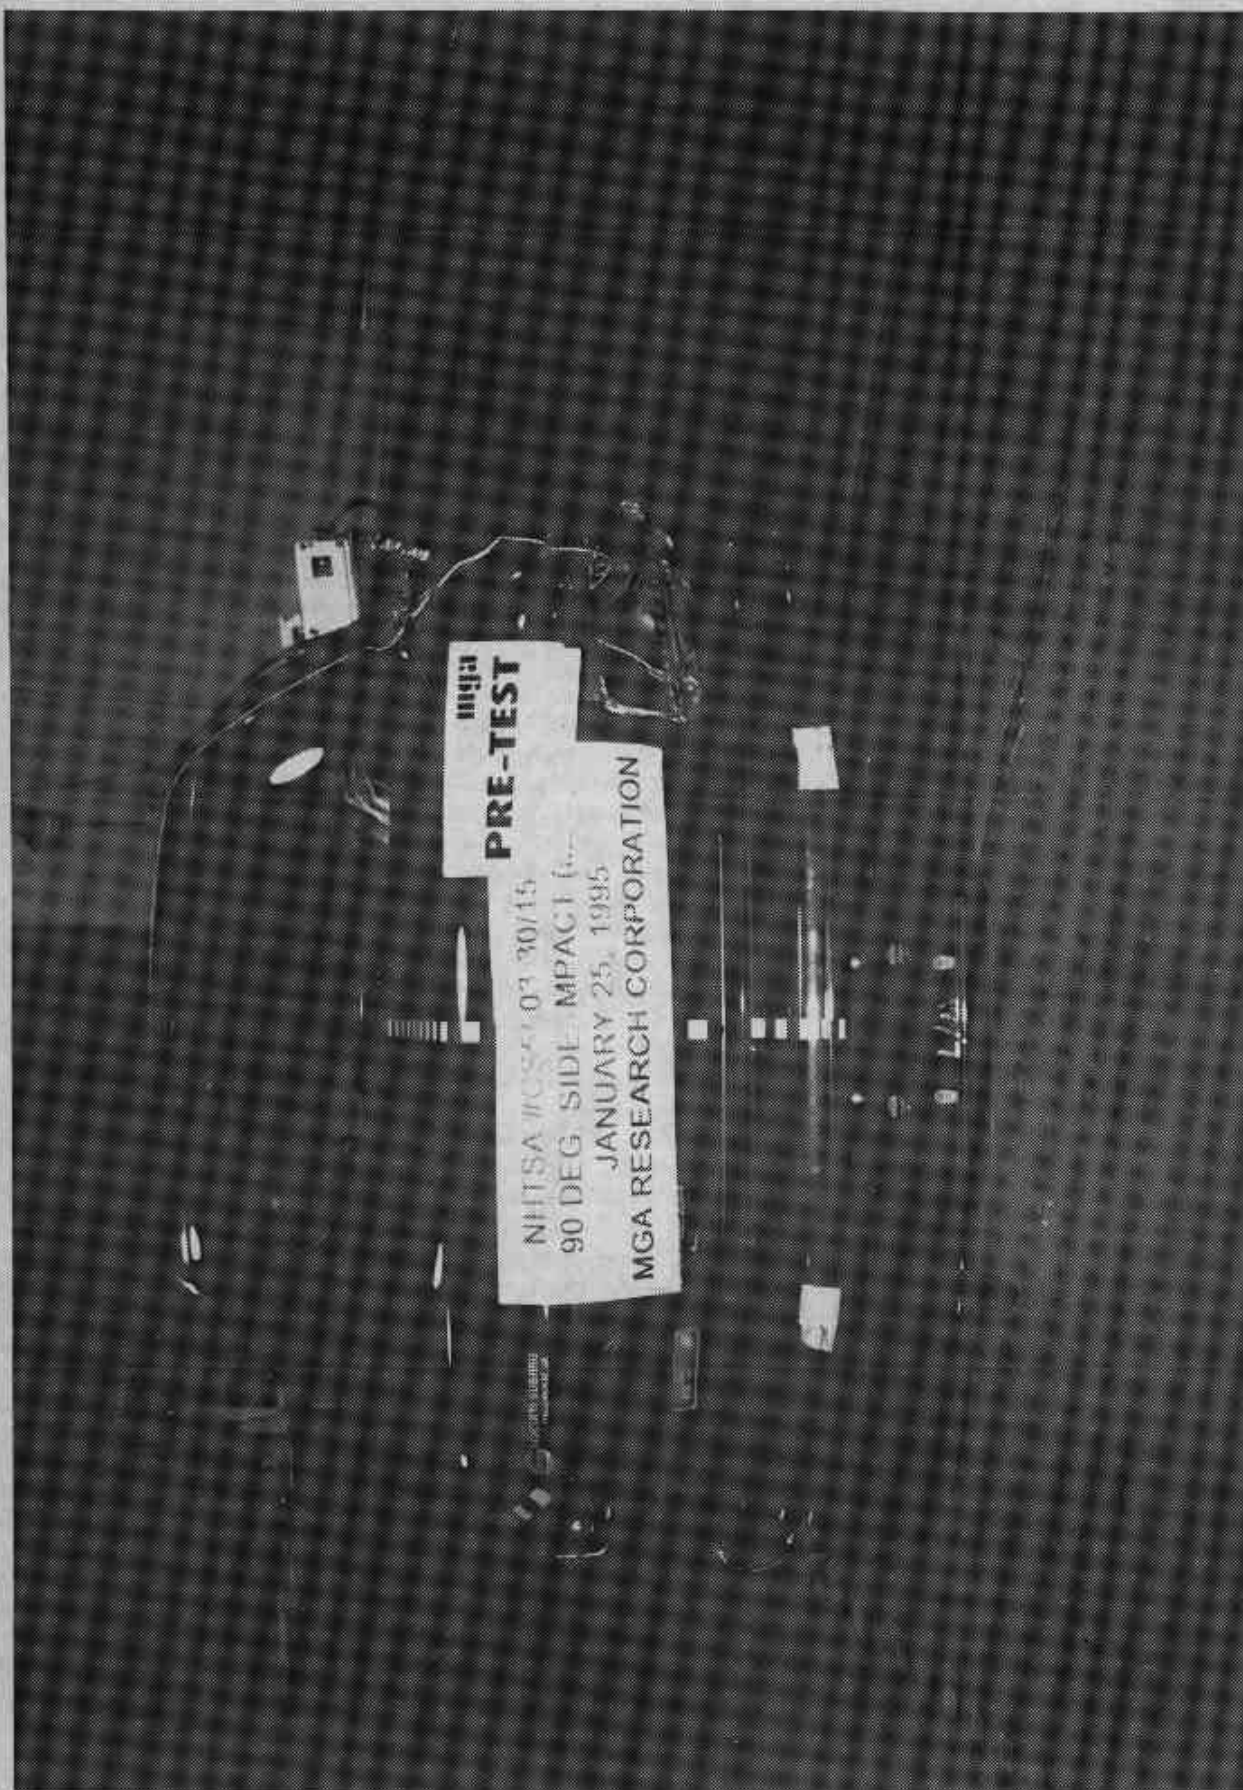
Photo No. A-3 - Pre-Test Rear View of Test Vehicle

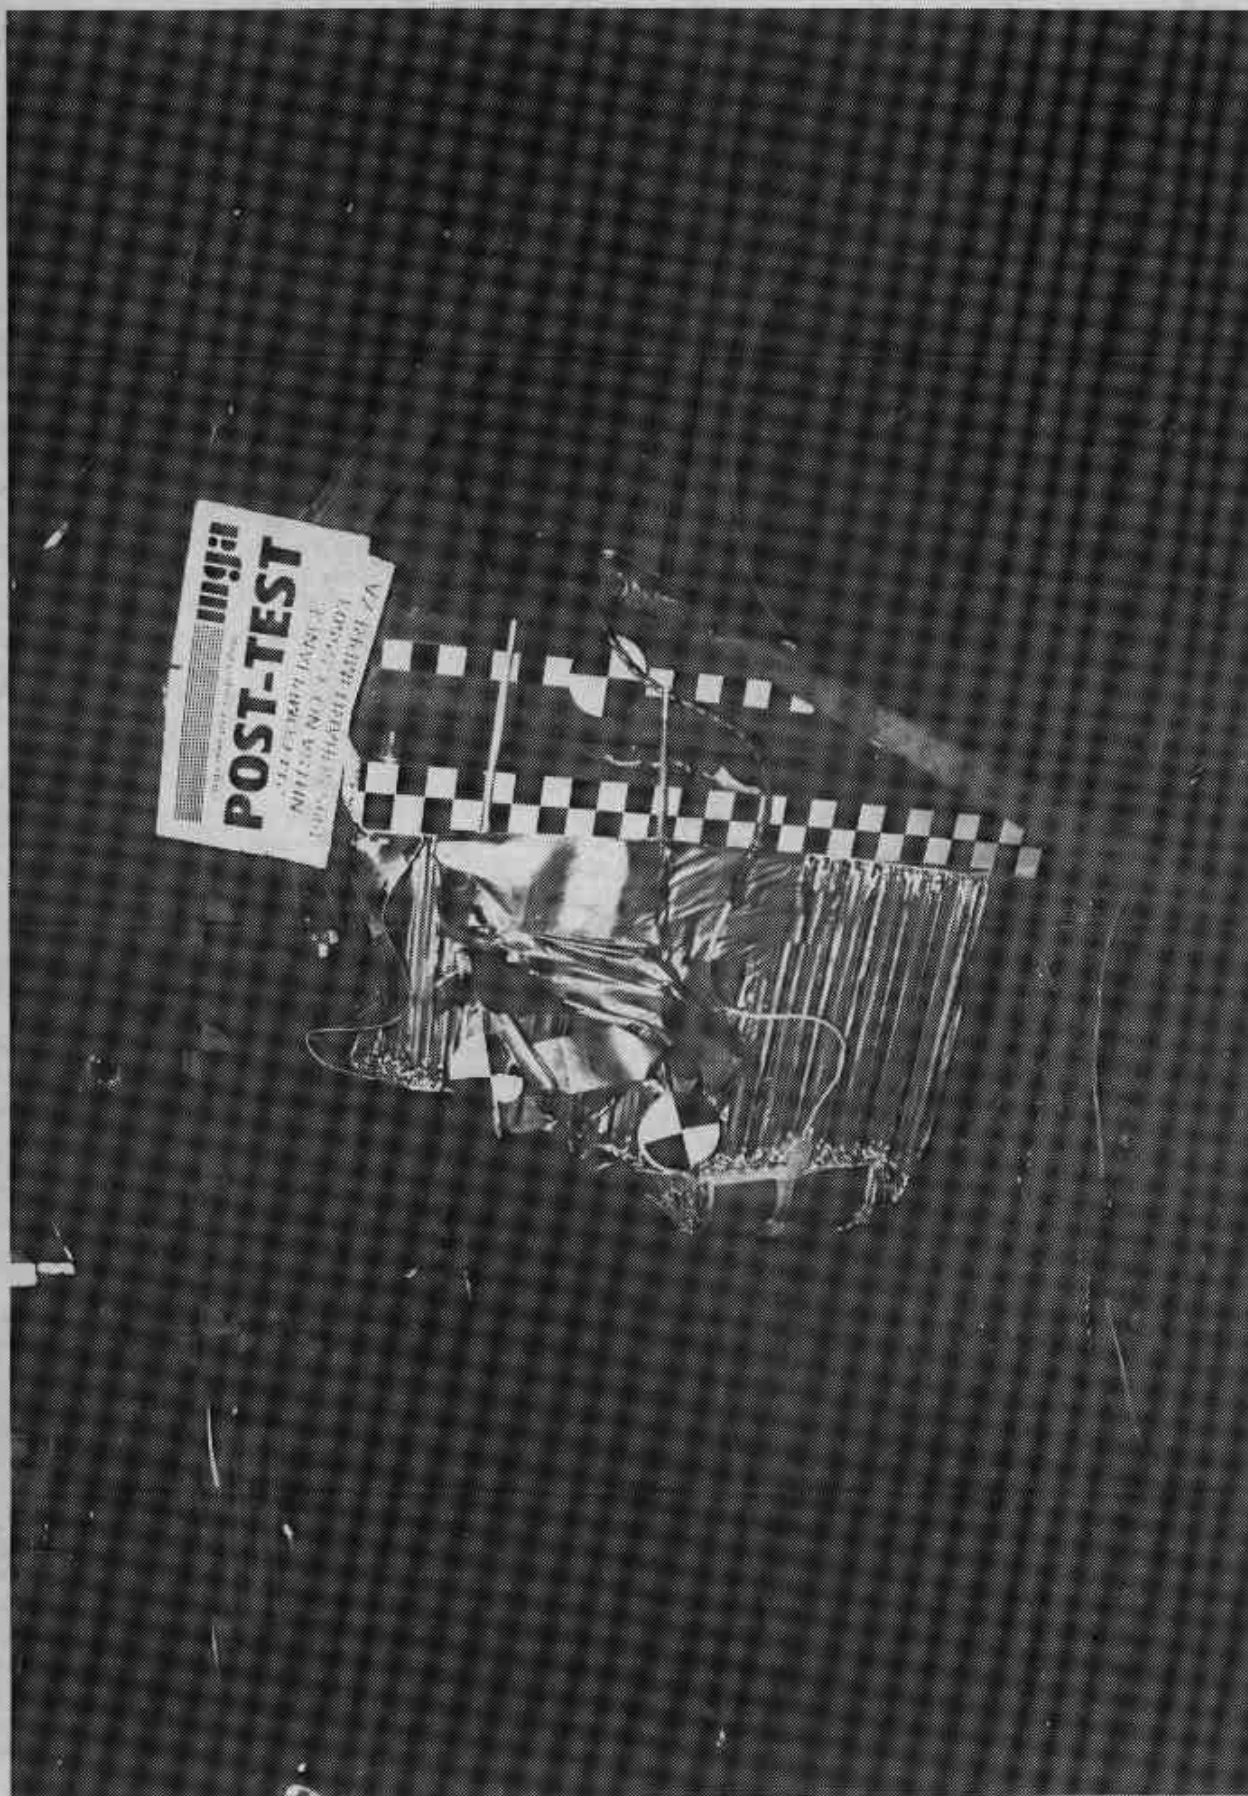
Photo No. A-10 - Post-Test MDB Position Against Vehicle (left side)

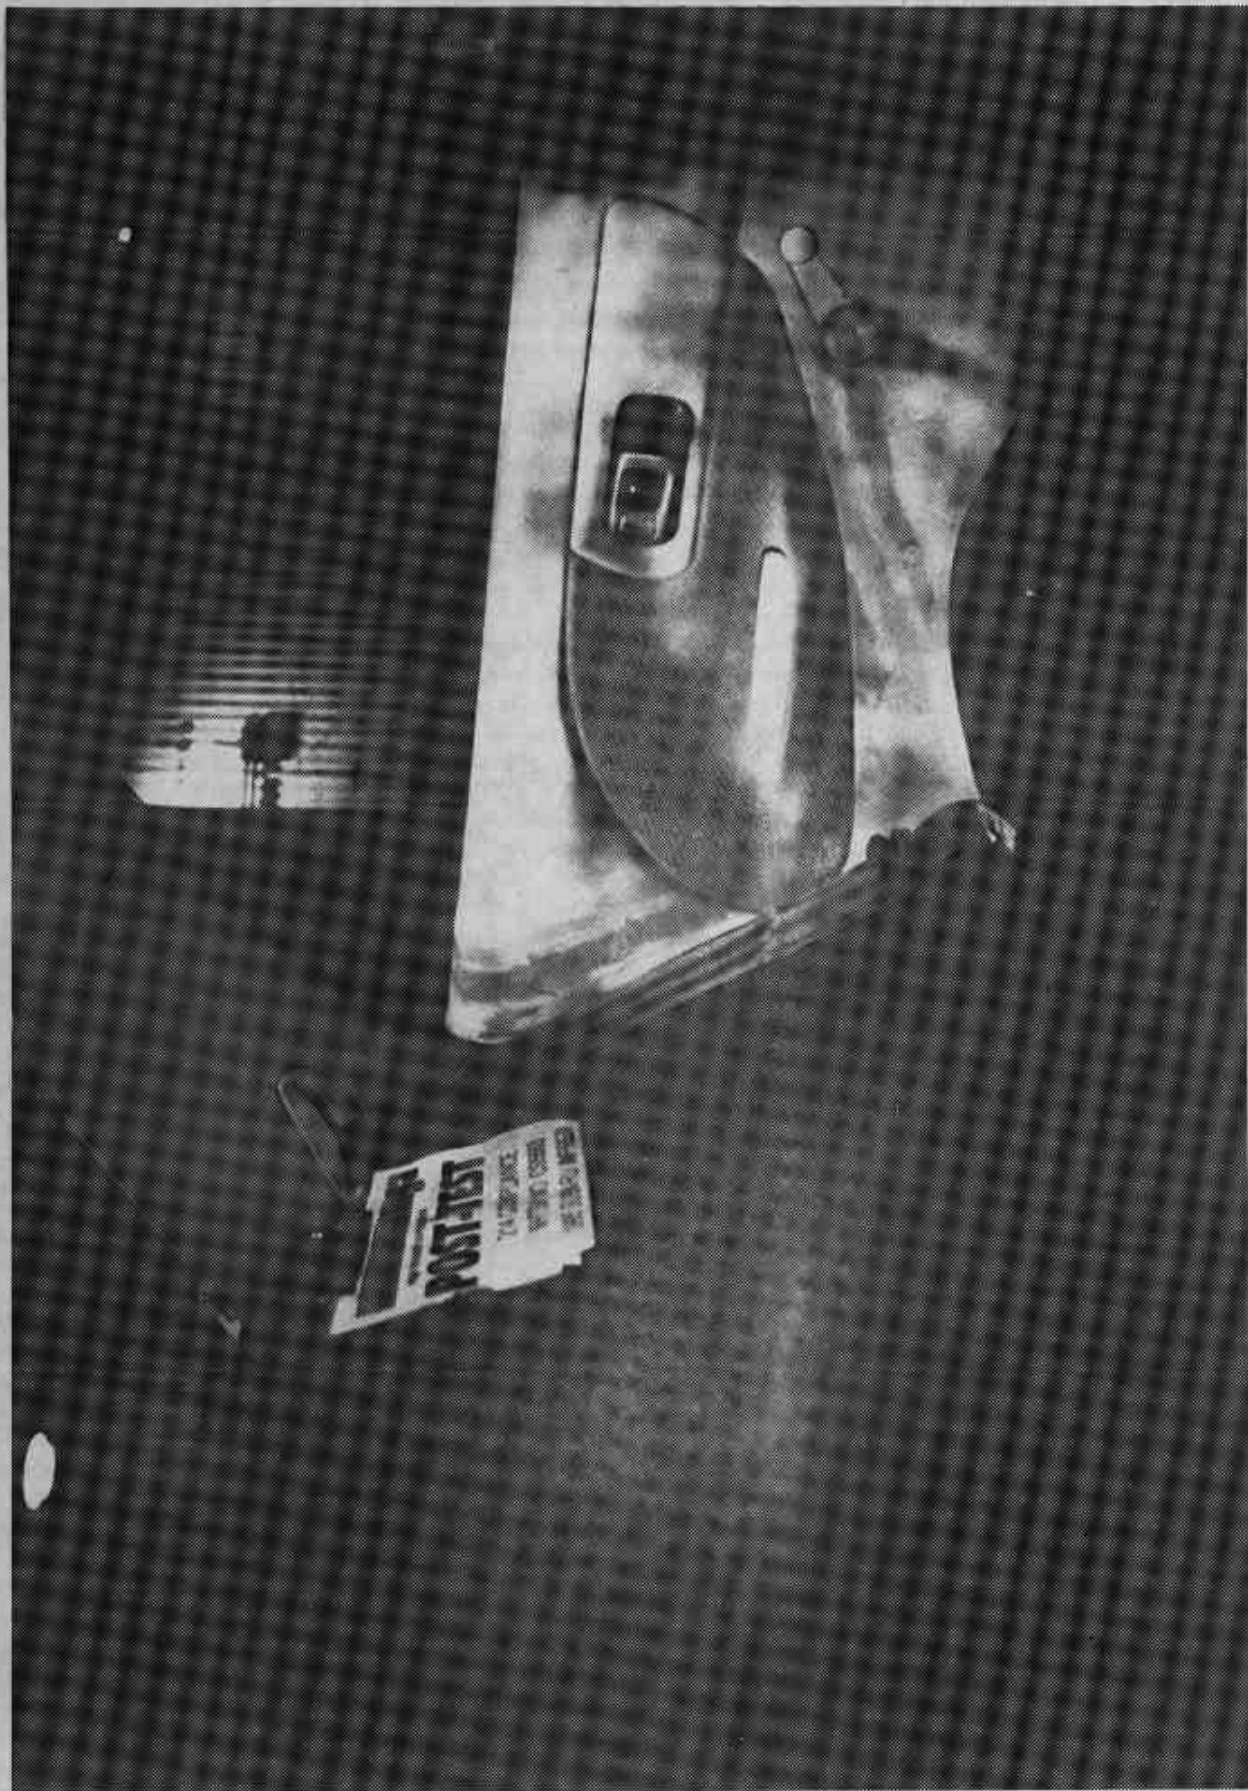
Photo No. A-33 - Post-Test Passenger Dummy Contact
