REPORT NO. MGA-95-21418

SAFETY COMPLIANCE TESTING FOR FMVSS 214

"SIDE IMPACT PROTECTION - PASSENGER CARS"

1995 SAAB 900 SE CONVERTIBLE
NHTSA NO. CS0506

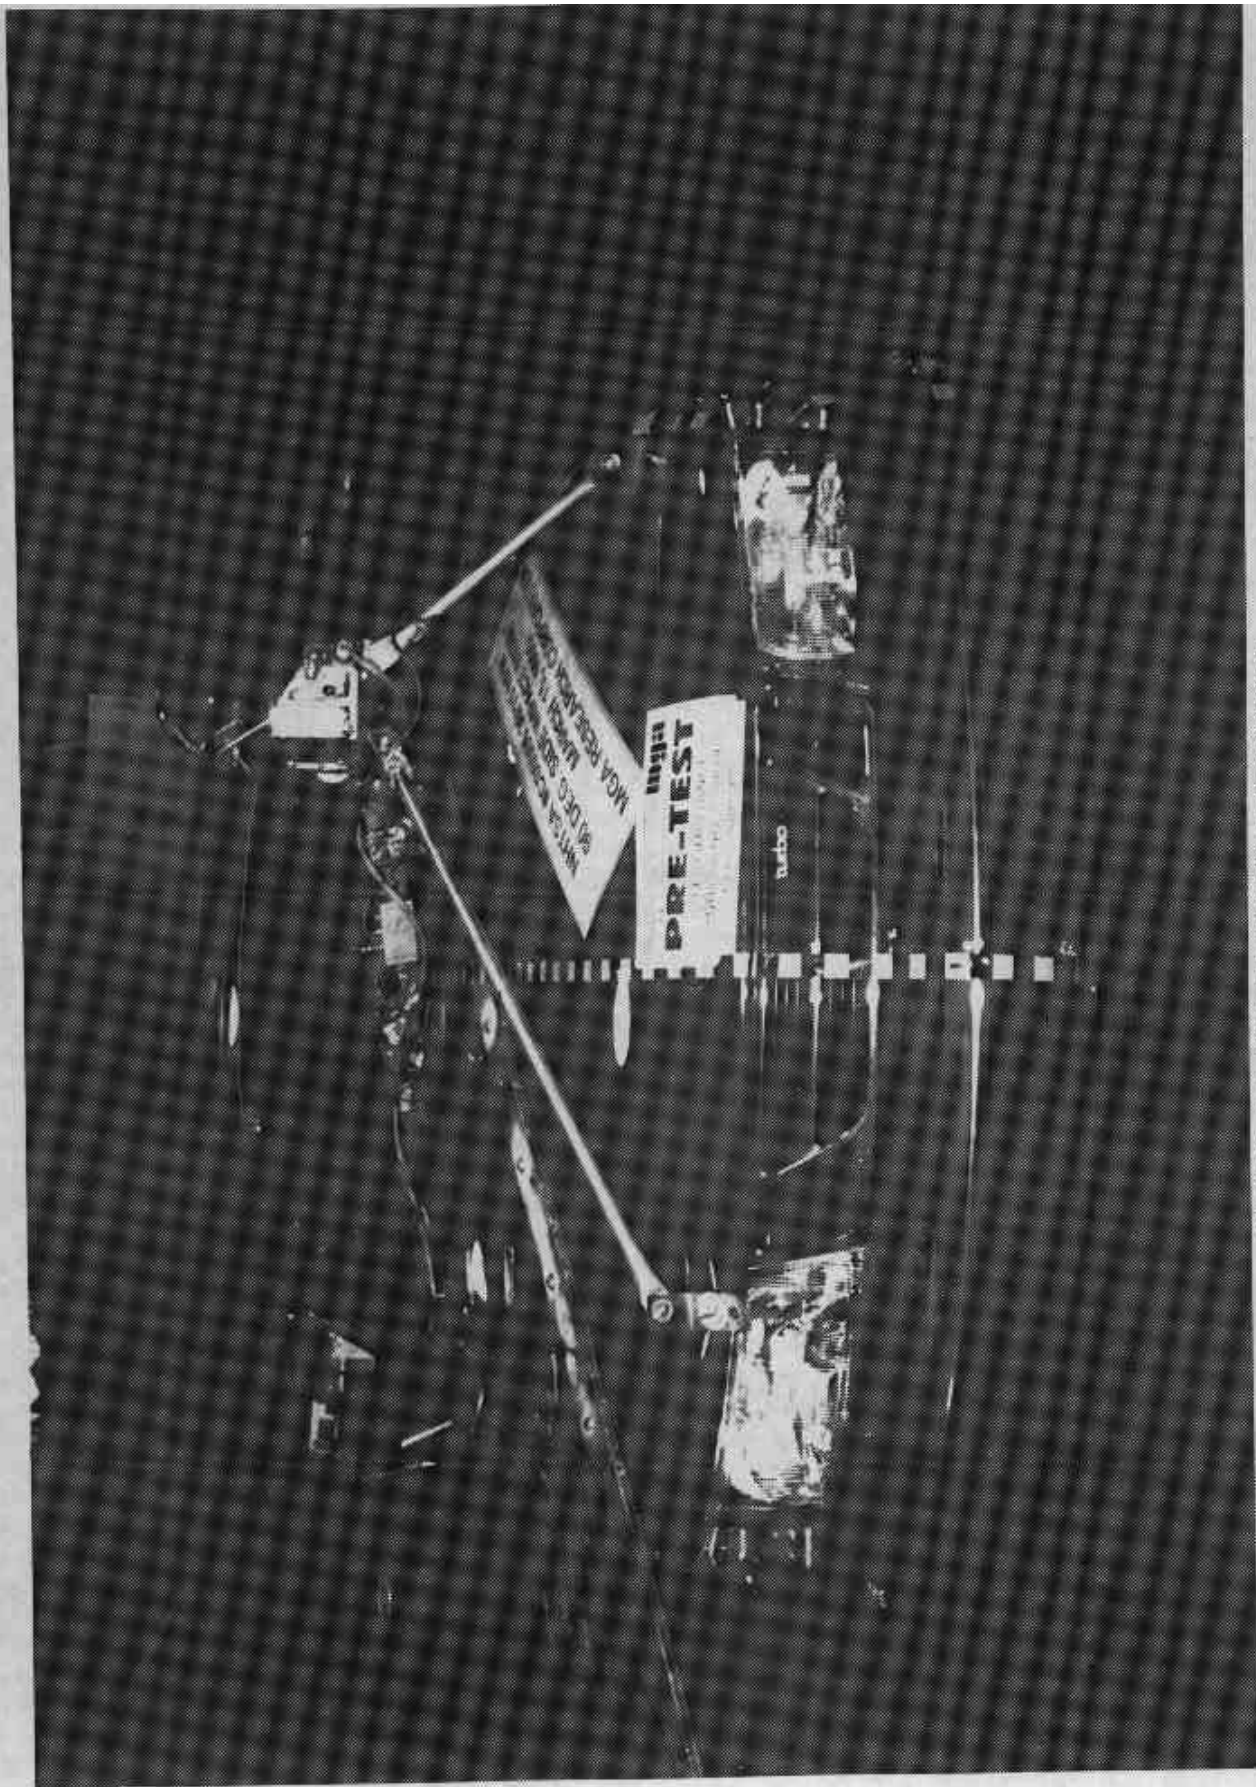
Photo No. A-1 - Pre-Test Front View of Test Vehicle

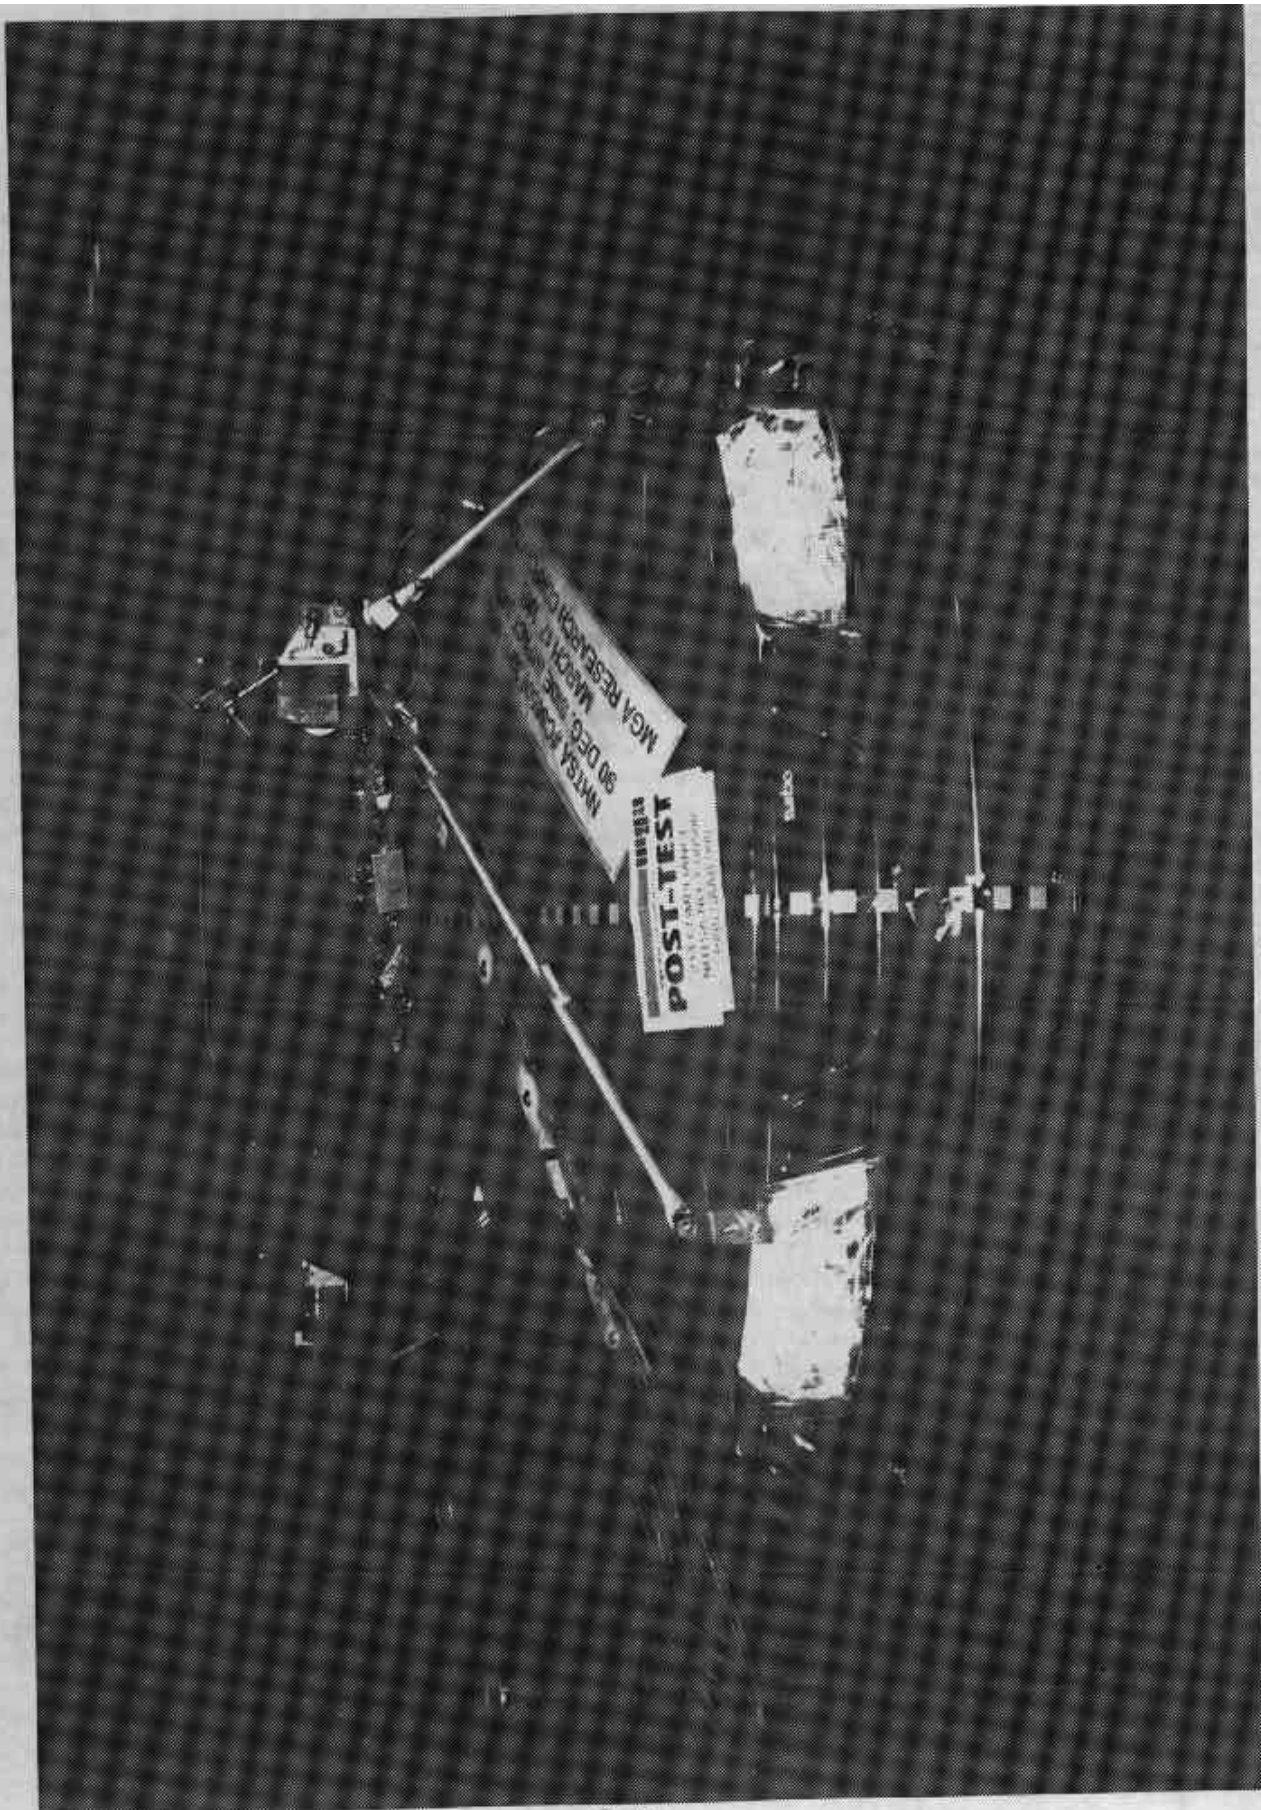
Photo No. A-2 - Post-Test Front View of Test Vehicle

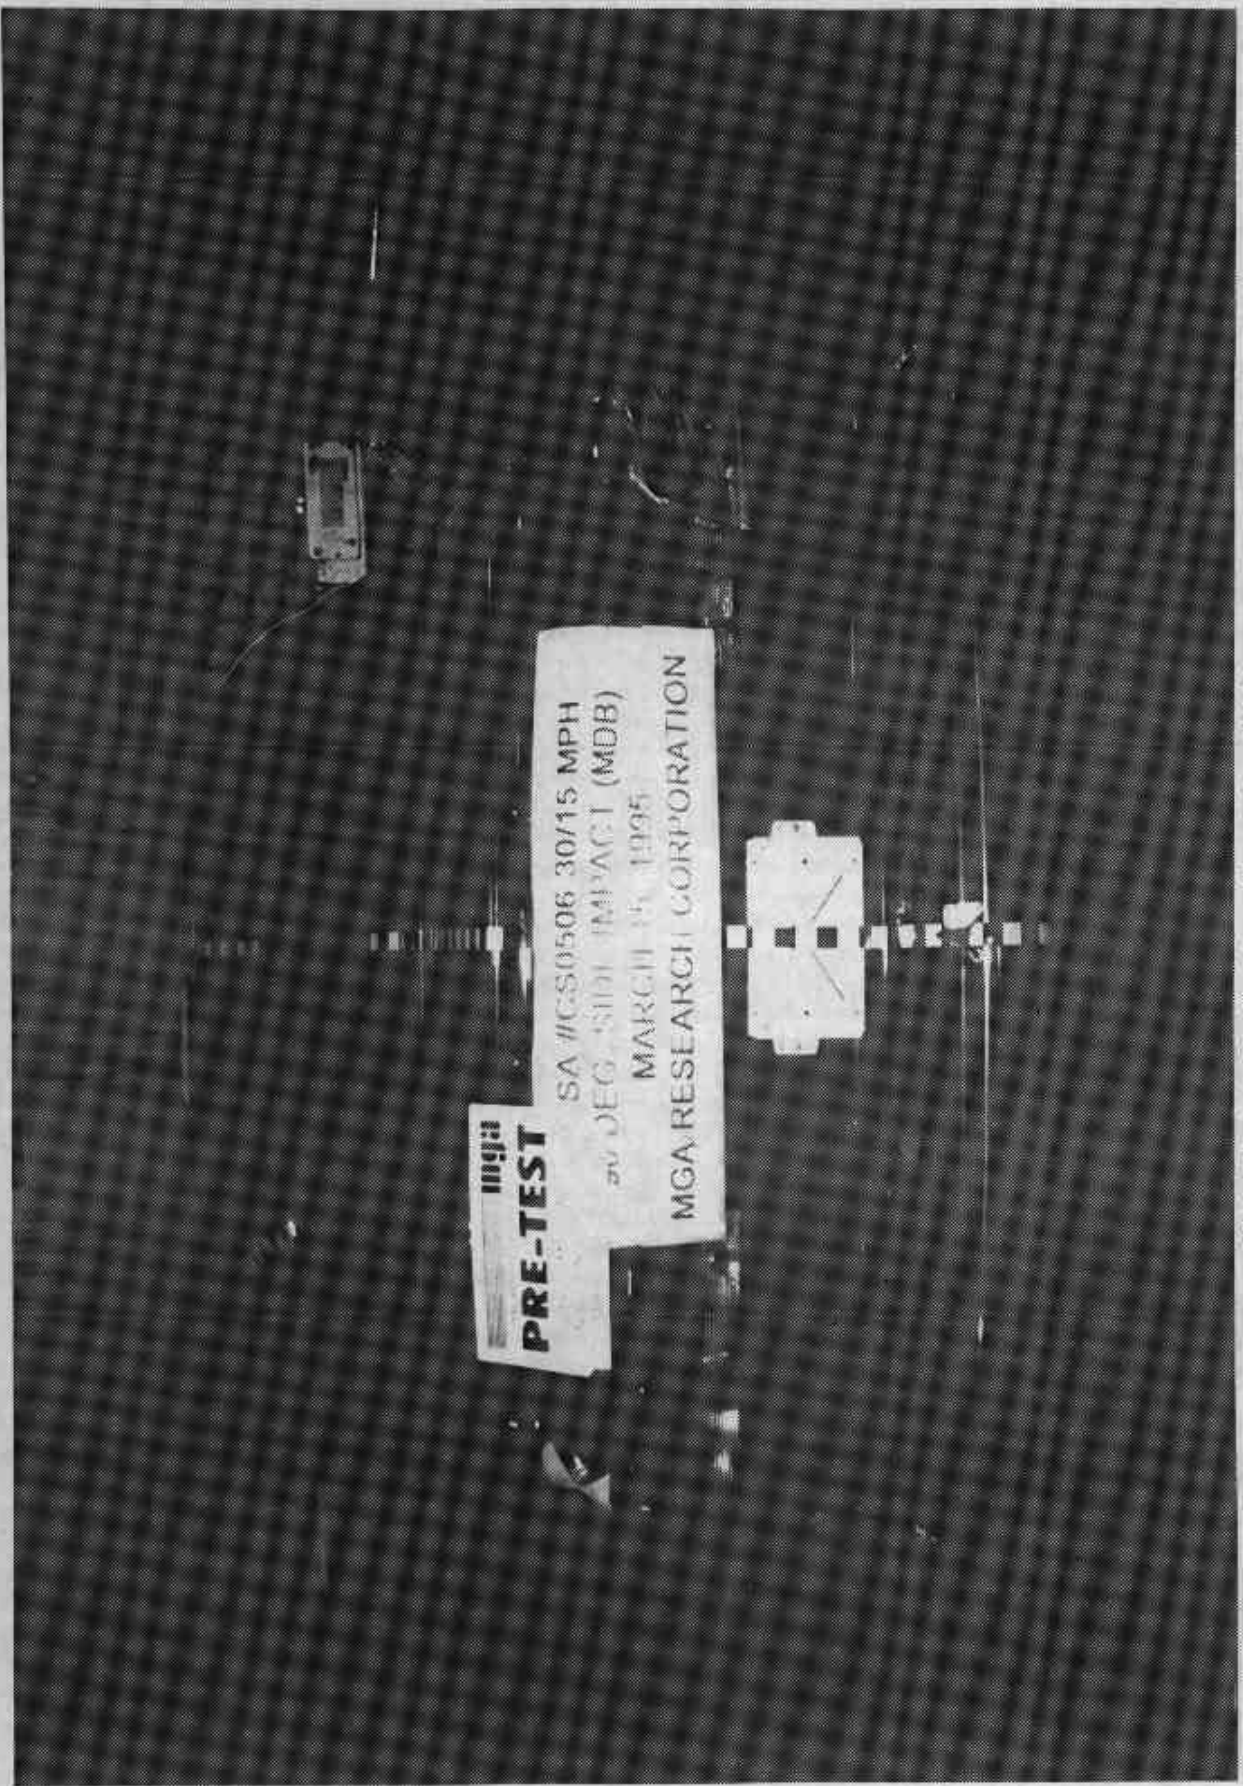
Photo No. A-3 - Pre-Test Rear View of Test Vehicle

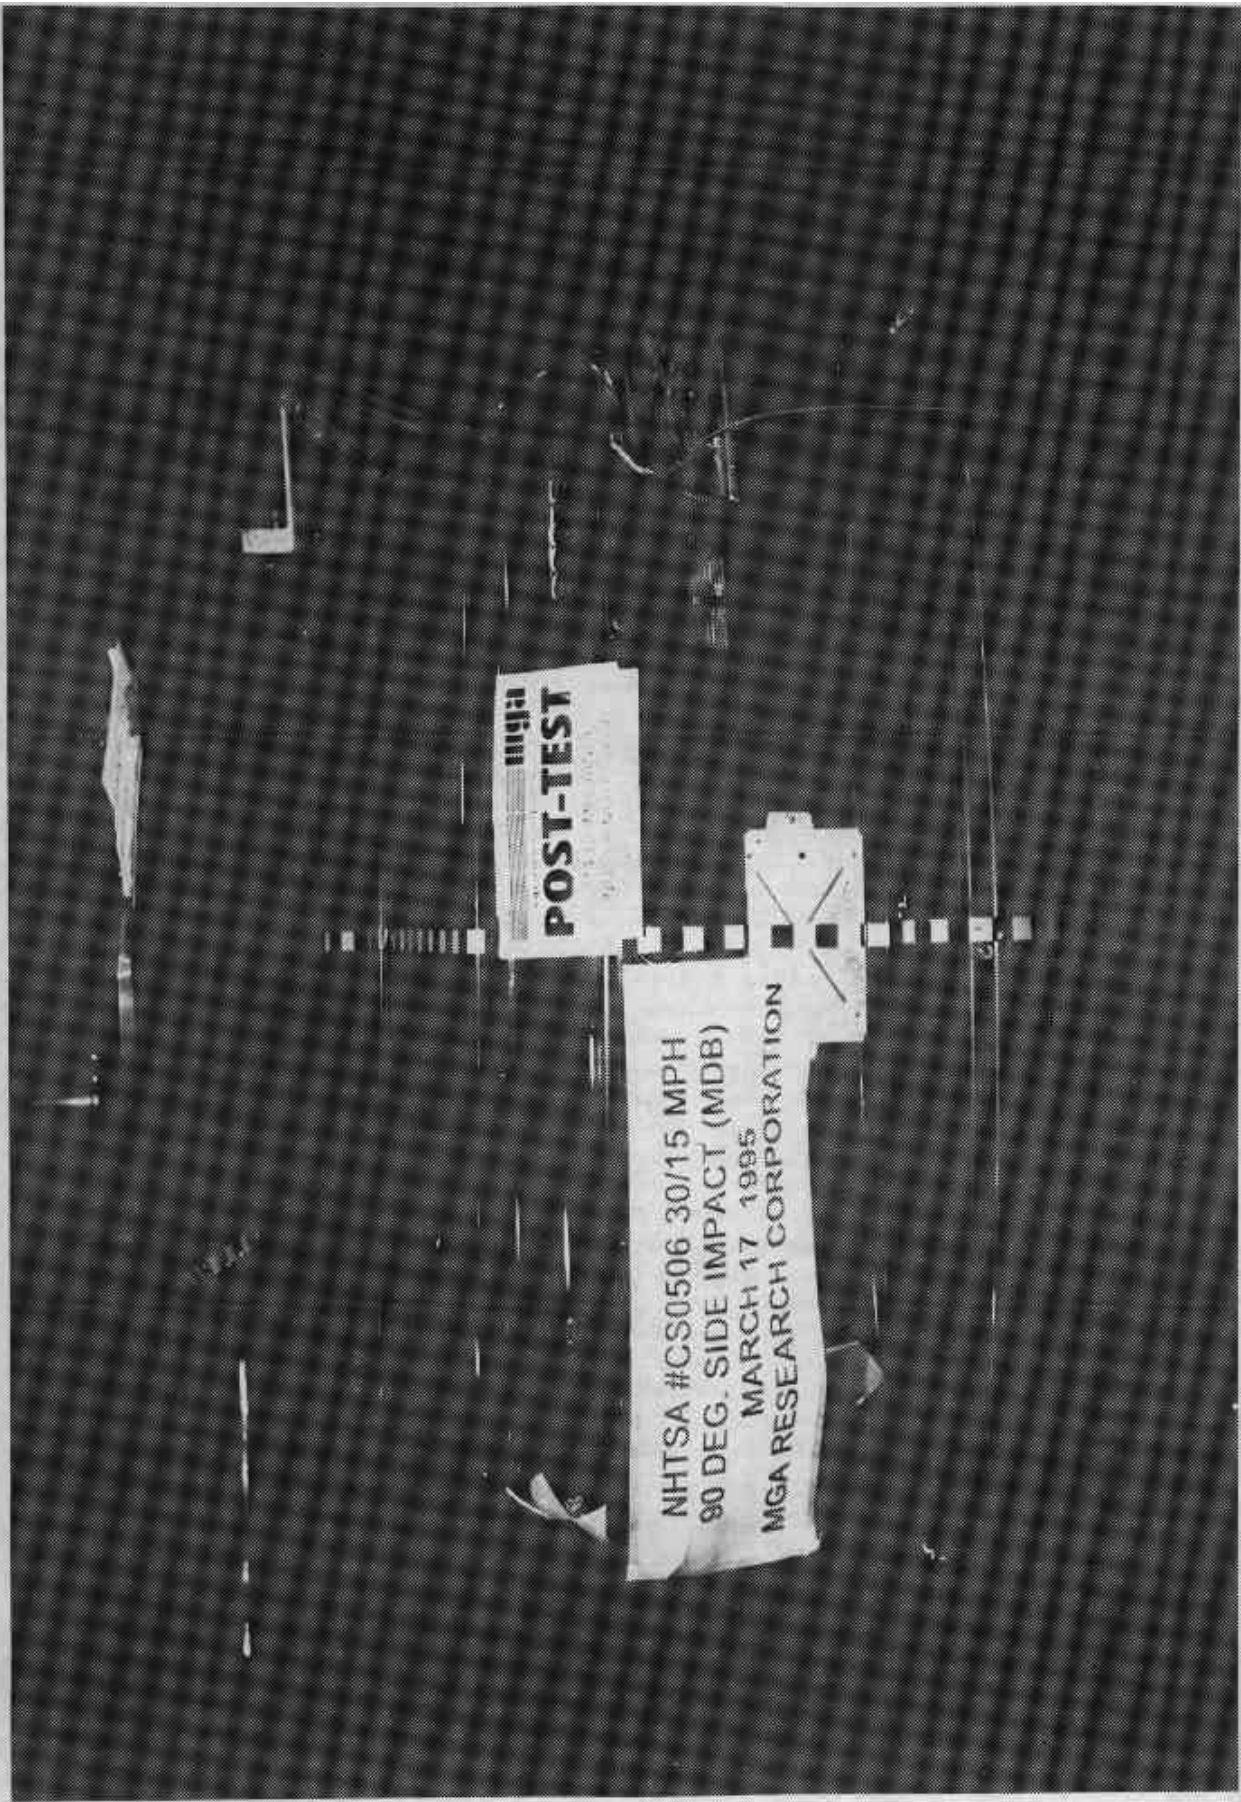
Photo No. A-4 - Post-Test Rear View of Test Vehicle

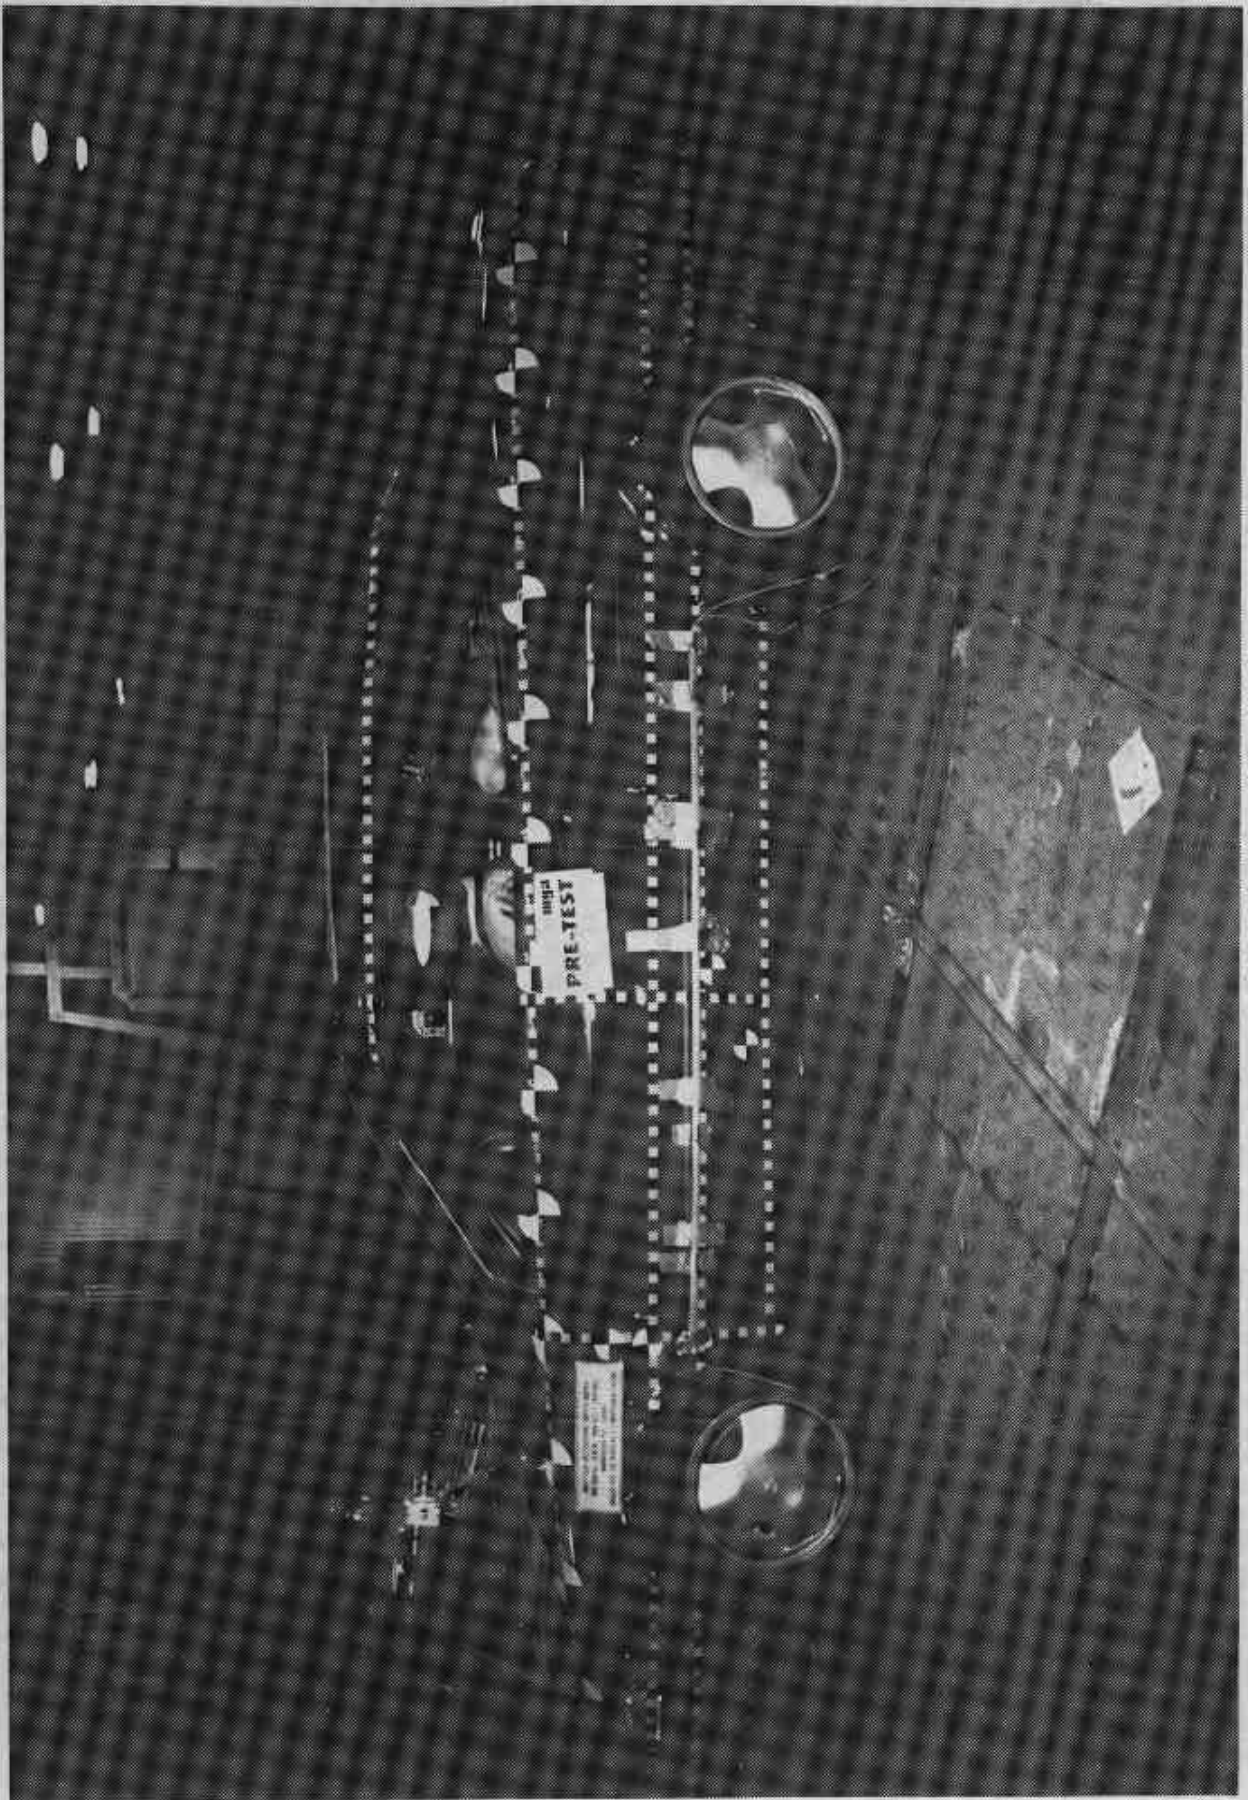
Photo No. A-5 - Pre-Test Left Side View of Test Vehicle

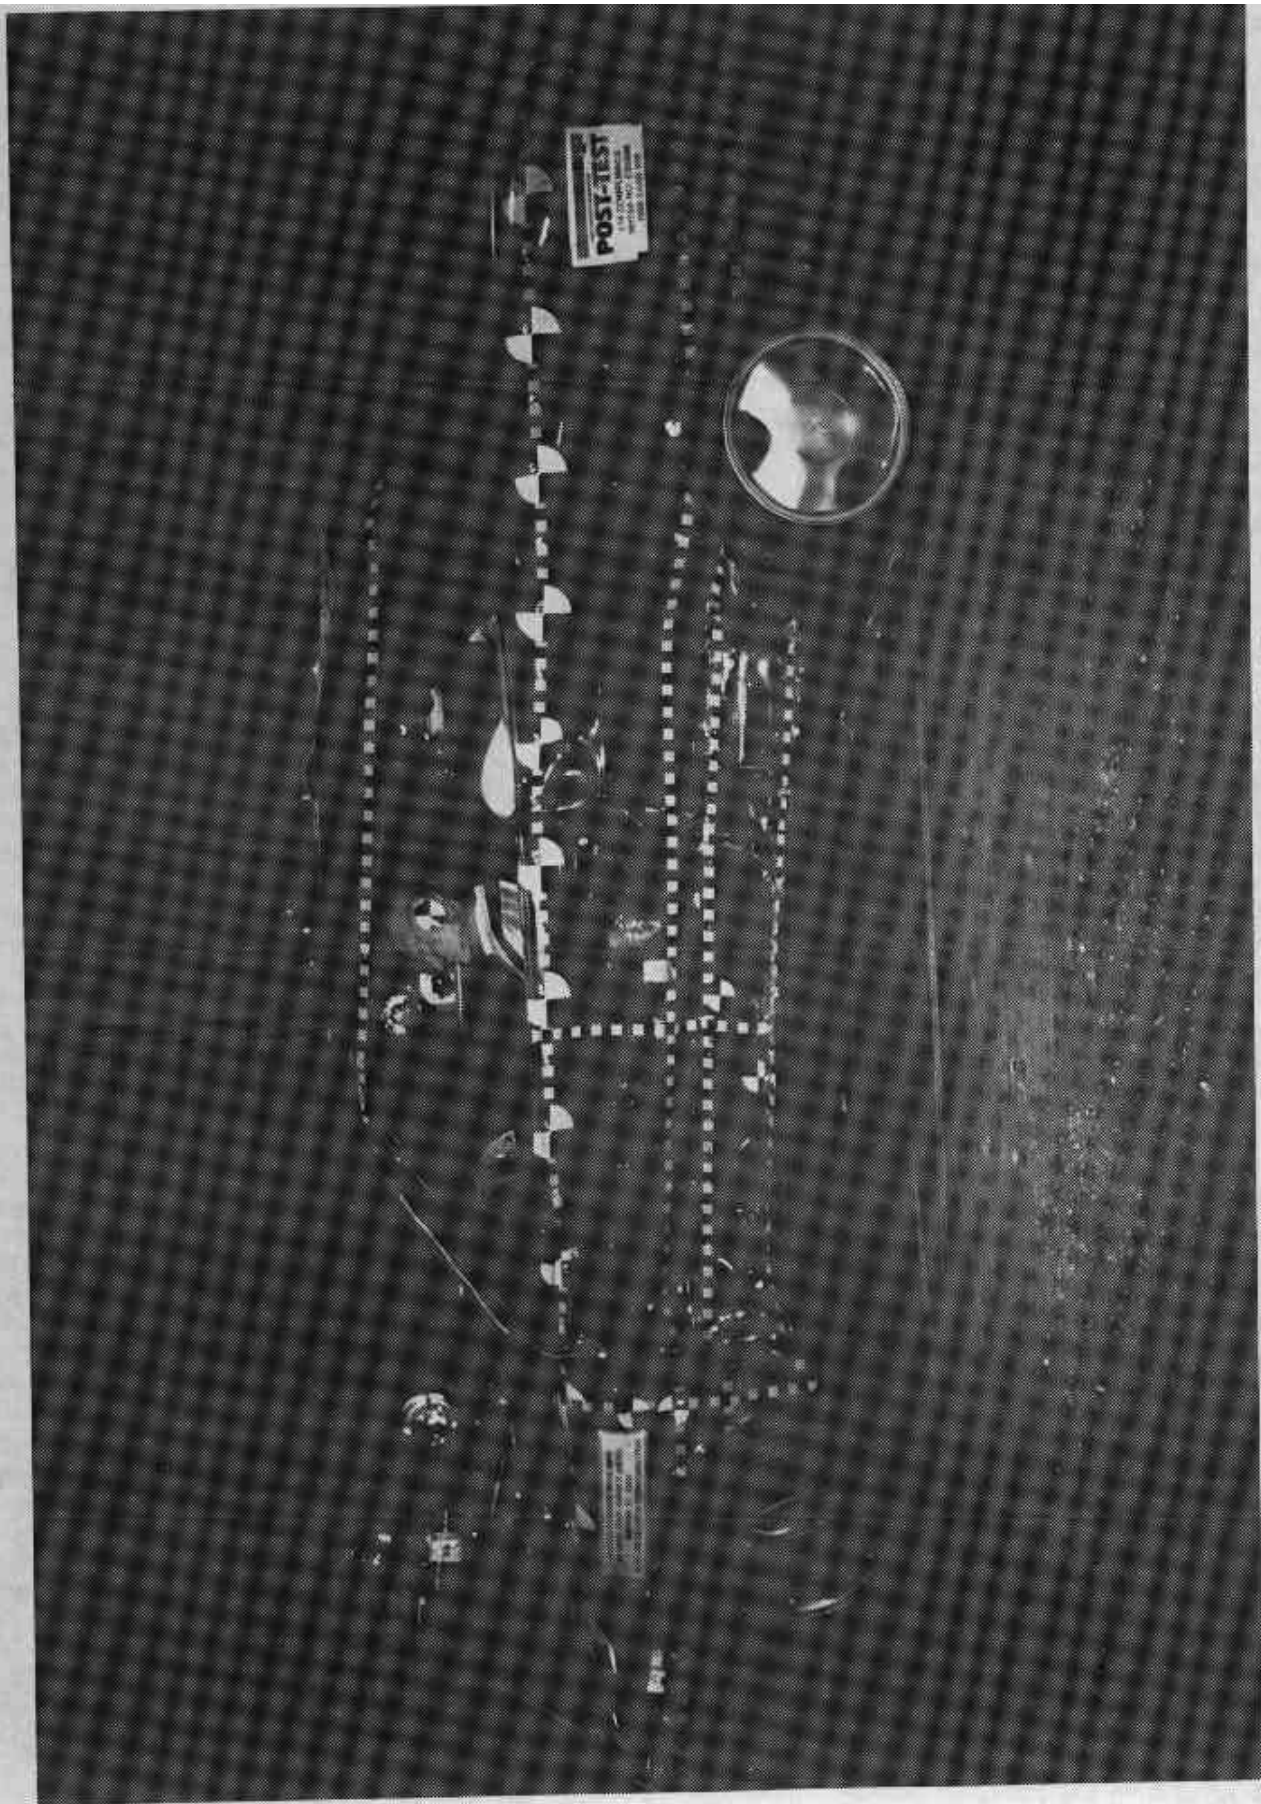
Photo No. A-6 - Post-Test Left Side View of Test Vehicle

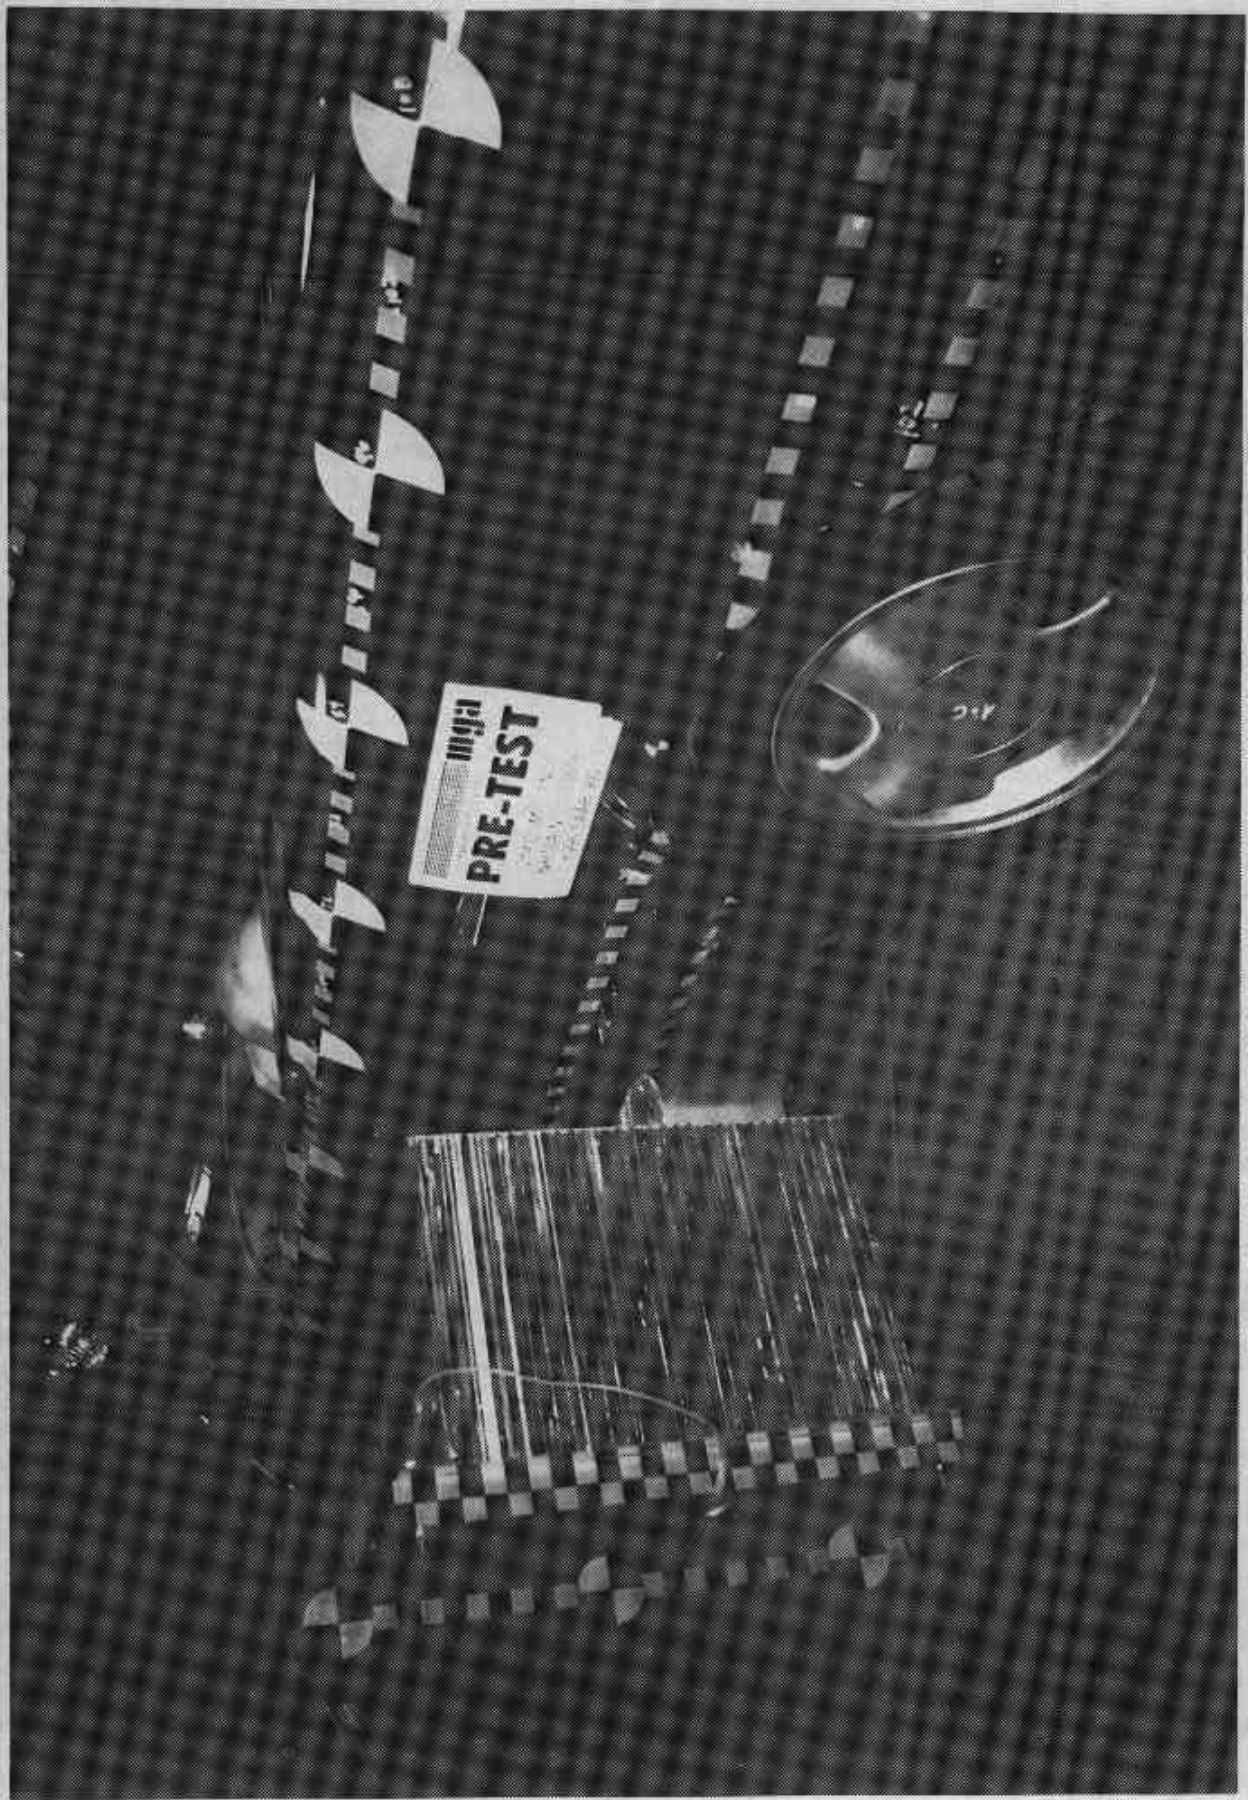
Photo No. A-8 - Pre-Test MDB Positioned Against Vehicle (right side)

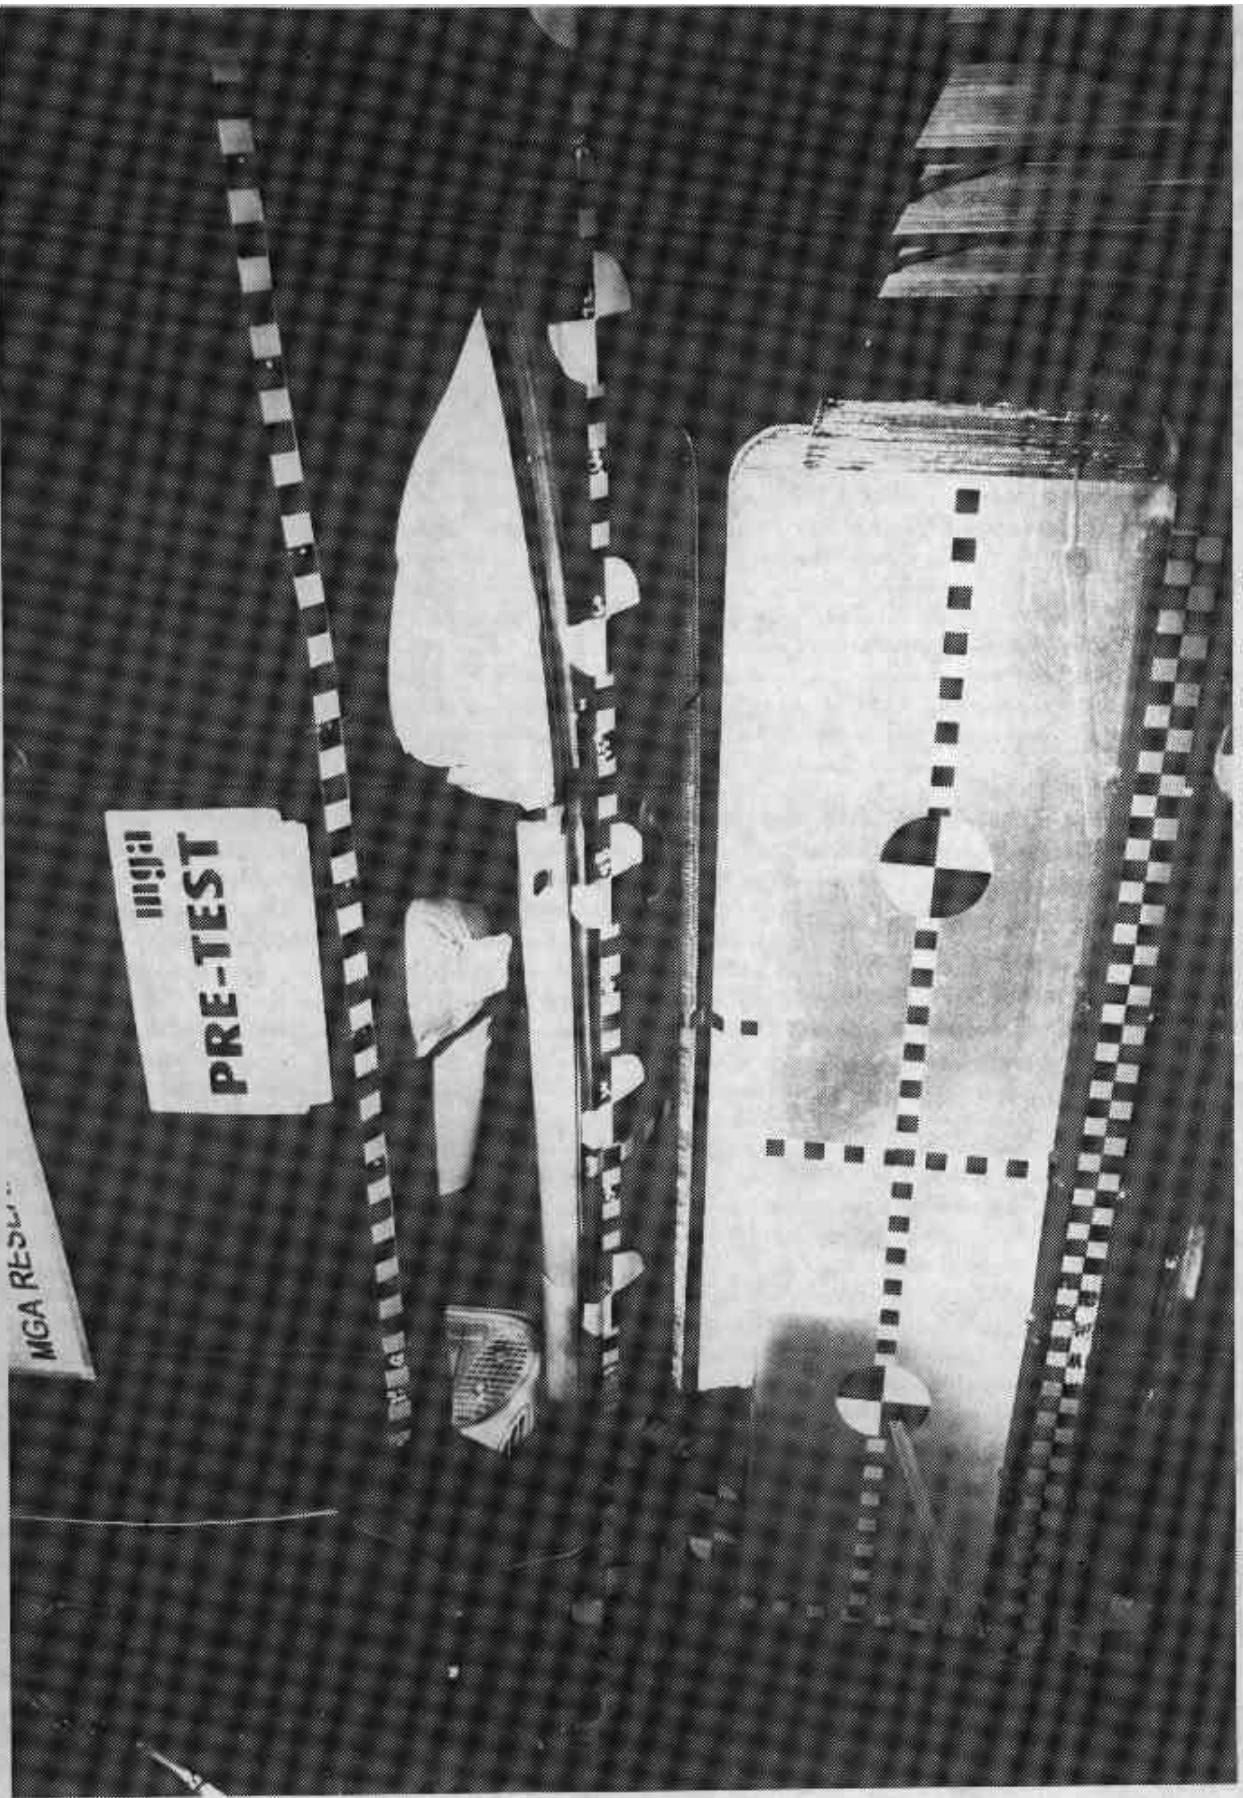
Photo No. A-9 - Pre-Test MDB Position Against Vehicle Overhead View

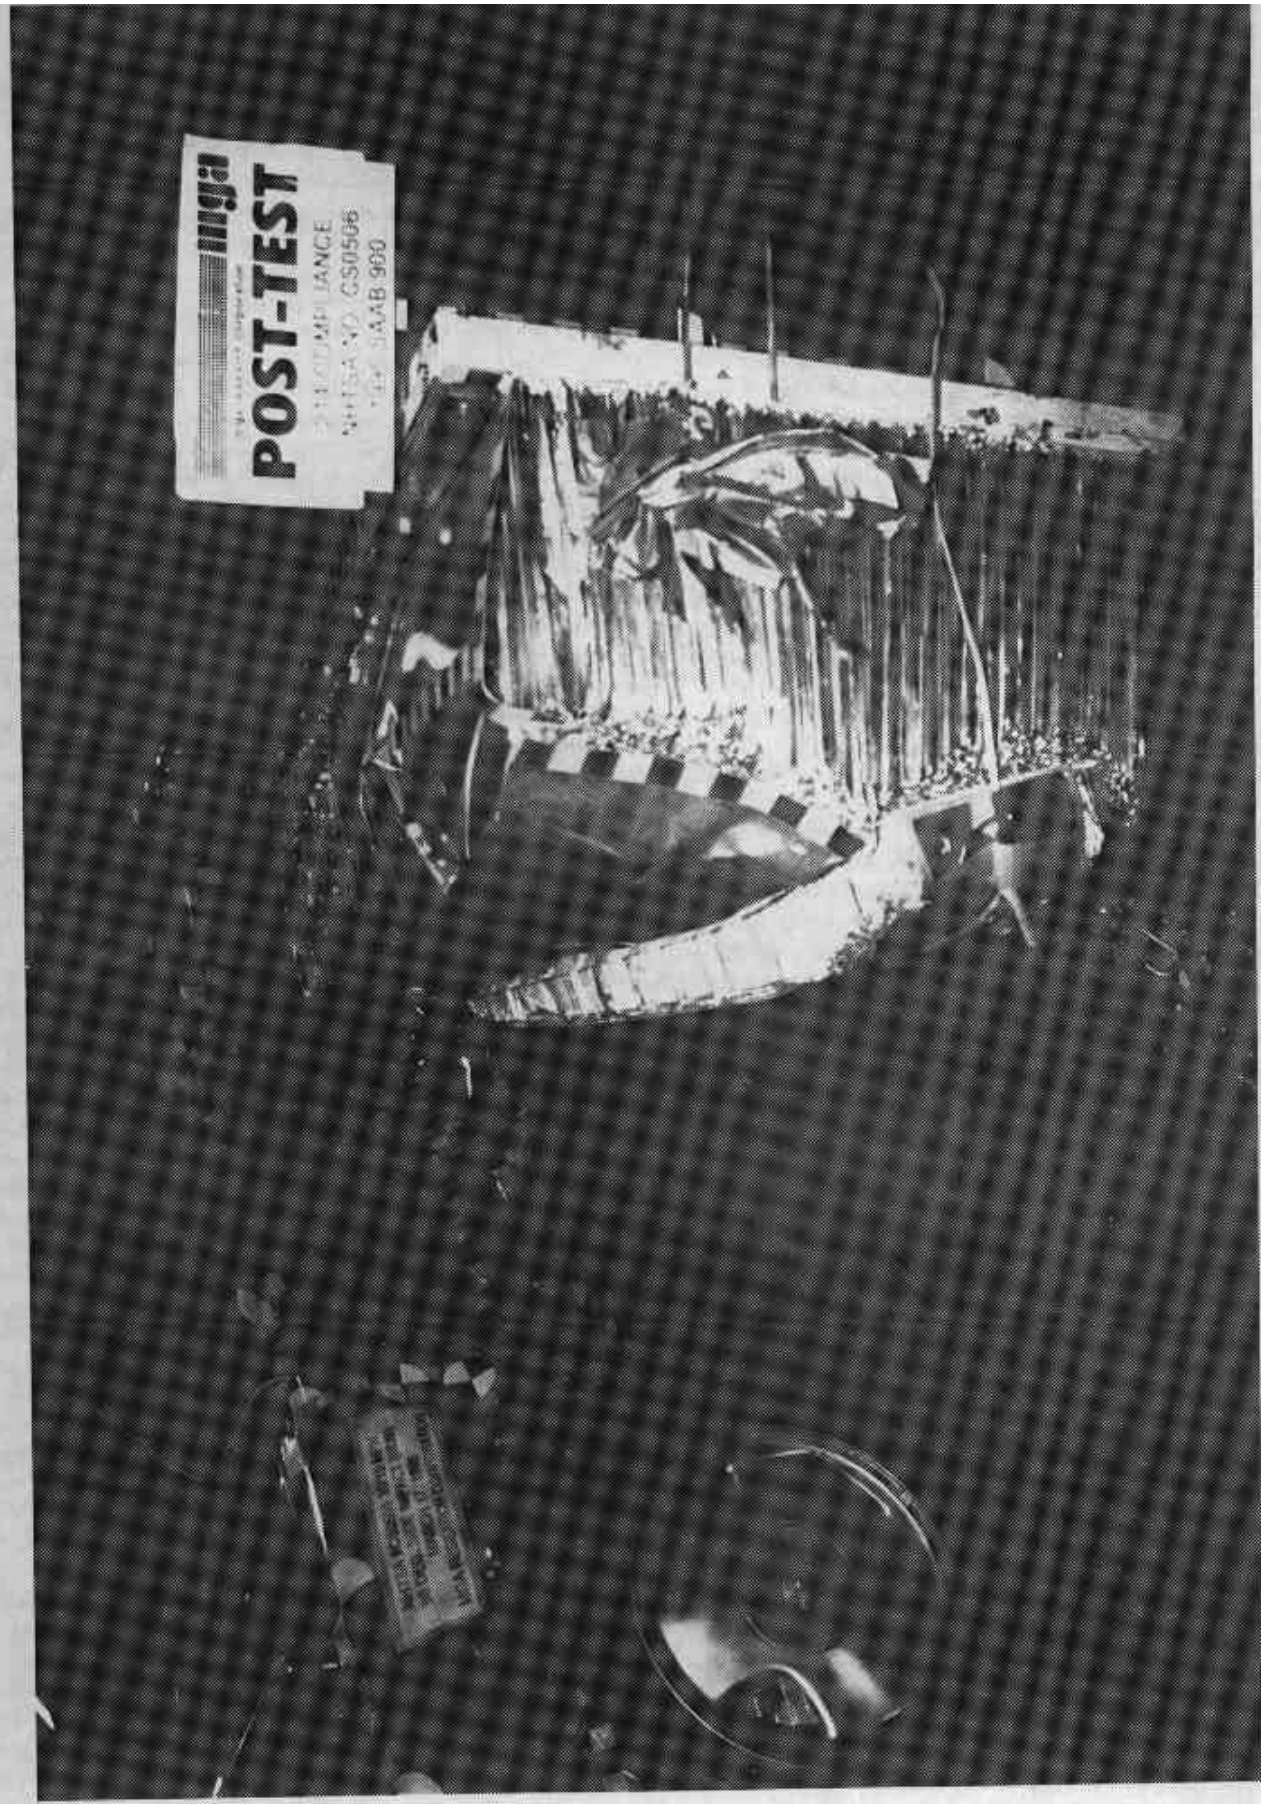
Photo No. A-10 - Post-Test MDB Position Against Vehicle (left side)

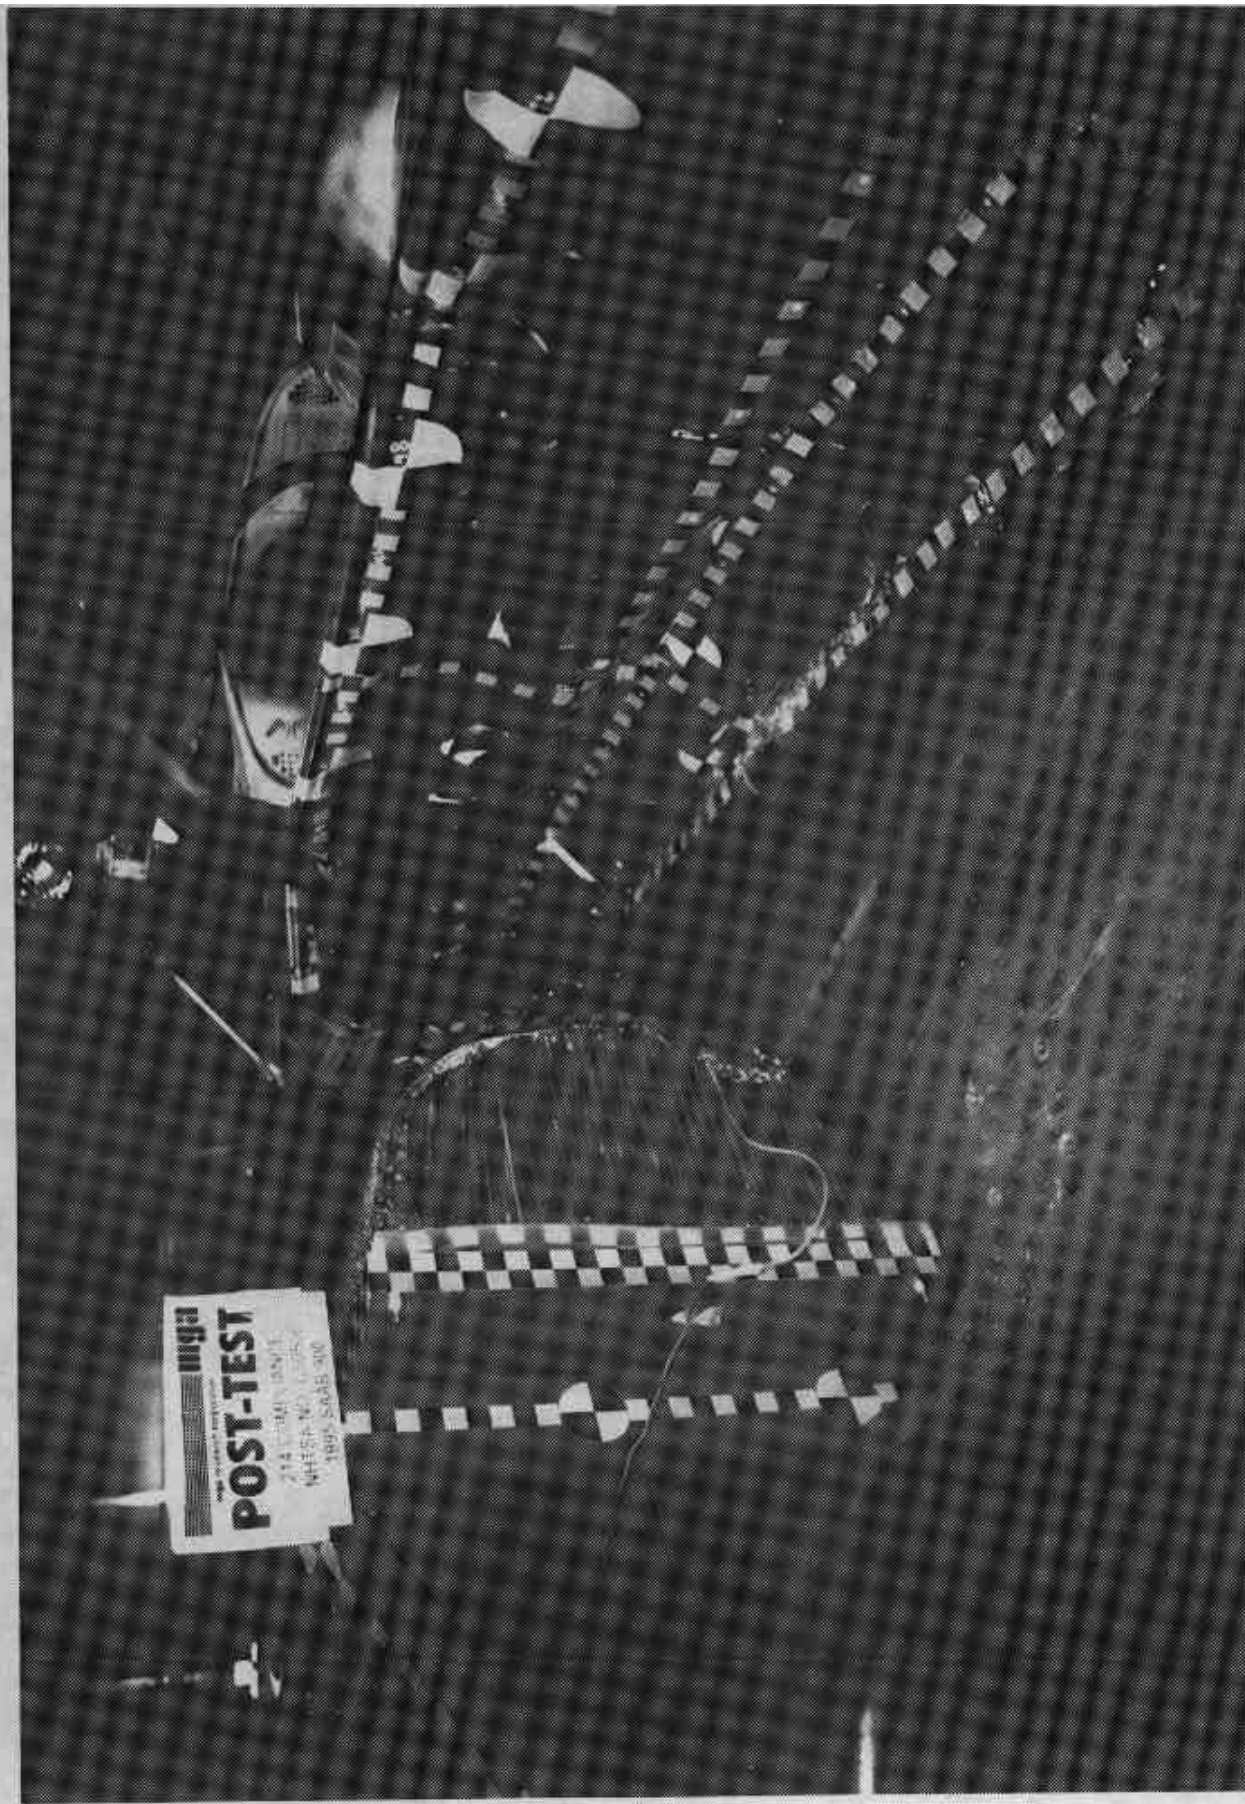
Photo No. A-11 - Post-Test MDB Positioned Against Vehicle (right side)
