REPORT NO. MGA-95-21418

SAFETY COMPLIANCE TESTING FOR FMVSS 214

"SIDE IMPACT PROTECTION - PASSENGER CARS"

1995 SAAB 900 SE CONVERTIBLE
NHTSA NO. CS0506

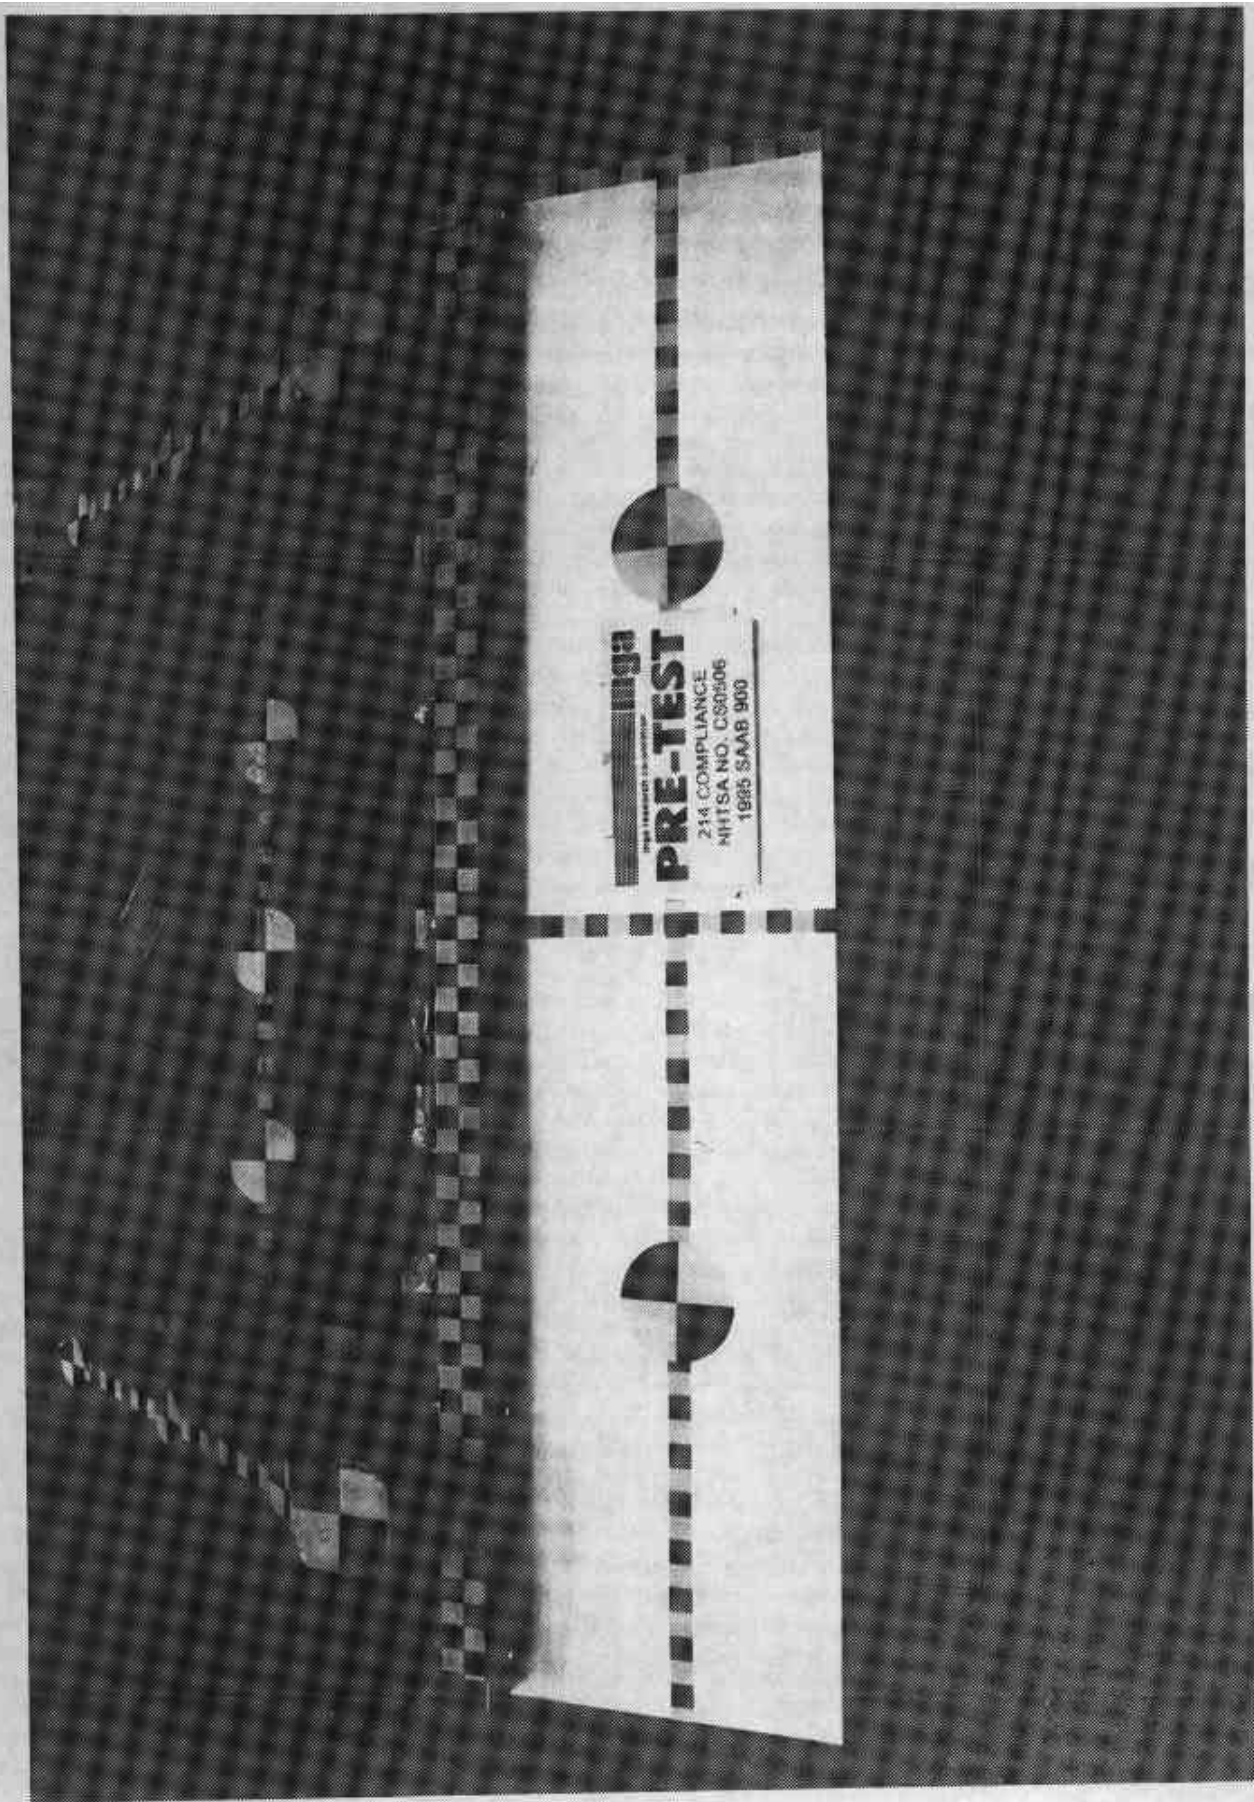
Photo No. A-12 - Pre-Test MDB Top View

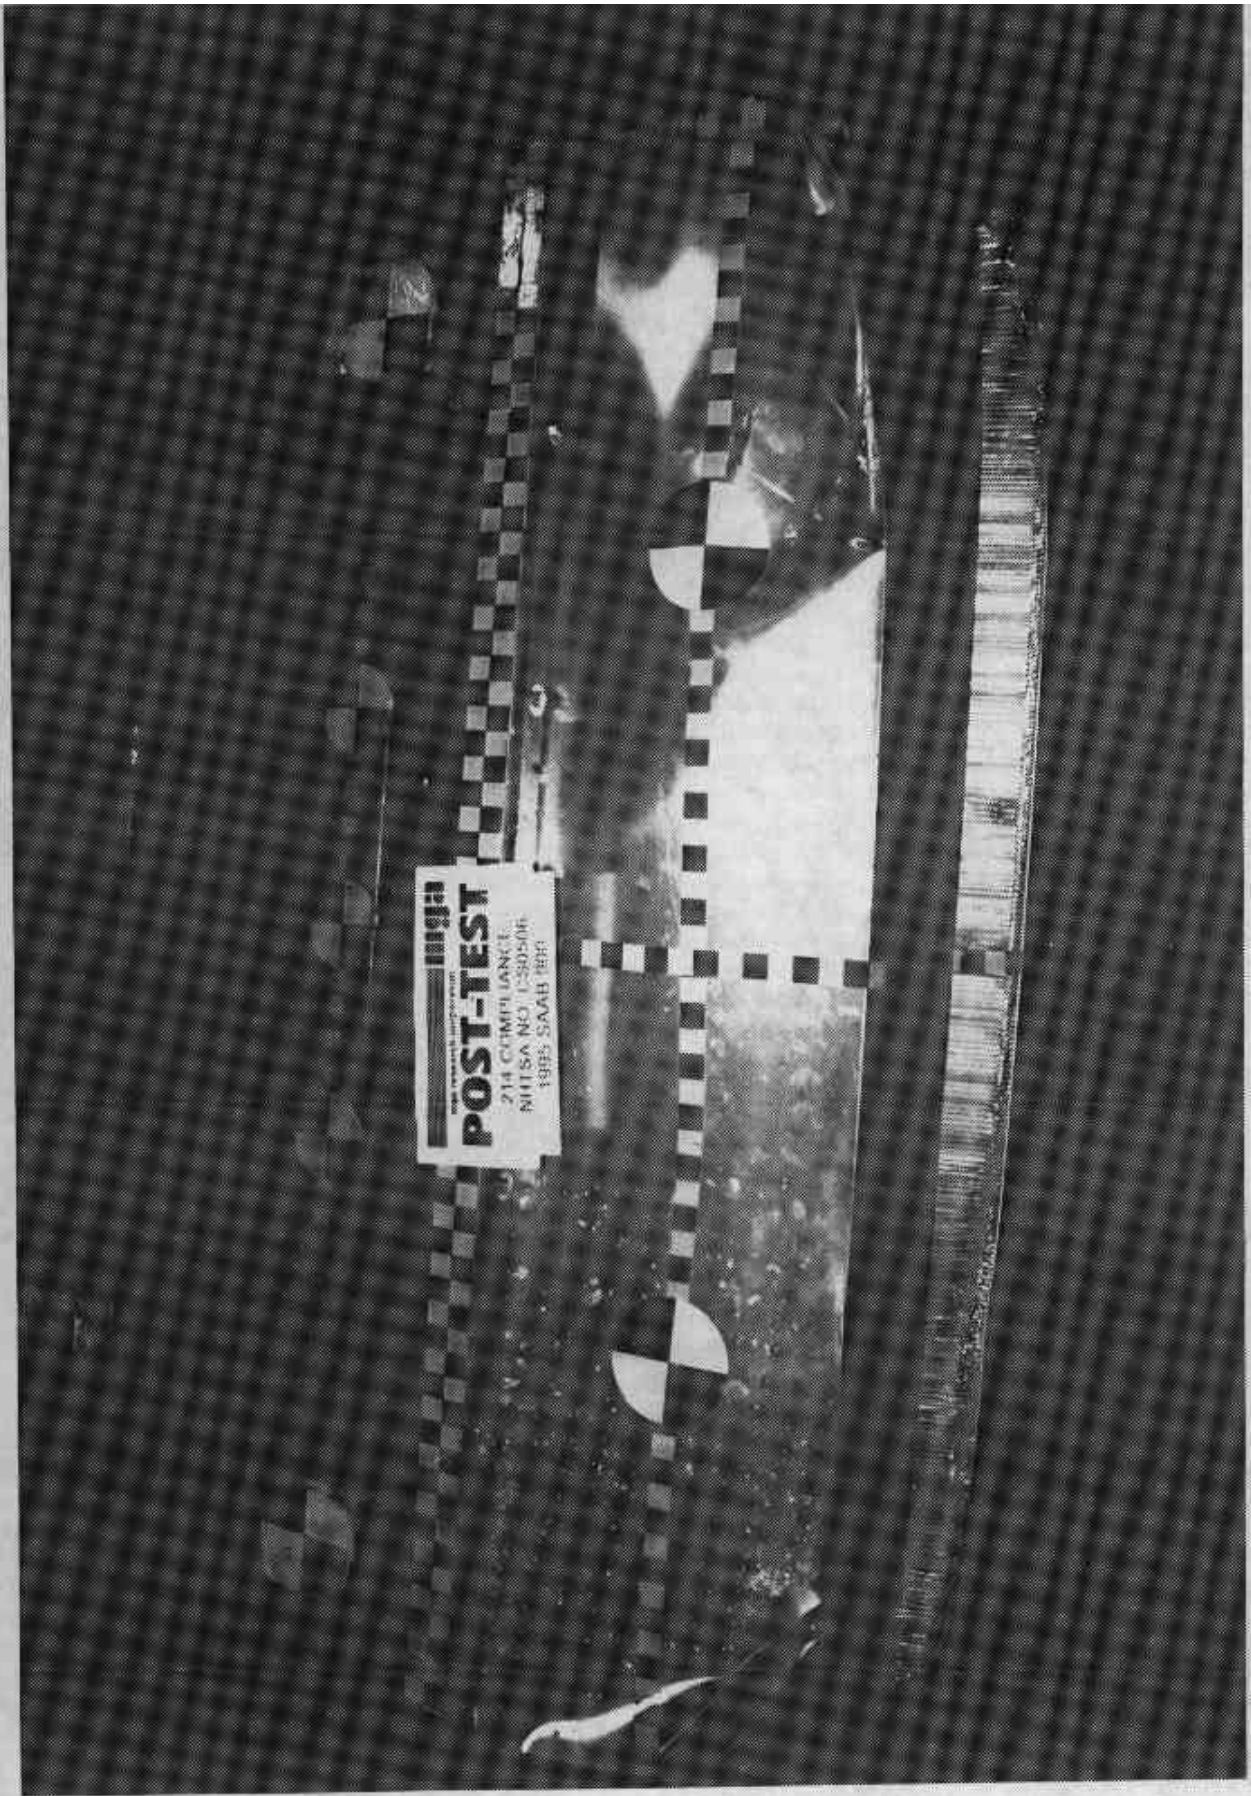
Photo No. A-13 - Post-Test MDB Top View

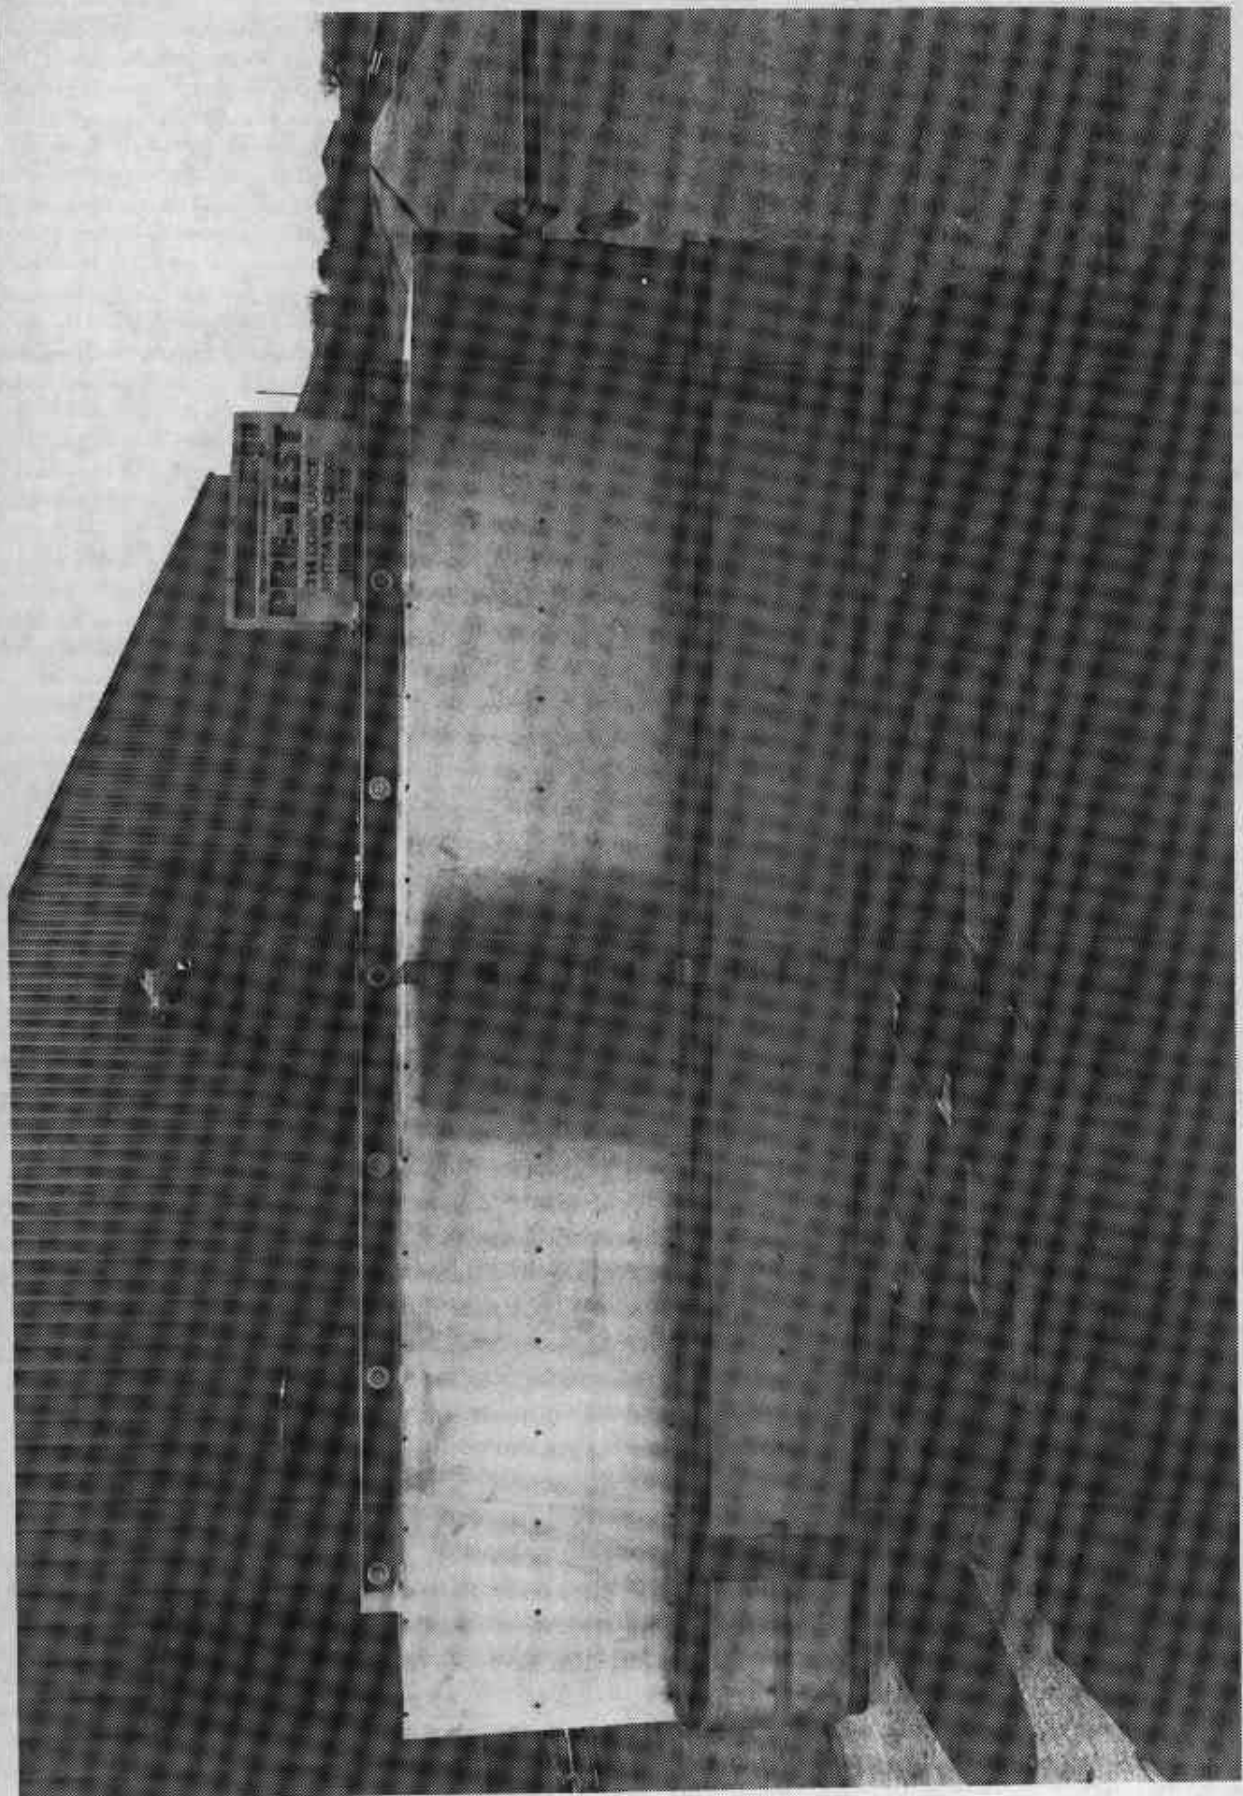
Photo No. A-14 - Pre-Test MDB Front View

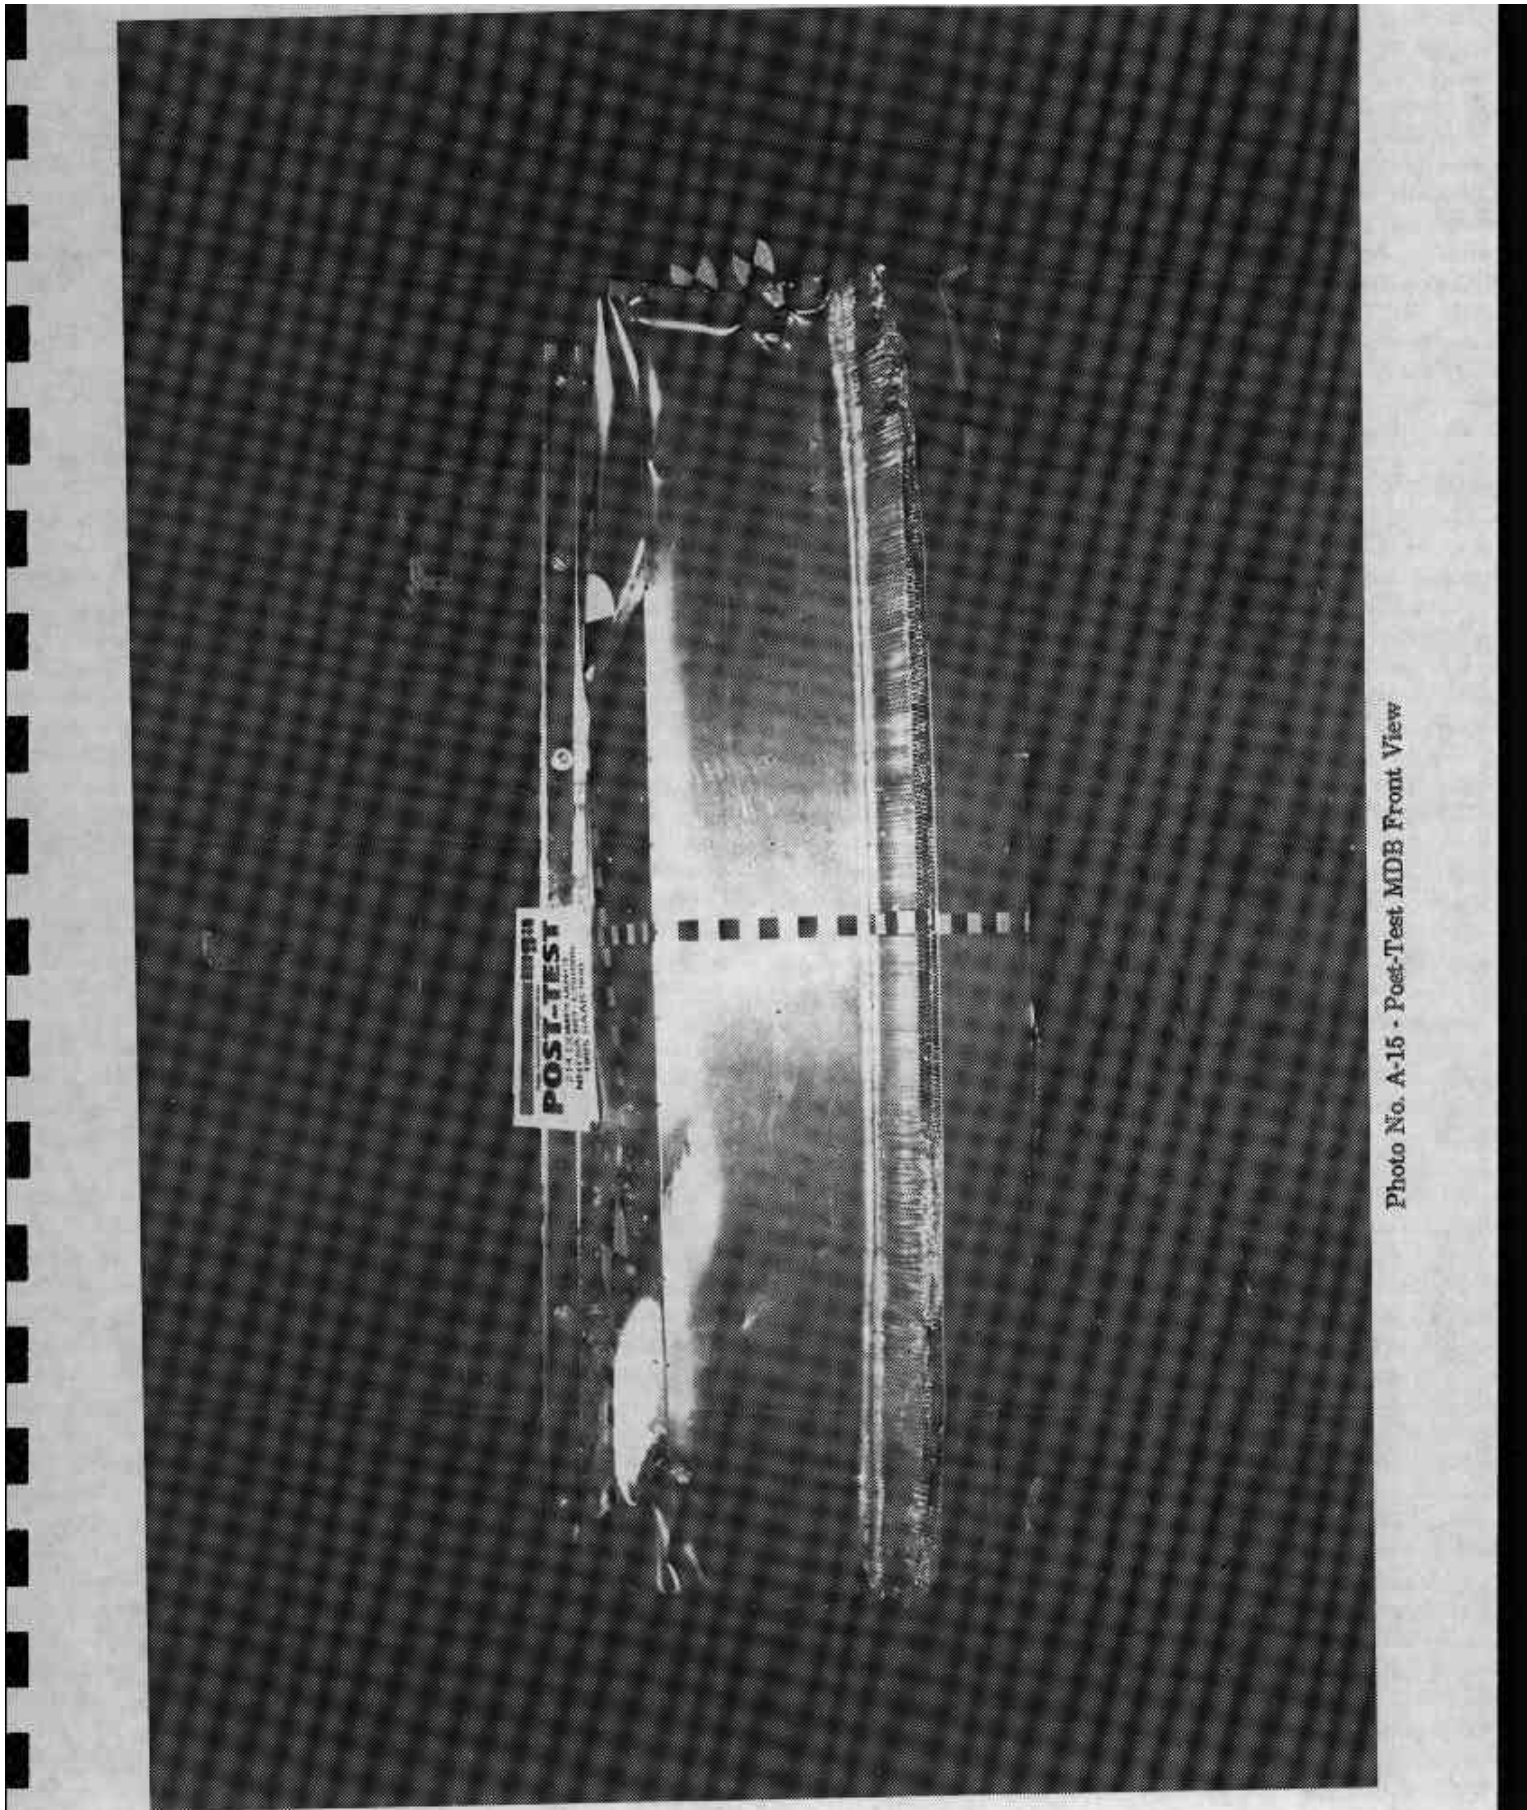
Photo No. A-15 - Post-Test MDE Front View

1.	Row A Top of Stack (33 in)	=	<u>100</u> mm
2.	Row B Mid Stack (27 in)	=	<u>81</u> mm
3.	Row C Top of Bumper (21 in)	=	<u>55</u> mm
4.	Row D Center of Bumper (17 in)	=	<u>90</u> mm

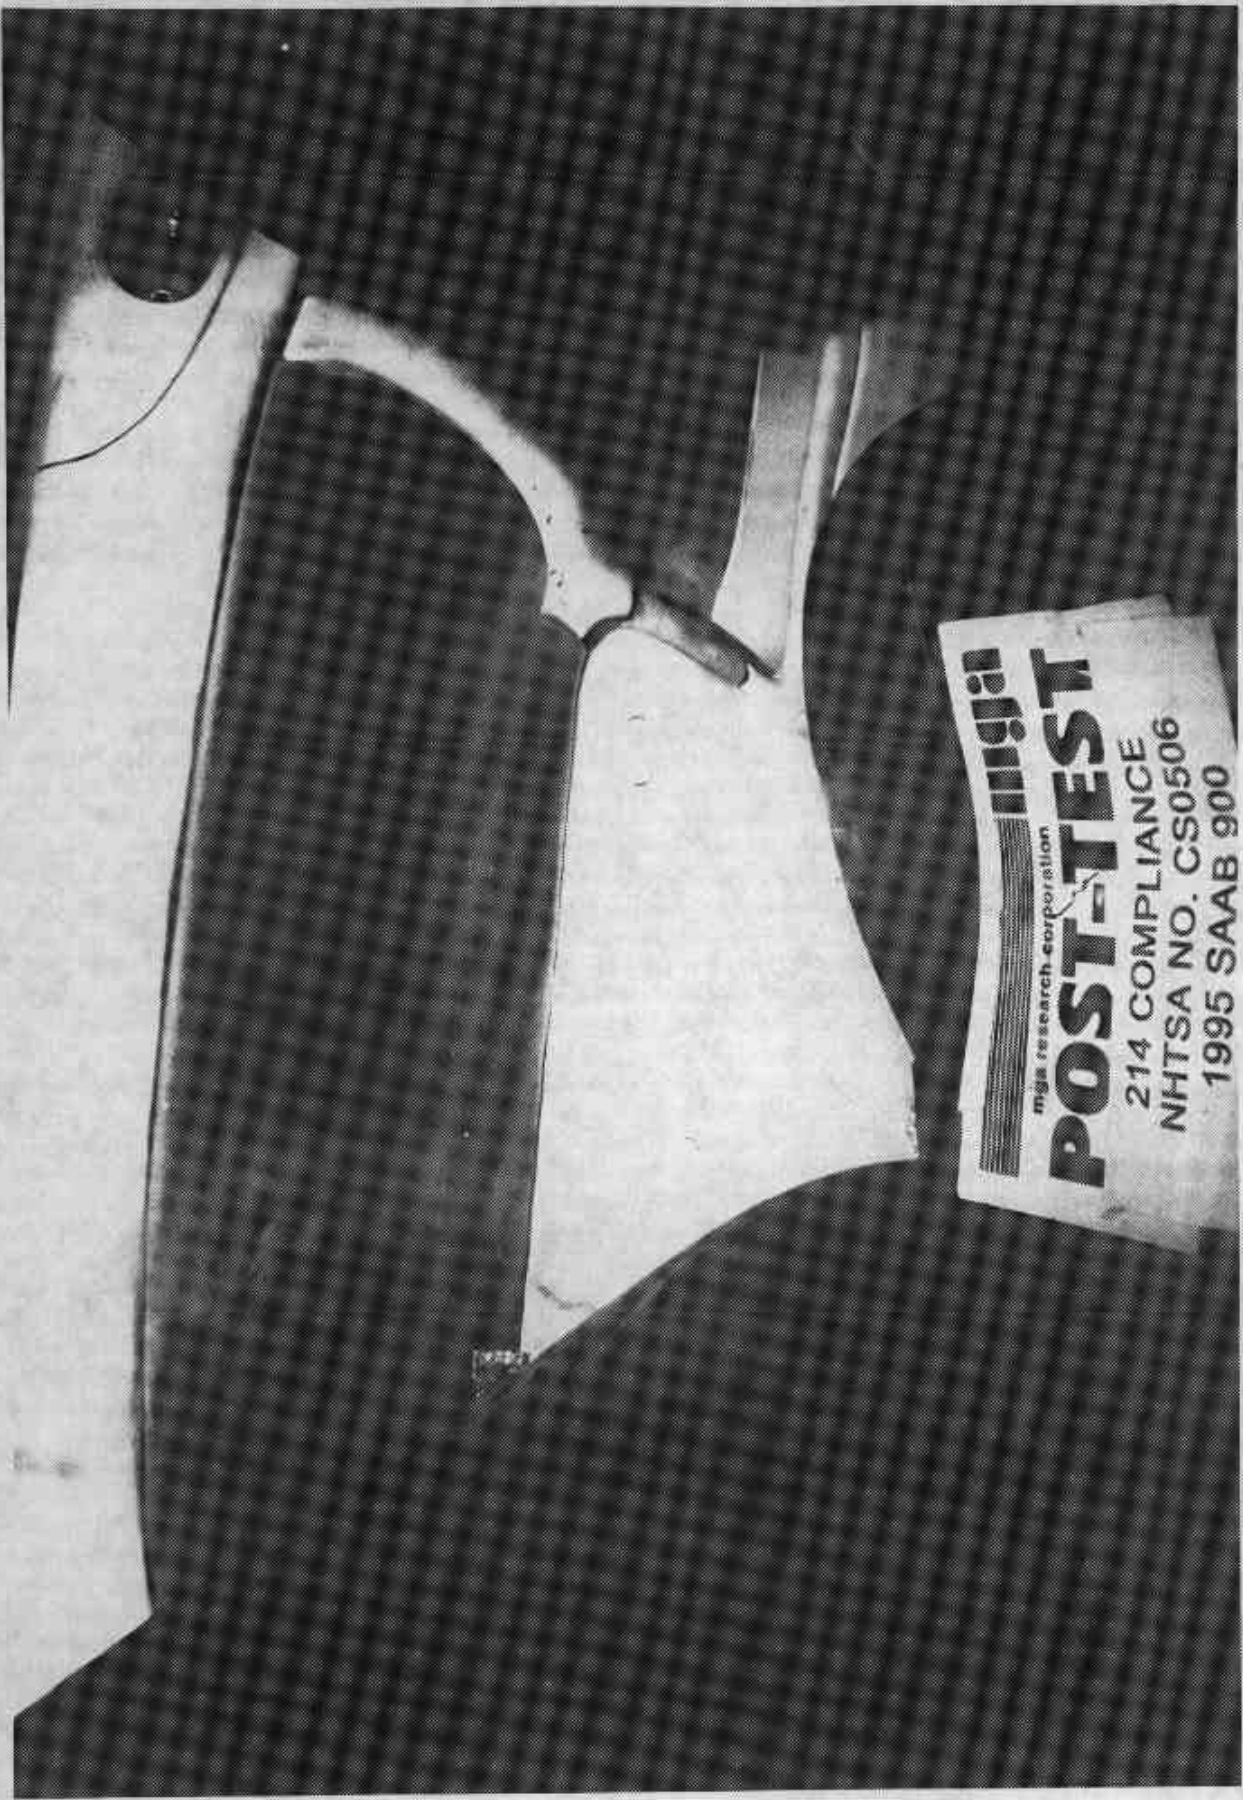
Photo No. A-27 - Post-Test Driver Dummy Contact

<u>LEFT FRONT SID</u>	<u>LEFT REAR SID</u>
Head	<u>to shoulder belt and shoulder</u>	<u>to soft top</u>
Arm	<u>to door</u>	<u>to C post</u>
Pelvis	<u>to armrest</u>	<u>to armrest</u>
Left Knee	<u>to armrest</u>	<u>to armrest and window</u>
Right Knee	<u>to left knee</u>	<u>to left knee</u>

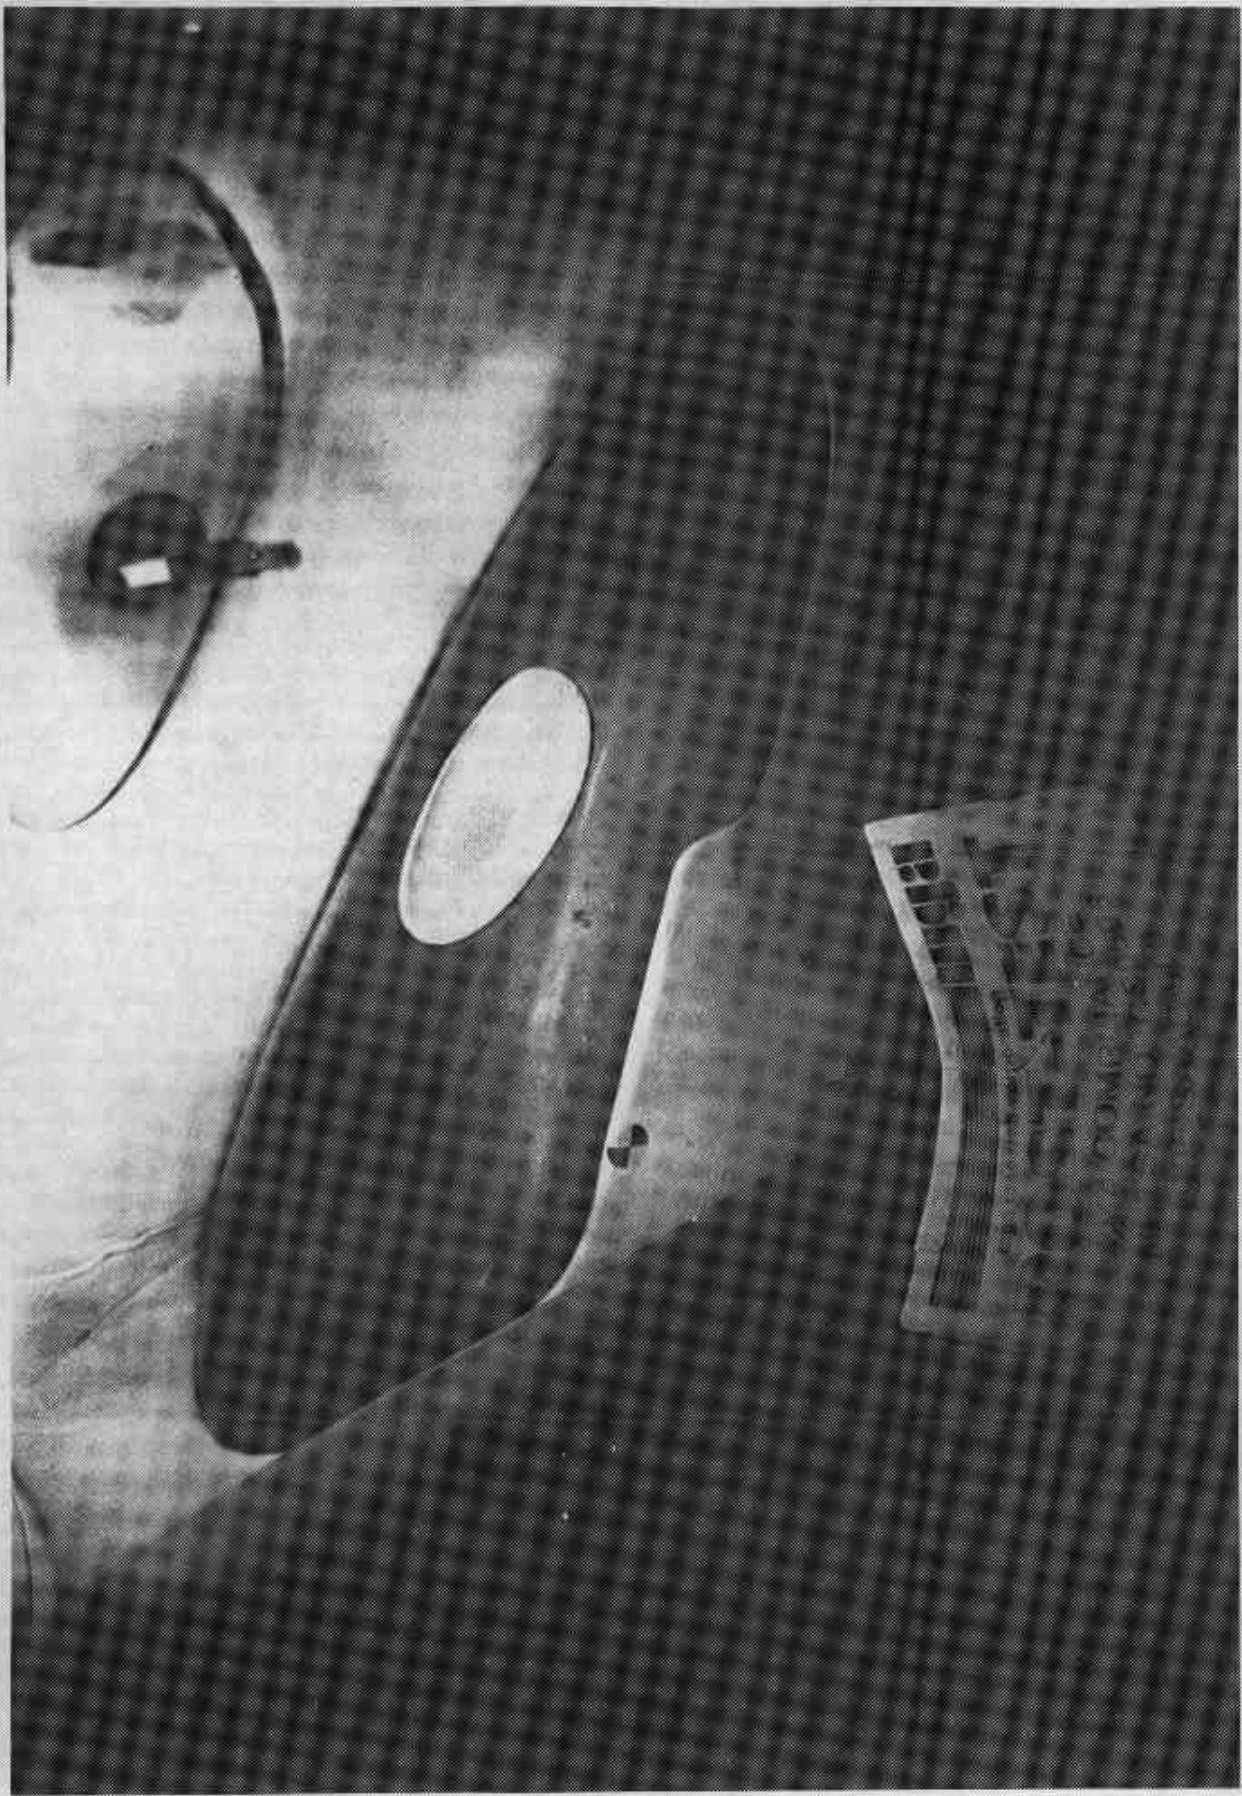
Photo No. A-94 - Post-Test Passenger Dummy Contact

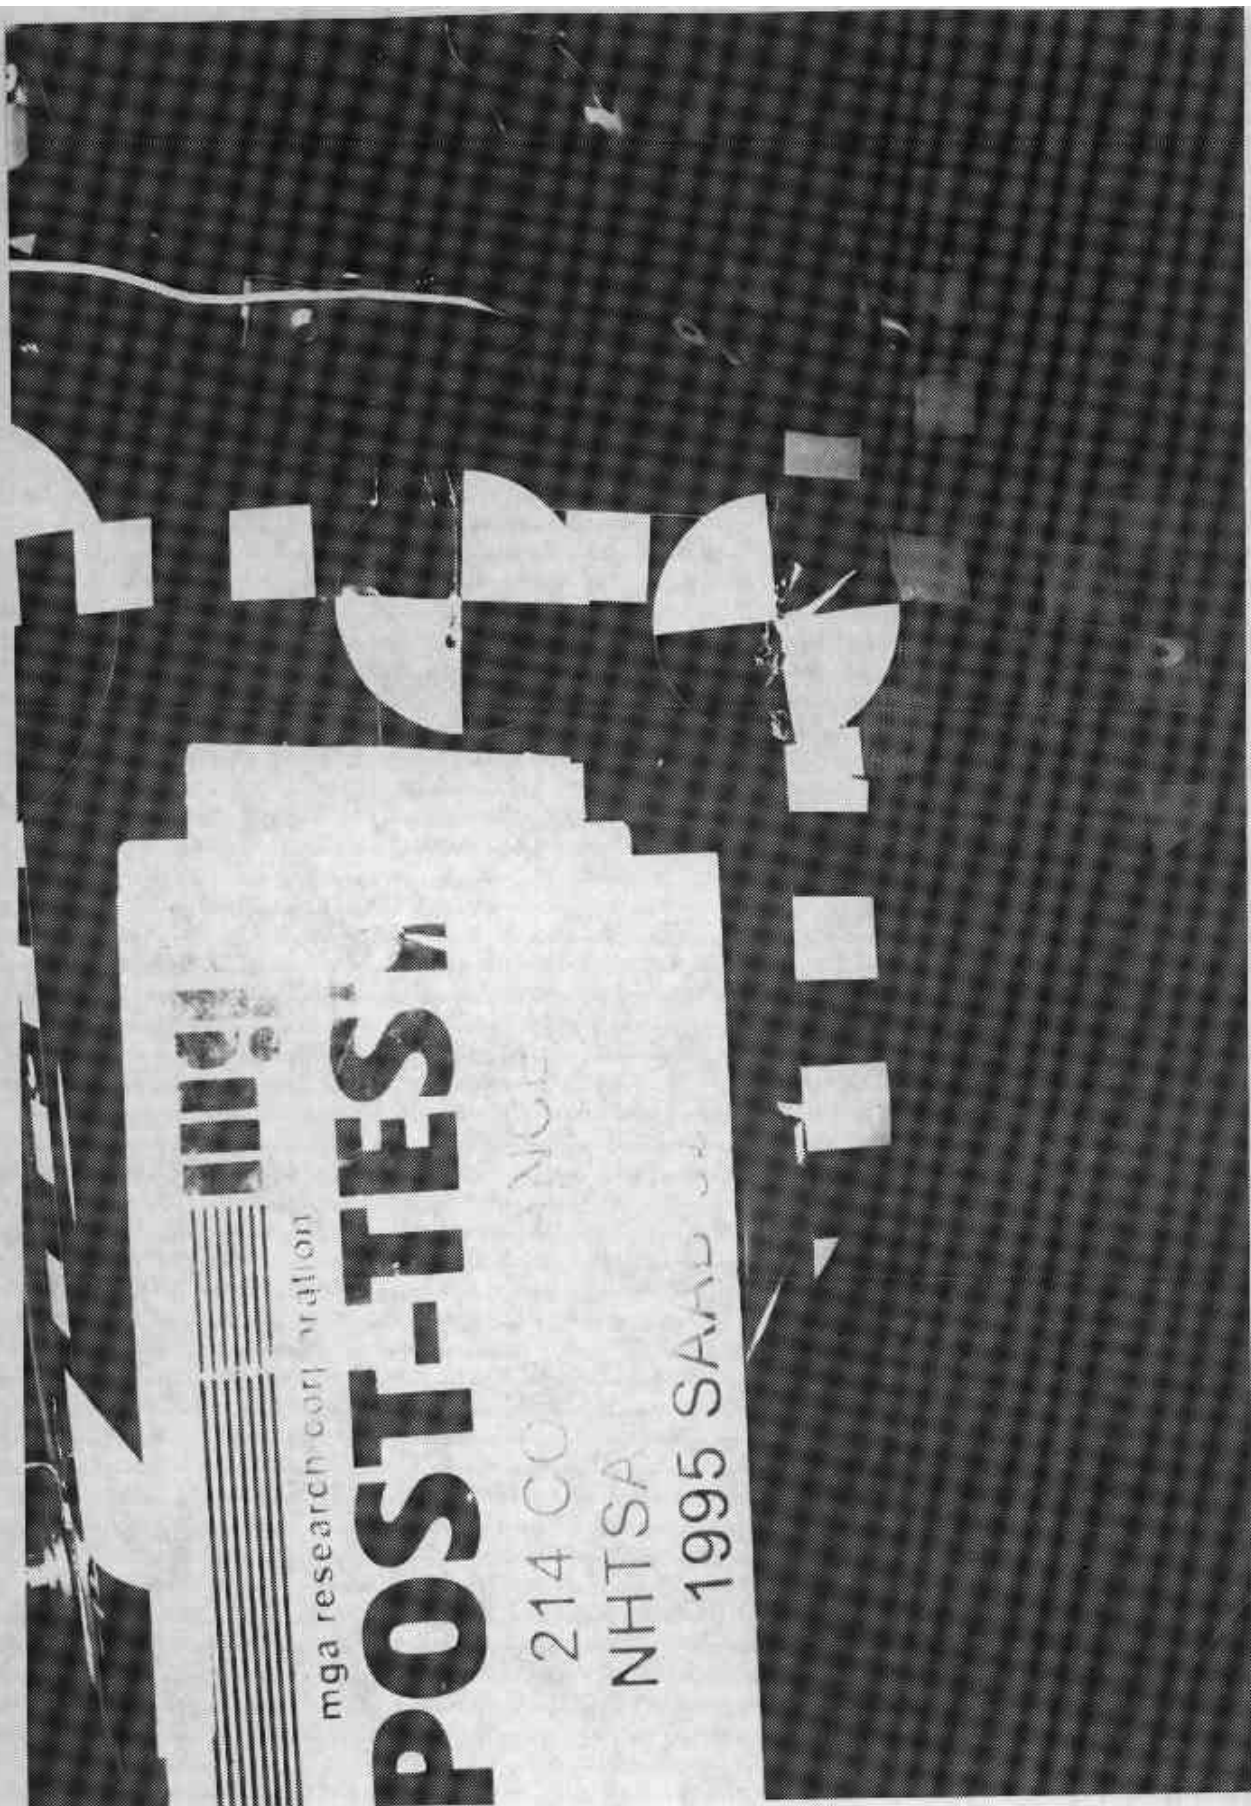
Photo No. A-35 - Left Front Impact Point on Vehicle

Impact Point is 14.2 in (360 mm) rearward of front axle centerline

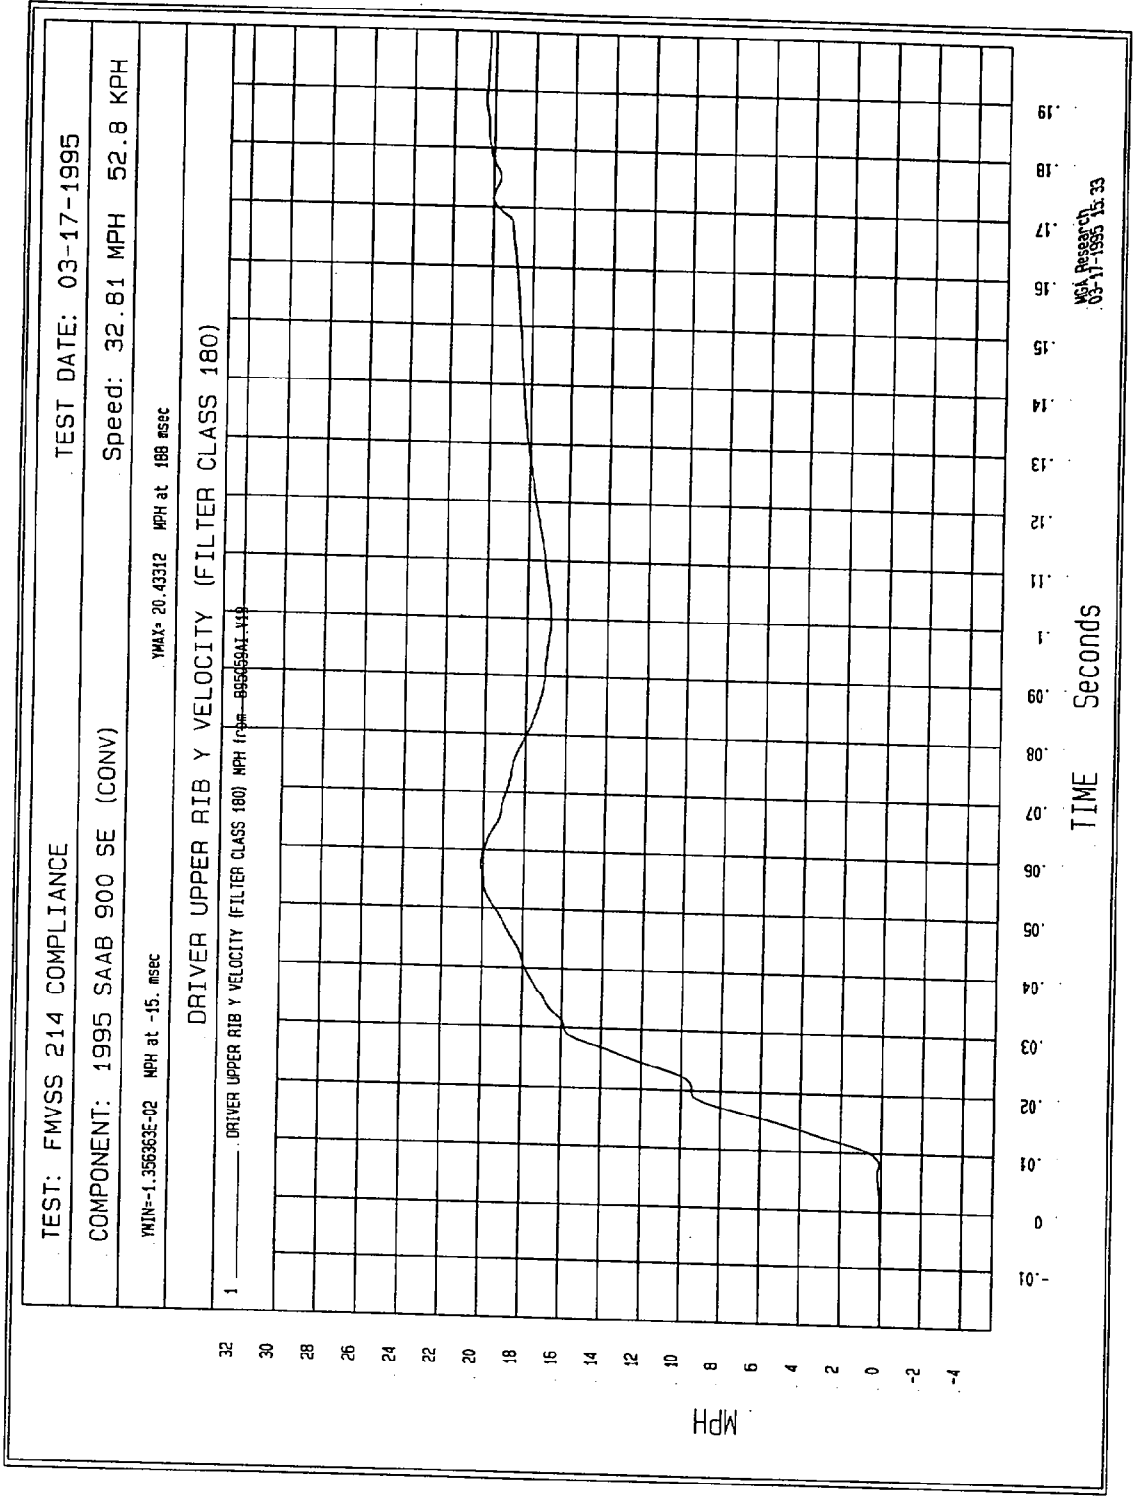
Figure B-2 - Driver Upper Rib Y Velocity vs. Time

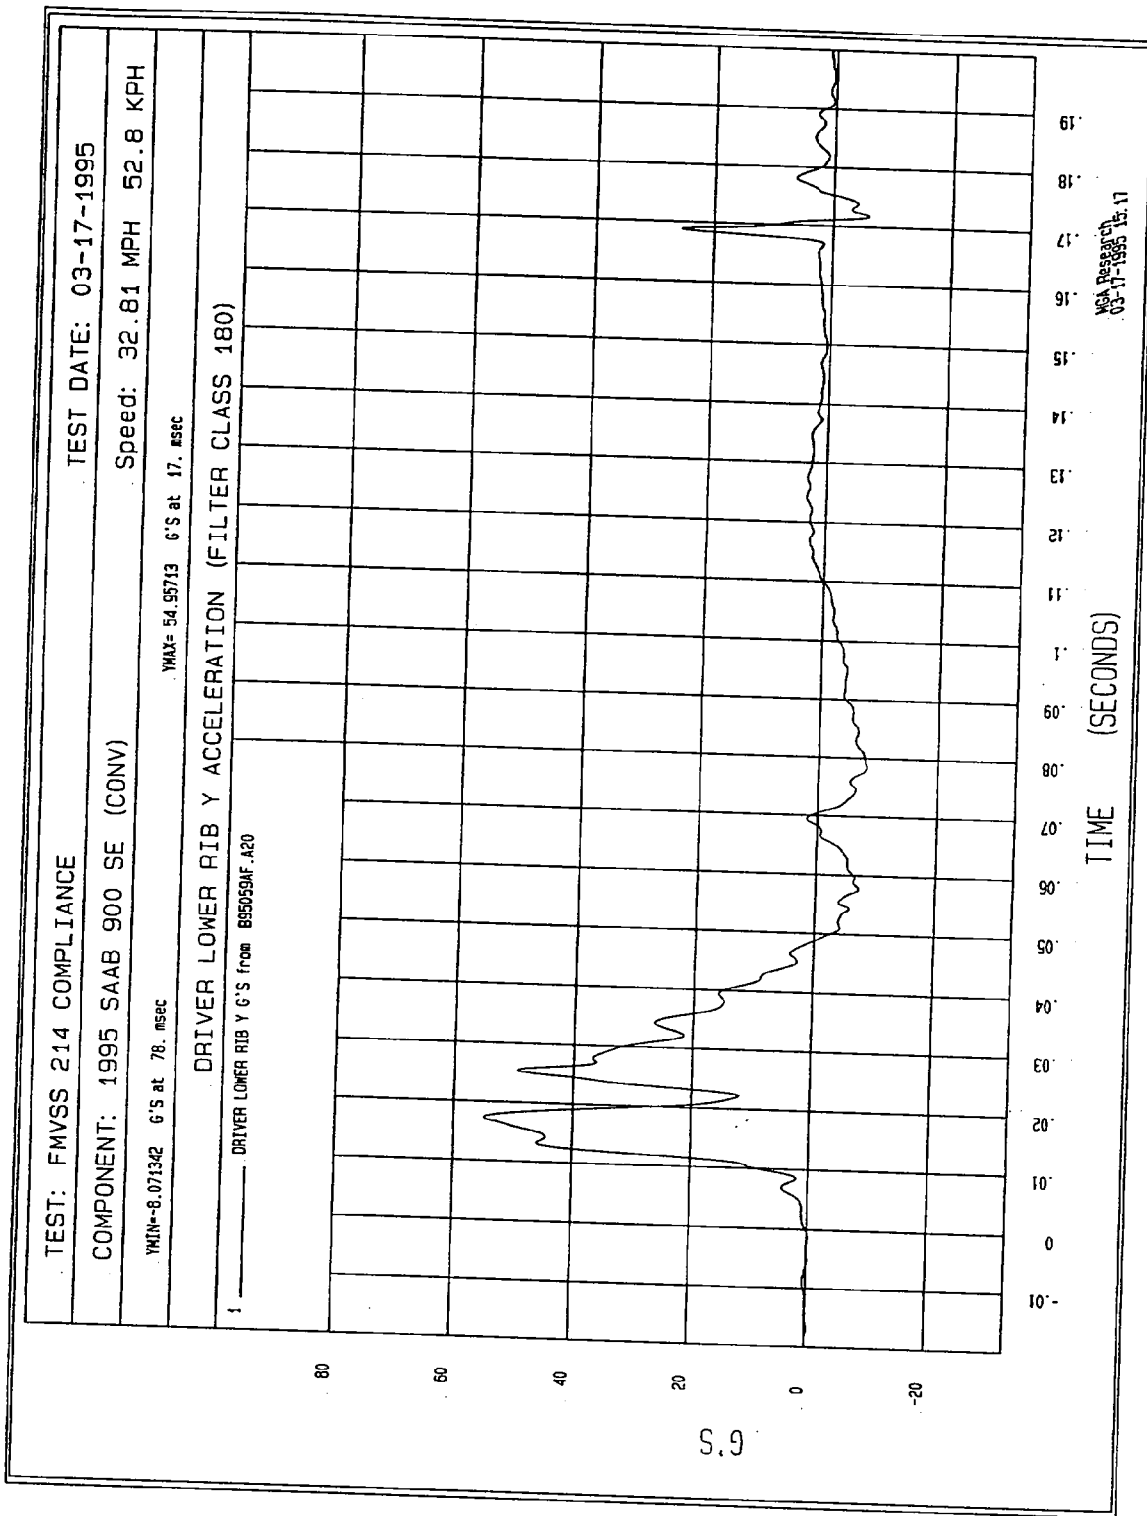
Figure B-3 - Driver Lower Rib Y Acceleration vs. Time

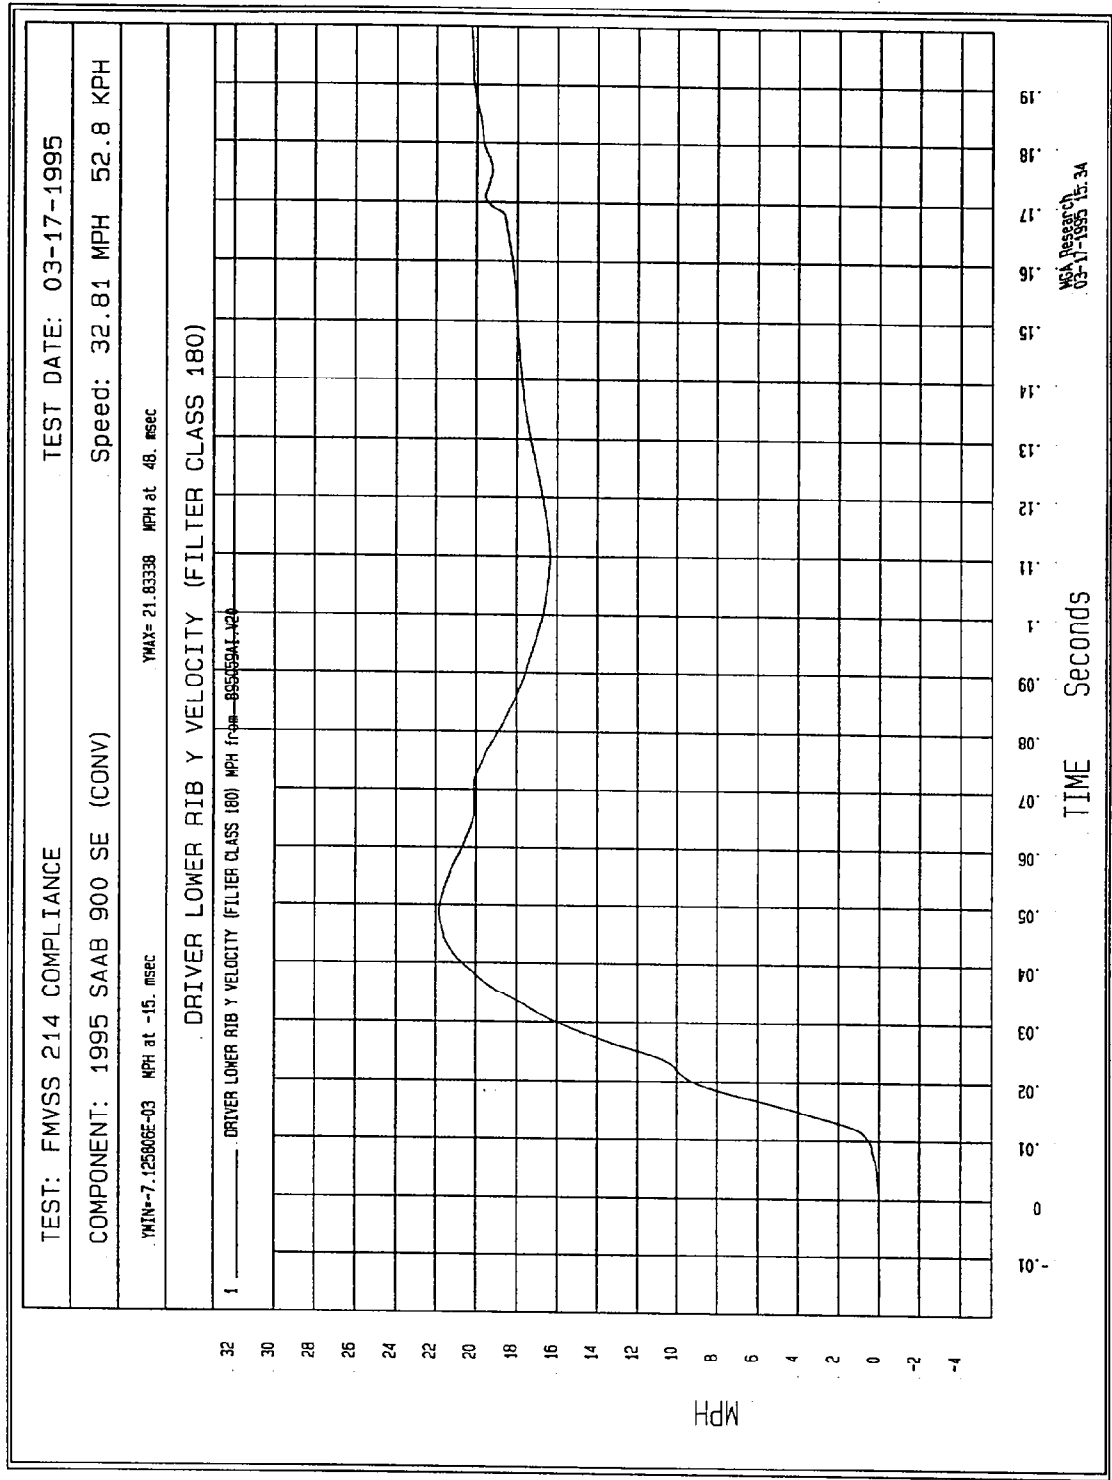
Figure B-4 - Driver Lower Rib Y Velocity vs. Time

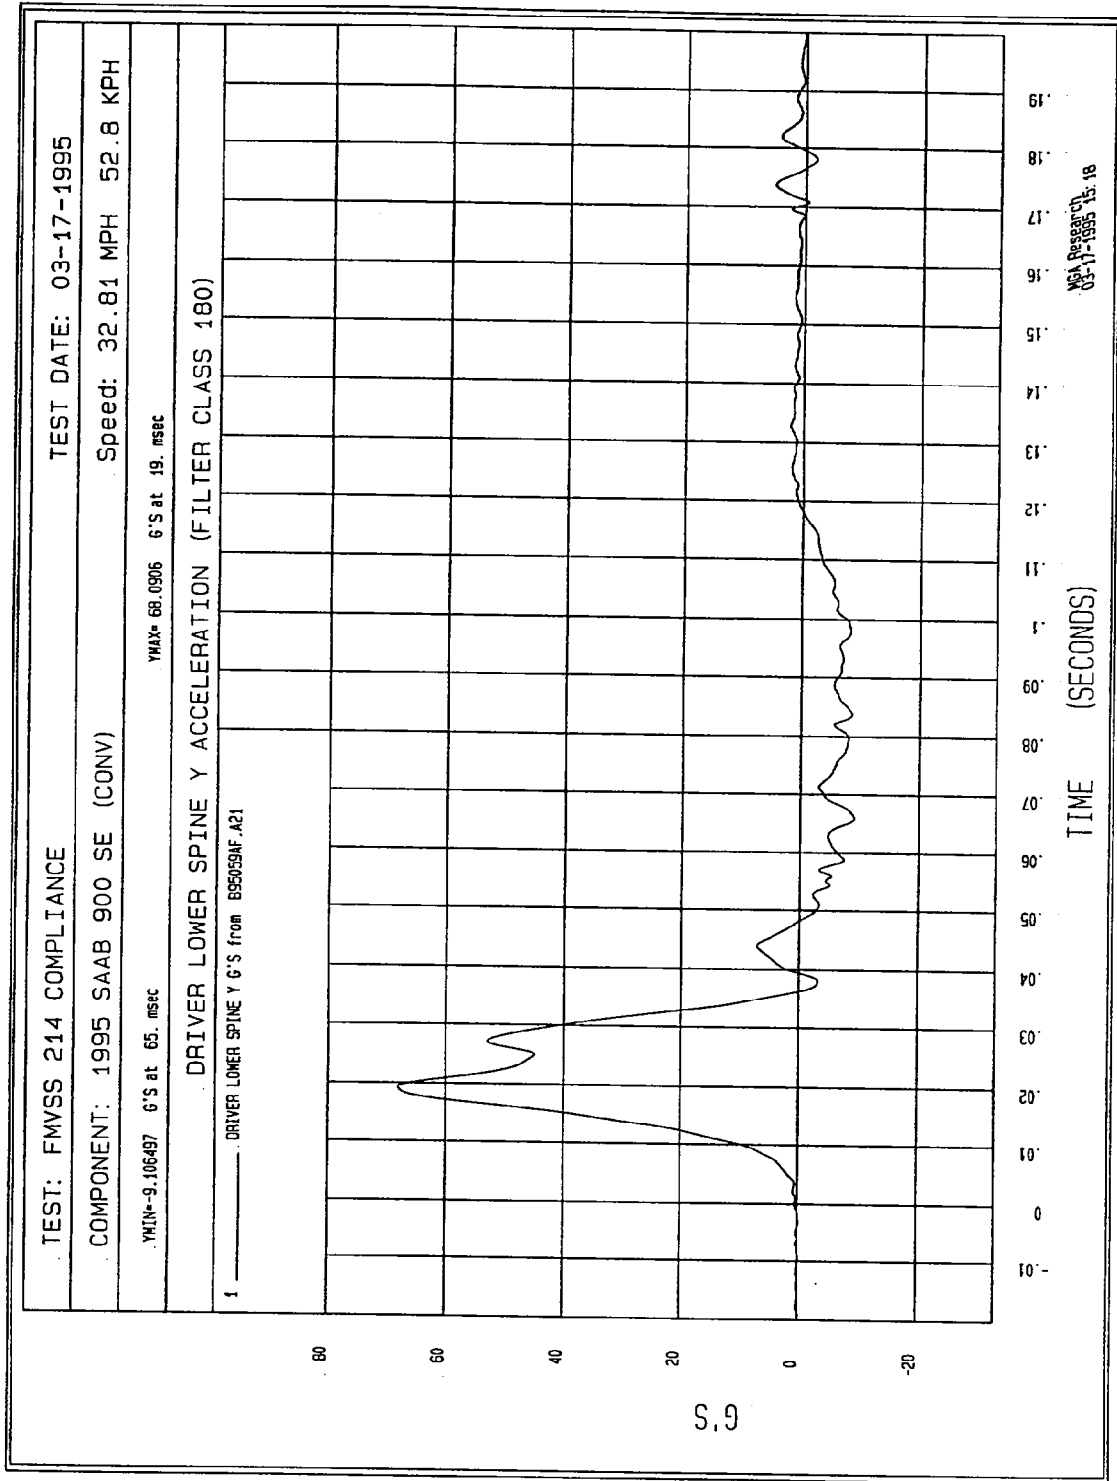
Figure B-5 - Driver Lower Spine Y Acceleration vs. Time
