REPORT NO. MGA-95-21418

SAFETY COMPLIANCE TESTING FOR FMVSS 214

"SIDE IMPACT PROTECTION - PASSENGER CARS"

1995 SAAB 900 SE CONVERTIBLE
NHTSA NO. CS0506

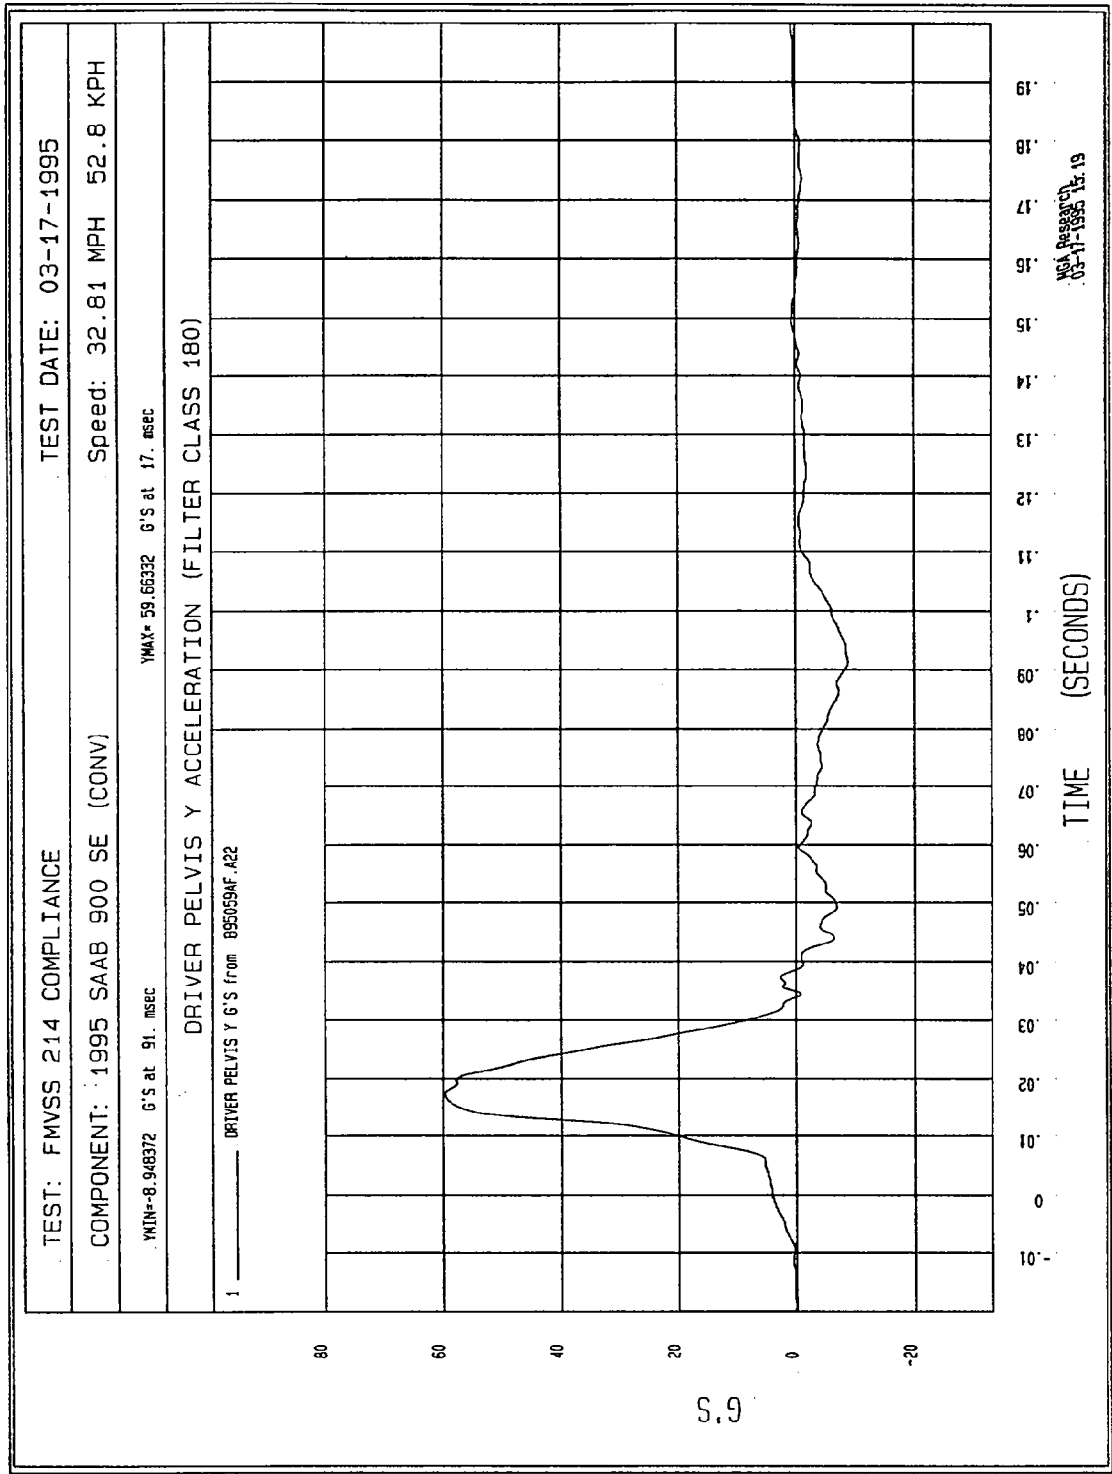
Figure B-7 - Driver Pelvis Y Acceleration vs. Time

The driver's Thoracic Trauma Index (TTI) was 59 g's. Maximum pelvic Y acceleration was 55 g's.

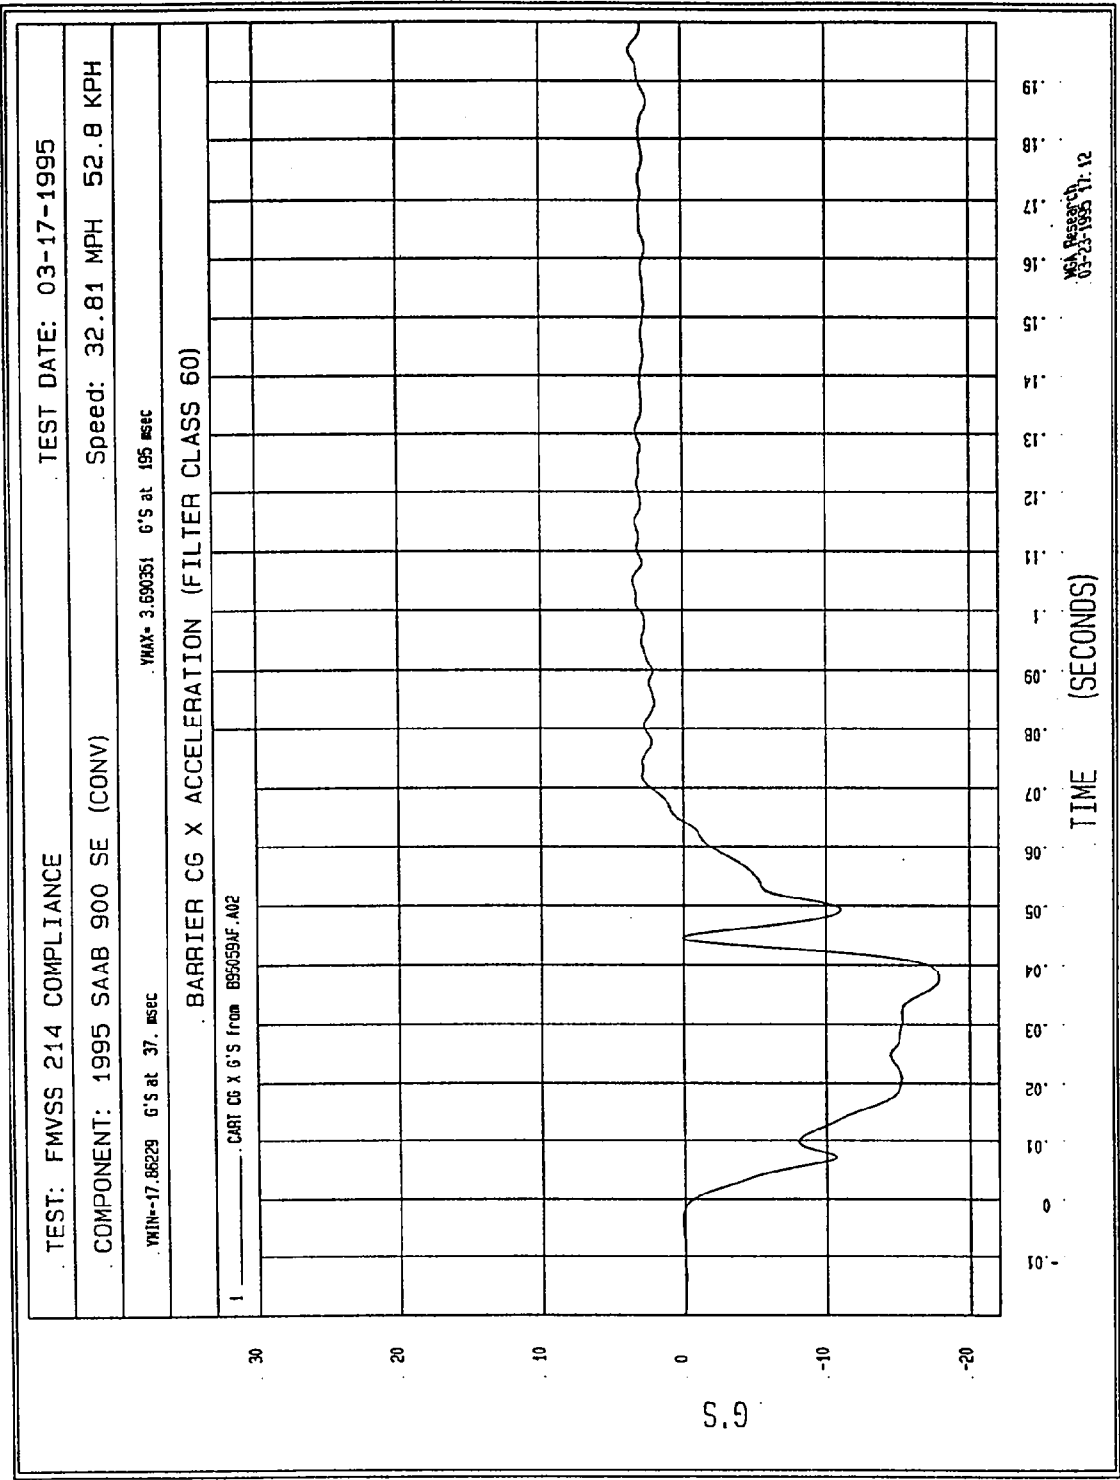
Figure B-52 - Moving Barrier Center of Gravity X Acceleration vs. Time

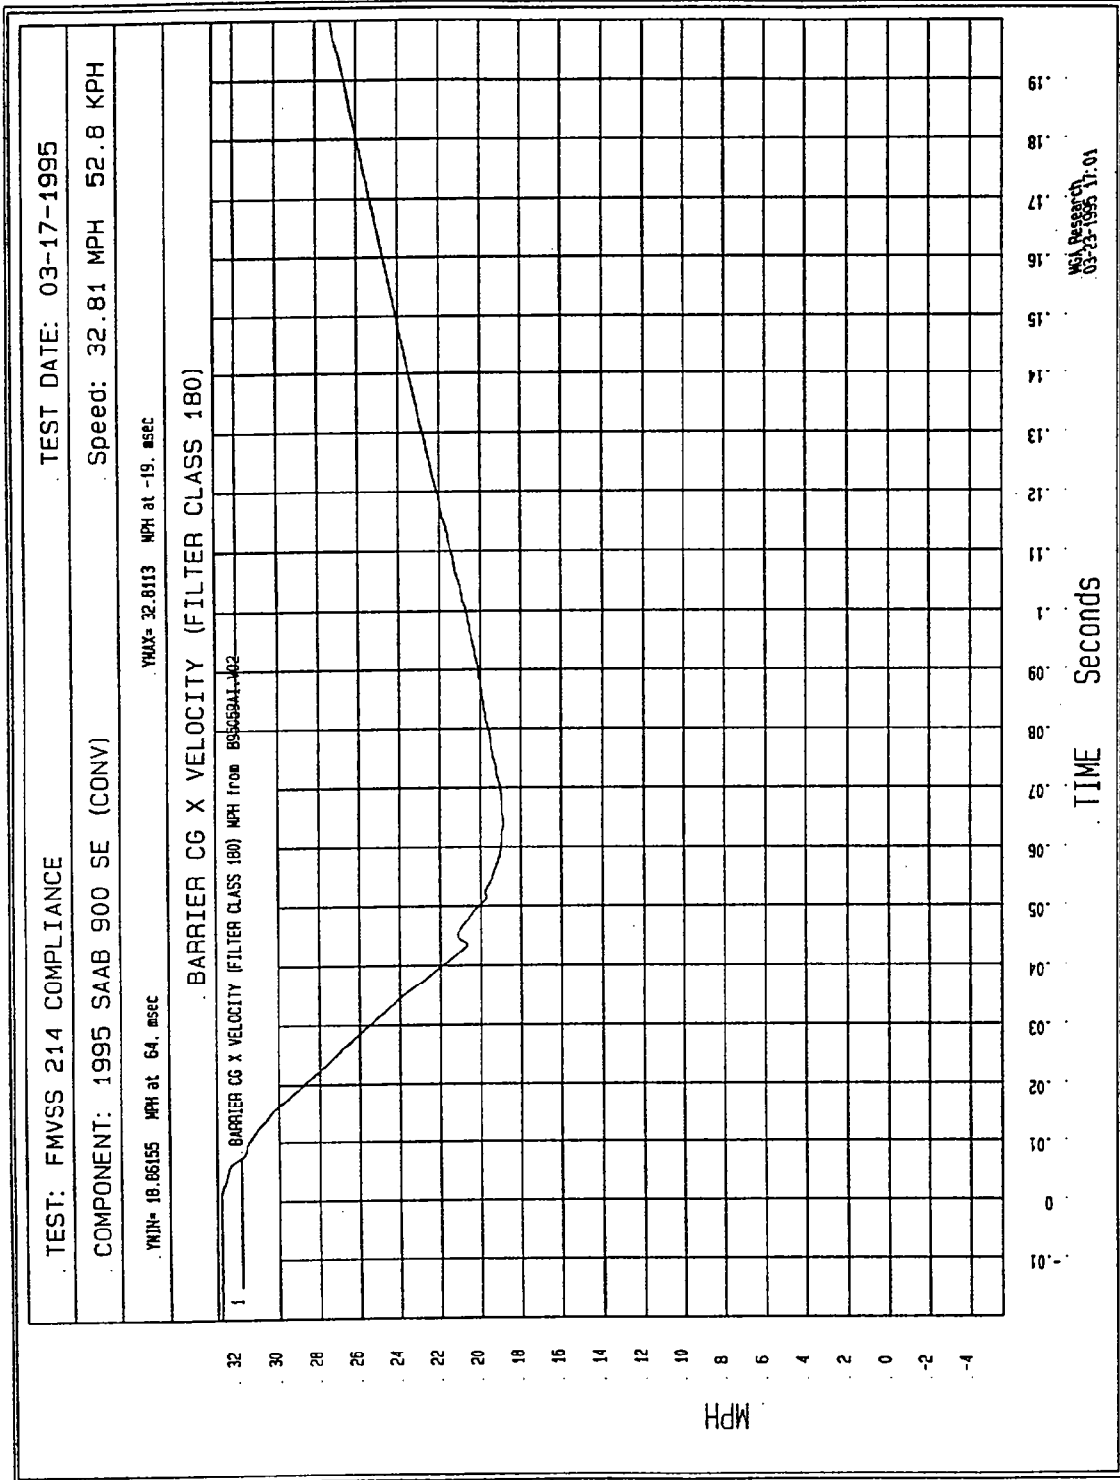
Figure B-53 - Moving Barrier Center of Gravity X Velocity vs. Time
