REPORT NO. 208-MGA-95-11  
212-MGA-95-11  
301-MGA-95-11

VEHICLE SAFETY COMPLIANCE TESTING  
FOR  
FMVSS 208, OCCUPANT CRASH PROTECTION  
FMVSS 212, WINDSHIELD MOUNTING  
FMVSS 219, WINDSHIELD INTRUSION (PARTIAL)  
FMVSS 301, FUEL SYSTEM INTEGRITY

CHRYSLER CORPORATION  
1995 DODGE RAM 2500 VAN  
NHTSA NO. CS0314

MGA RESEARCH CORPORATION  
5000 WARREN ROAD  
BURLINGTON, WI 53105

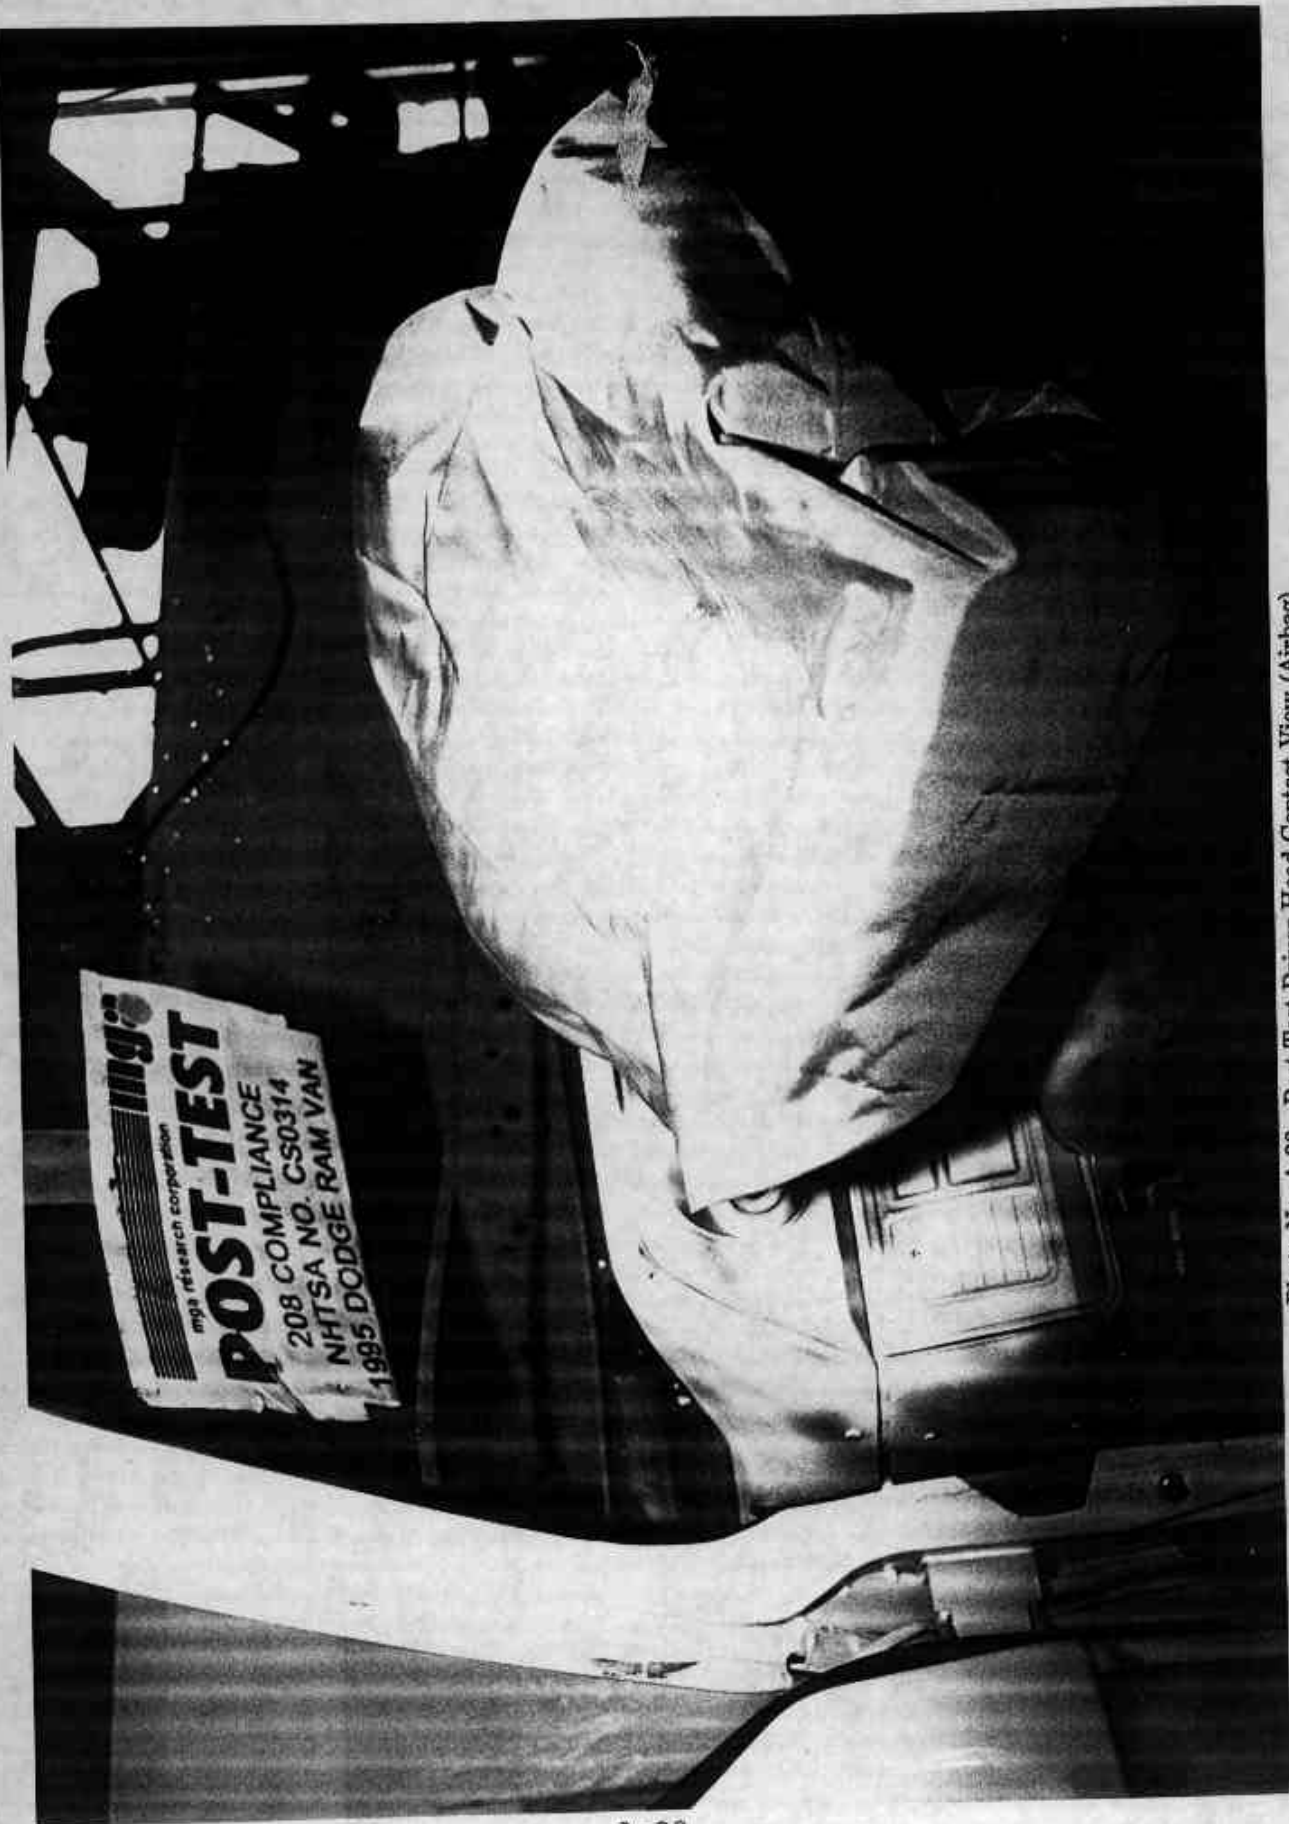
Photo No. A-33 - Post-Test Driver Head Contact View (Airbag)

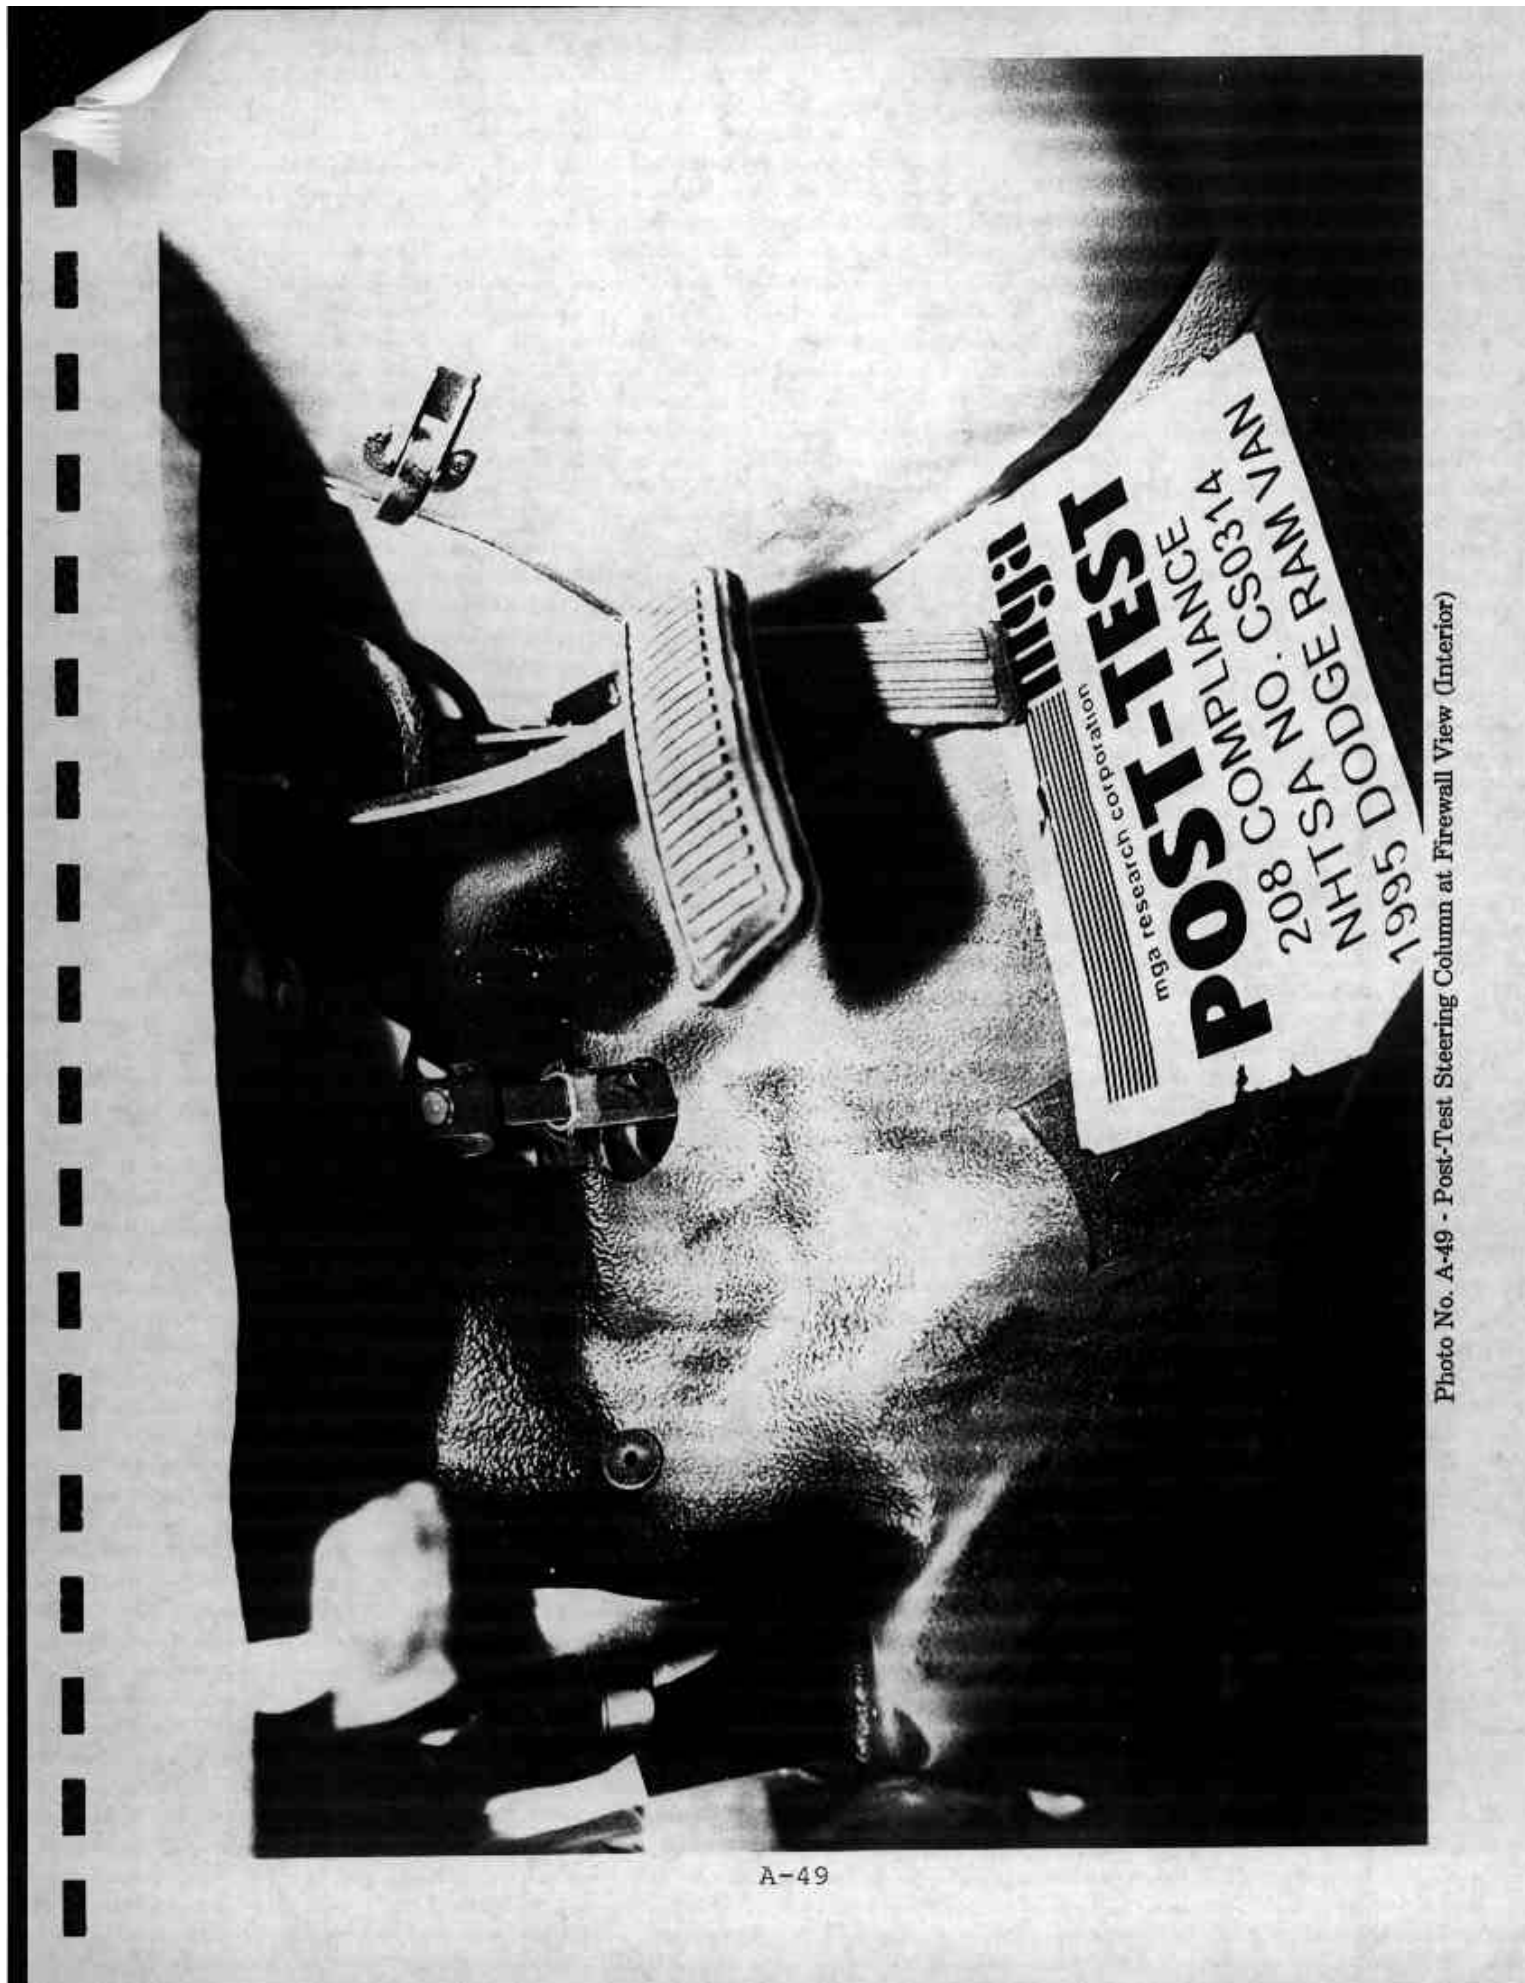
Photo No. A-49 - Post-Test Steering Column at Firewall View (Interior)
