REPORT NO.: 214-MGA-96-002  
SAFETY COMPLIANCE TESTING FOR  
FMVSS 214 "SIDE IMPACT PROTECTION -  
PASSENGER CARS"

GENERAL MOTORS CORPORATION  
1996 SATURN SL1 4 Door  
NHTSA NO: CT0100

MGA PROVING GROUNDS  
5000 WARREN ROAD  
BURLINGTON, WI 53105

FINAL REPORT

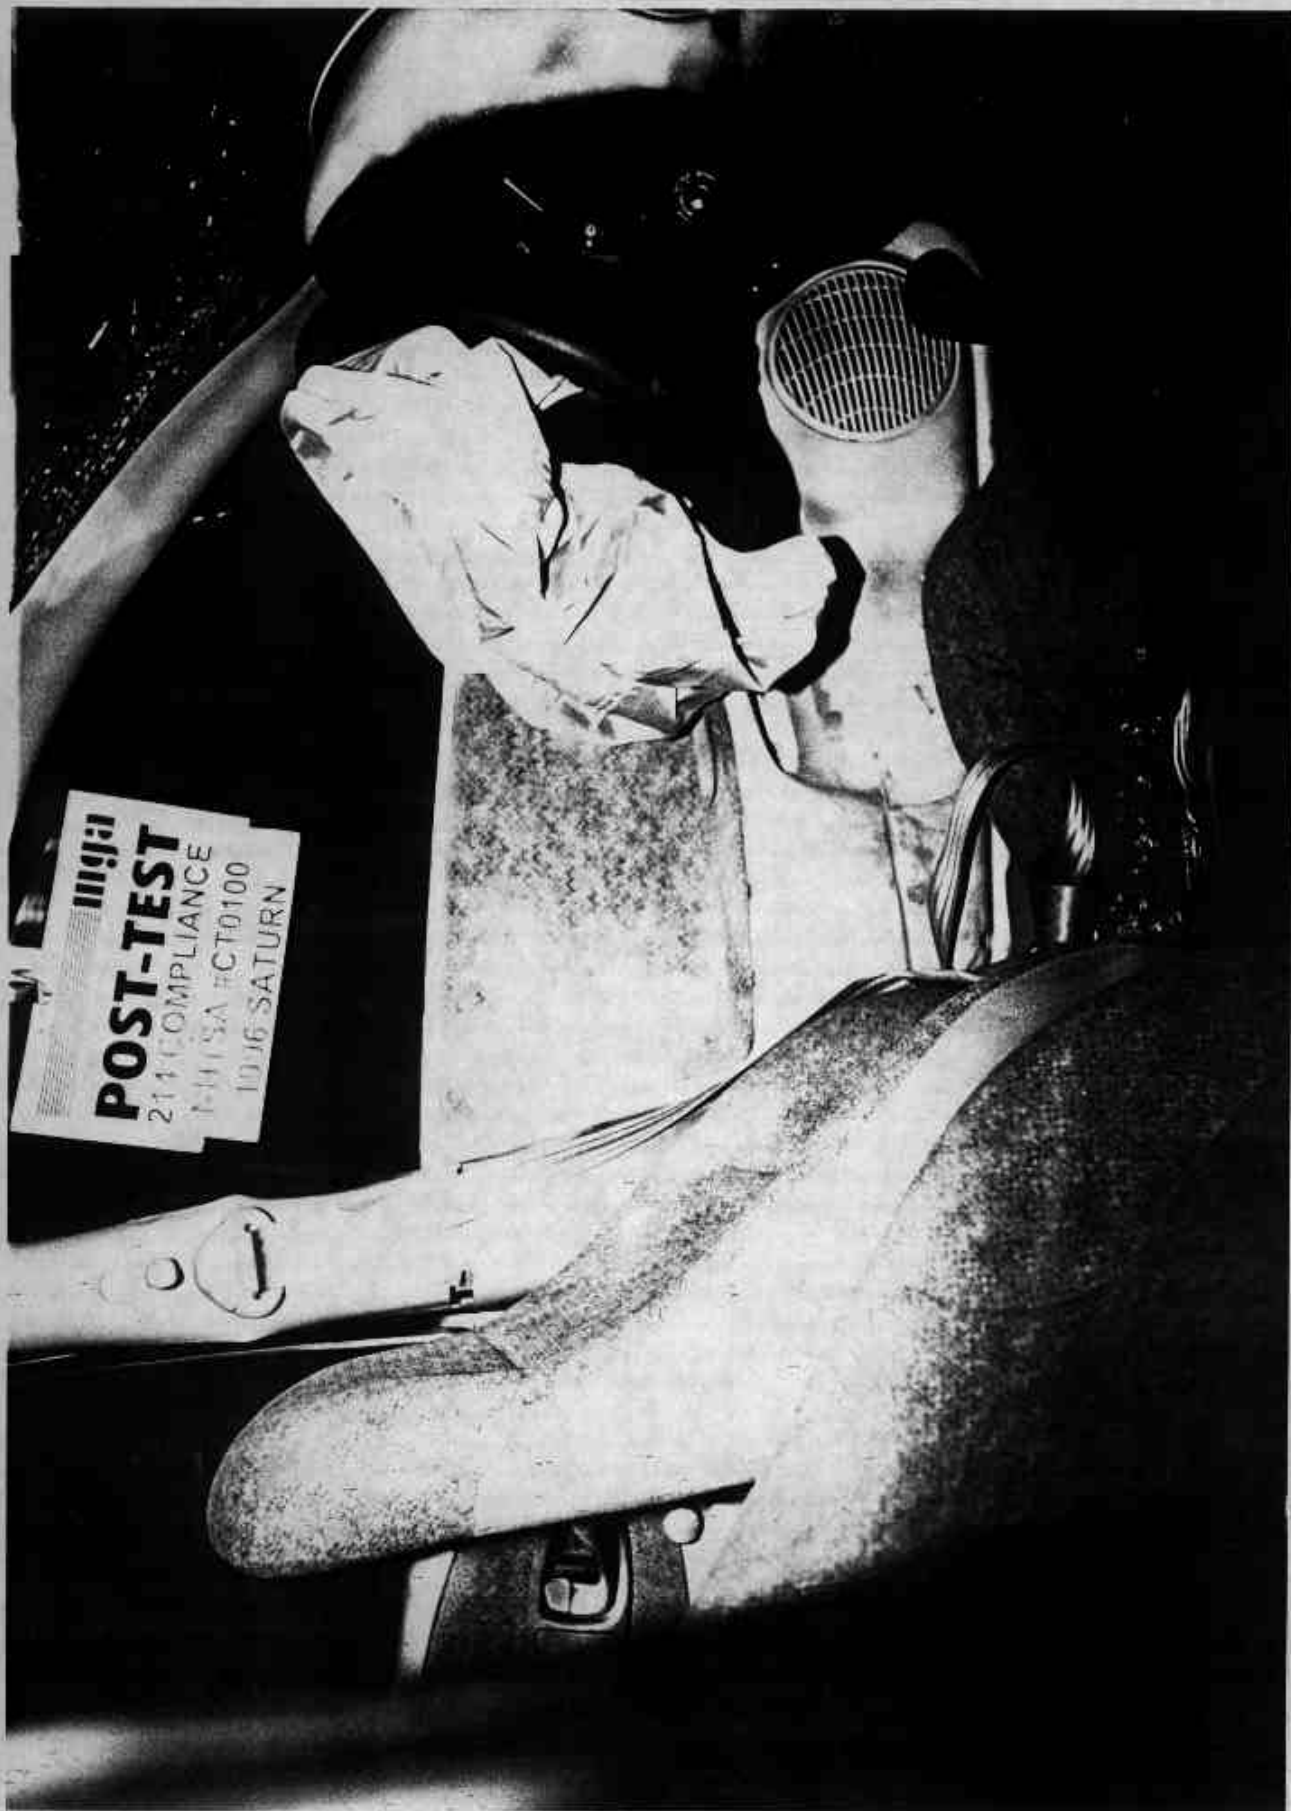
Photo No. A-28 - Post-Test Driver Dummy Contact

VISIBLE DUMMY CONTACT POINTS:

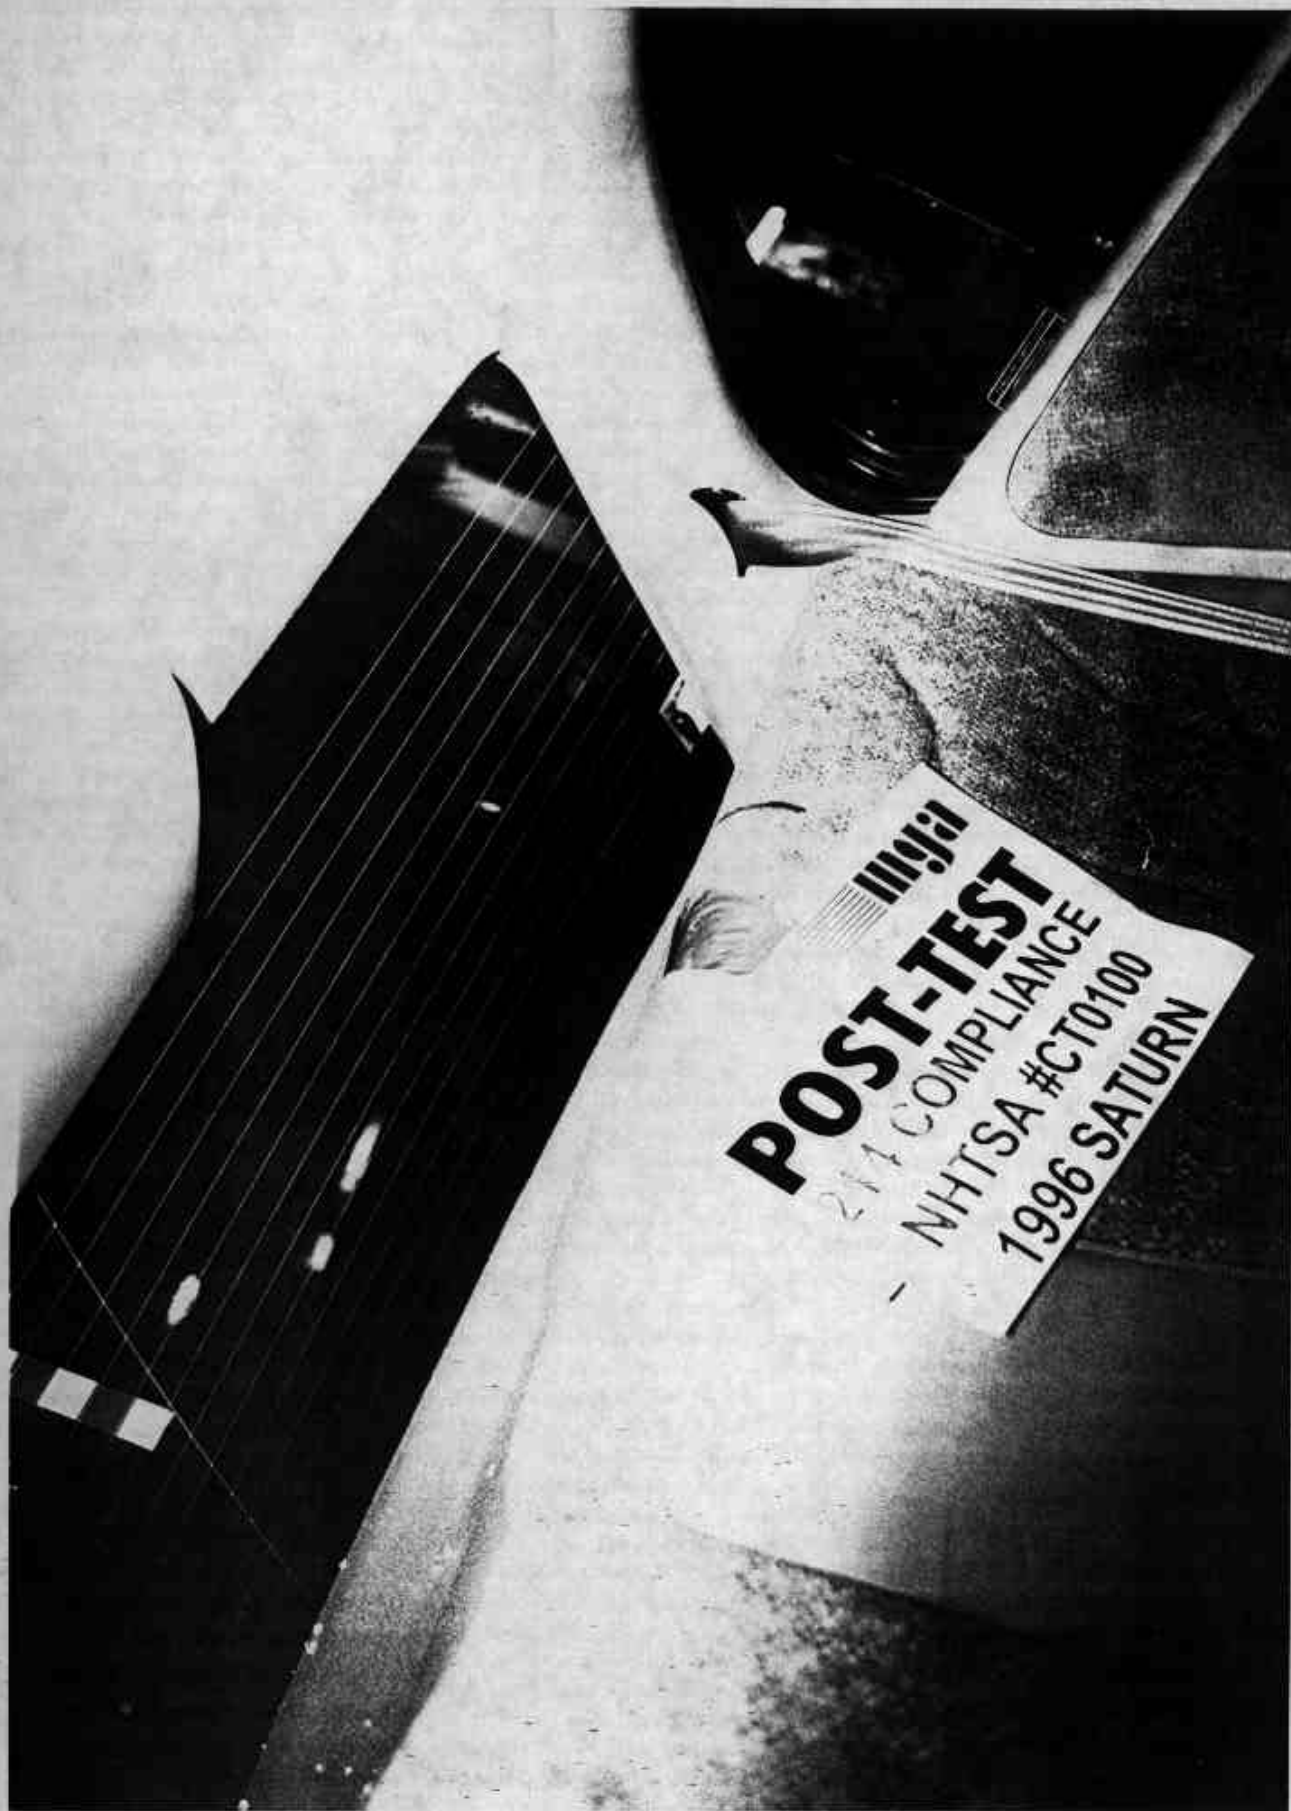
Photo No. A-36 - Post-Test Passenger Dummy Contact
