Vehicle Safety Compliance Testing  
for Occupant Crash Protection,  
Windshield Mounting, Windshield Zone Intrusion,  
and Fuel System Integrity

1996 Pontiac Bonneville

NHTSA Number: CT0103

Final Report

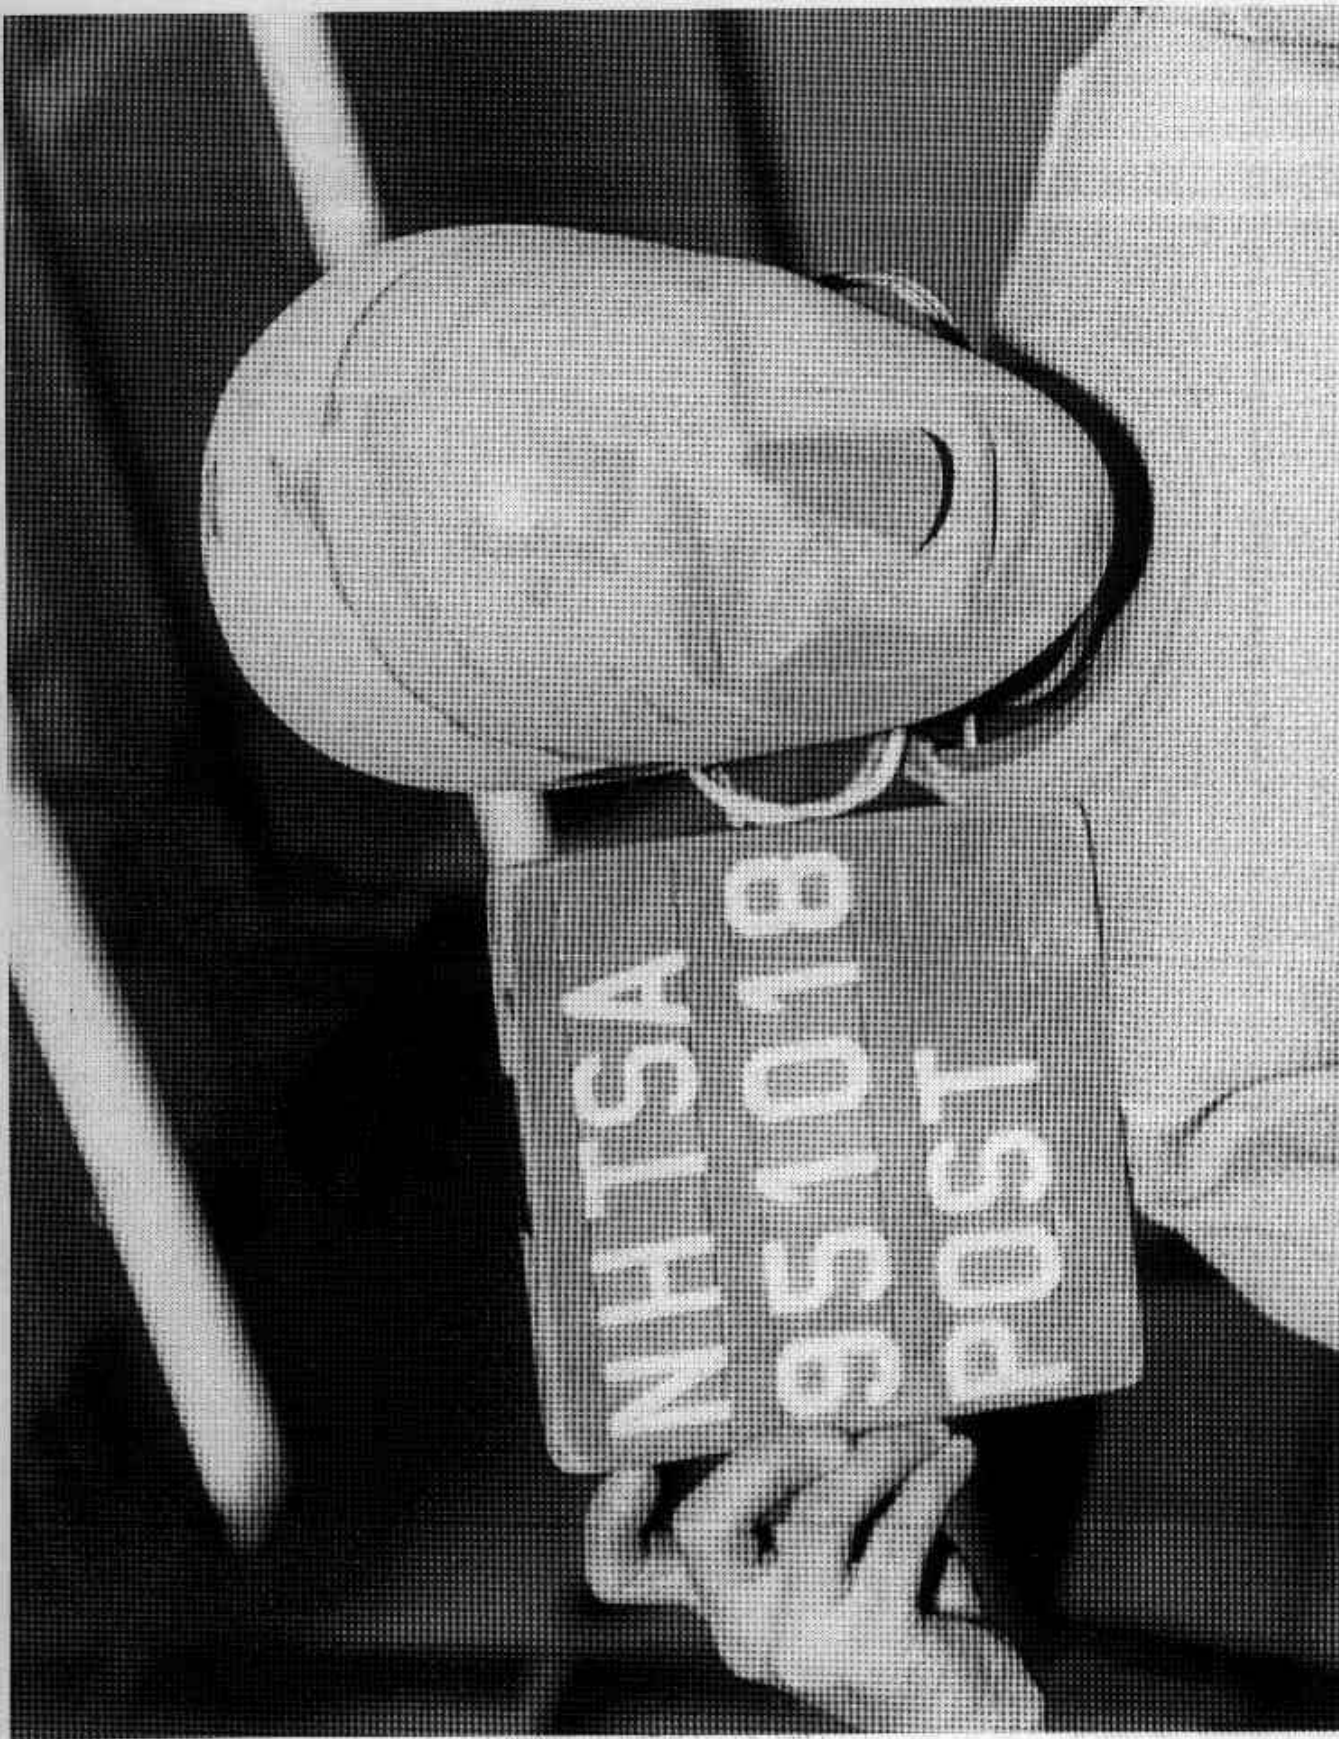
Figure A-17. Post-Test Driver Dummy Head Contact - View 1

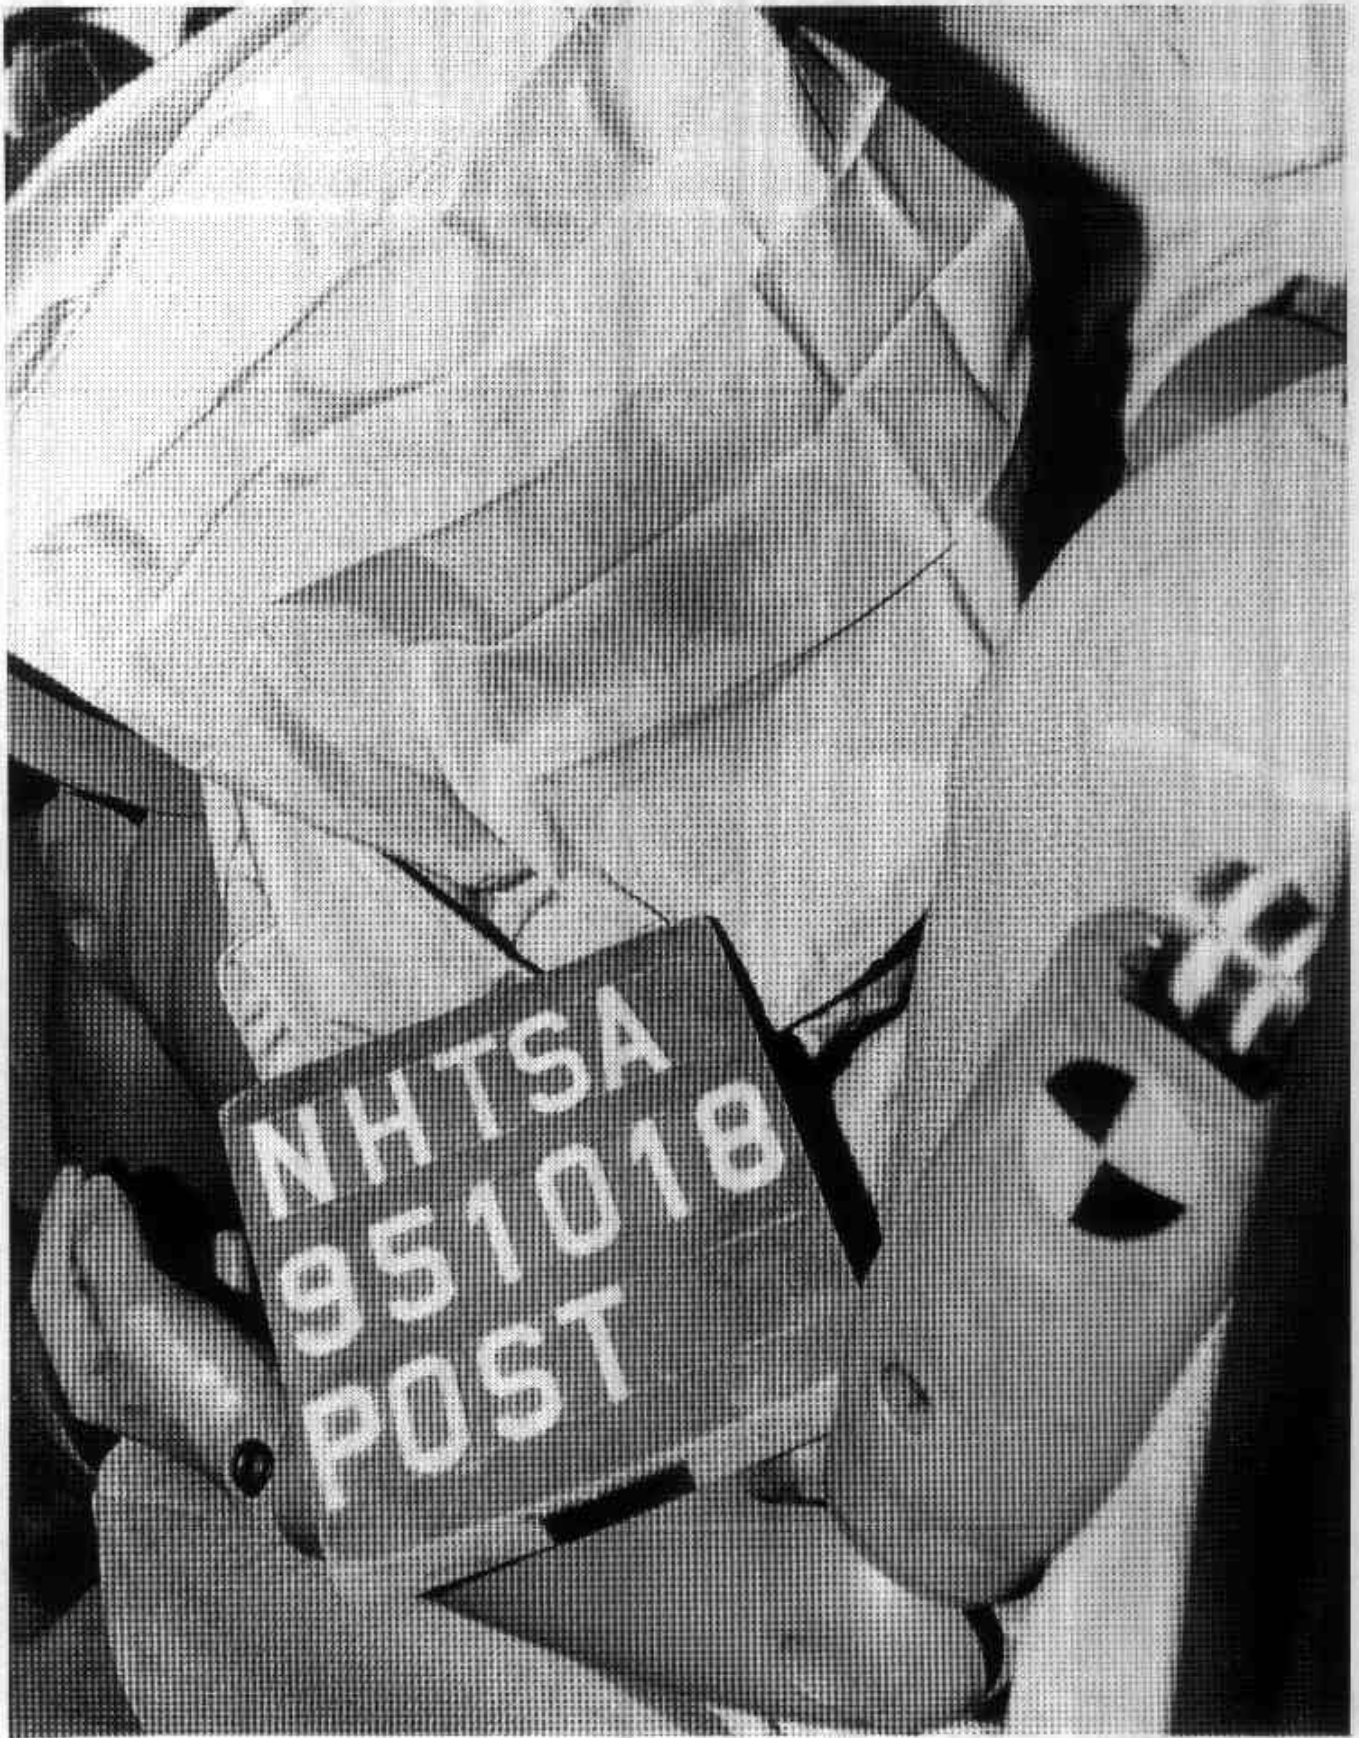
Figure A-18. Post-Test Driver Dummy Head Contact - View 2
