Vehicle Safety Compliance Testing  
for Occupant Crash Protection,  
Windshield Mounting, Windshield Zone Intrusion,  
and Fuel System Integrity

1996 Volvo 850

NHTSA Number: CT5900

TRC Test Number: 951116

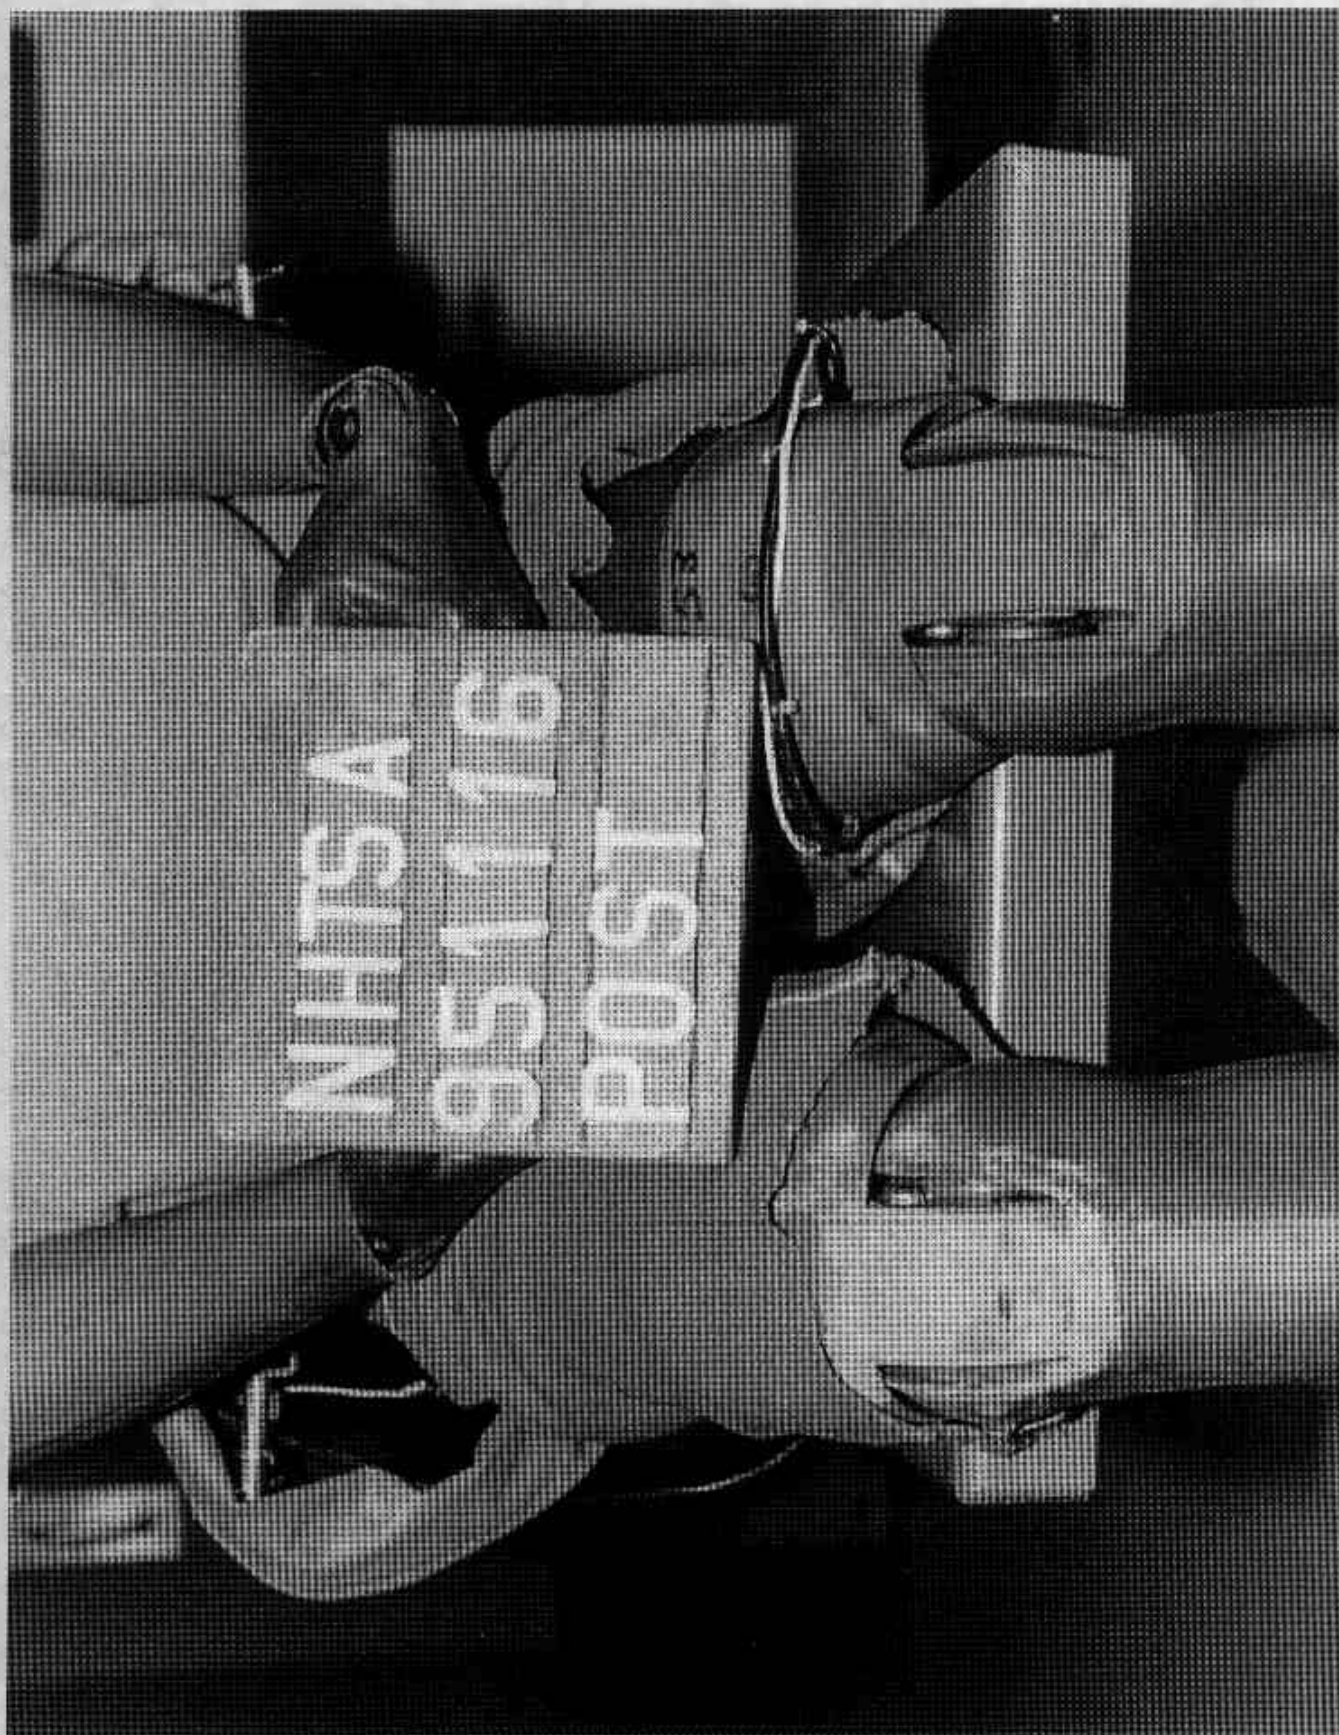
Figure A-23. Post-Test Driver Dummy Knee Contact - View 1

| Left knee: | Instrument panel | Instrument panel |
| Right knee: | Instrument panel | Instrument panel |

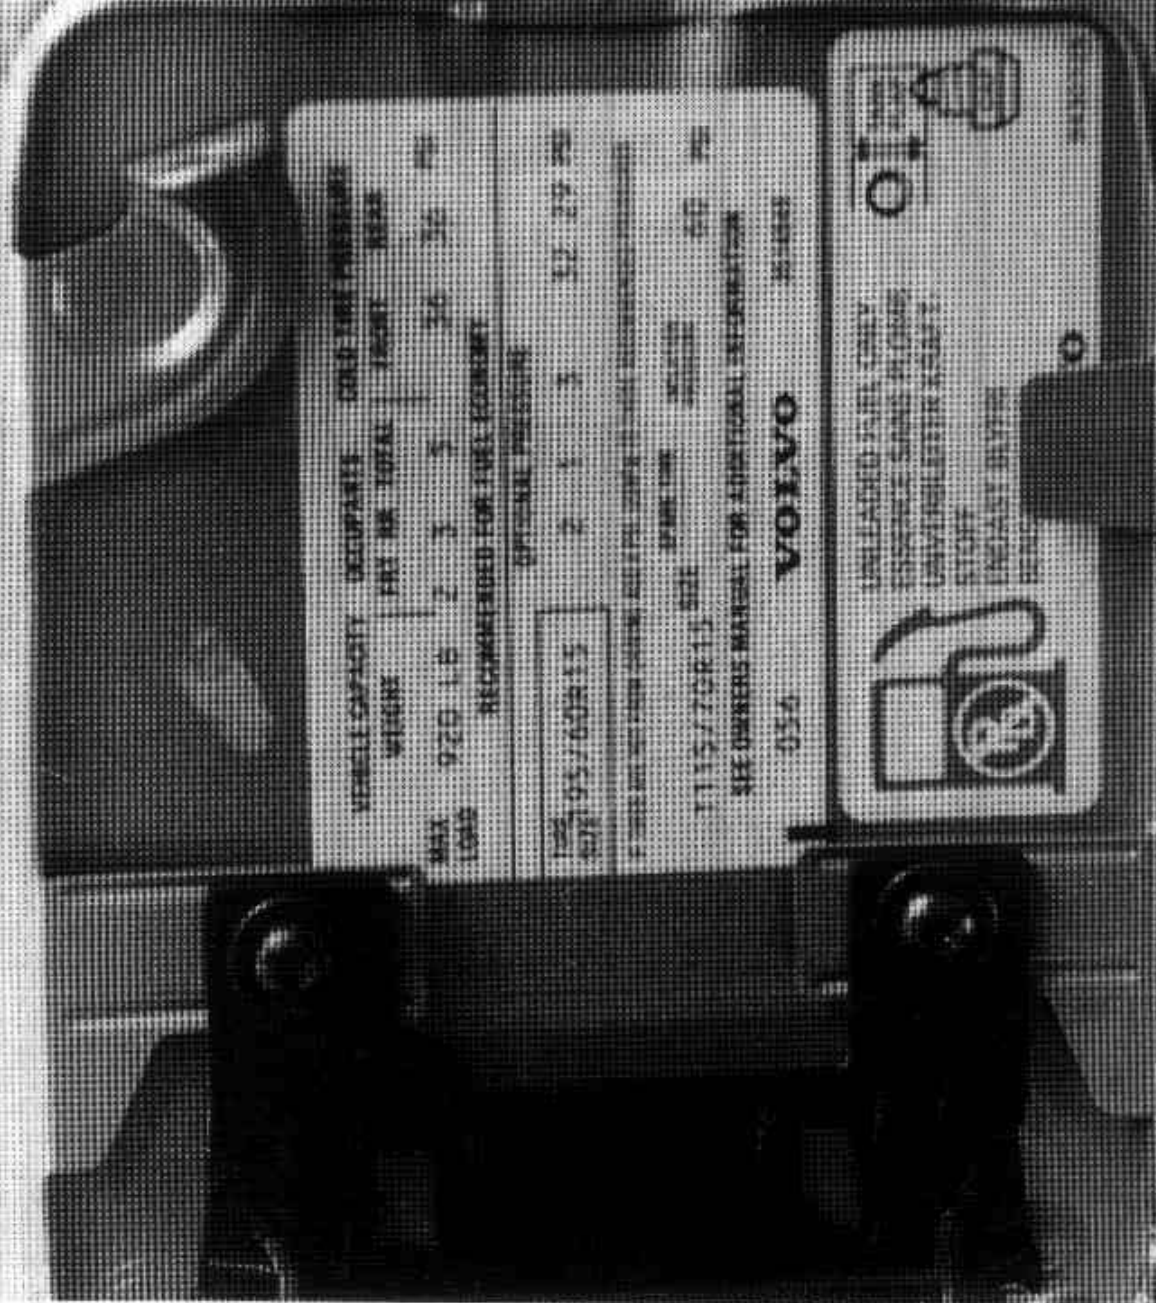
Figure A-30. Pre-Test Recommended Tire Pressure View

Recommended tire size: P195/60R15  
Recommended cold tire pressure:  
Front: 36 psi  
Rear: 36 psi  
Designated Seating Capacity:  
Front 2  
Rear 3  
Total 5  
Vehicle Capacity Weight: 920 lbs.
