REPORT NO.: 214-MGA-96-004  
SAFETY COMPLIANCE TESTING FOR  
FMVSS 214 "SIDE IMPACT PROTECTION -  
PASSENGER CARS"

FORD MOTOR CORPORATION  
1996 FORD MUSTANG  
NHTSA NO: CT0204

MGA PROVING GROUNDS  
5000 WARREN ROAD  
BURLINGTON, WI 53105

FINAL REPORT

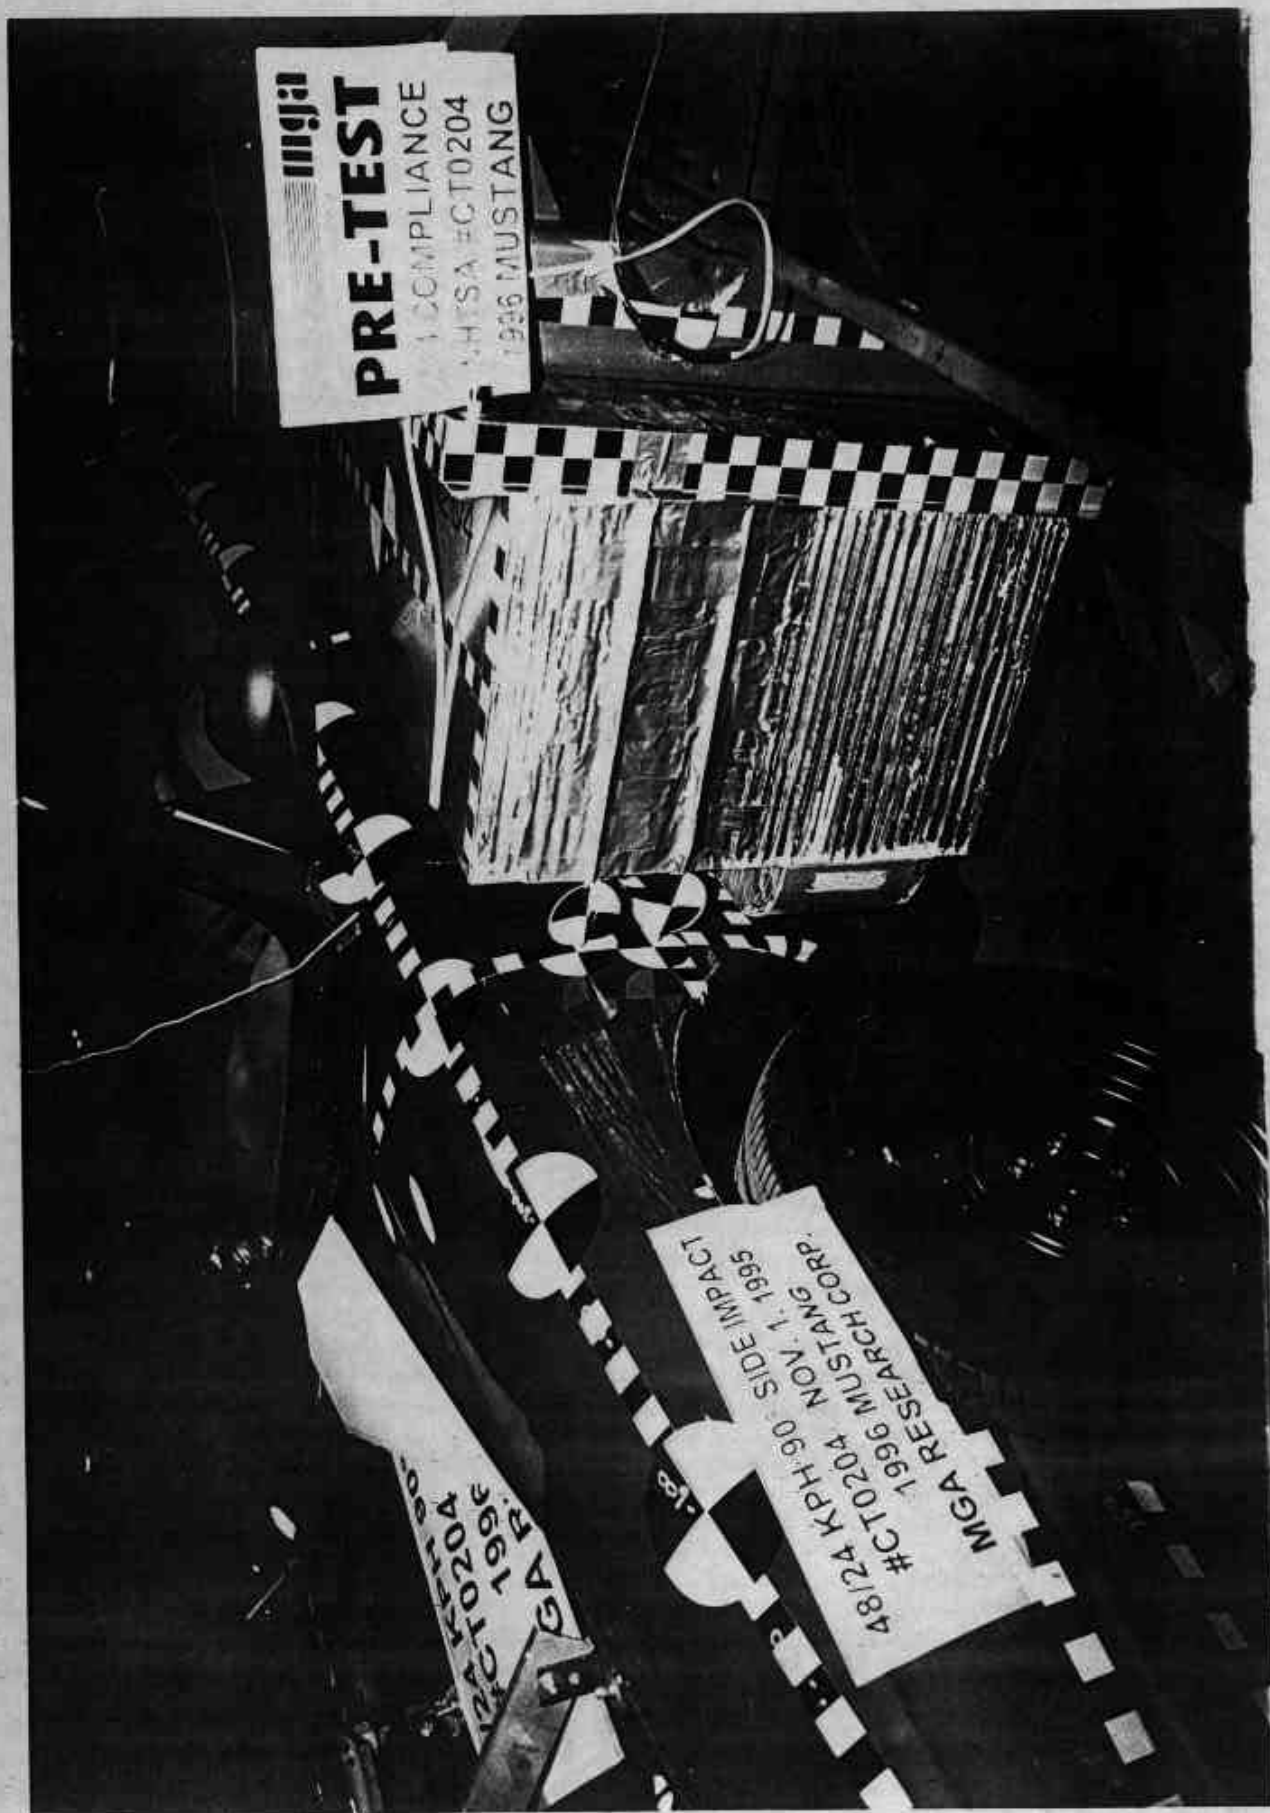
Photo No. A-7 - Pre-Test MDB Positioned Against Vehicle (left side)
