REPORT NO.: 214-MGA-96-005  
SAFETY COMPLIANCE TESTING FOR  
FMVSS 214 "SIDE IMPACT PROTECTION -  
PASSENGER CARS"

HONDA MOTOR COMPANY  
1996 ACURA 2.5 TL 4 DOOR SEDAN  
NHTSA NO: CT5300

MGA PROVING GROUNDS  
5000 WARREN ROAD  
BURLINGTON, WI 53105

FINAL REPORT

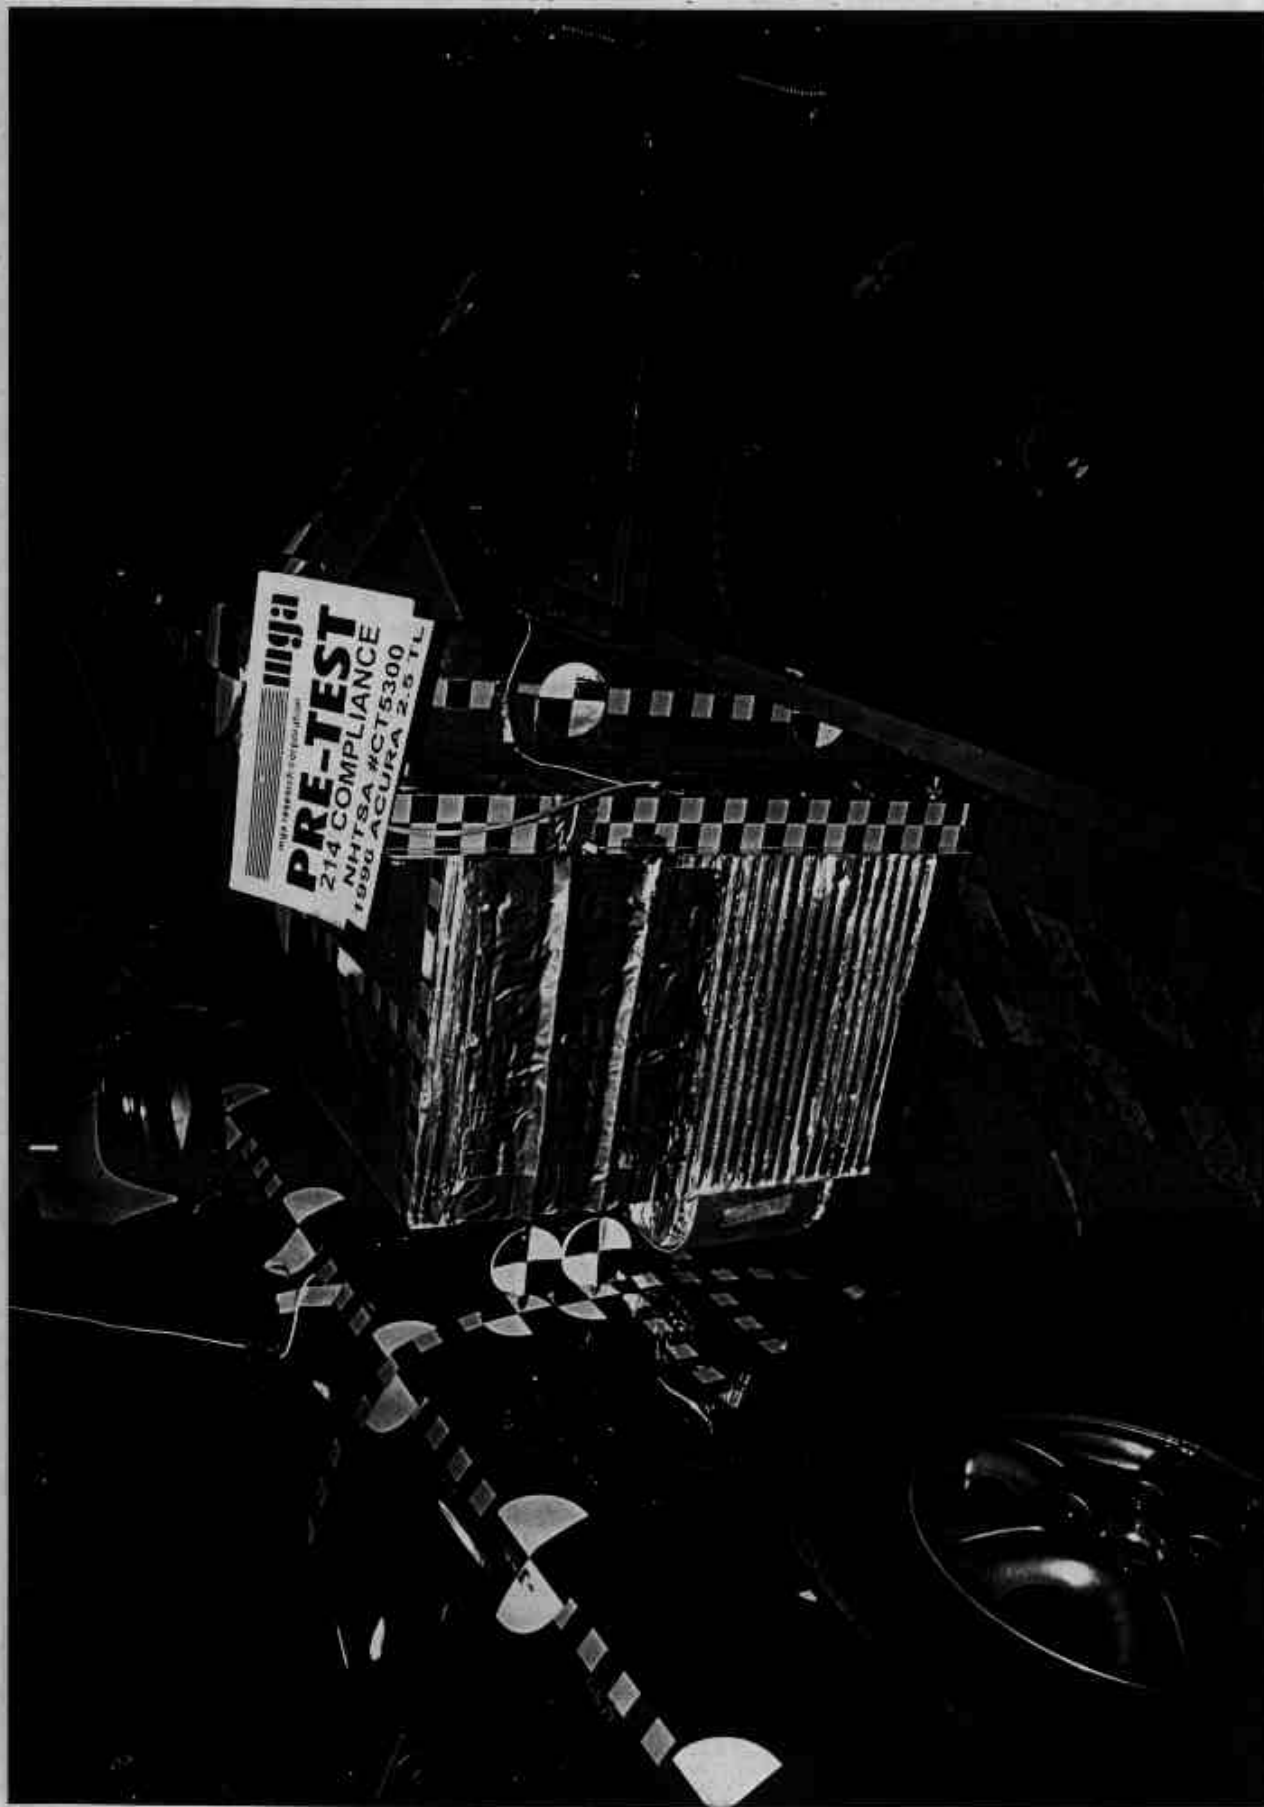
Photo No. A-7 - Pre-Test MDB Positioned Against Vehicle (left side)

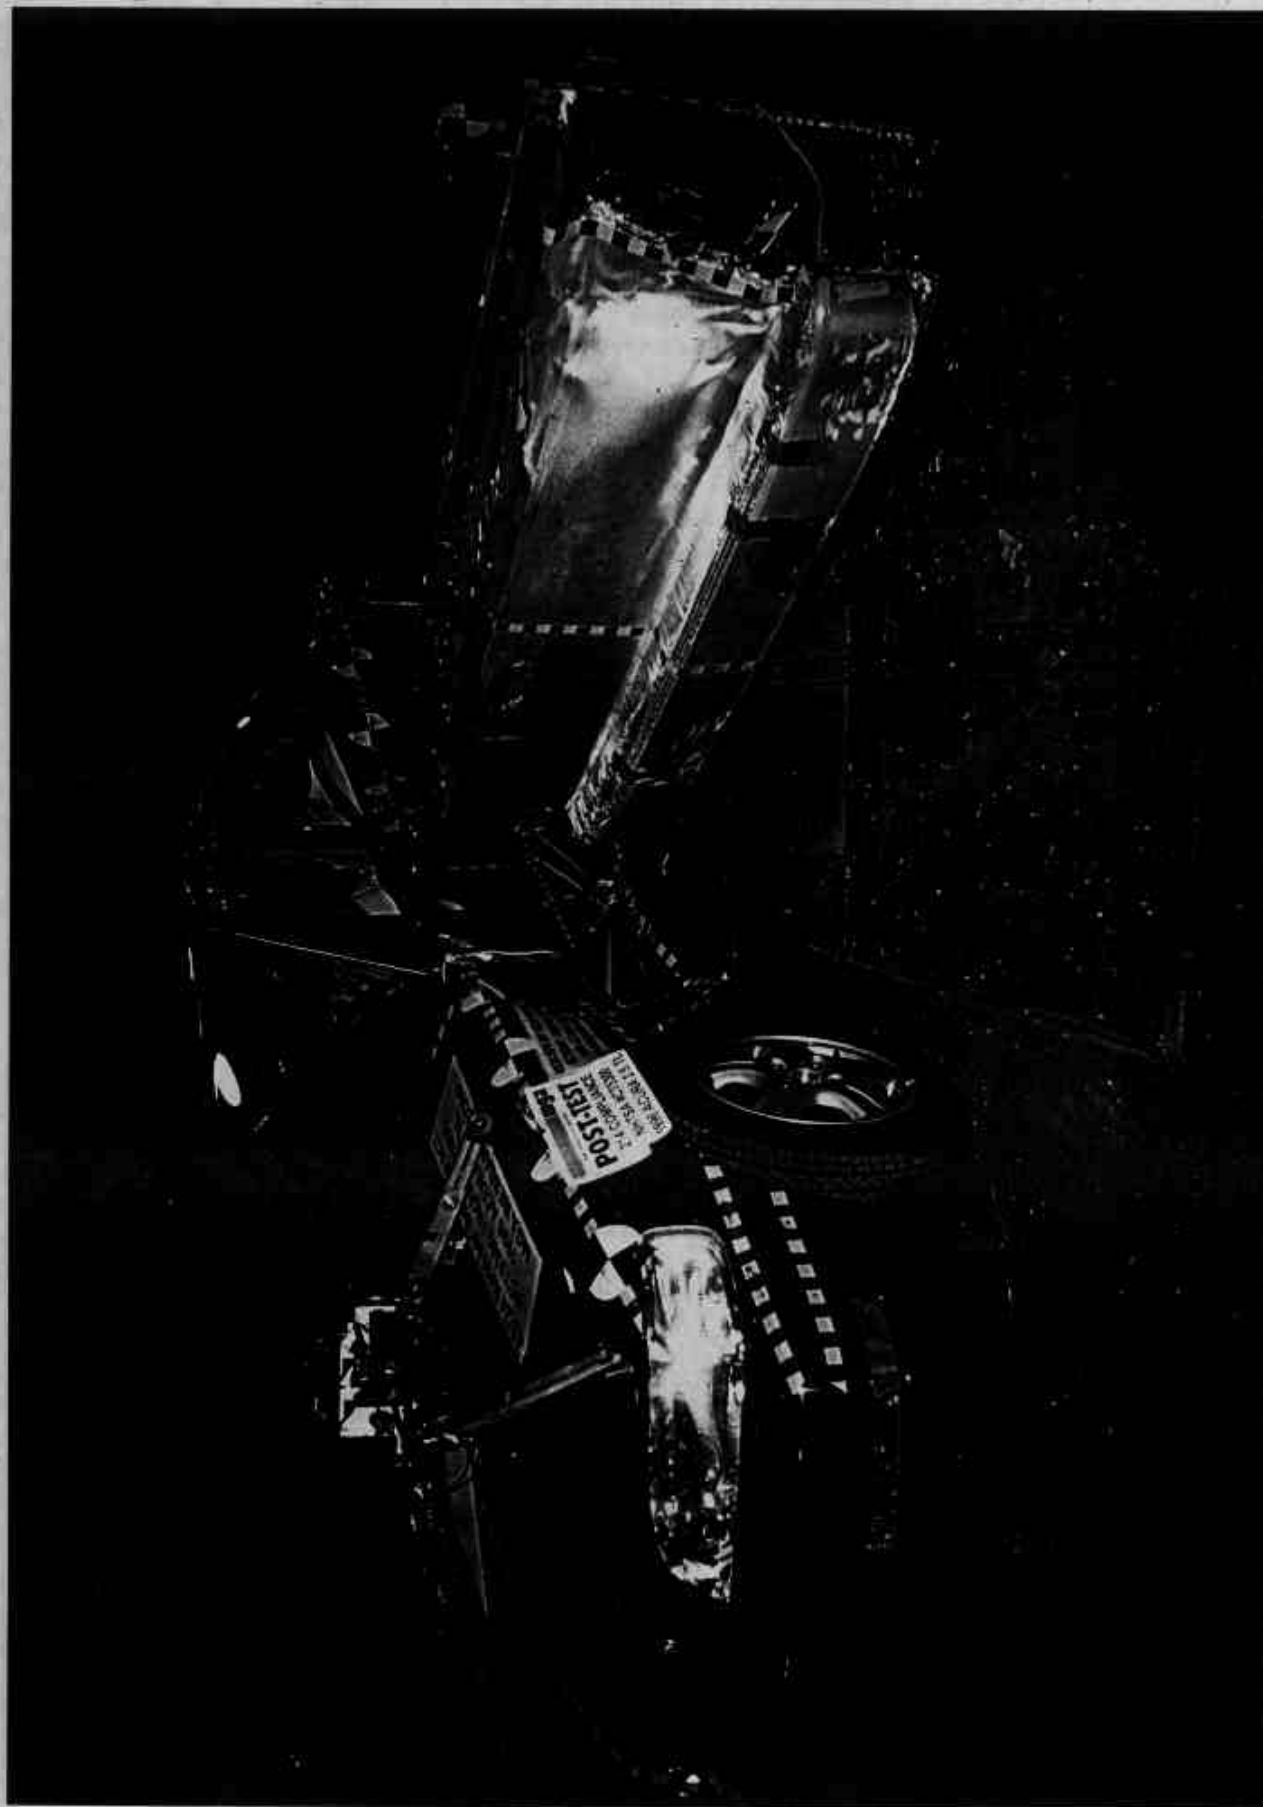
Photo No. A-10 - Post-Test MDB Positioned Against Vehicle (left side)

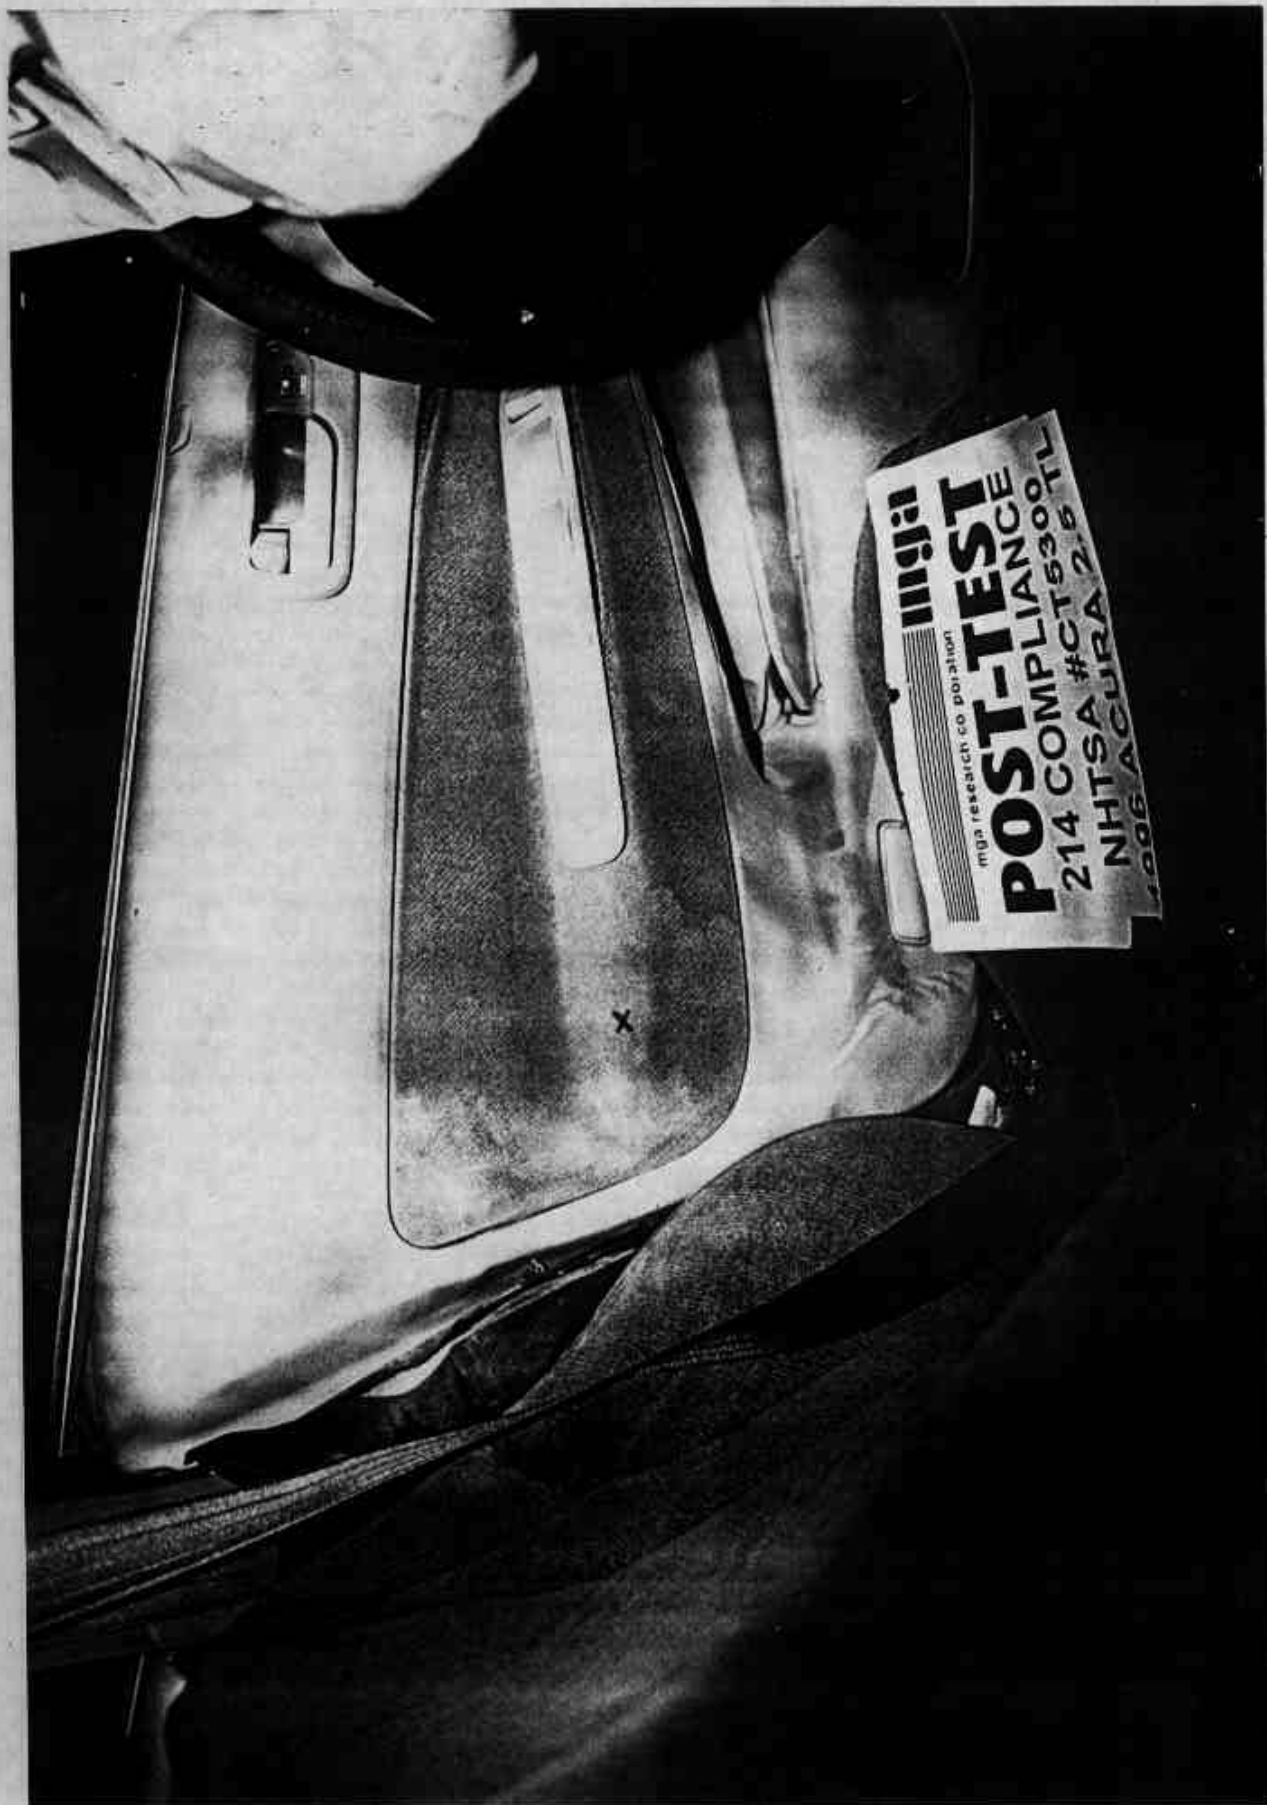
Photo No. A-28 - Post-Test Driver Dummy Contact

| | <u>LEFT FRONT SID</u> | <u>LEFT REAR SID</u> |
|---|---|---|
| Head | <u>back of head to headrest</u> | <u>to C Post</u> |
| Arm | <u>to door and B-Post</u> | <u>to door</u> |
| Pelvis | <u>to B-Post</u> | <u>to door</u> |

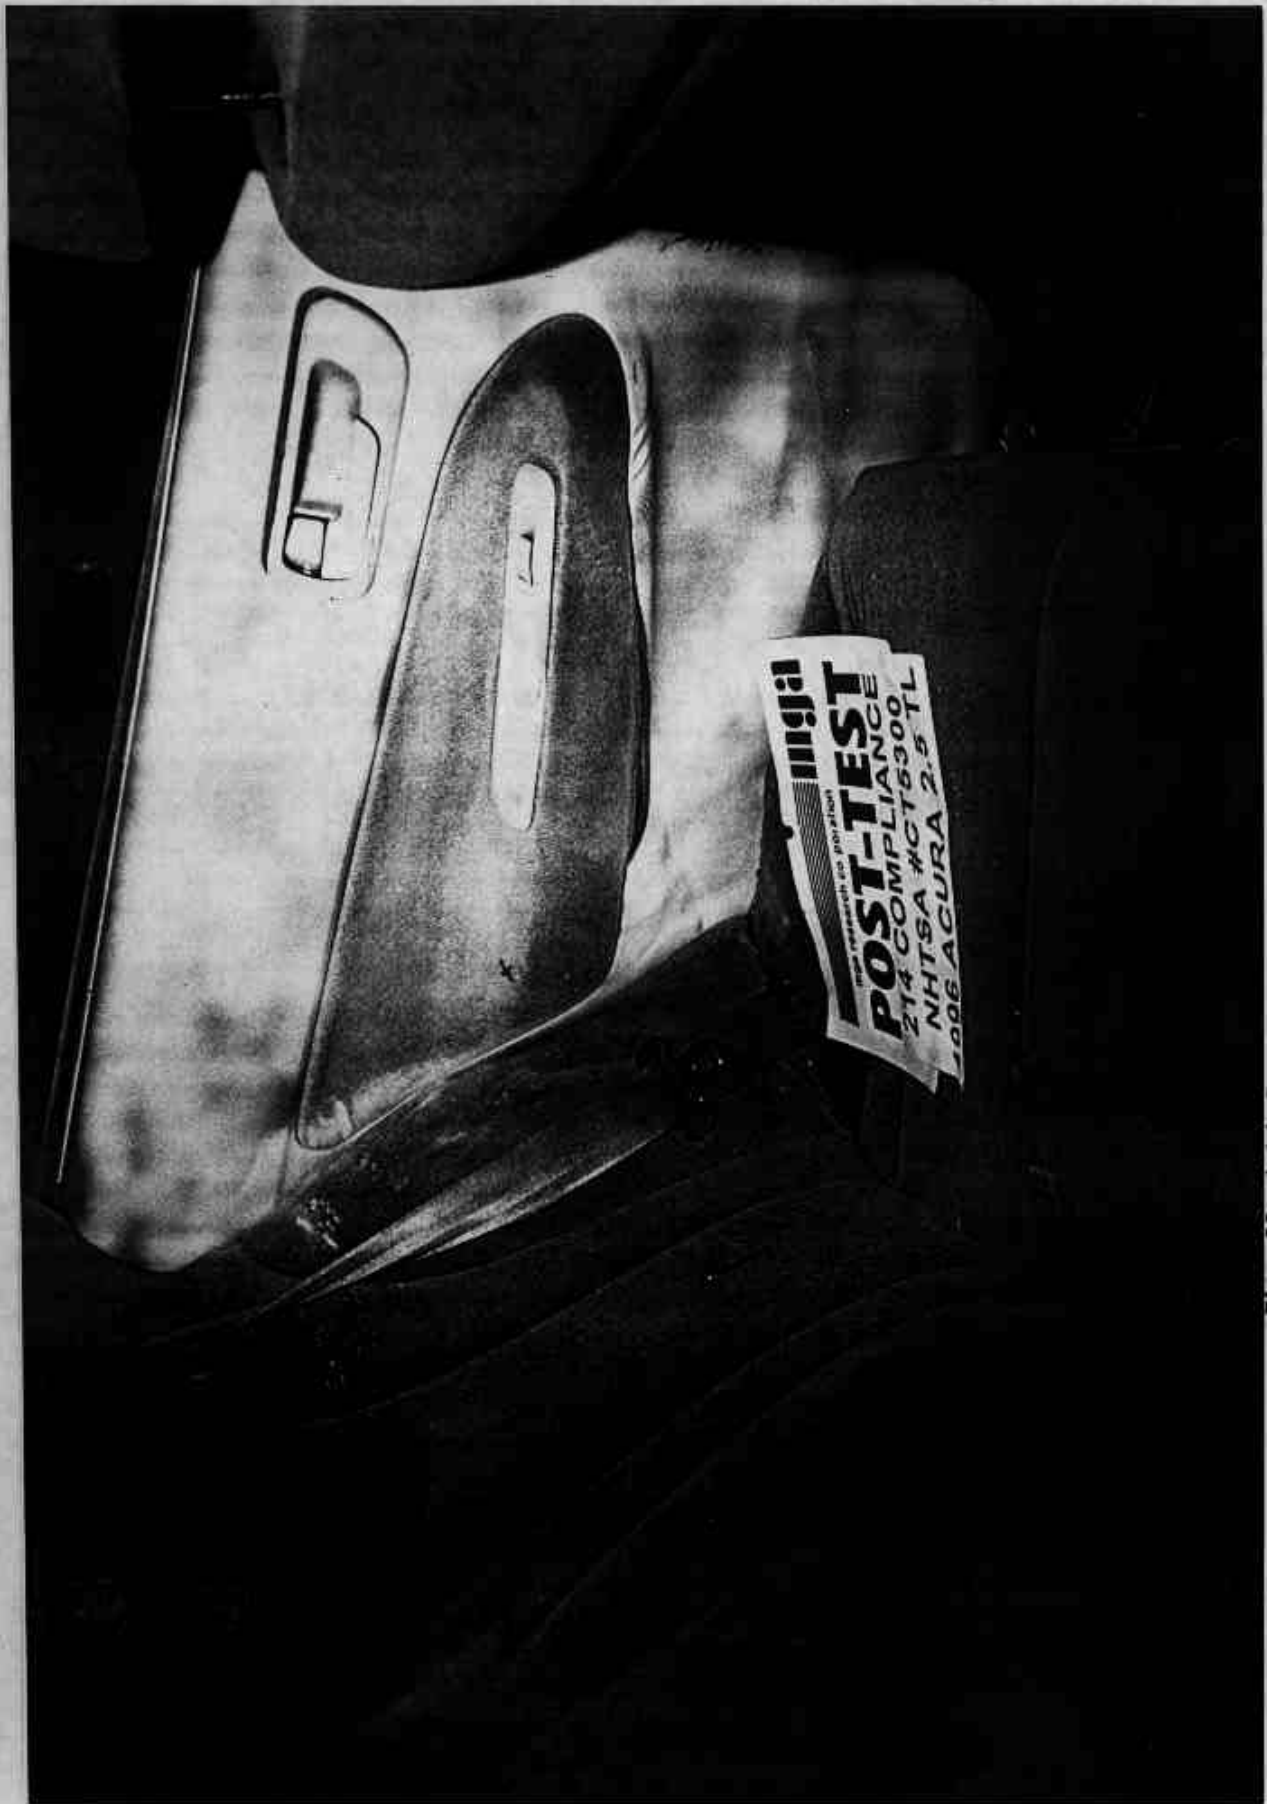
Photo No. A-36 - Post-Test Passenger Dummy Contact

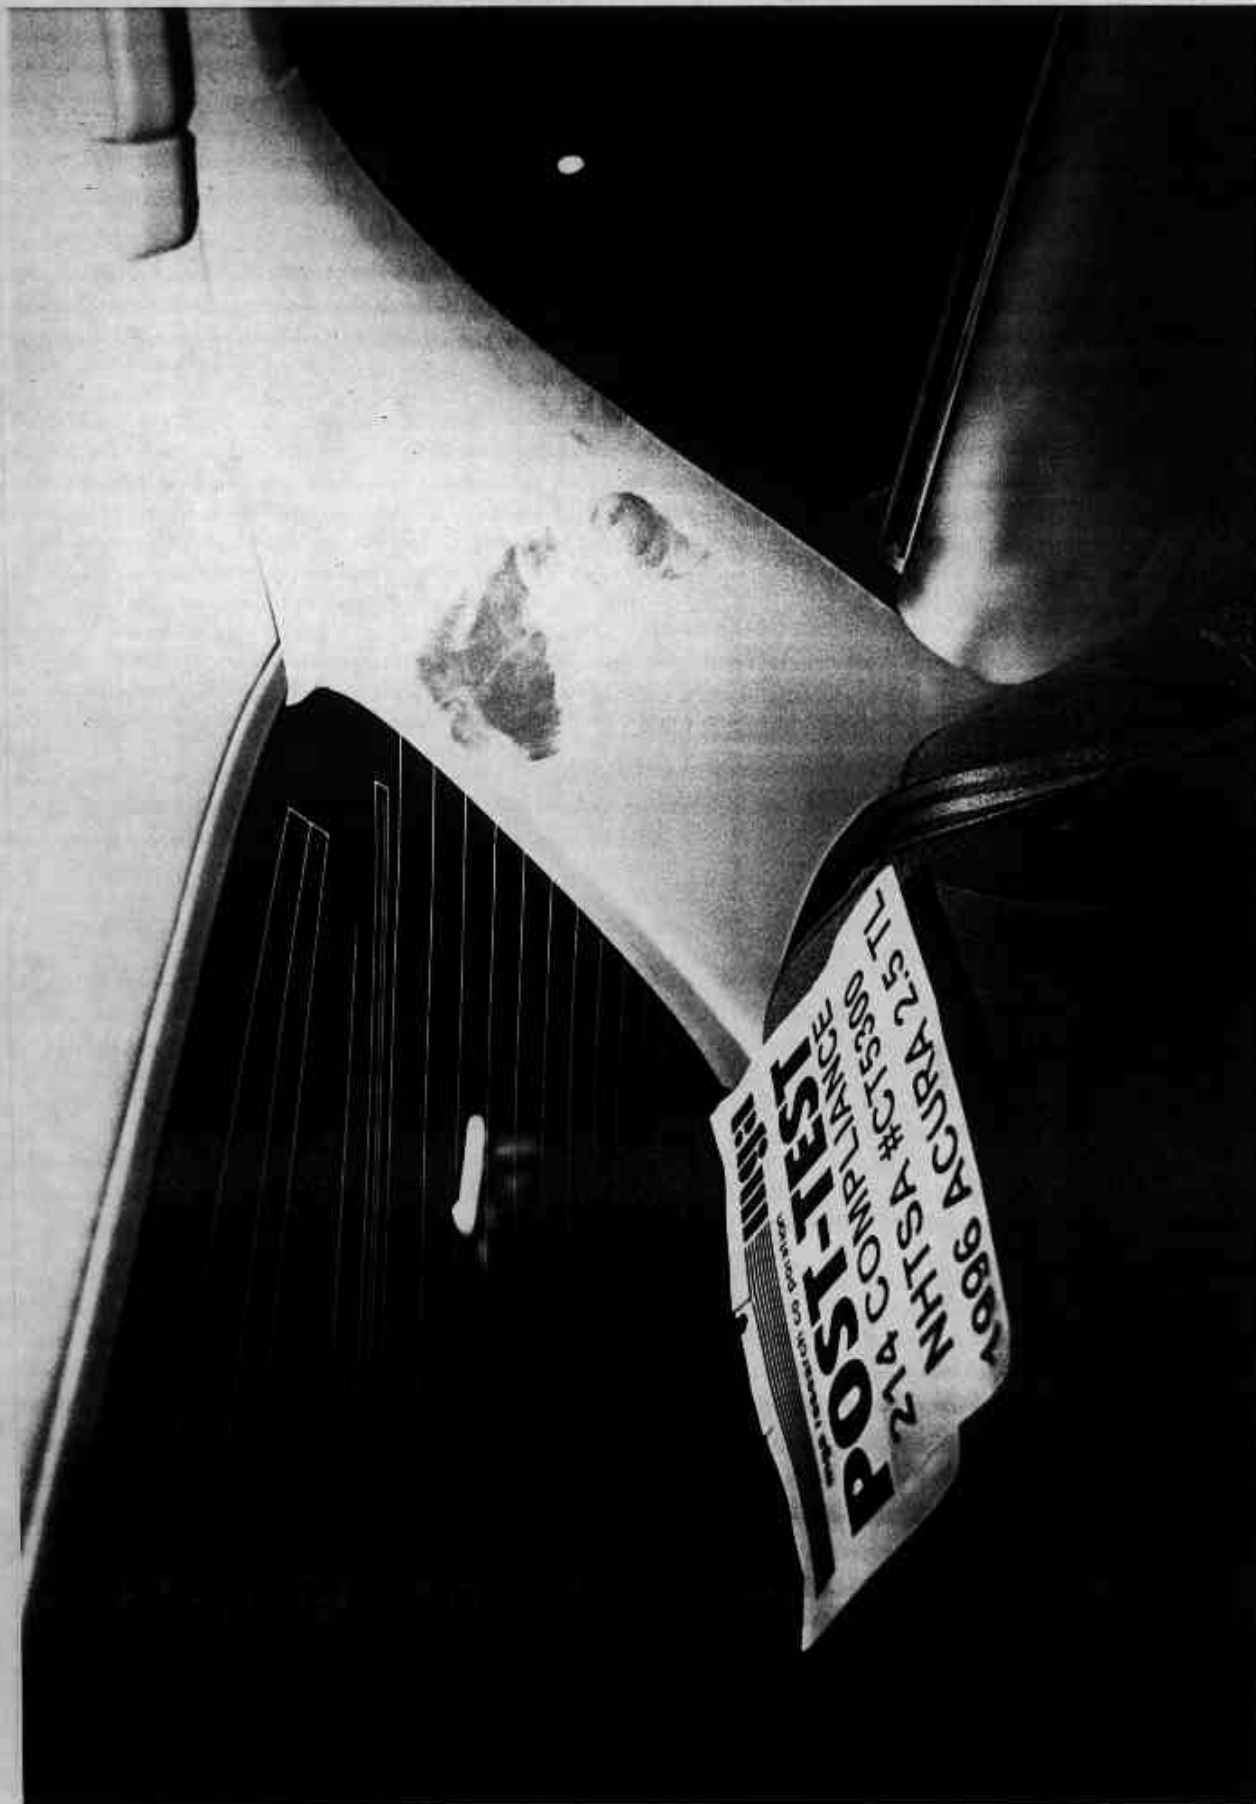
Photo No. A-37 - Post-Test Passenger Dummy Contact

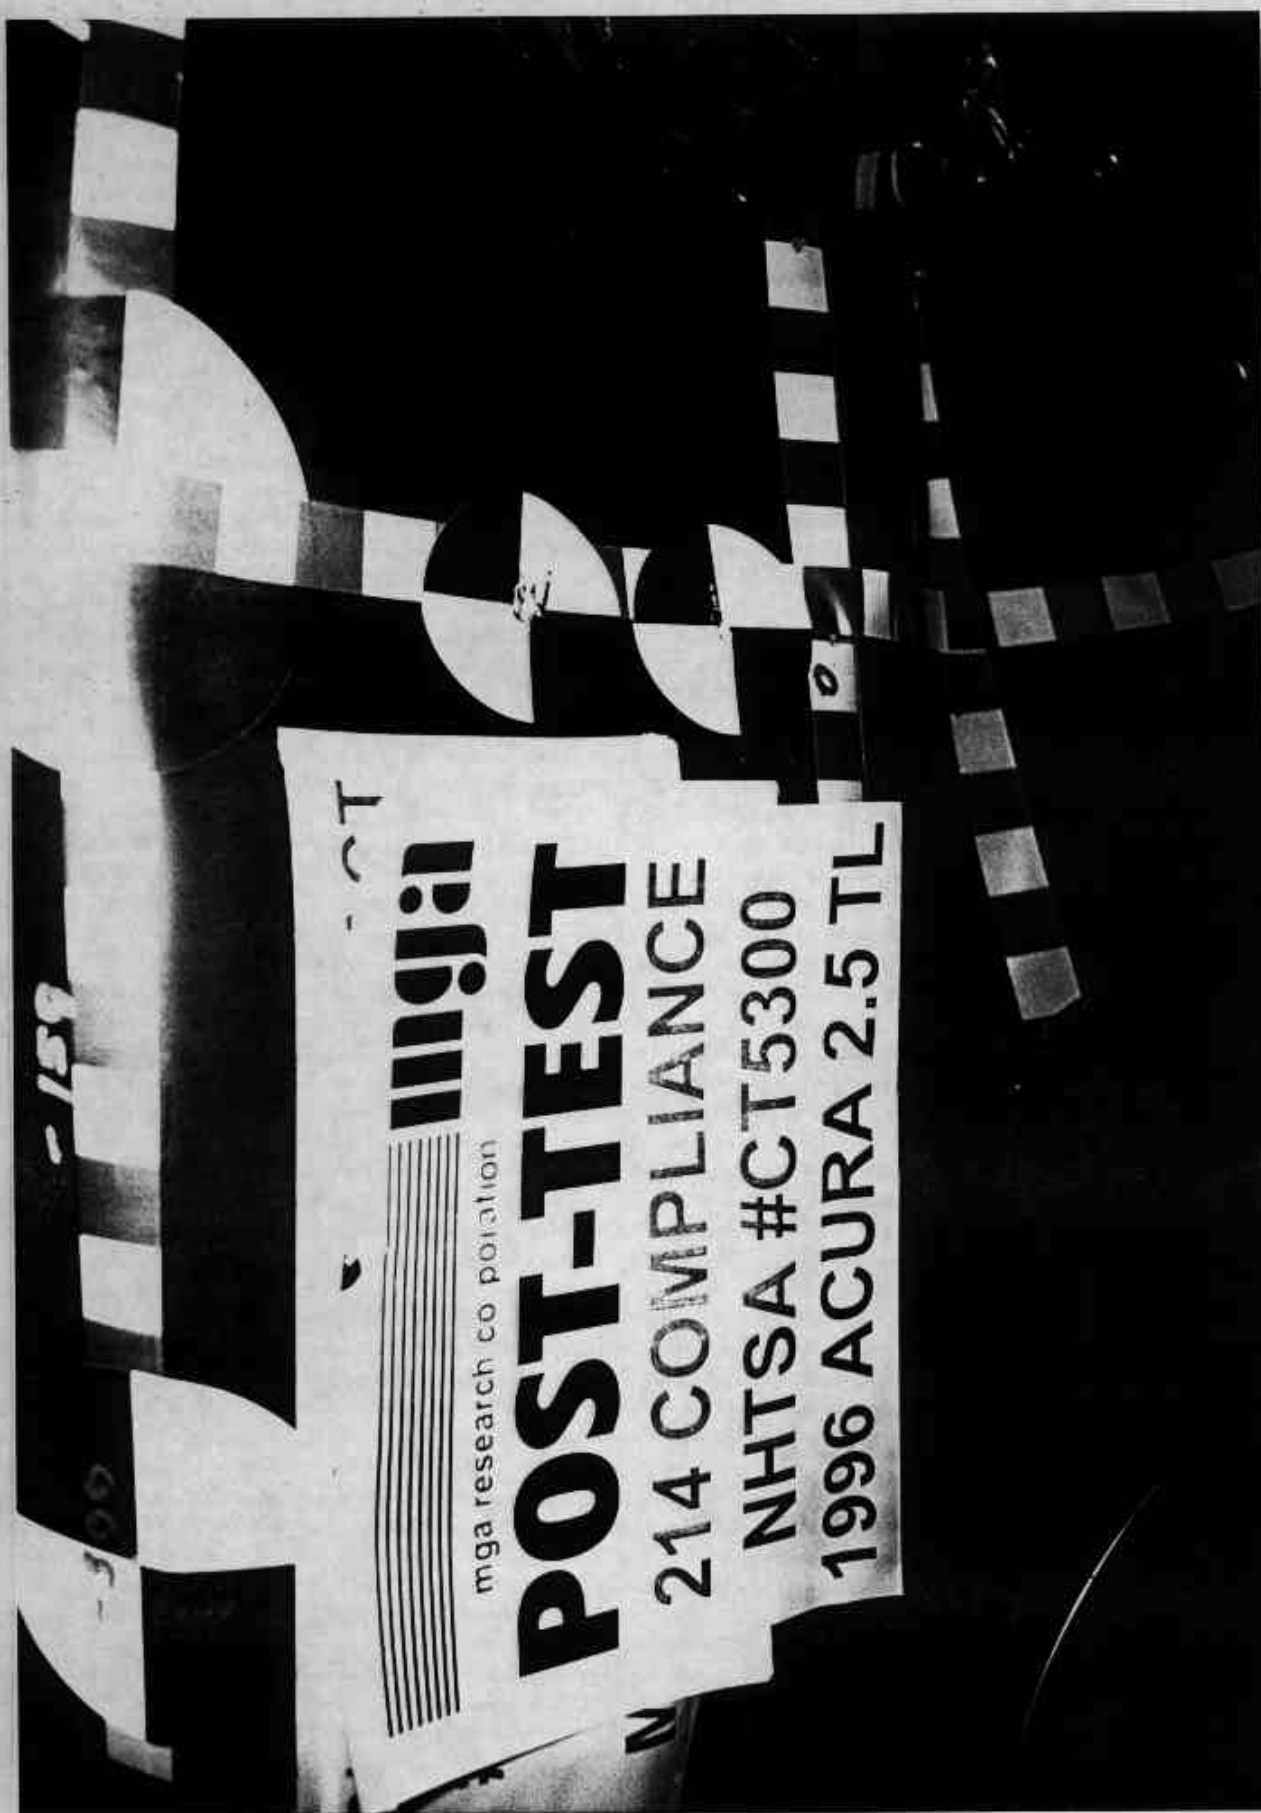
Photo No. A-39 - Post-Test Left Front Impact Point on Vehicle

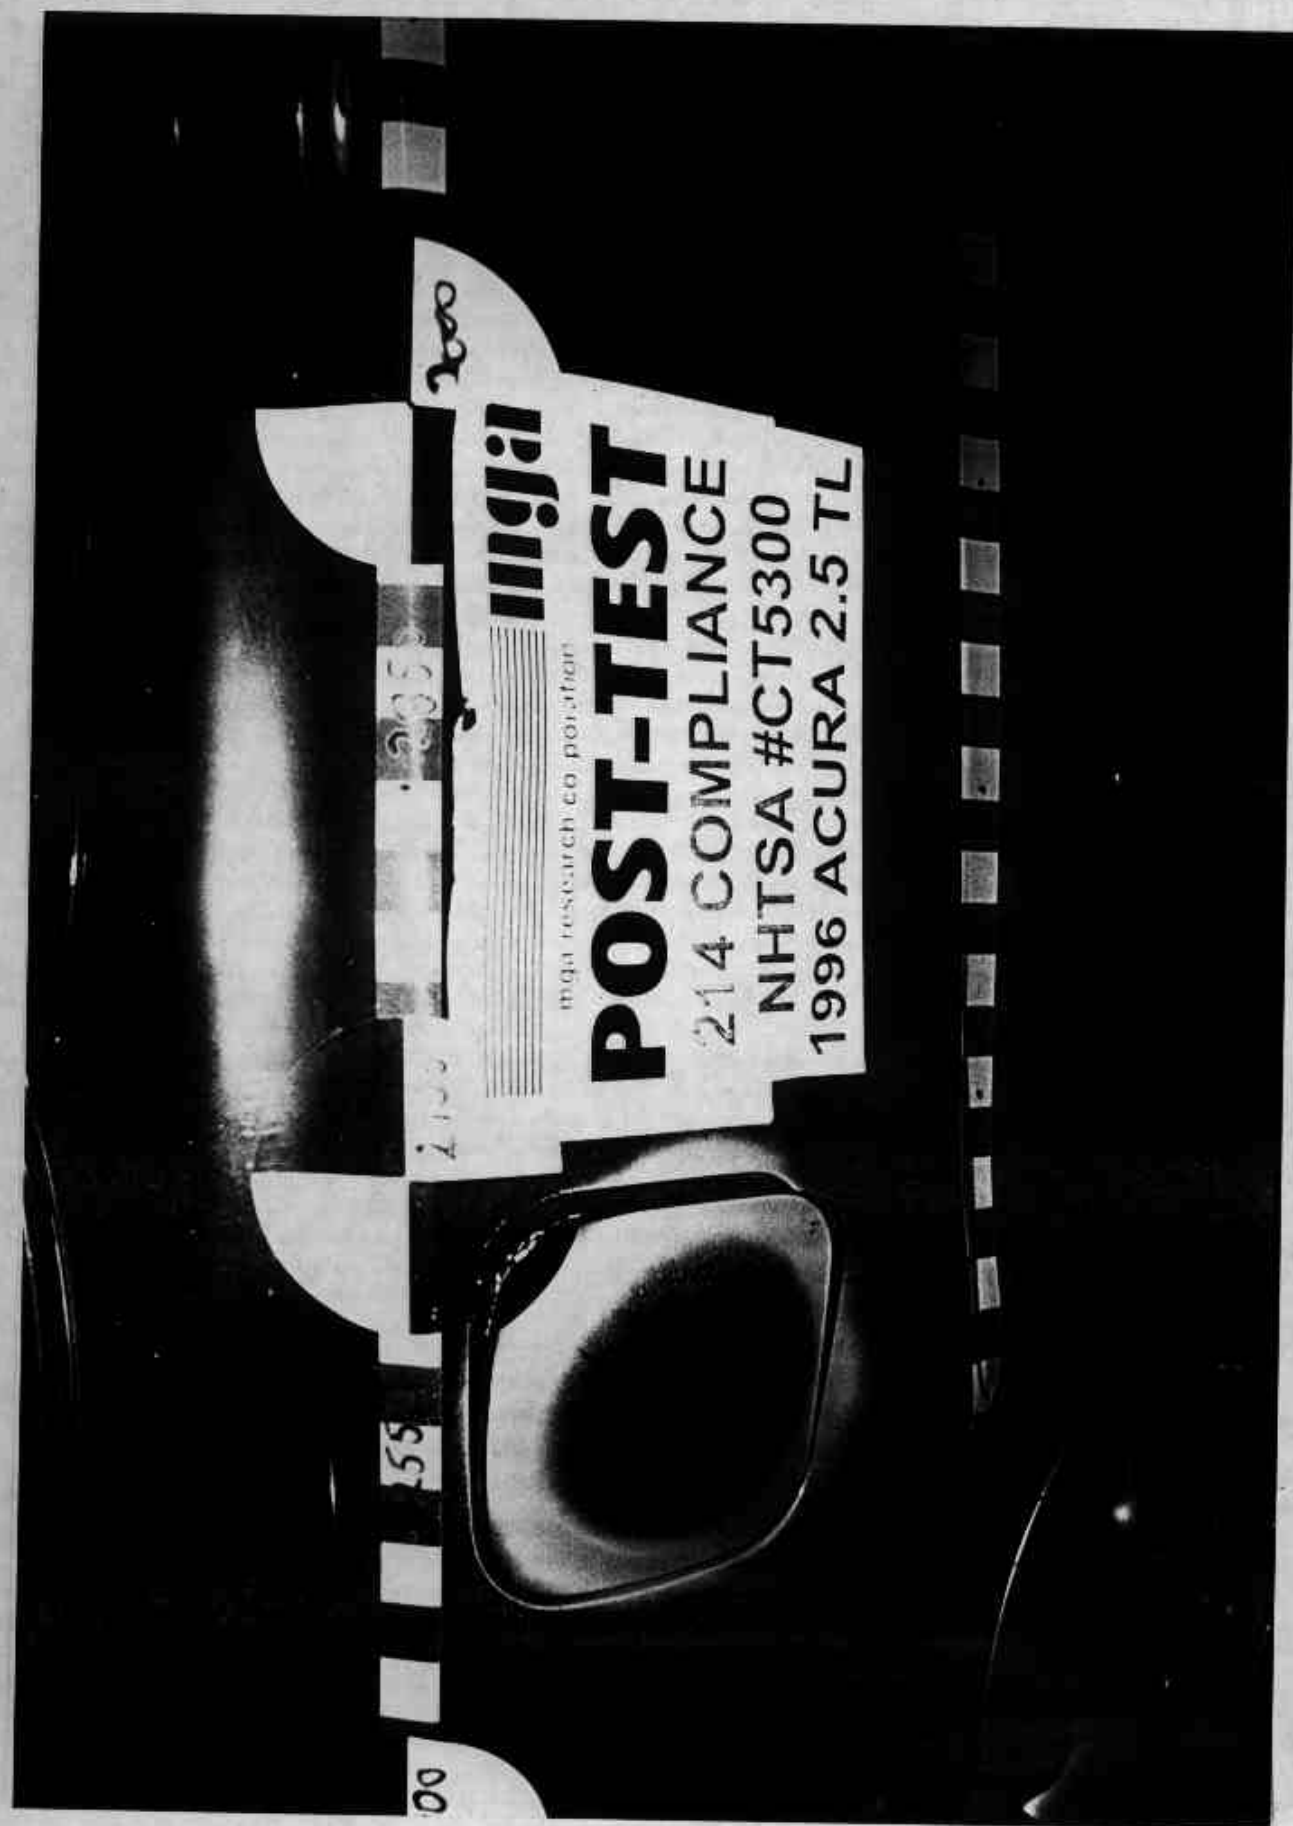
Photo No. A-44 - Post-Test Fuel Filler View

Airbags fired and fuel cap door came open
