REPORT NO.: 214-MGA-96-007  
SAFETY COMPLIANCE TESTING FOR  
FMVSS 214 "SIDE IMPACT PROTECTION -  
PASSENGER CARS"

NISSAN MOTOR CORPORATION  
1996 NISSAN SENTRA 4 DOOR  
NHTSA NO: CT5201

MGA PROVING GROUNDS  
5000 WARREN ROAD  
BURLINGTON, WI 53105

FINAL REPORT

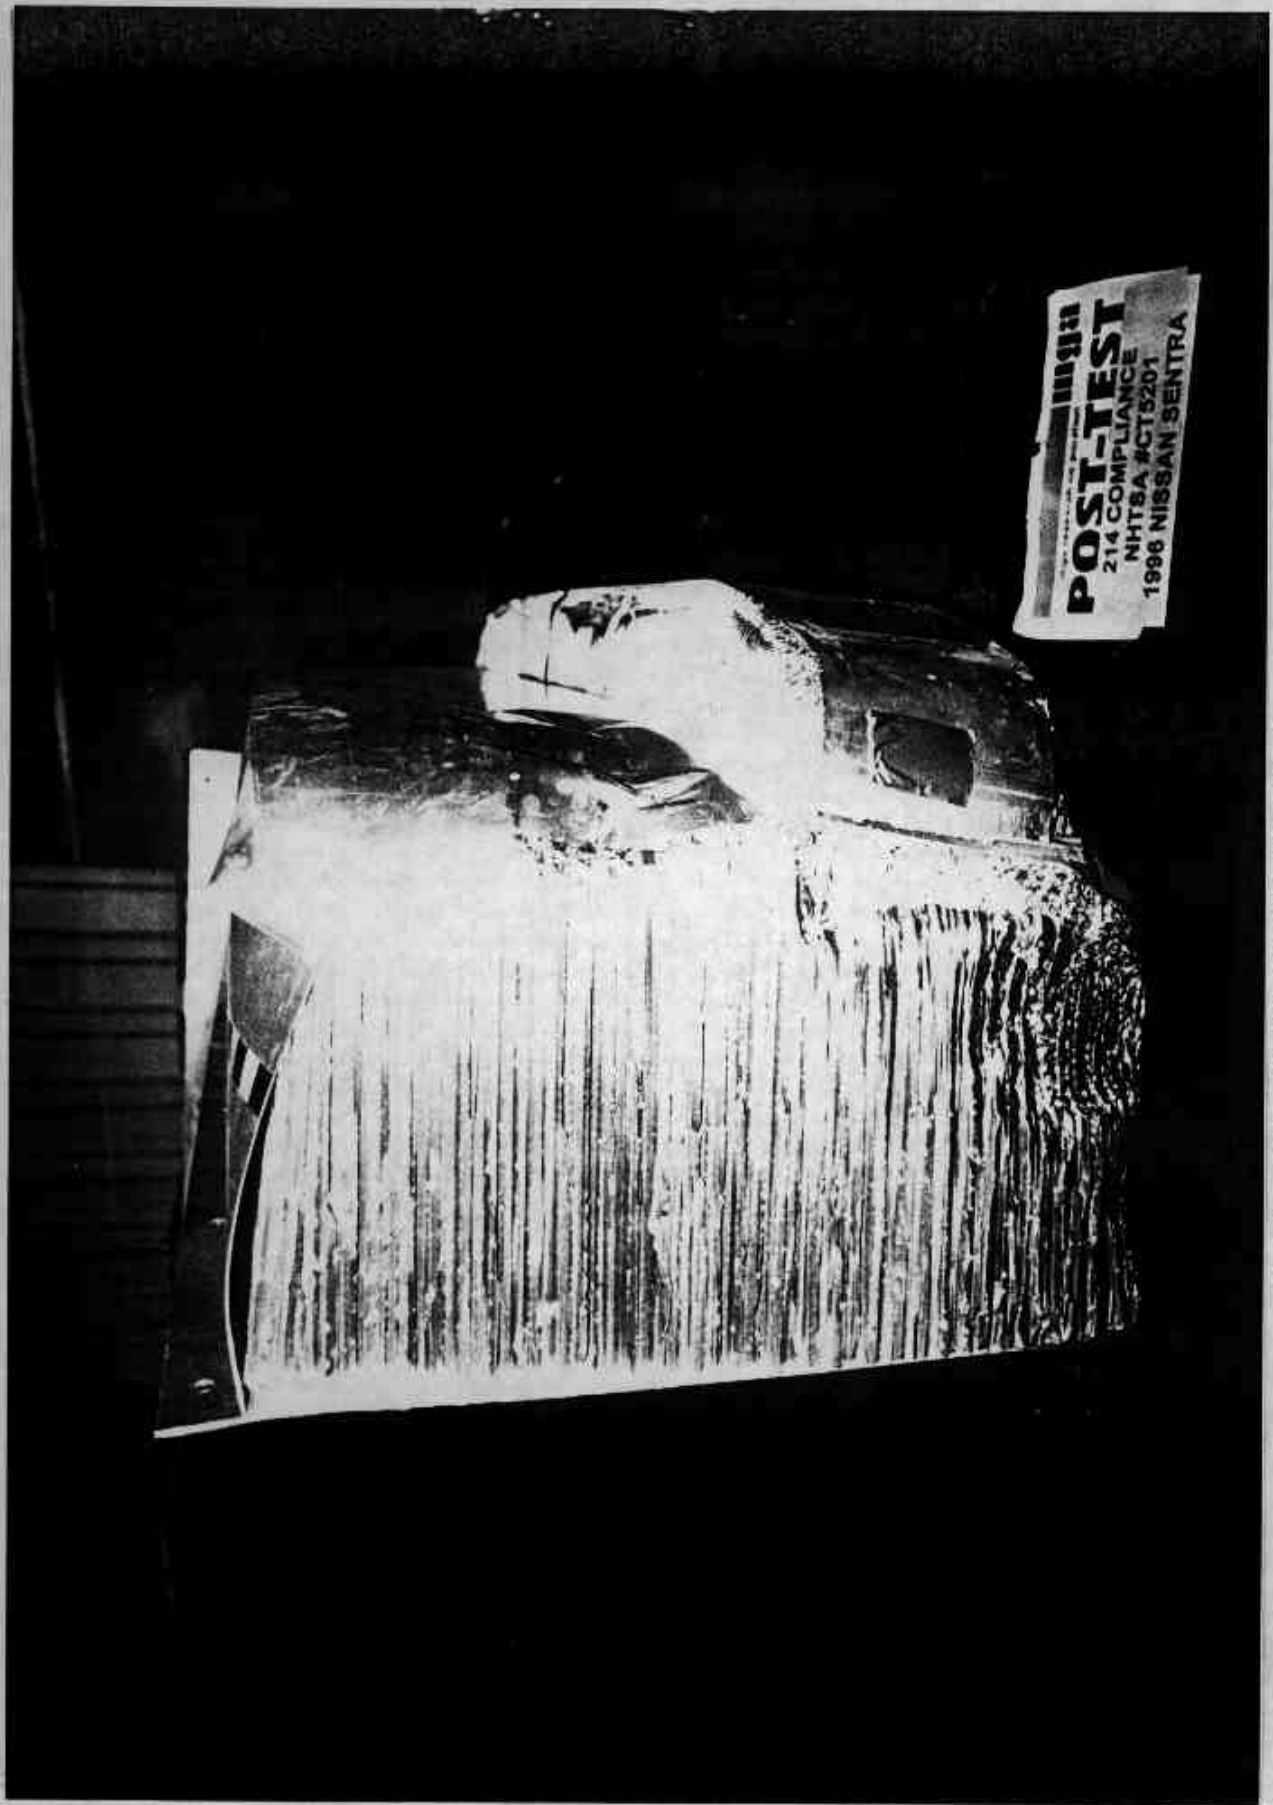
Photo No. A-11 - Post-Test MDB Right Side View

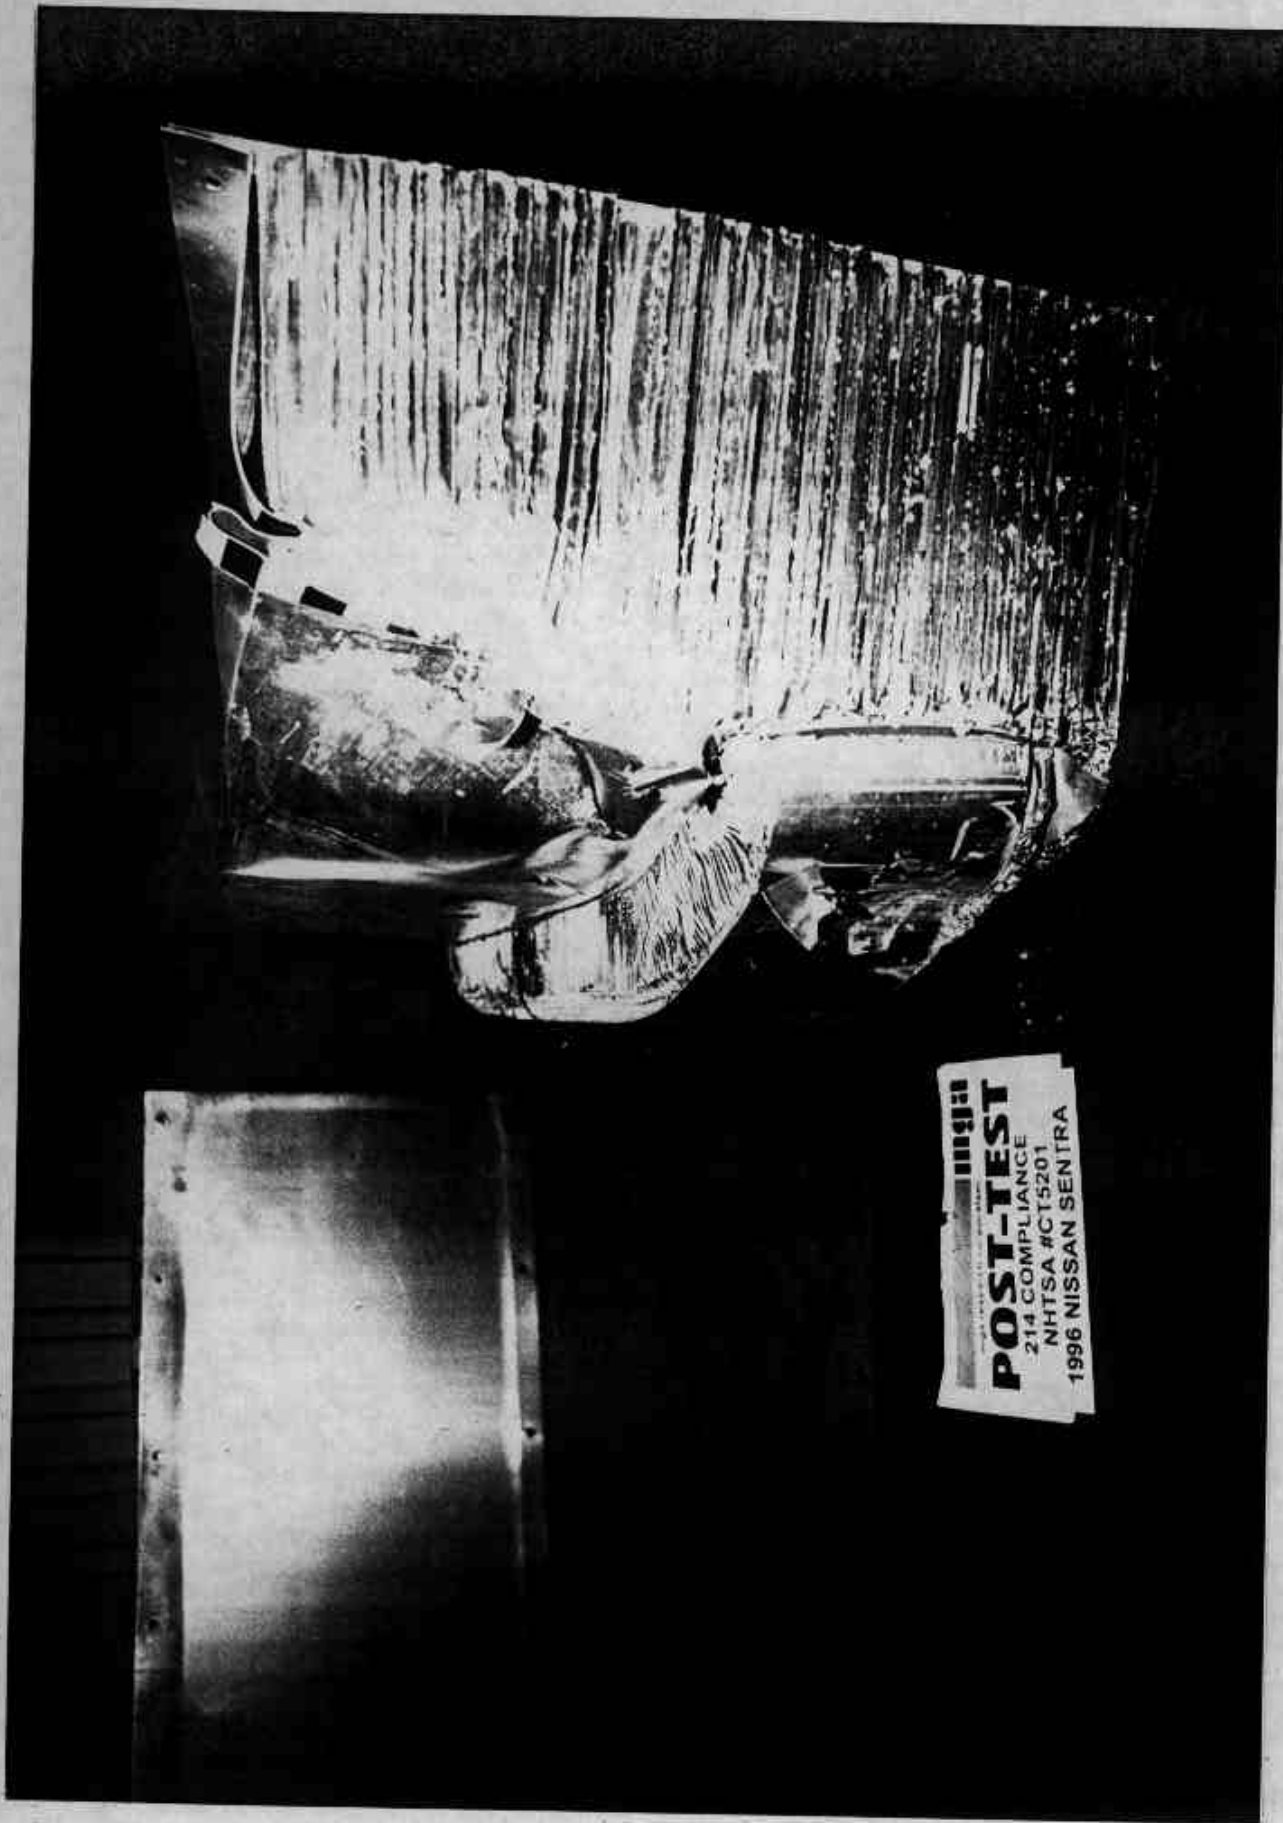
Photo No. A-12 - Post-Test MDB Left Side View

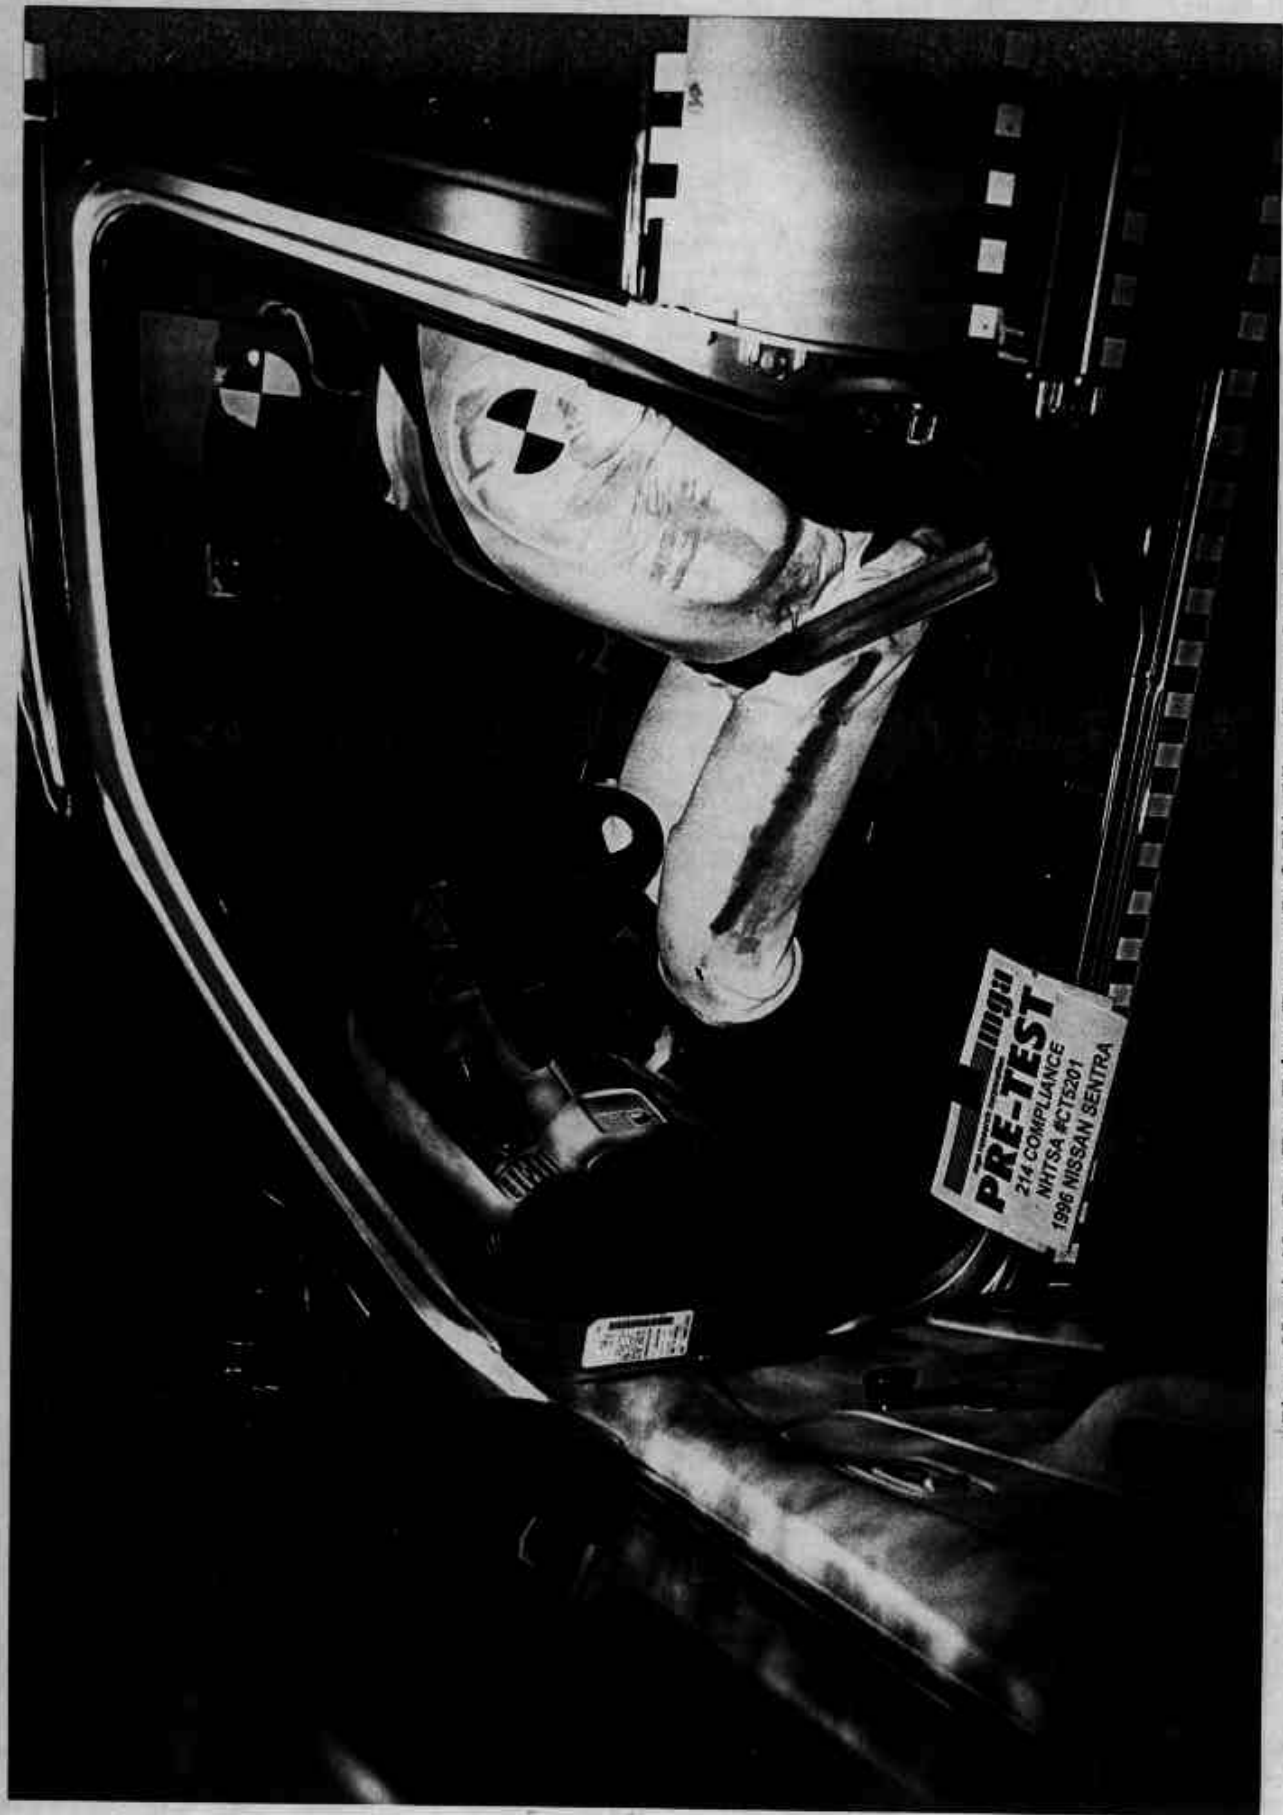
Photo No. A-13 - Pre-Test Driver Dummy Left Side View (Door Open)

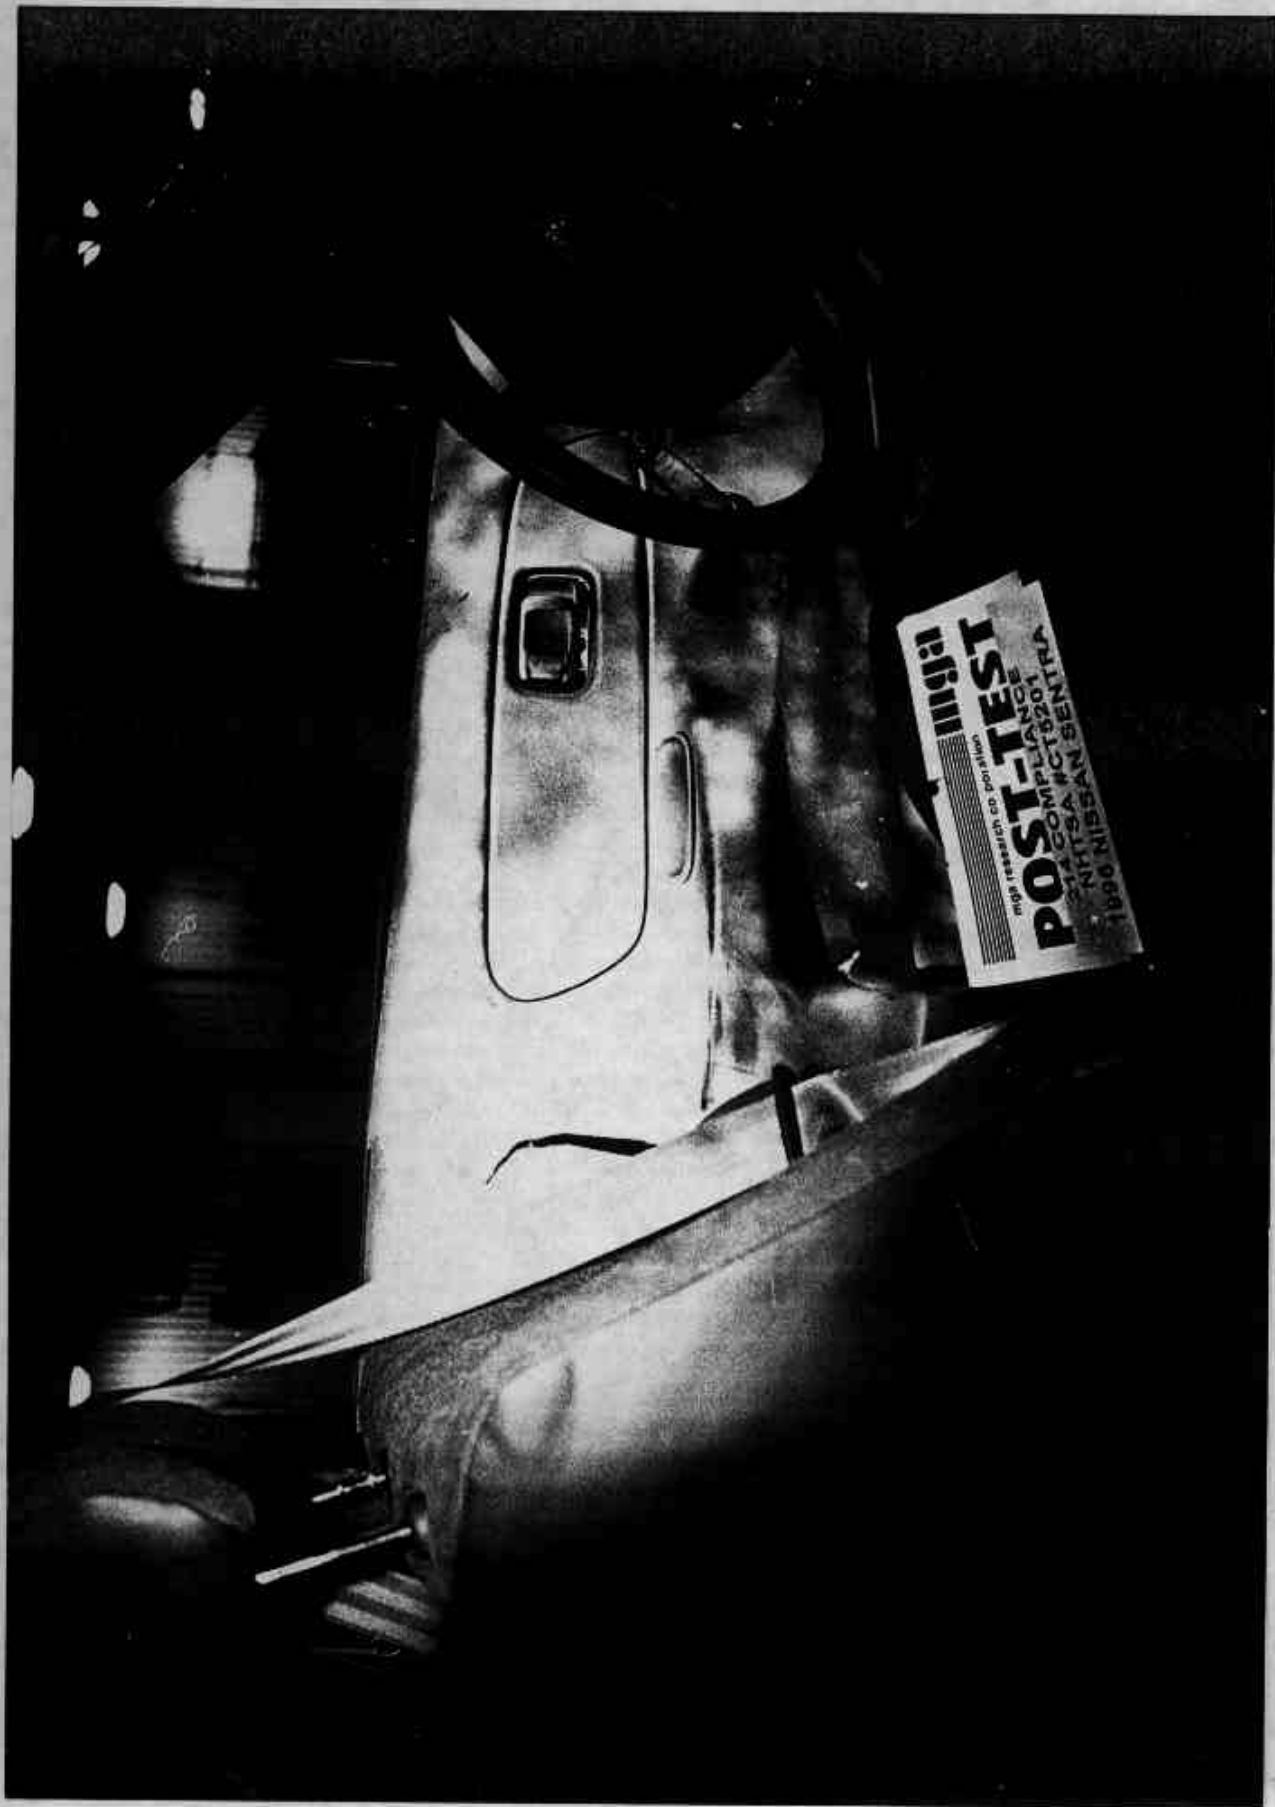
Photo No. A-14 - Post-Test Driver Dummy Contact

| | <u>LEFT FRONT SID</u> | <u>LEFT REAR SID</u> |
|---|---|---|
| Head | <u>to headrest</u> | <u>to C Post, rear window</u> |
| Arm | <u>to door</u> | <u>to door</u> |
| Pelvis | <u>to door</u> | <u>to door</u> |

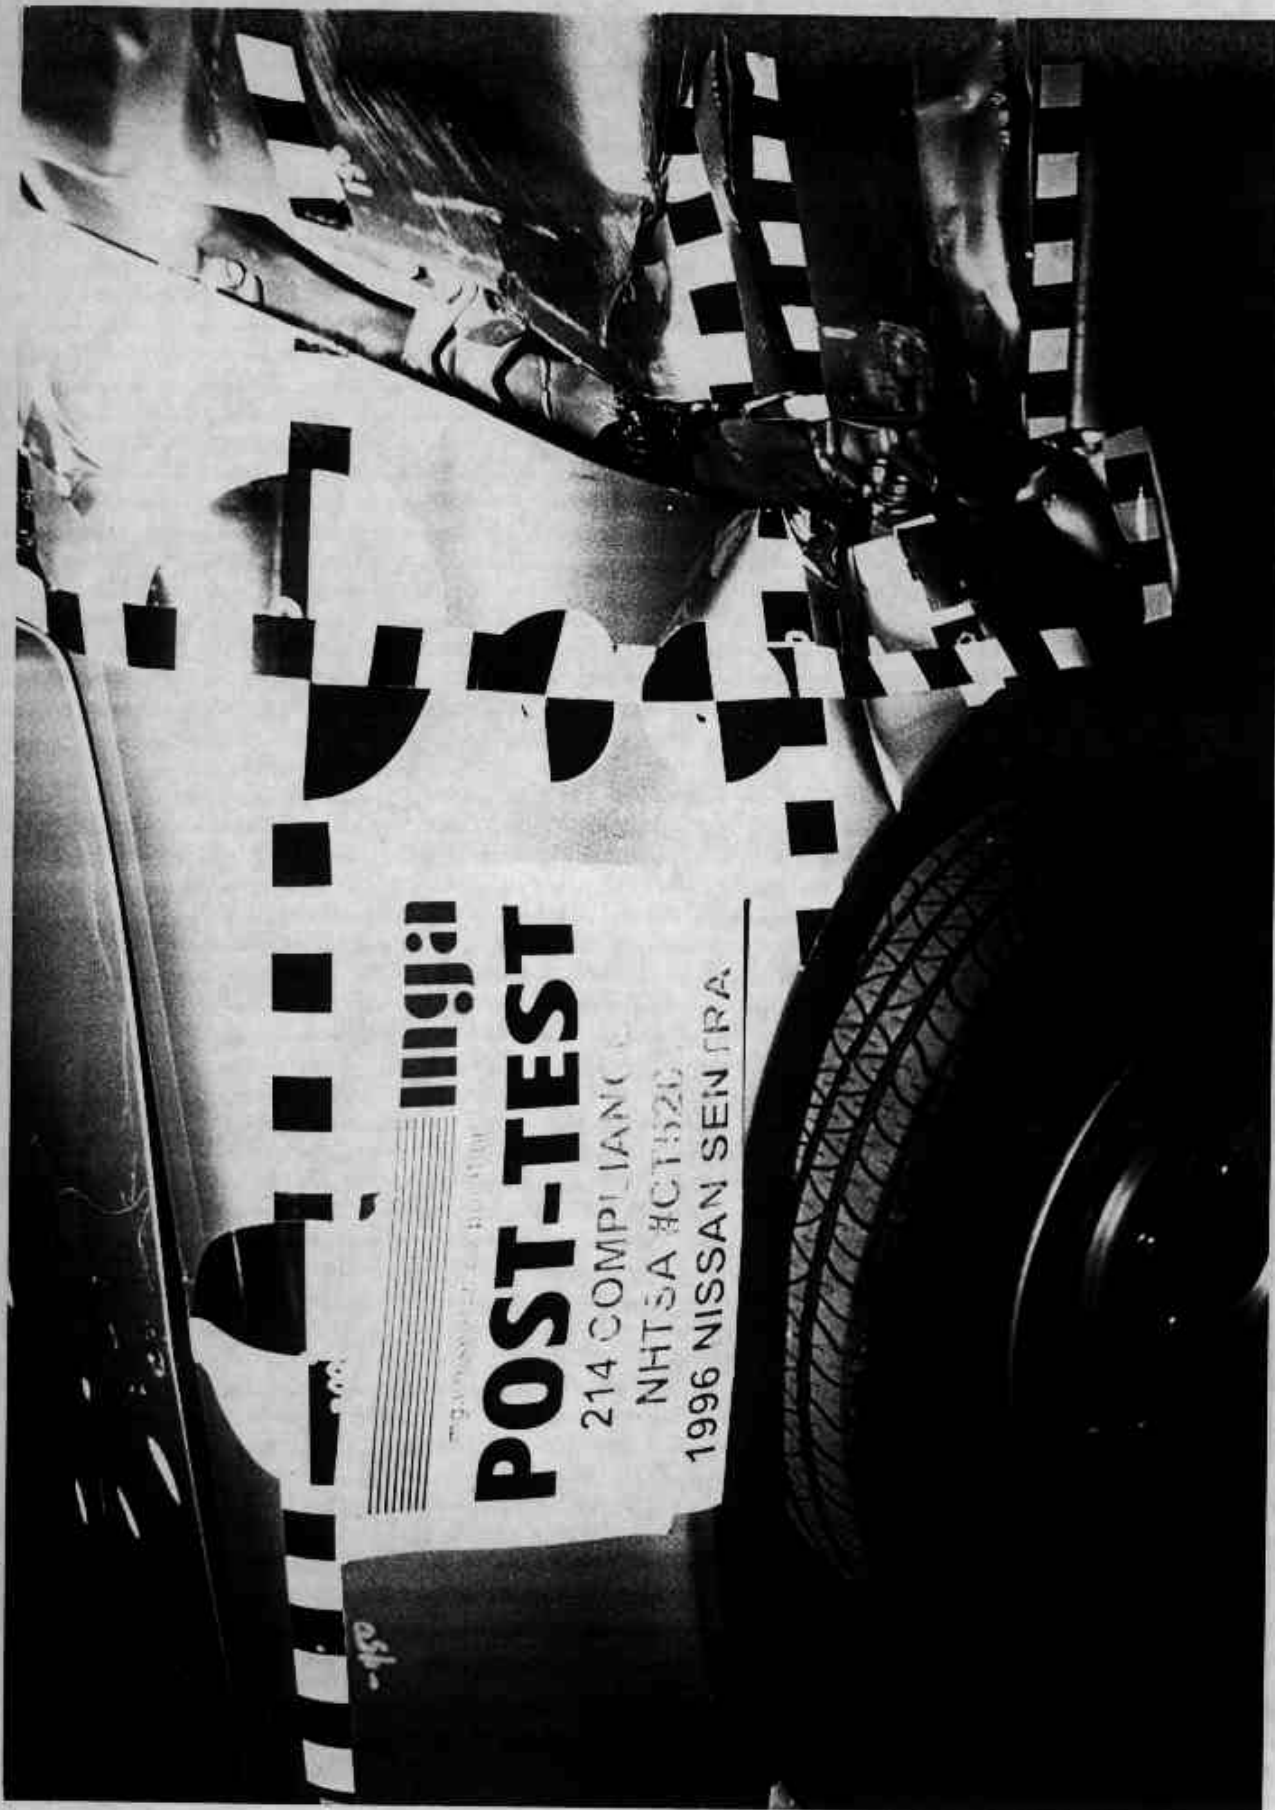
Photo No. A-18 - Left Front Impact Point on Vehicle

Impact Point is 328 mm rearward of front axle centerline

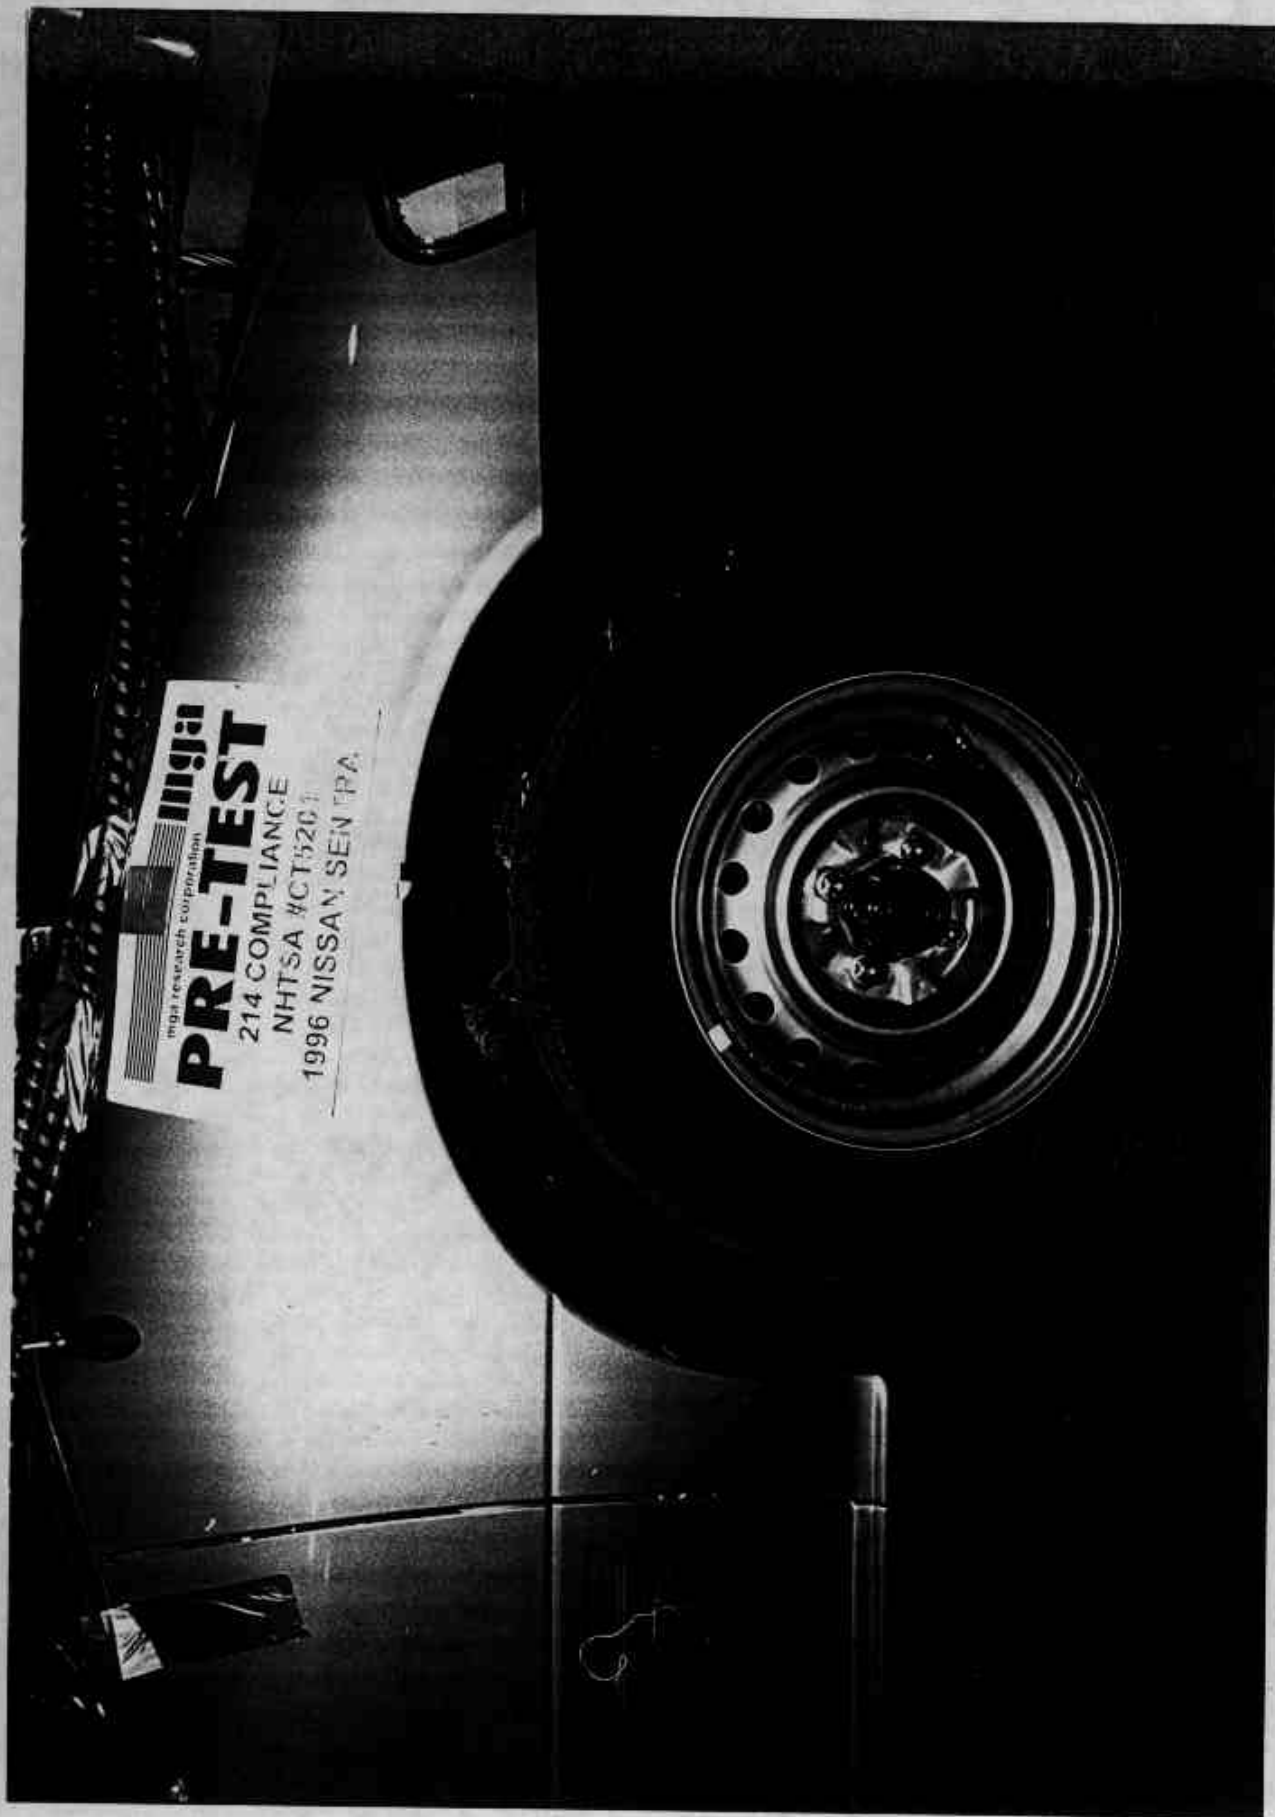
Photo No. A-21 - Right Front Attitude Point
