REPORT NO.: 214-MGA-96-011  
SAFETY COMPLIANCE TESTING FOR  
FMVSS 214 "SIDE IMPACT PROTECTION -  
PASSENGER CARS"

SUBARU MOTORS CORPORATION  
1996 SUBARU IMPREZA 2 DOOR  
NHTSA NO: CT5501

FINAL REPORT

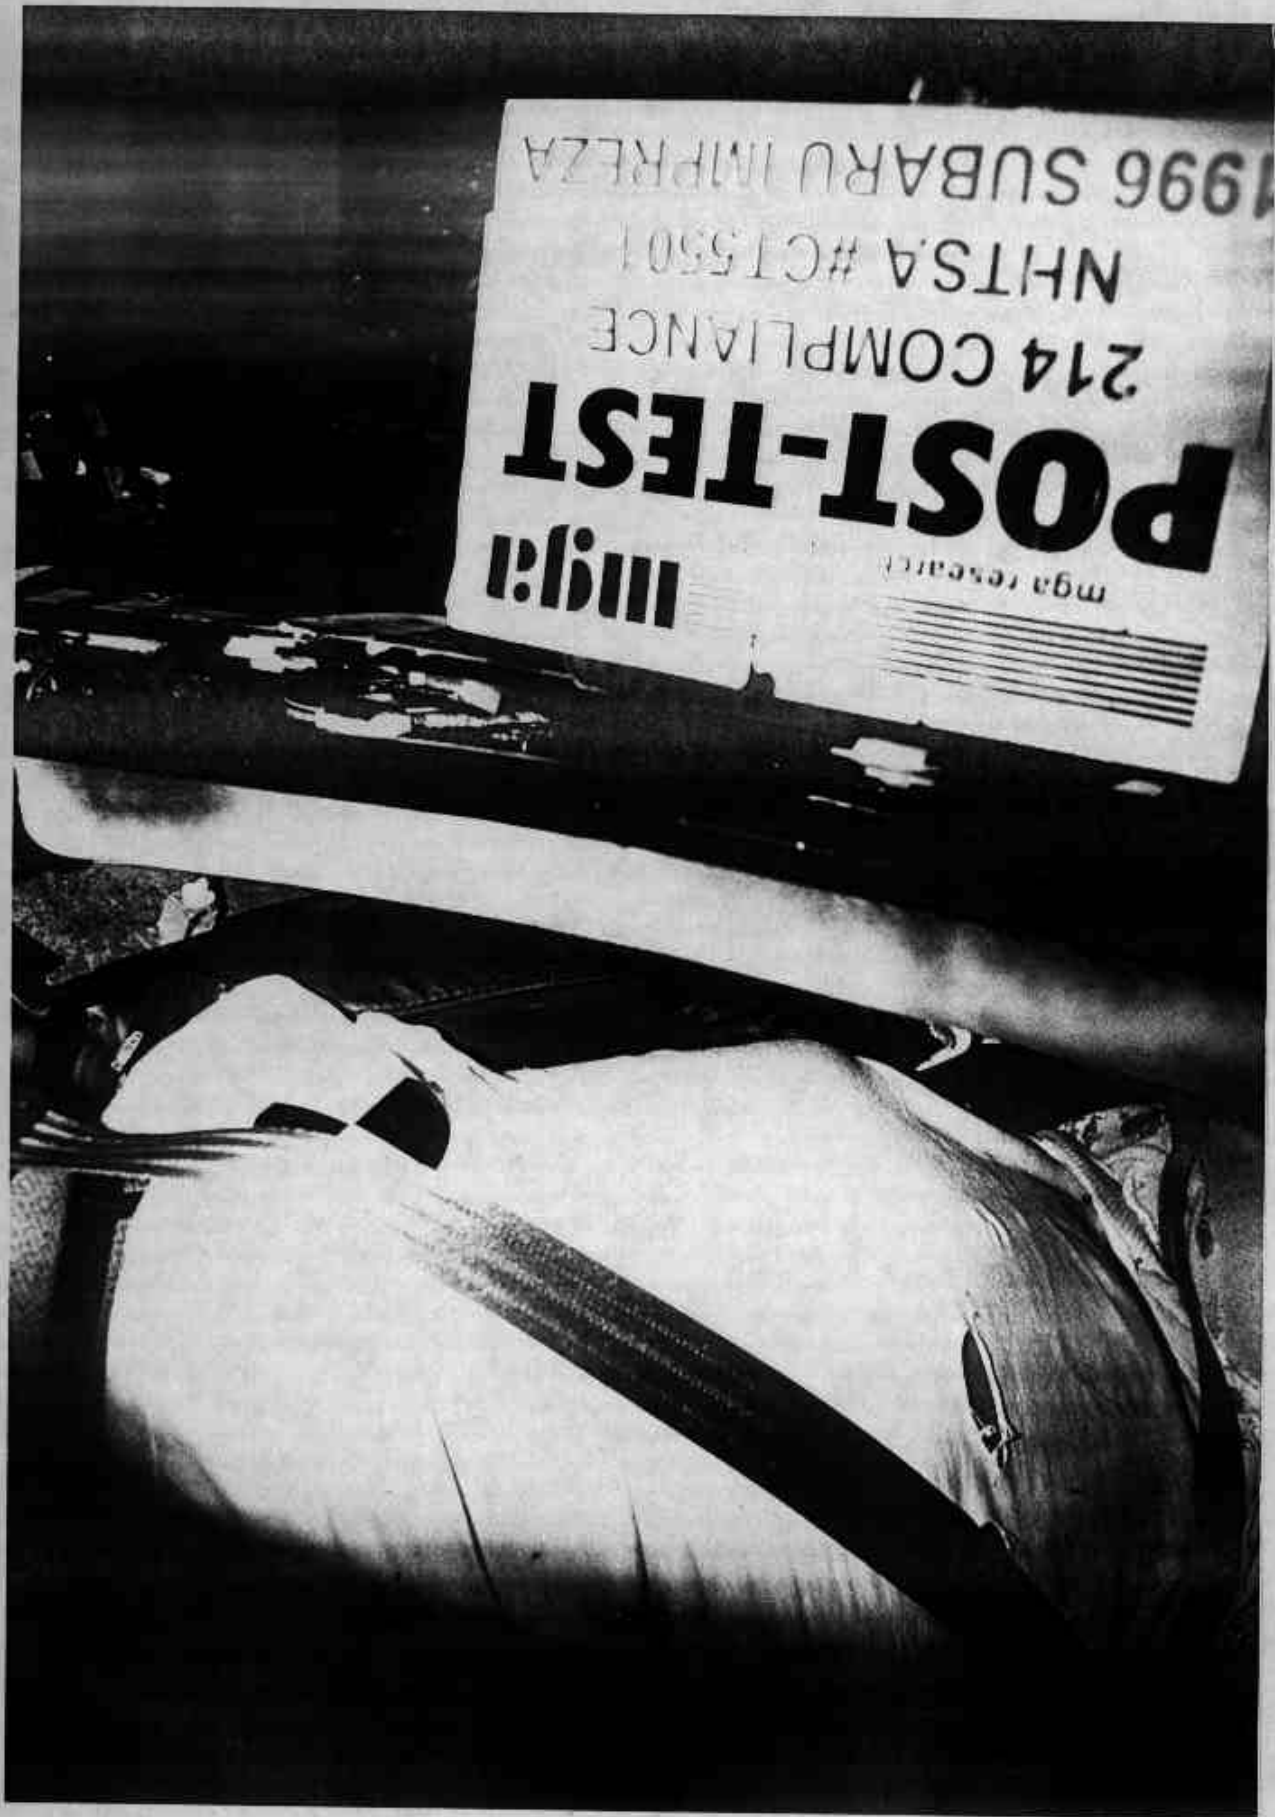
Photo No. A-27 - Post-Test Driver Dummy Shoulder and Door Top View

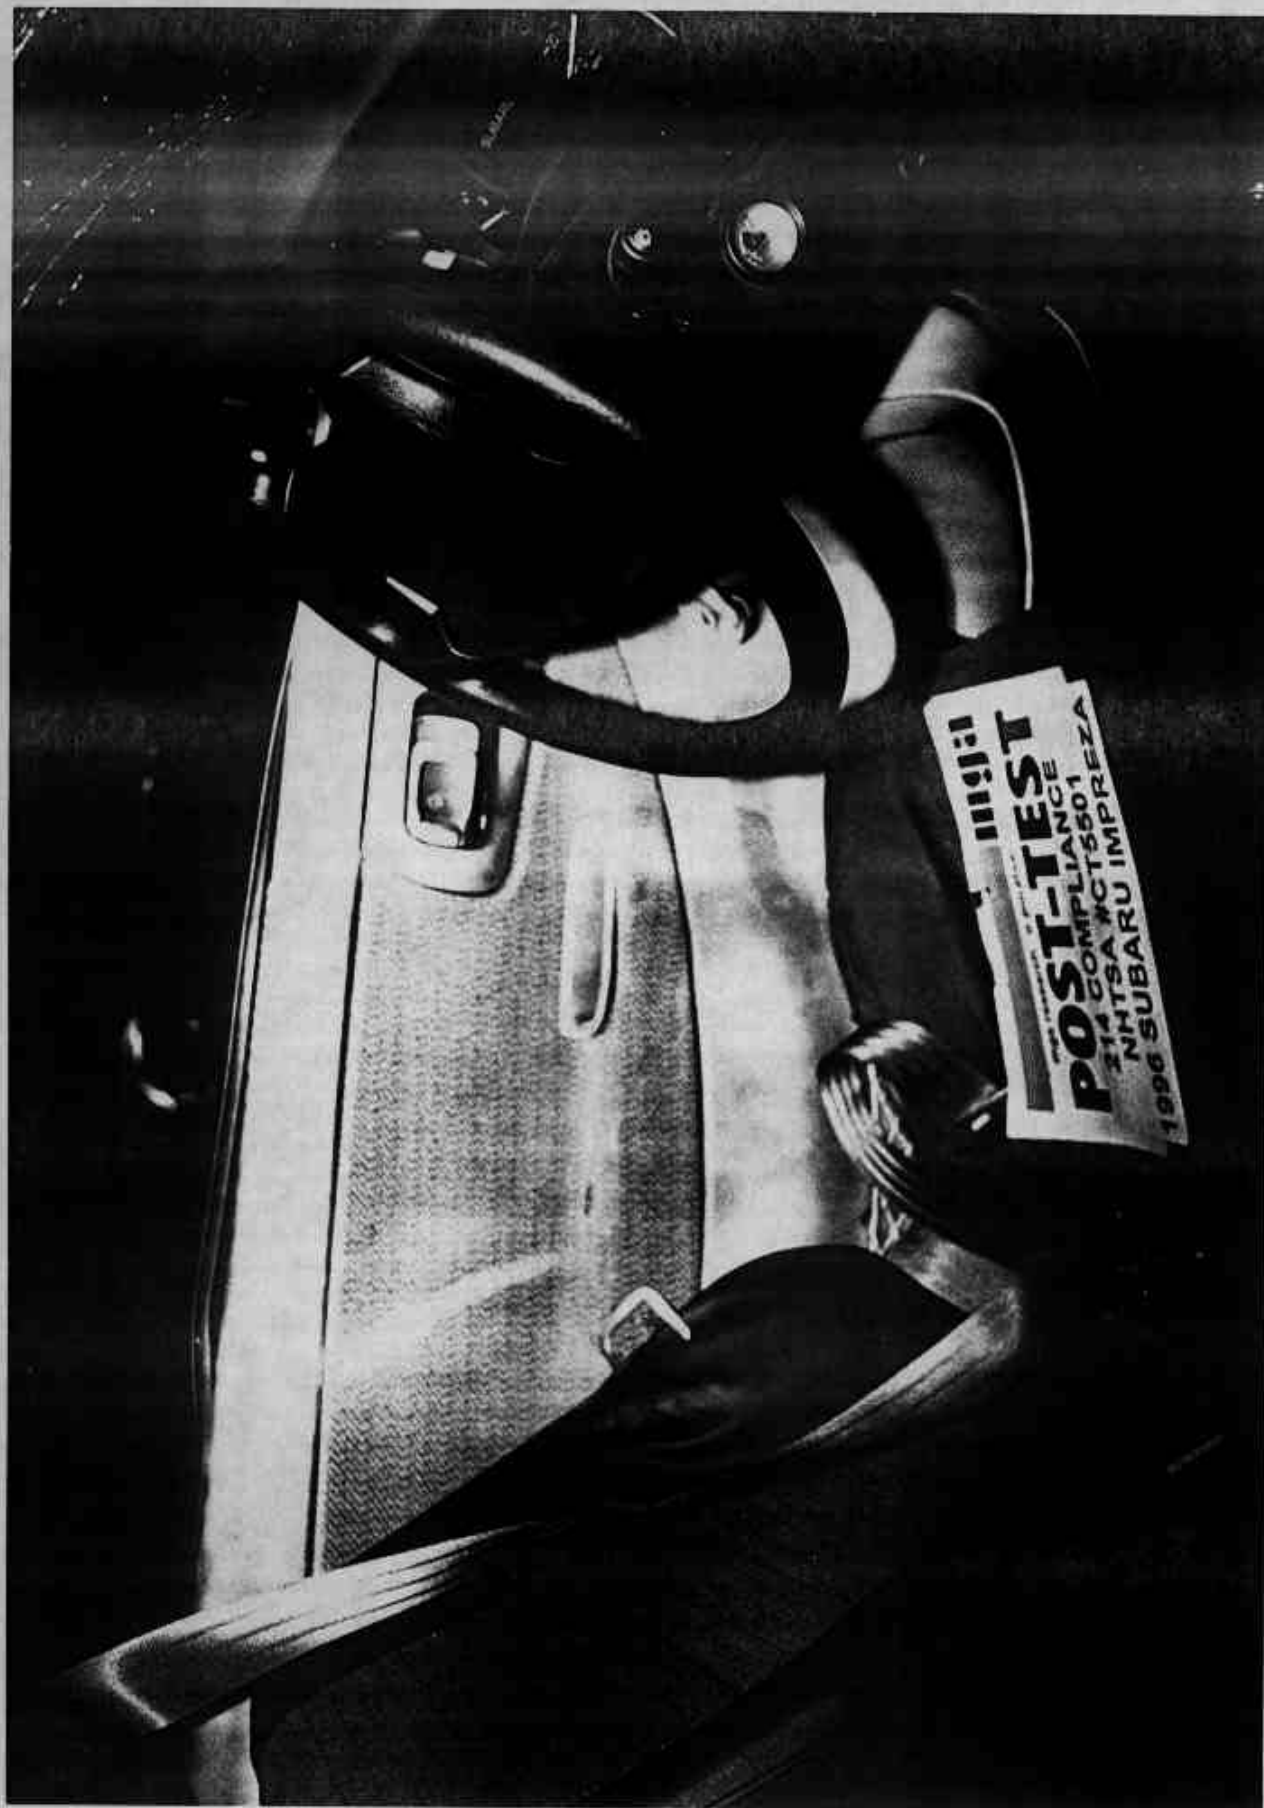
Photo No. A-28 - Post-Test Driver Dummy Contact

| | <u>LEFT FRONT SID</u> | <u>LEFT REAR SID</u> |
|---|---|---|
| Head | <u>to shoulder</u> | <u>to C Post</u> |
| Arm | <u>to door</u> | <u>to trim panel</u> |
| Pelvis | <u>to door</u> | <u>to trim panel</u> |
| Left Knee | <u>to door</u> | <u>to trim panel</u> |

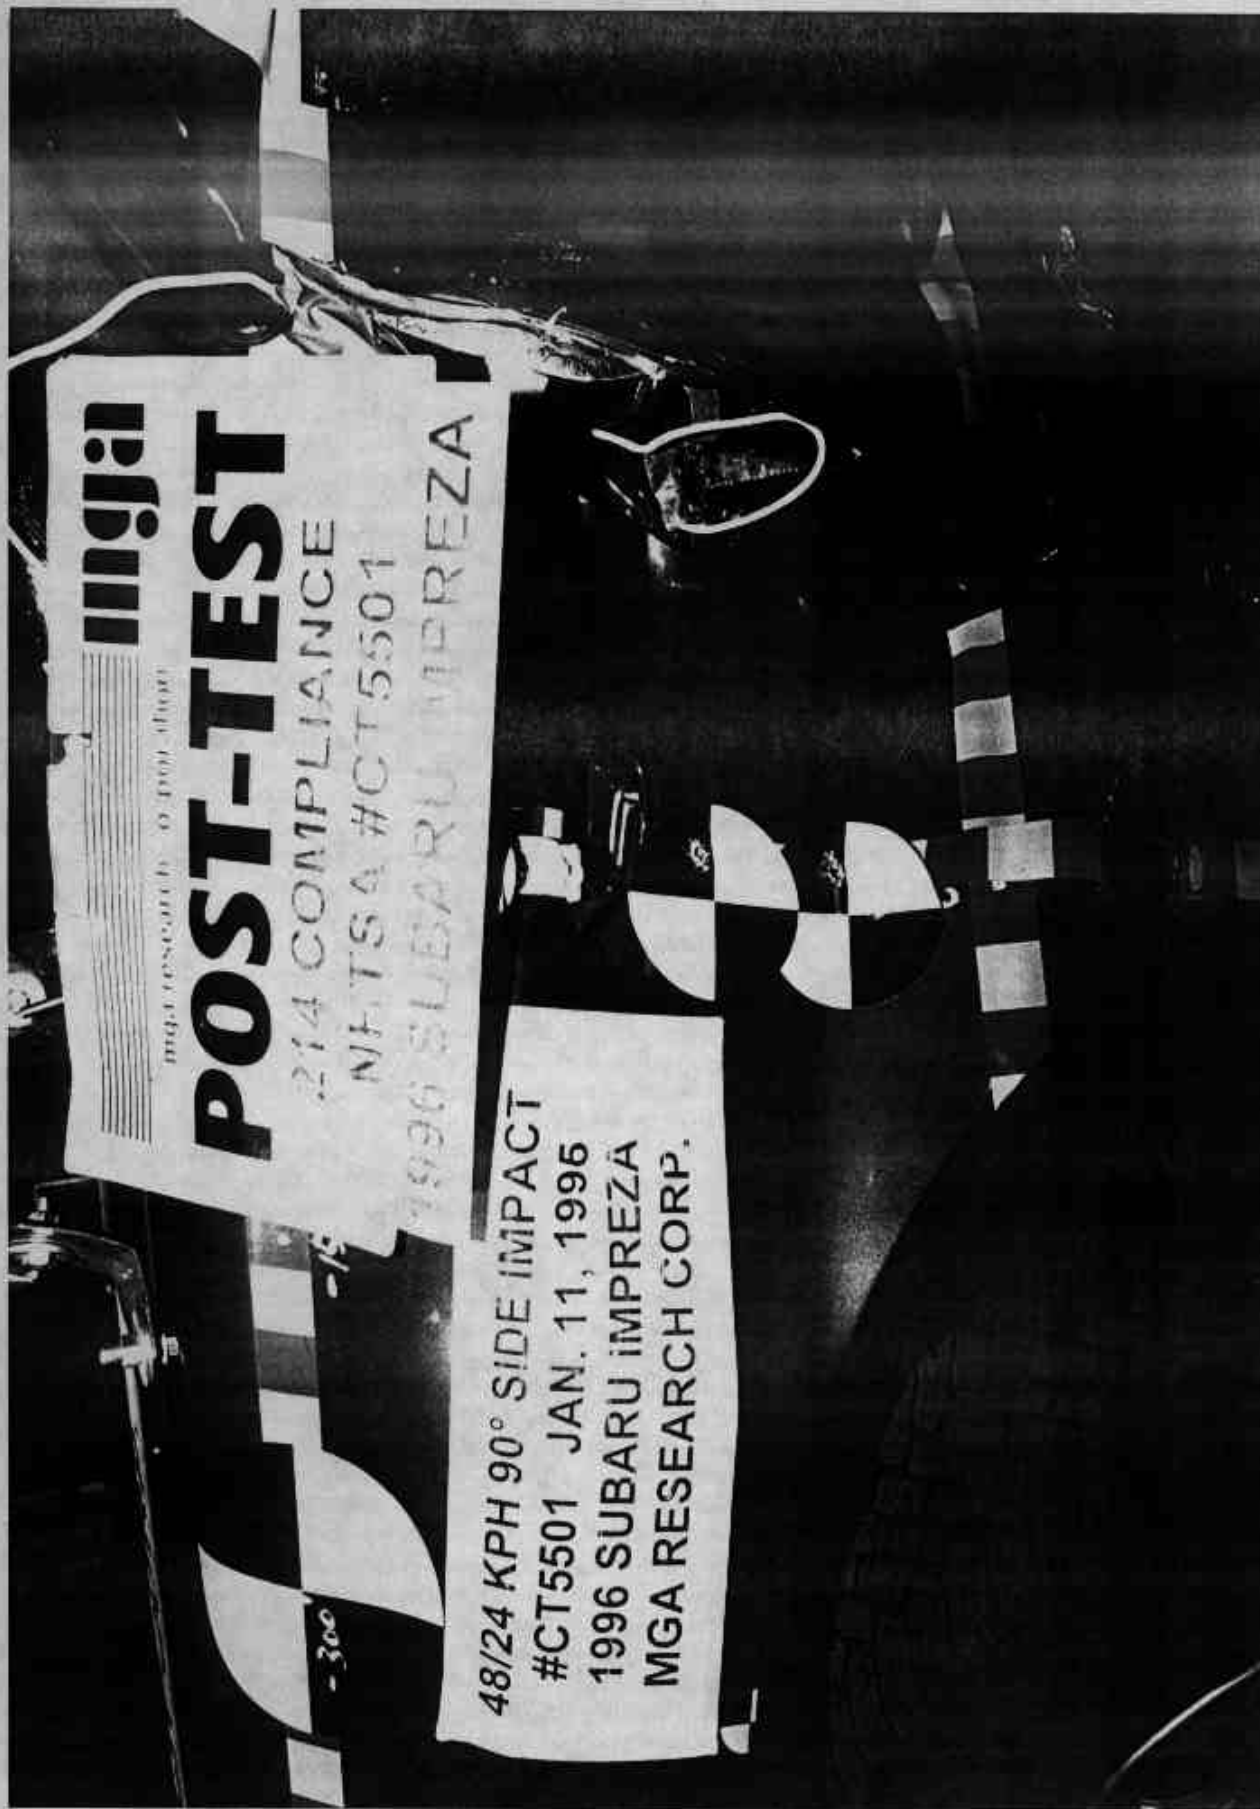
Photo No. A-37 - Post-Test Left Front Impact Point on Vehicle

Horizontal: 16 mm rearward      Vertical: 6 mm high
