REPORT NO.: 214-MGA-96-013  
SAFETY COMPLIANCE TESTING FOR  
FMVSS 214 "SIDE IMPACT PROTECTION -  
PASSENGER CARS"

HONDA MOTOR COMPANY  
1996 HONDA ACCORD 2 DOOR  
NHTSA NO: CT5306

MGA PROVING GROUNDS  
5000 WARREN ROAD  
BURLINGTON, WI 53105

FINAL REPORT

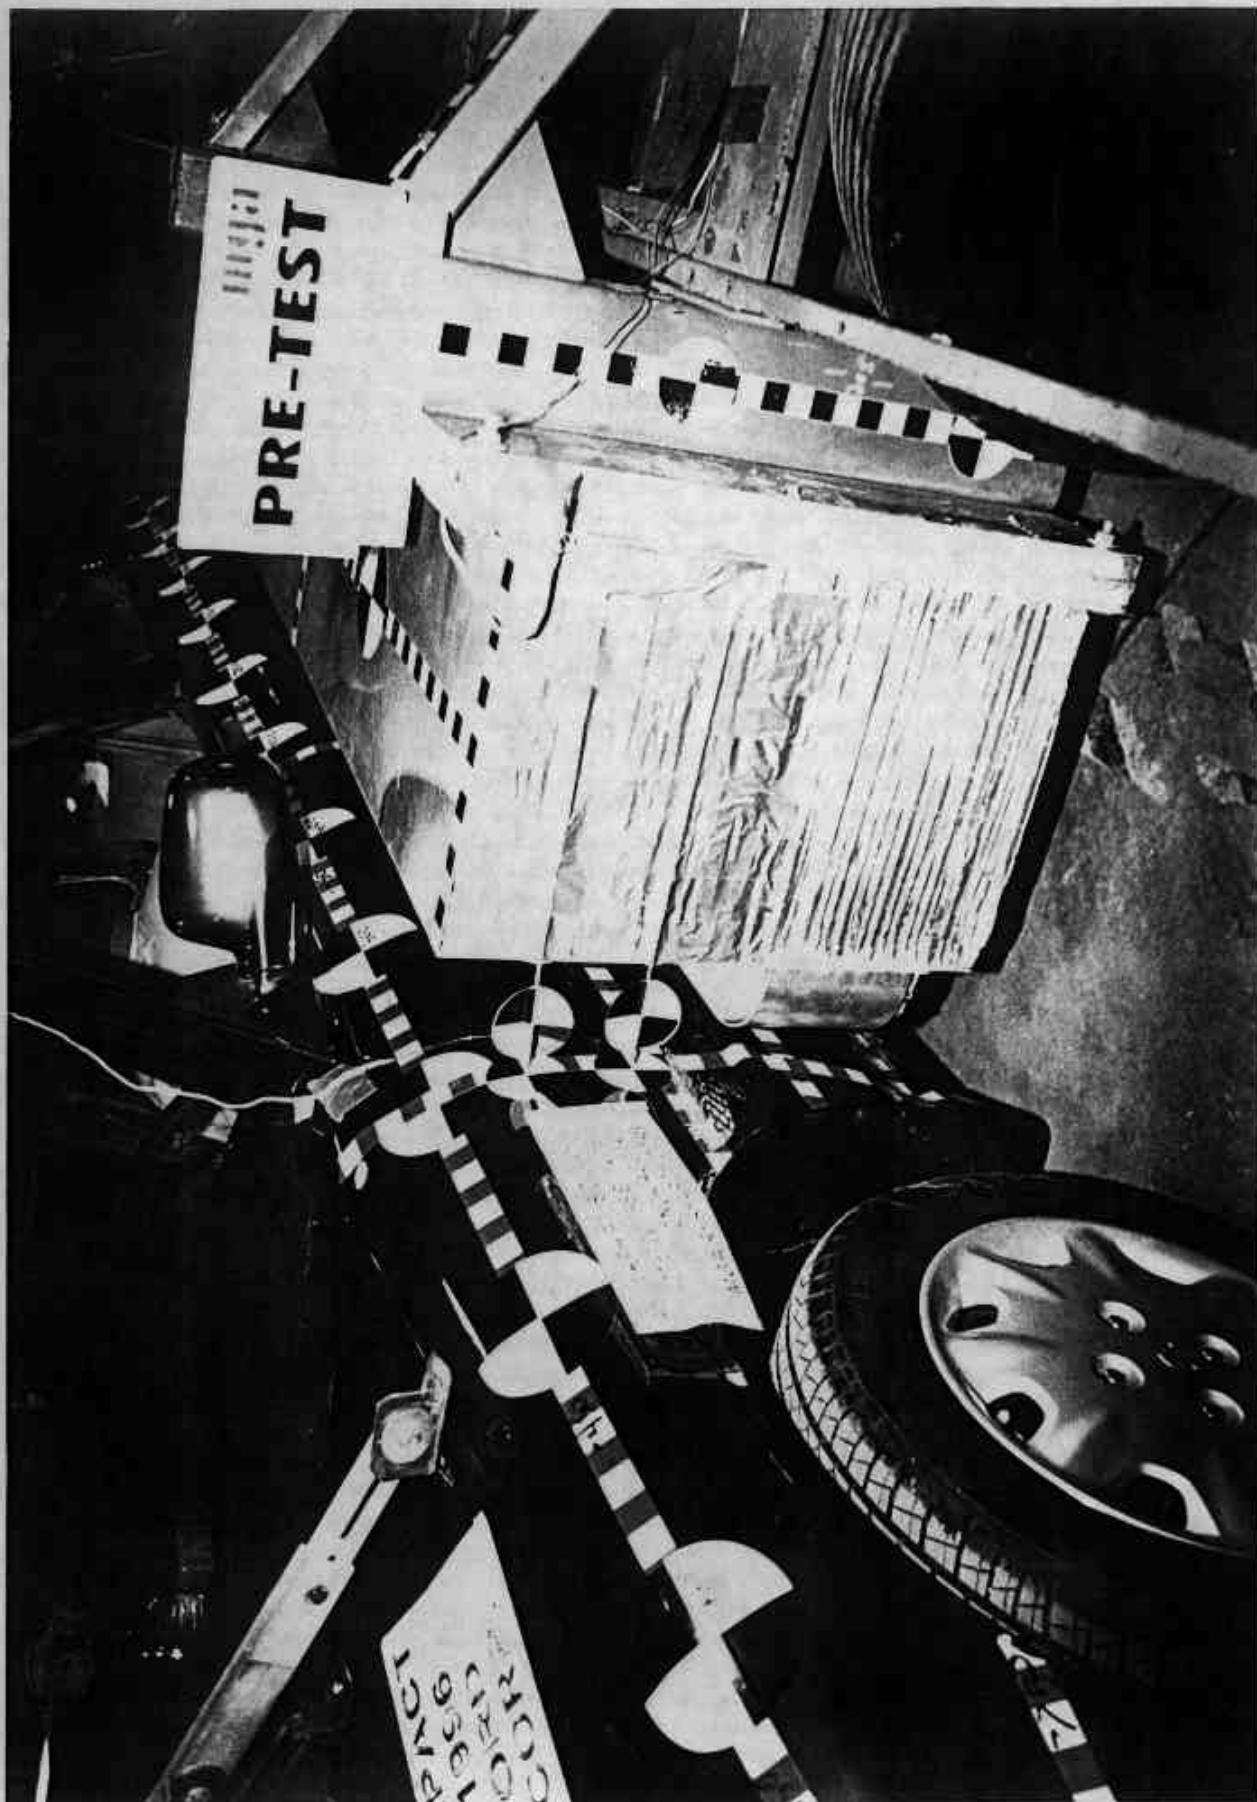
Photo No. A-7 - Pre-Test MDB Positioned Against Vehicle (left side)

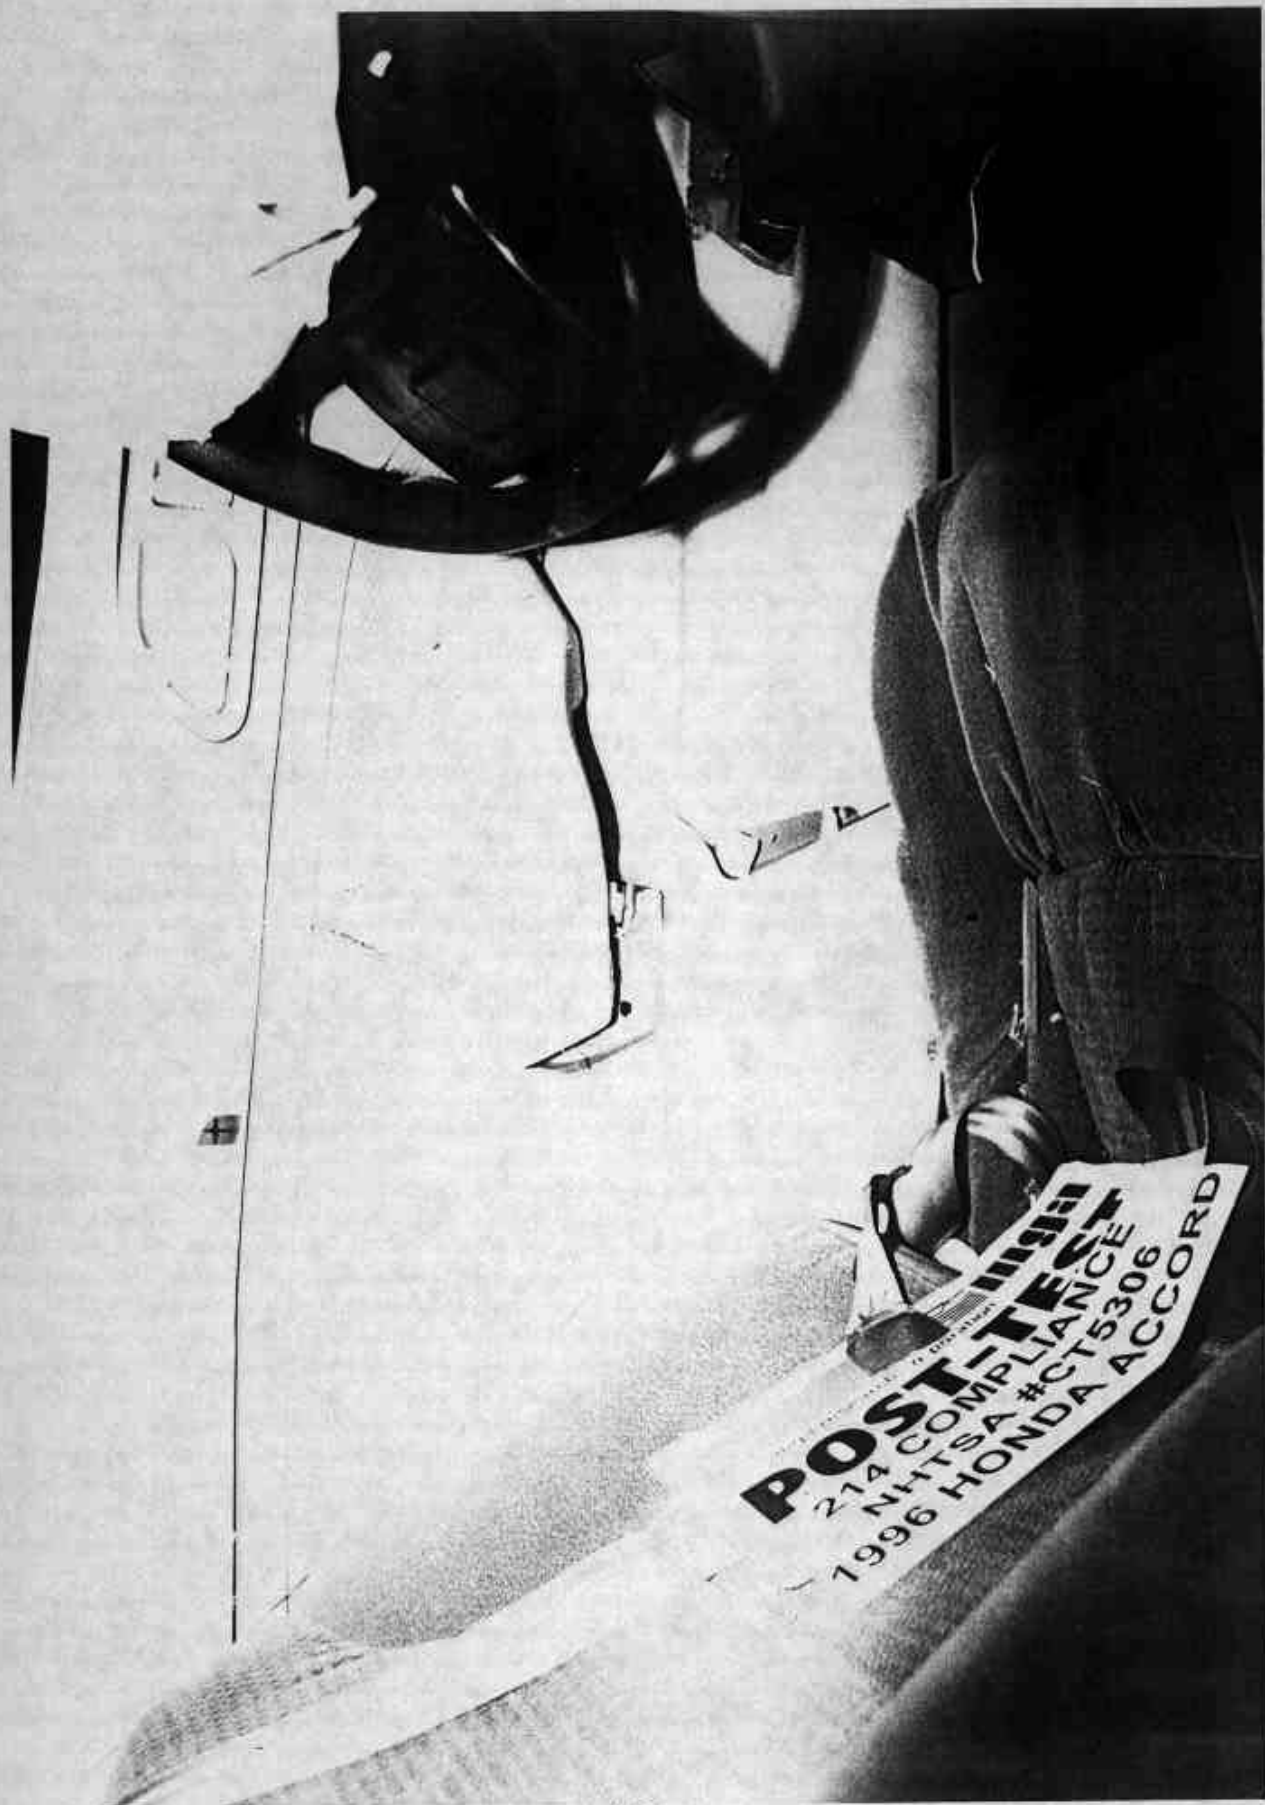
| | <u>LEFT FRONT SID</u> | <u>LEFT REAR SID</u> |
|---|---|---|
| Head | <u>to window sill, shoulder</u> | <u>to C Post</u> |
| Arm | <u>to door panel</u> | <u>to side panel</u> |
| Pelvis | <u>to door panel</u> | <u>to side panel</u> |
| Left Knee | <u>to door panel</u> | <u>to side panel, B post</u> |

Photo No. A-28 - Post-Test Driver Dummy Contact

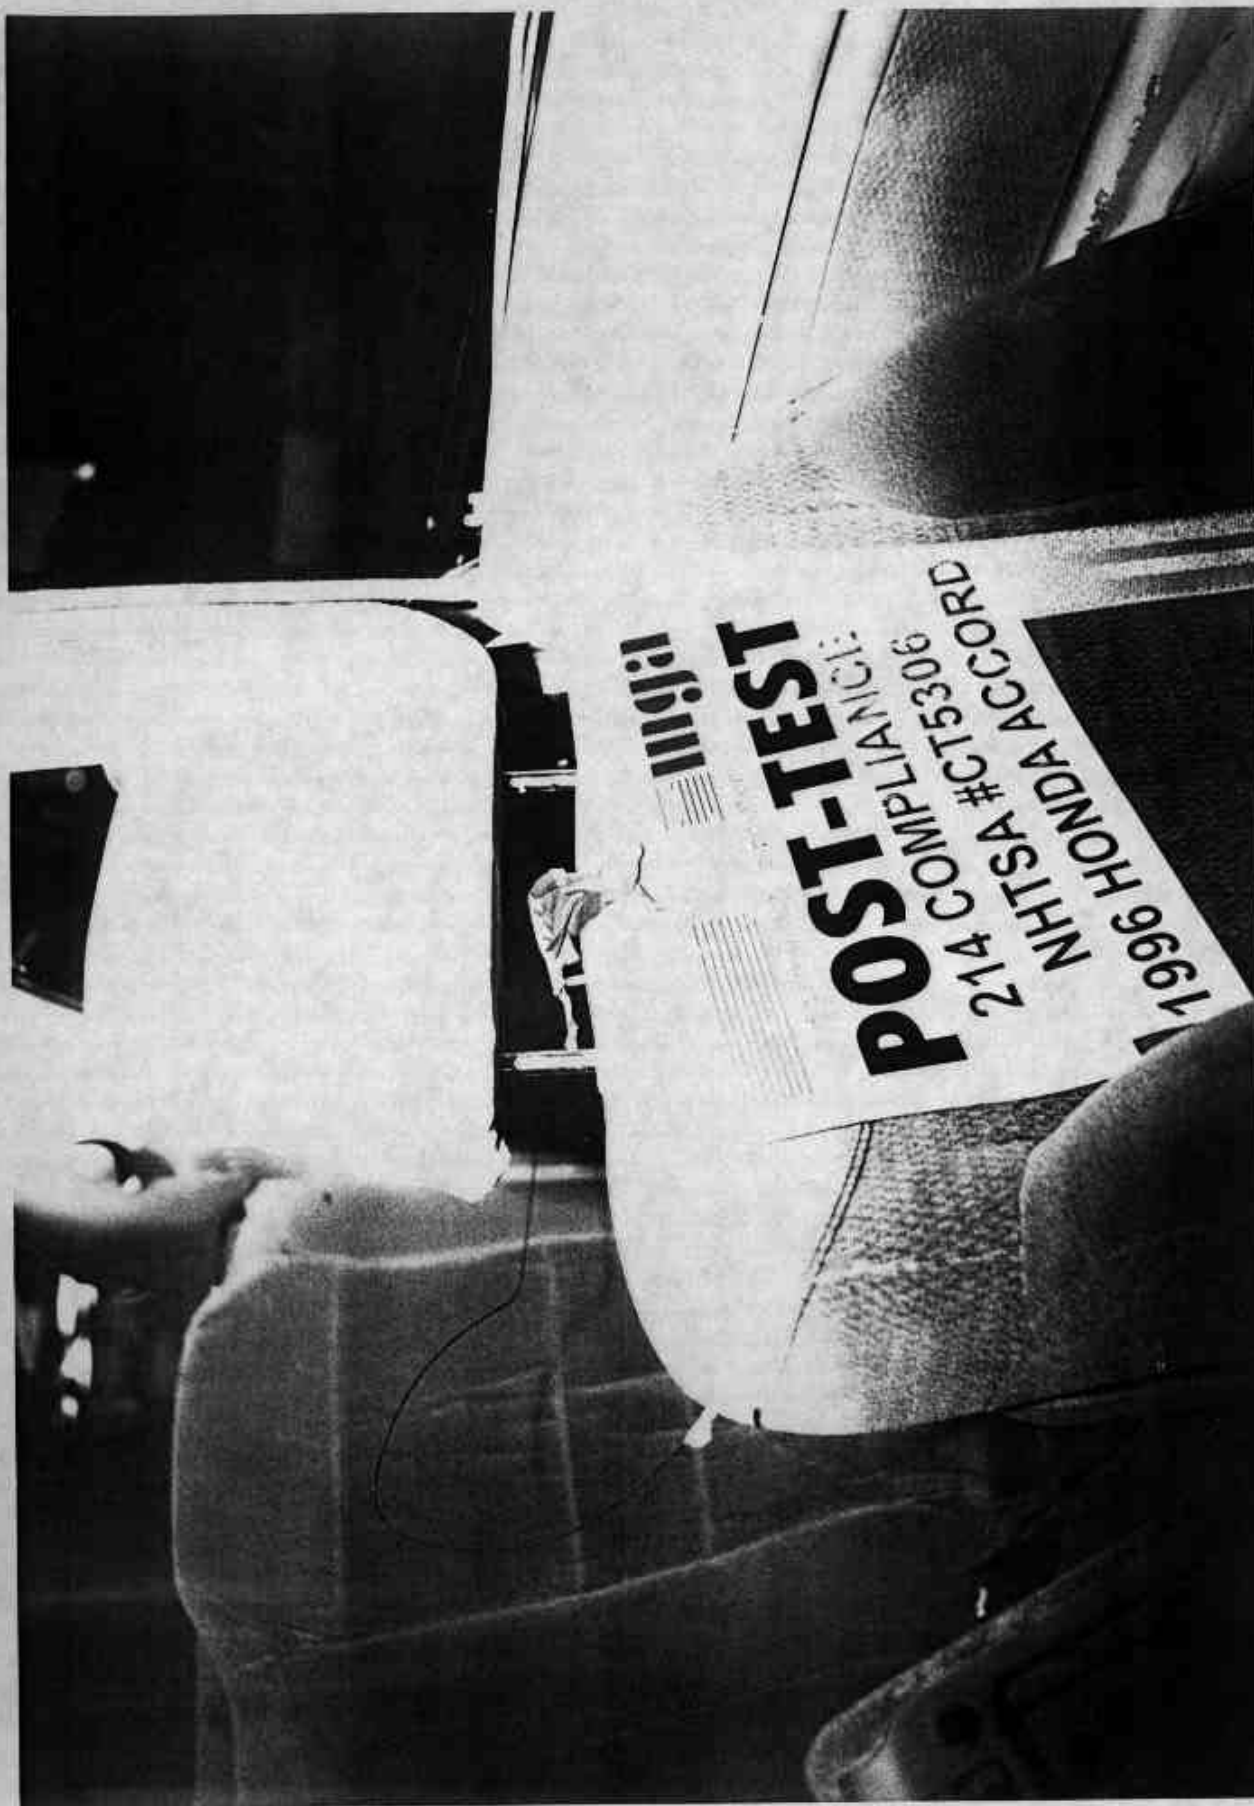
Photo No. A-29 - Post-Test Driver Dummy Contact

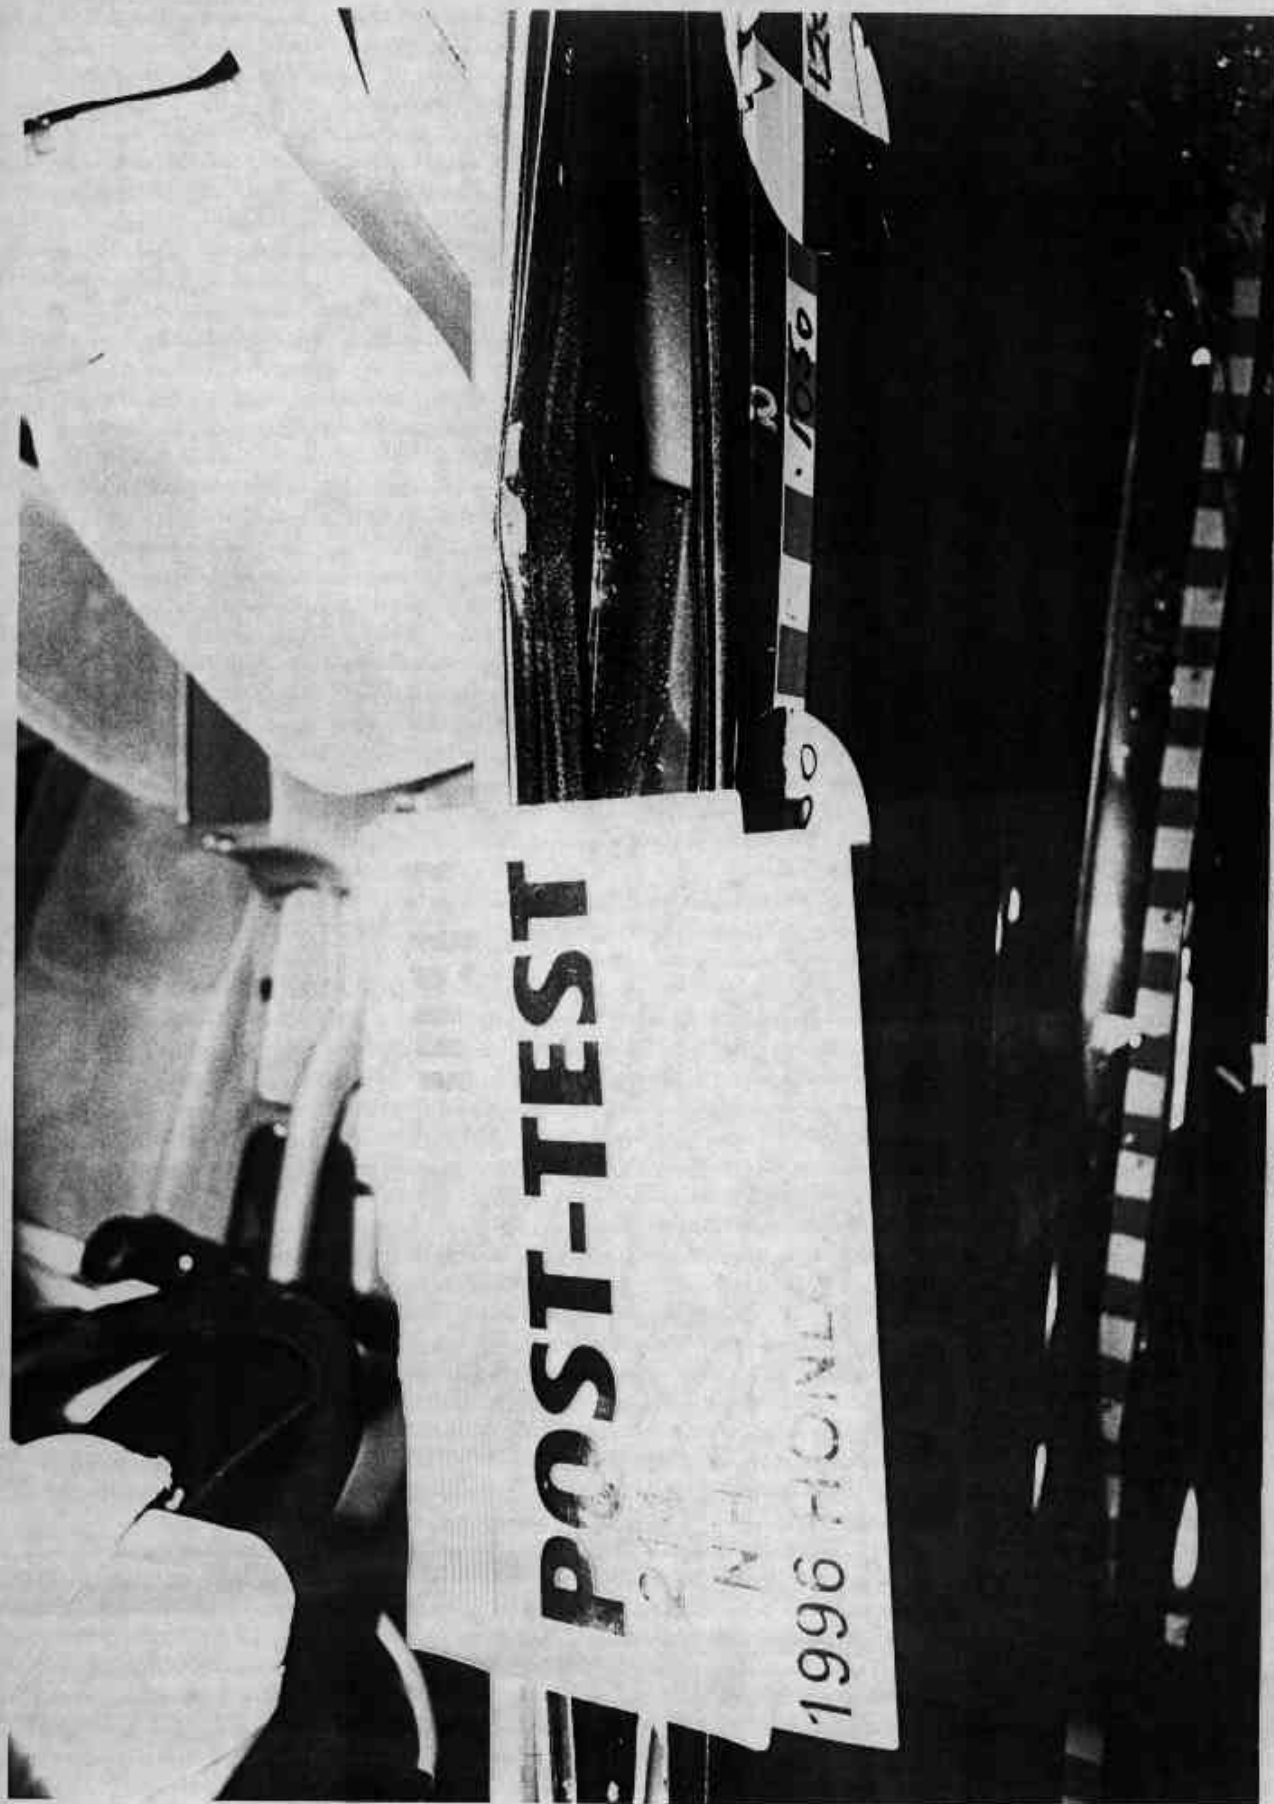
Photo No. A-30 - Post-Test Driver Dummy Contact

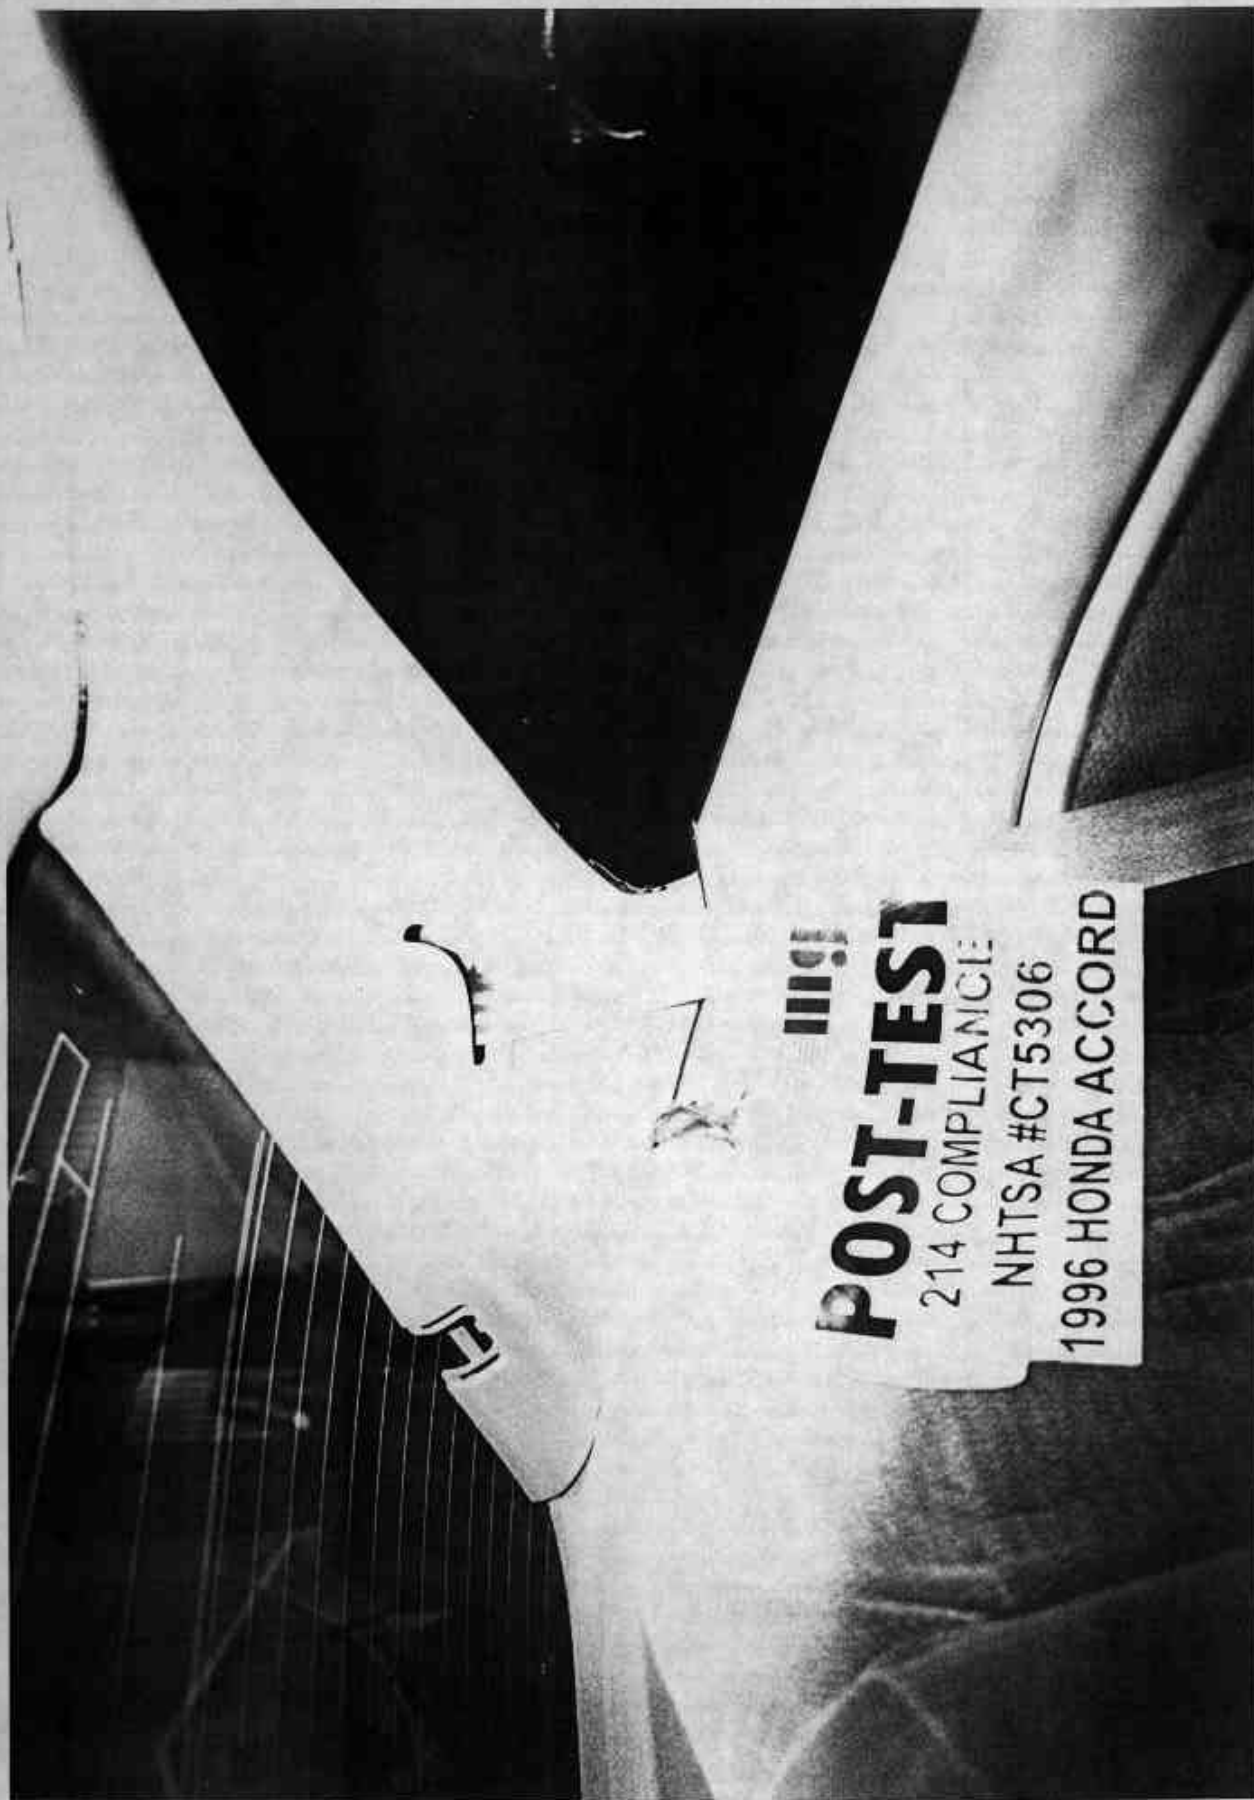
Photo No. A-38 - Post-Test Passenger Dummy Contact

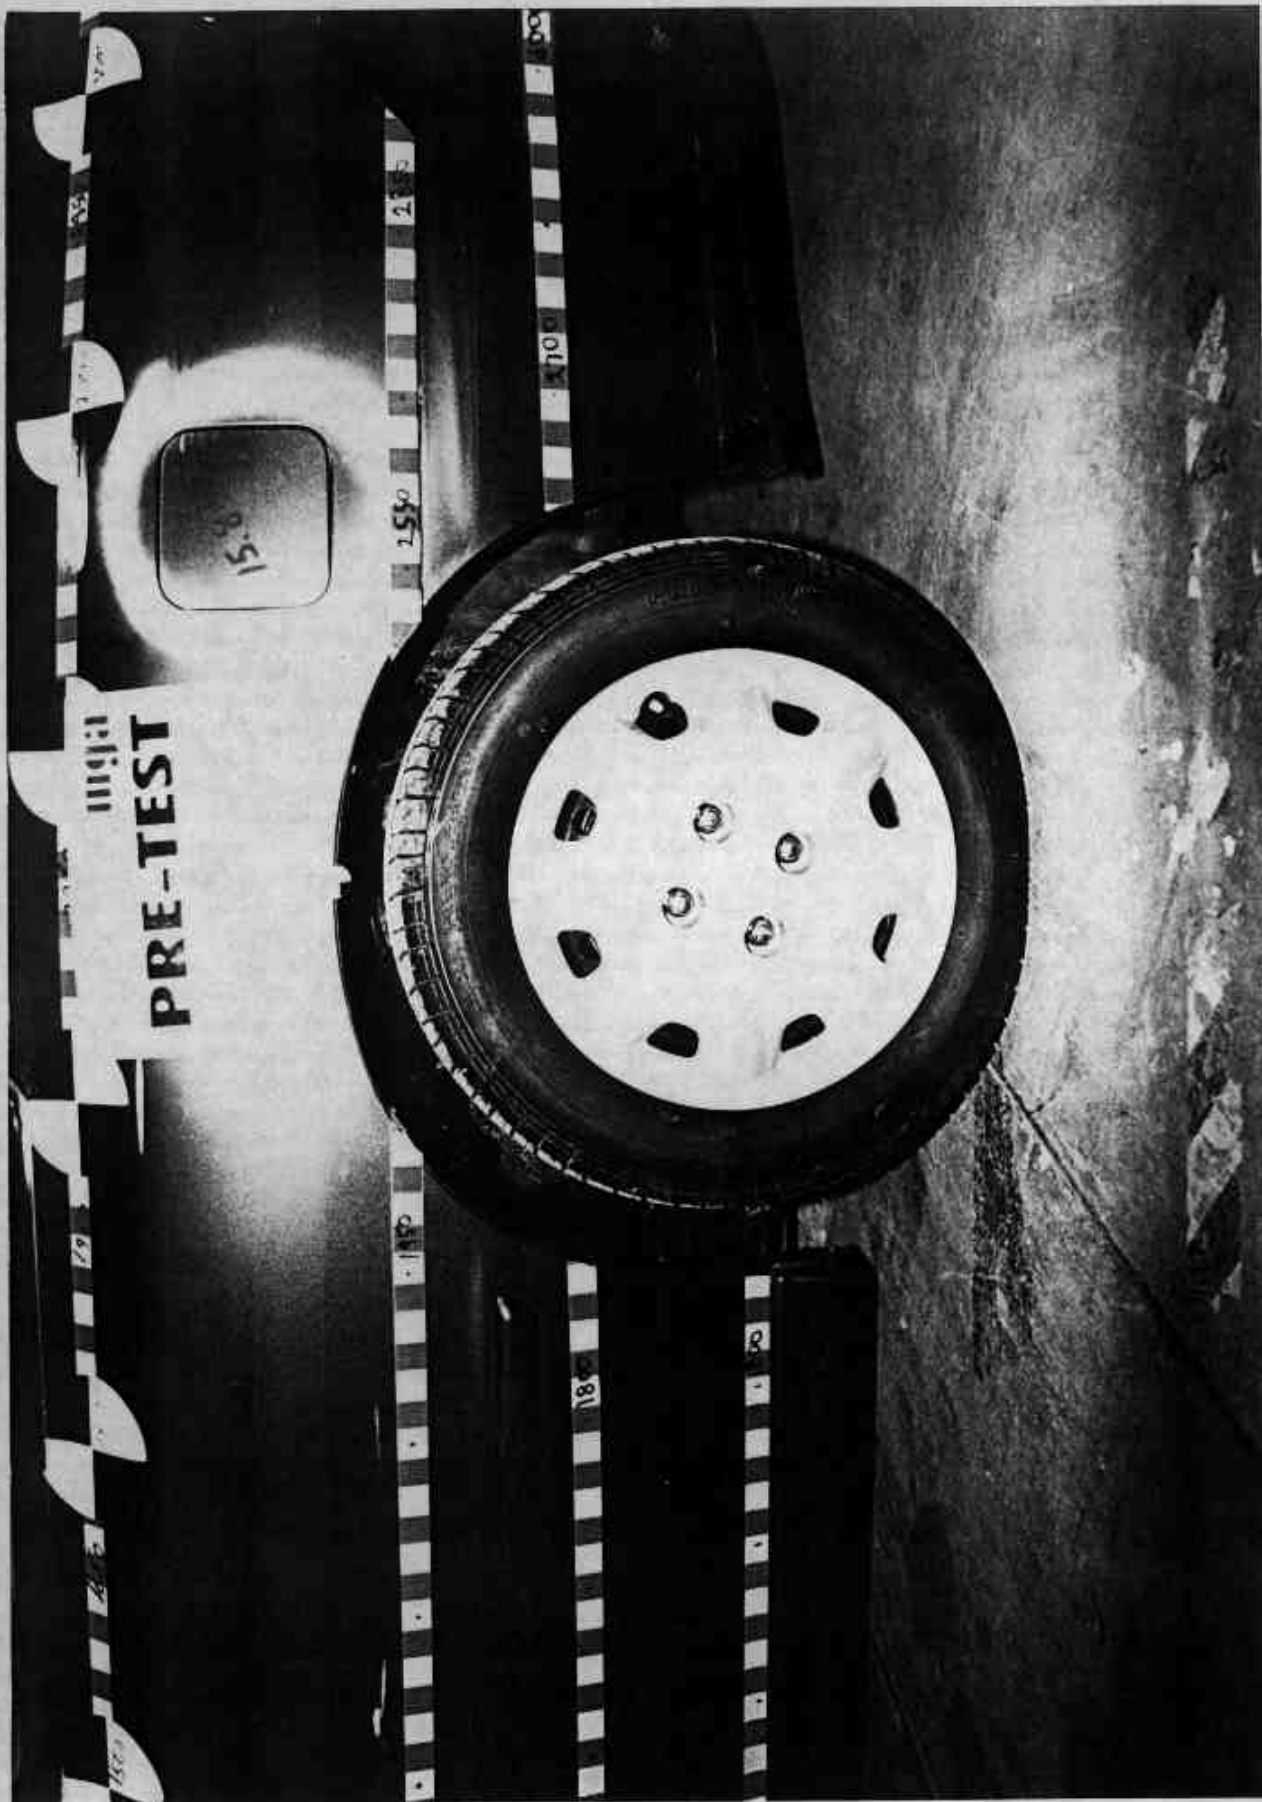
Photo No. A-49 - Left Rear Attitude Point

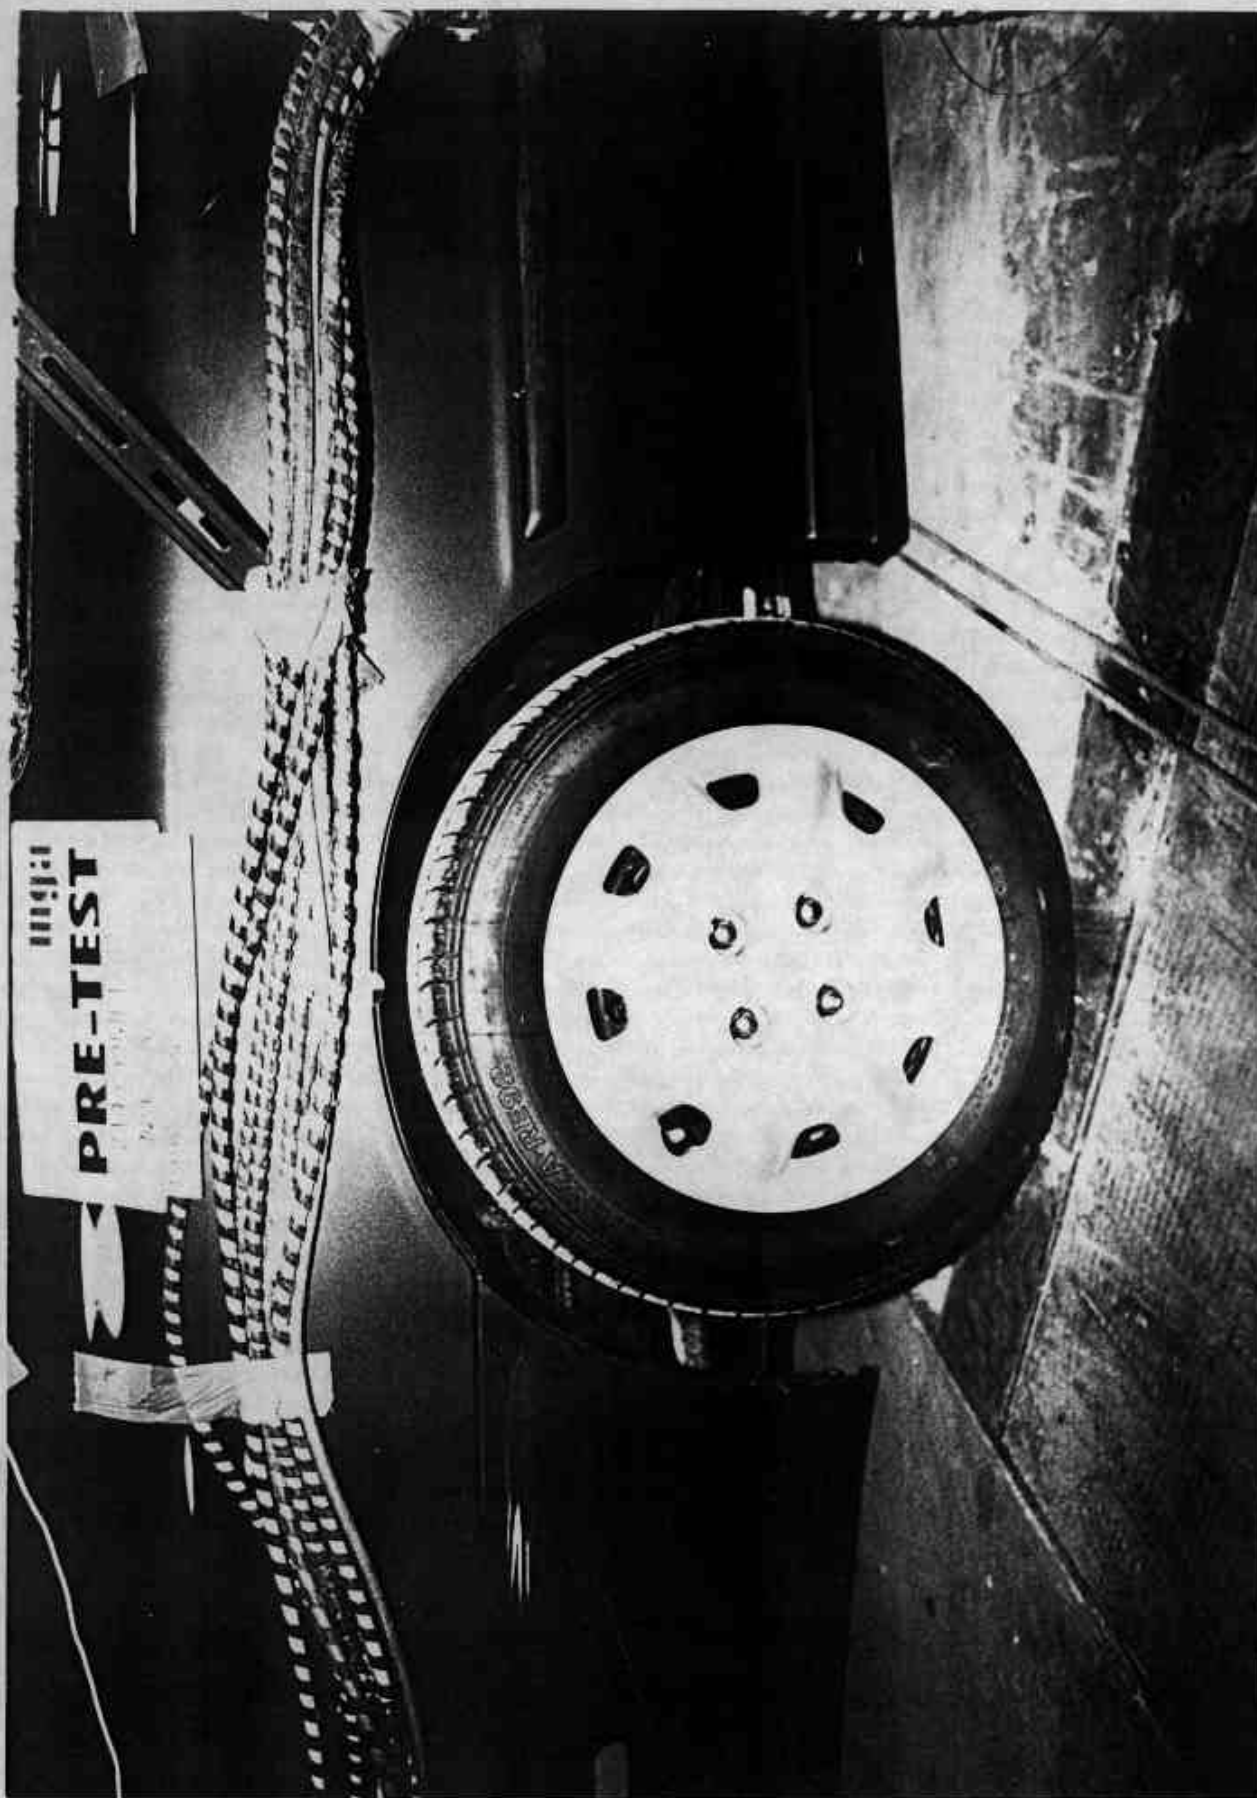
Photo No. A-50 - Right Rear Attitude Point
