Vehicle Safety Compliance Testing  
for Occupant Crash Protection,  
Windshield Mounting, Windshield Zone Intrusion,  
and Fuel System Integrity

Isuzu Motors  
1996 Isuzu Rodeo  
4-door MPV  
NHTSA Number: CT5701  
TRC Test Number: 960207

Transportation Research Center Inc.  
10820 State Route 347  
East Liberty, Ohio 43319

Final Report

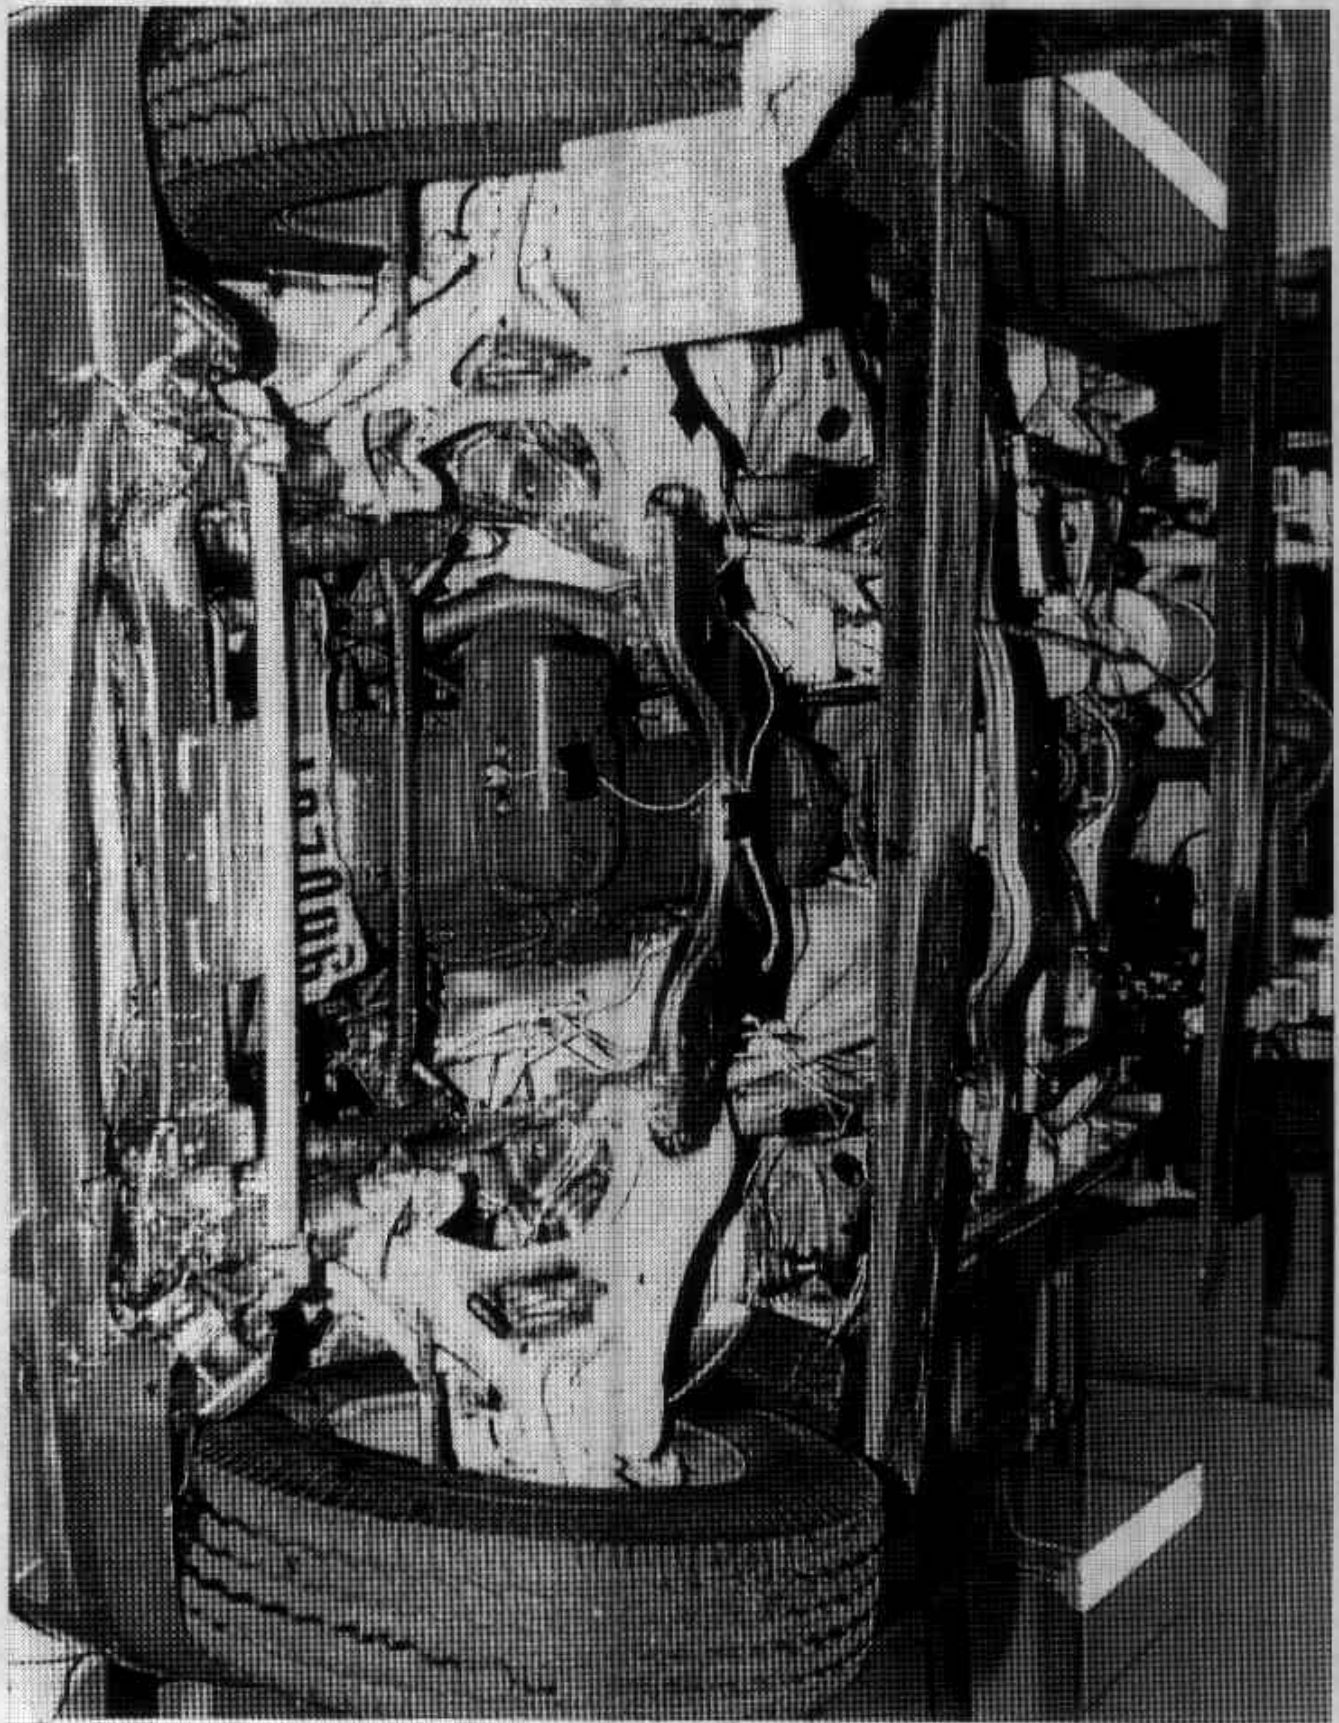
Figure A-8. Post-Test Front Underbody View
