REPORT NO.: 214-MGA-96-017  
SAFETY COMPLIANCE TESTING FOR  
FMVSS 214 "SIDE IMPACT PROTECTION -  
PASSENGER CARS"

CHRYSLER CORPORATION  
1996 CHRYSLER SEBRING JX CONVERTIBLE  
NHTSA NO: CT0309

MGA PROVING GROUNDS  
5000 WARREN ROAD  
BURLINGTON, WI 53105

FINAL REPORT

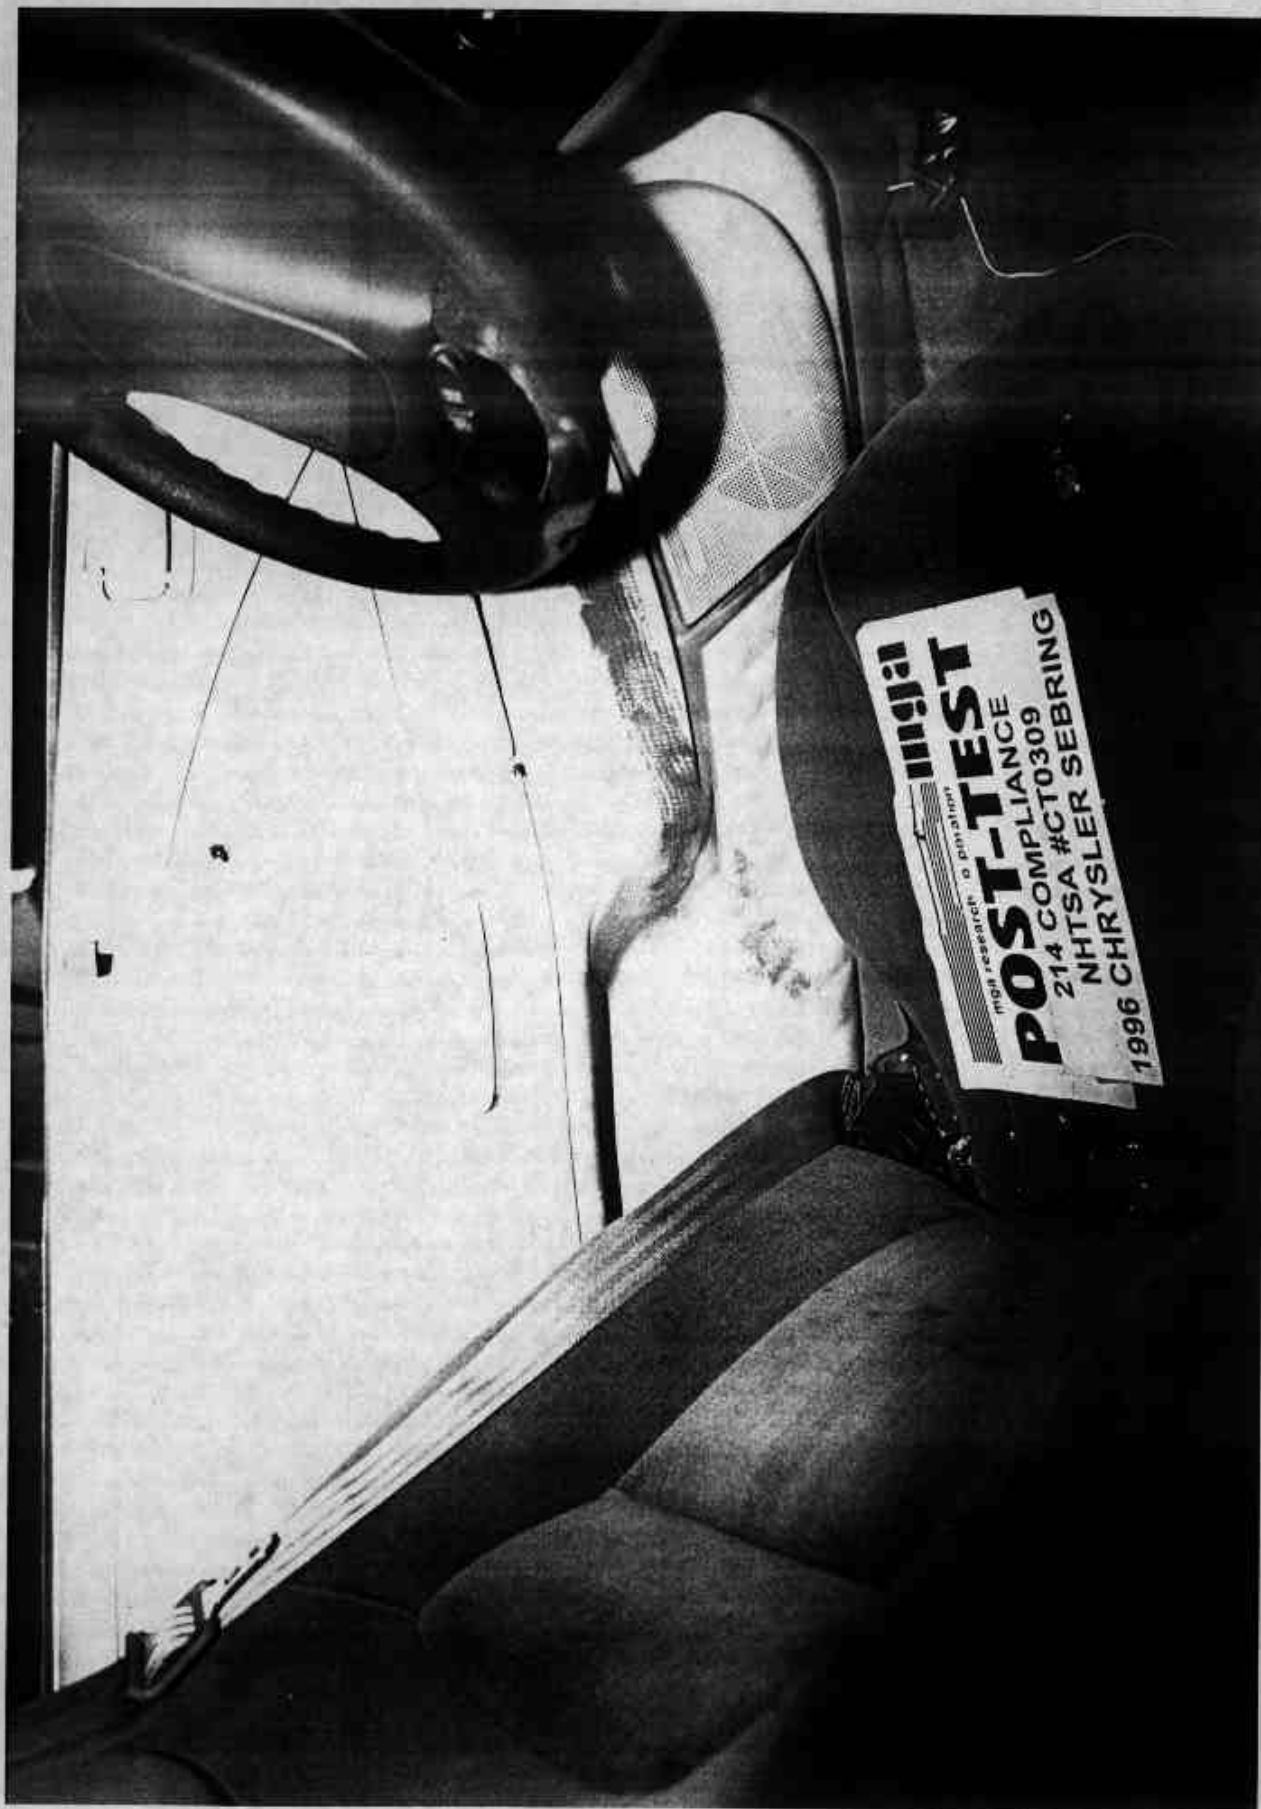
Photo No. A-28 - Post-Test Driver Dummy Contact

VISIBLE DUMMY CONTACT POINTS:

| | <u>LEFT FRONT SID</u> | <u>LEFT REAR SID</u> |
|---|---|---|
| Arm | <u>to mid door panel</u> | <u>to side panel</u> |
| Left Knee | <u>to lower arm rest</u> | <u>to side panel</u> |

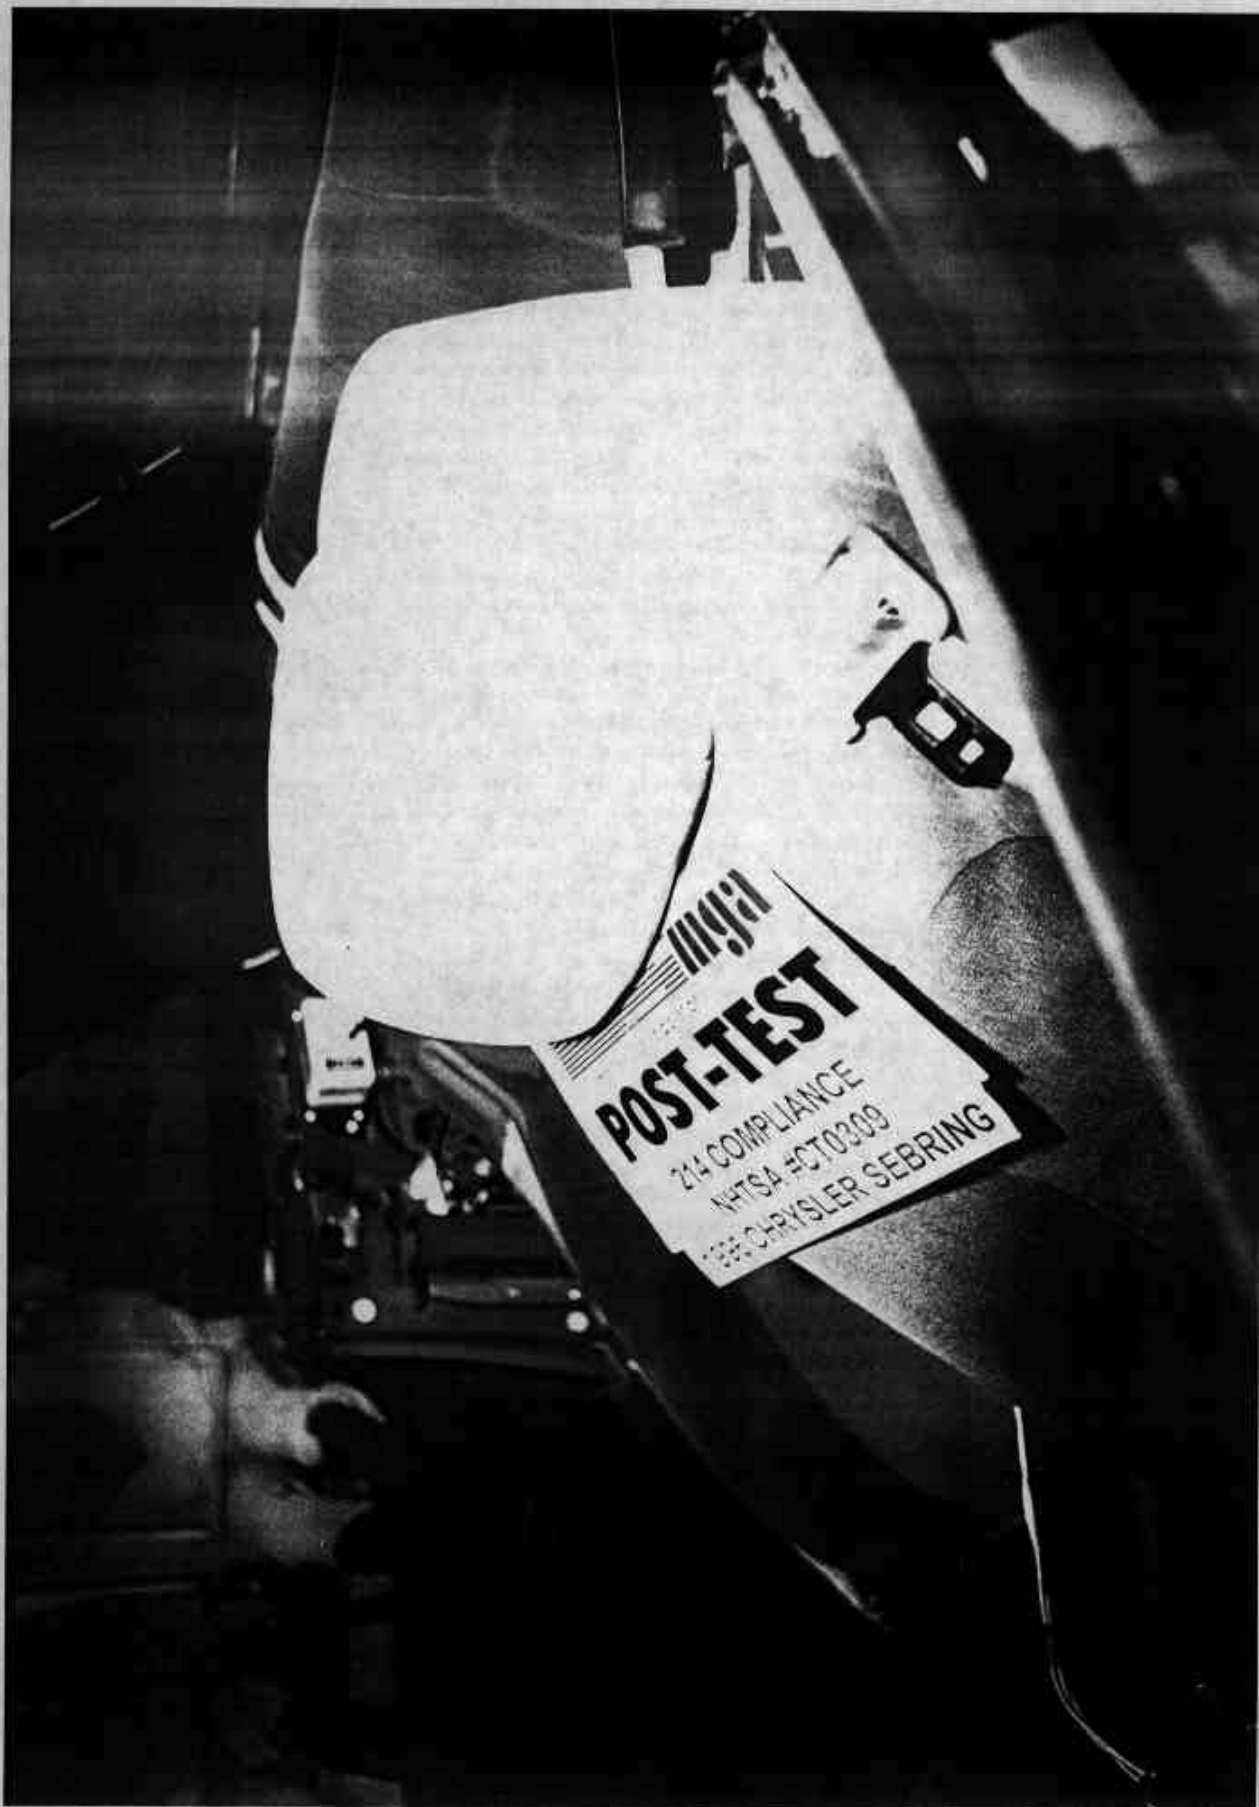
Photo No. A-29 - Post-Test Driver Dummy Head Contact

| | <u>LEFT FRONT SID</u> | <u>LEFT REAR SID</u> |
|---|---|---|
| Head | <u>to head rest, window, window sill</u> | <u>to C pillar</u> |

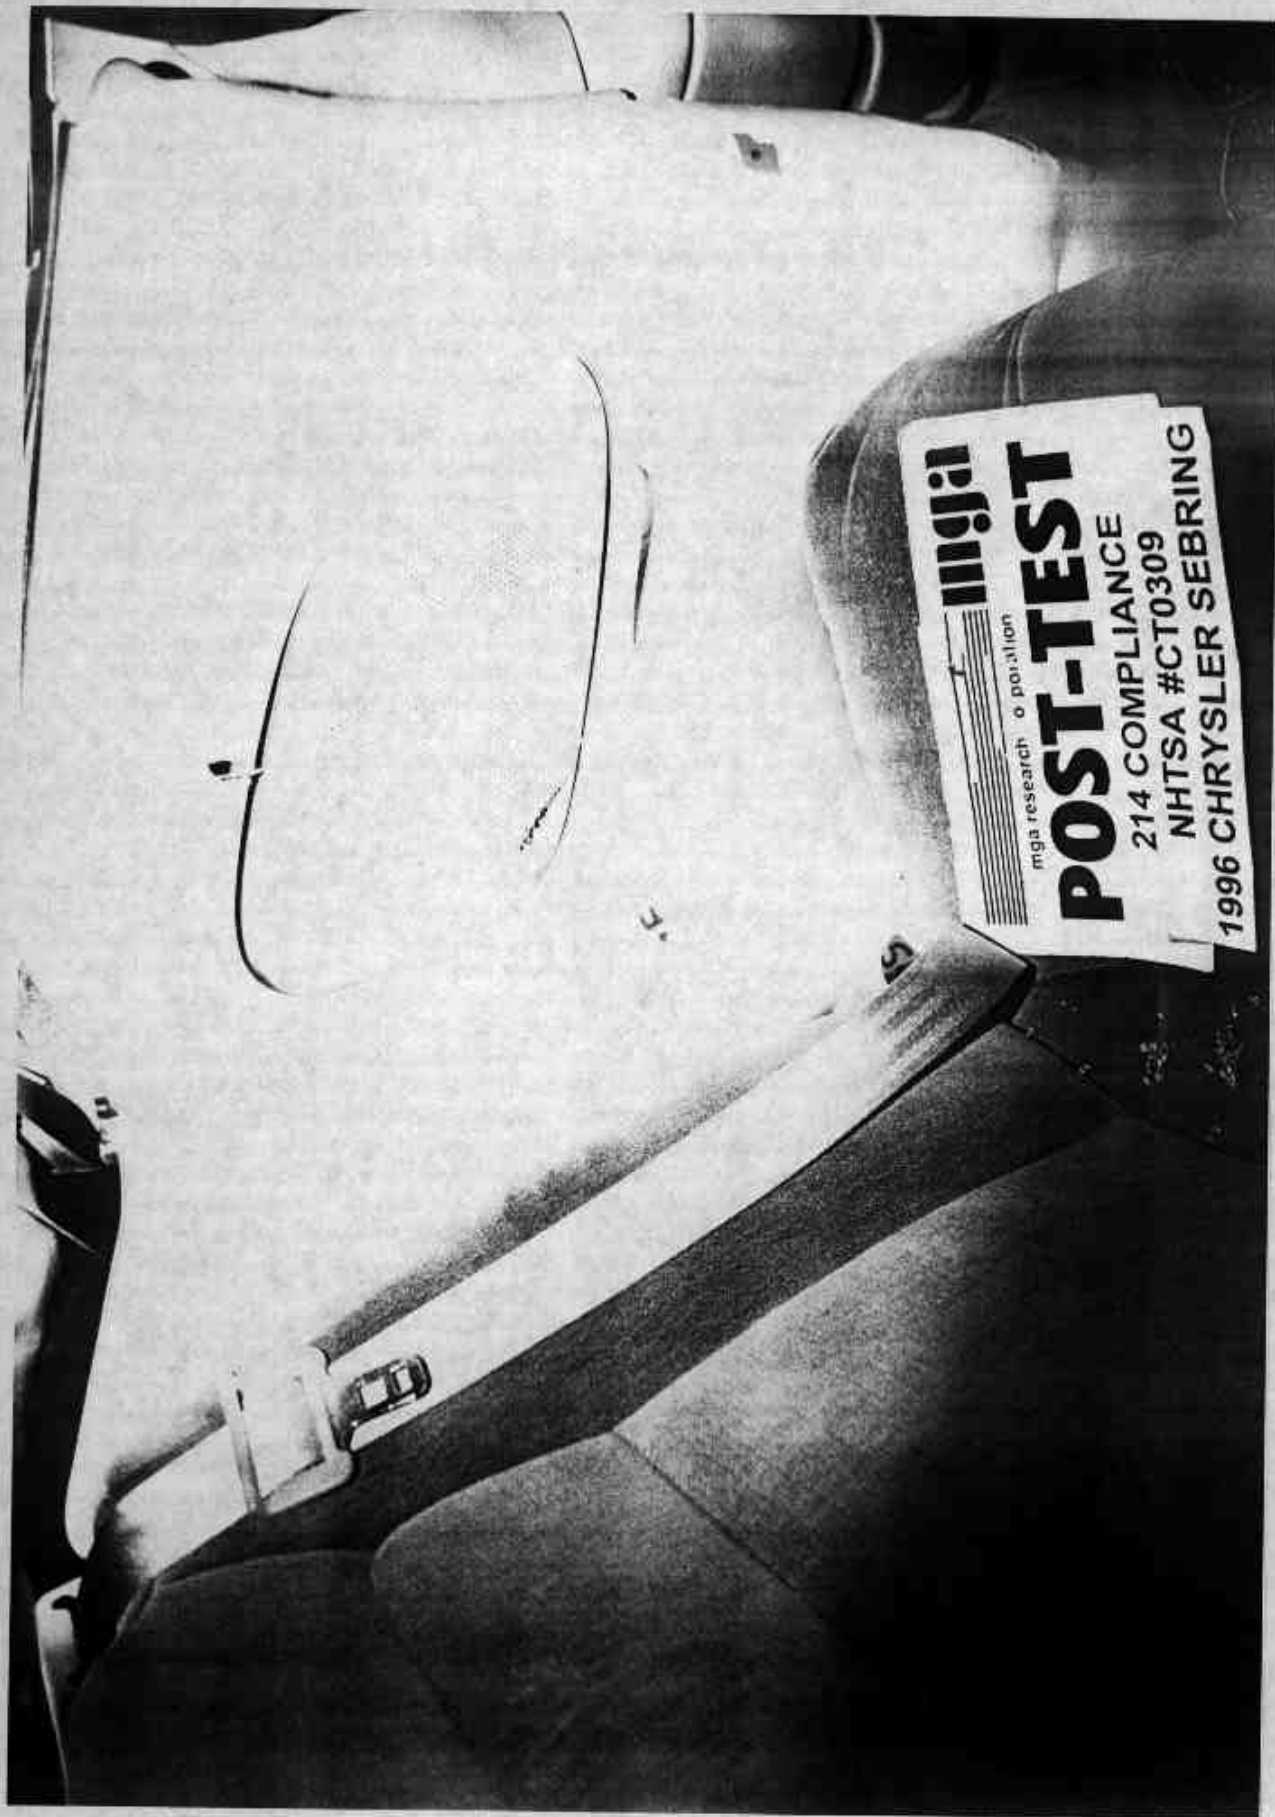
Photo No. A-35 - Post-Test Passenger Dummy Contact

| | <u>LEFT FRONT SID</u> | <u>LEFT REAR SID</u> |
|---|---|---|
| Pelvis | <u>no visible contact</u> | <u>to arm rest</u> |

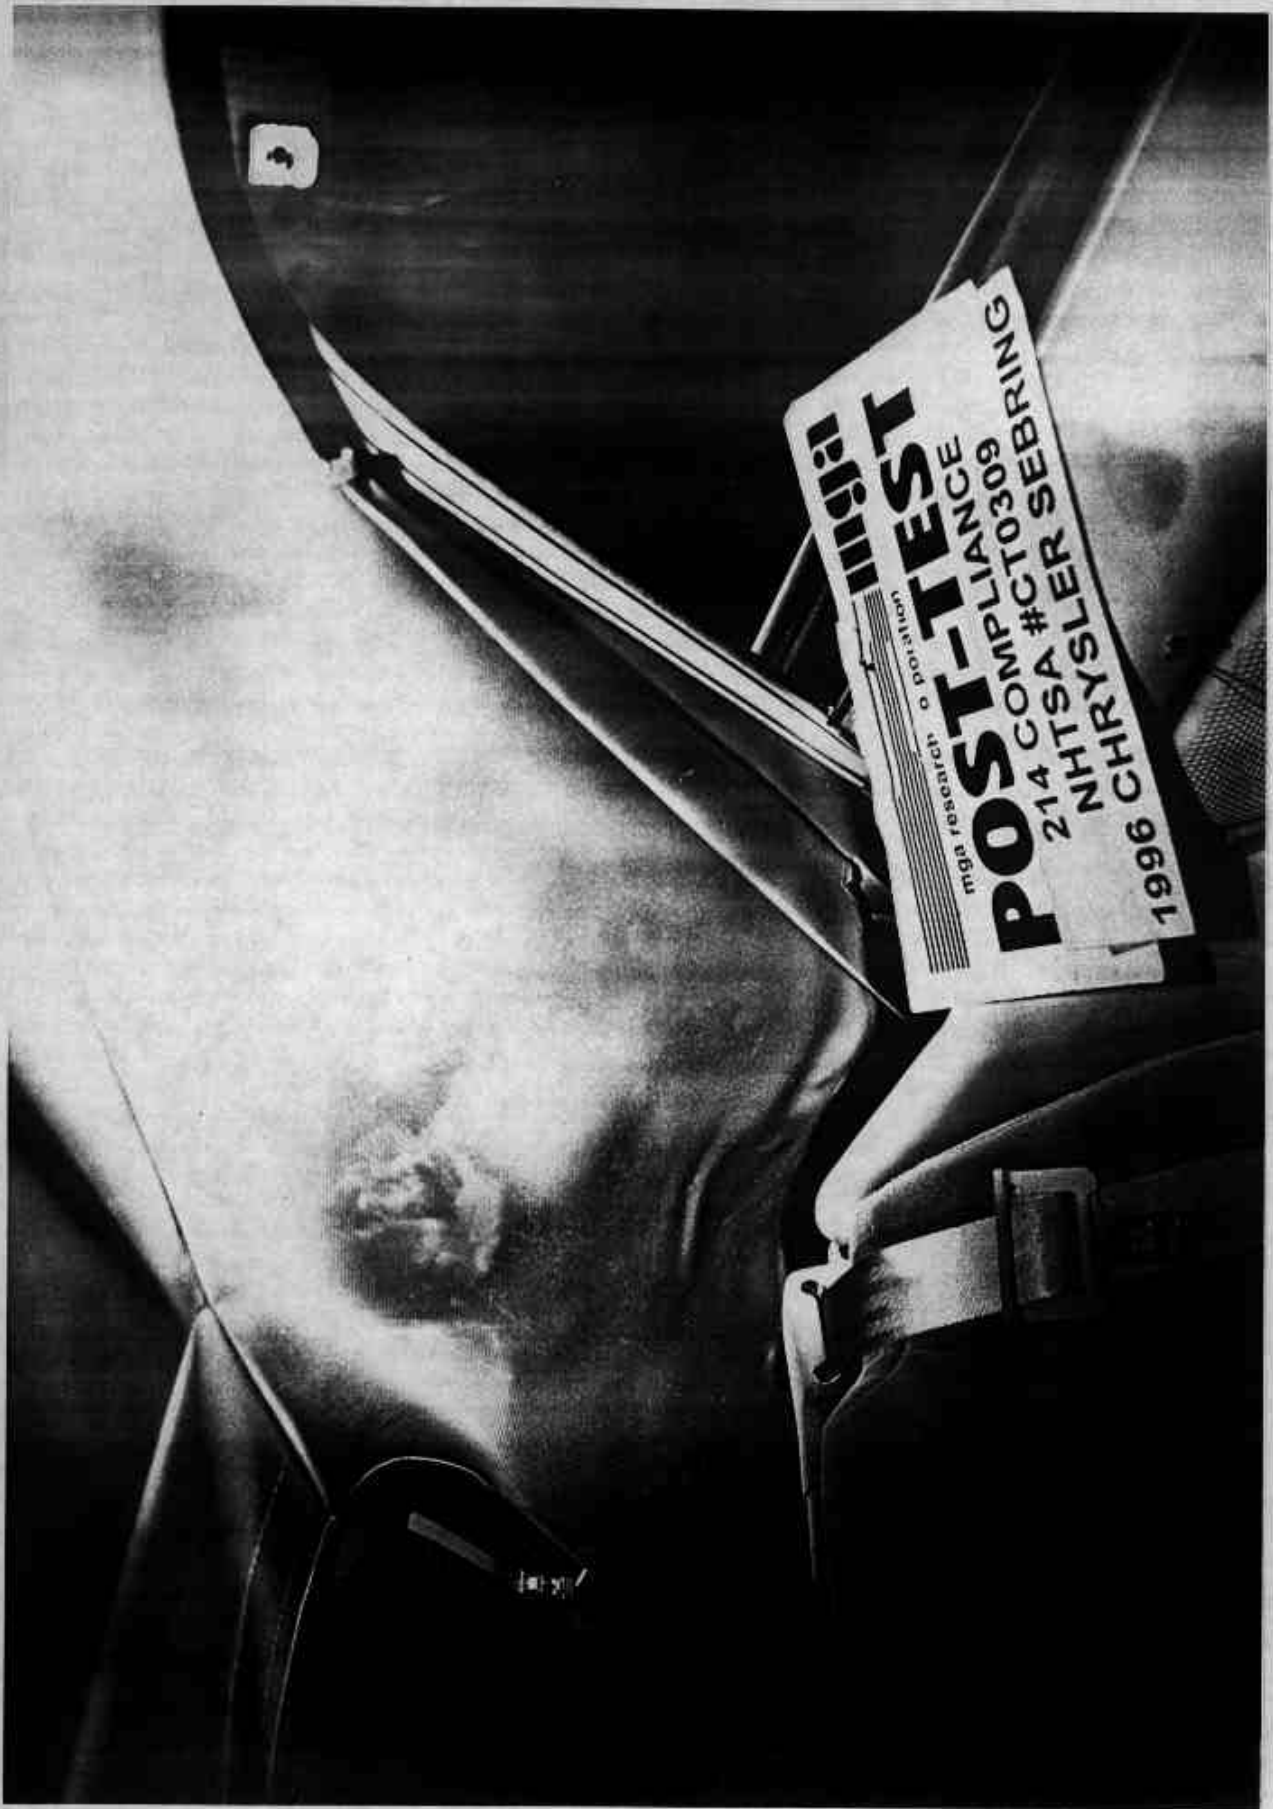
Photo No. A-36 - Post-Test Passenger Dummy Head Contact

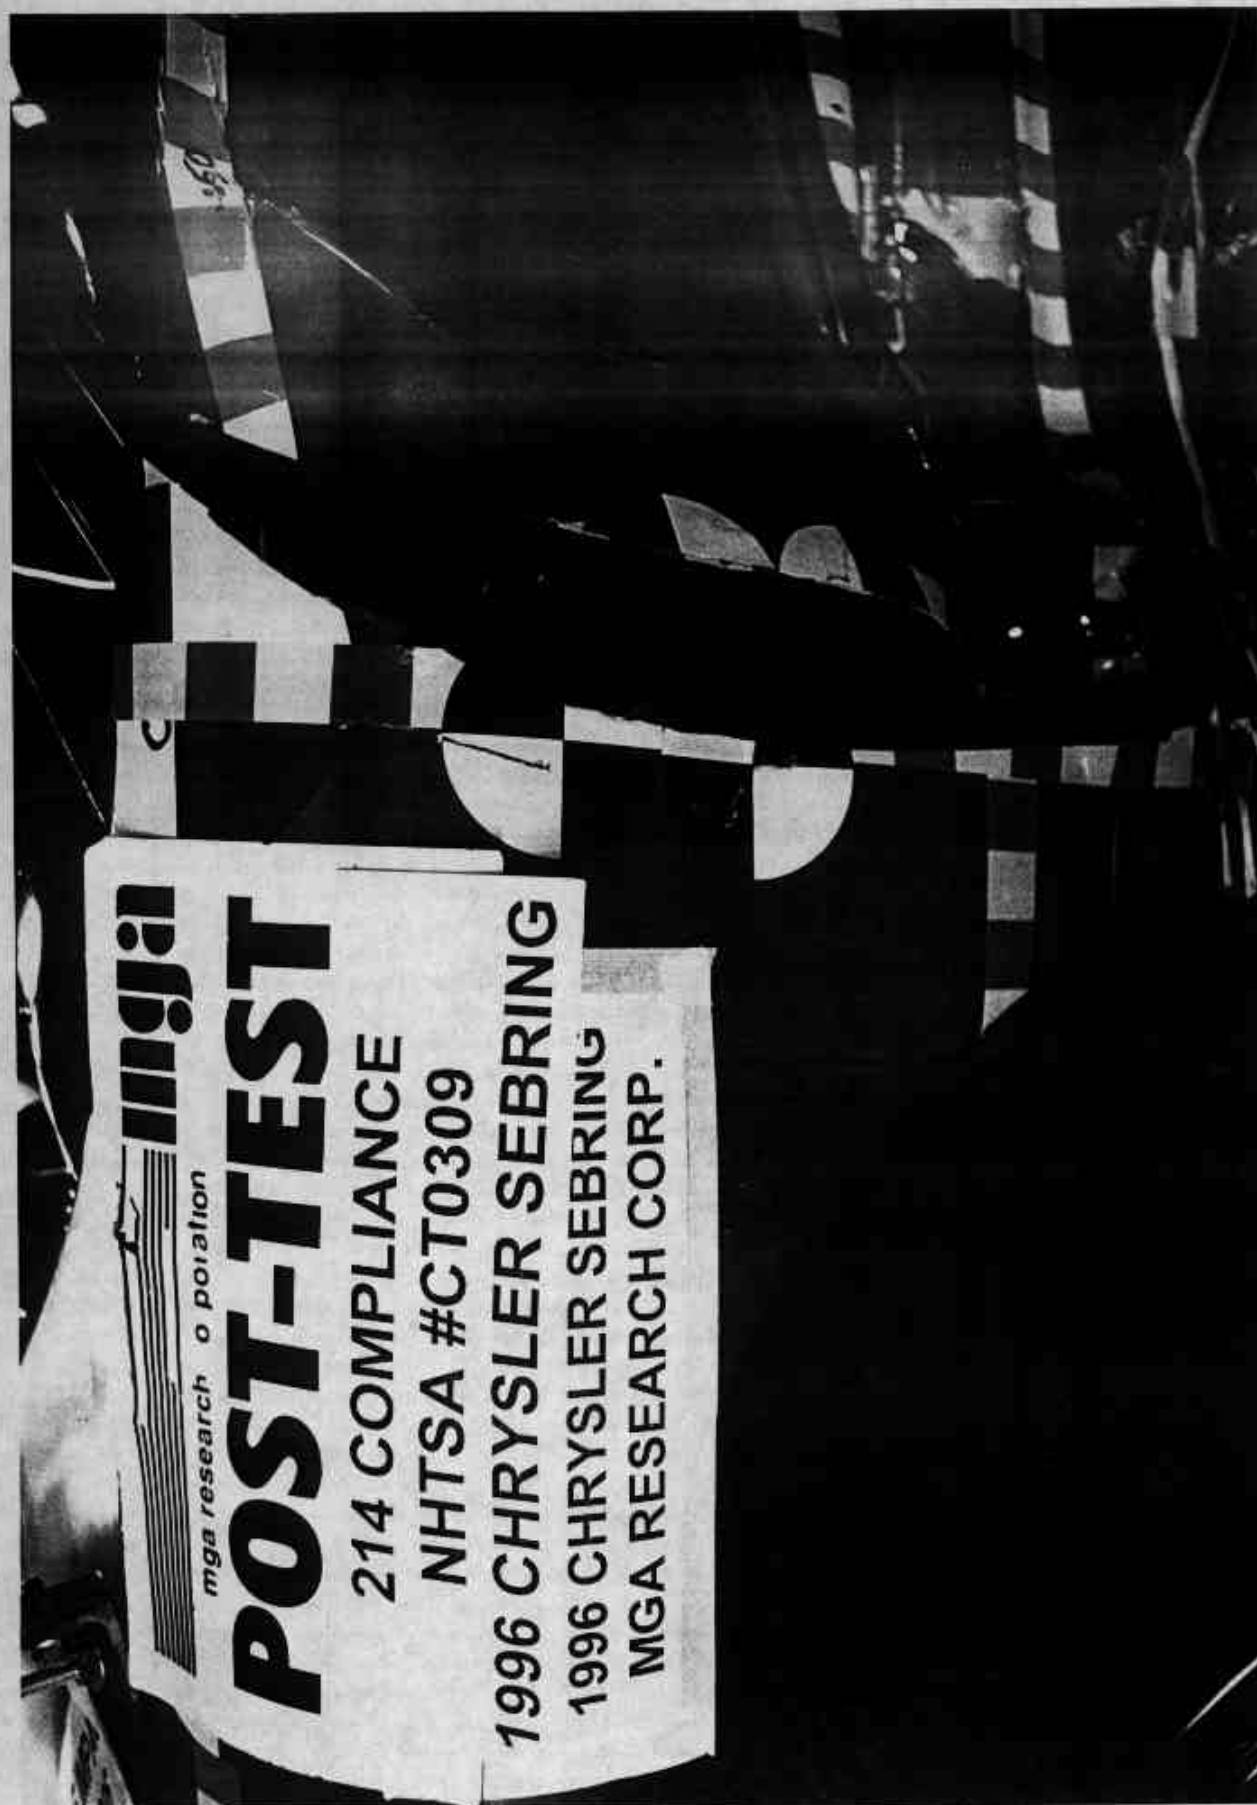
Photo No. A-38 - Post-Test Left Front Impact Point on Vehicle

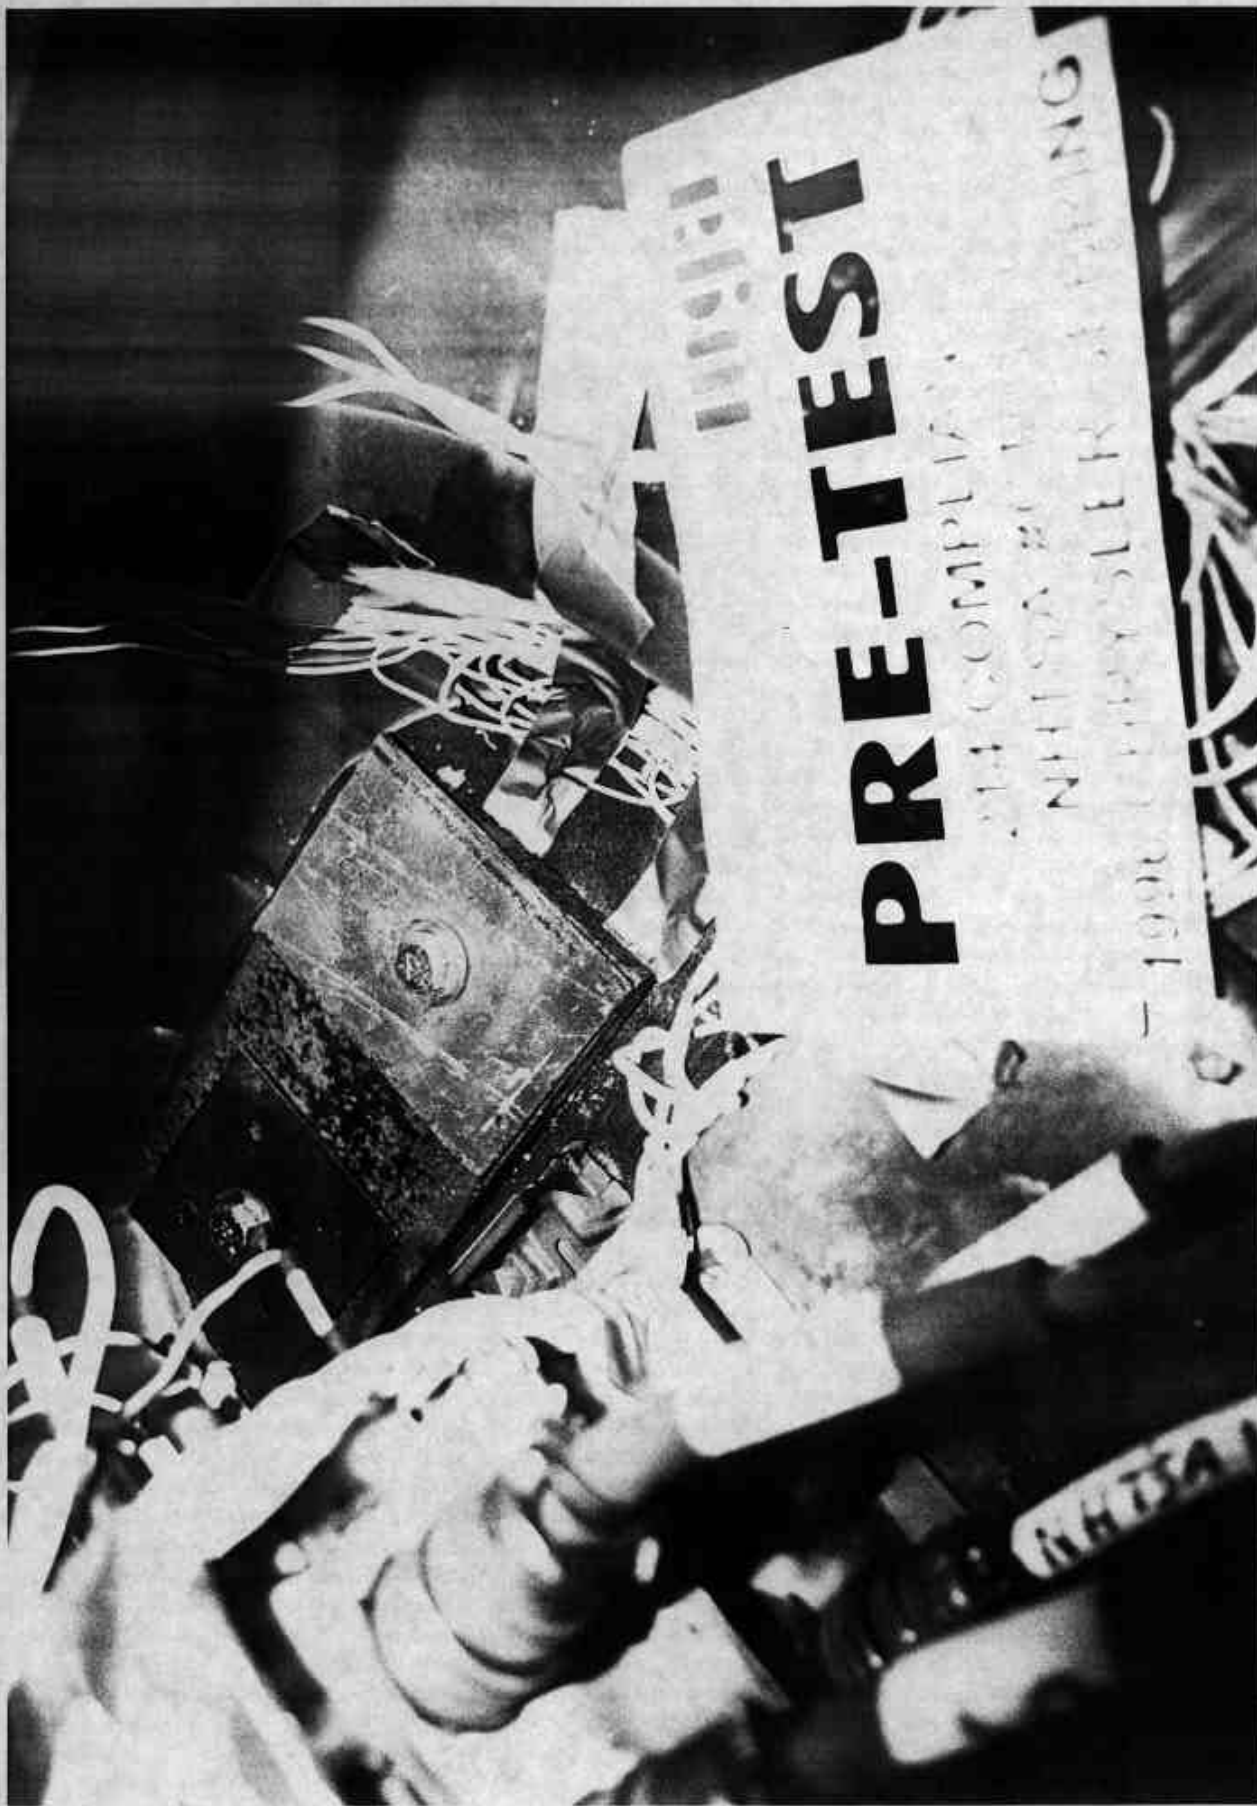
Photo No. A-39 - Ballast Added to Vehicle Trunk
