**NEW CAR ASSESSMENT PROGRAM (NCAP)
FRONTAL BARRIER IMPACT TEST**

**CHRYSLER CORPORATION
1996 DODGE CARAVAN
MPV**

NHTSA NUMBER: MT0305

CALSPAN TEST NUMBER: 8313-11

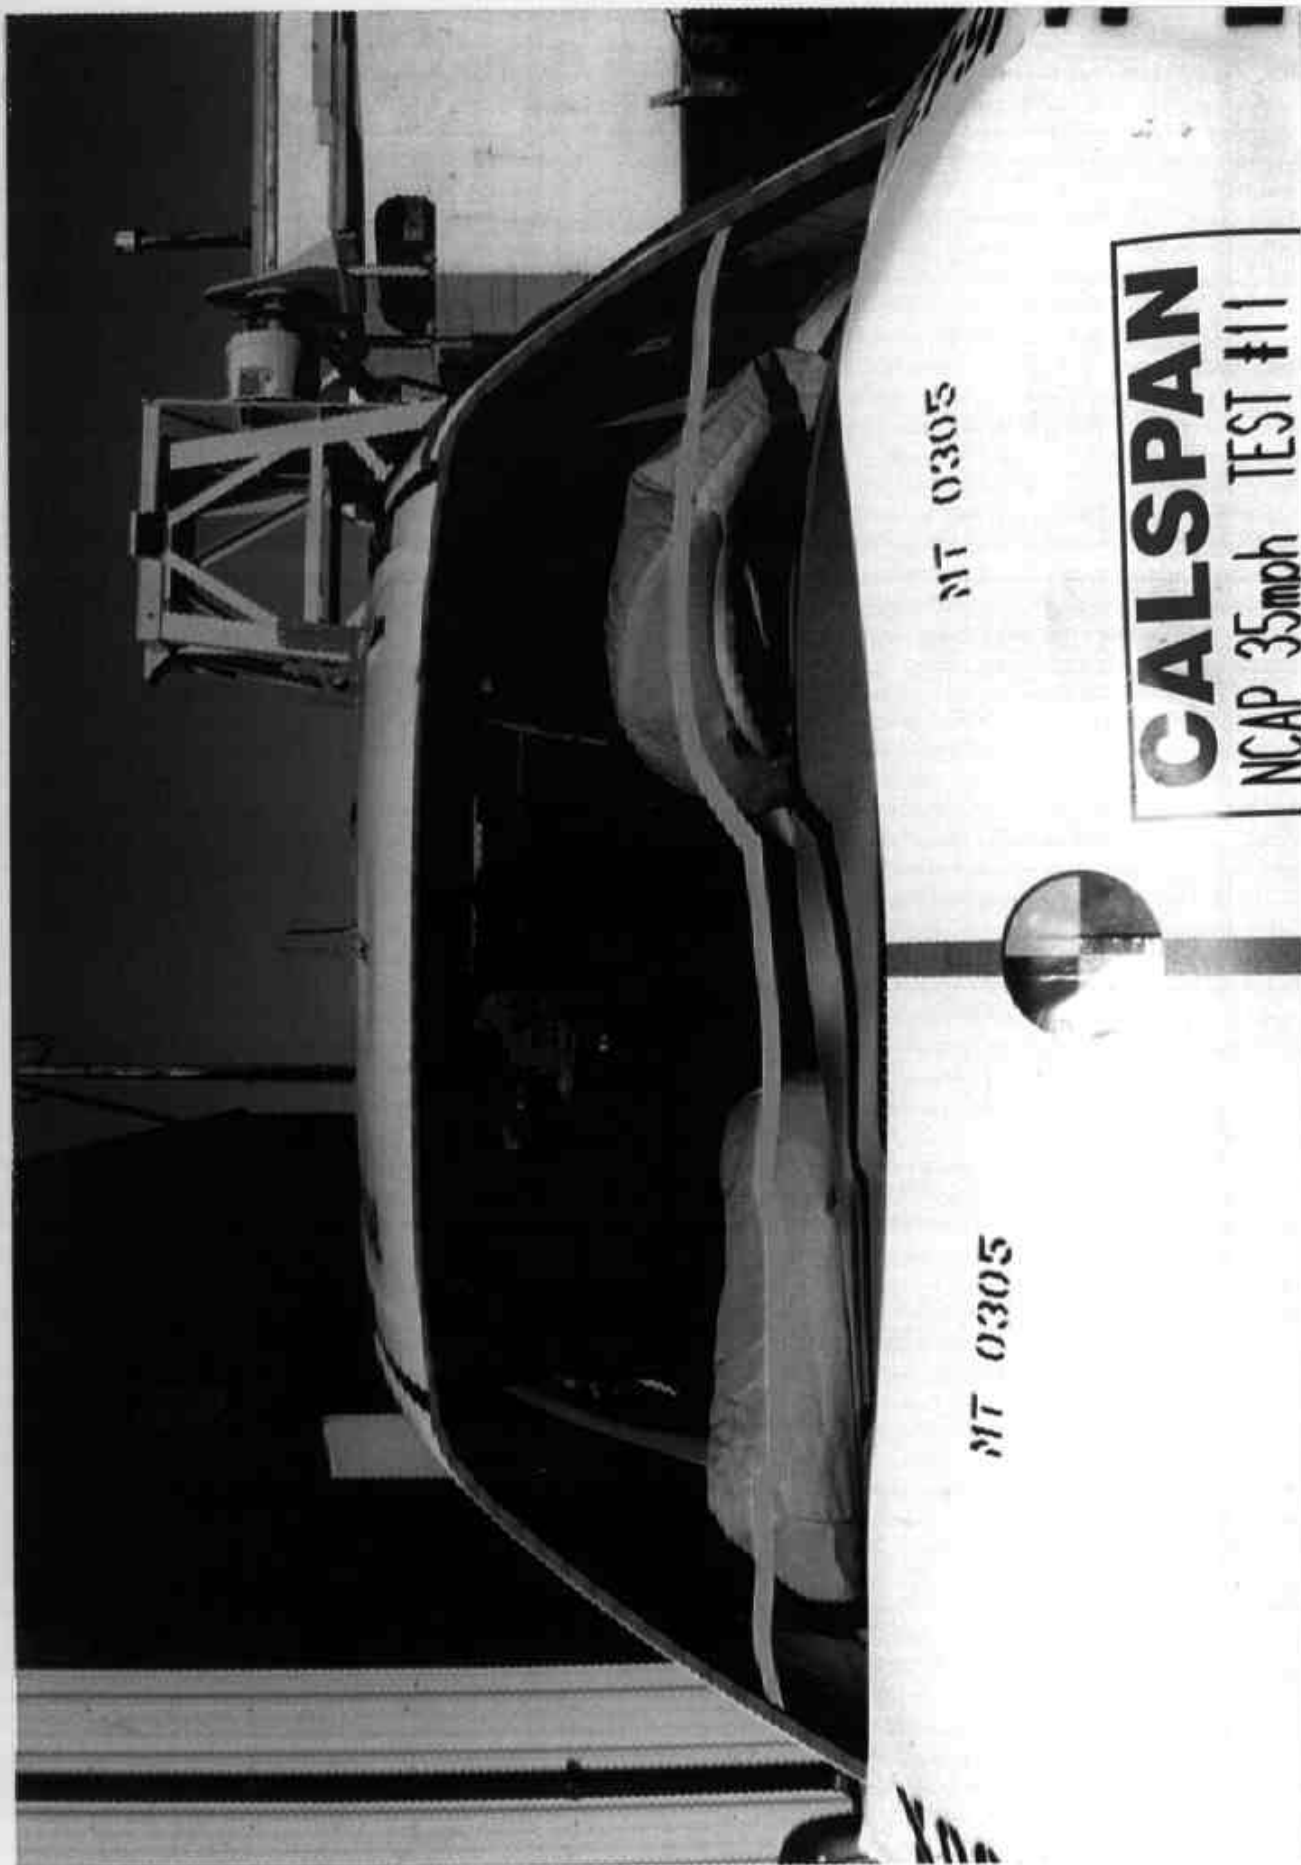
Figure A-13 POST-TEST WINDSHIELD VIEW

<u>Front</u>		<u>Rear</u>	
	<u>Left</u>	<u>Right</u>	<u>Left</u>	<u>Right</u>
Door Opening	<u>Operable</u>	<u>Operable</u>	<u>-</u>	<u>Operable</u>
	<u>Front</u>		<u>Rear</u>	
<u>Seat Movement</u>	<u>Left</u>	<u>Right</u>	<u>Left</u>	<u>Right</u>
Seat Back Failure	<u>None</u>	<u>None</u>	<u>-</u>	<u>None</u>
Seat Shift (mm.)	<u>3 mm</u>	<u>0 mm</u>	<u>-</u>	<u>0</u>
<u>Glazing Damage</u>				
Backlight/Windshield:	<u>cracked on lower left side</u>			
Other Notable Impact Effects:	<u>None</u>
