REPORT NO. MGA-96-N019

NEW CAR ASSESSMENT PROGRAM (NCAP)

FRONTAL BARRIER IMPACT TEST

TOYOTA MOTOR CORPORATION  
1996 TOYOTA PASEO  
NHTSA NO. MT5101

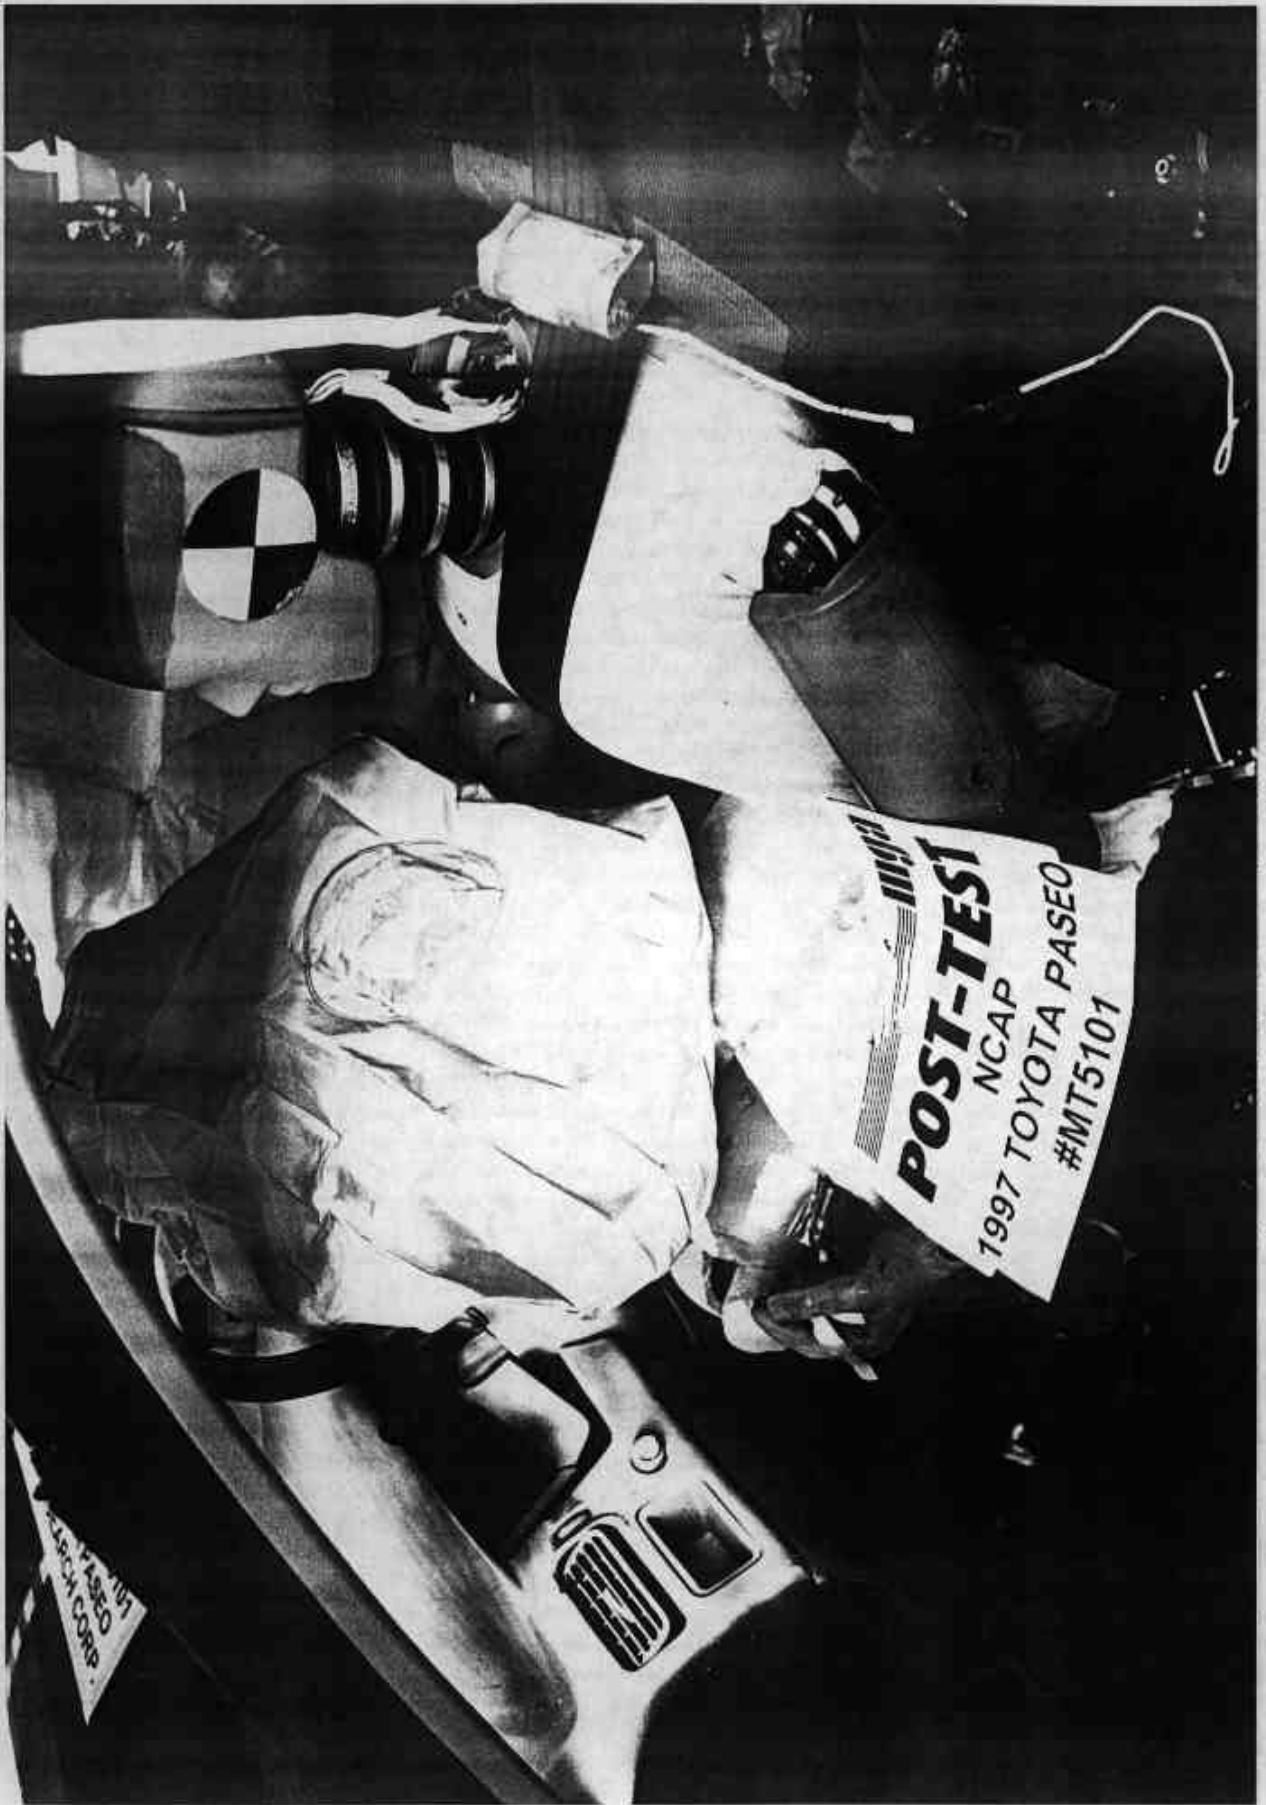
Photo No. A-34 - Post-Test Driver Airbag Contact

The driver's head struck the inflated airbag. The driver HIC was 632 and the maximum chest (CLIP) deceleration over 3 milliseconds was 47.8 g's. The maximum chest displacement was 31 mm. The left and right femur loads were 2395 and 3886 Newtons respectively.
