Report Numbers: 208-TRC-97-001
212-TRC-97-001
301-TRC-97-001

Vehicle Safety Compliance Testing
for Occupant Crash Protection,
Windshield Retention, Windshield Zone Intrusion,
and Fuel System Integrity

Ford Motor Company
1997 Ford Expedition
Multi-Purpose Passenger Vehicle
NHTSA Number: CV0211
TRC Test Number: 961010

Final Report

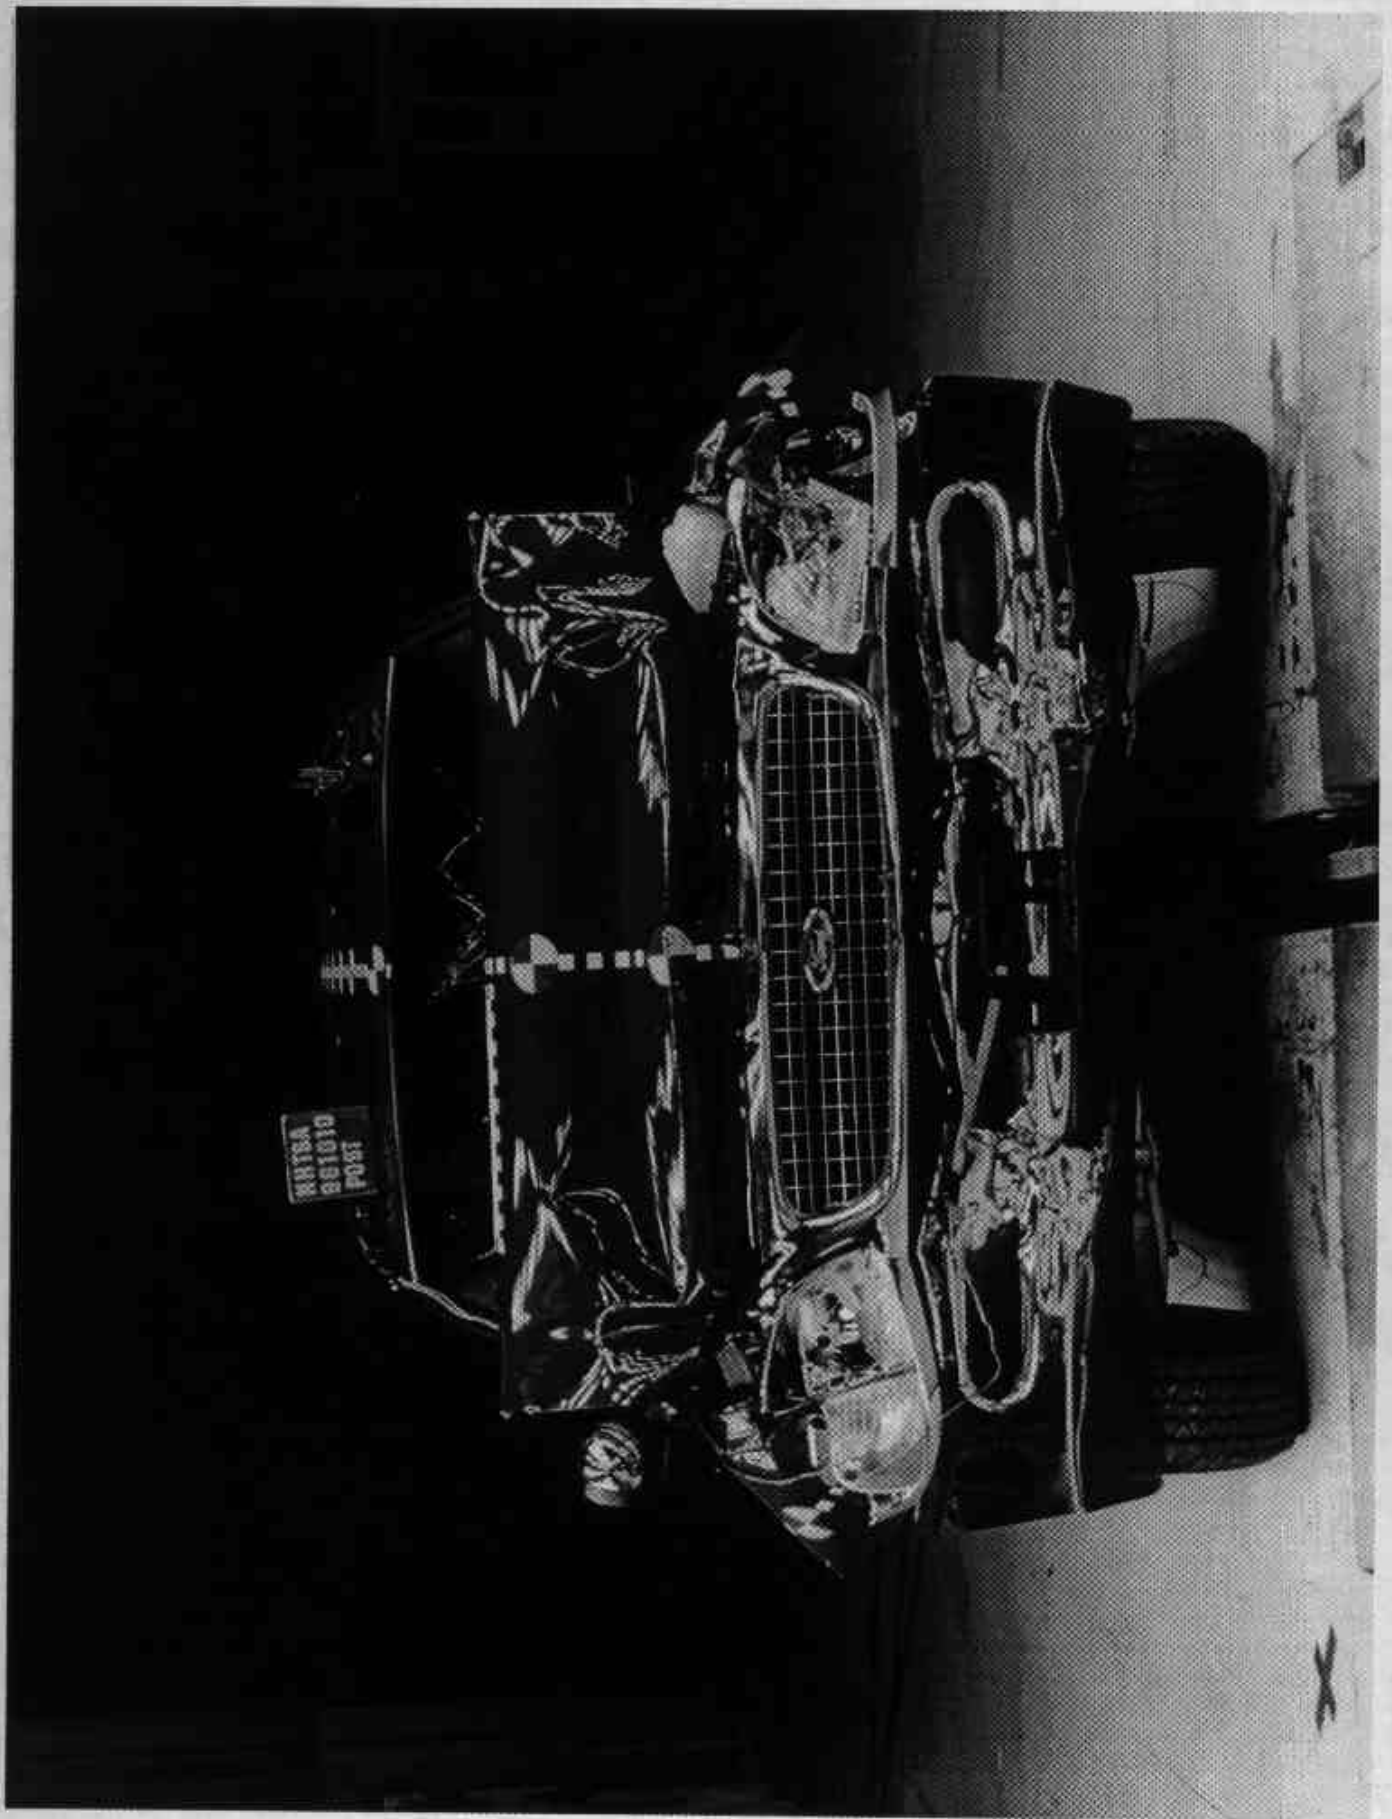
Figure A-2. Post-test Front View

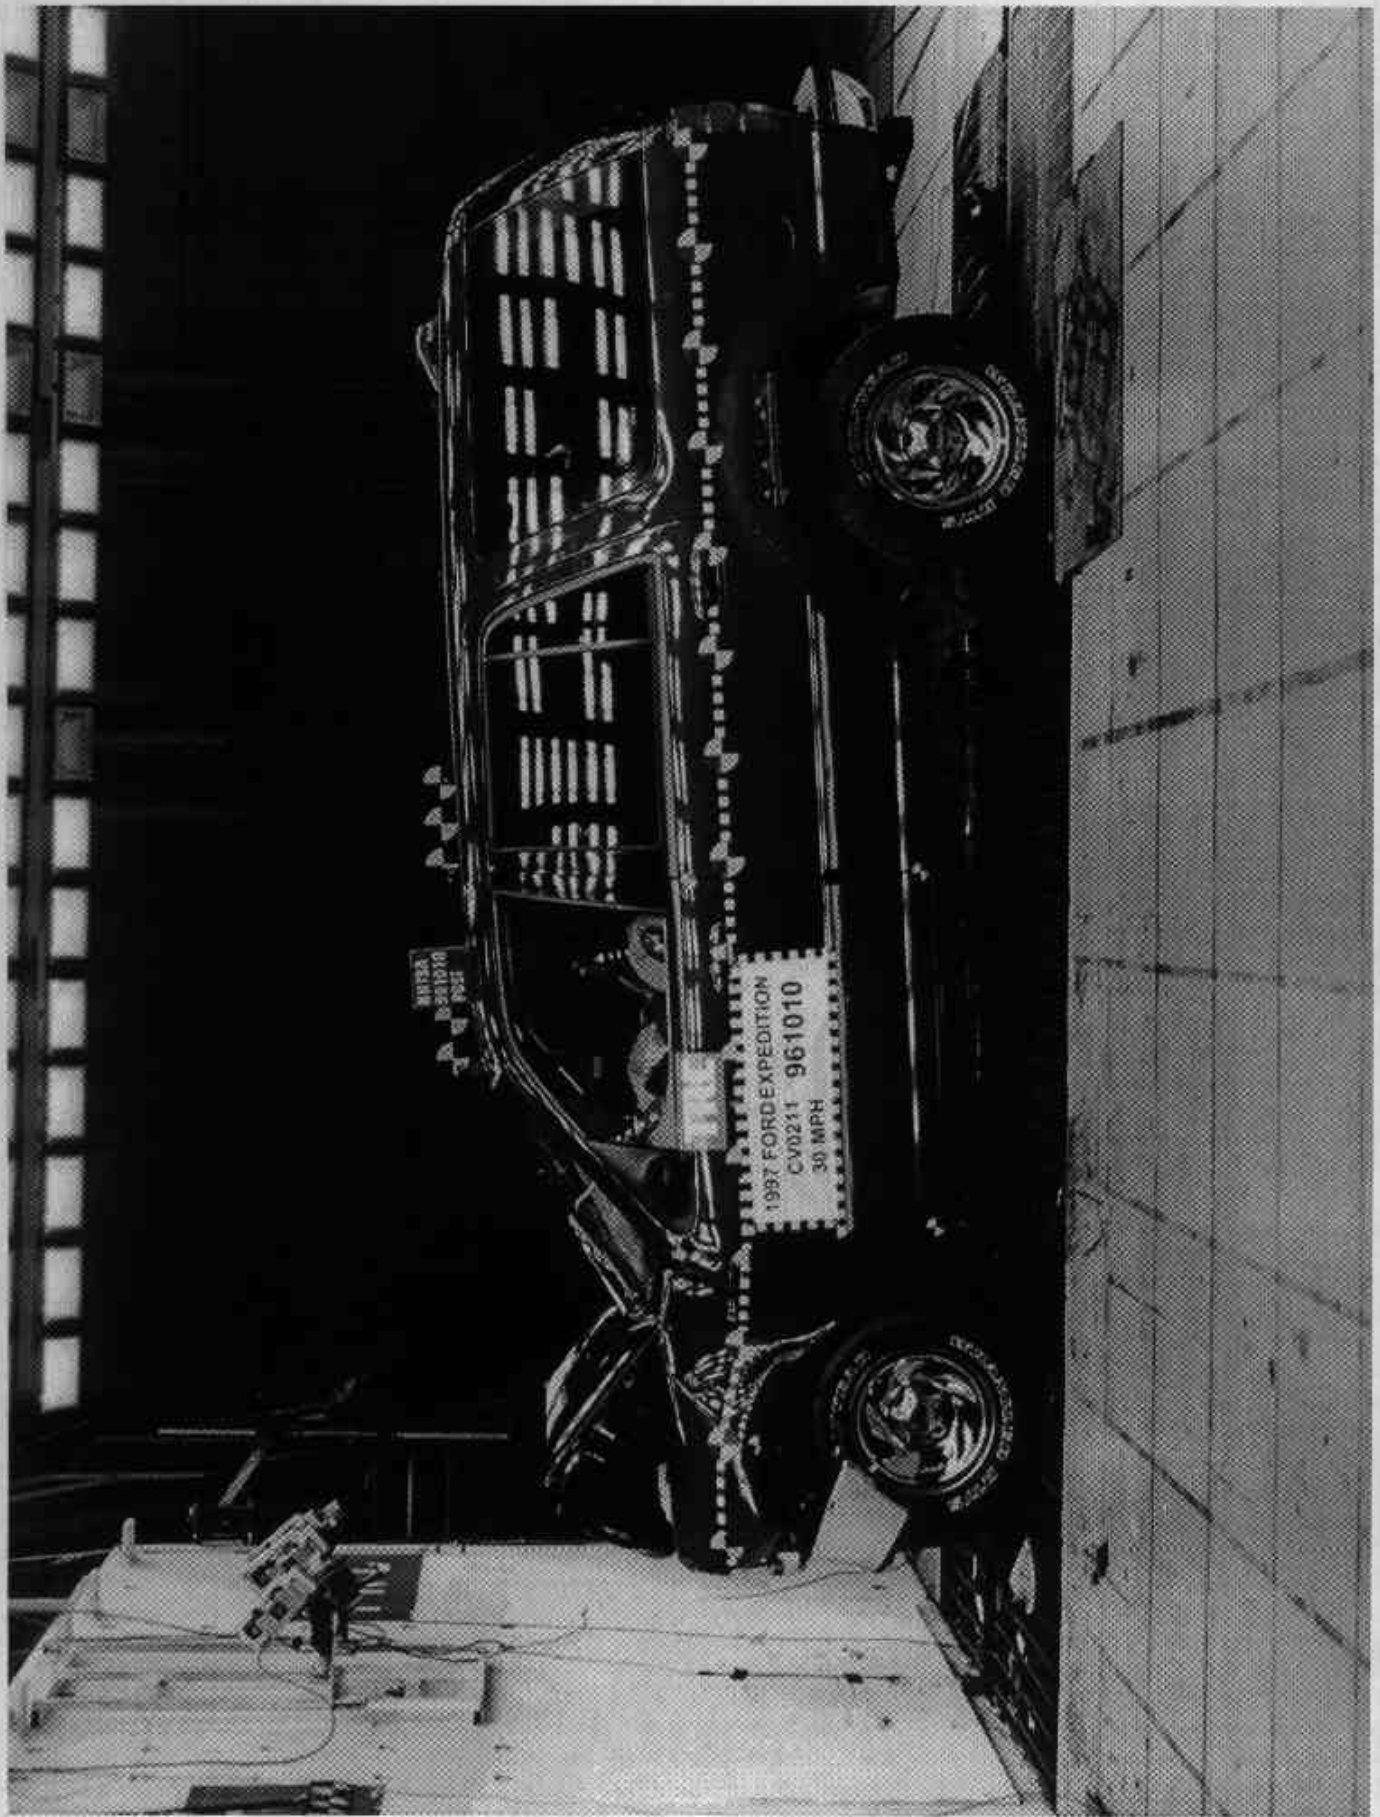
Figure A-4. Post-test Left Side View

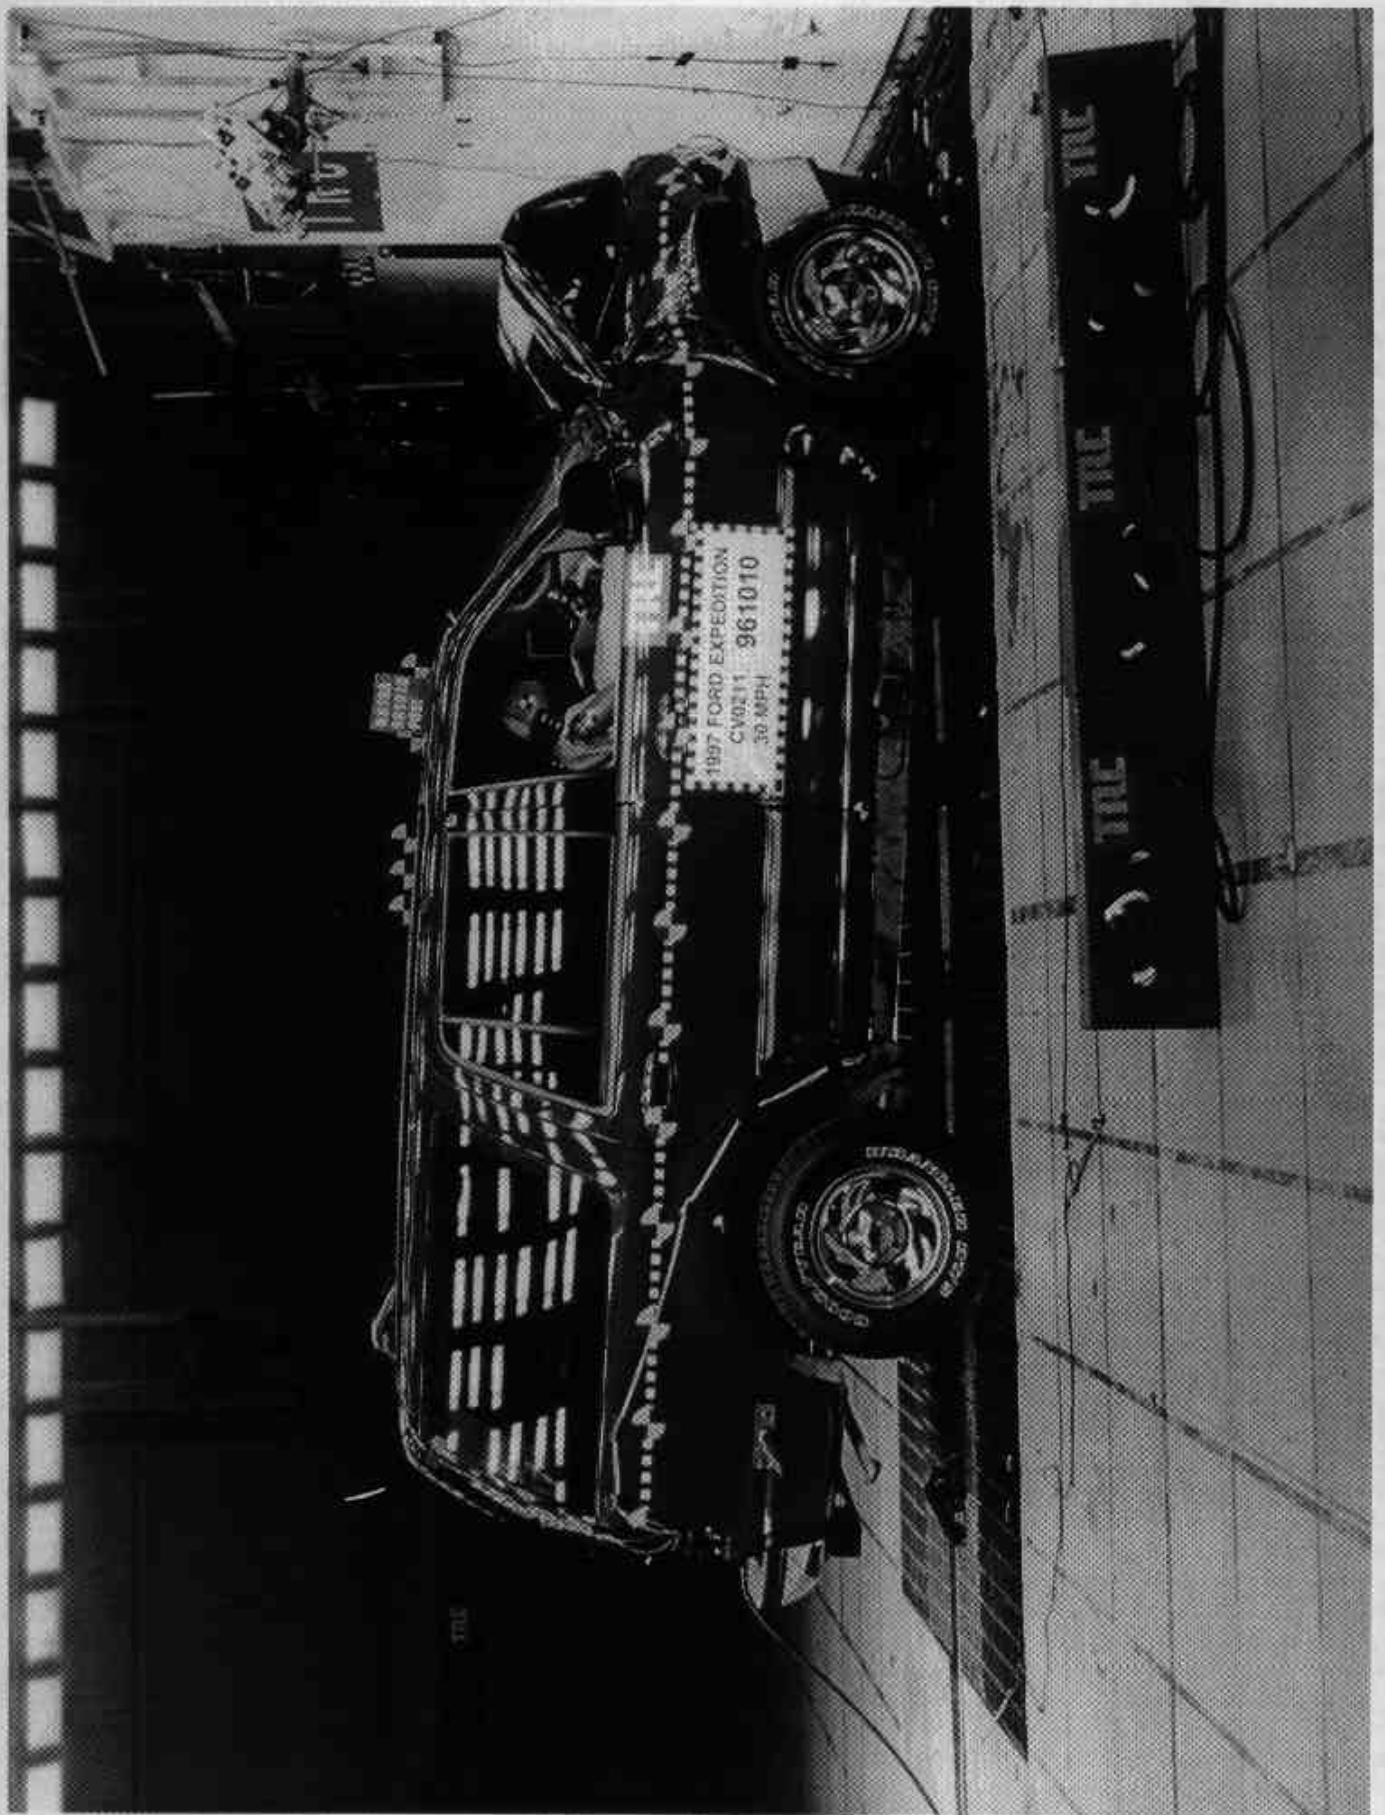
Figure A-6. Post-test Right Side View

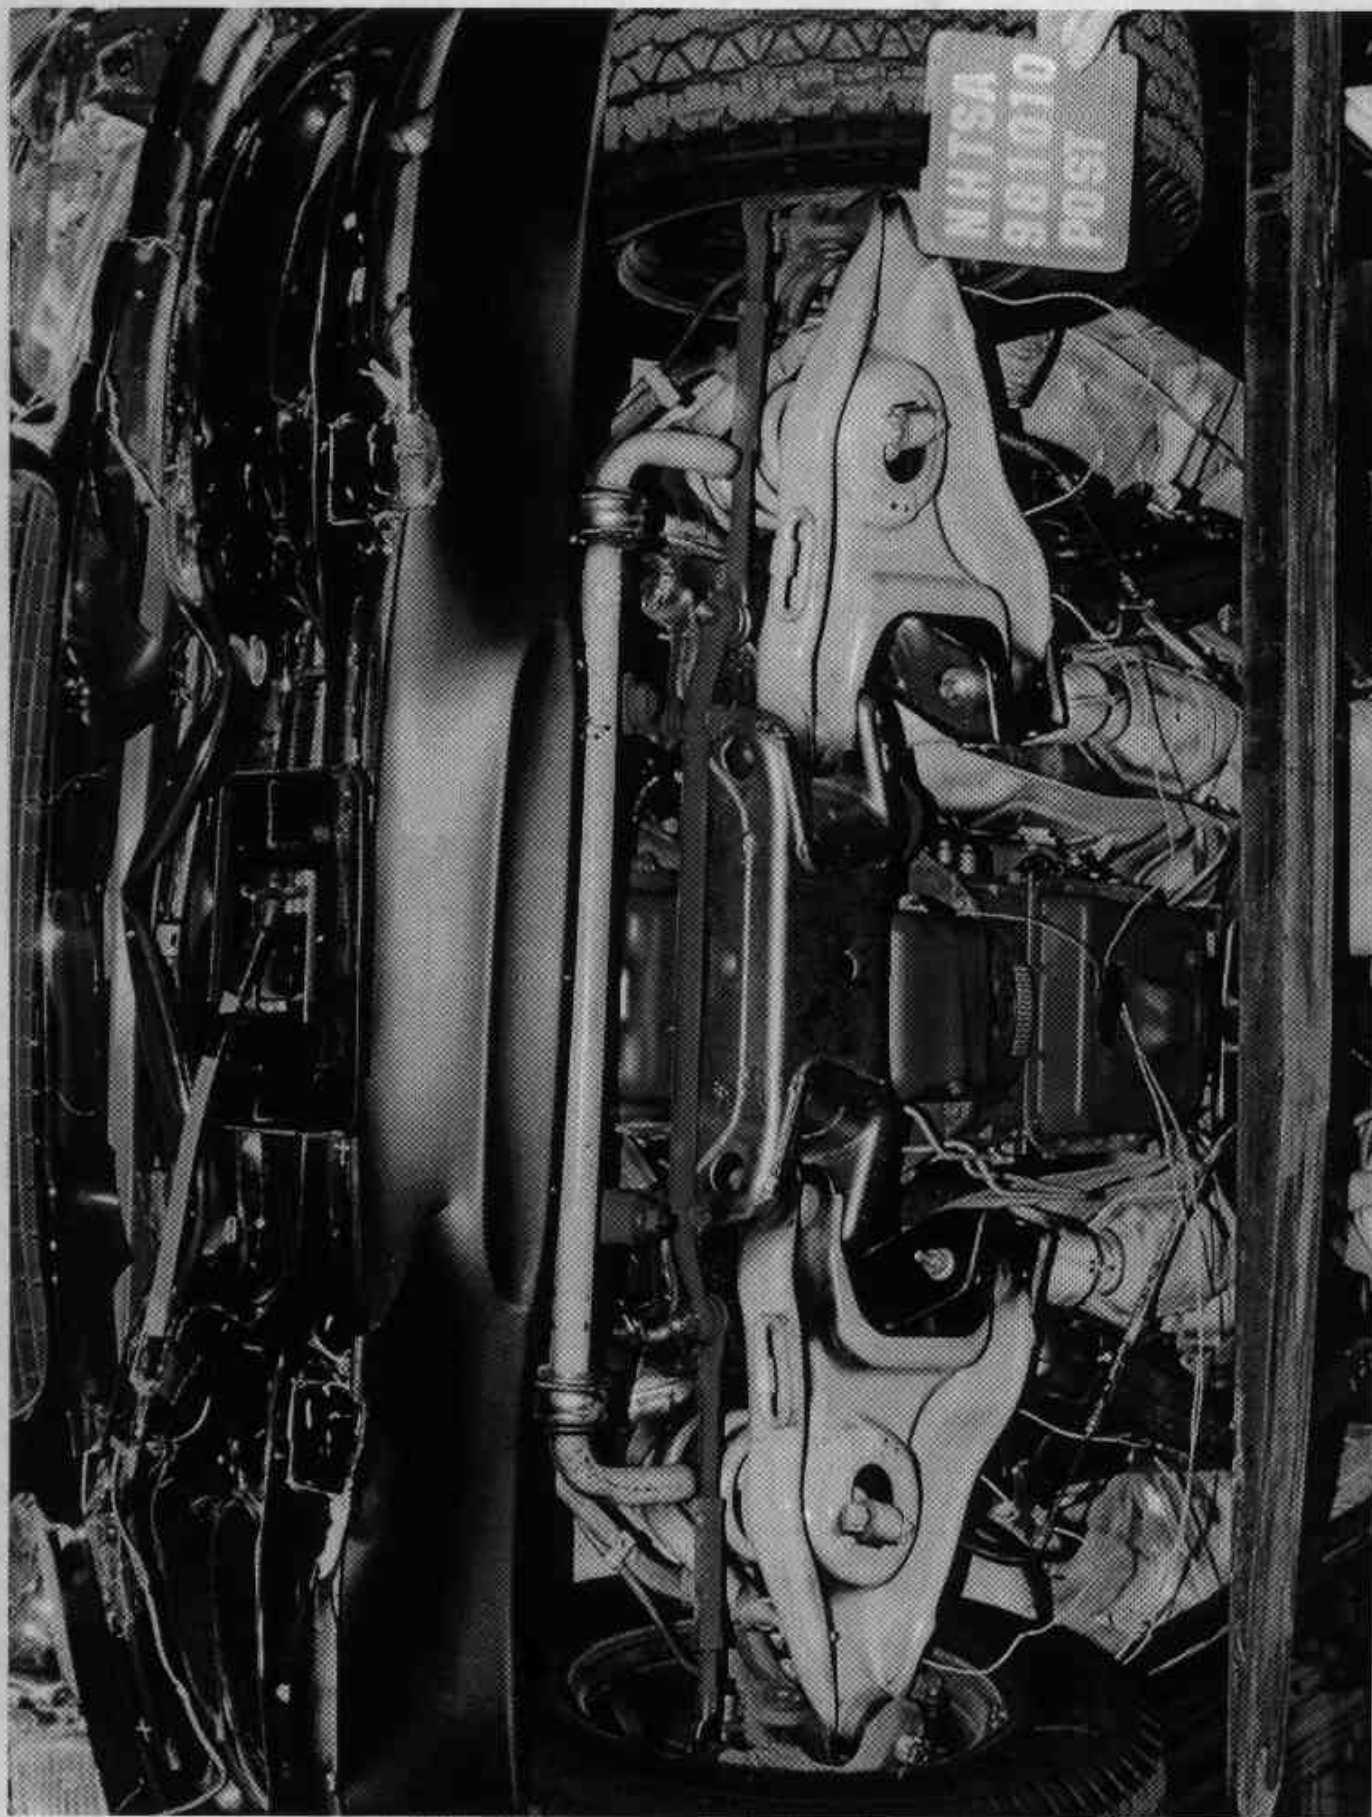
Figure A-8. Post-test Front Underbody View

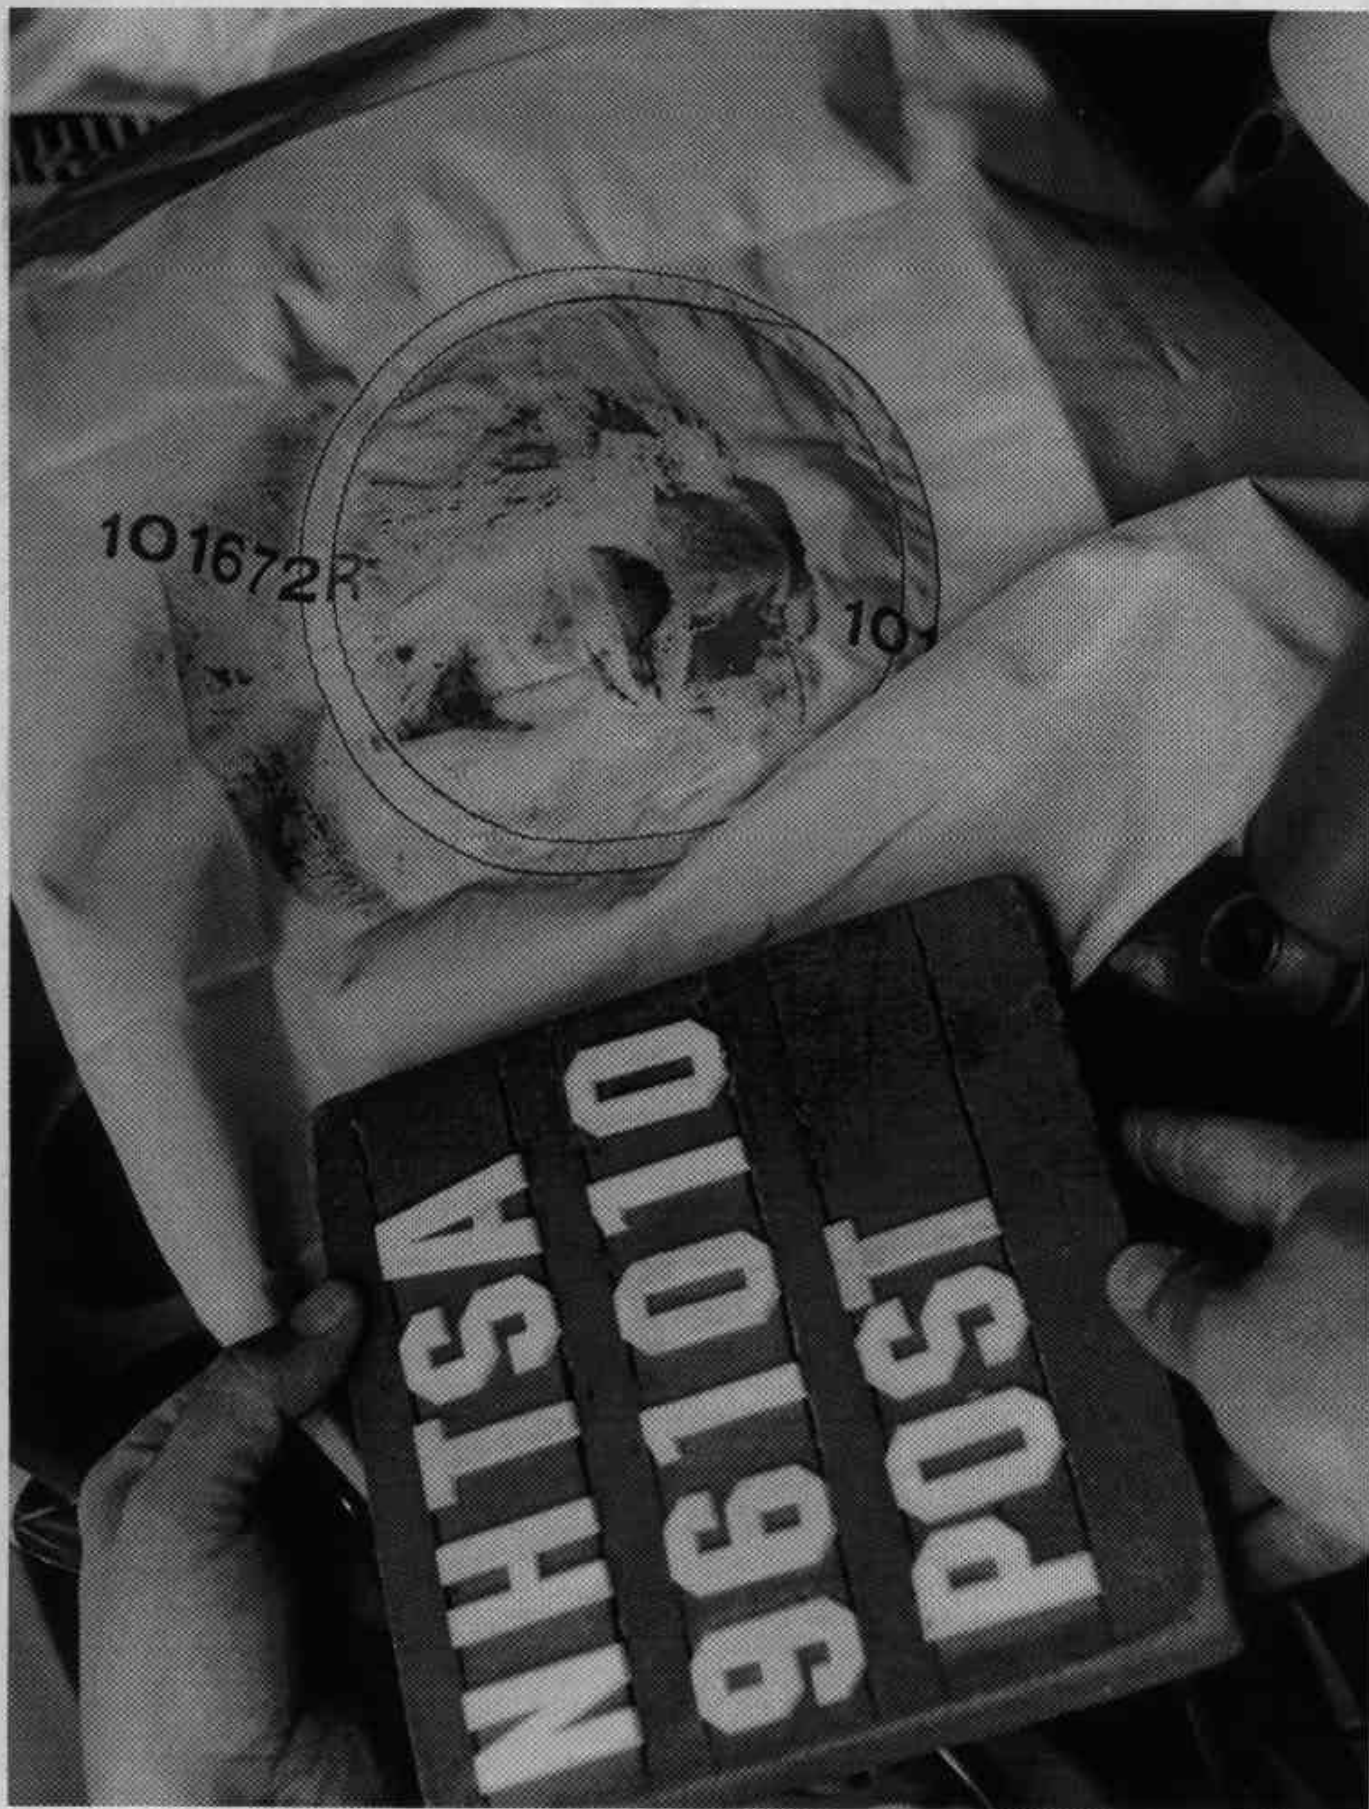
Figure A-15. Post-test Driver Dummy Head Contact - View 1

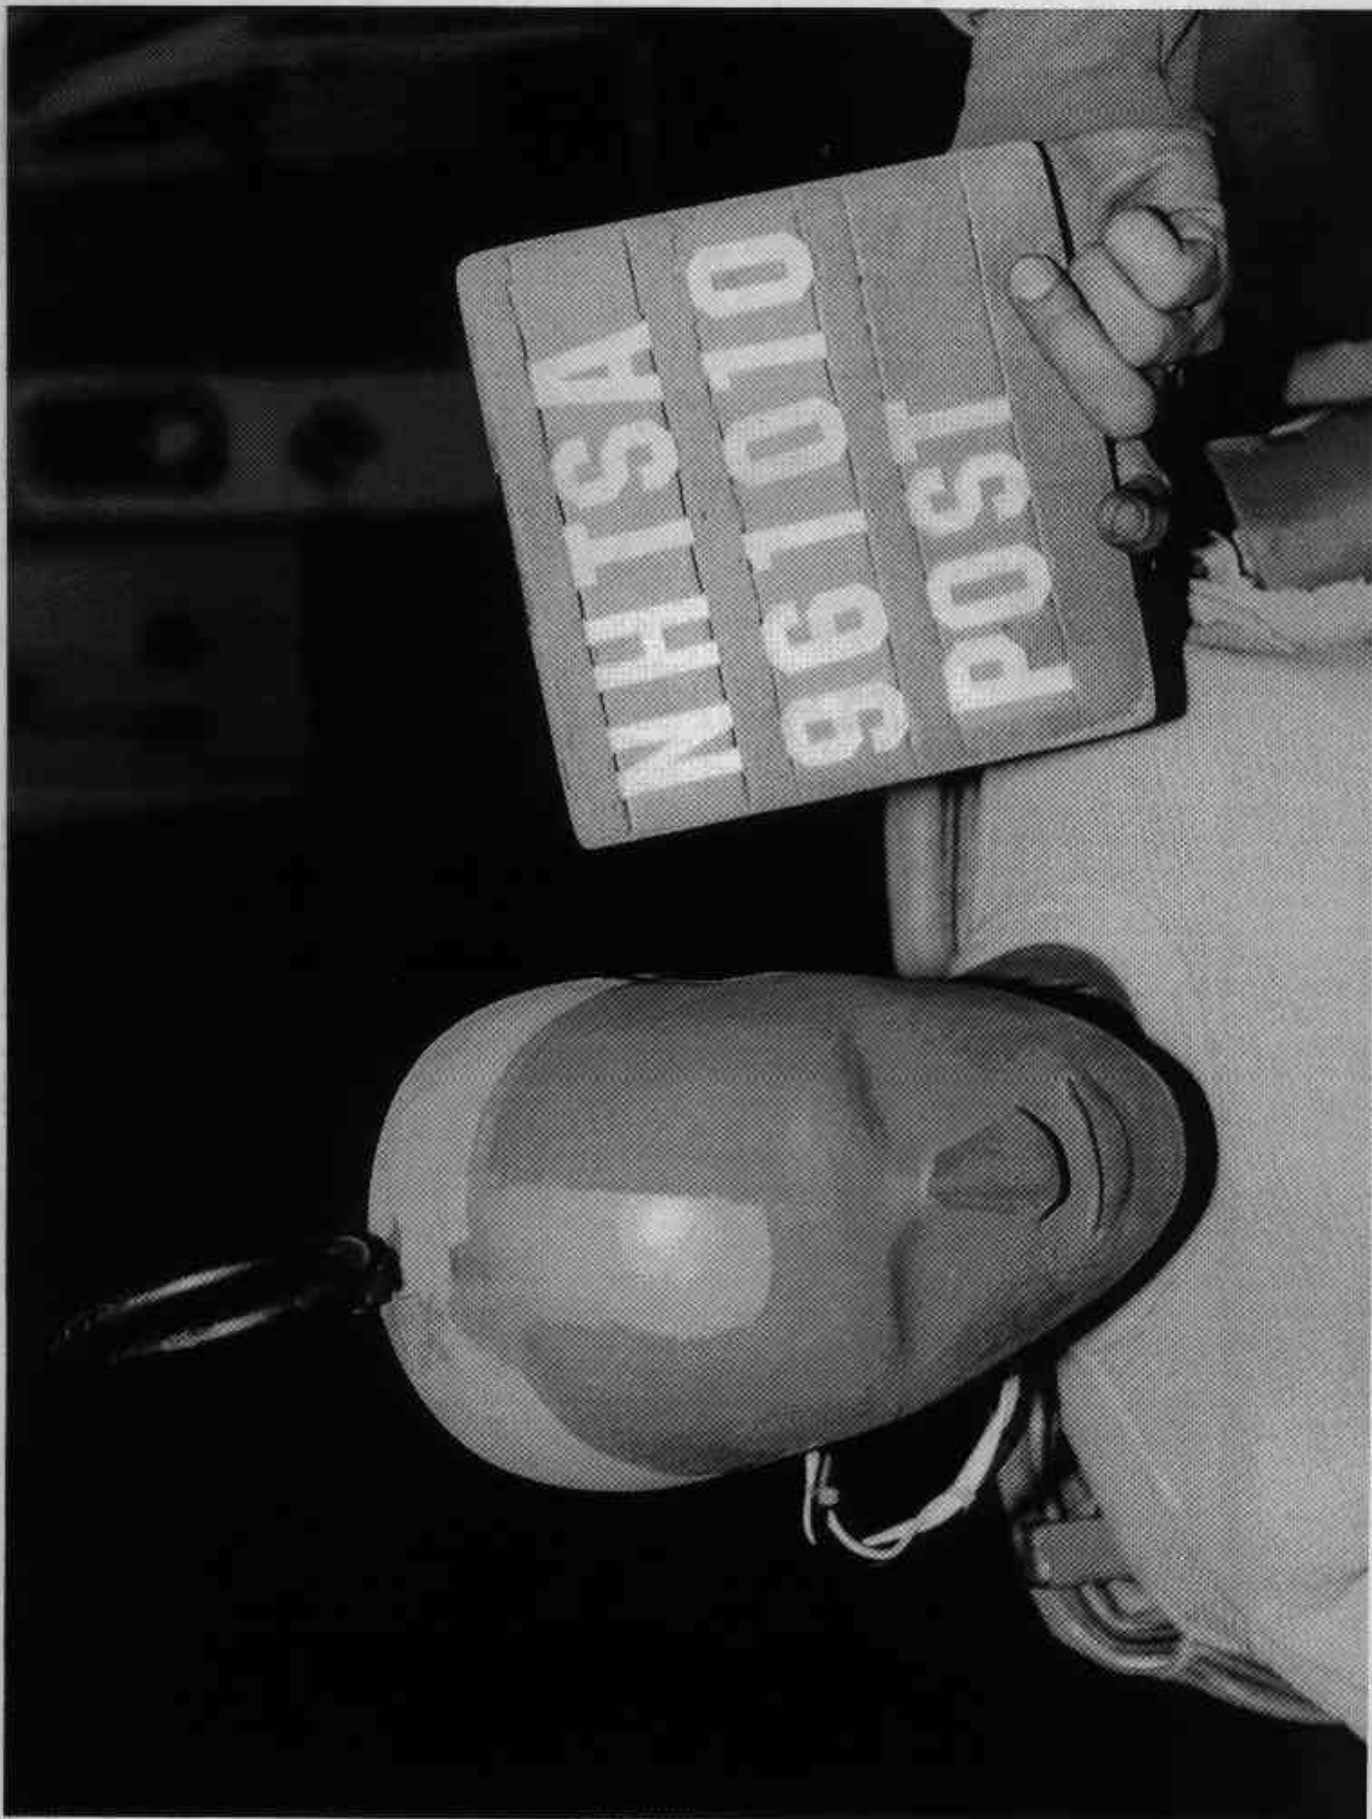
Figure A-16. Post-test Driver Dummy Head Contact - View 2

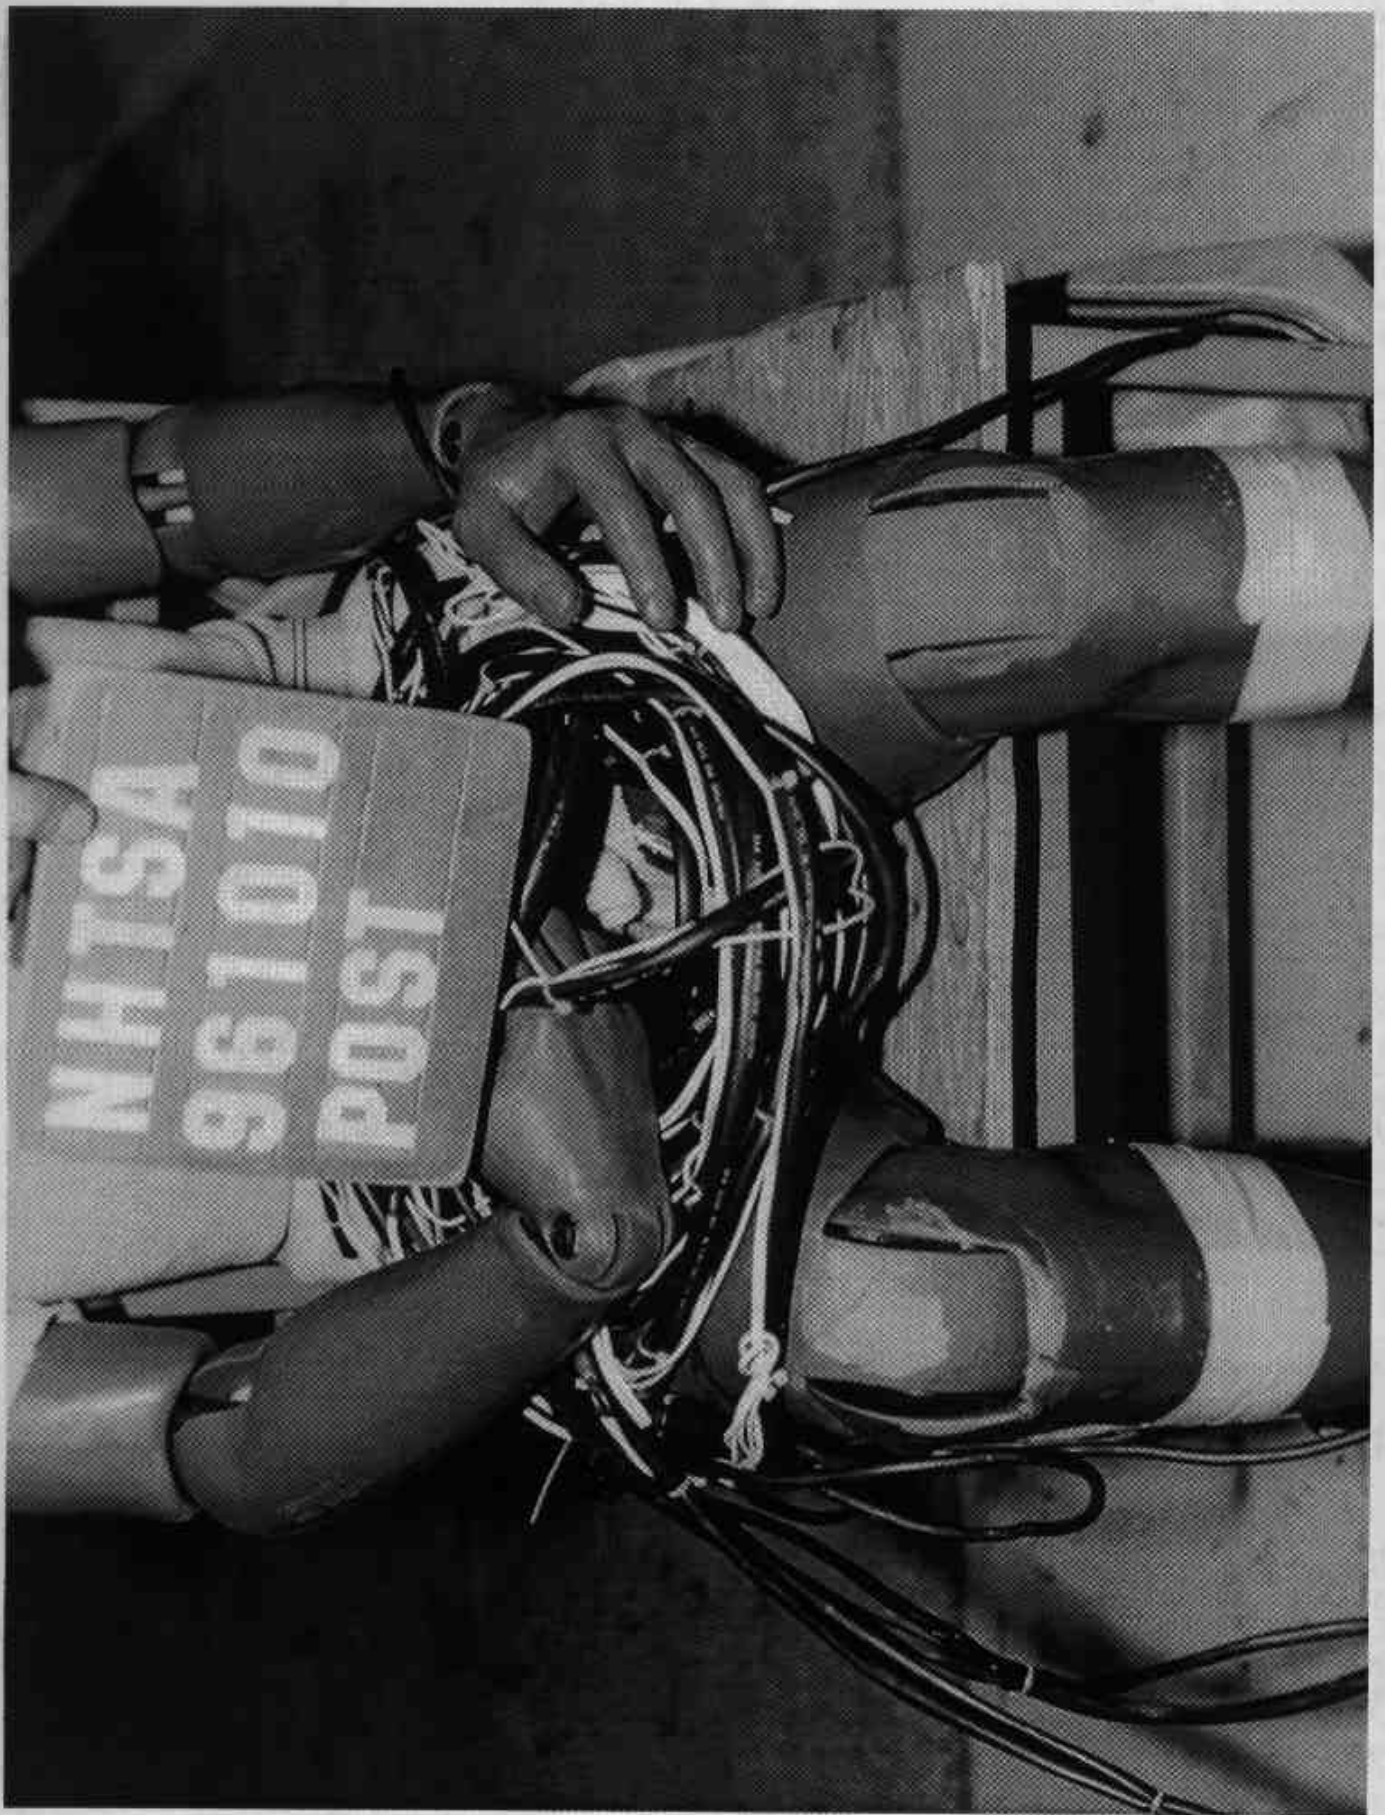
Figure A-17. Post-test Driver Dummy Knee Contact - View 1

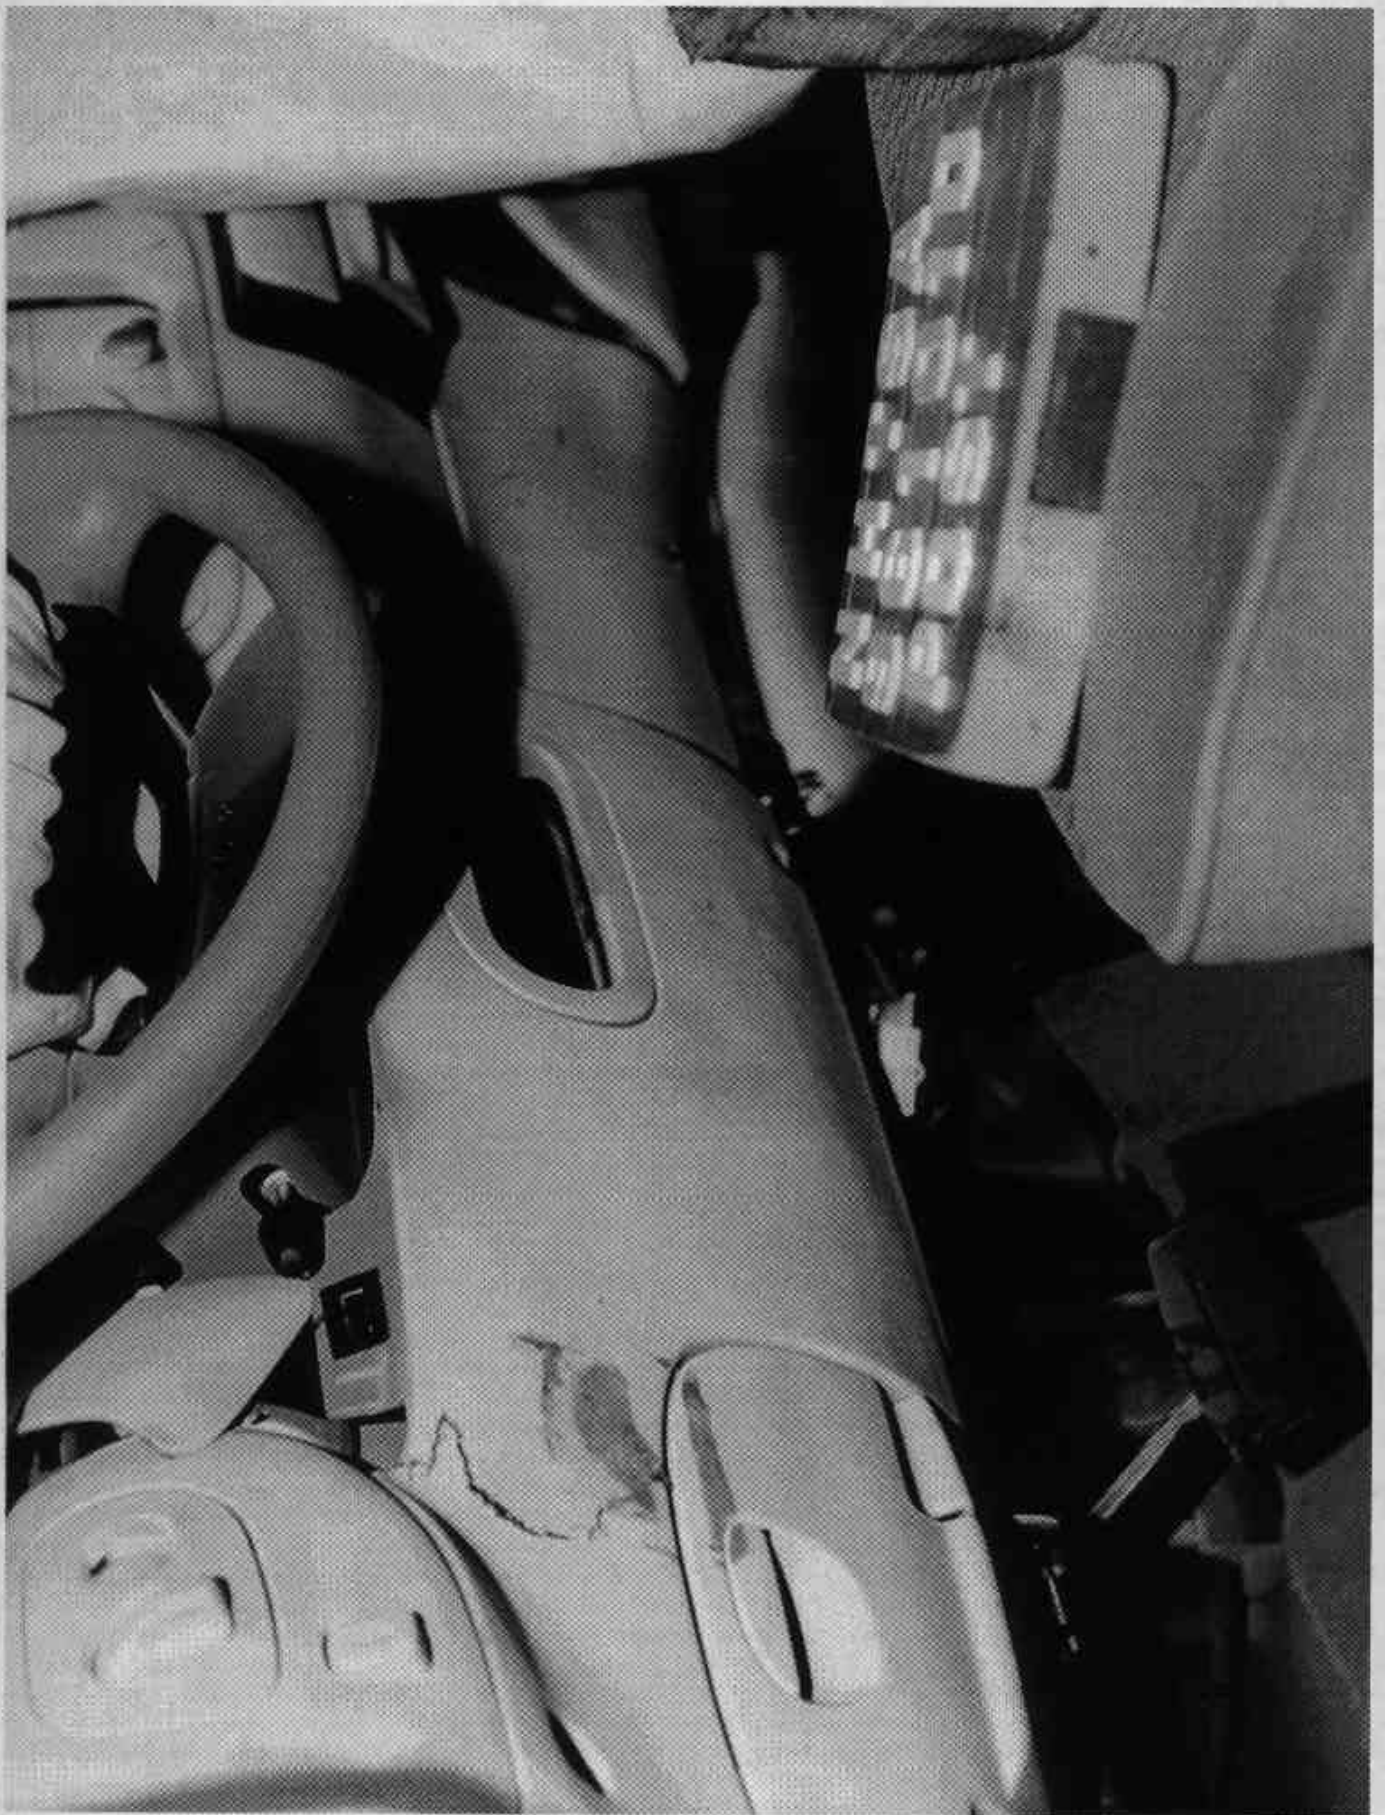
Figure A-18. Post-test Driver Dummy Knee Contact - View 2

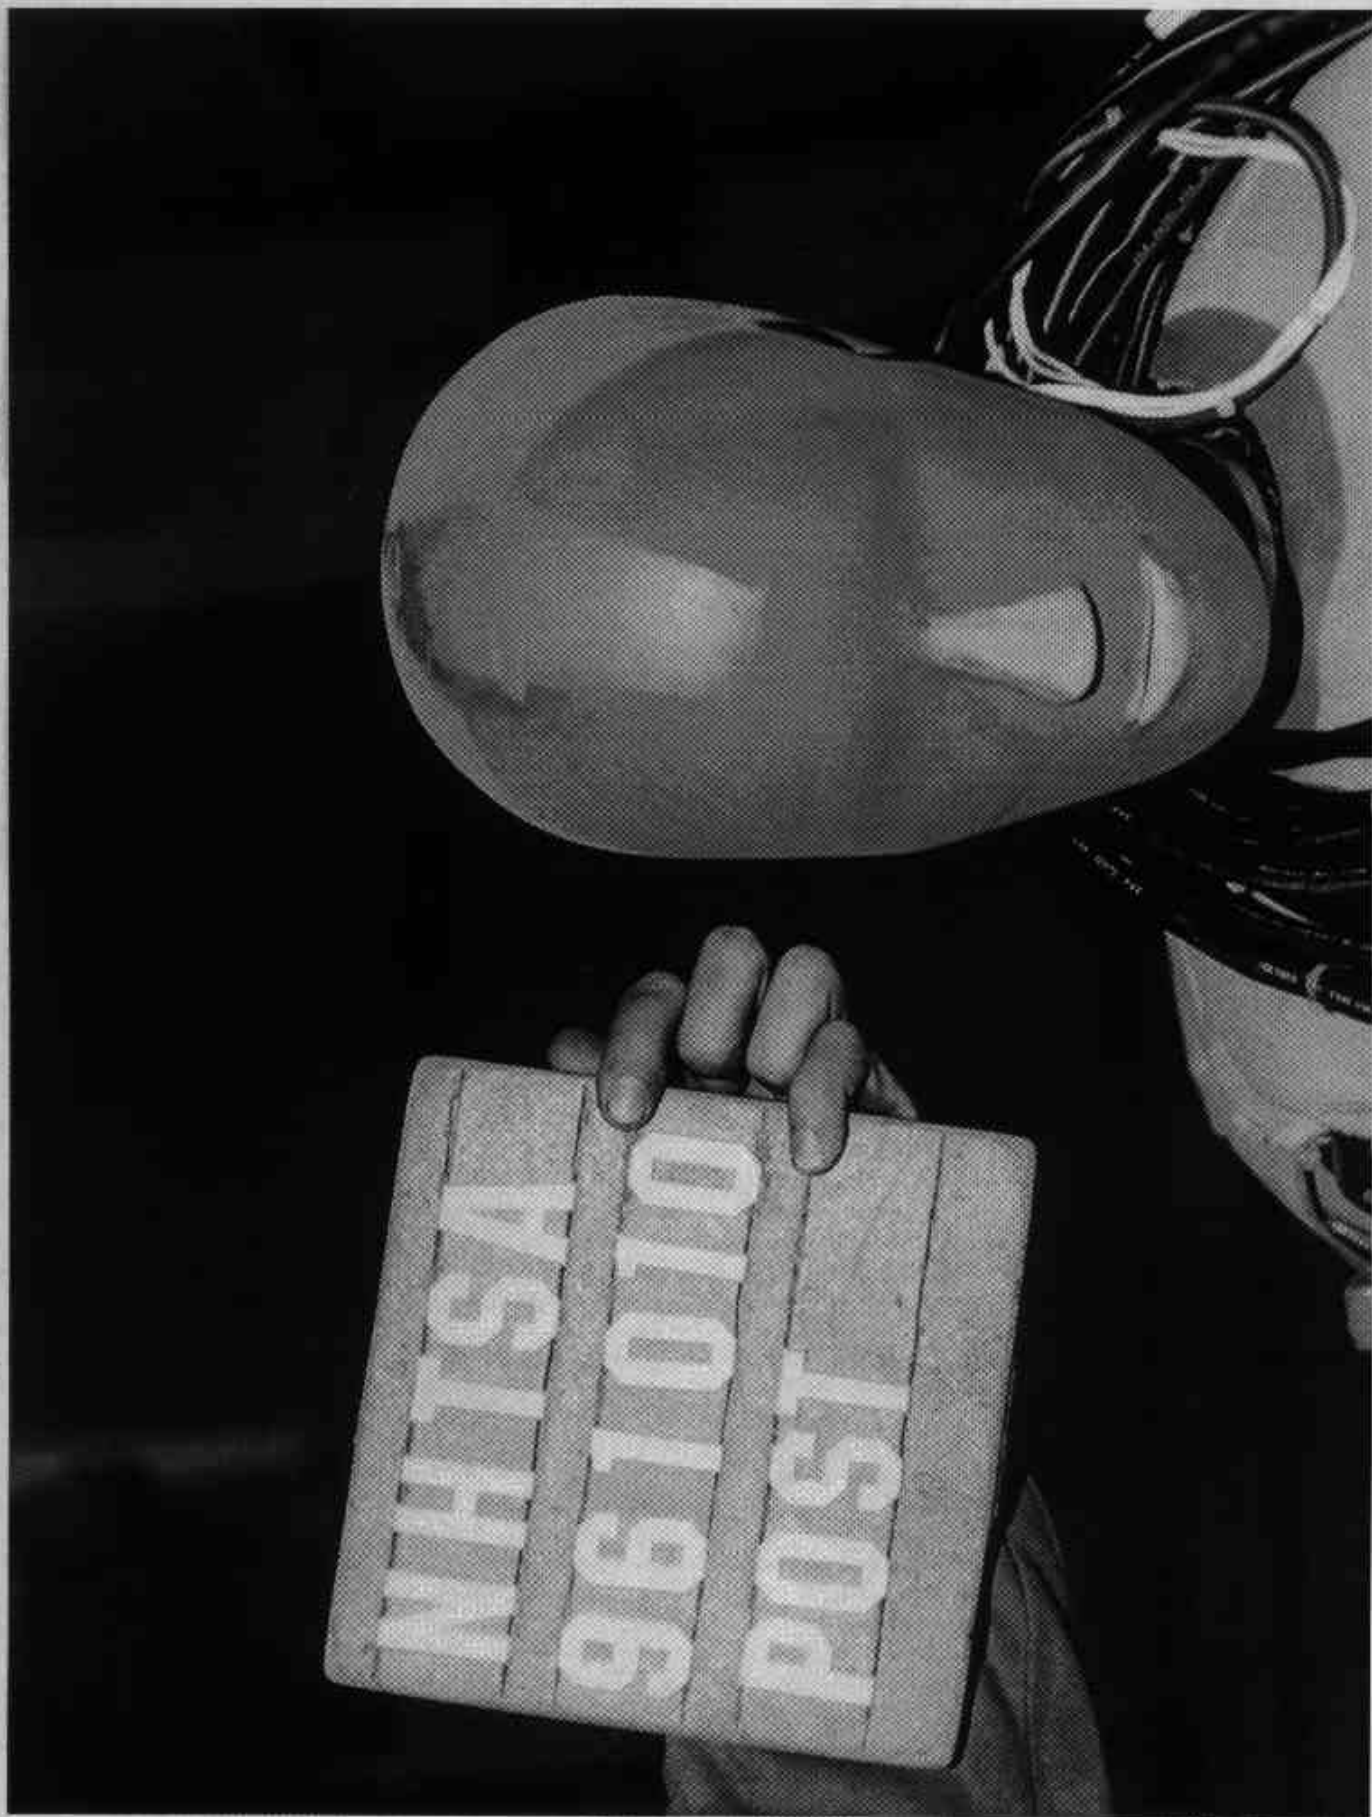
Figure A-19. Post-test Passenger Dummy Head Contact - View 1
