Report Numbers: 208-TRC-97-001
212-TRC-97-001
301-TRC-97-001

Vehicle Safety Compliance Testing
for Occupant Crash Protection,
Windshield Retention, Windshield Zone Intrusion,
and Fuel System Integrity

Ford Motor Company
1997 Ford Expedition
Multi-Purpose Passenger Vehicle
NHTSA Number: CV0211
TRC Test Number: 961010

Final Report

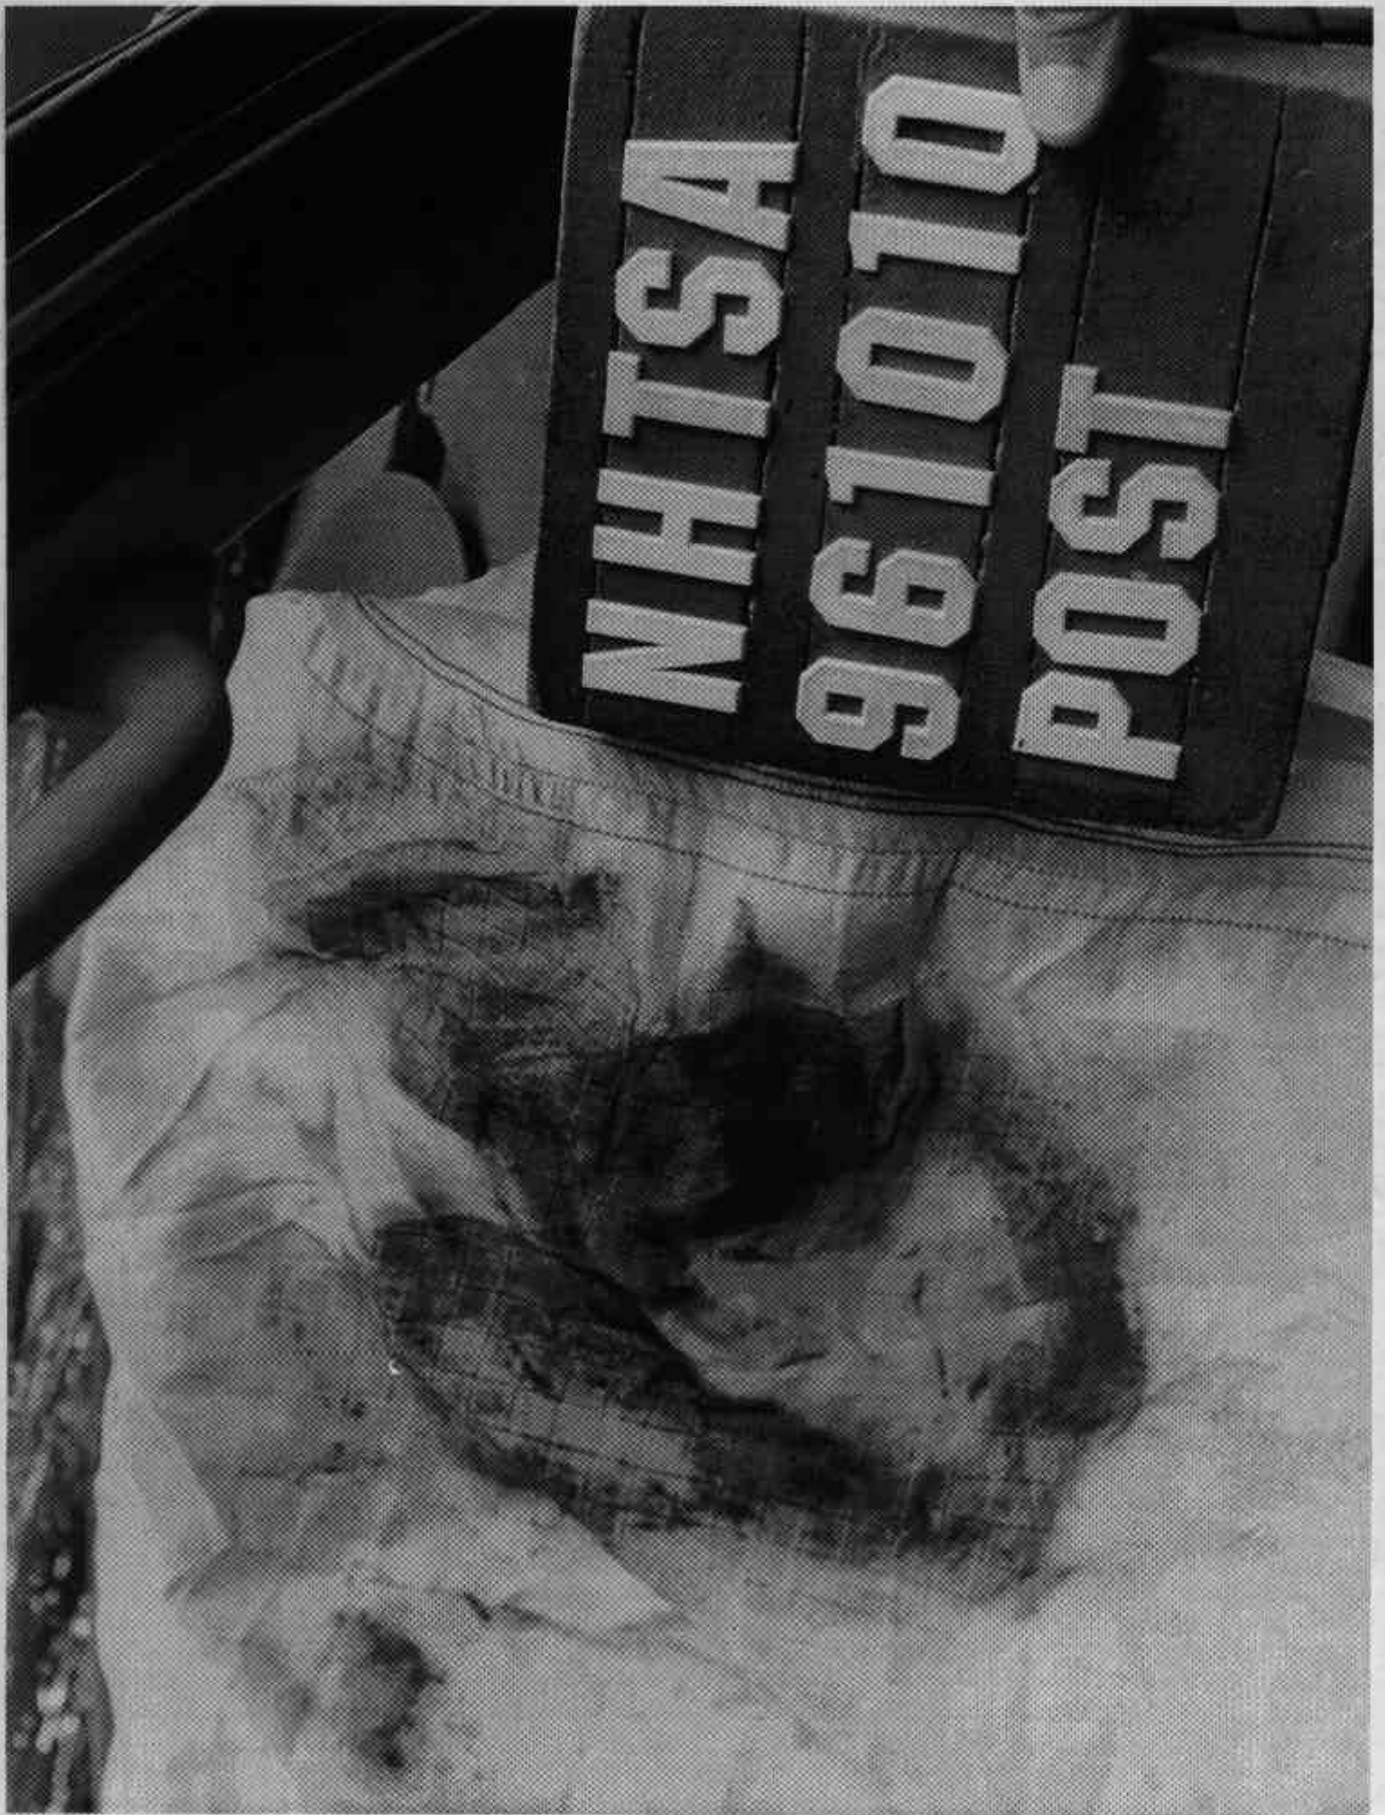
Figure A-20. Post-test Passenger Dummy Head Contact - View 2

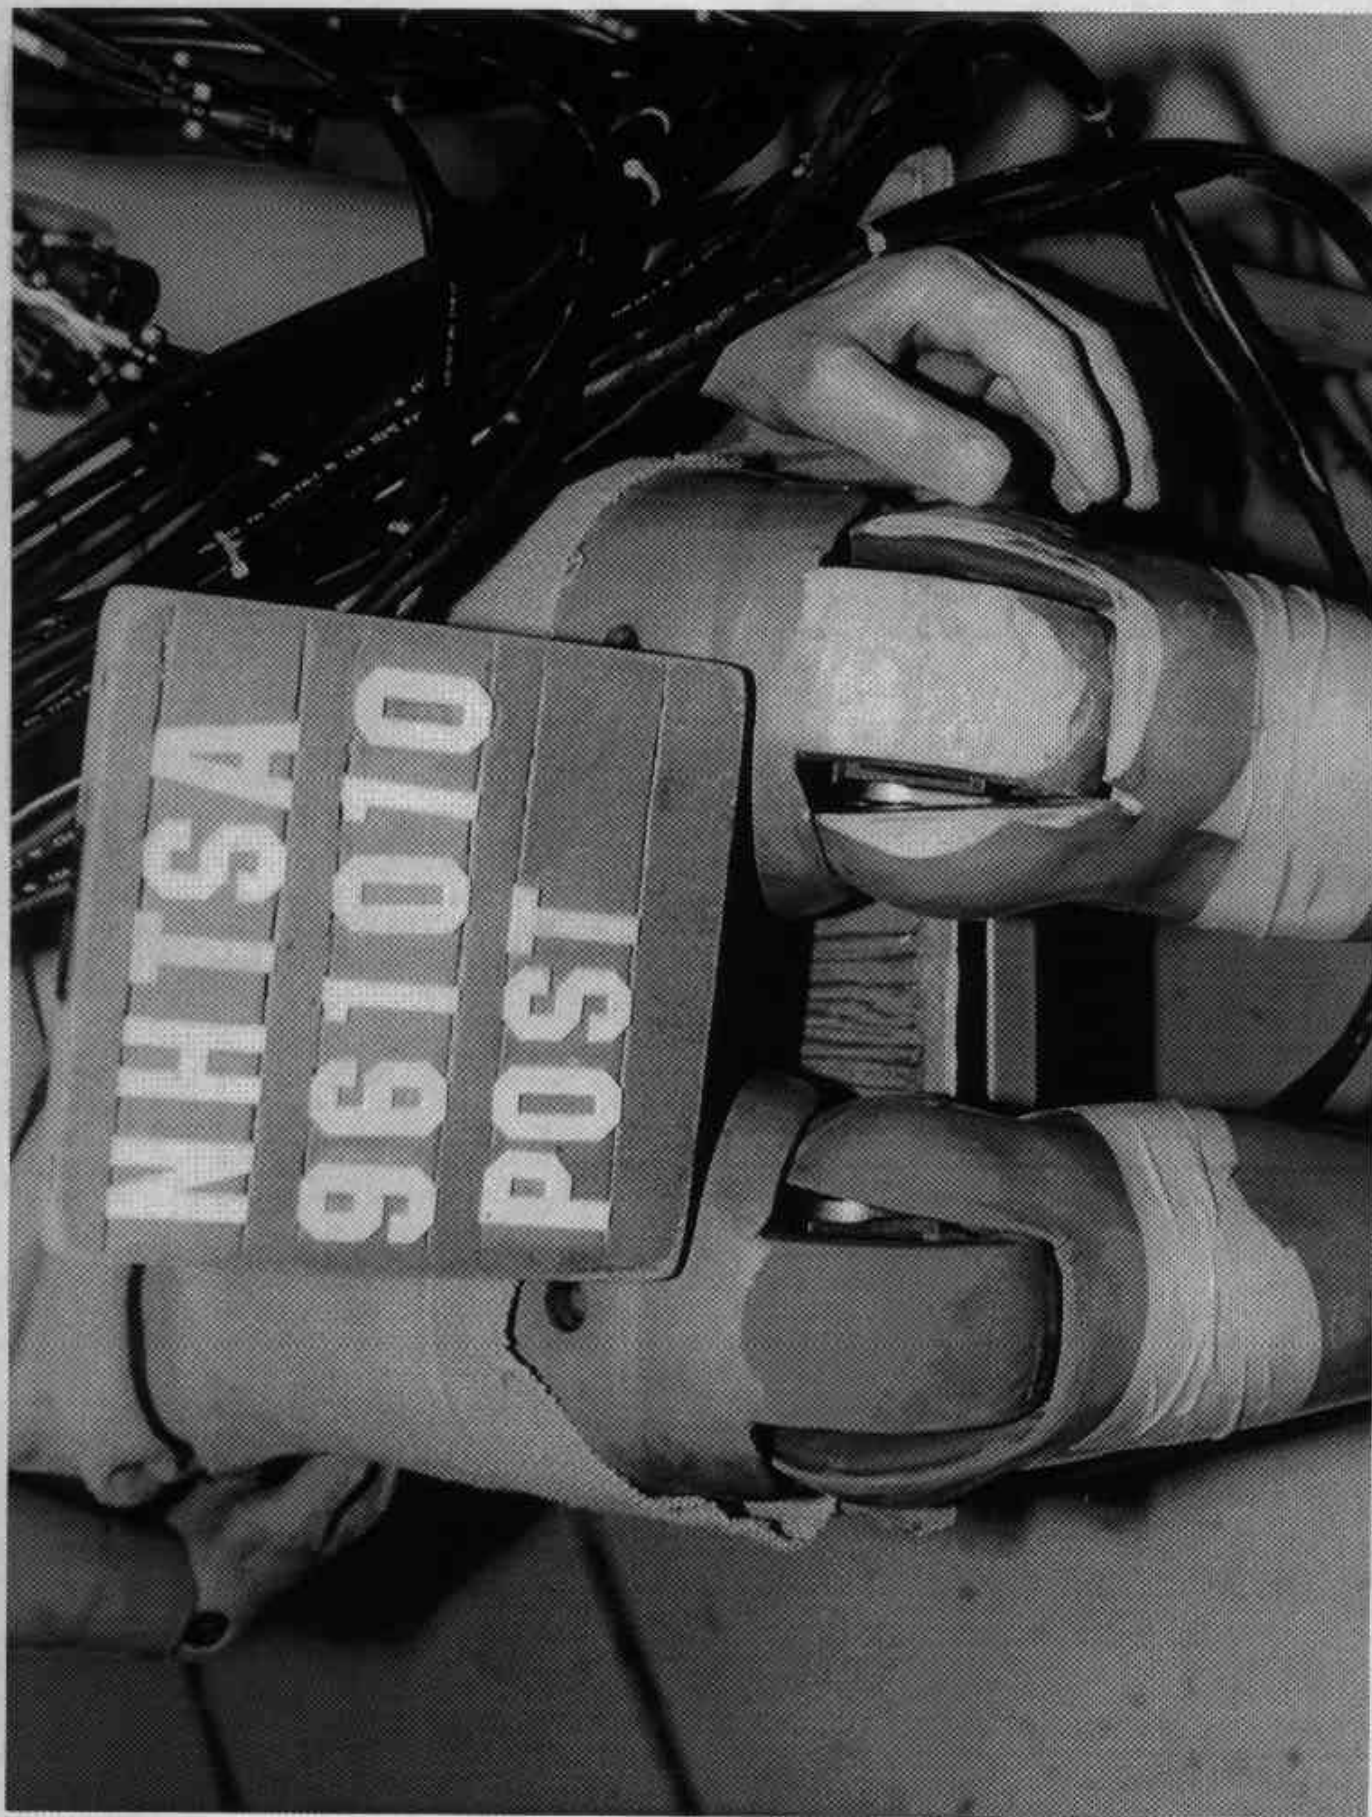
Figure A-21. Post-test Passenger Dummy Knee Contact - View 1

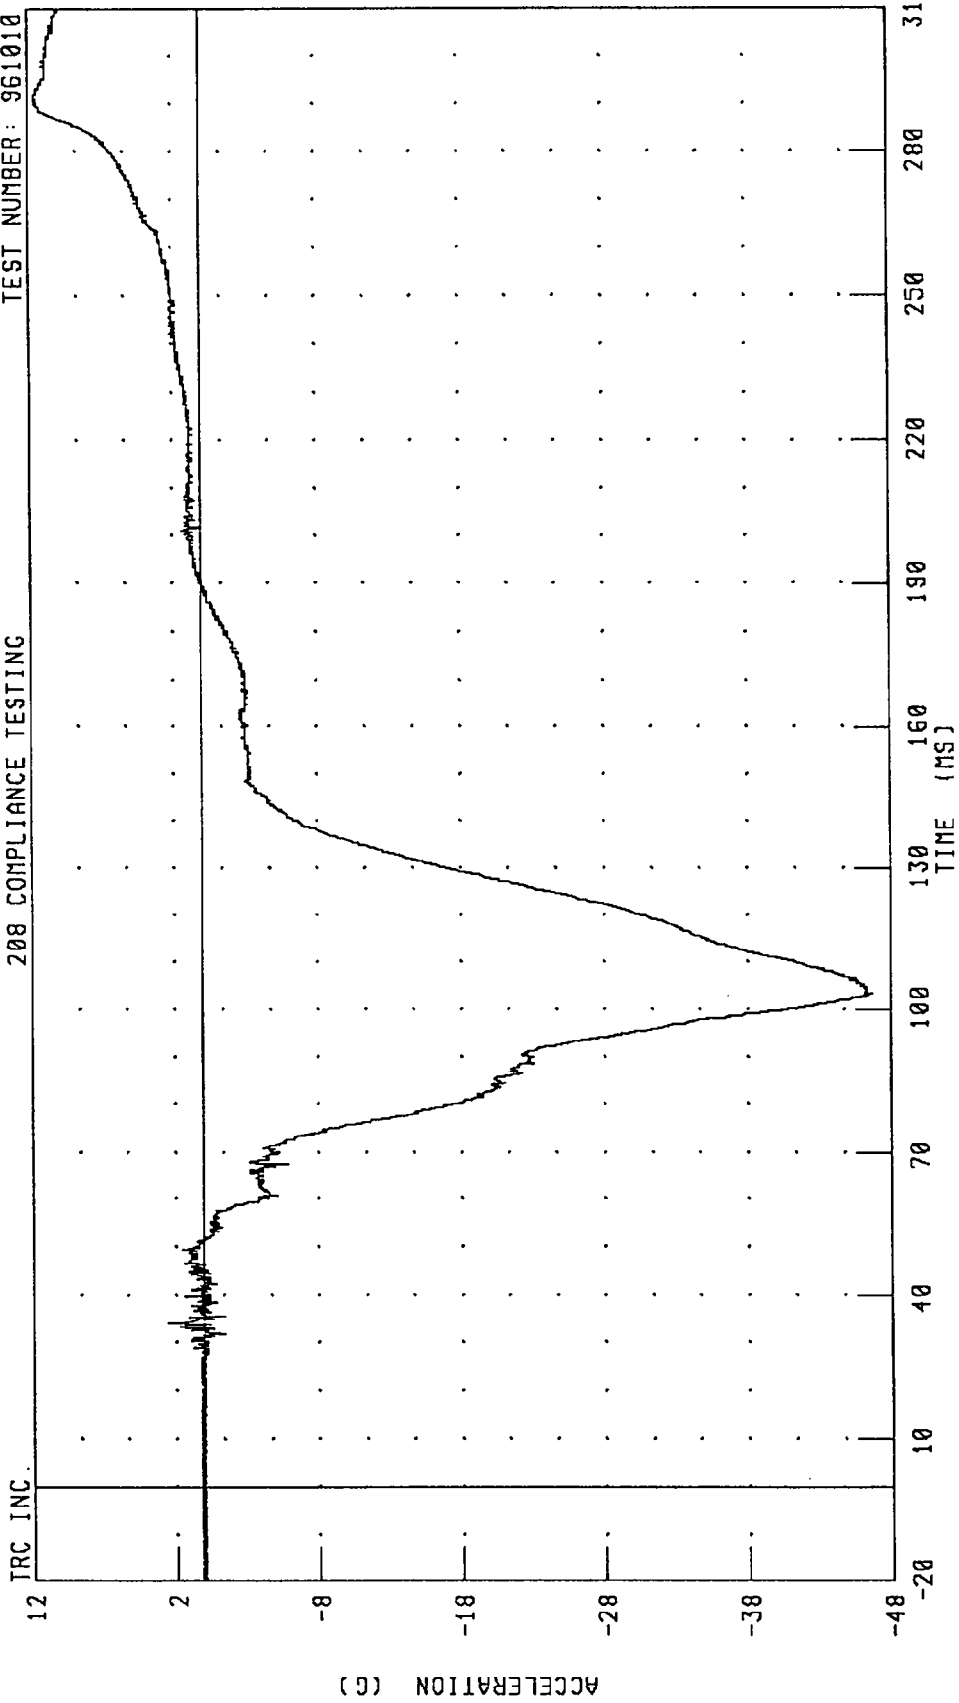
1997 FORD EXPEDITION INTO FLAT FRONTAL BARRIER
DRIVER HEAD X-AXIS ACCELERATION
208 COMPLIANCE TESTING

CHANNEL: HEDXG1 FILTER: CH. CLASS 1000
PEAK DATA: 11.60 G @ 289.92 MS; -46.67 G @ 103.28 MS

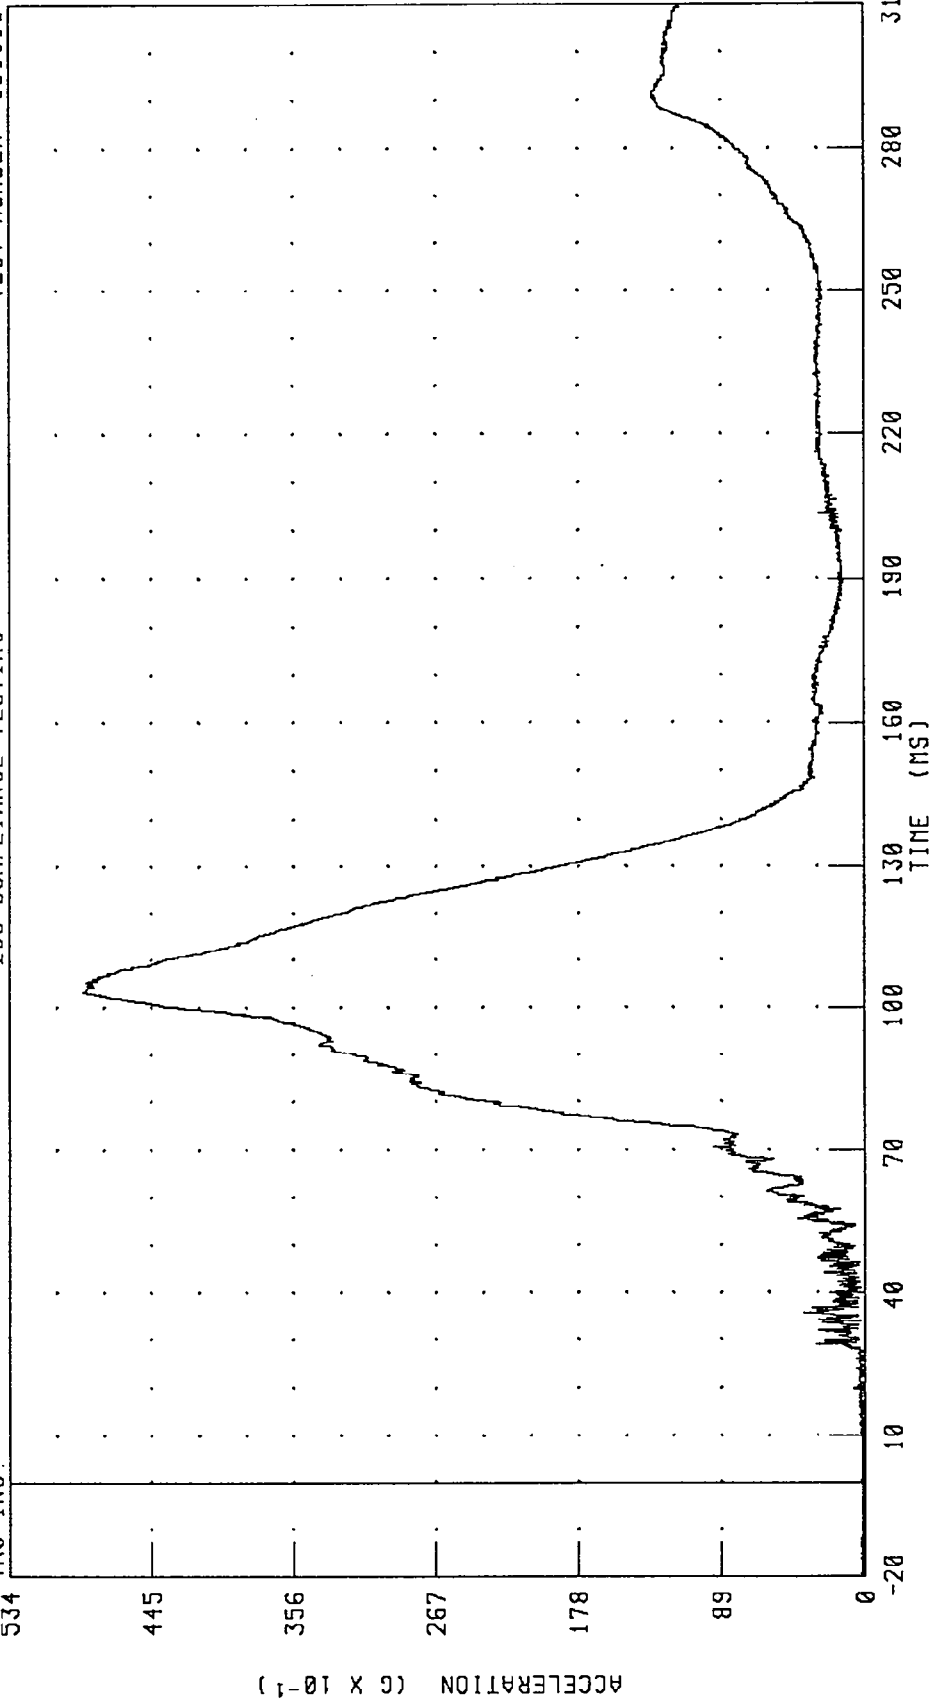
1997 FORD EXPEDITION INTO FLAT FRONTAL BARRIER
DRIVER HEAD RESULTANT ACCELERATION
208 COMPLIANCE TESTING

PEAK DATA: 48.81 G @ 103.28 MS; 0.09 G @ -20.00 MS

The driver's HIC was 330. The driver's chest maximum resultant acceleration with three (3) milliseconds minimum duration was 42.2 g. The driver's chest deflection was 1.1 inches. The driver's left and right femur maximum compressive forces were 1509 pounds and 1957 pounds, respectively.

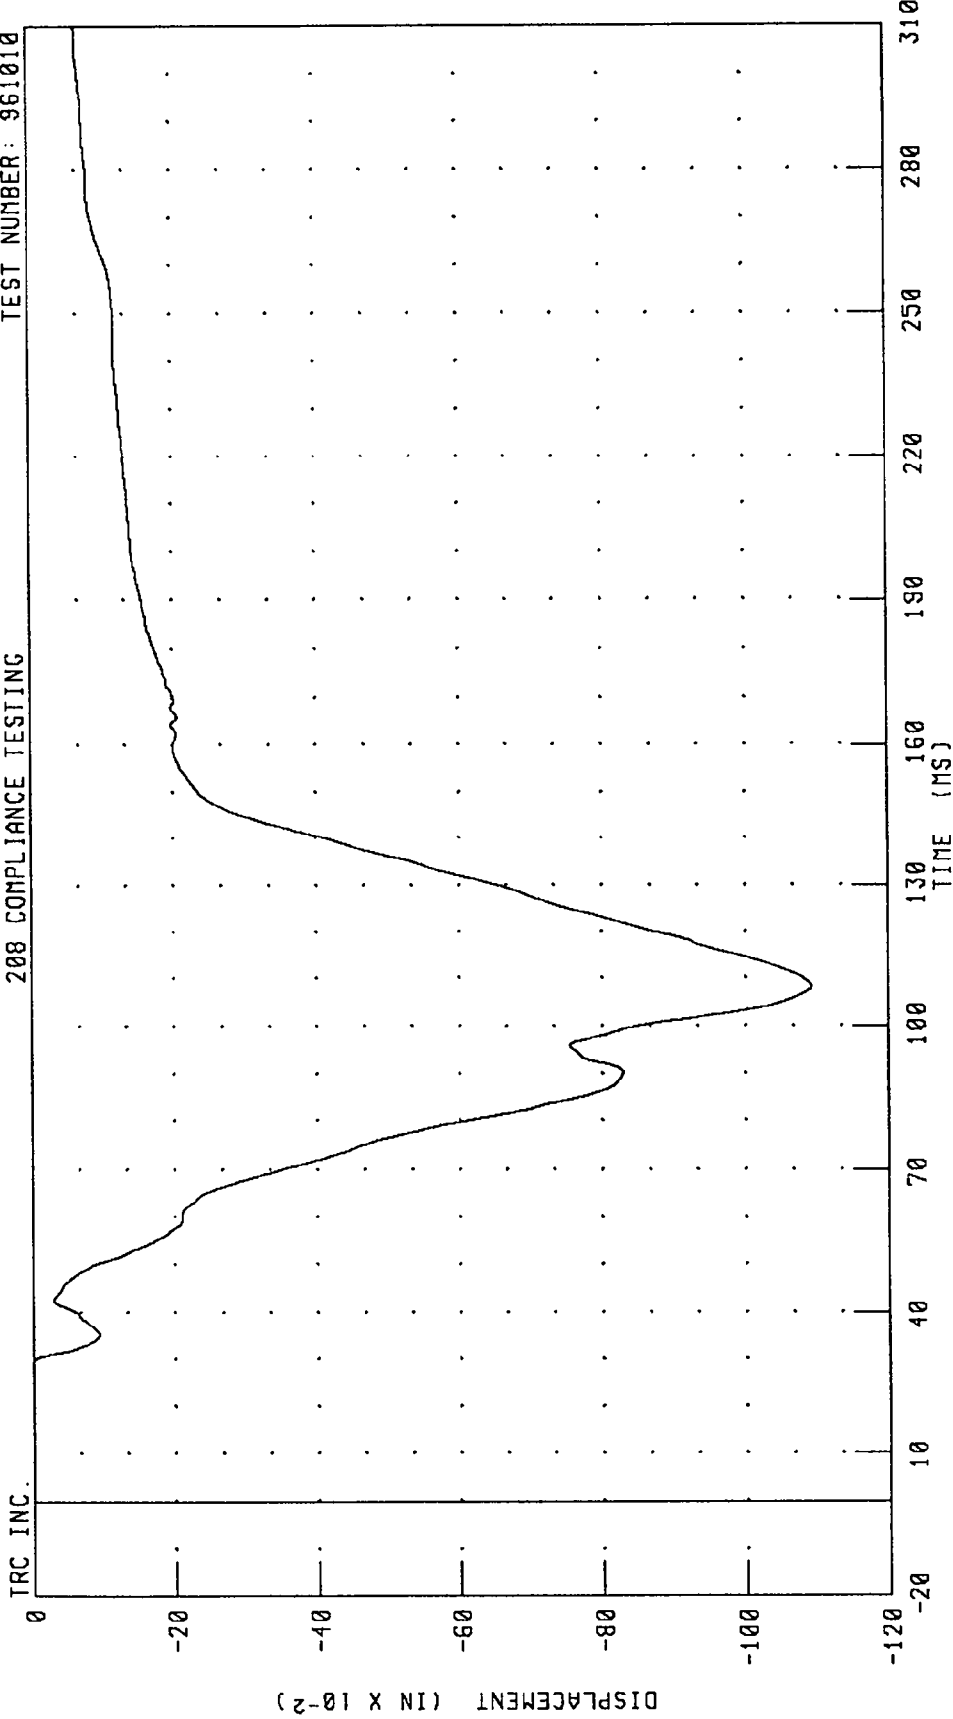
1997 FORD EXPEDITION INTO FLAT FRONTAL BARRIER
DRIVER CHEST DEFLECTION
208 COMPLIANCE TESTING

PEAK DATA: 0.00 IN @ 28.80 MS; -1.09 IN @ 108.24 MS

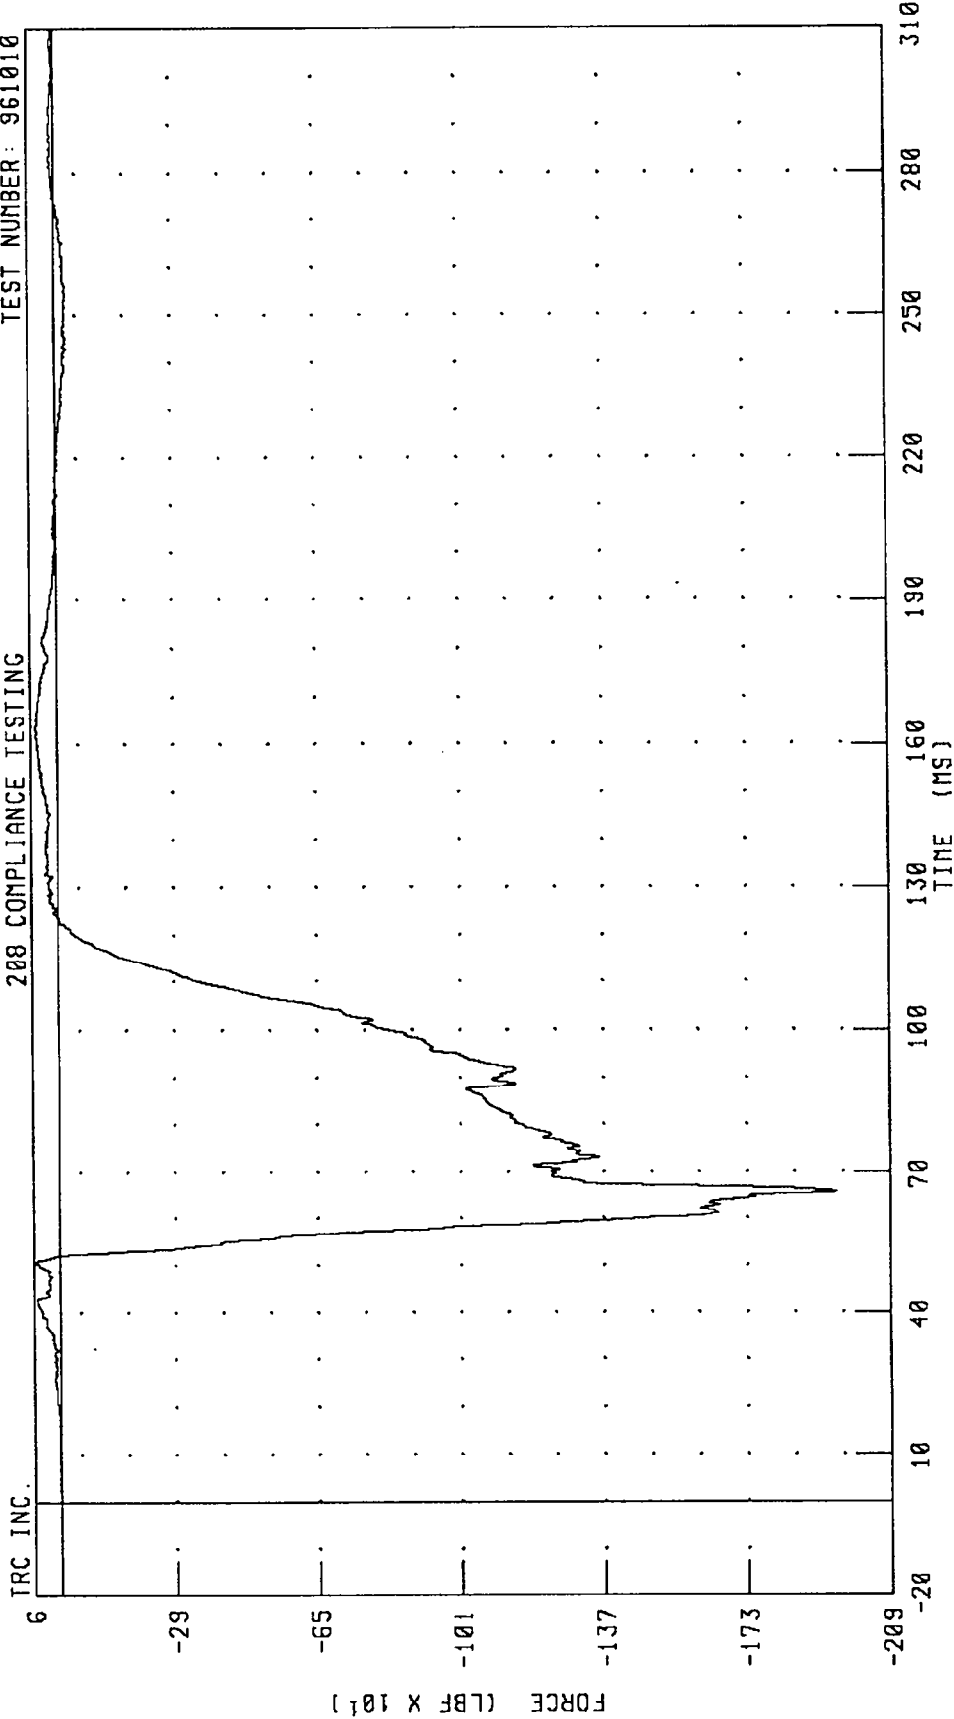
1997 FORD EXPEDITION INTO FLAT FRONTAL BARRIER
DRIVER RIGHT FEMUR FORCE
208 COMPLIANCE TESTING

PEAK DATA: 61.30 LBF @ 50.72 MS; -1956.71 LBF @ 65.84 MS

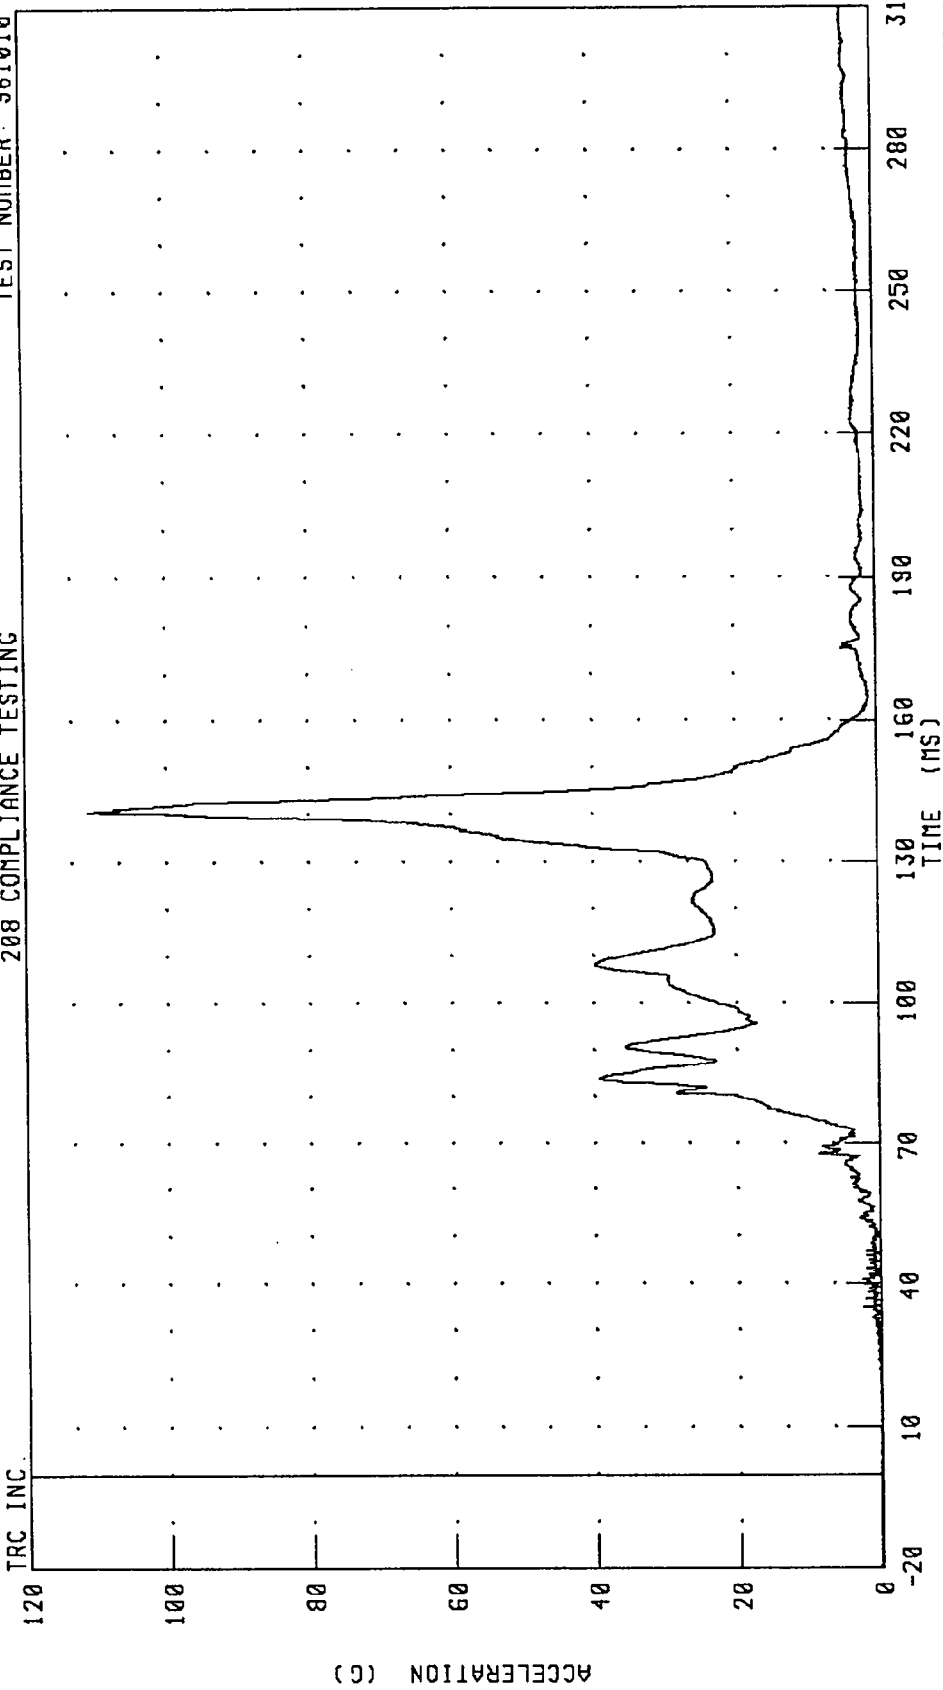
1997 FORD EXPEDITION INTO FLAT FRONTAL BARRIER
RIGHT FRONT PASSENGER HEAD RESULTANT ACCELERATION
208 COMPLIANCE TESTING

CHANNEL: HEDRG2 FILTER: CH. CLASS 1000

The right front passenger's HIC was 516. The right front passenger's chest maximum resultant acceleration with three (3) milliseconds minimum duration was 43.7 g. The passenger's chest deflection was 0.5 inch. The right front passenger's left and right femur maximum compressive forces were 1442 pounds and 1606 pounds, respectively.

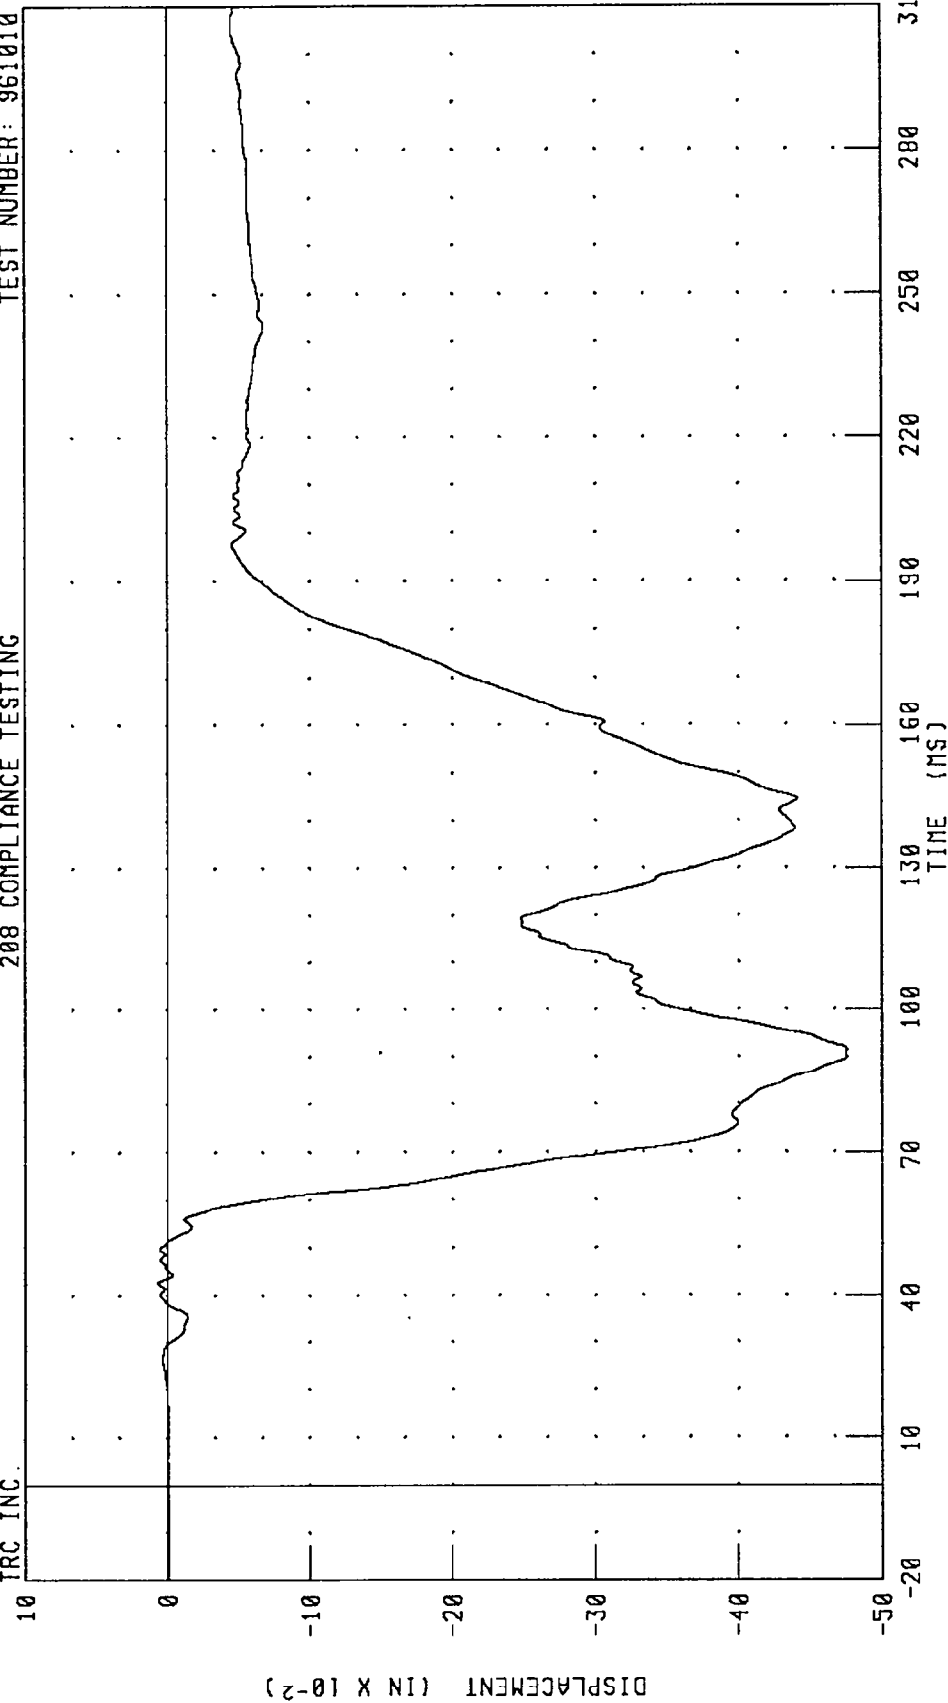
1997 FORD EXPEDITION INTO FLAT FRONTAL BARRIER
RIGHT FRONT PASSENGER CHEST DEFLECTION
208 COMPLIANCE TESTING

CHANNEL: CSTXD2 FILTER: CH. CLASS 180 PEAK DATA: 0.01 IN @ 42.72 MS; -0.48 IN @ 89.92 MS

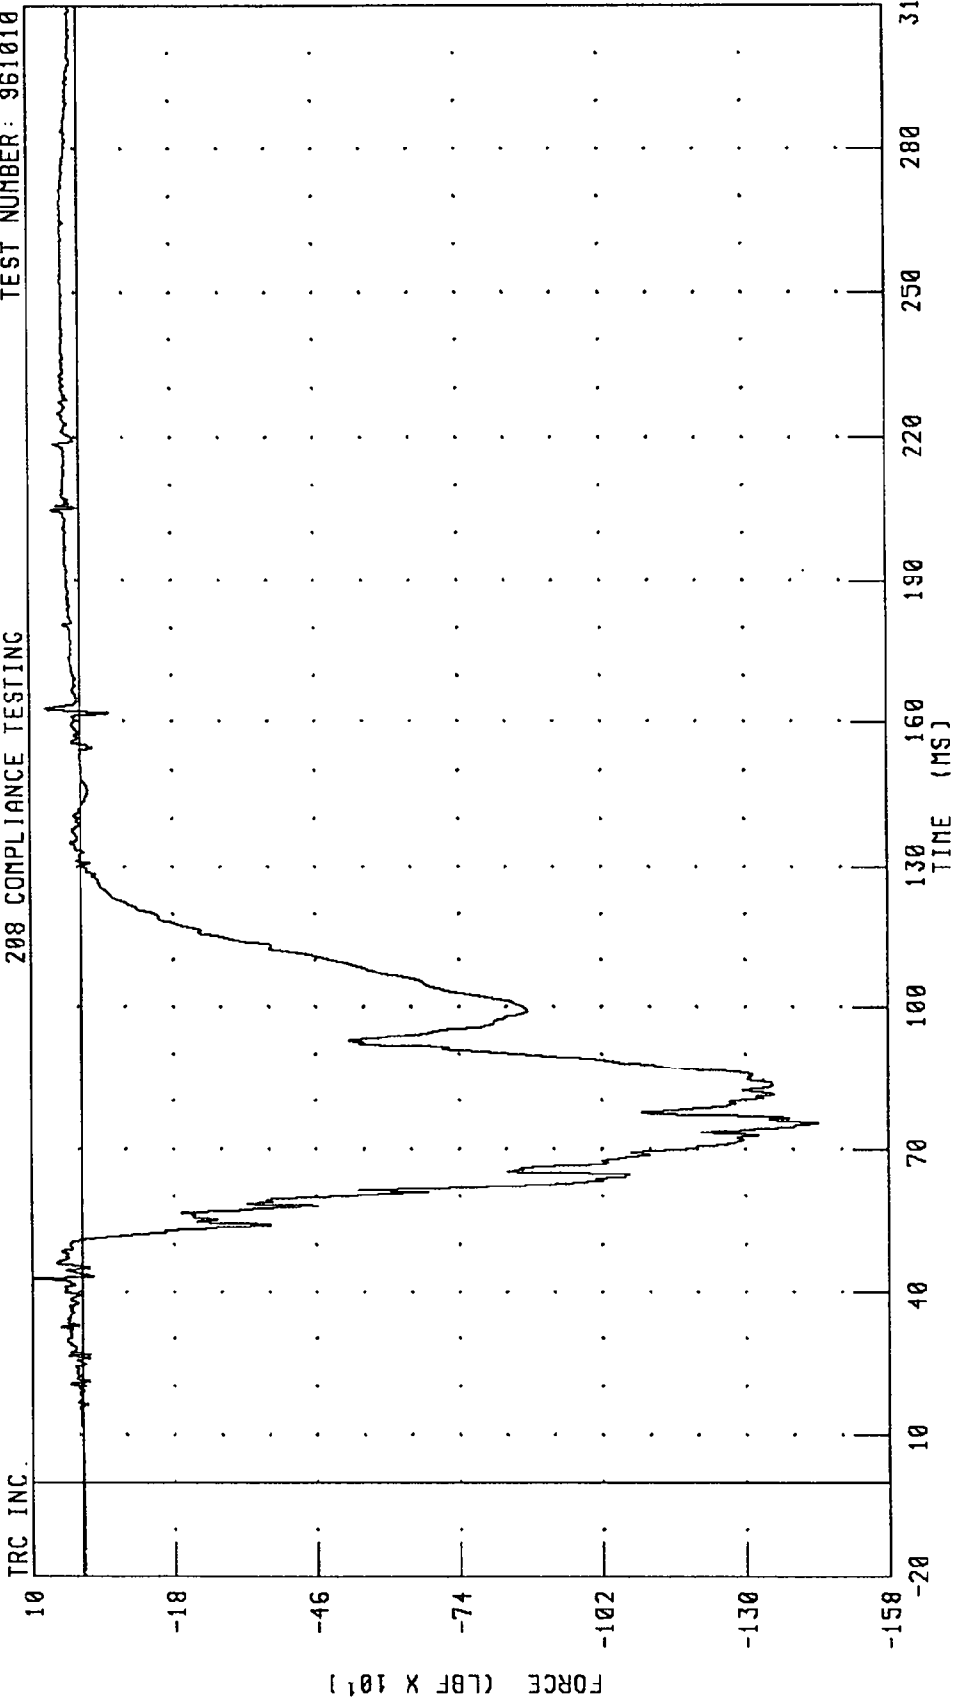
1997 FORD EXPEDITION INTO FLAT FRONTAL BARRIER
RIGHT FRONT PASSENGER LEFT FEMUR FORCE
208 COMPLIANCE TESTING

CHANNEL: LFMF2 FILTER: CH. CLASS 600
PEAK DATA: 98.43 LBF @ 42.96 MS; -1442.34 LBF @ 75.44 MS

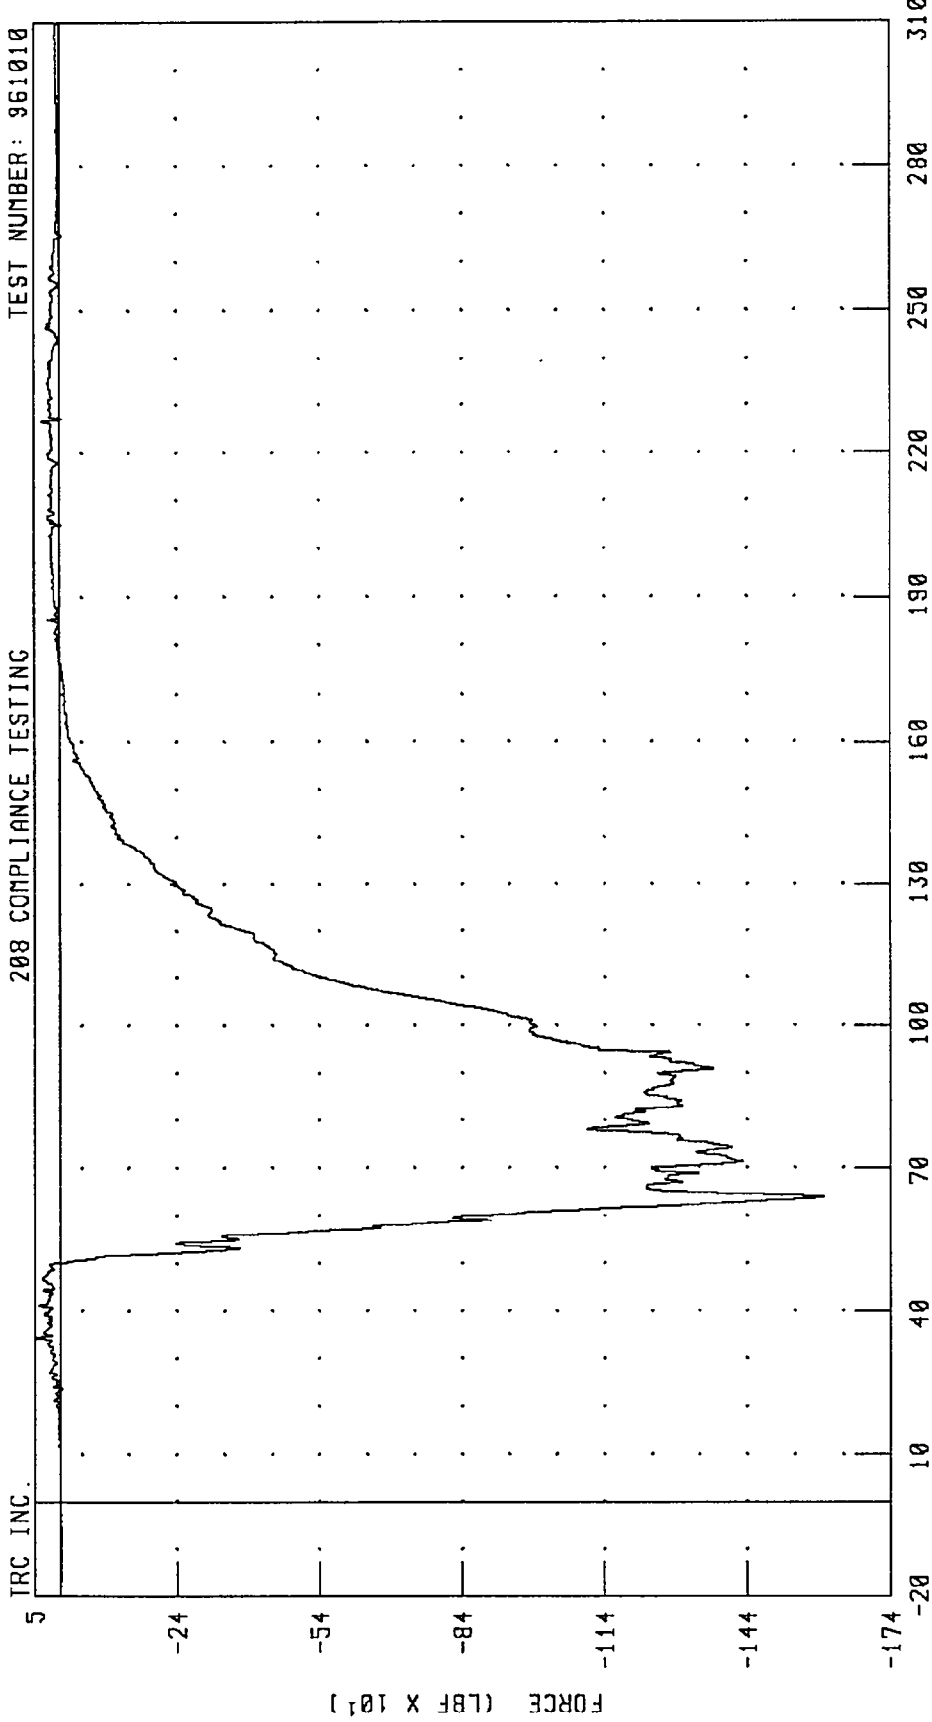
1997 FORD EXPEDITION INTO FLAT FRONTAL BARRIER
RIGHT FRONT PASSENGER RIGHT FEMUR FORCE
208 COMPLIANCE TESTING

CHANNEL: RFMF2 FILTER: CH. CLASS 600
PEAK DATA: 48.31 LBF @ 34.64 MS; -1606.19 LBF @ 64.00 MS

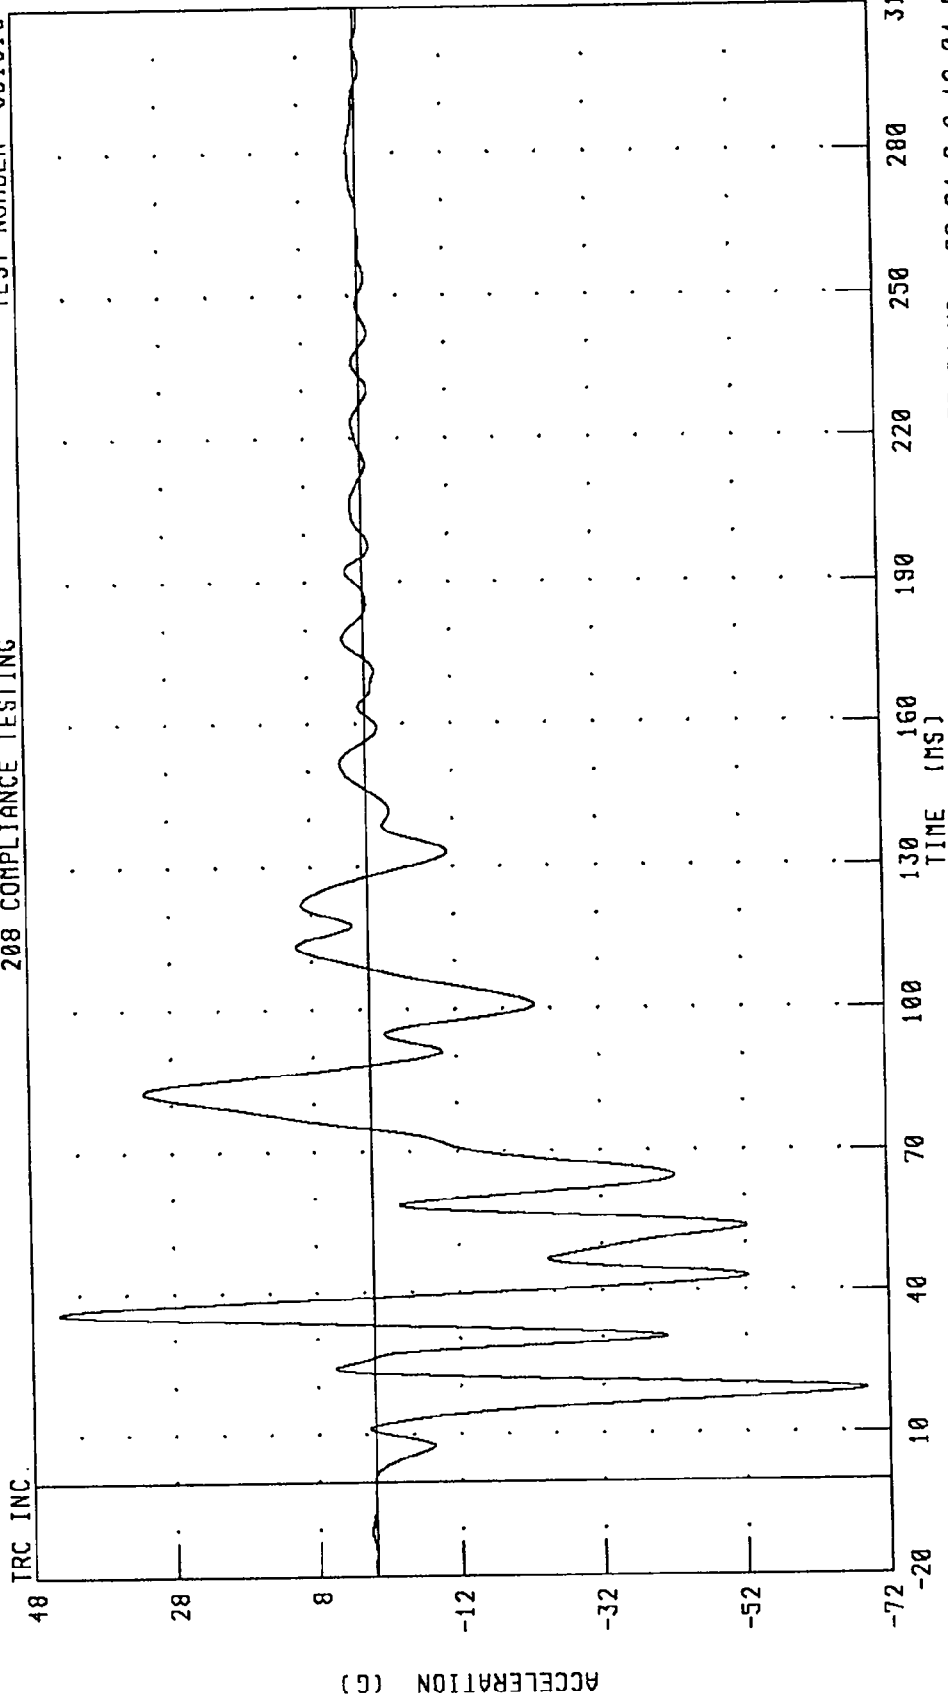
1997 FORD EXPEDITION INTO FLAT FRONTAL BARRIER
RIGHT BRAKE CALIPER X-AXIS ACCELERATION
208 COMPLIANCE TESTING

CHANNEL: BCRXG1 FILTER: CH. CLASS 60 PEAK DATA: 44.09 G @ 35.84 MS; -68.64 G @ 19.04 MS
