NEW CAR ASSESSMENT PROGRAM
SIDE IMPACT TESTING
PASSENGER CARS

1997 FORD THUNDERBIRD
2 DOOR
NHTSA NO: MV0203

FINAL REPORT

1. Report No. 214D-MGA-97-05		2. Government Accession No.		3. Recipient's Catalog No.																			
4. Title and Subtitle New Car Assessment Program Side Impact Test of a 1997 Ford Thunderbird 2 Door NHTSA No. MV0203				5. Report Date December 10, 1996																			
				6. Performing Organization Code MGA																			
7. Author(s) David Winkelbauer, Project Engineer				8. Performing Organization Report No. MGA-DOT-214D-05																			
9. Performing Organization Name and Address MGA Research Corporation 5000 Warren Road Burlington, WI 53105				10. Work Unit No.																			
				11. Contract or Grant No. DTNH22-93-C-02047																			
12. Sponsoring Agency Name and Address U.S. Department of Transportation National Highway Traffic Safety Administration Office of Crashworthiness Standards 400 Seventh St, S.W., Washington, D.C. 20590				13. Type of Report and Period Covered Final Test Report December 4, 1996 to December 10, 1996																			
				14. Sponsoring Agency Code NSA-30																			
15. Supplementary Notes

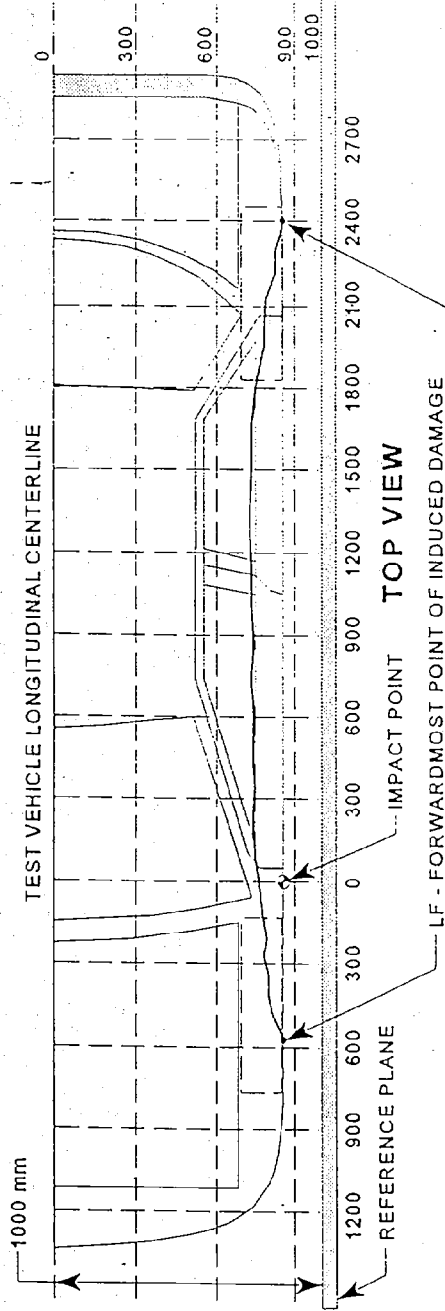
VEHICLE DAMAGE PROFILE DISTANCES

MEASUREMENT CONVENTIONS:
 LR - REARWARDMOST POINT OF INDUCED DAMAGE
 Forward of the impact point (towards front of vehicle) is considered negative (-).
 Rearward of the impact point (toward rear of vehicle) is considered positive (+).

DPD MEASUREMENTS	POST-TEST (mm)	PRE-TEST (mm)	STATIC CRUSH (mm)
1. (LF = <u>-1050</u> mm)	578	578	0
2. <u>-180</u> mm	592	531	61
3. <u>690</u> mm	859	519	340
4. <u>1560</u> mm	996	521	475
5. <u>2430</u> mm	572	555	17
6. (LR = <u>3300</u> mm)	630	630	0

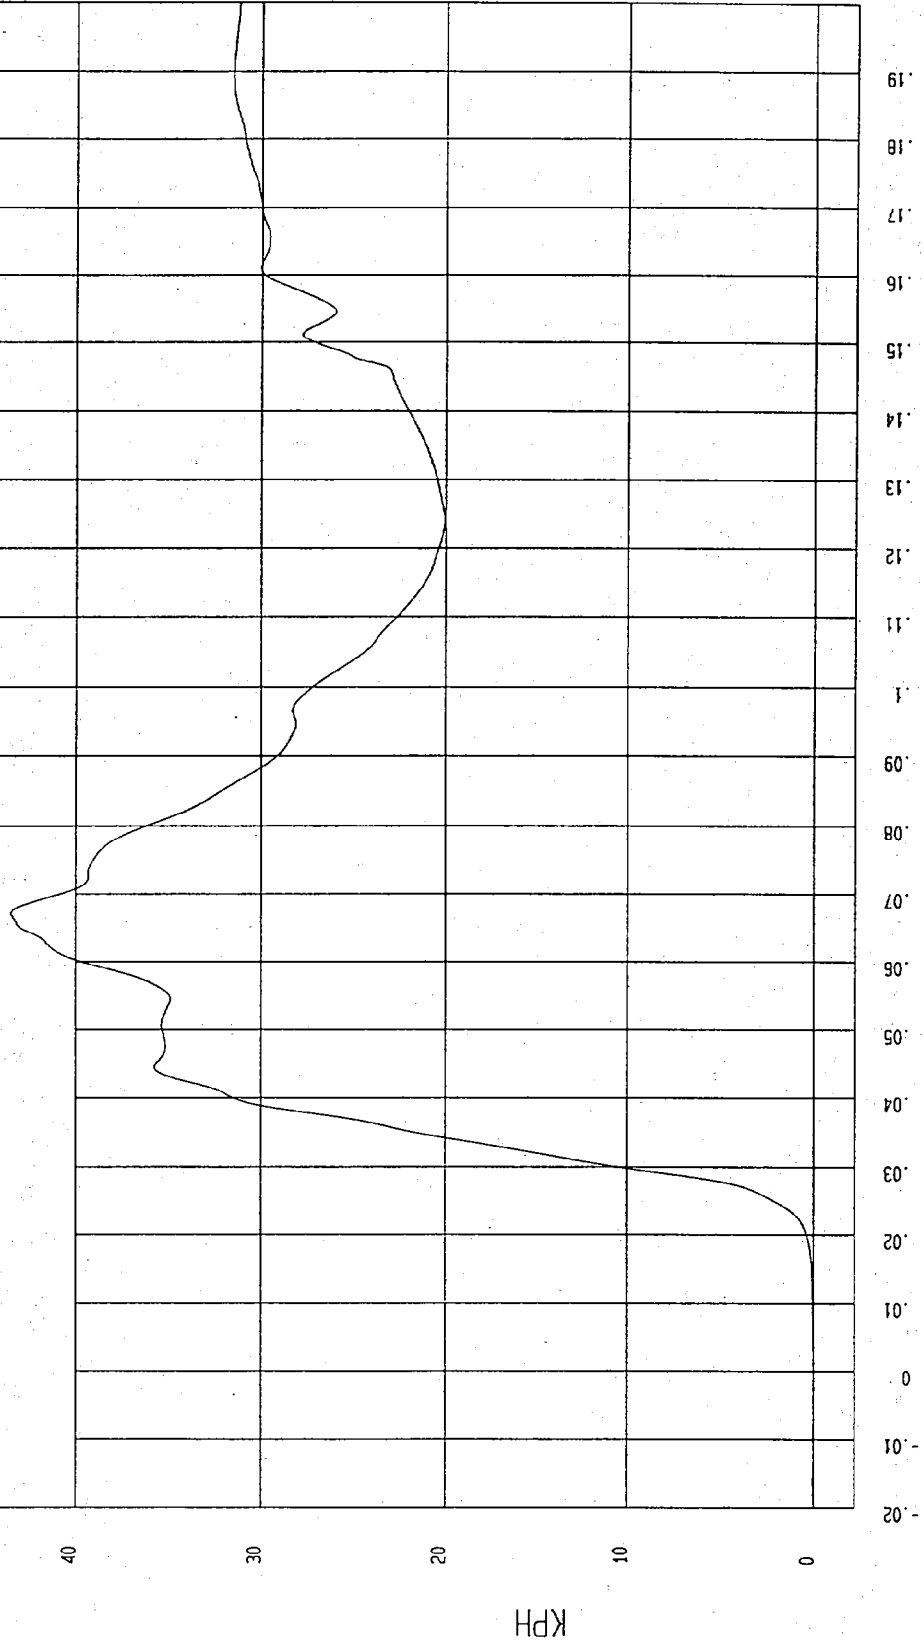
DRIVER UPPER RIB Y VELOCITY

1 896132A1.V15 Filterclass (180)

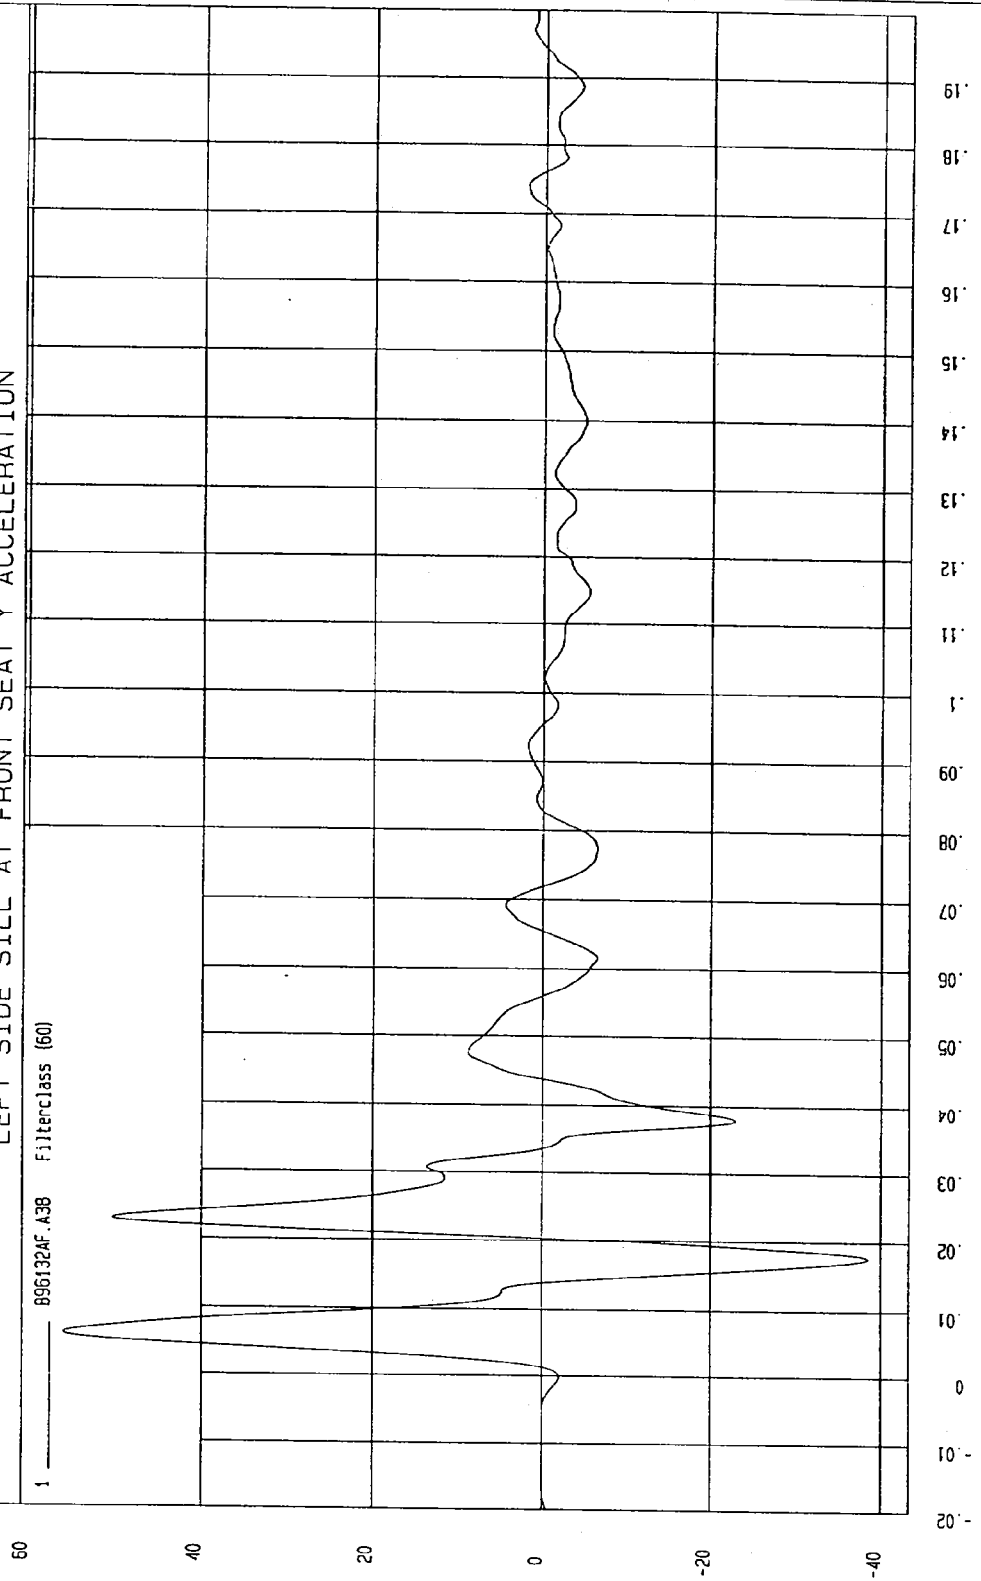
LEFT SIDE SILL AT FRONT SEAT Y ACCELERATION

1 896132AF.A38 FilterClass (60)

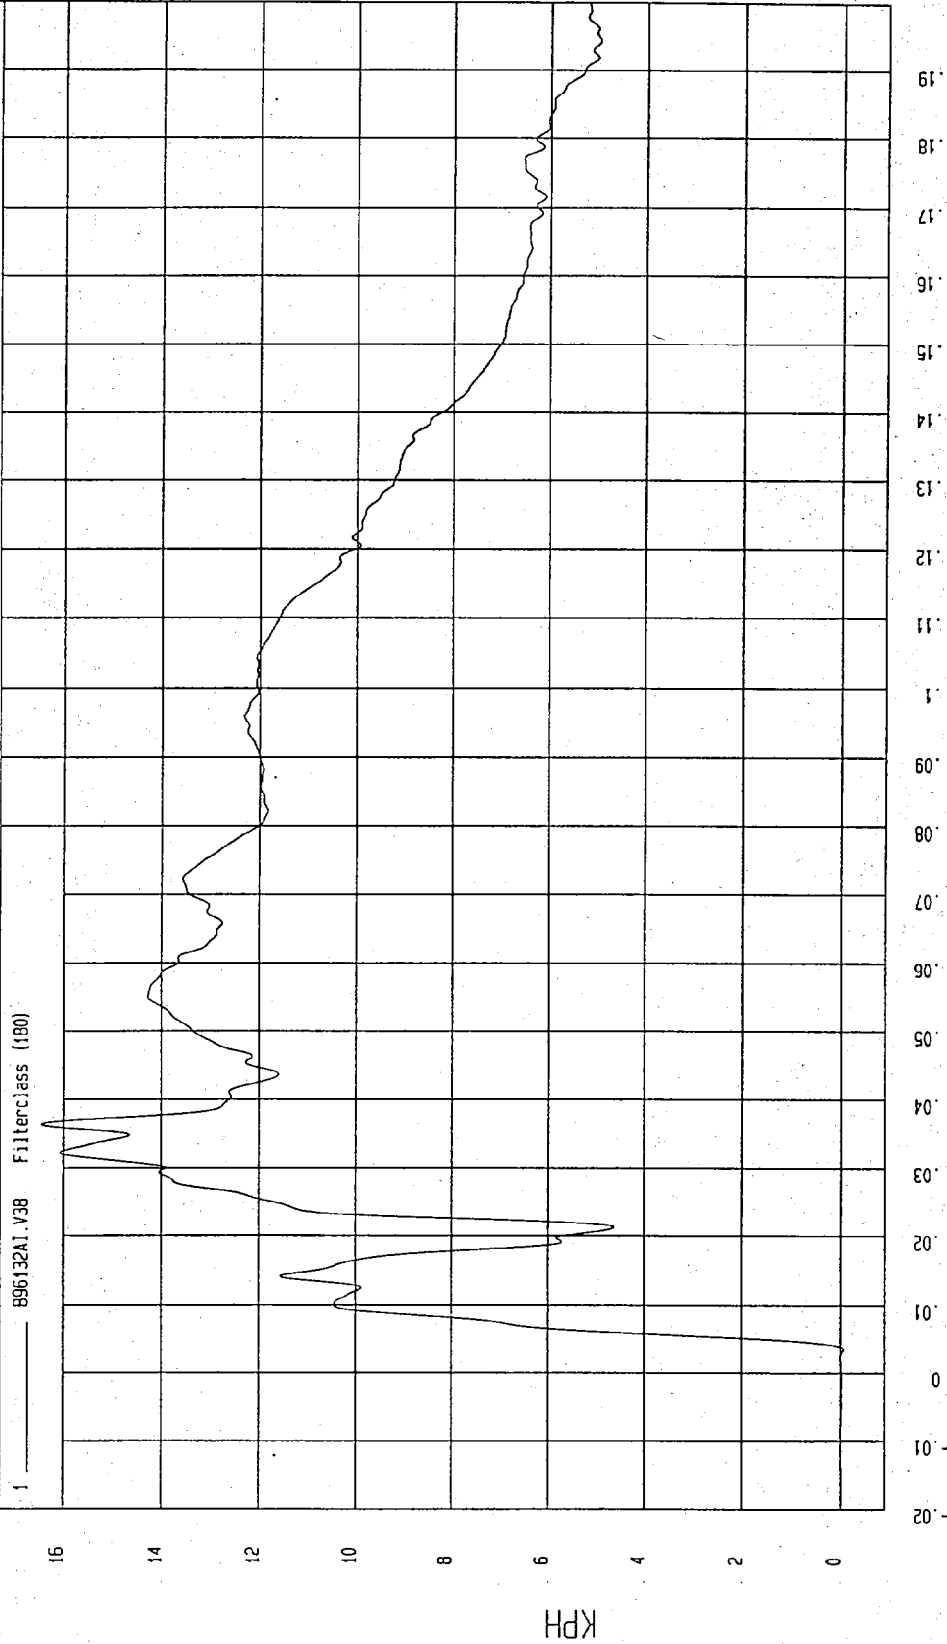
LEFT SIDE SILL AT FRONT SEAT Y VELOCITY

1 ——— 896132A1.V38 Filterclass (180)

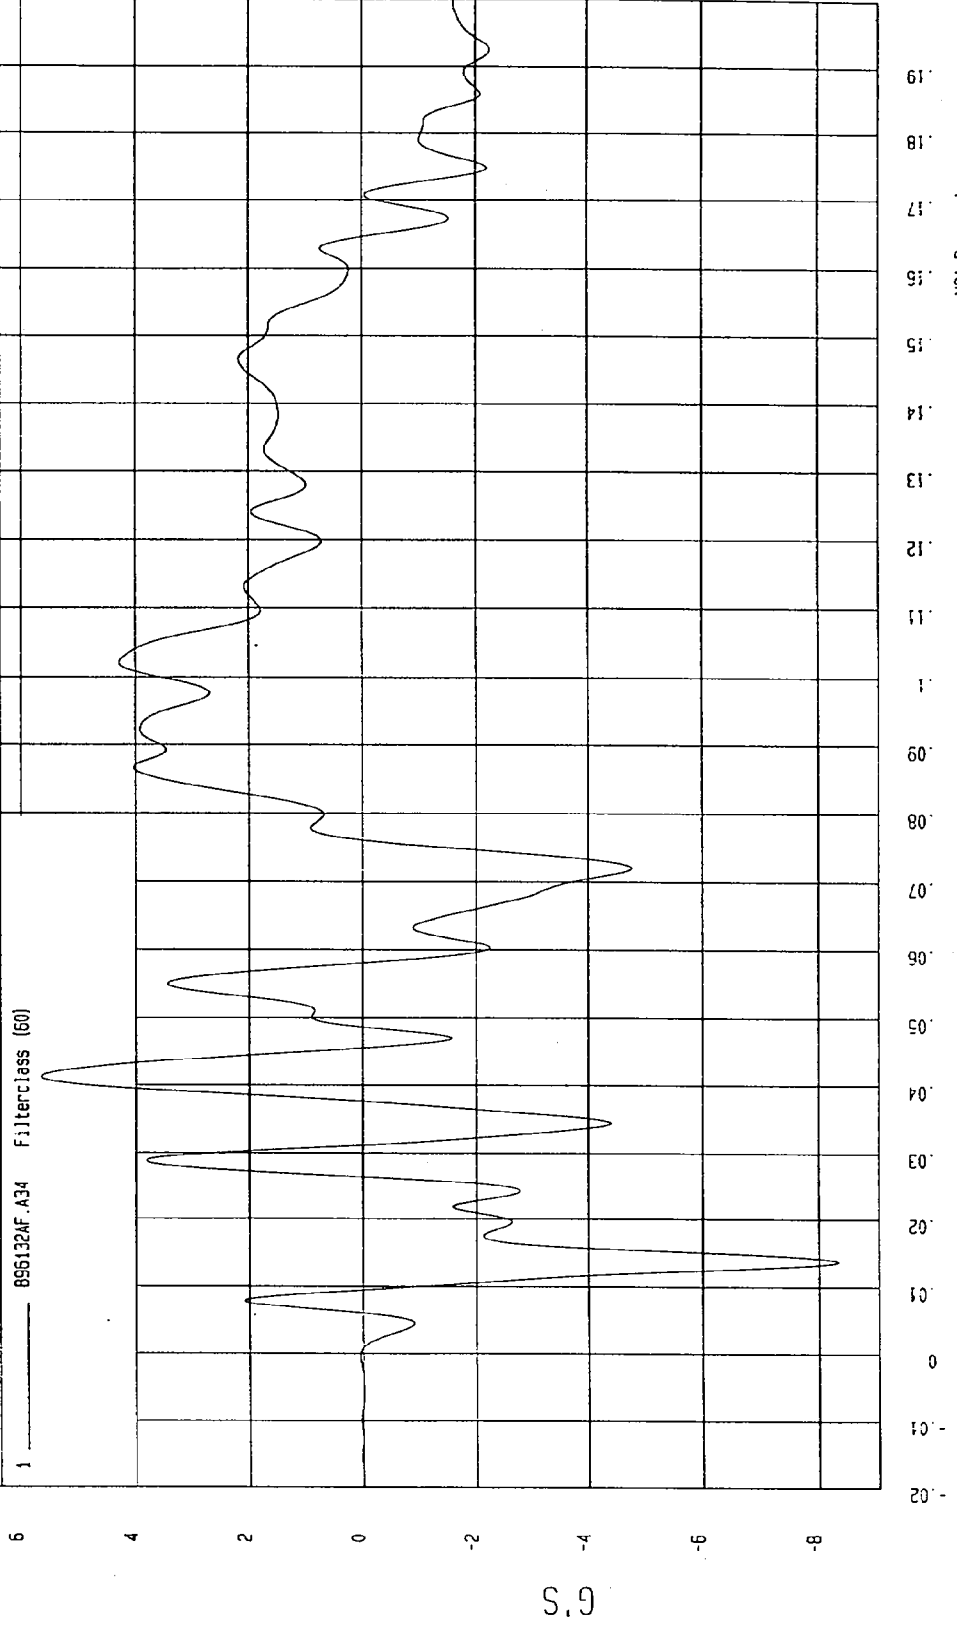
RIGHT SIDE SILL AT FRONT SEAT Z ACCELERATION

1 896132AF.A34 Filterclass (60)

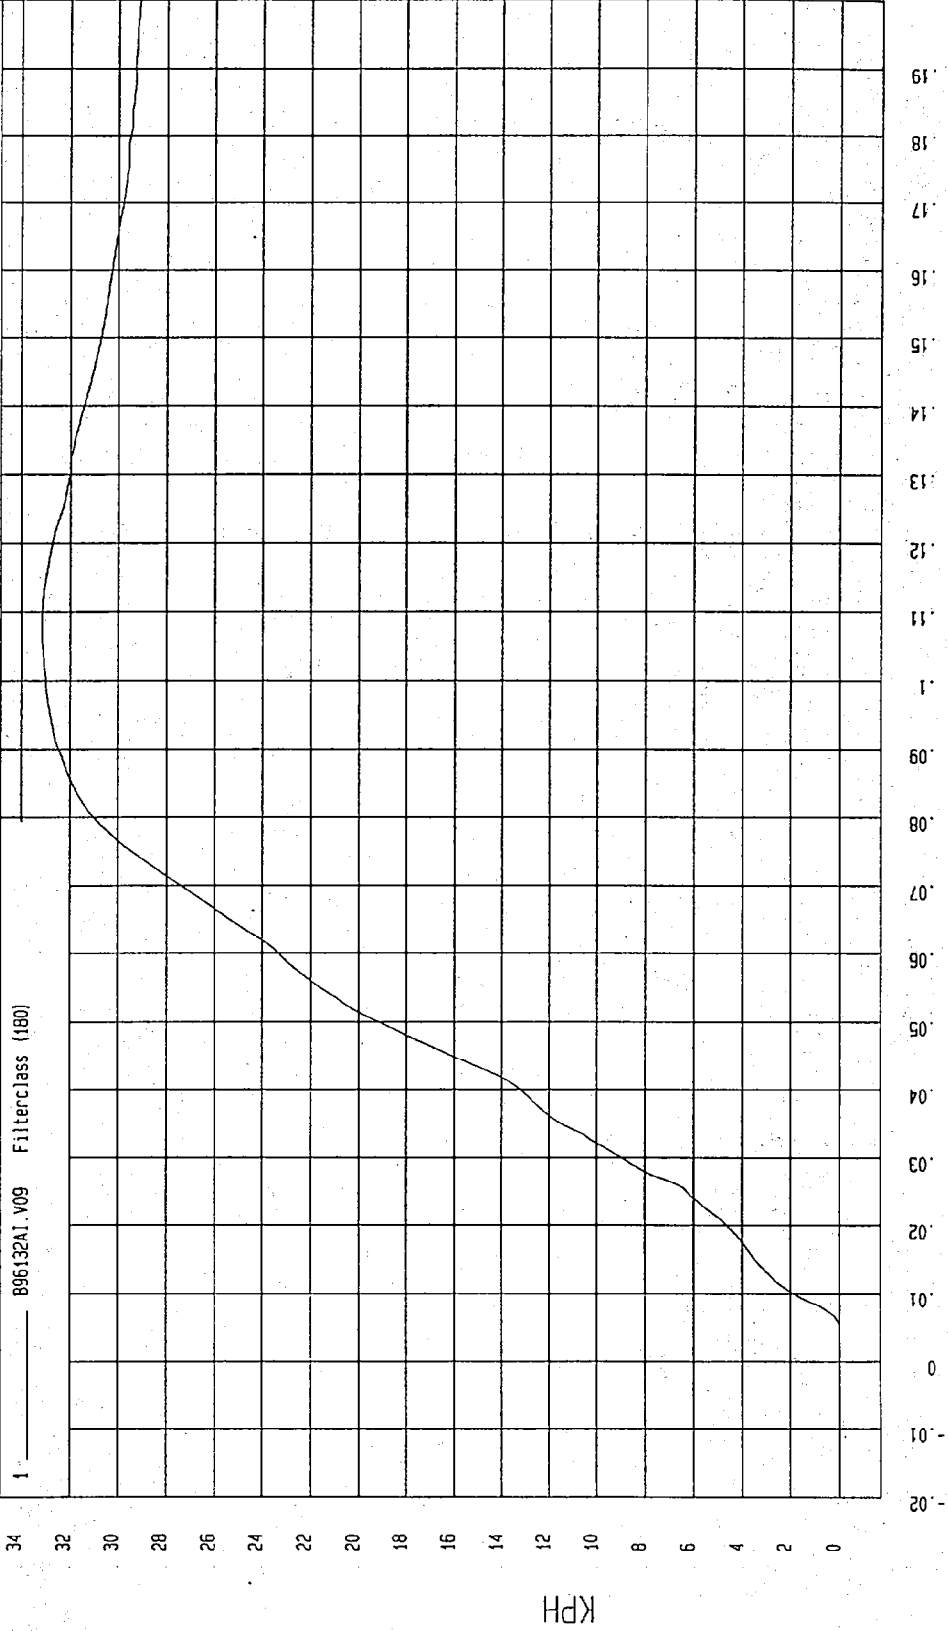
REAR FLOORPAN ABOVE AXLE Y VELOCITY

1 ——— B96132A1.V09 Filterclass (180)

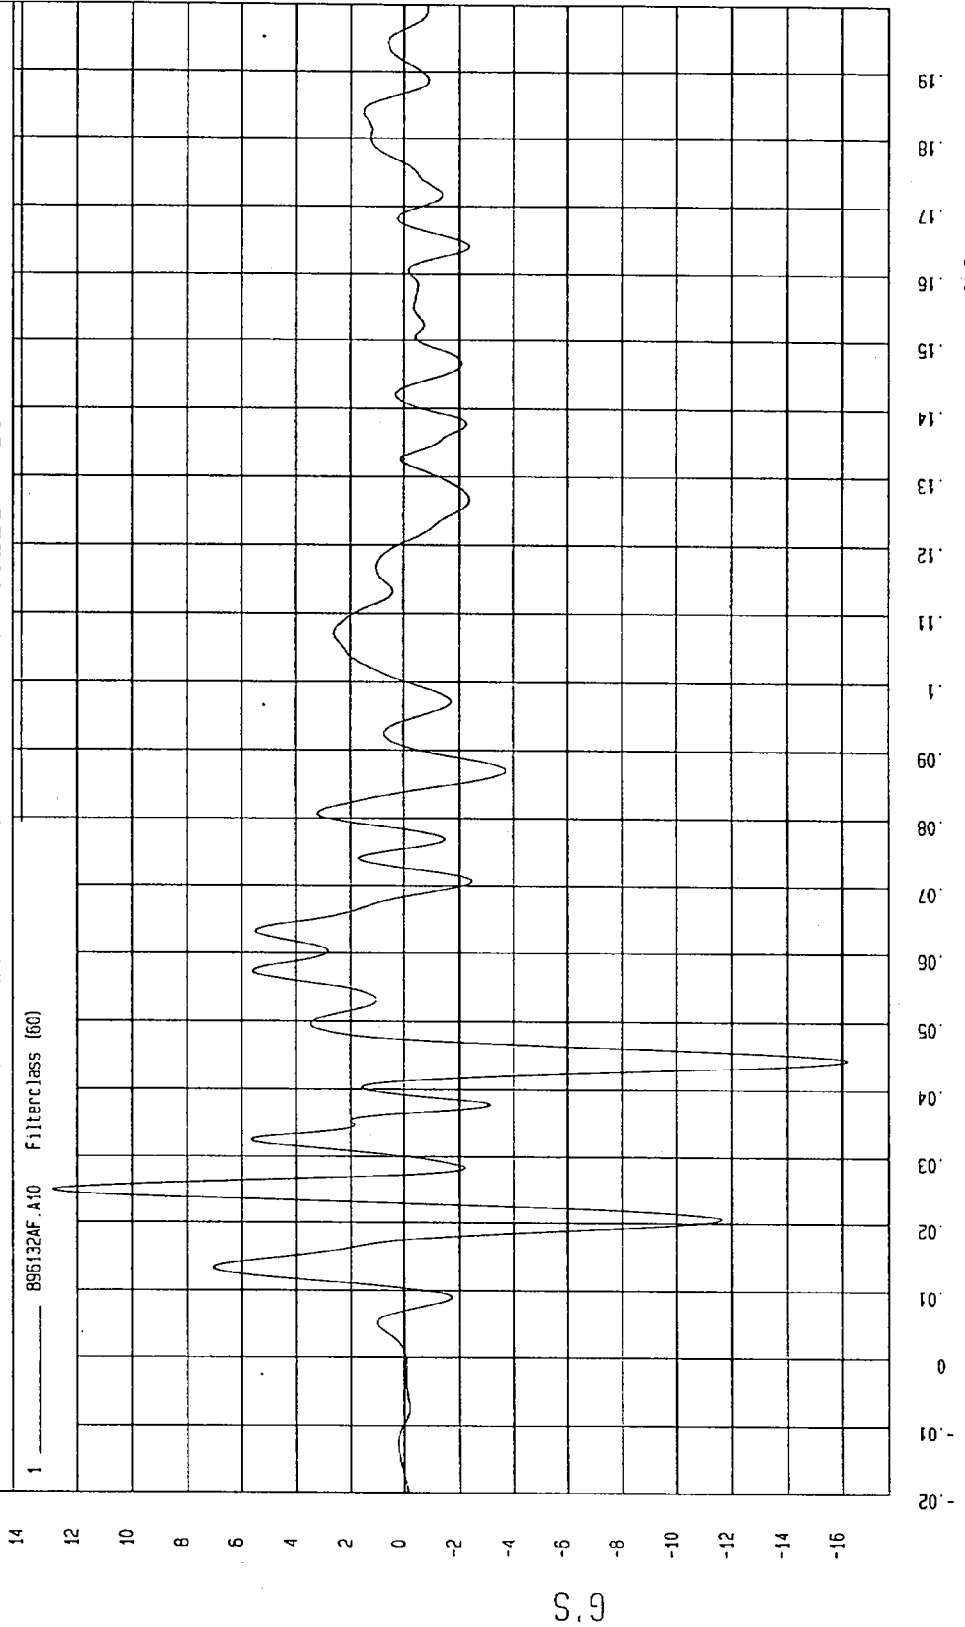
REAR FLOORPAN ABOVE AXLE Z ACCELERATION

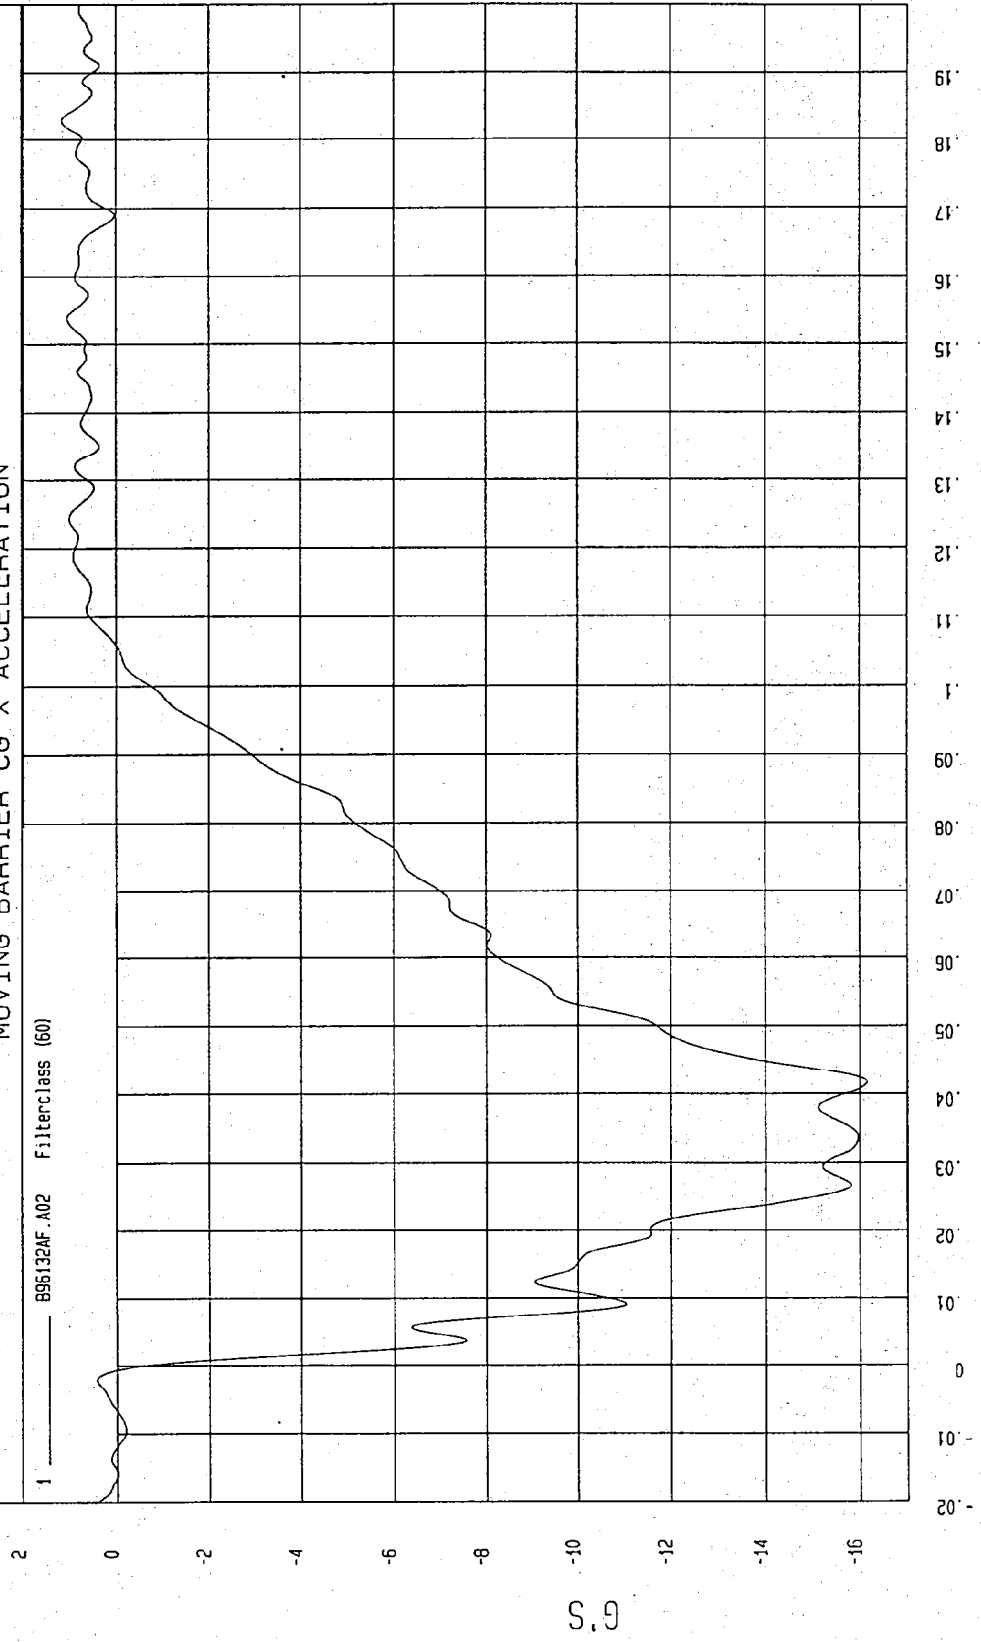
MOVING BARRIER CG X ACCELERATION

1 895132AF.A02 Filterclass (60)

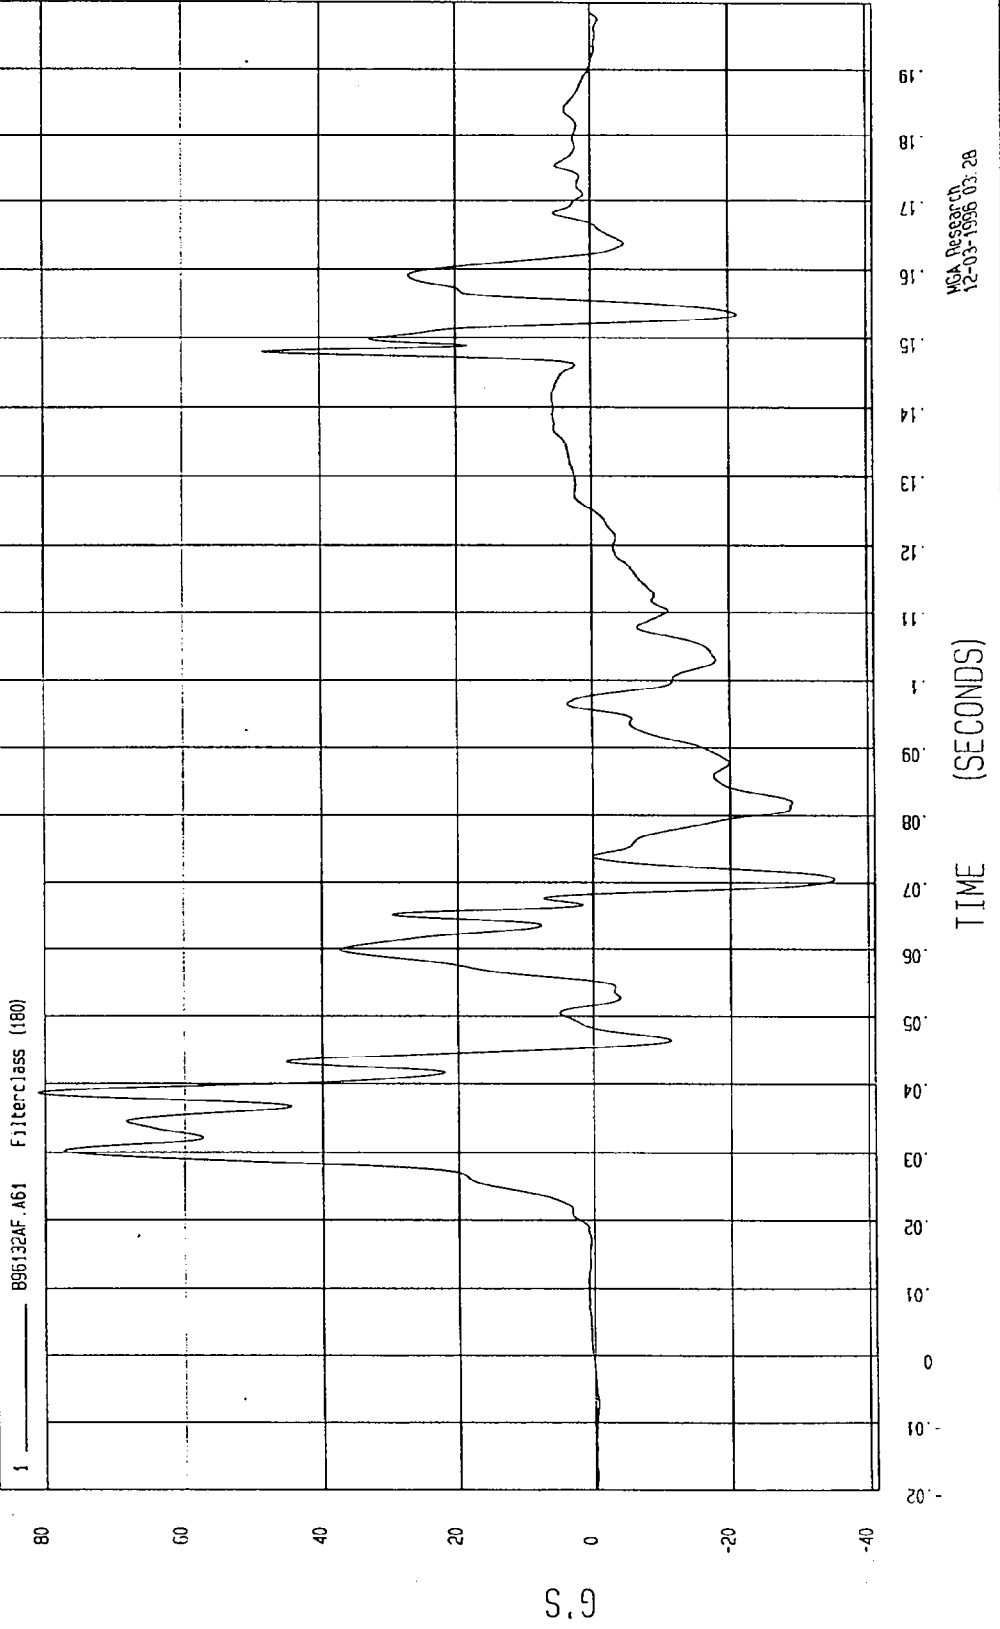
DRIVER UPPER RIB Y REDUNDANT ACCELERATION

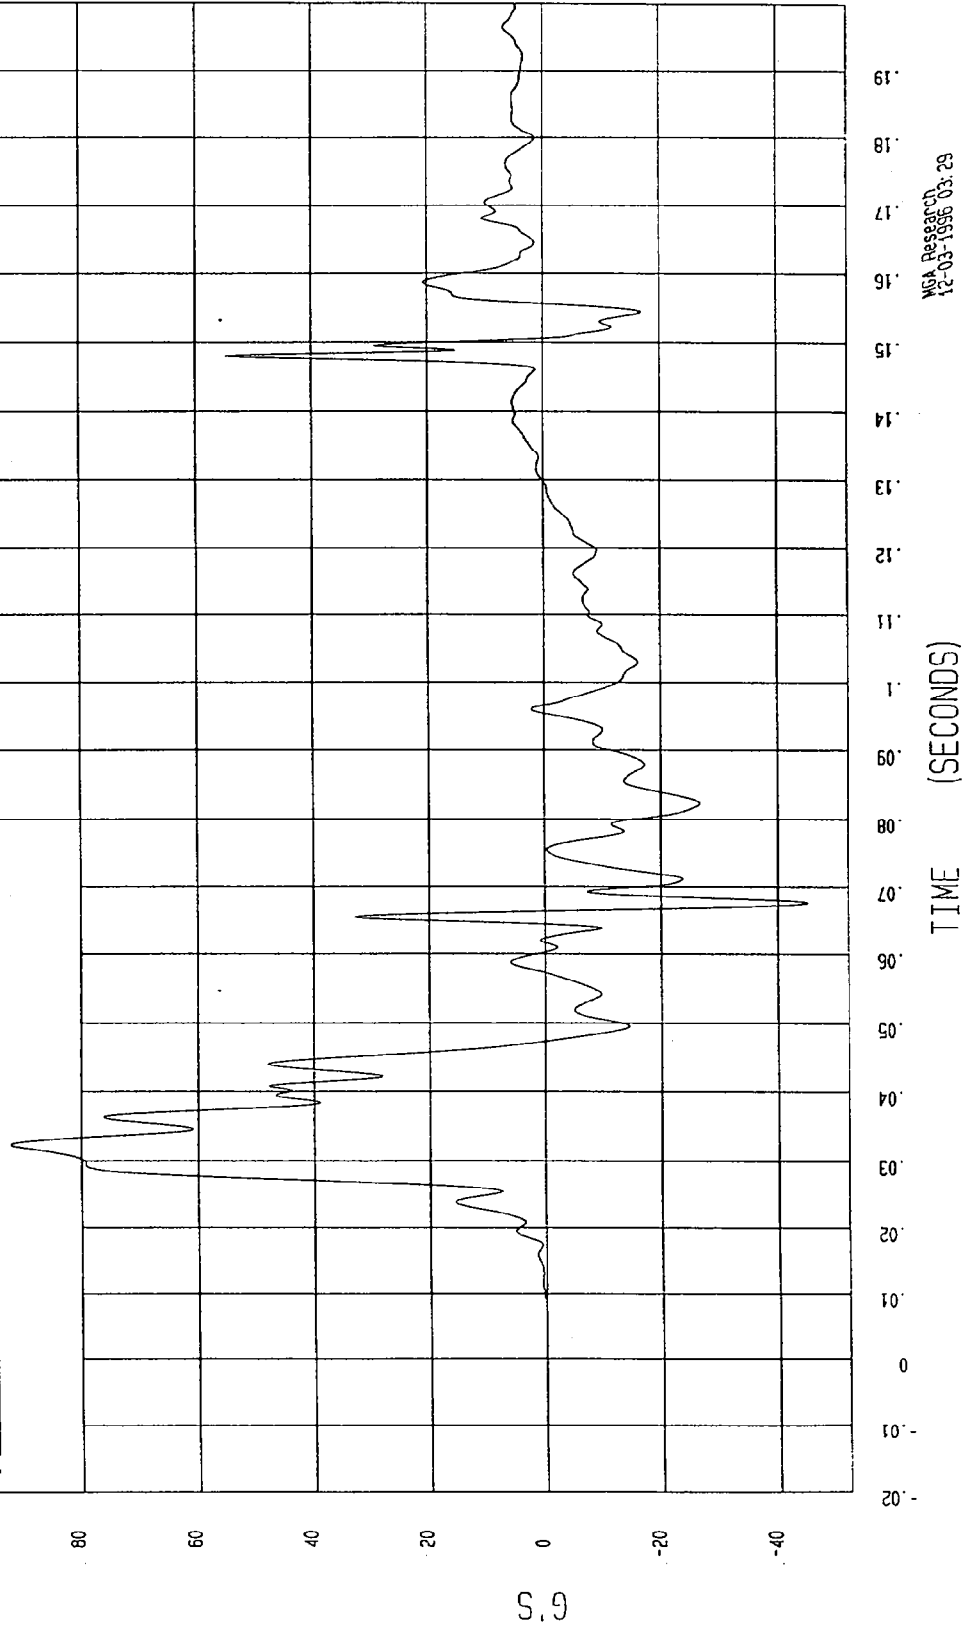
DRIVER LOWER RIB Y REDUNDANT ACCELERATION

1 _____ 895132AF.A62 Filterclass (180)

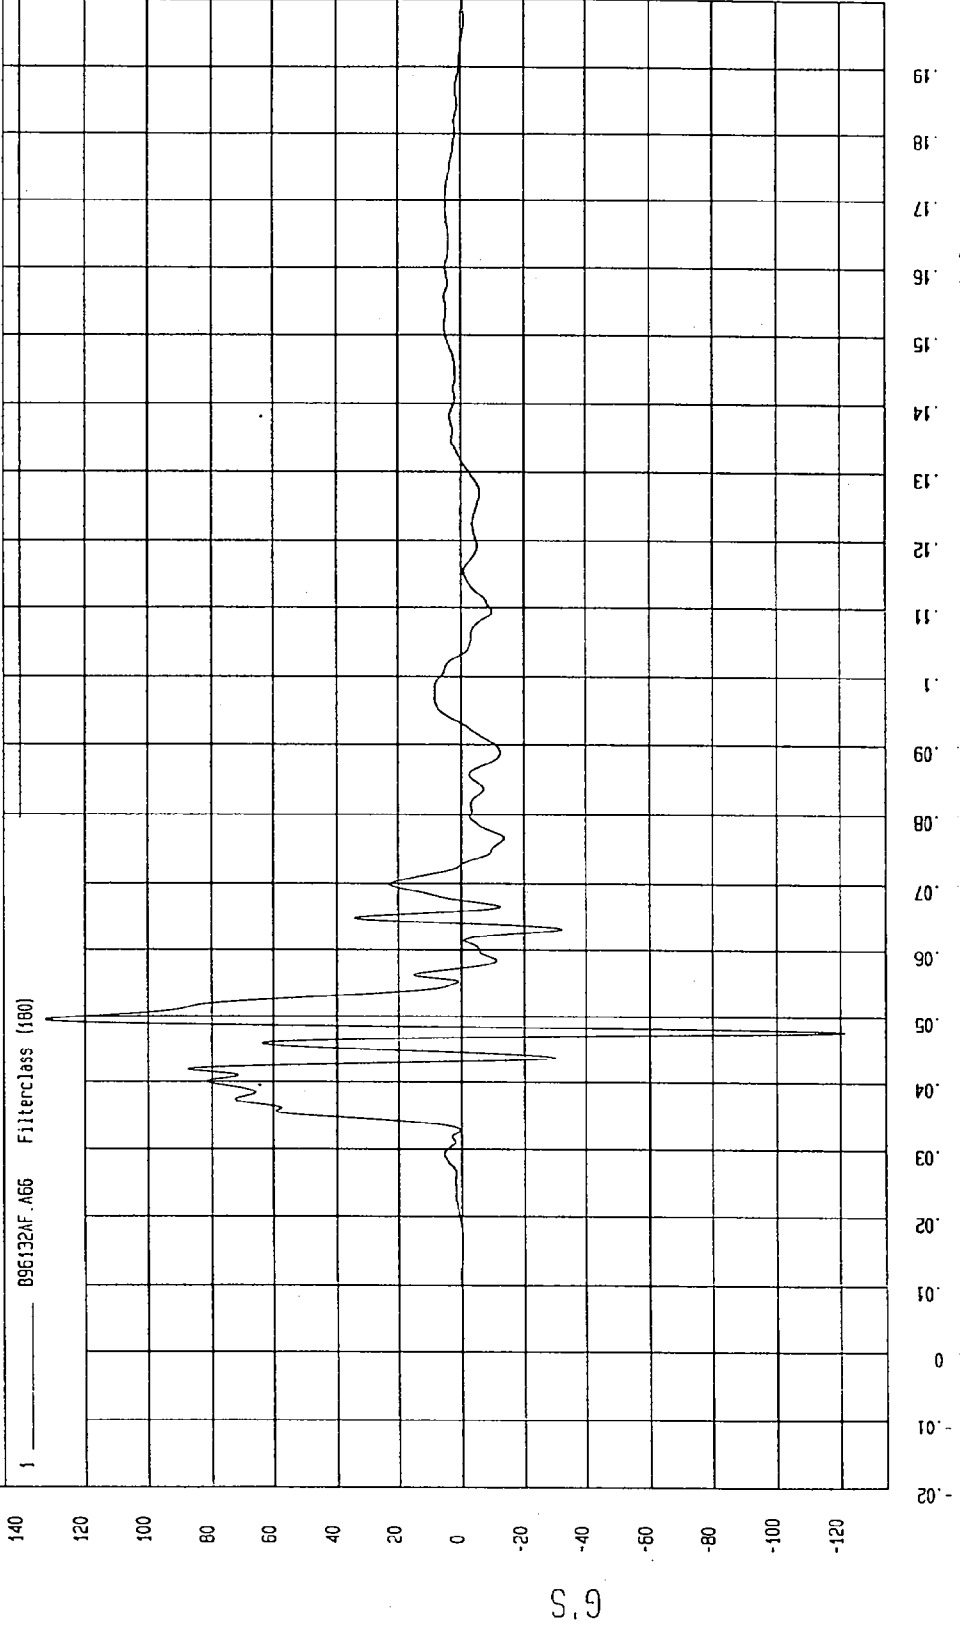
REAR PASSENGER UPPER RIB Y REDUNDANT ACCELERATION

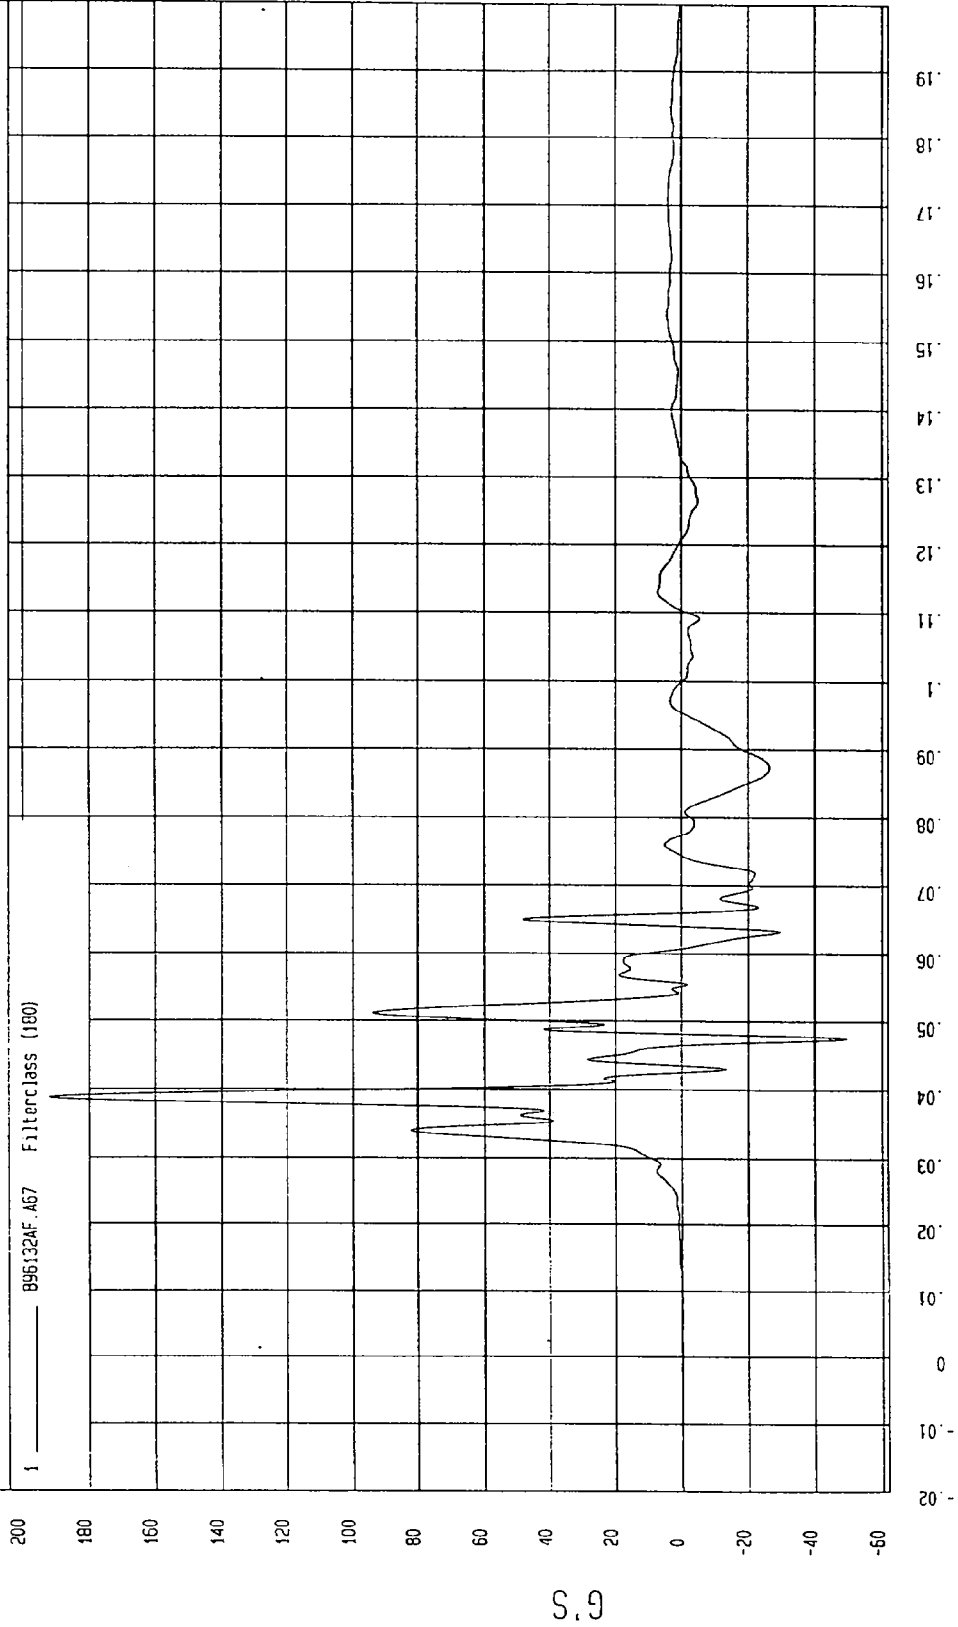
REAR PASSENGER LOWER RIB Y REDUNDANT ACCELERATION

1 996132AF.A67 Filterclass (180)

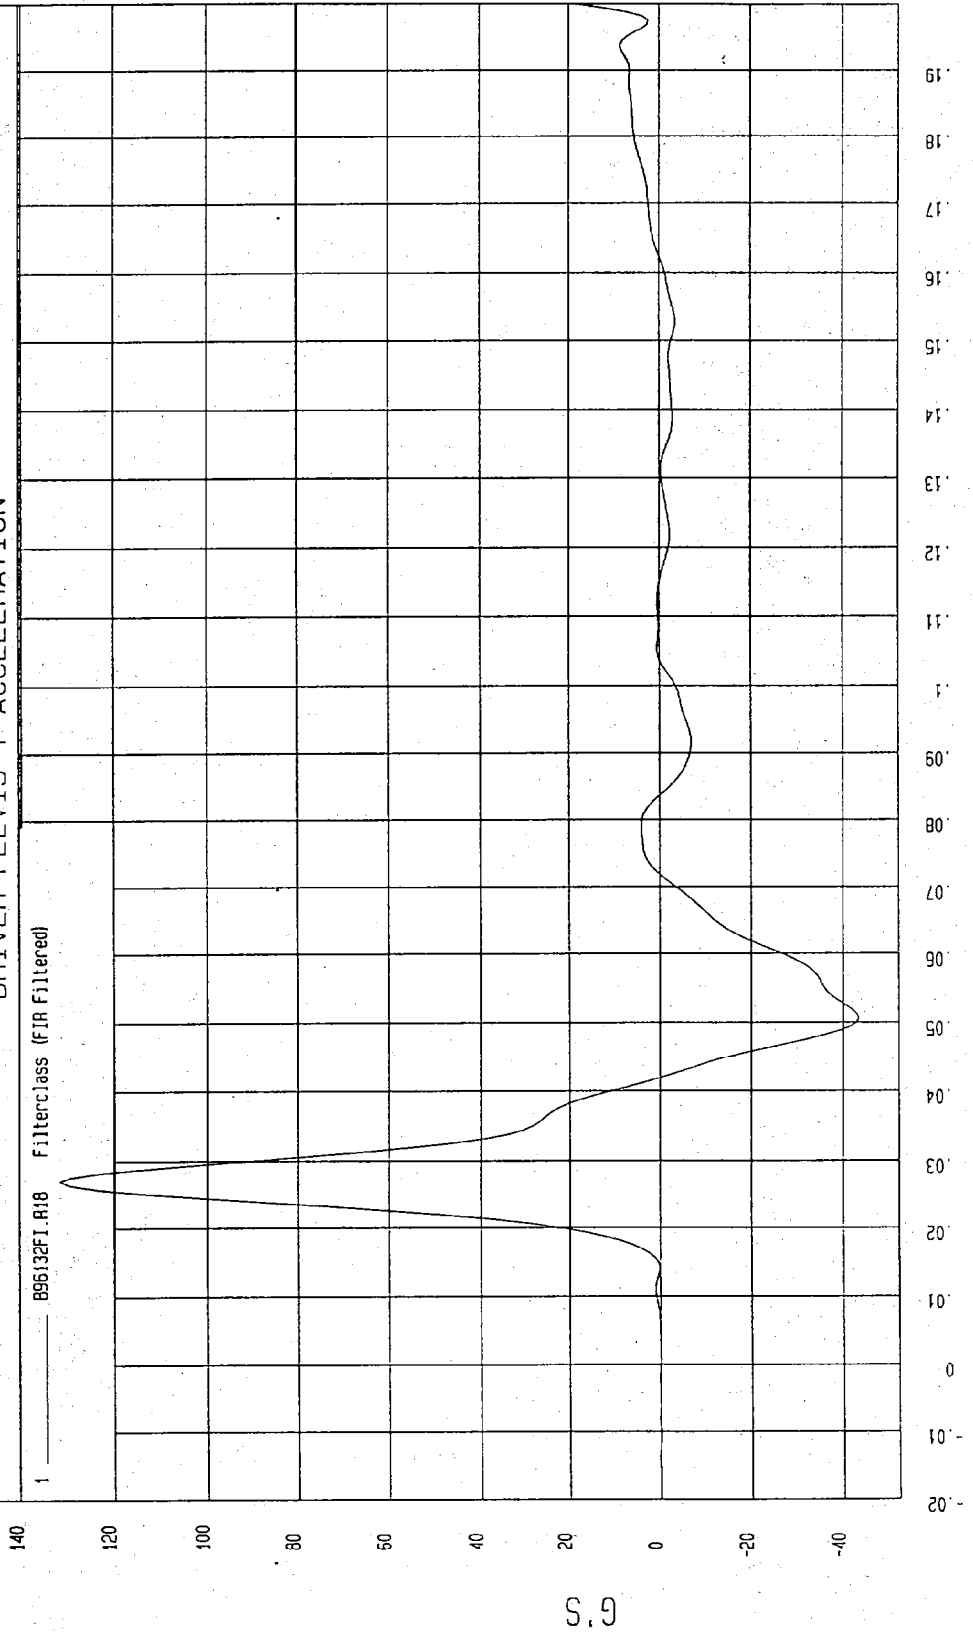
DRIVER PELVIS Y ACCELERATION

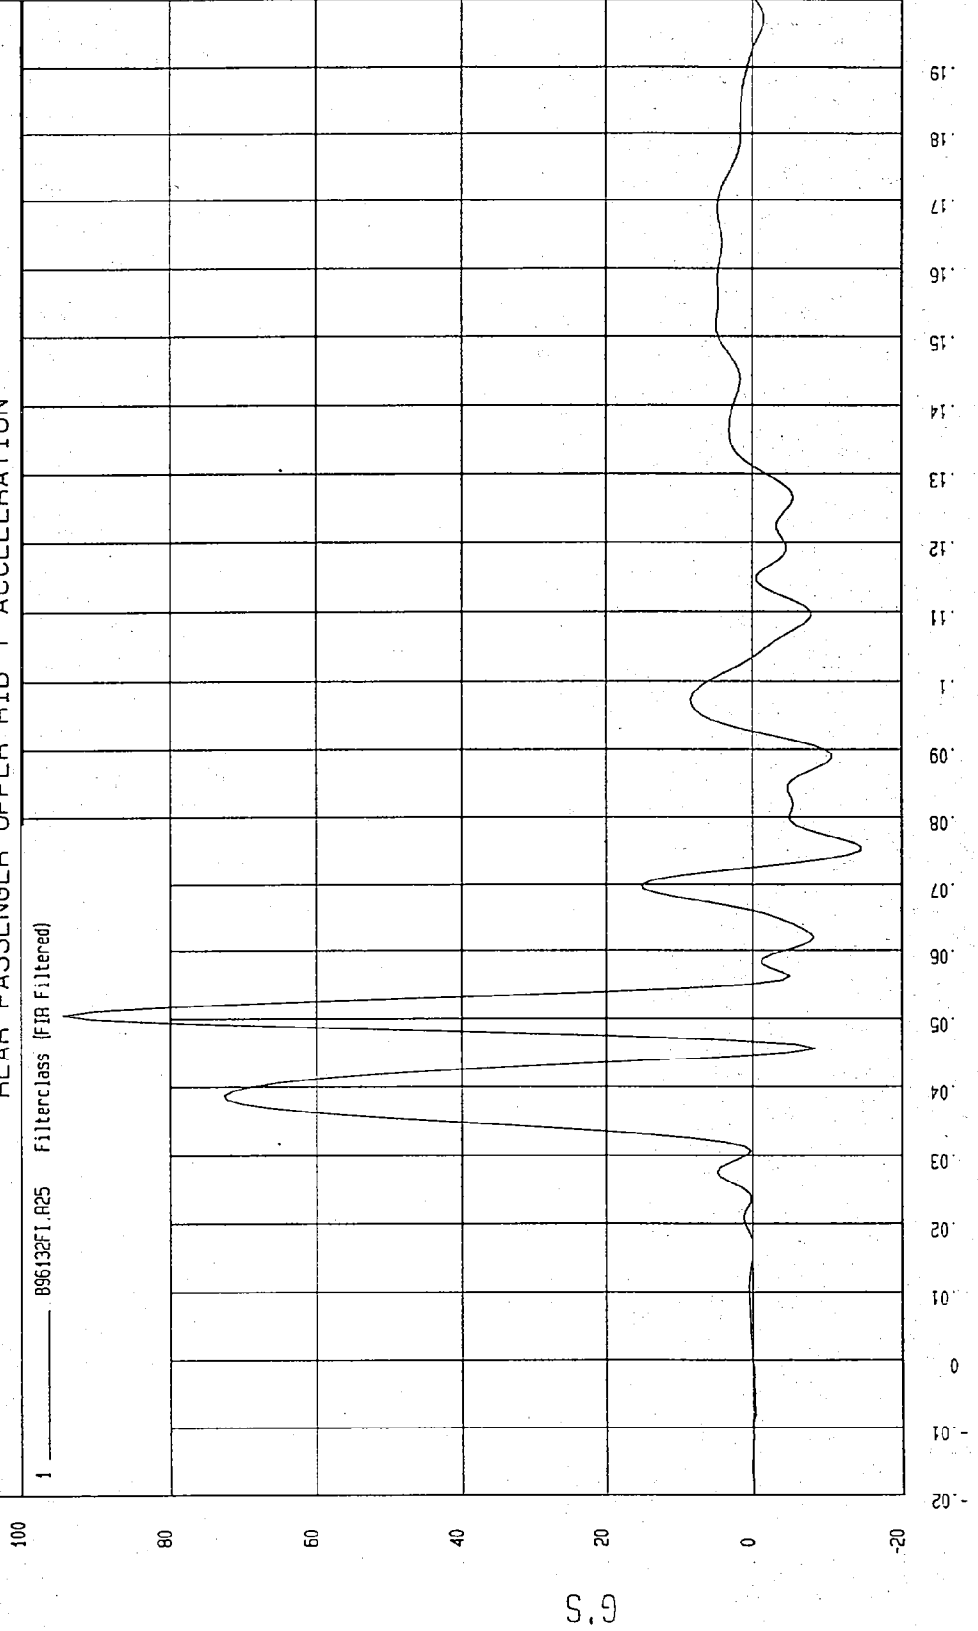
REAR PASSENGER UPPER RIB Y ACCELERATION

1 896132F1.R25 Filterclass (FIR Filtered)

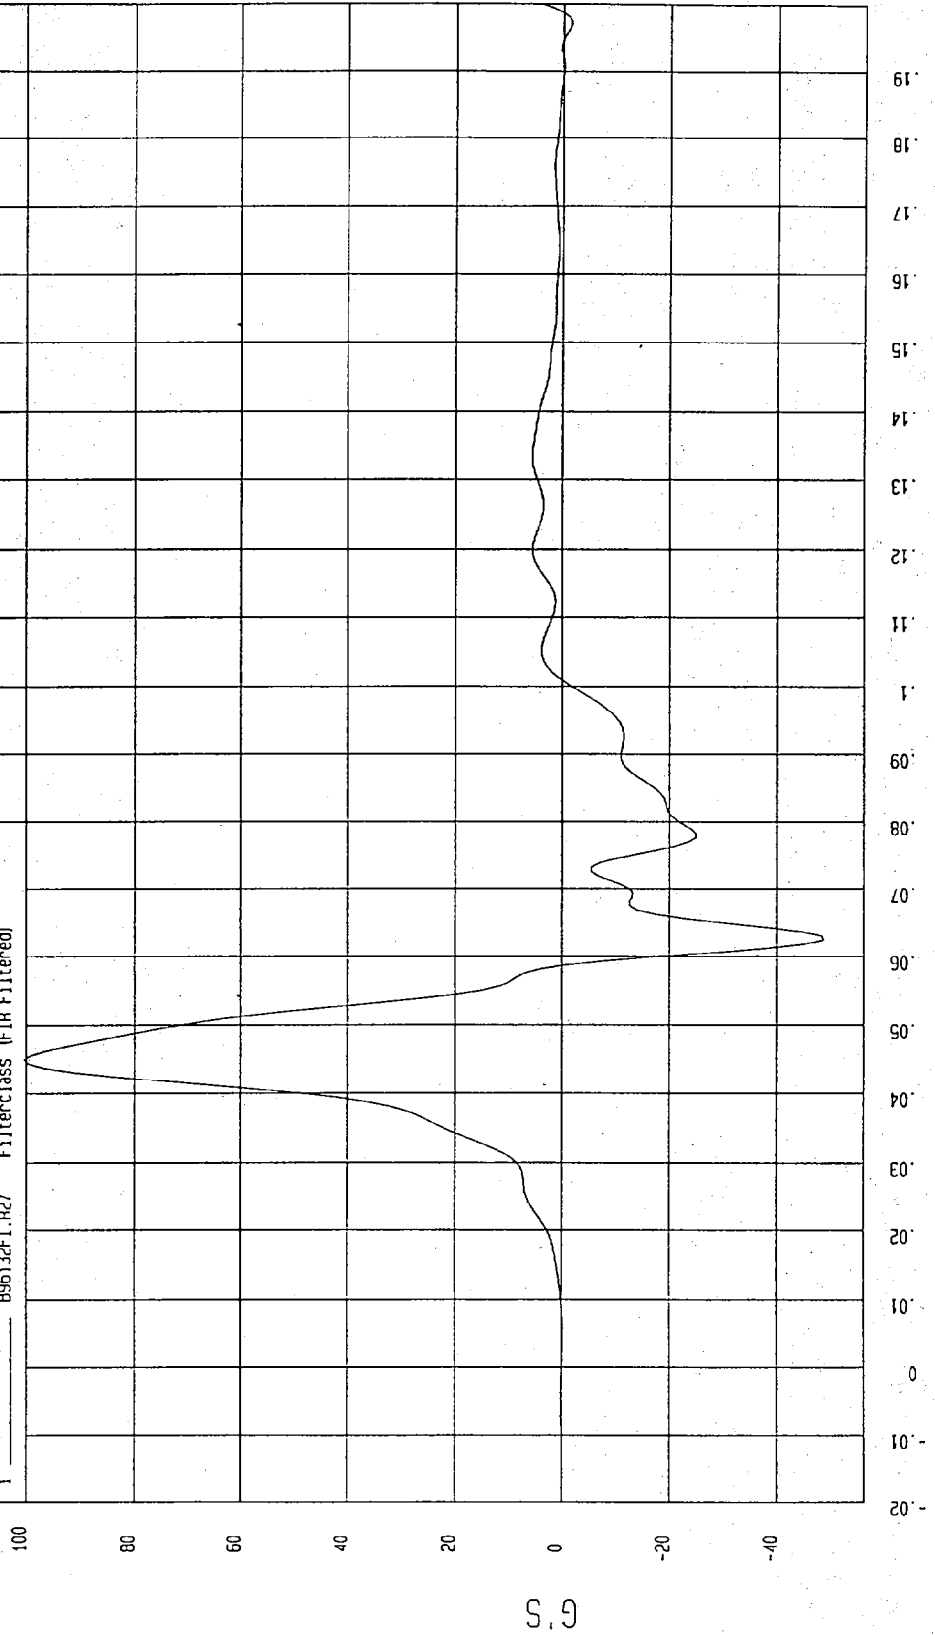
REAR PASSENGER LOWER SPINE Y ACCELERATION

896132FLR27 Filterclass (FIR Filtered)
