NEW CAR ASSESSMENT PROGRAM
SIDE IMPACT TESTING
PASSENGER CARS

1997 FORD THUNDERBIRD
2 DOOR
NHTSA NO: MV0203

FINAL REPORT

1. Report No. 214D-MGA-97-05		2. Government Accession No.		3. Recipient's Catalog No.																			
4. Title and Subtitle New Car Assessment Program Side Impact Test of a 1997 Ford Thunderbird 2 Door NHTSA No. MV0203				5. Report Date December 10, 1996																			
				6. Performing Organization Code MGA																			
7. Author(s) David Winkelbauer, Project Engineer				8. Performing Organization Report No. MGA-DOT-214D-05																			
9. Performing Organization Name and Address MGA Research Corporation 5000 Warren Road Burlington, WI 53105				10. Work Unit No.																			
				11. Contract or Grant No. DTNH22-93-C-02047																			
12. Sponsoring Agency Name and Address U.S. Department of Transportation National Highway Traffic Safety Administration Office of Crashworthiness Standards 400 Seventh St, S.W., Washington, D.C. 20590				13. Type of Report and Period Covered Final Test Report December 4, 1996 to December 10, 1996																			
				14. Sponsoring Agency Code NSA-30																			
15. Supplementary Notes

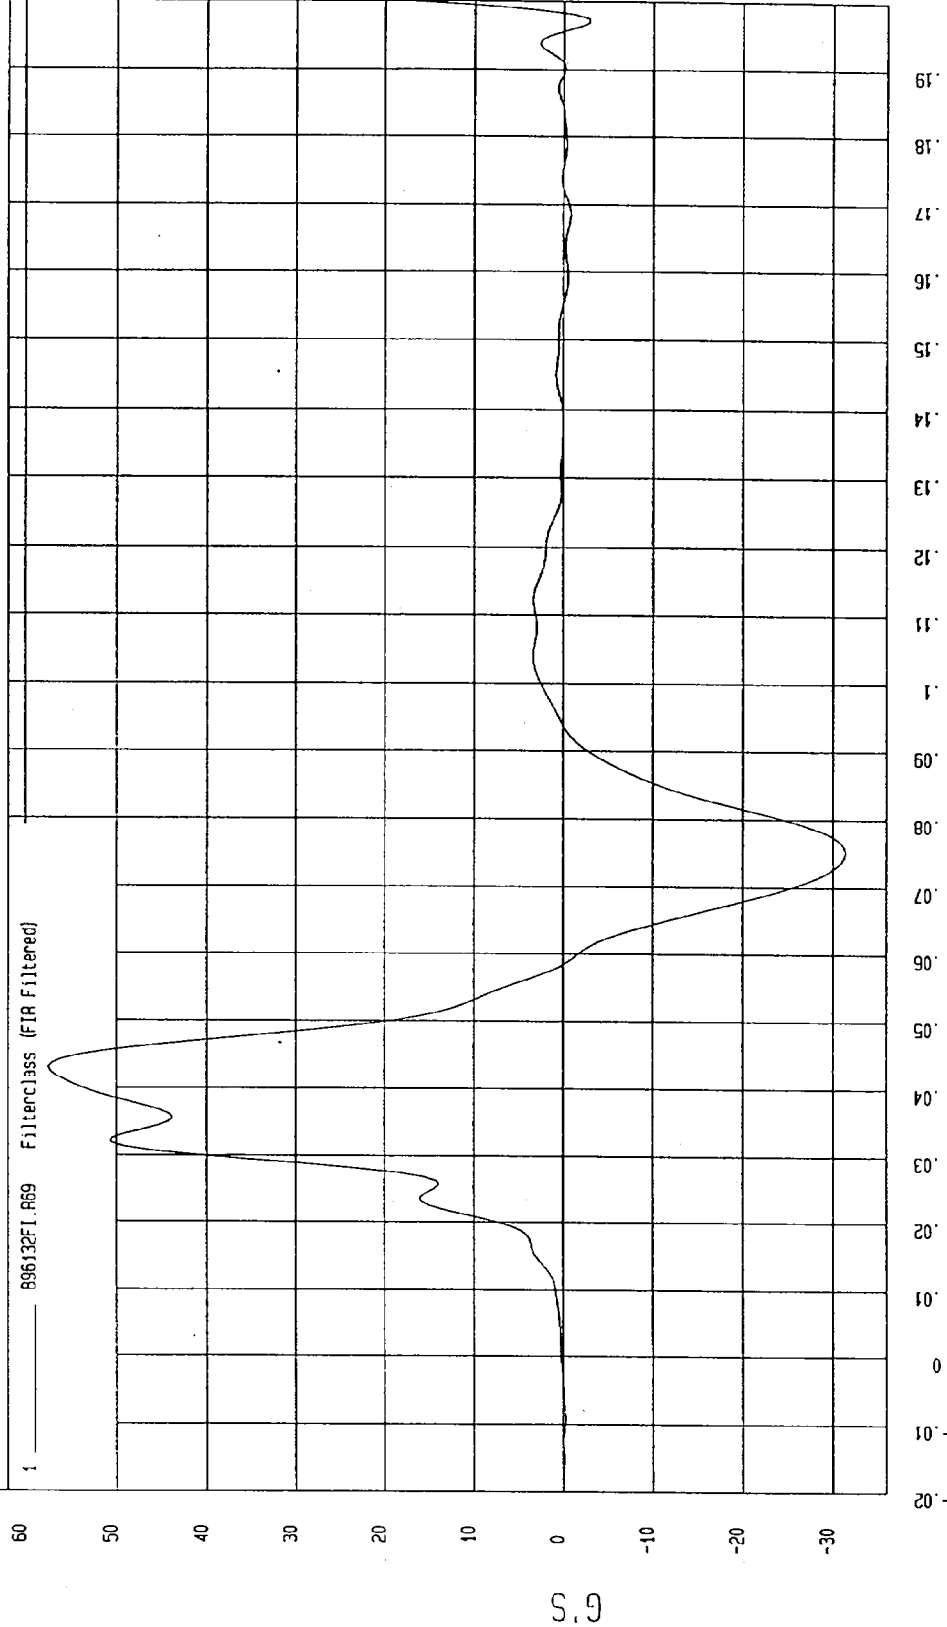
REAR PASSENGER PELVIS Y REDUNDANT ACCELERATION

1 896132FI.069 FilterClass (FIR Filtered)
