NEW CAR ASSESSMENT PROGRAM  
SIDE IMPACT TESTING  
PASSENGER CARS

1997 FORD ESCORT  
4-DOOR SEDAN  
NHTSA NO: MV0202

MGA PROVING GROUNDS  
5000 WARREN ROAD  
BURLINGTON, WI 53105

FINAL REPORT

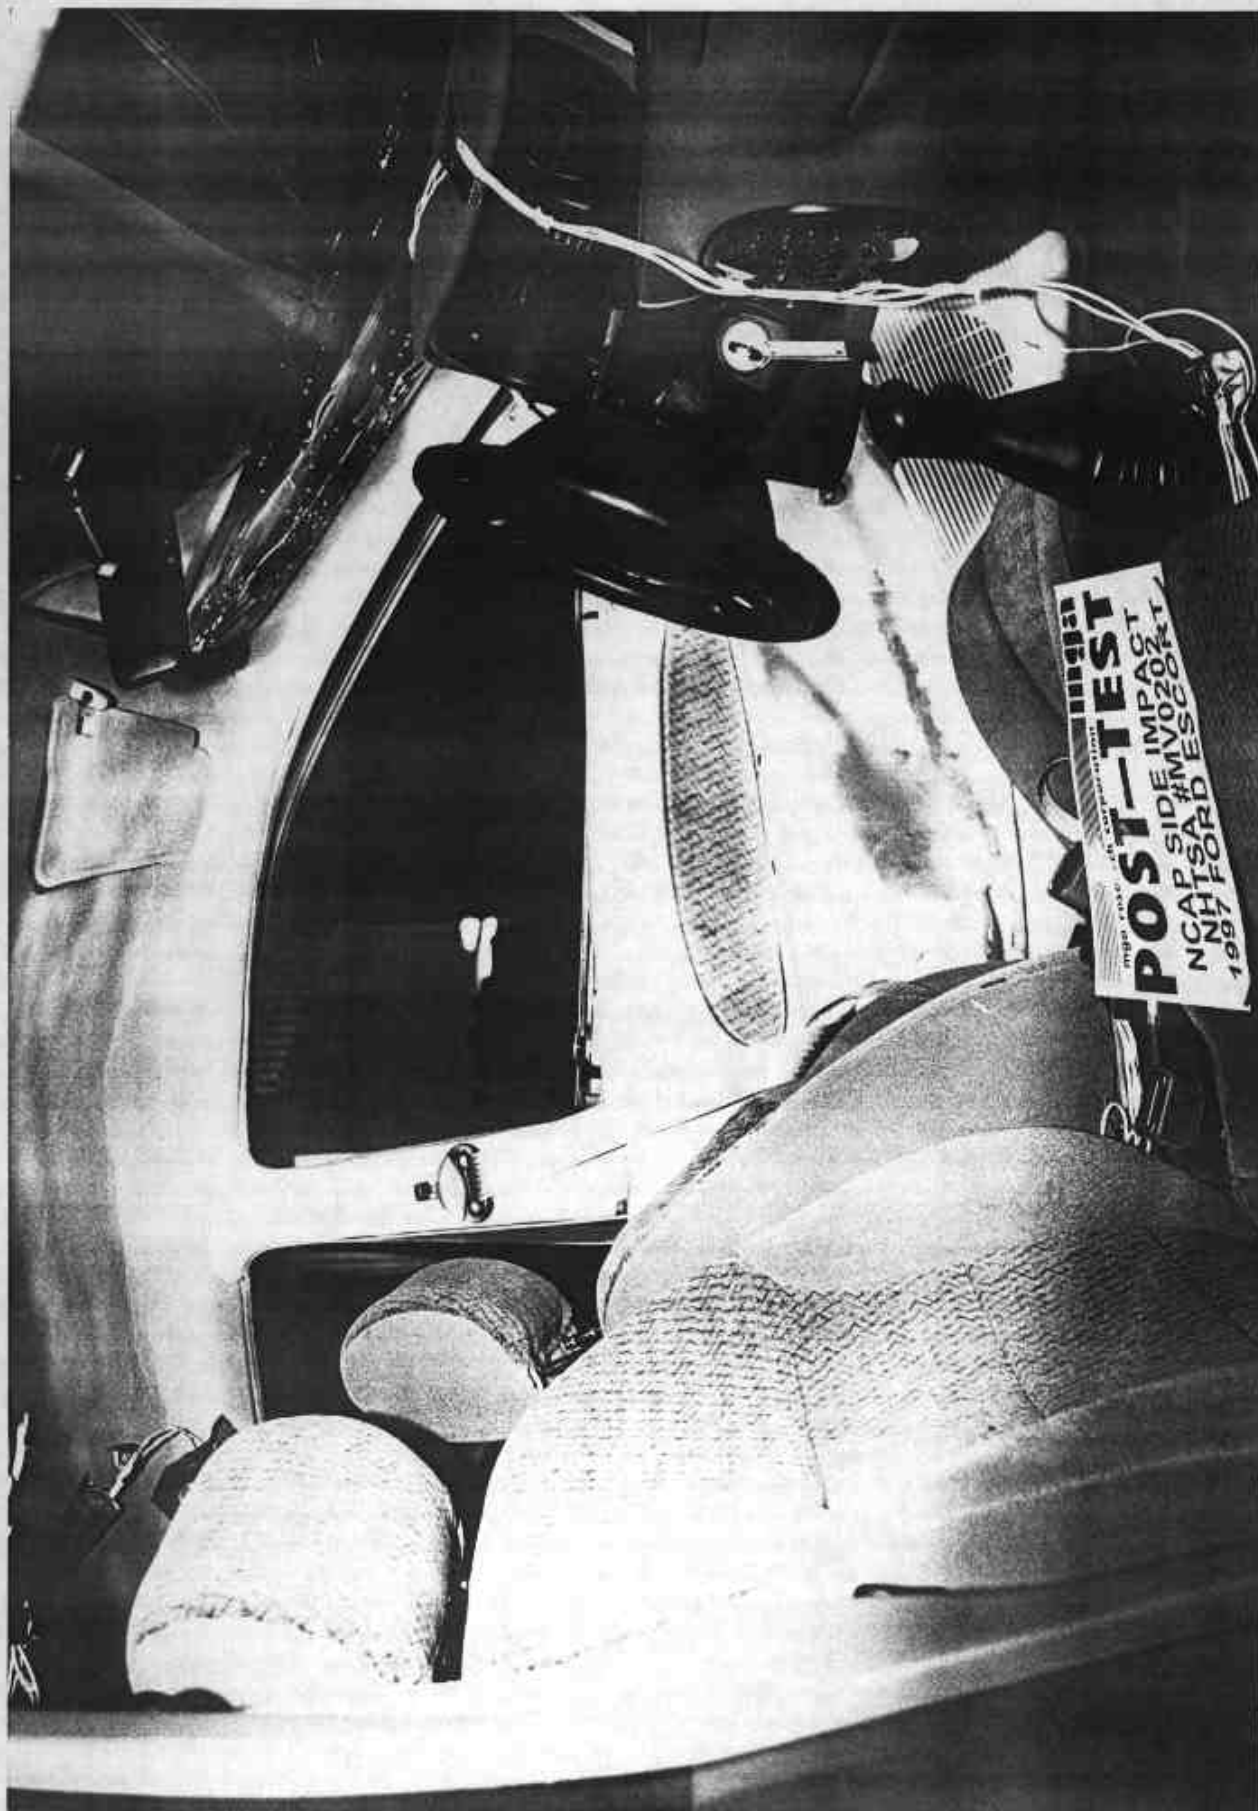
Photo No. A-28 - Post-Test Driver Dummy Contact

| | <u>LEFT FRONT SID</u> | <u>LEFT REAR SID</u> |
|---|---|---|
| Head | <u>to window sill and left</u><br><u>shoulder</u> | <u>to C-Post and roof</u> |
| Arm | <u>to door</u> | <u>to door</u> |
| Pelvis | <u>to door</u> | <u>to door</u> |
| Left Knee | <u>to door</u> | <u>to door</u> |
| Right Knee | <u>to left knee</u> | <u>to left knee</u> |

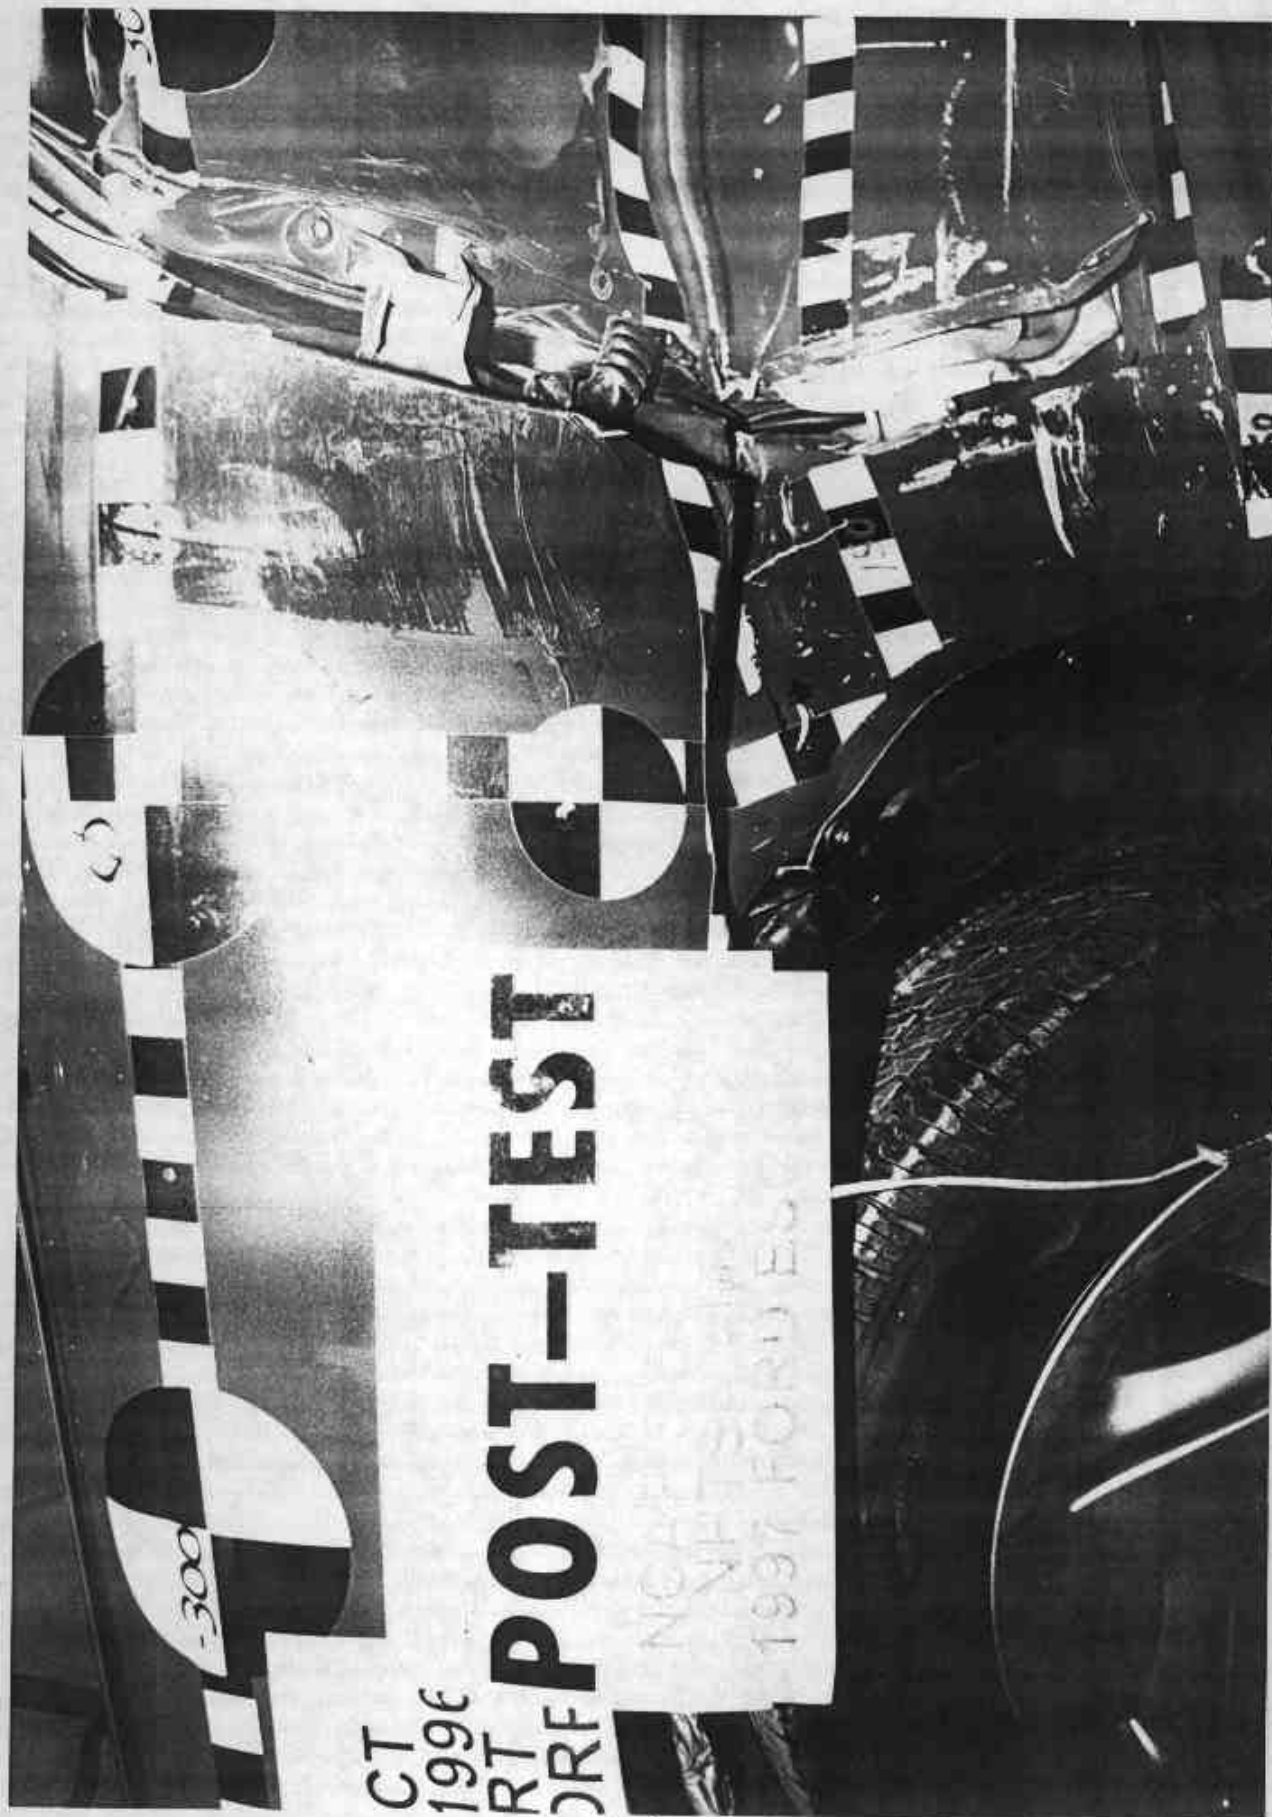
Photo No. A-38 - Post-Test Left Front Impact Point on Vehicle

Horizontal: 2 mm forward      Vertical: 12 mm high
