REPORT NO.: 214-MGA-97-11  
SAFETY COMPLIANCE TESTING FOR  
FMVSS 214 "SIDE IMPACT PROTECTION -  
PASSENGER CARS"

FORD MOTOR COMPANY  
1997 FORD CROWN VICTORIA  
NHTSA NO: CV0206

MGA PROVING GROUNDS  
5000 WARREN ROAD  
BURLINGTON, WI 53105

FINAL REPORT

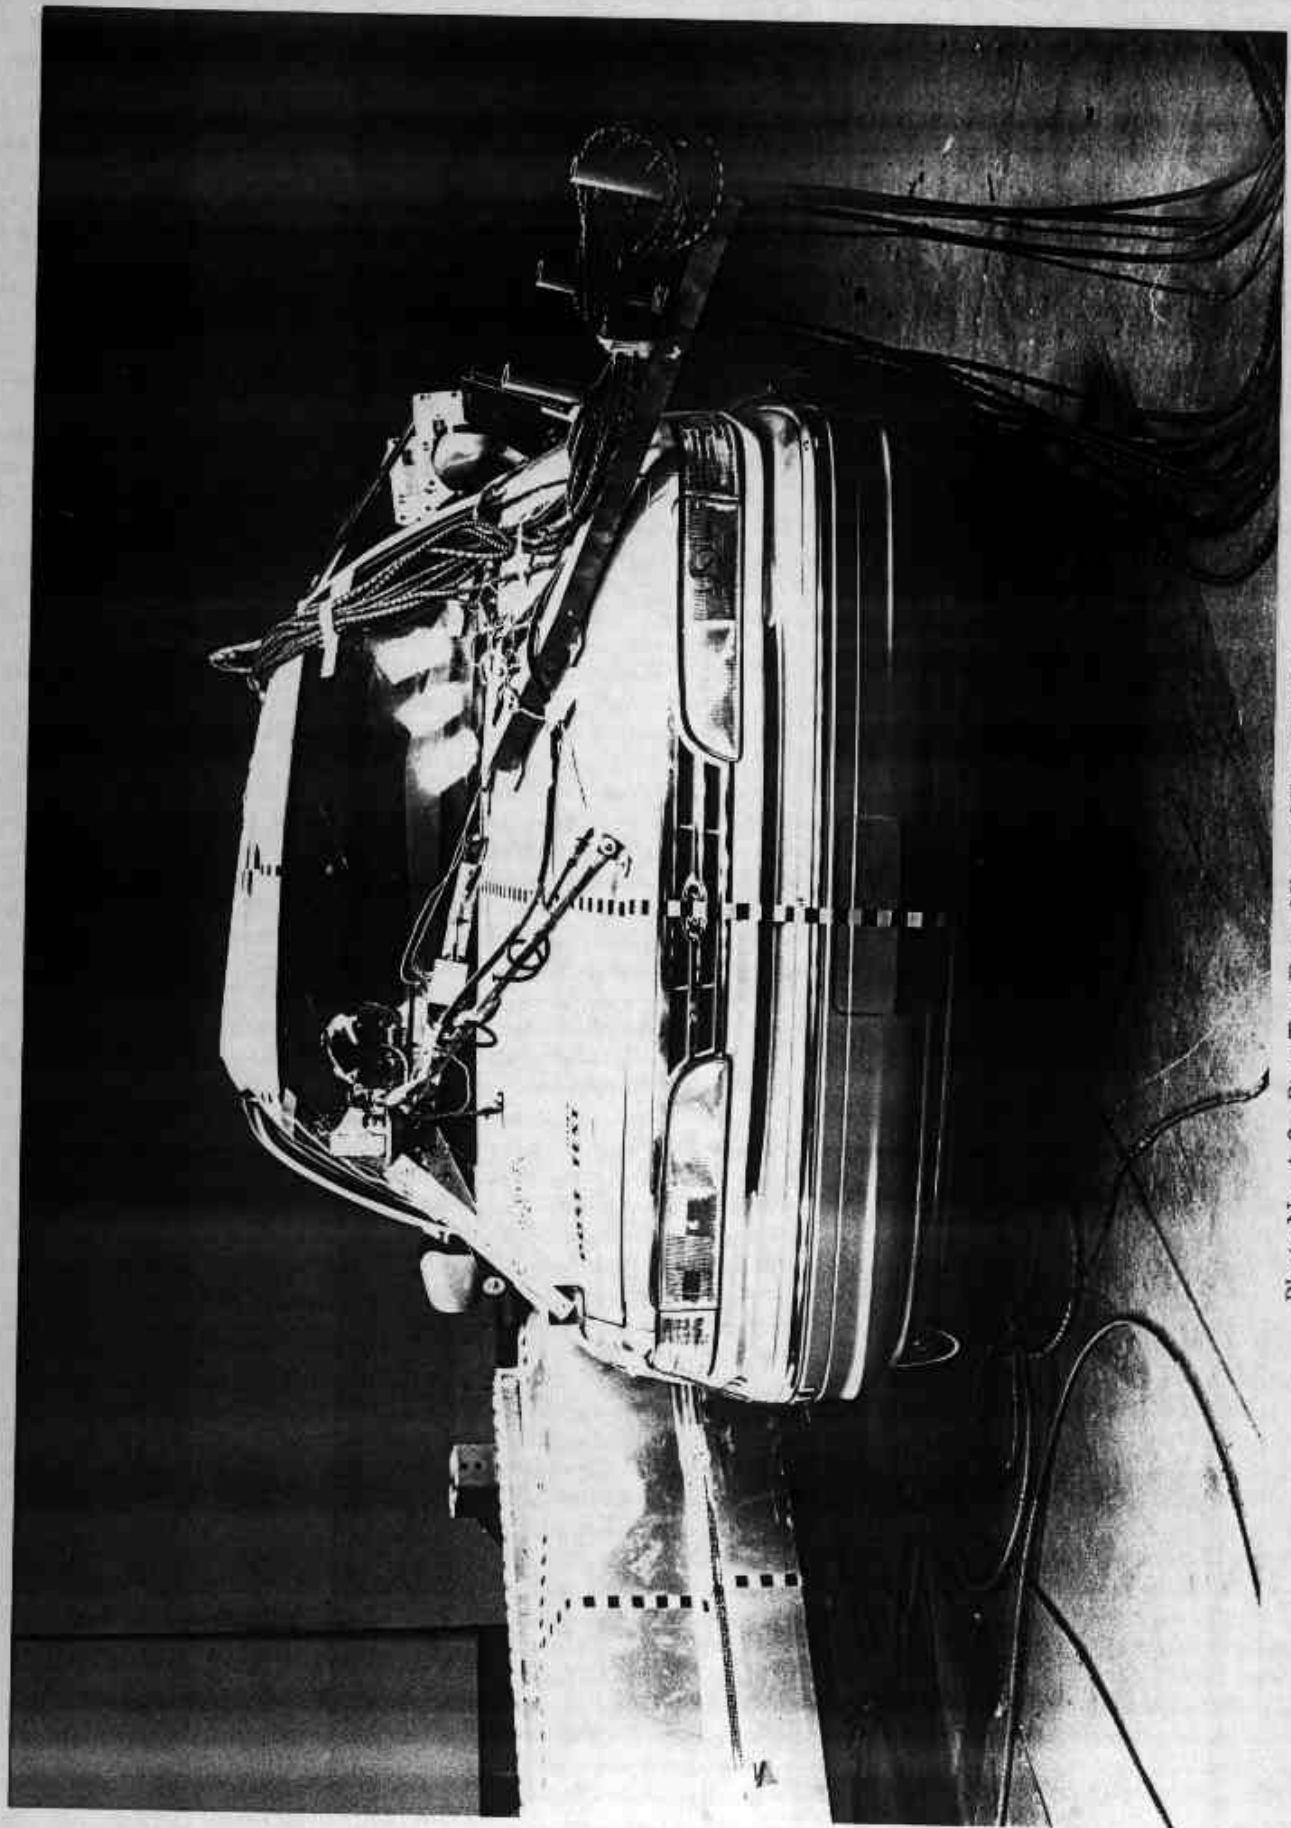
Photo No. A-2 - Post-Test Front View of Test Vehicle

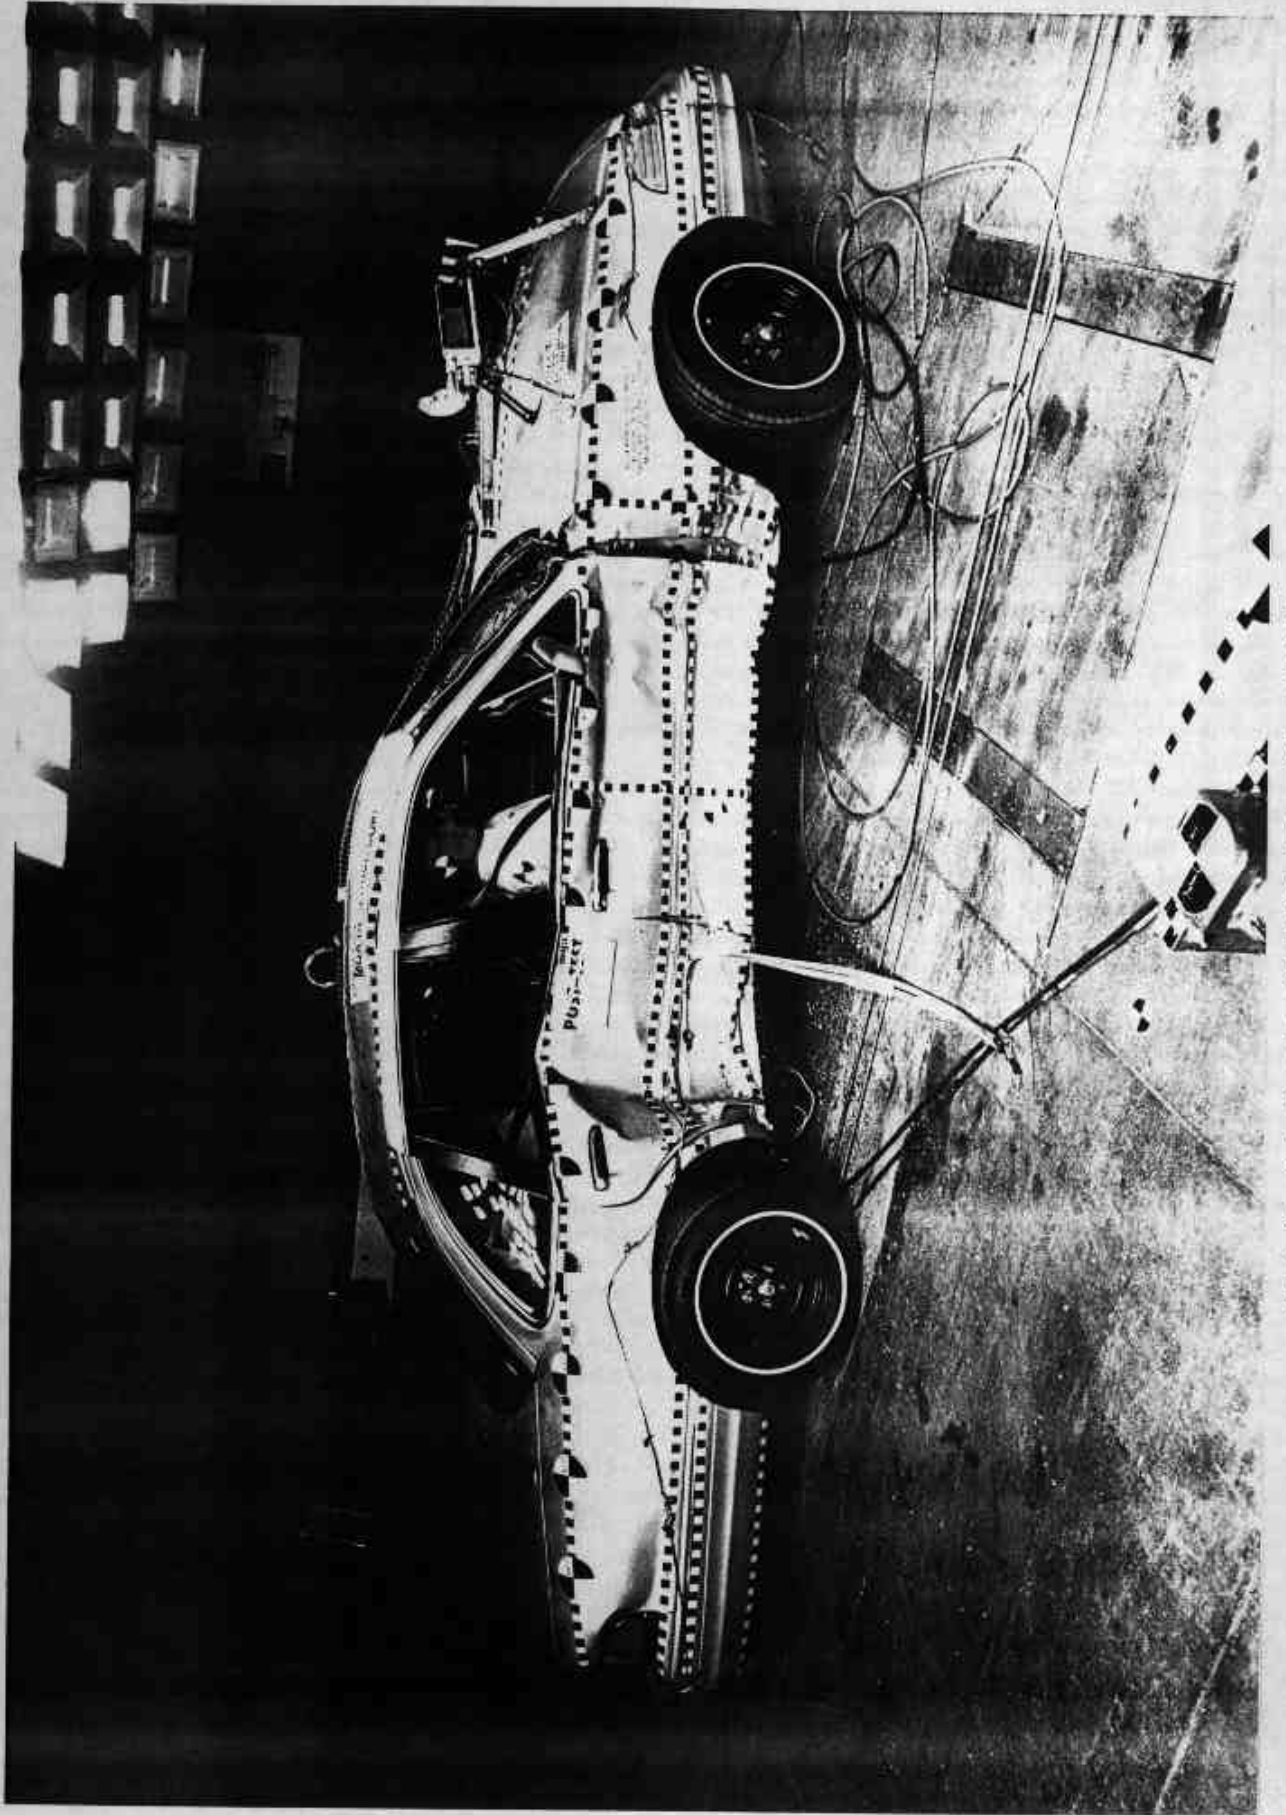
Photo No. A-6 - Post-Test Right Side View of Test Vehicle

Right side windows broken. windshield cracked

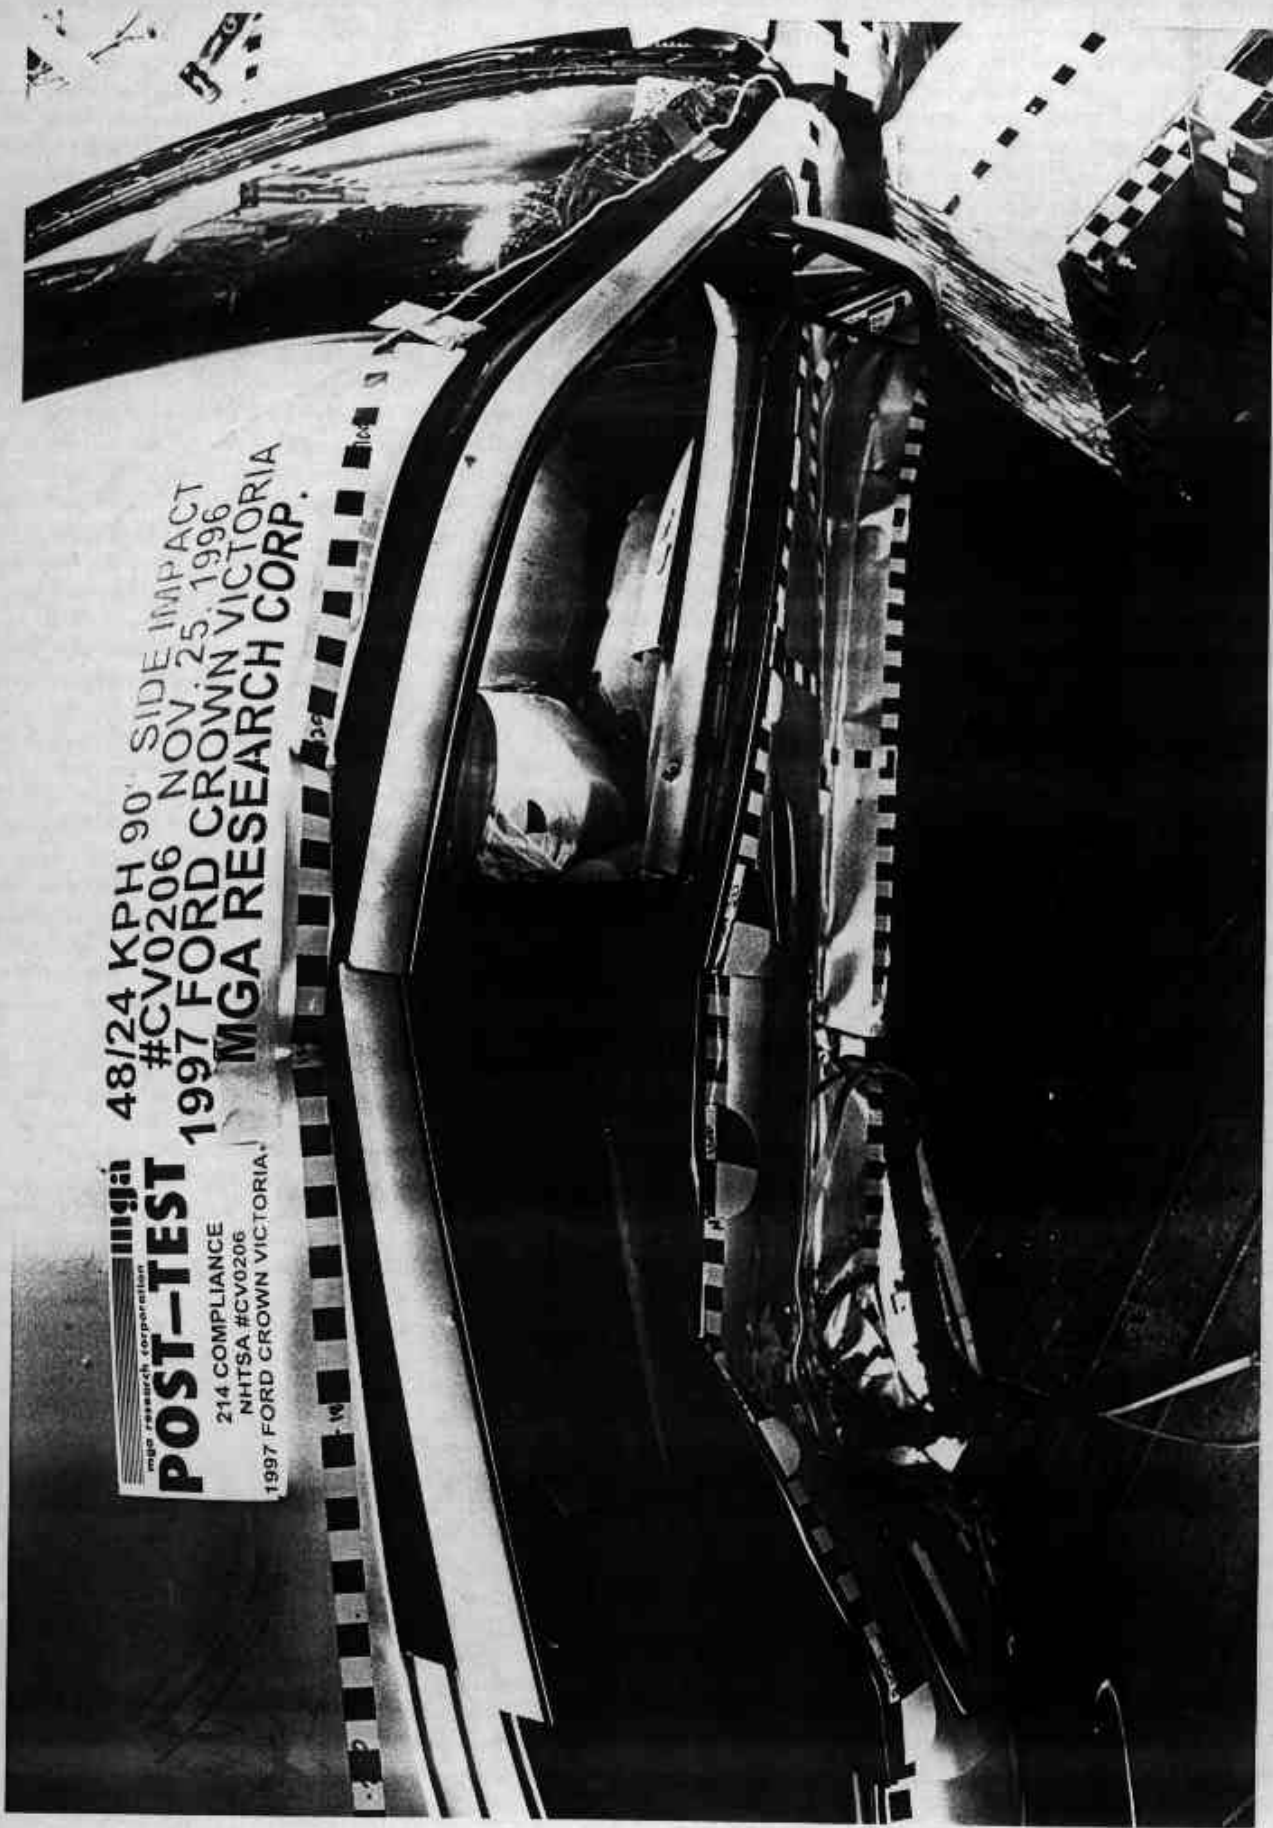
Photo No. A-12 - Post-Test MDB Positioned Against Vehicle Overhead View

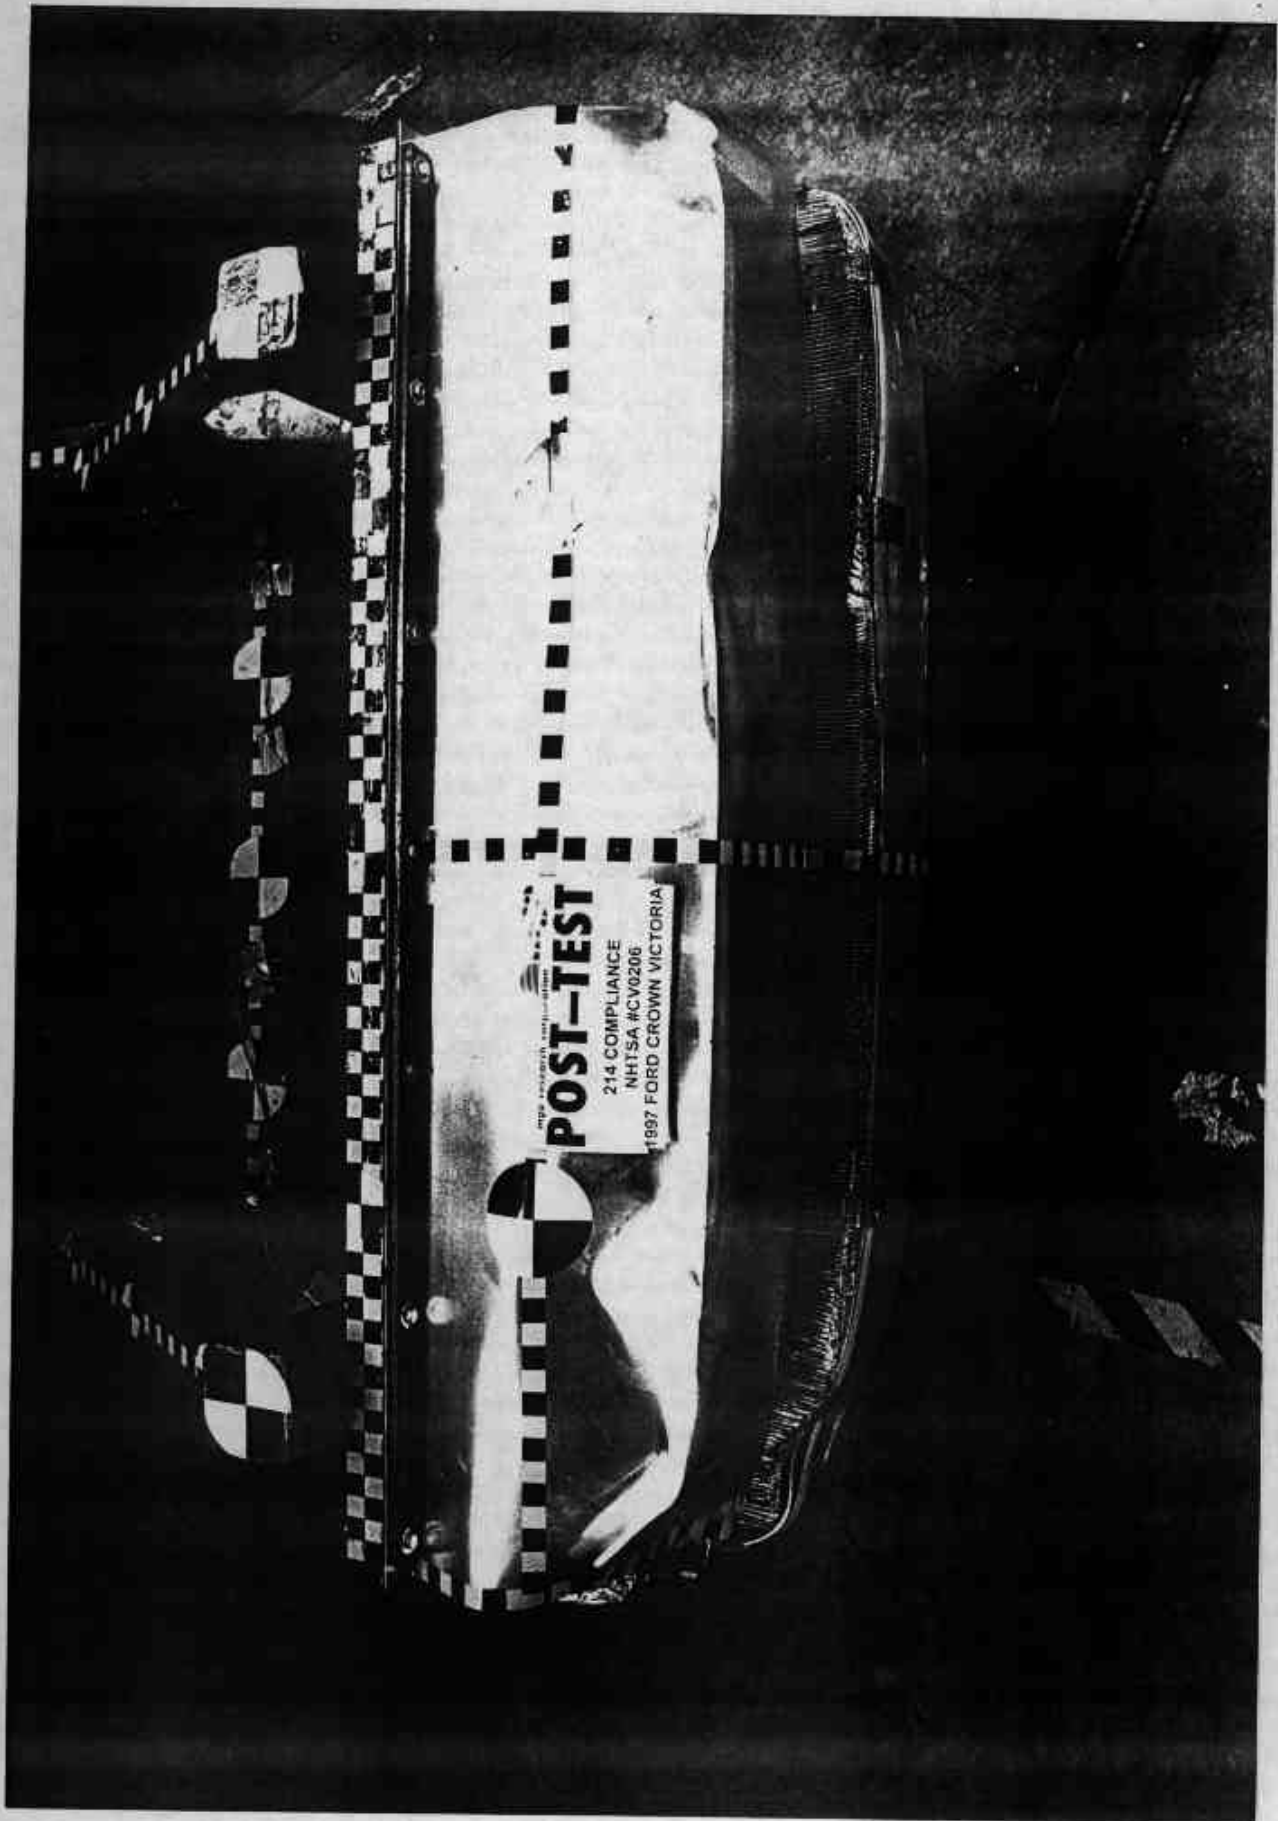
Photo No. A-14 - Post-Test MDB Top View

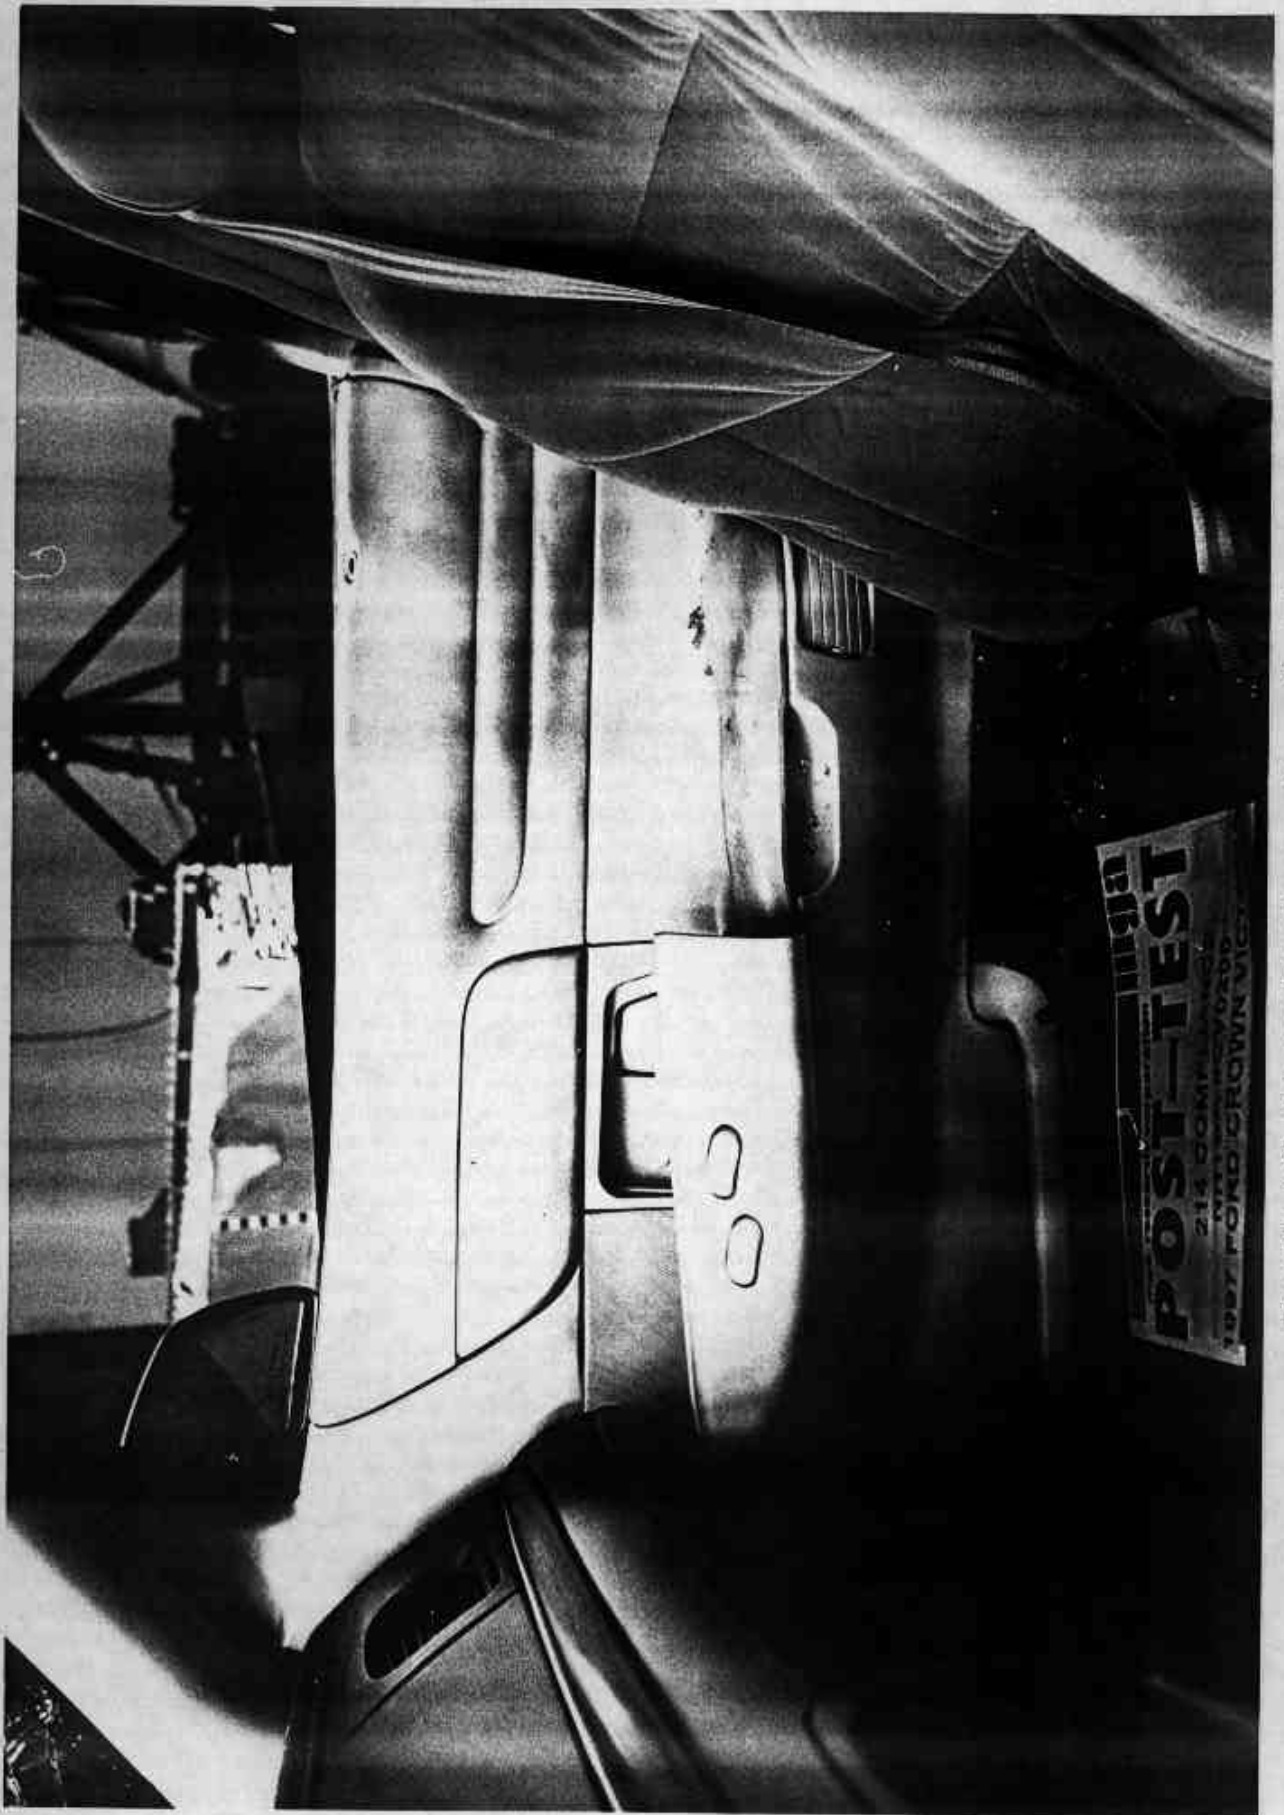
Photo No. A-29 - Post-Test Front Passenger Dummy Contact

<u>RIGHT FRONT SID</u>	<u>RIGHT REAR SID</u>
Head	<u>none noted</u>	<u>to C Post and header</u>
Arm	<u>to door</u>	<u>to door</u>
Pelvis	<u>to armrest</u>	<u>none noted</u>
Left Knee	<u>to right knee</u>	<u>to right knee</u>
Right Knee	<u>to armrest</u>	<u>to door</u>

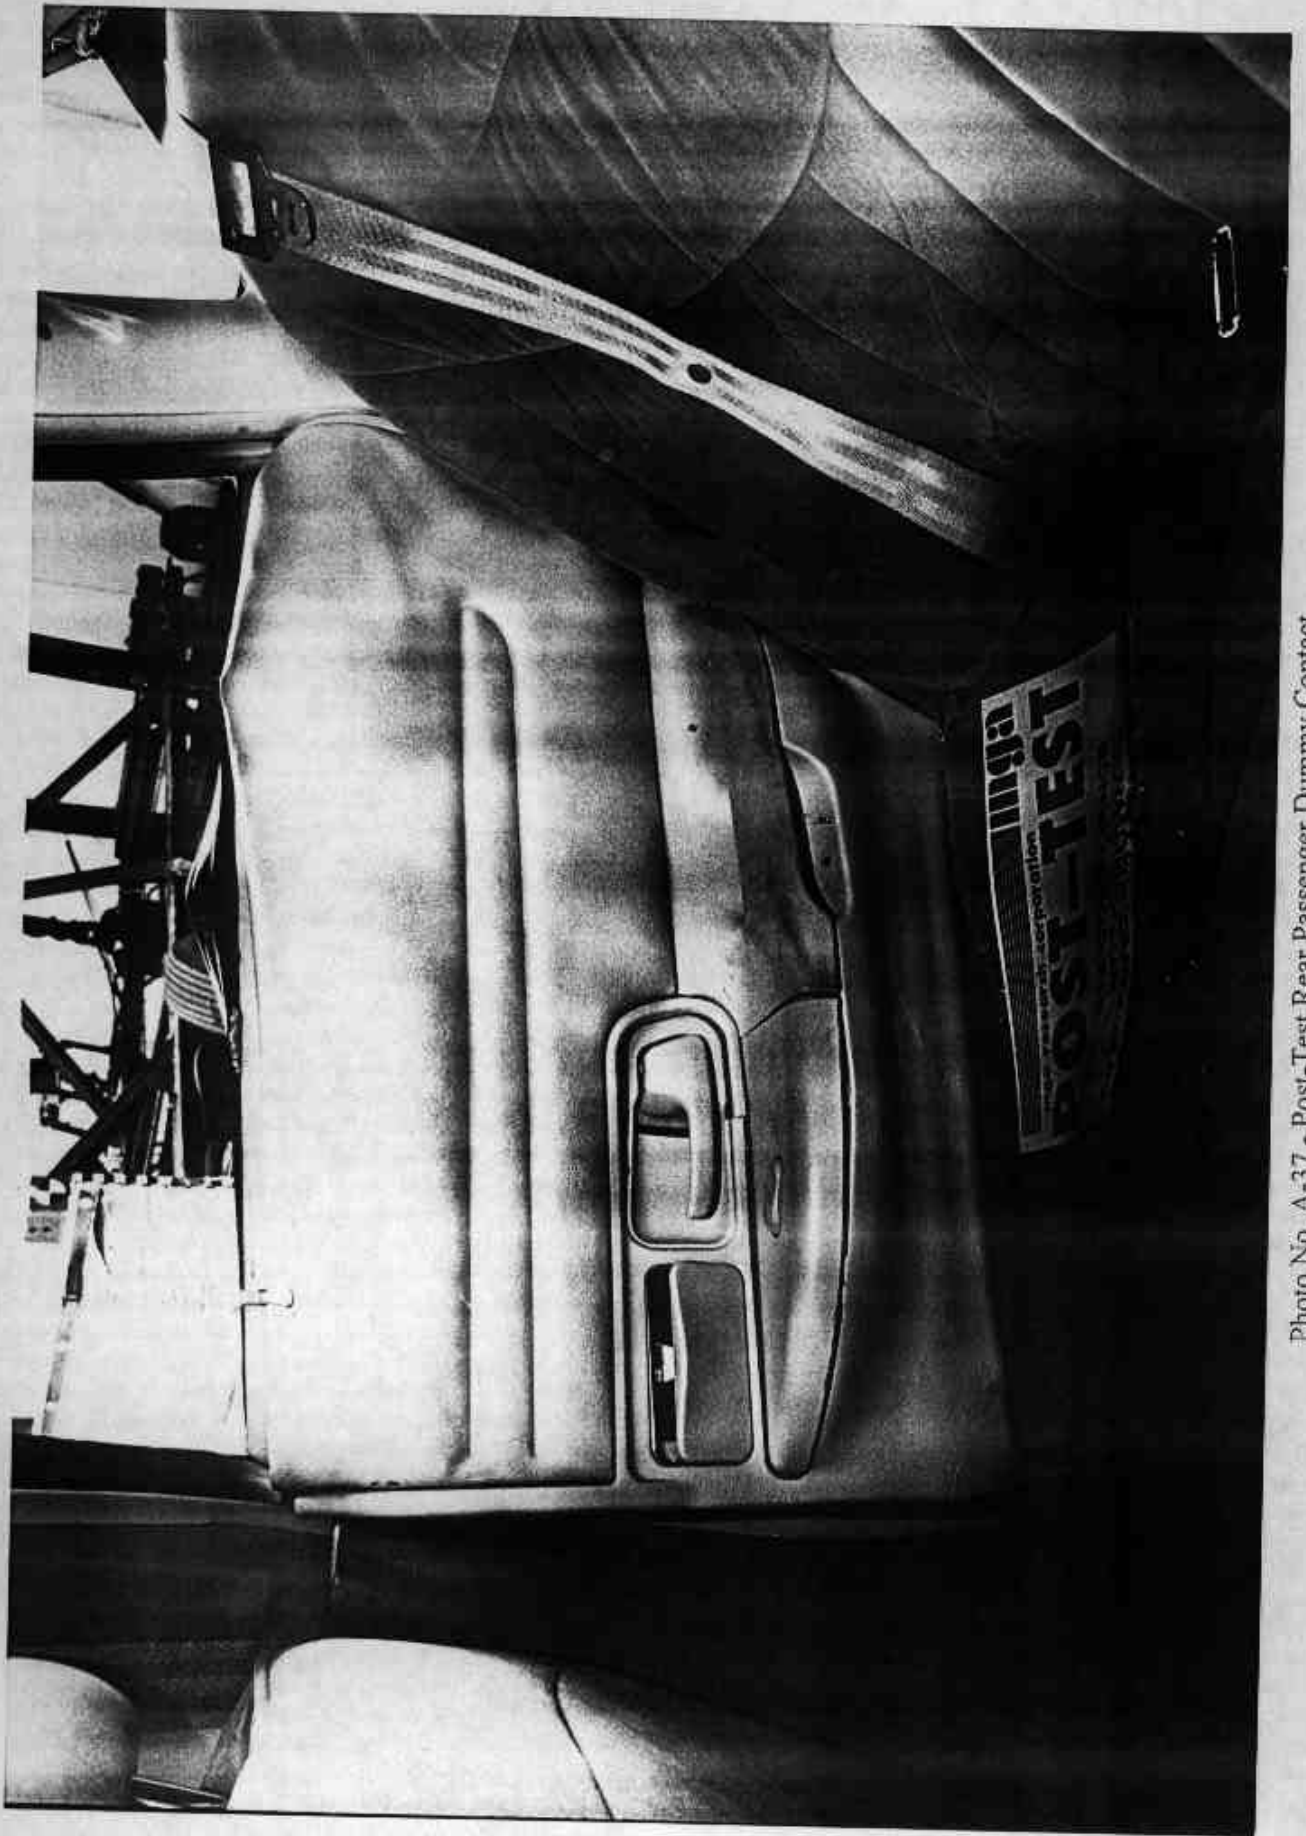
Photo No. A-37 - Post-Test Rear Passenger Dummy Contact

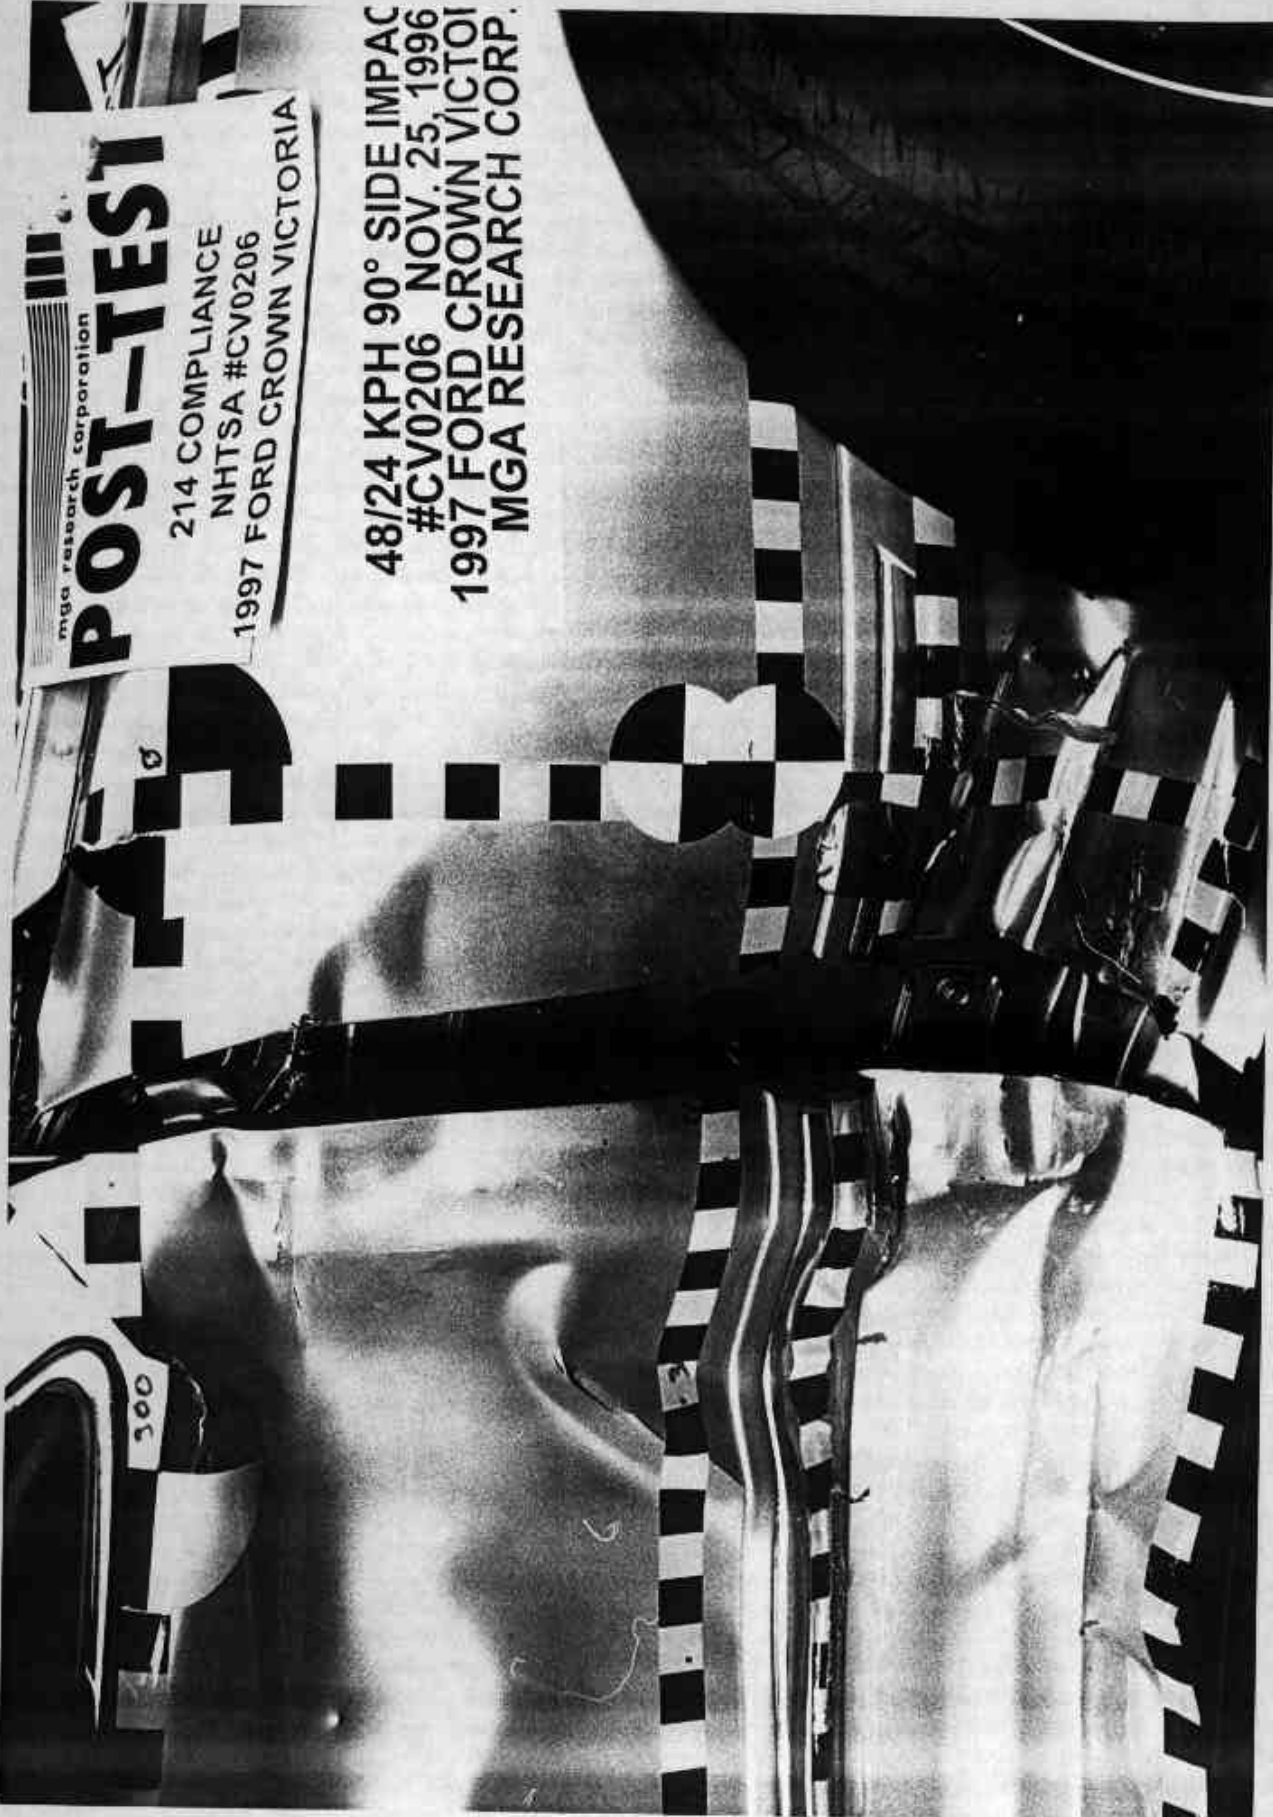
Photo No. A-40 - Post-Test Right Front Impact Point on Vehicle
