REPORT NO.: 214-MGA-97-02
SAFETY COMPLIANCE TESTING FOR
FMVSS 214 "SIDE IMPACT PROTECTION -
PASSENGER CARS"

GENERAL MOTORS CORPORATION
1997 SATURN SL2 4 DOOR
NHTSA NO: CV0104

MGA PROVING GROUNDS
5000 WARREN ROAD
BURLINGTON, WI 53105

FINAL REPORT

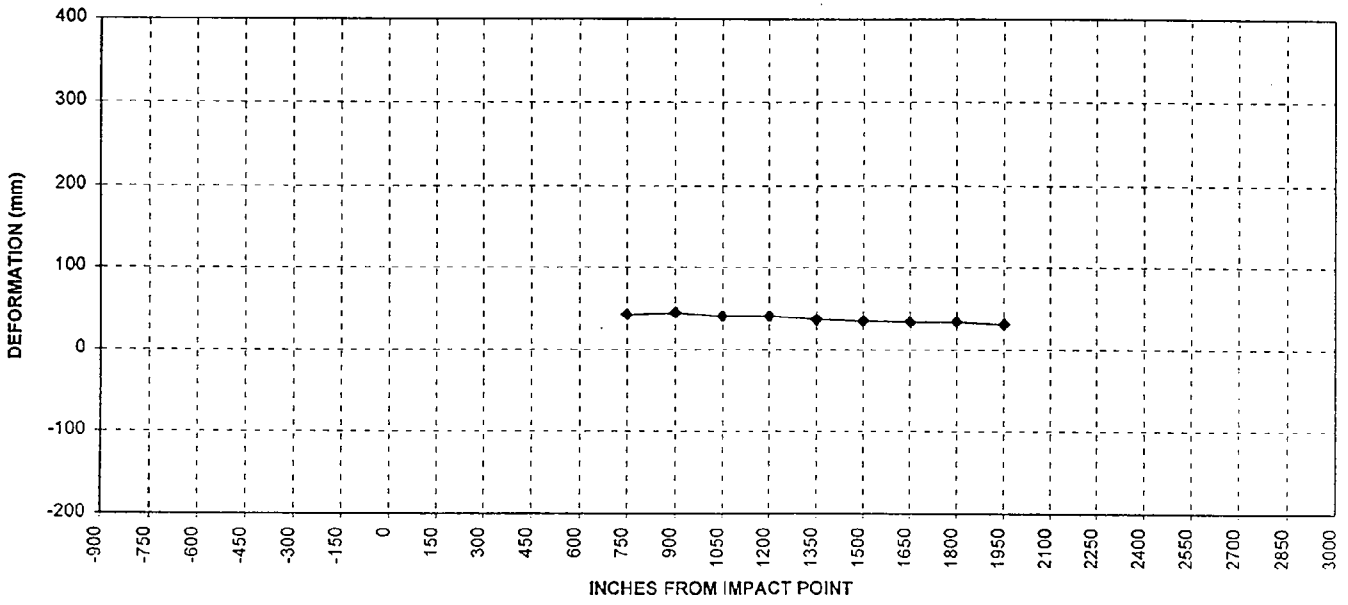
LEVEL 5 - WINDOW TOP

1. LEVEL 1 (268 mm above ground) = * mm
 2. LEVEL 2 (419 mm above ground) = * mm
 3. LEVEL 3 (565 mm above ground) = * mm
 4. LEVEL 4 (842 mm above ground) = * mm
 5. LEVEL 5 (1274 mm above ground) = 45 mm
- Maximum Post-Test Intrusion = * mm

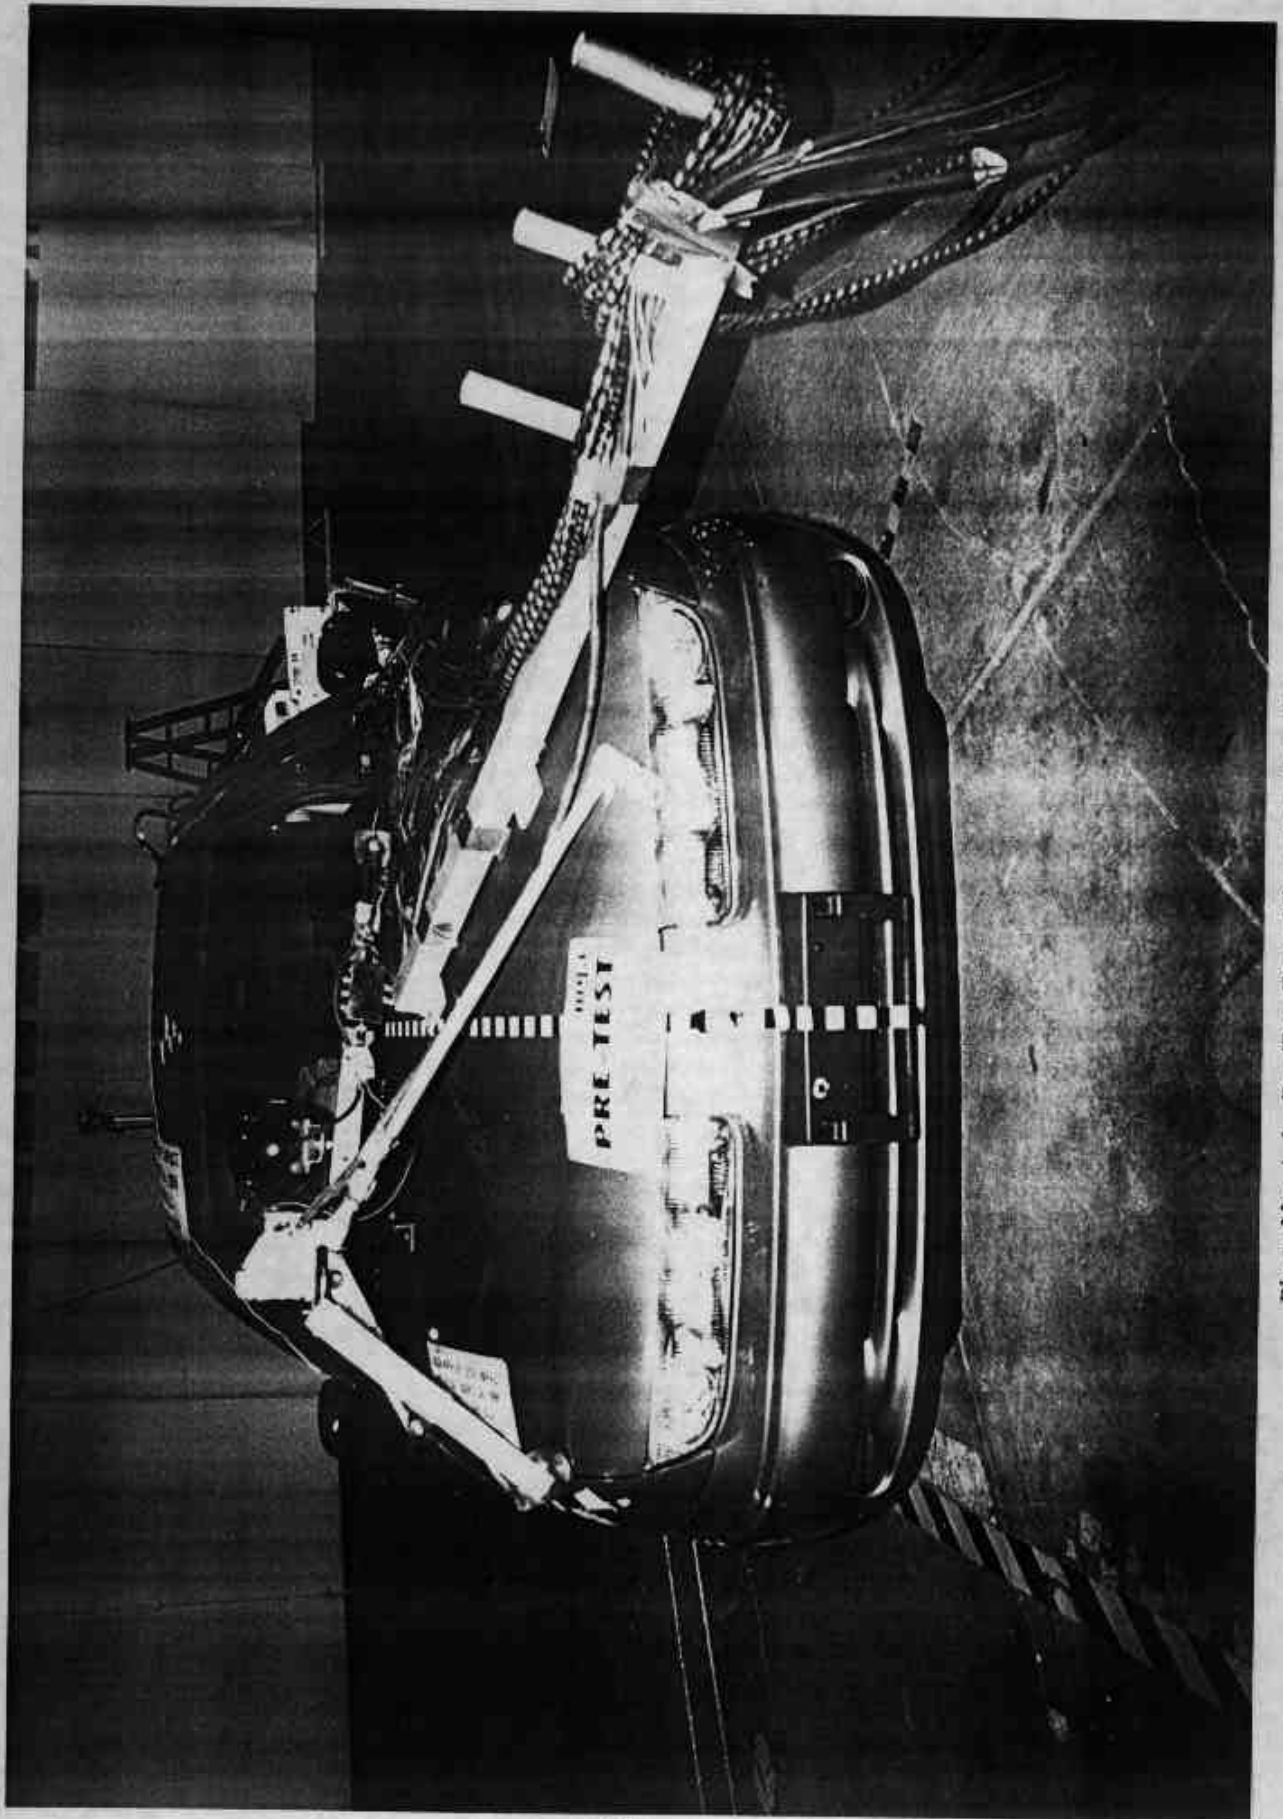
Photo No. A-1 - Pre-Test Front View of Test Vehicle

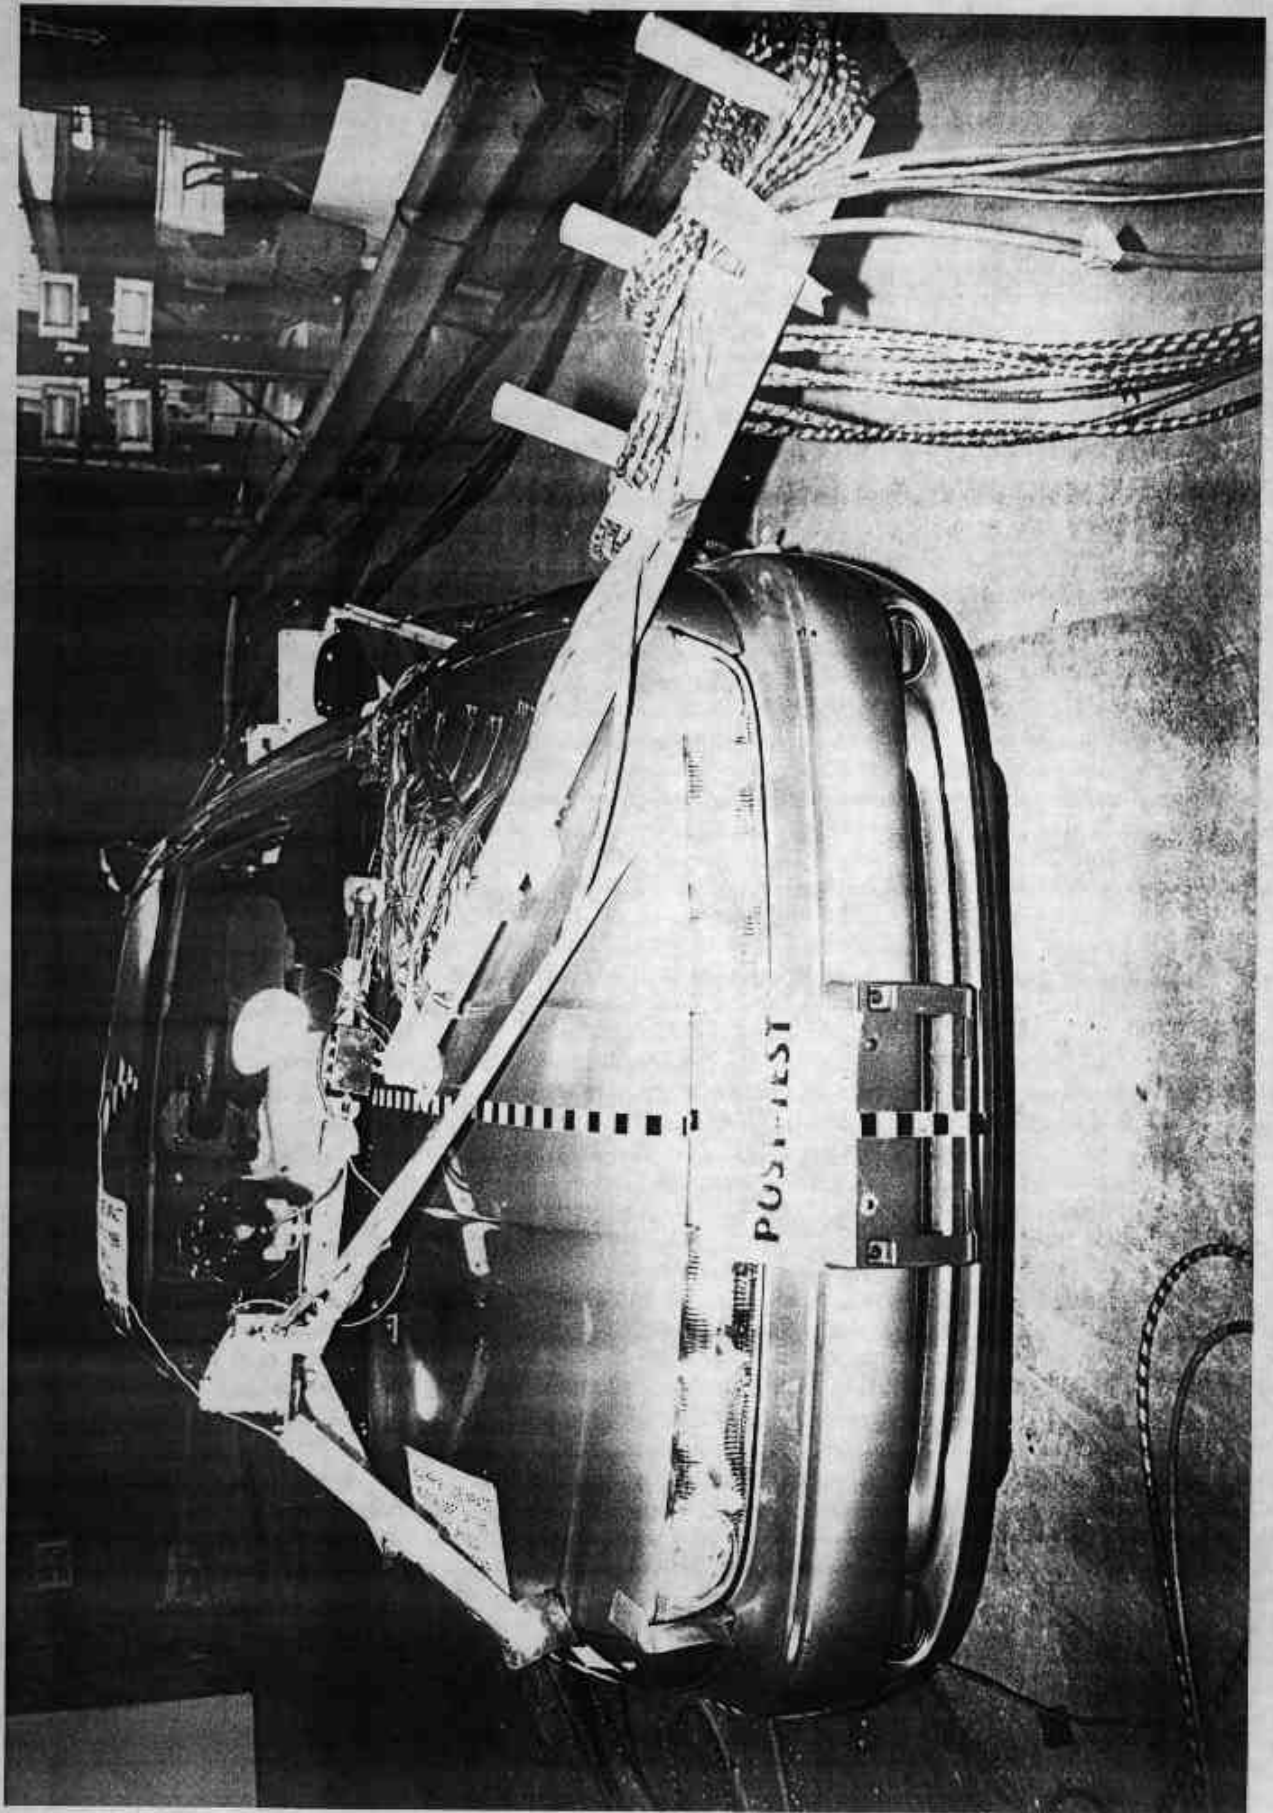
Photo No. A-2 - Post-Test Front View of Test Vehicle

Windshield cracked, both impact side door glass broken

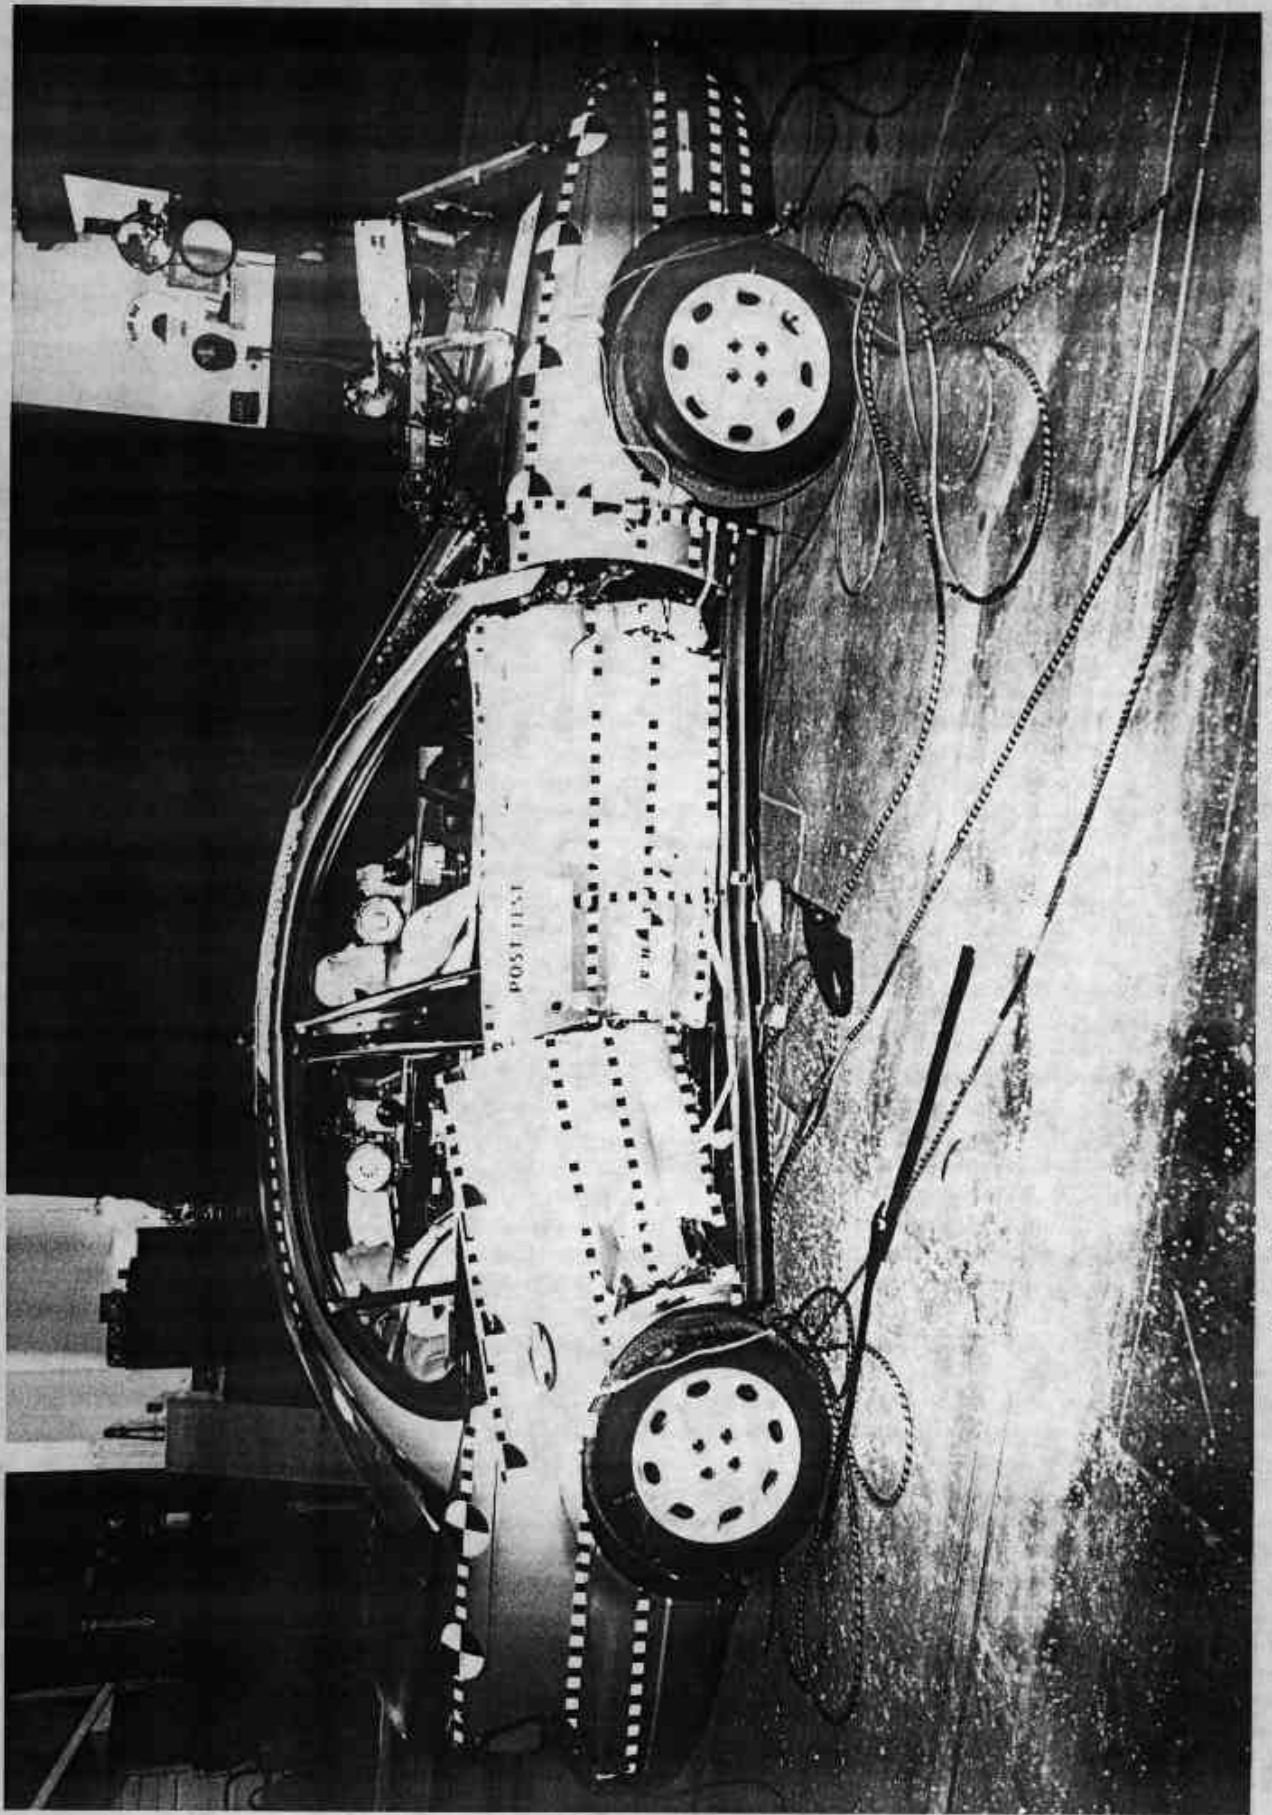
Photo No. A-6 - Post-Test Right Side View of Test Vehicle

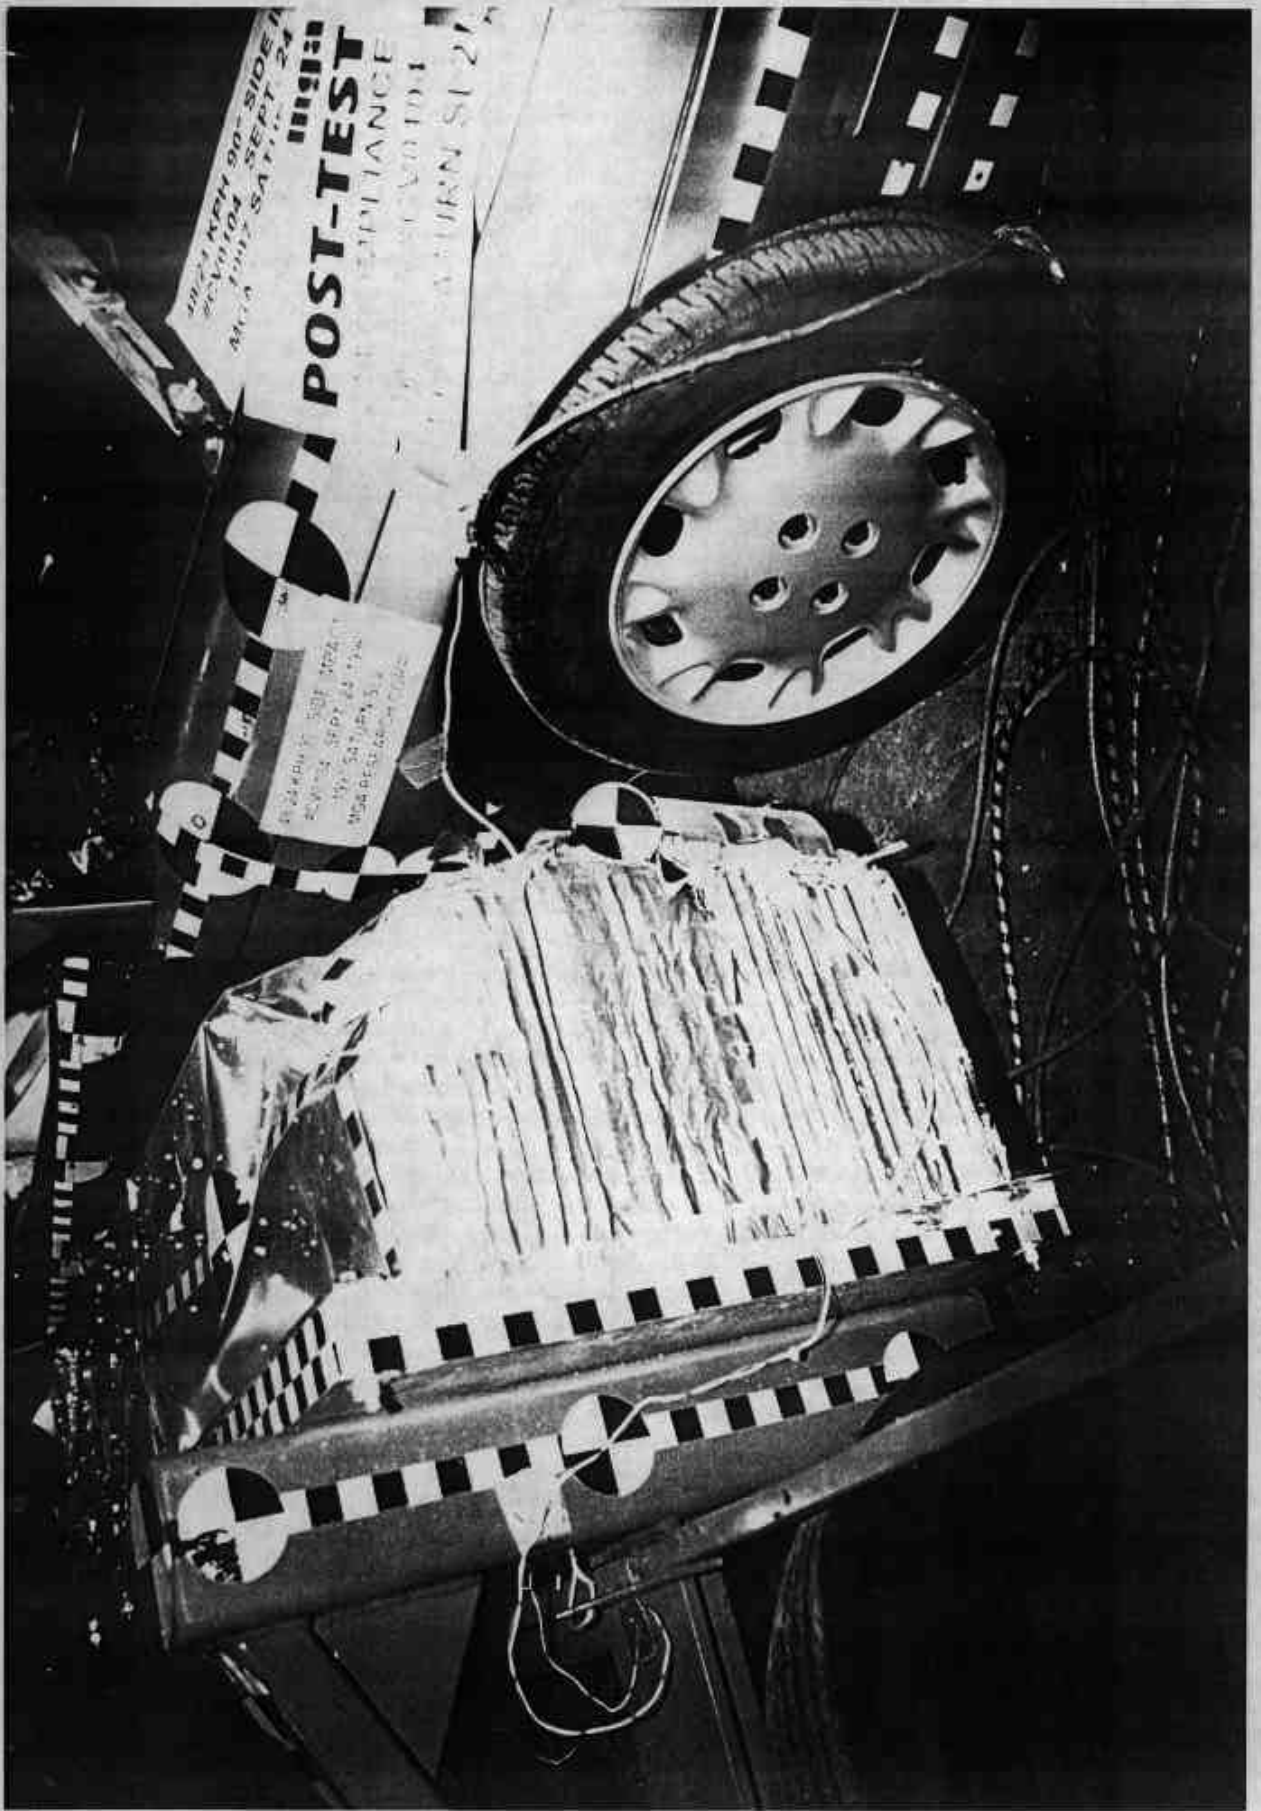
Photo No. A-10 - Post-Test MDB Positioned Against Vehicle (right side)

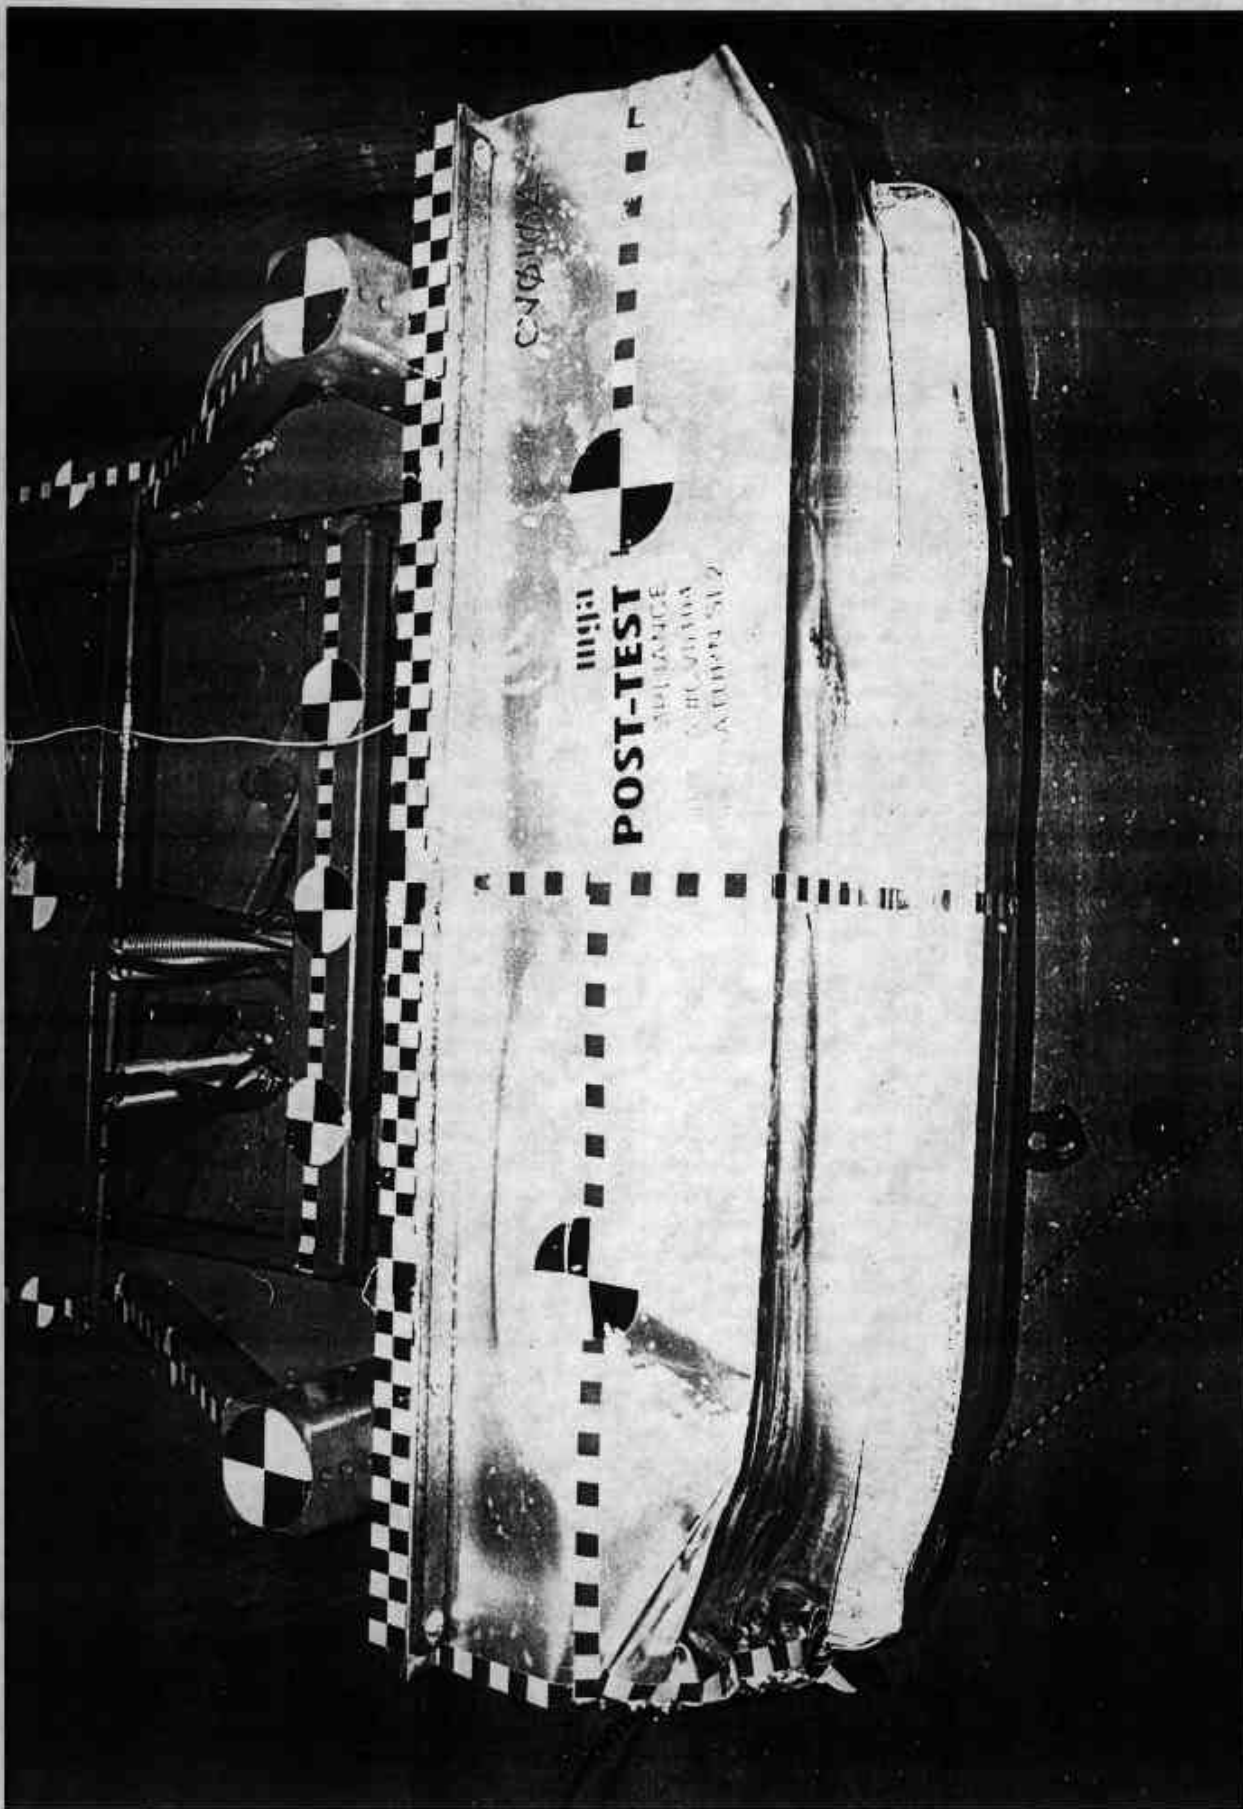
Photo No. A-14 - Post-Test MDB Top View

1. Row A Top of Stack (813 mm) = 108 mm
2. Row B Mid Stack (686 mm) = 76 mm
3. Row C Top of Bumper (533 mm) = 47 mm
4. Row D Center of Bumper (432 mm) = 127 mm

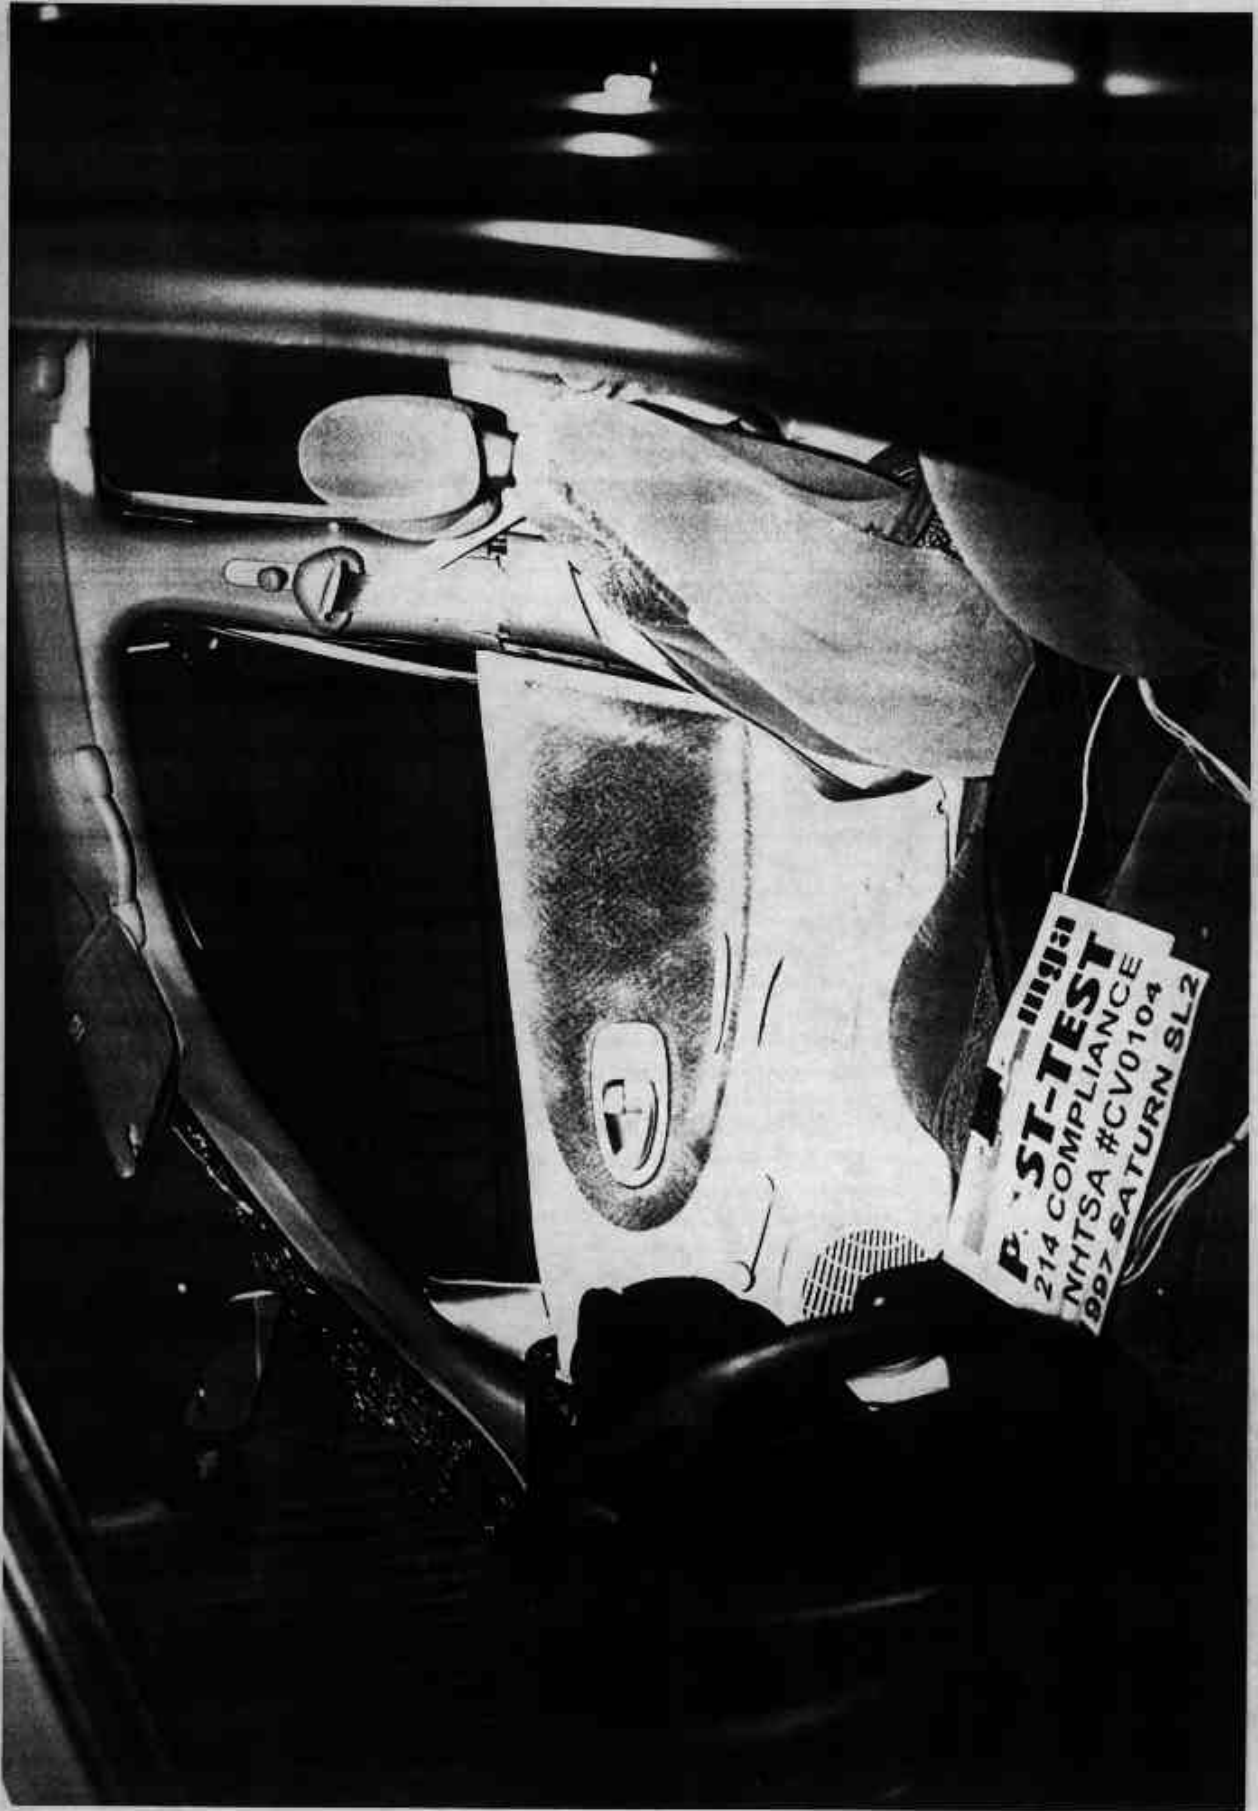
Photo No. A-28 - Post-Test Front Passenger Dummy Contact

| | <u>RIGHT FRONT SID</u> | <u>RIGHT REAR SID</u> |
|---|---|---|
| Head | <u>to B Post & D Ring</u> | <u>to C Post</u> |
| Arm | <u>to door</u> | <u>to door</u> |
| Pelvis | <u>to door</u> | <u>to door</u> |

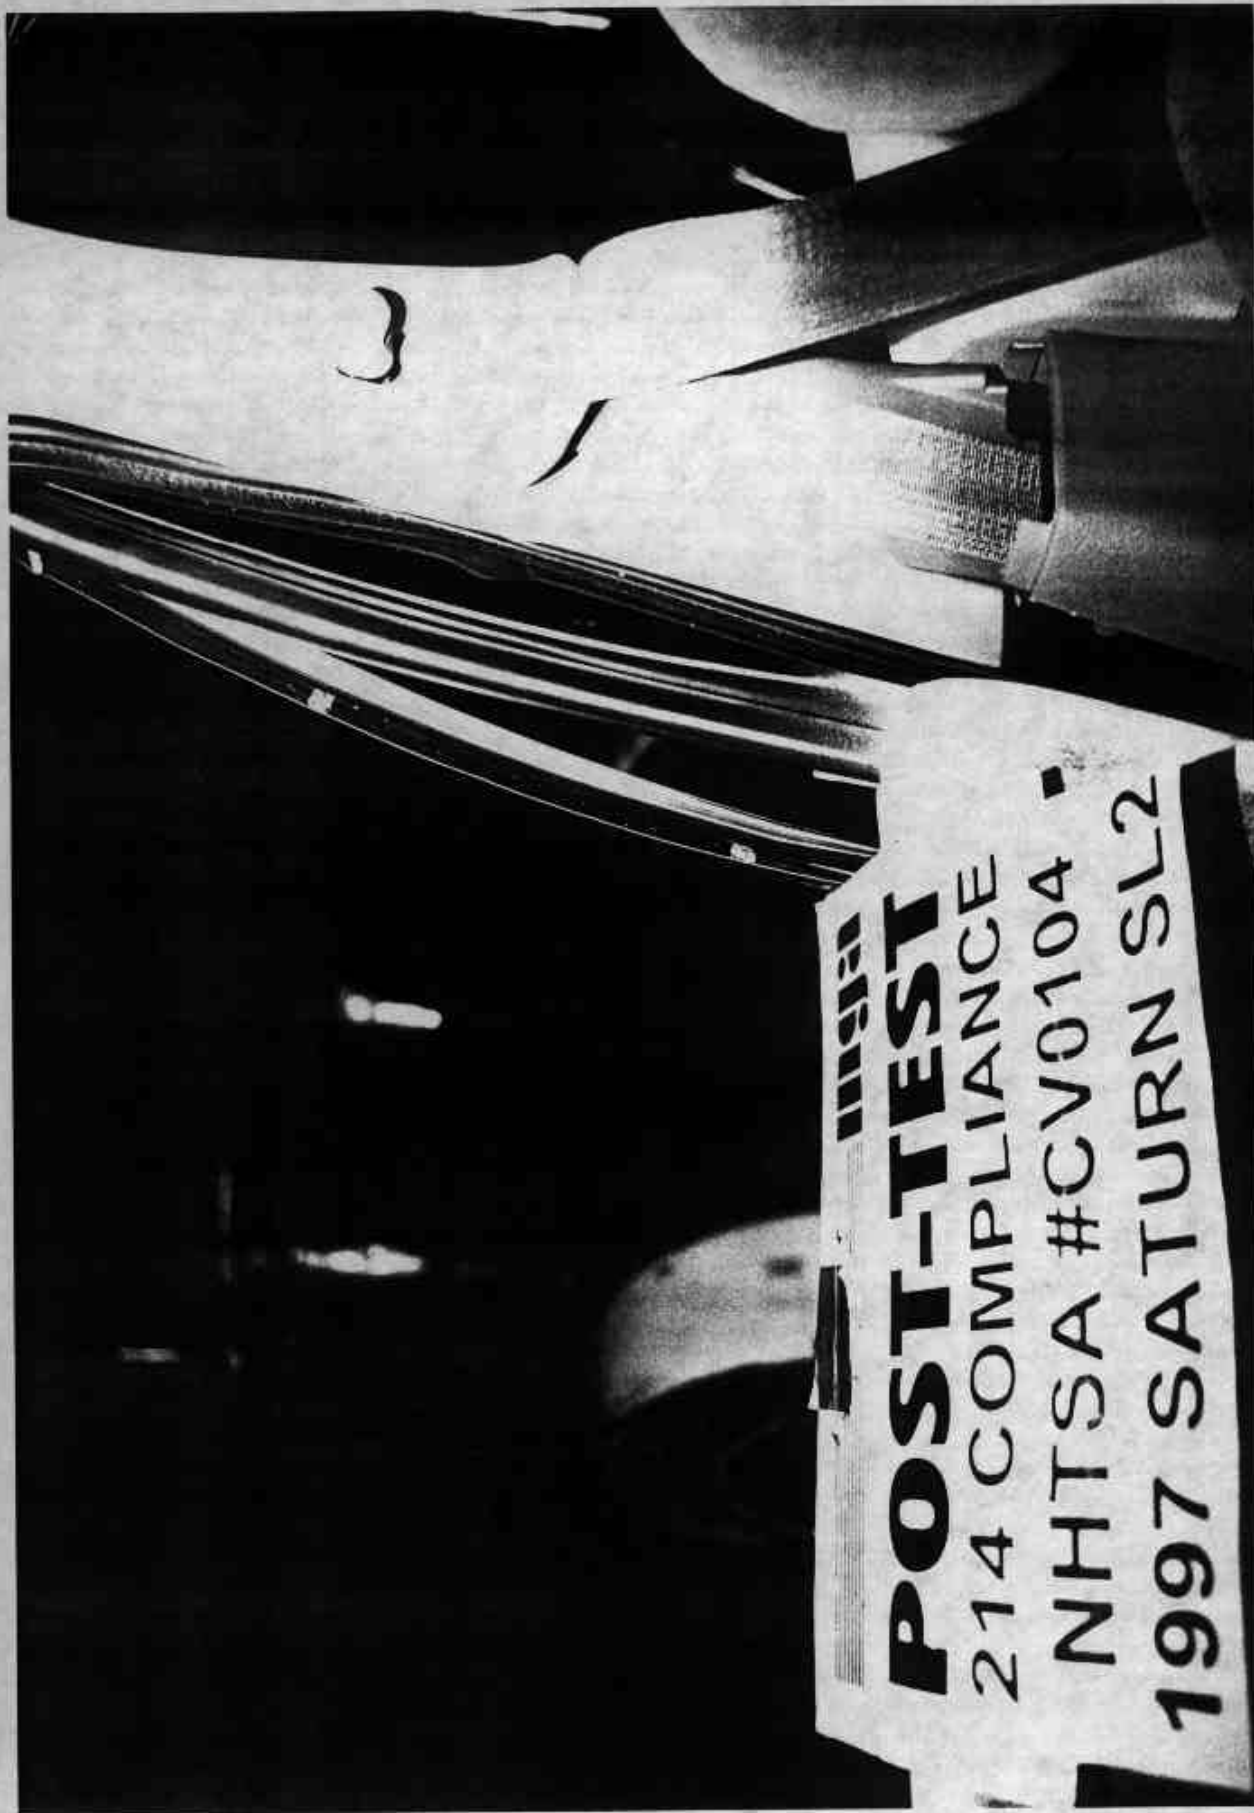
Photo No. A-29 - Post-Test Front Passenger Head Contact

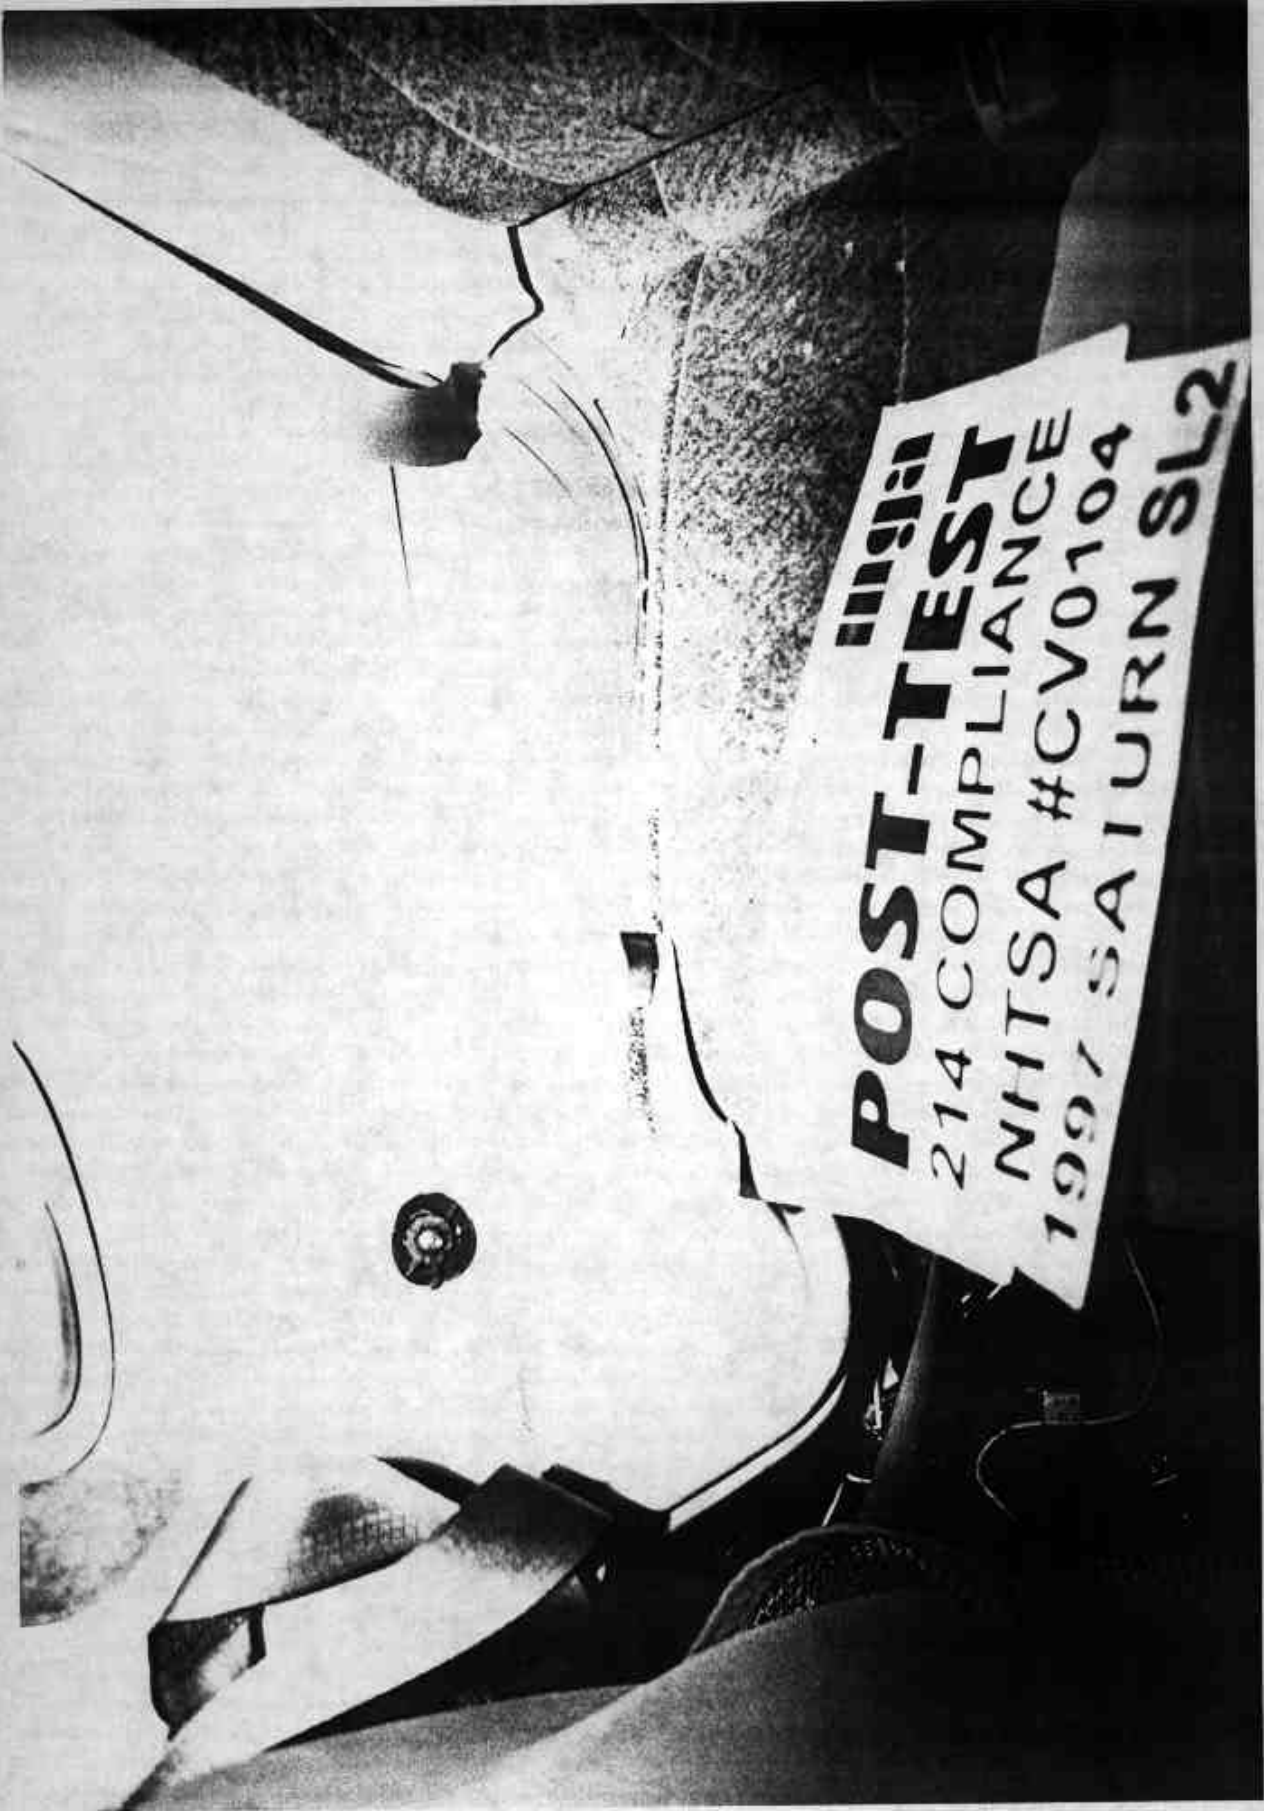
Photo No. A-37 - Post-Test Rear Passenger Dummy Contact

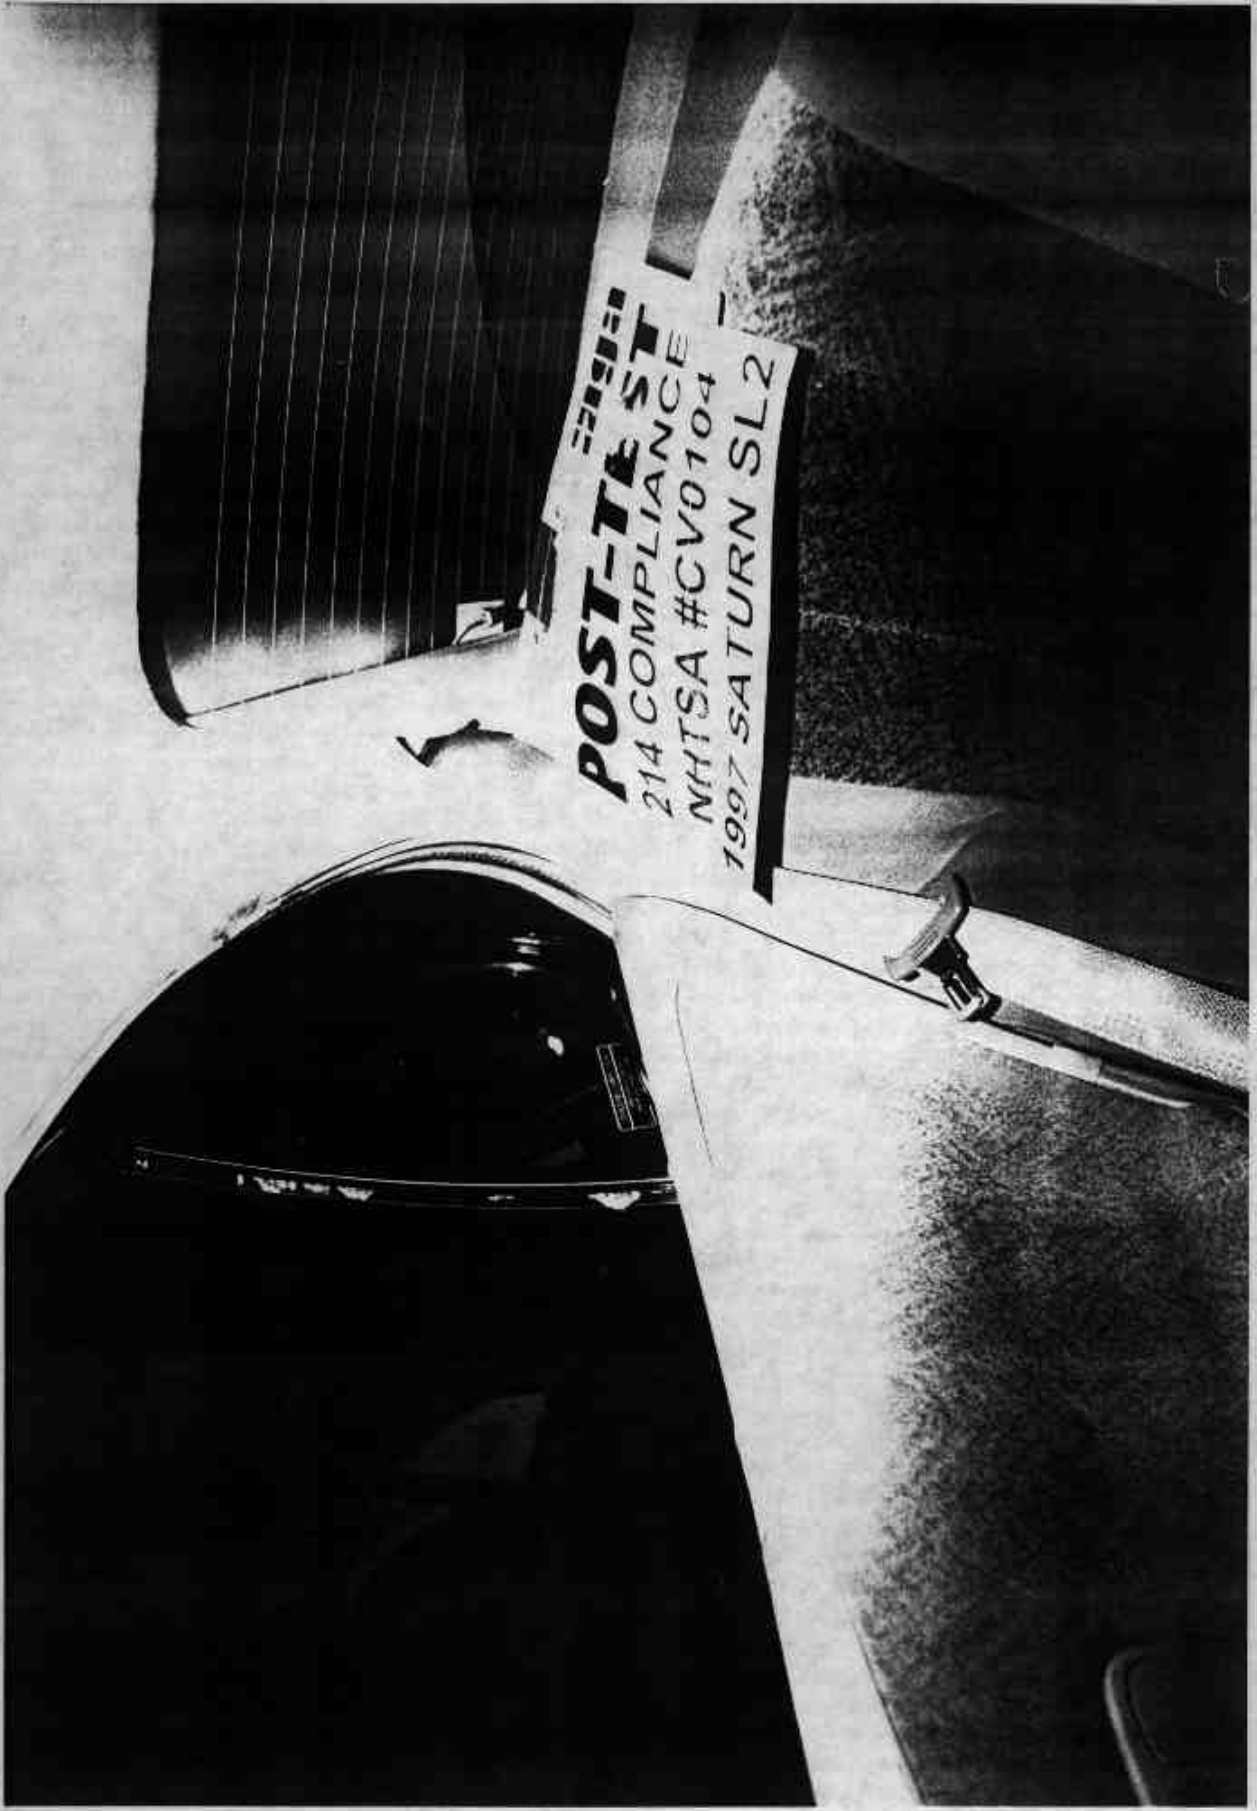
Photo No. A-38 - Post-Test Rear Passenger Dummy Head Contact

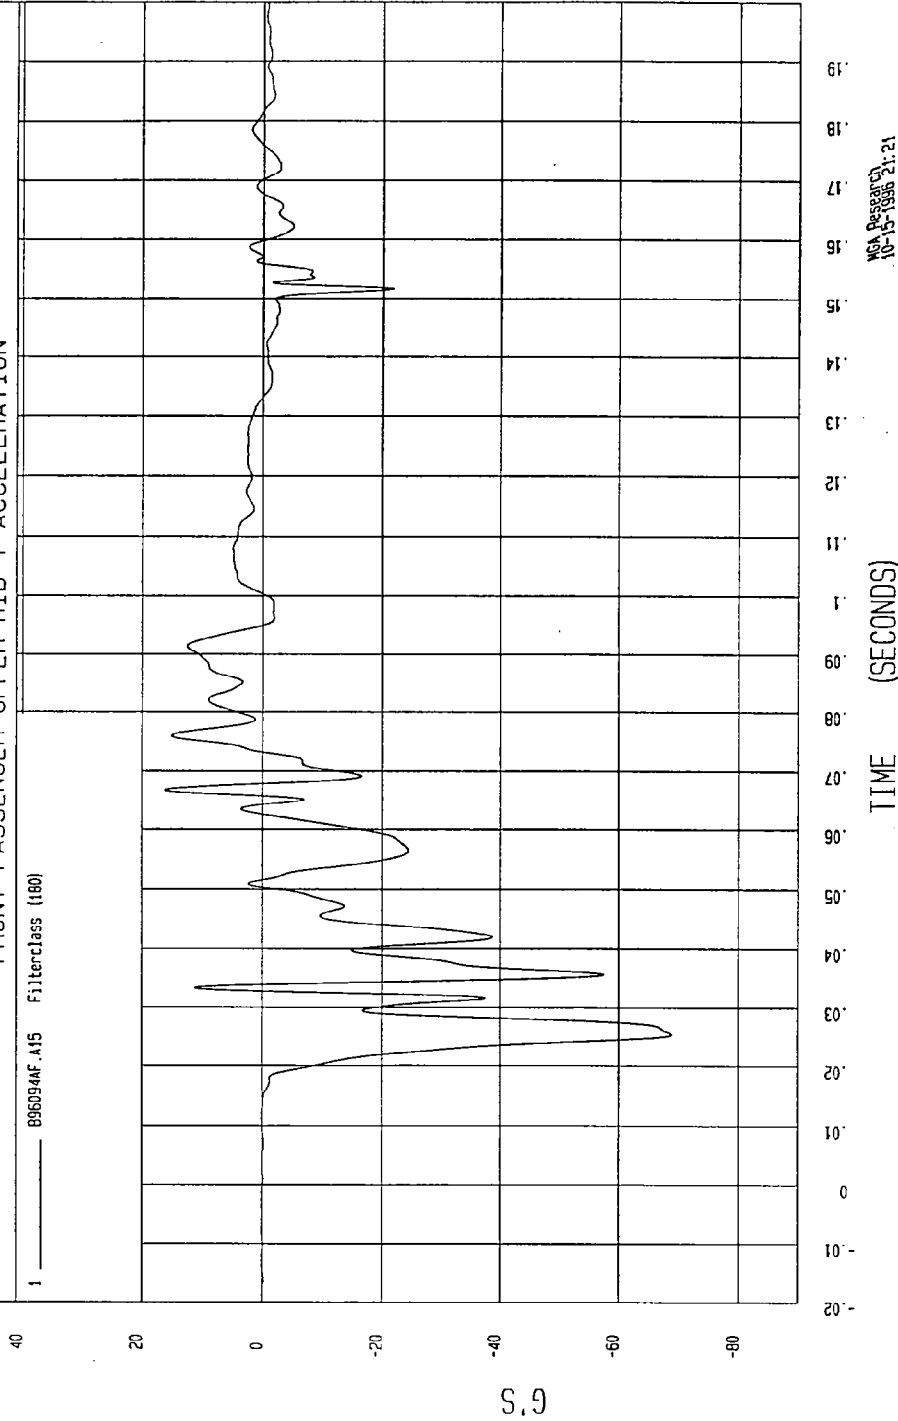
FRONT PASSENGER UPPER RIB Y ACCELERATION

1 ——— B96094F.A15 Filterclass (160)

<table><tr> <th></th> <th style="text-align: center;"><u>RIGHT FRONT PASS.</u></th> <th style="text-align: center;"><u>RIGHT REAR PASS.</u></th> </tr><tr> <td>Right Upper Rib (RUR) Accel., g</td> <td style="text-align: center;">64</td> <td style="text-align: center;">60</td> </tr></table>
