REPORT NO.: 214-MGA-97-02
SAFETY COMPLIANCE TESTING FOR
FMVSS 214 "SIDE IMPACT PROTECTION -
PASSENGER CARS"

GENERAL MOTORS CORPORATION
1997 SATURN SL2 4 DOOR
NHTSA NO: CV0104

MGA PROVING GROUNDS
5000 WARREN ROAD
BURLINGTON, WI 53105

FINAL REPORT

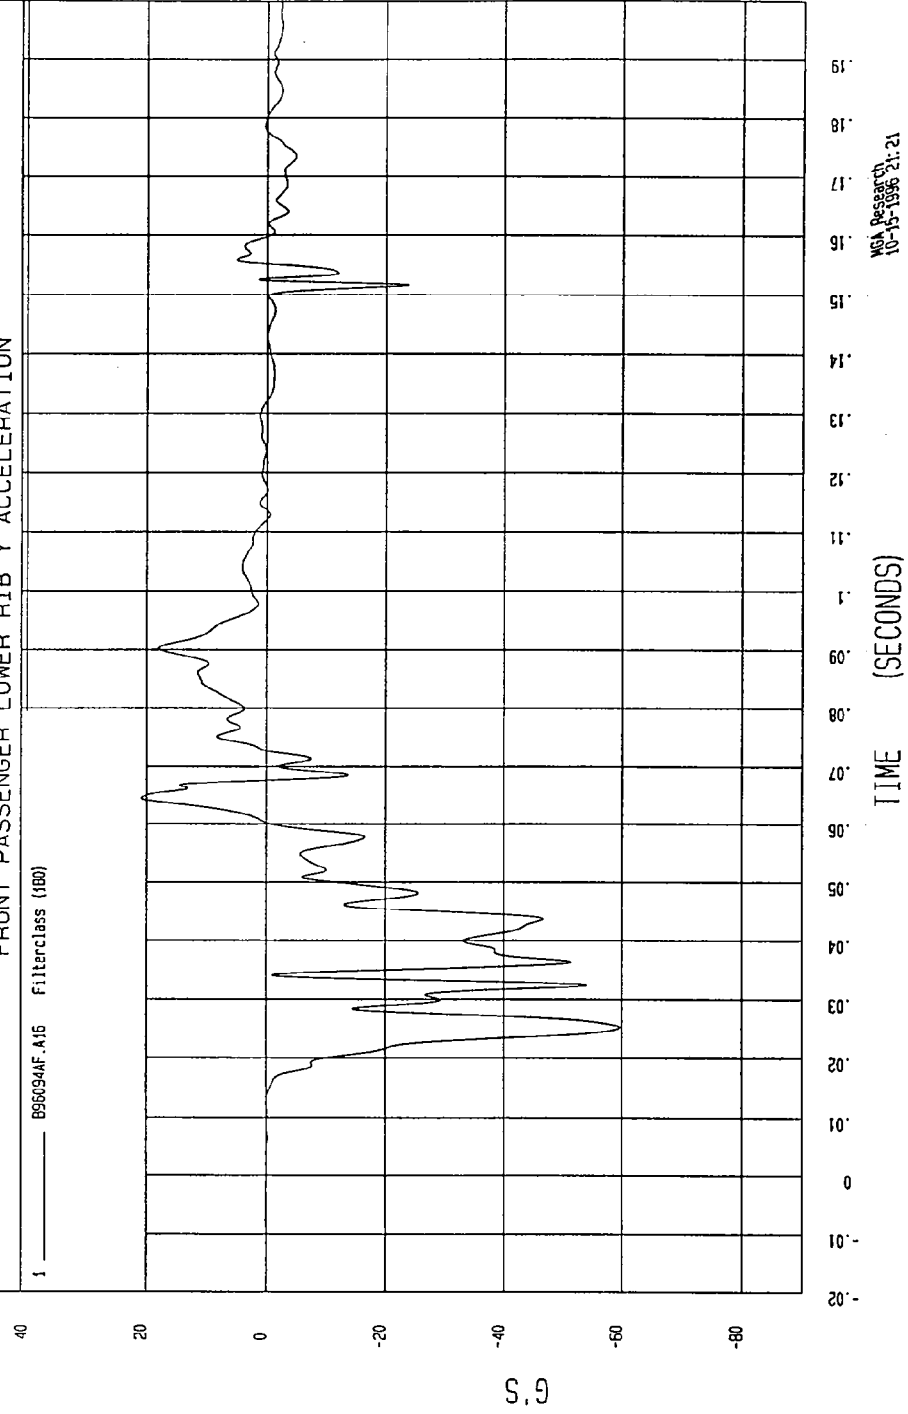
FRONT PASSENGER LOWER RIB Y ACCELERATION

1 ——— B96094F.A16 Filterclass (180)

<table><tr> <th></th> <th style="text-align: center;"><u>RIGHT FRONT PASS.</u></th> <th style="text-align: center;"><u>RIGHT REAR PASS.</u></th> </tr><tr> <td>Right Lower Rib (RLR) Accel., g</td> <td style="text-align: center;">53</td> <td style="text-align: center;">65</td> </tr></table>

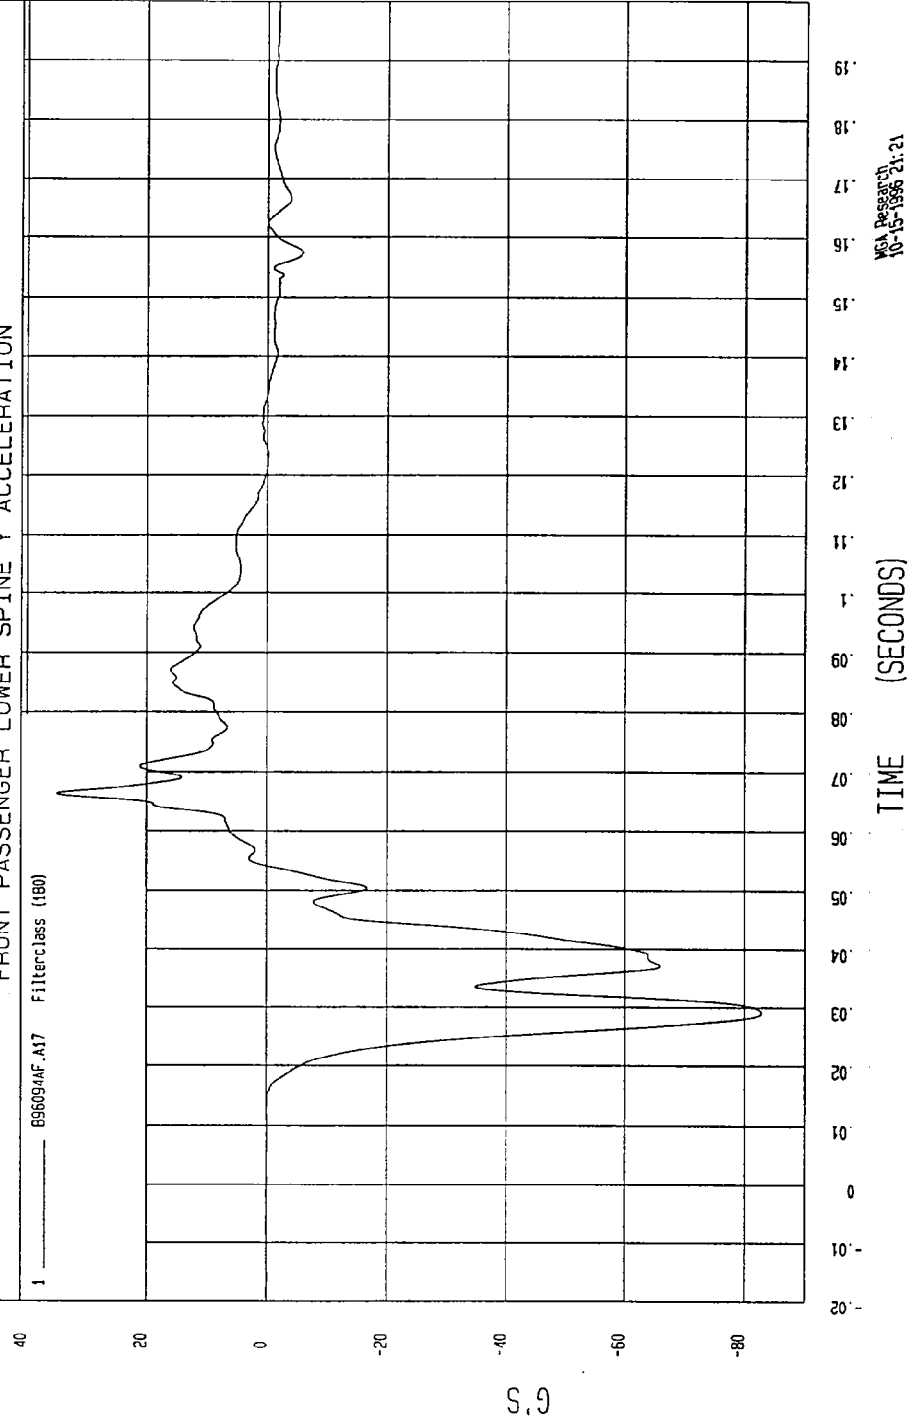
FRONT PASSENGER LOWER SPINE Y ACCELERATION

1 ——— B96094AF.A17 Filter: bass (180)

<table><tr> <th></th> <th style="text-align: center;"><u>RIGHT FRONT PASS.</u></th> <th style="text-align: center;"><u>RIGHT REAR PASS.</u></th> </tr><tr> <td>Lower Spine (T₁₂) Accel., g</td> <td style="text-align: center;">84</td> <td style="text-align: center;">68</td> </tr></table>

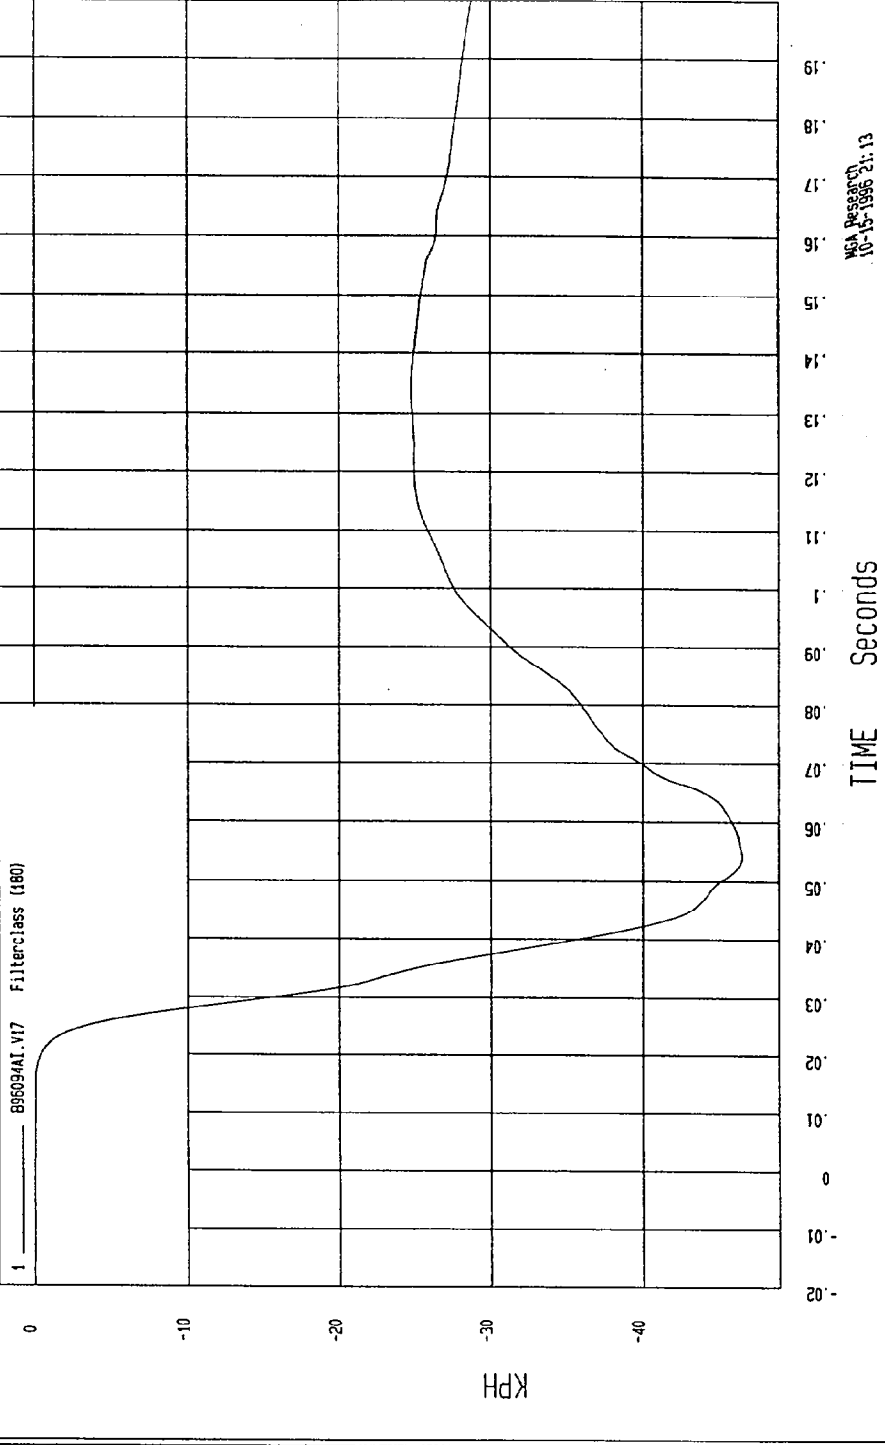
FRONT PASSENGER LOWER SPINE Y VELOCITY

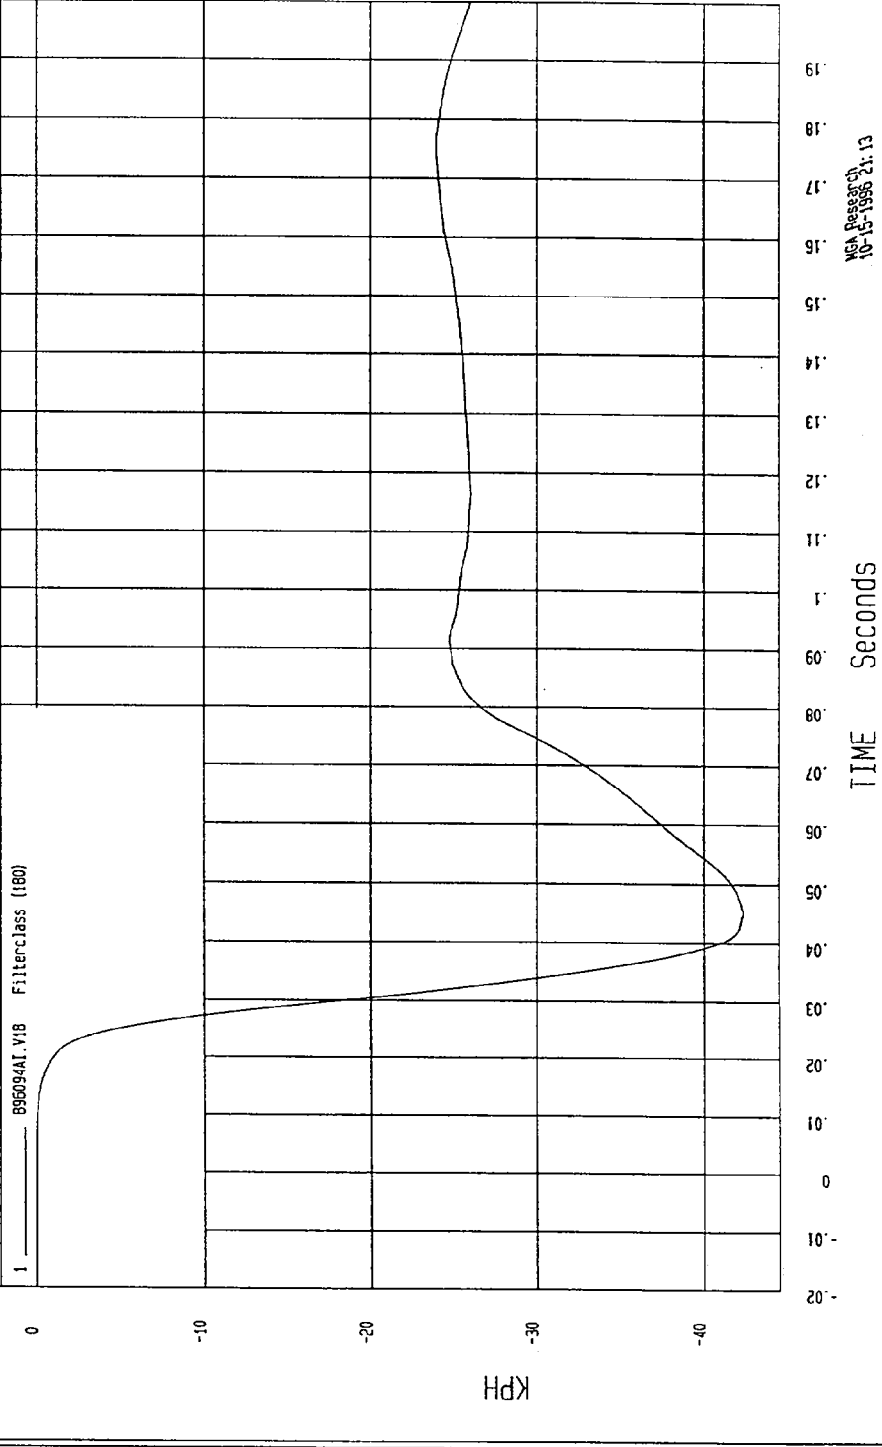
FRONT PASSENGER PELVIS Y VELOCITY

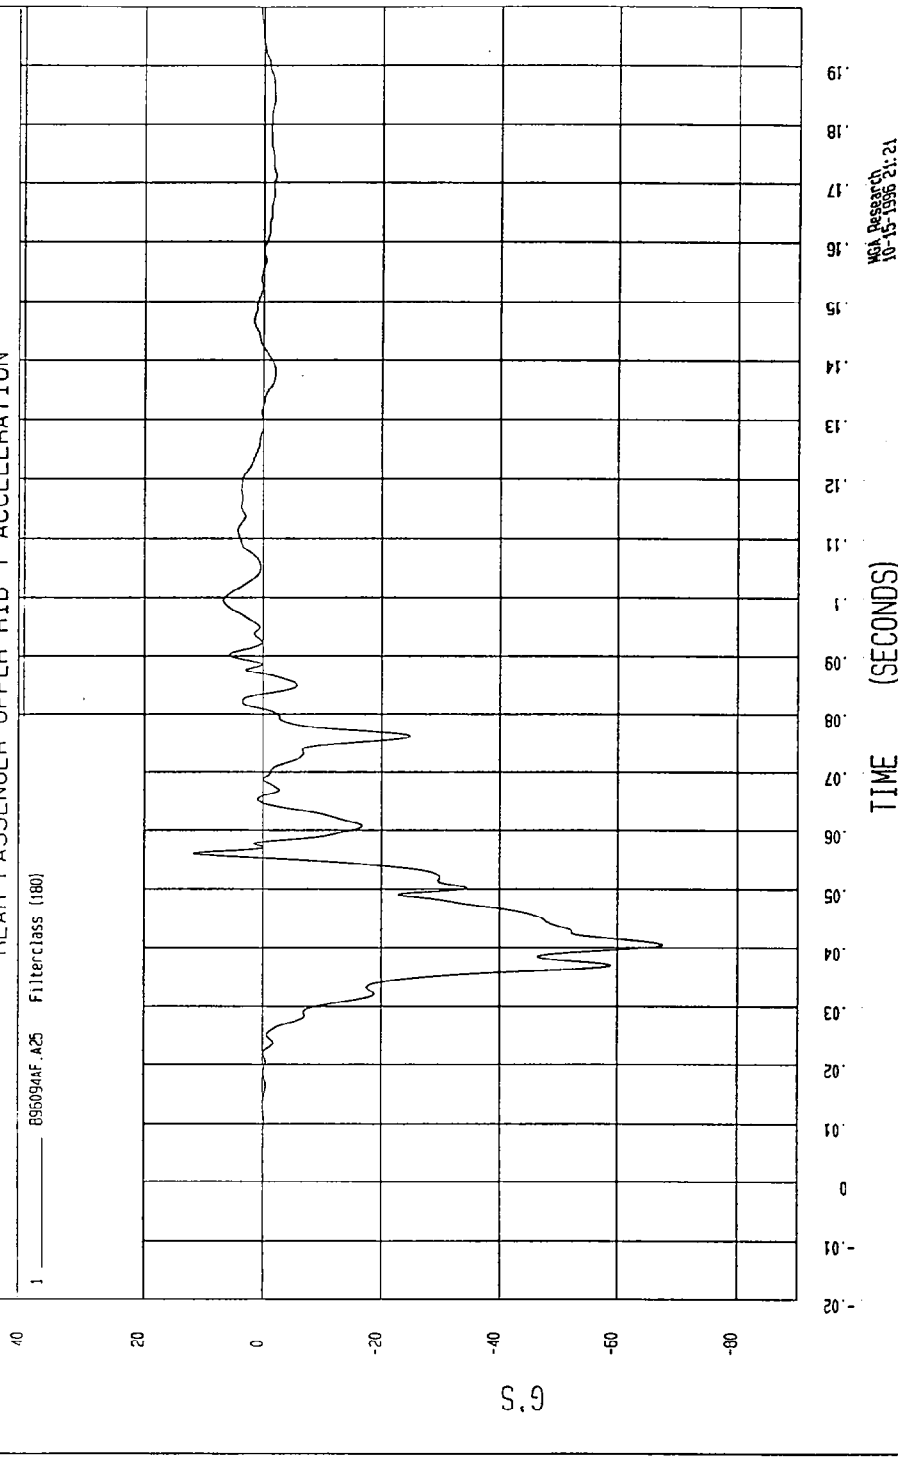
REAR PASSENGER UPPER RIB Y ACCELERATION

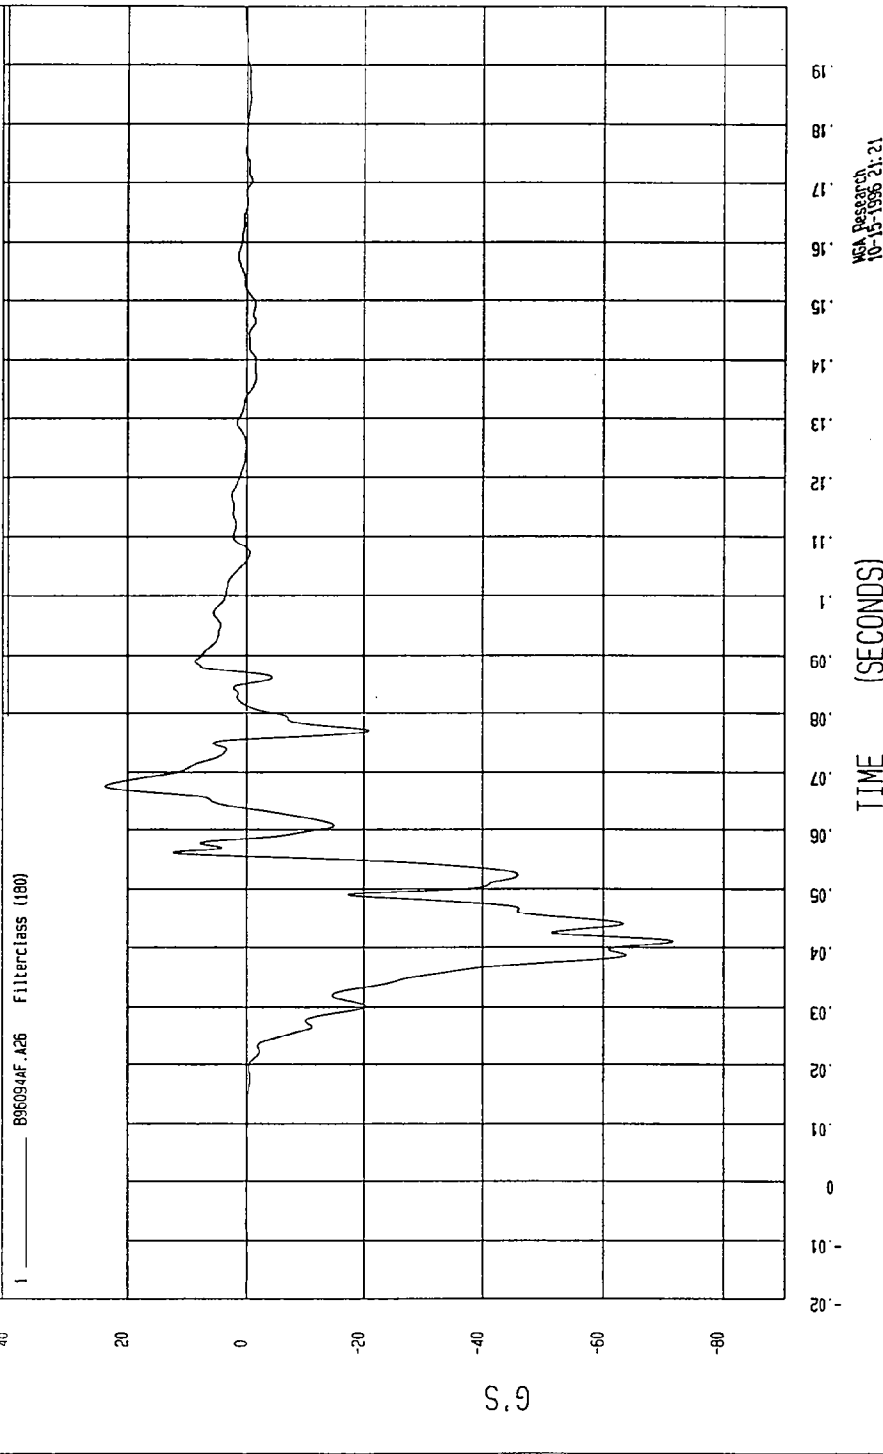
REAR PASSENGER LOWER RIB Y ACCELERATION

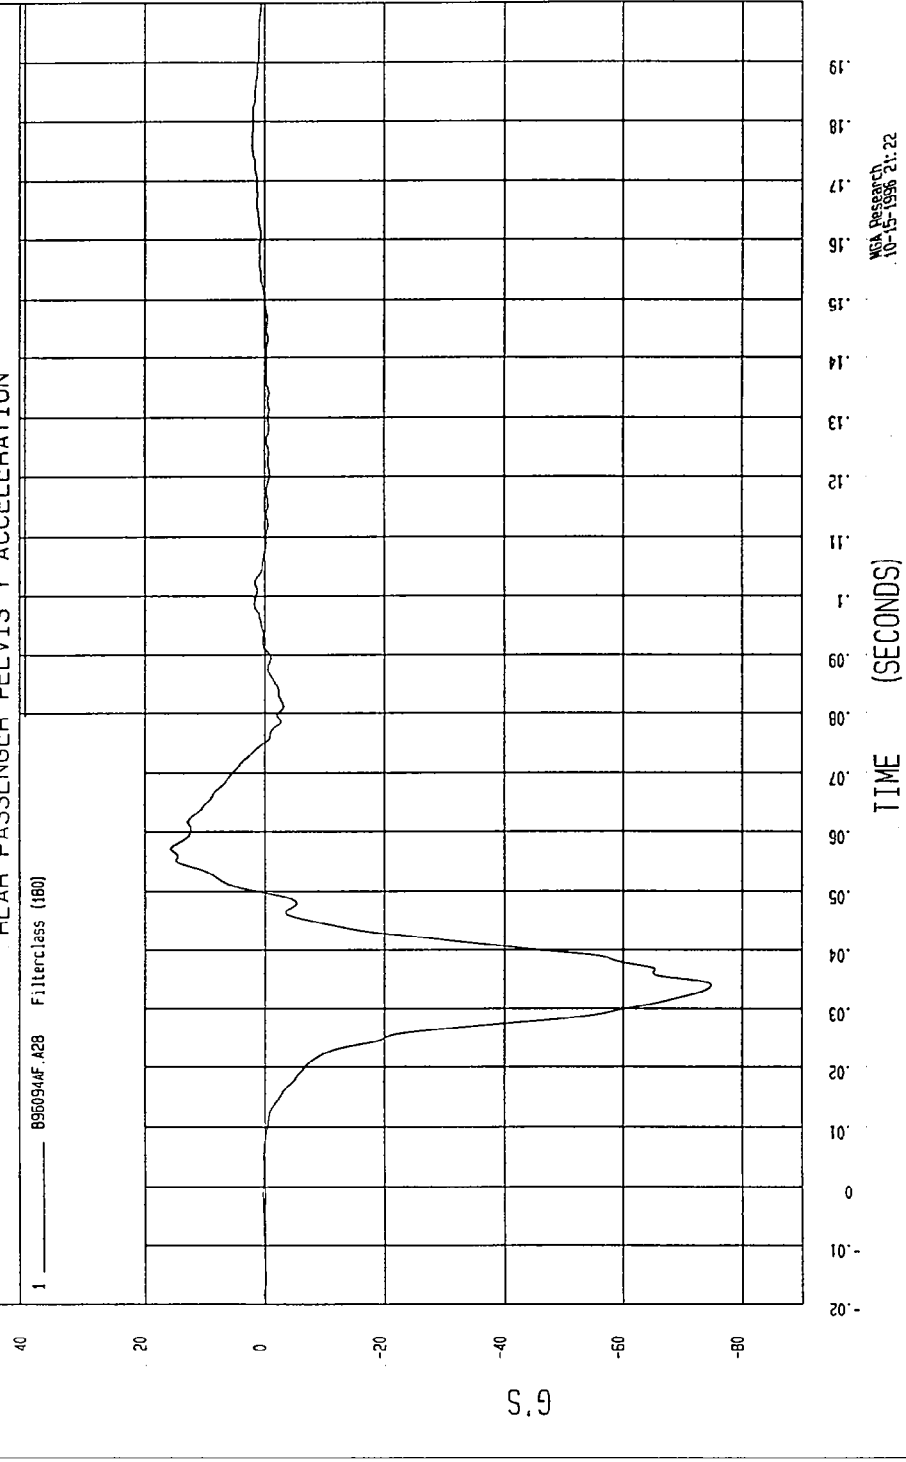
REAR PASSENGER PELVIS Y ACCELERATION

1 ——— B95094AF A28 Filterclass (180)

<table><tr> <th></th> <th style="text-align: center;"><u>RIGHT FRONT PASS.</u></th> <th style="text-align: center;"><u>RIGHT REAR PASS.</u></th> </tr><tr> <td>Pelvis (PEV) Accel., g</td> <td style="text-align: center;">92</td> <td style="text-align: center;">73</td> </tr></table>

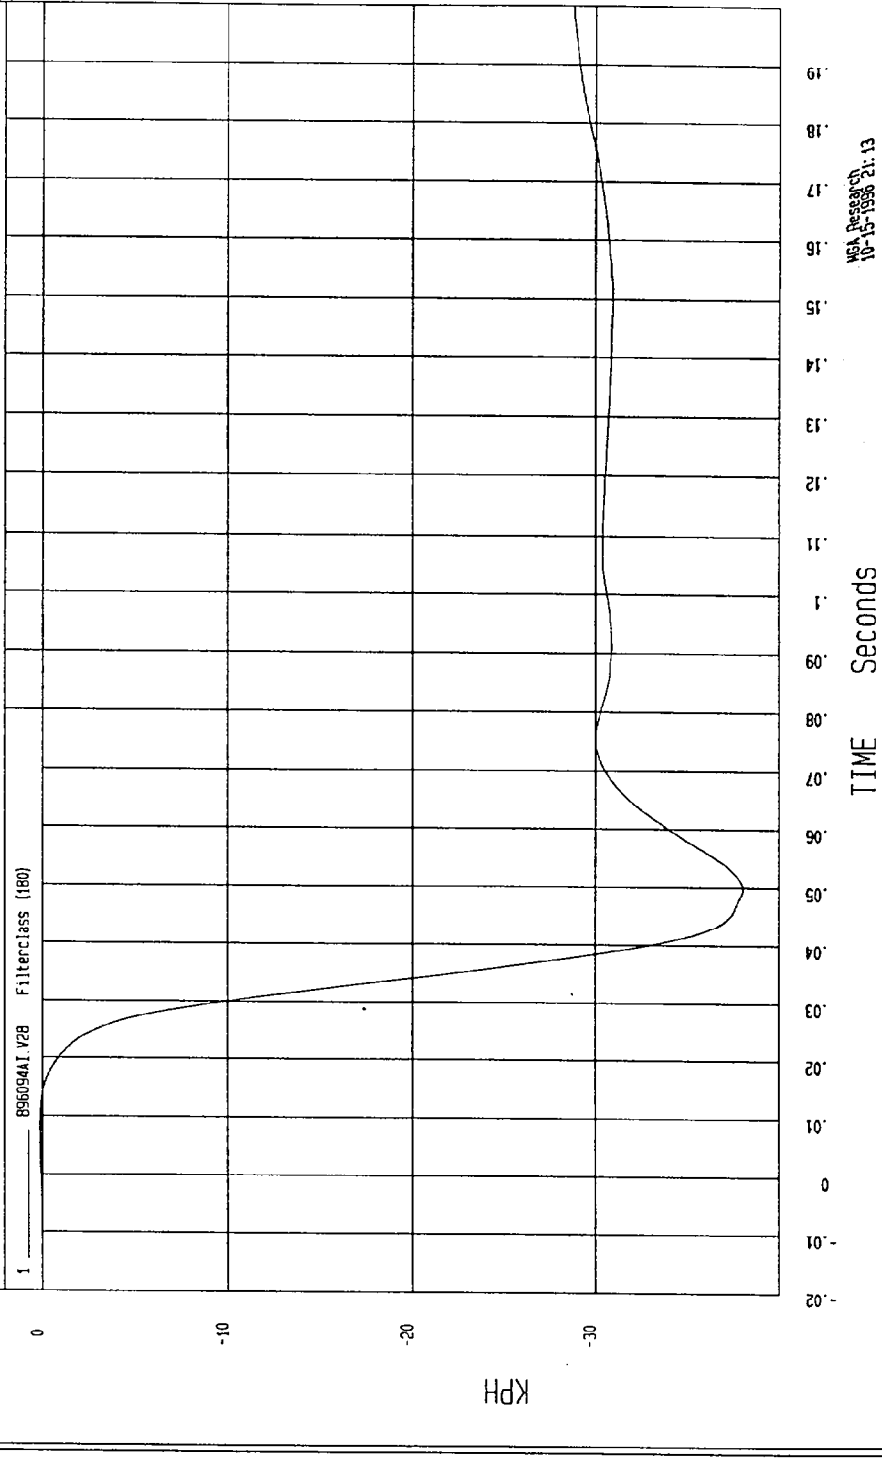
REAR PASSENGER PELVIS Y VELOCITY

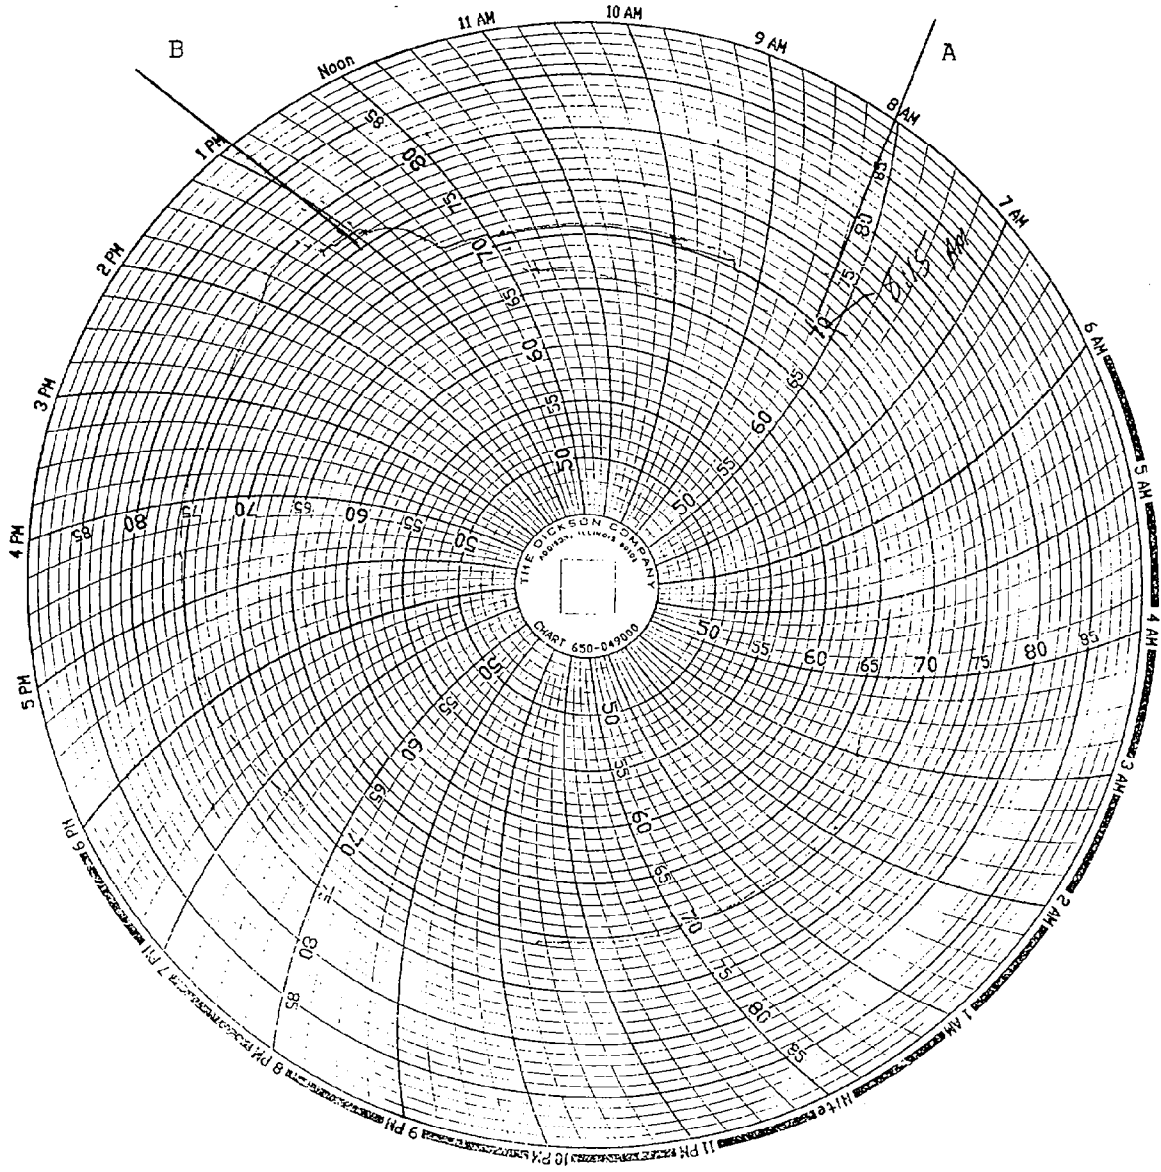
VEHICLE AND DUMMY TEMPERATURE

A = Dummies installed in vehicle
B = Test conducted
