REPORT NO. 208-MGA-97-003  
212-MGA-97-003  
301-MGA-97-003

VEHICLE SAFETY COMPLIANCE TESTING  
FOR  
FMVSS 208, OCCUPANT CRASH PROTECTION  
FMVSS 212, WINDSHIELD MOUNTING  
FMVSS 219, WINDSHIELD INTRUSION (PARTIAL)  
FMVSS 301, FUEL SYSTEM INTEGRITY

Ford Motor Company  
1997 Econoline Van E150  
NHTSA NO. CV0212

MGA RESEARCH CORPORATION  
5000 WARREN ROAD  
BURLINGTON, WI 53105

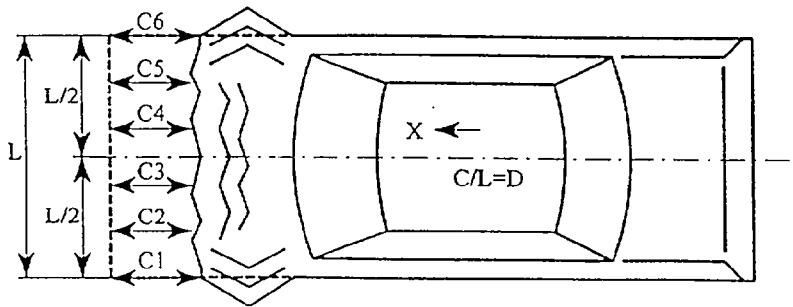
Midpoint of Damage: D = Vehicle Longitudinal Centerline

Length of Damaged Region: L = 70.3 inches

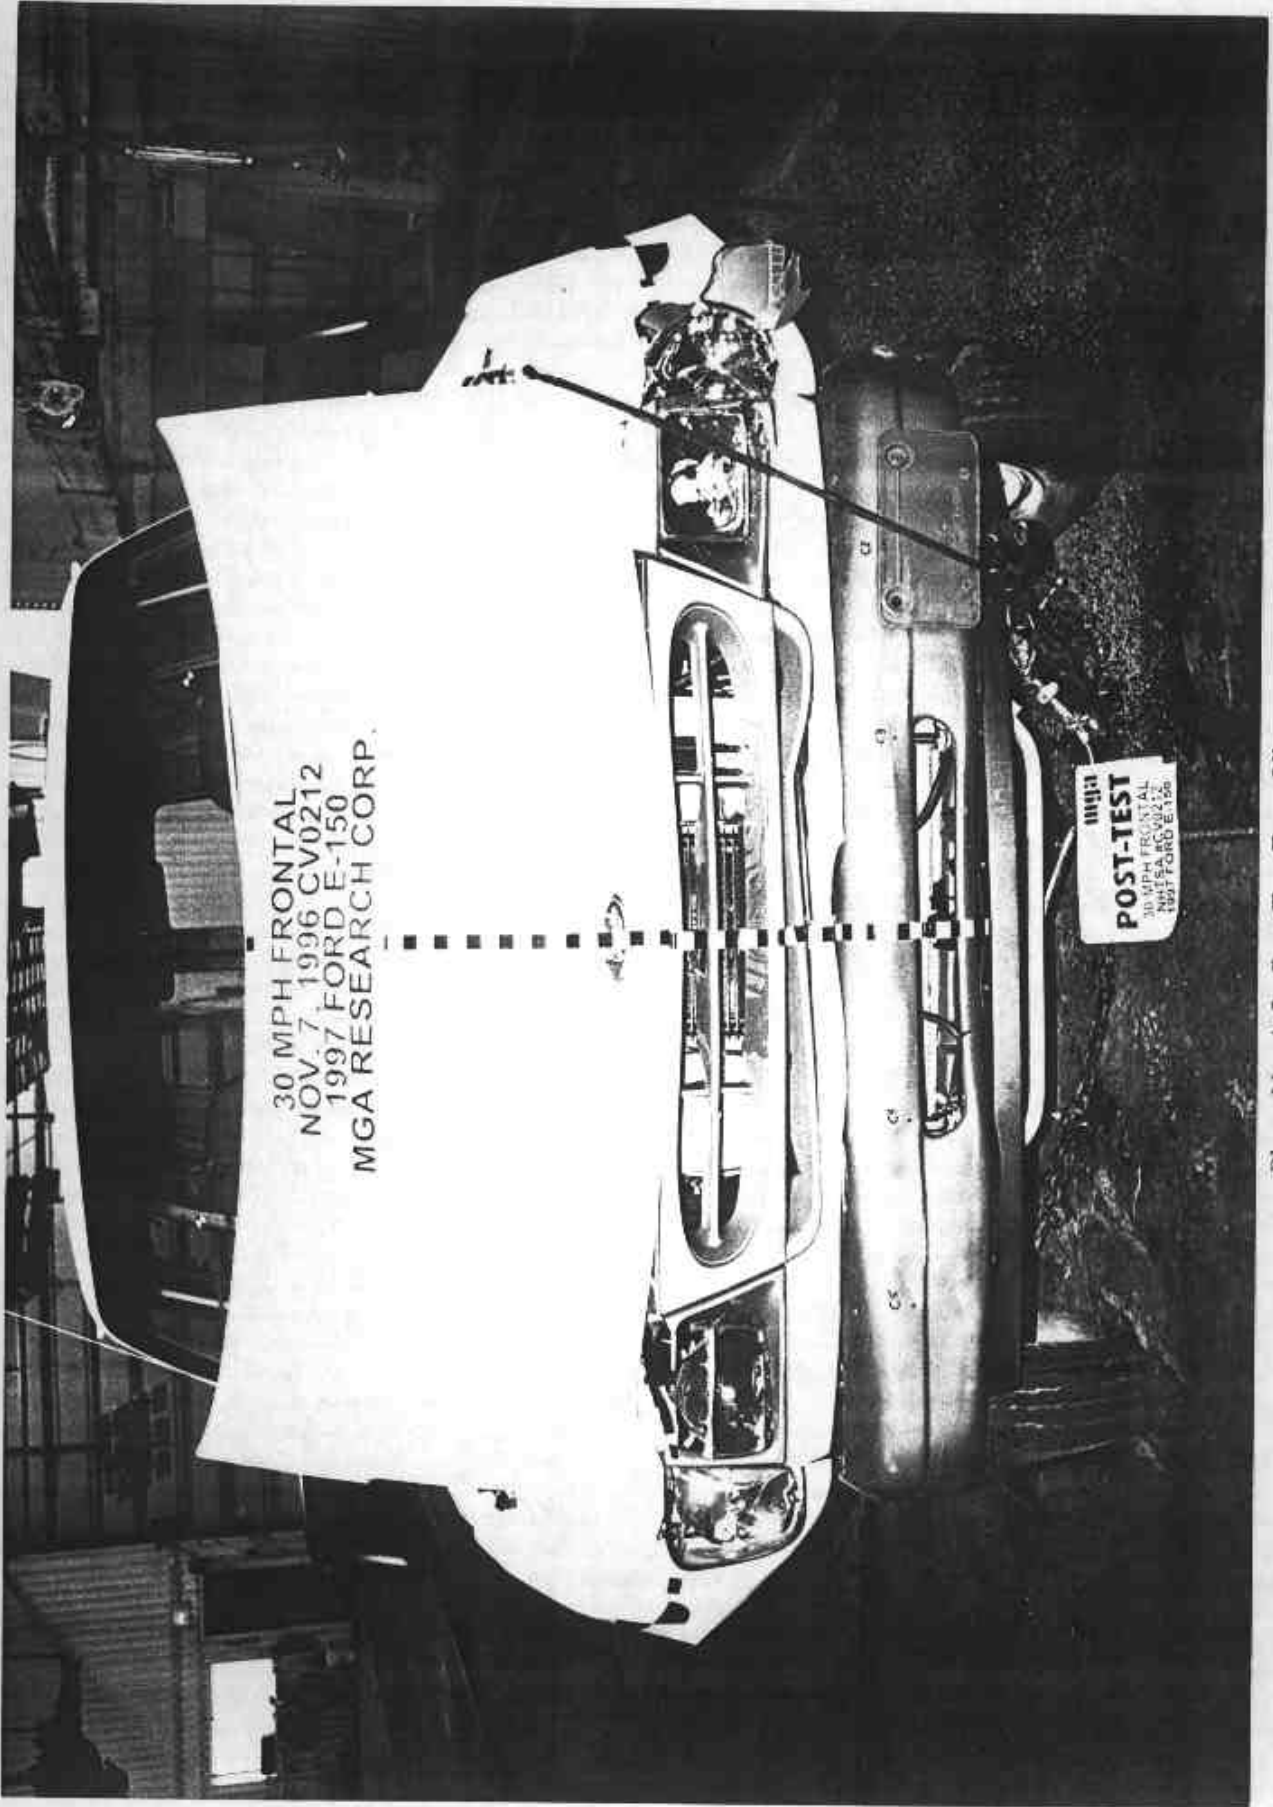
Photo No. A-2 - Post-Test Front View

The vehicle was subjected to a 30 mph frontal crash test. There is severe structural damage on the front body. Various interior and exterior portions of the vehicle have been painted and have had holes drilled to facilitate attachment of instrumentation. Various body parts have been removed. Stoddard solvent replaced the fuel in the fuel system and engine. THE VEHICLE IS FOR SALVAGE ONLY AND IS NOT TO BE REPAIRED FOR HIGHWAY USE.

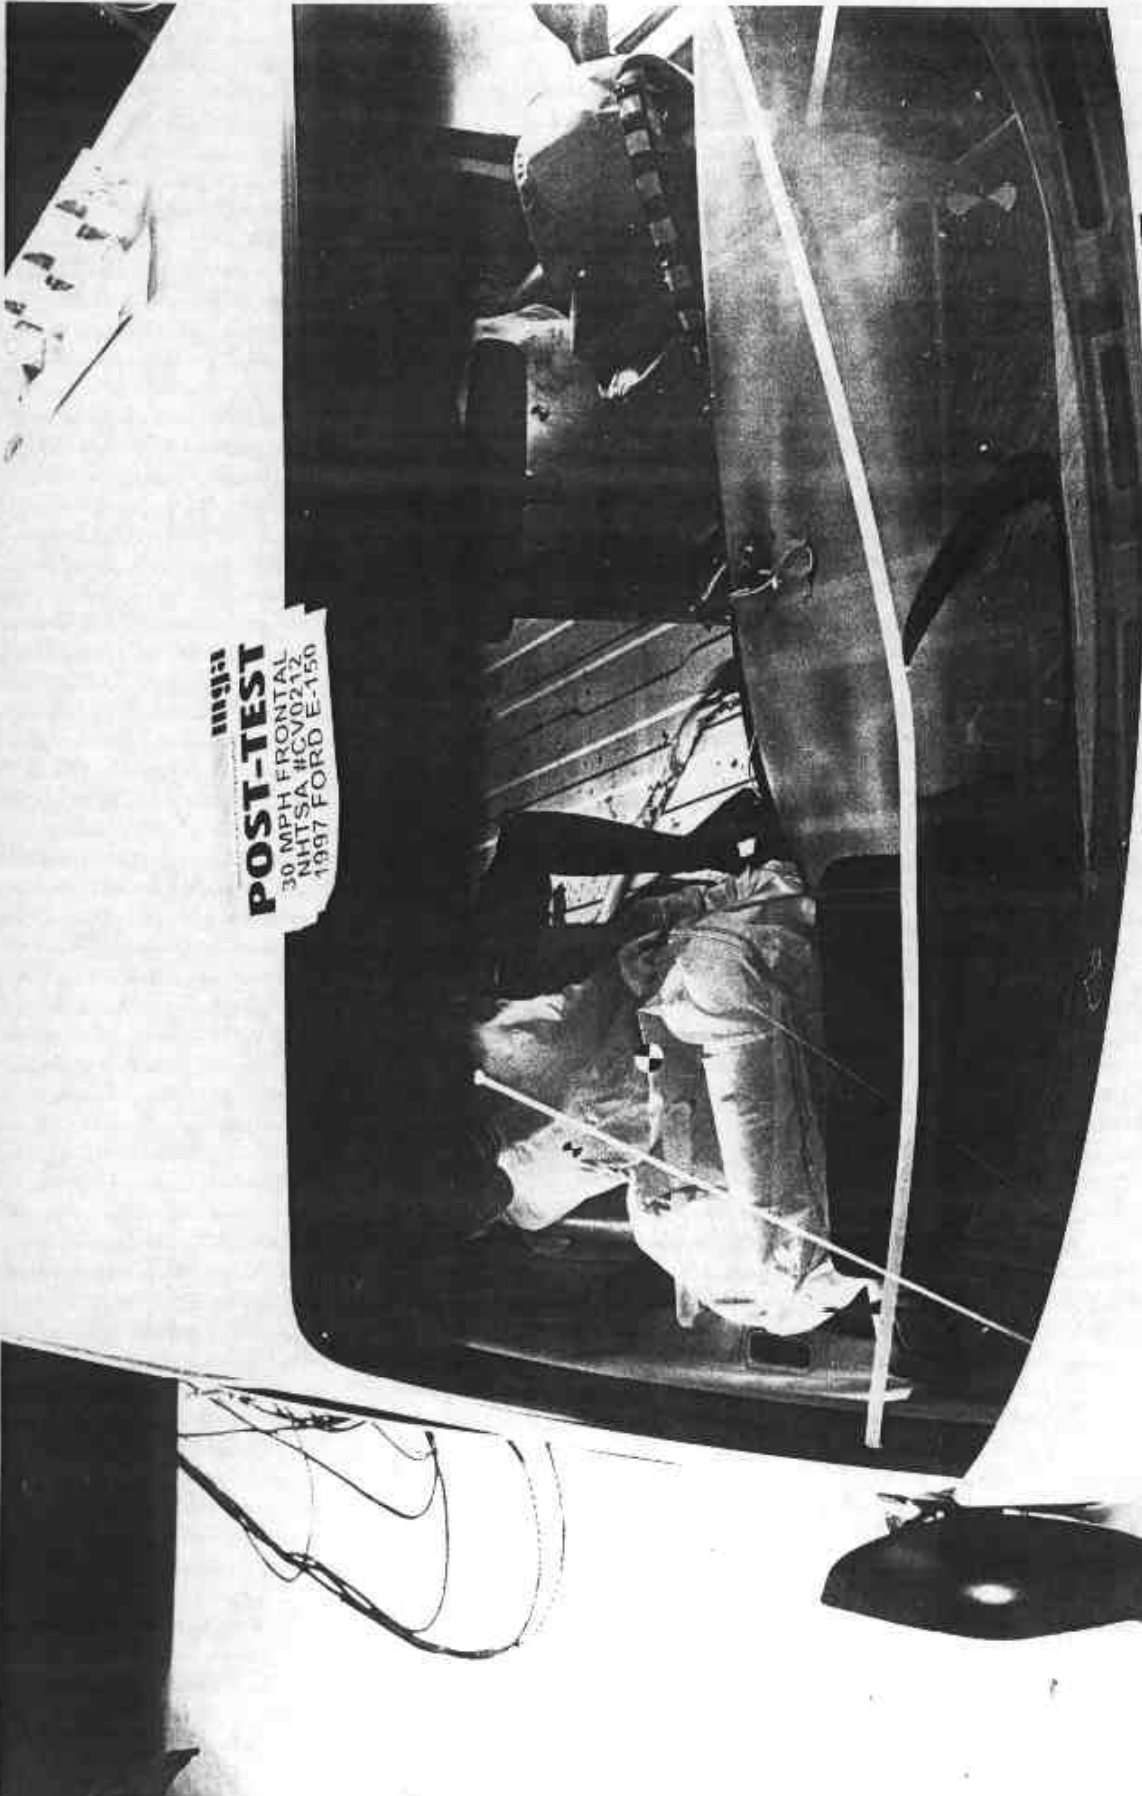
Photo No. A-37 - Post-Test Passenger Dummy Windshield View

There was no loss of windshield periphery retention and no penetration through the windshield.

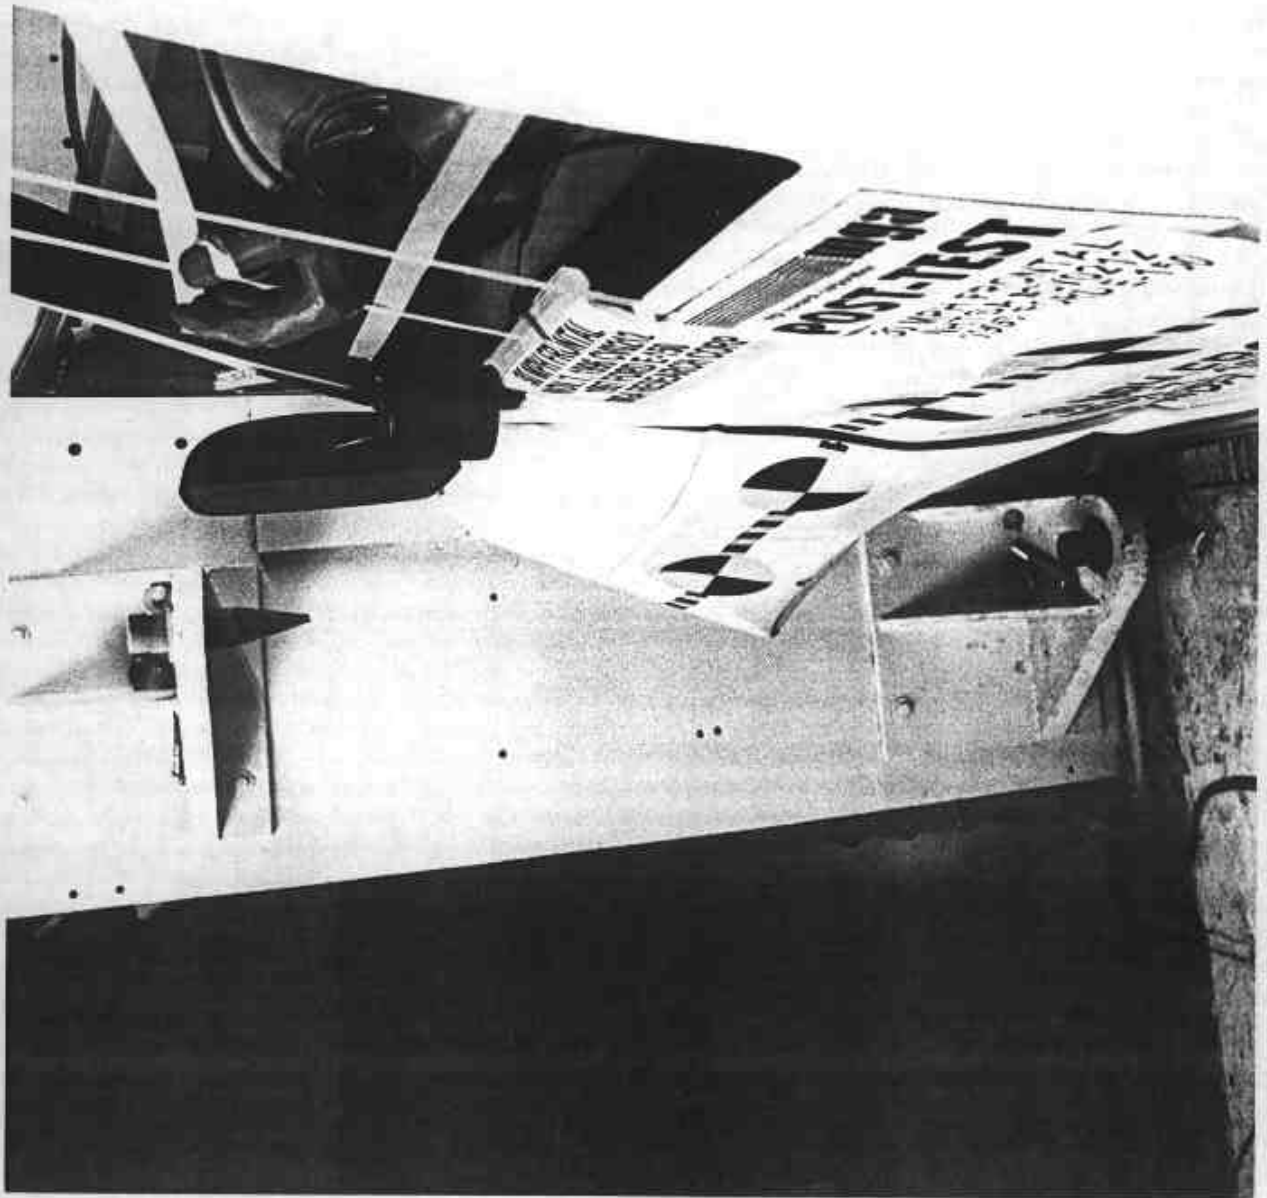
Photo No. A-51 - Post-Test Driver Dummy Arm Position View

1. The driver dummy's hand was outside the plane of the vehicle window following the impact.
