REPORT NO.: 214-MGA-97-010  
SAFETY COMPLIANCE TESTING FOR  
FMVSS 214 "SIDE IMPACT PROTECTION -  
PASSENGER CARS"

FORD MOTOR COMPANY  
1997 FORD ASPIRE 3 DOOR  
NHTSA NO: CV0207

MGA PROVING GROUNDS  
5000 WARREN ROAD  
BURLINGTON, WI 53105

FINAL REPORT

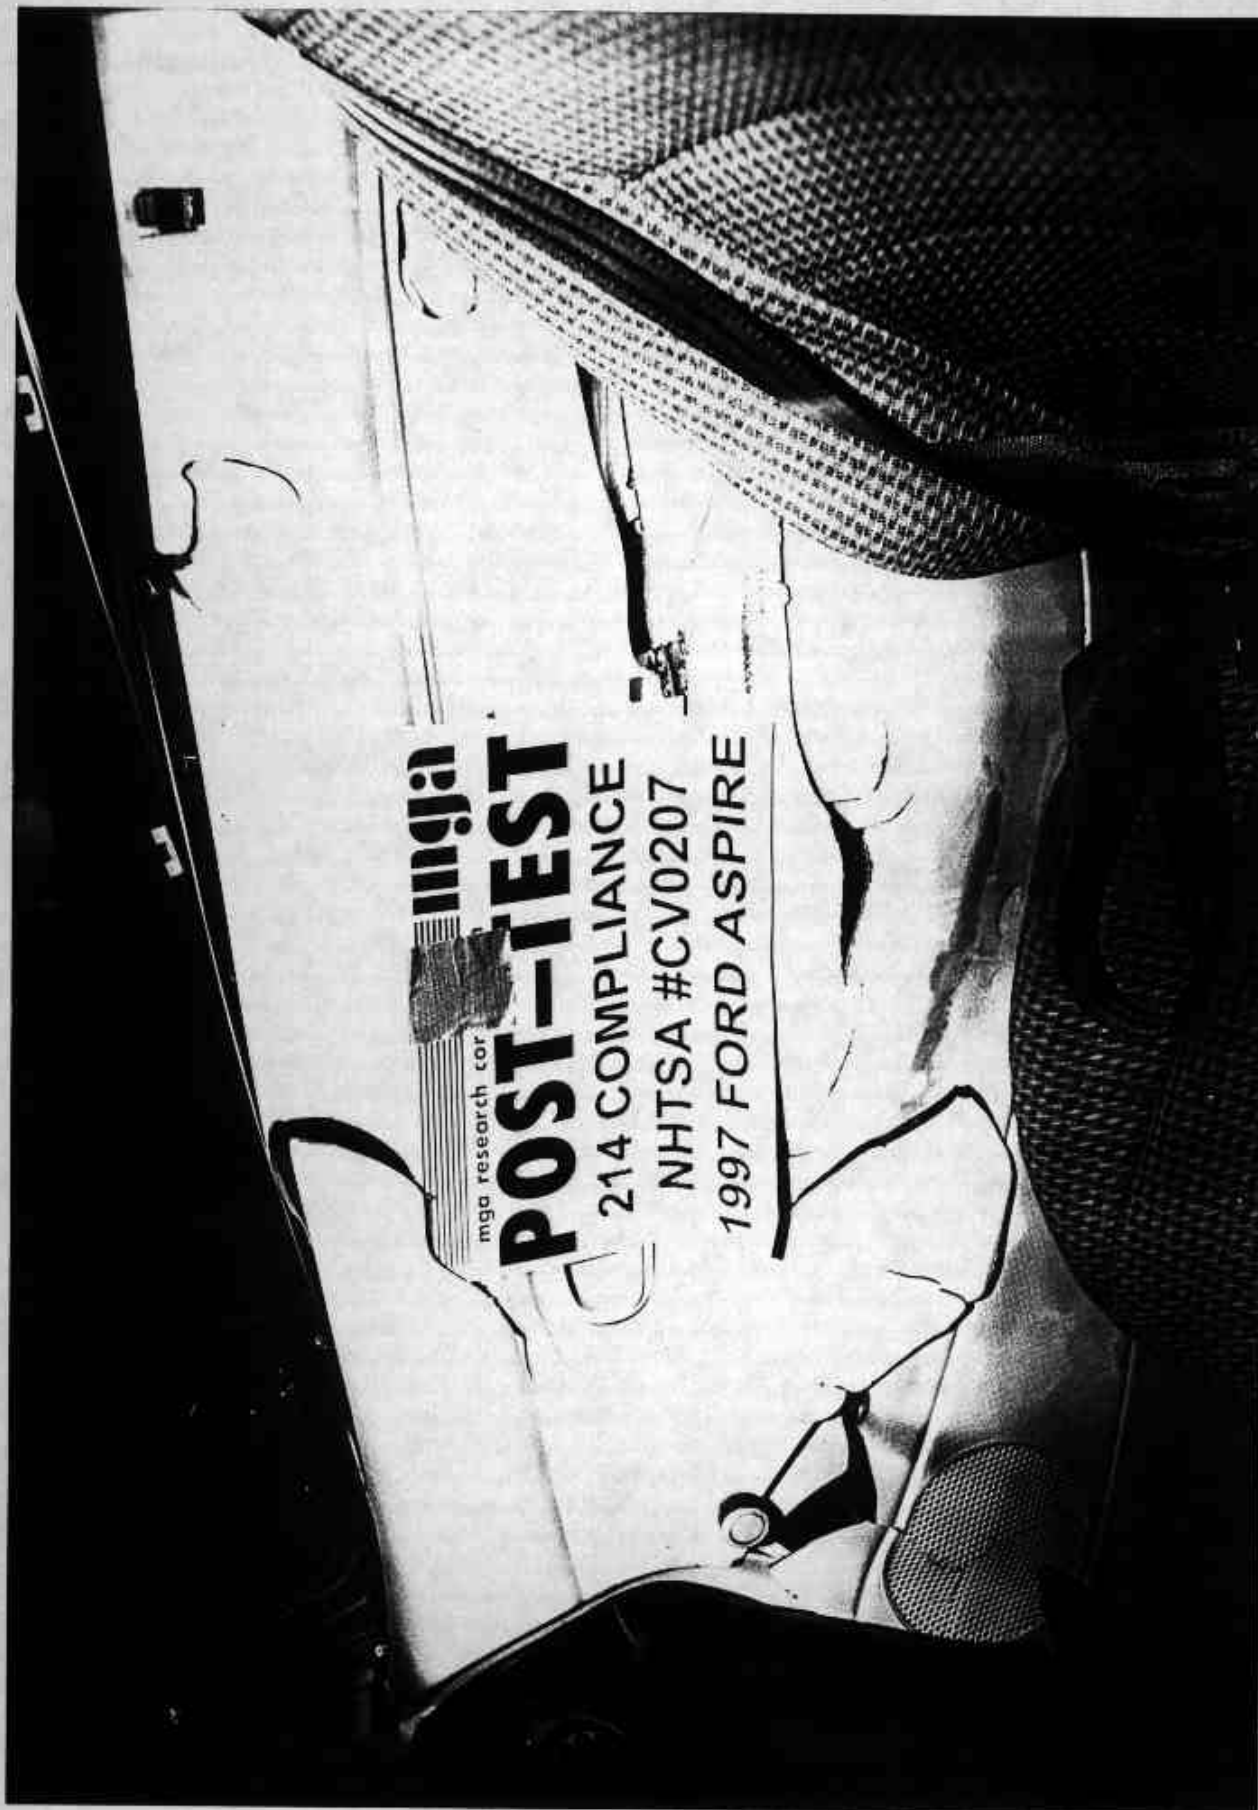
Photo No. A-29 - Post-Test Front Passenger Dummy Contact

VISIBLE DUMMY CONTACT POINTS:

| | <u>RIGHT FRONT SID</u> | <u>RIGHT REAR SID</u> |
|---|---|---|
| Head | <u>to top of window sill</u> | <u>to C Post, window &amp; front head to hatch frame opening</u> |
| Arm | <u>to door &amp; armrest</u> | <u>to side panel</u> |
| Pelvis | <u>to door panel</u> | <u>to side panel</u> |

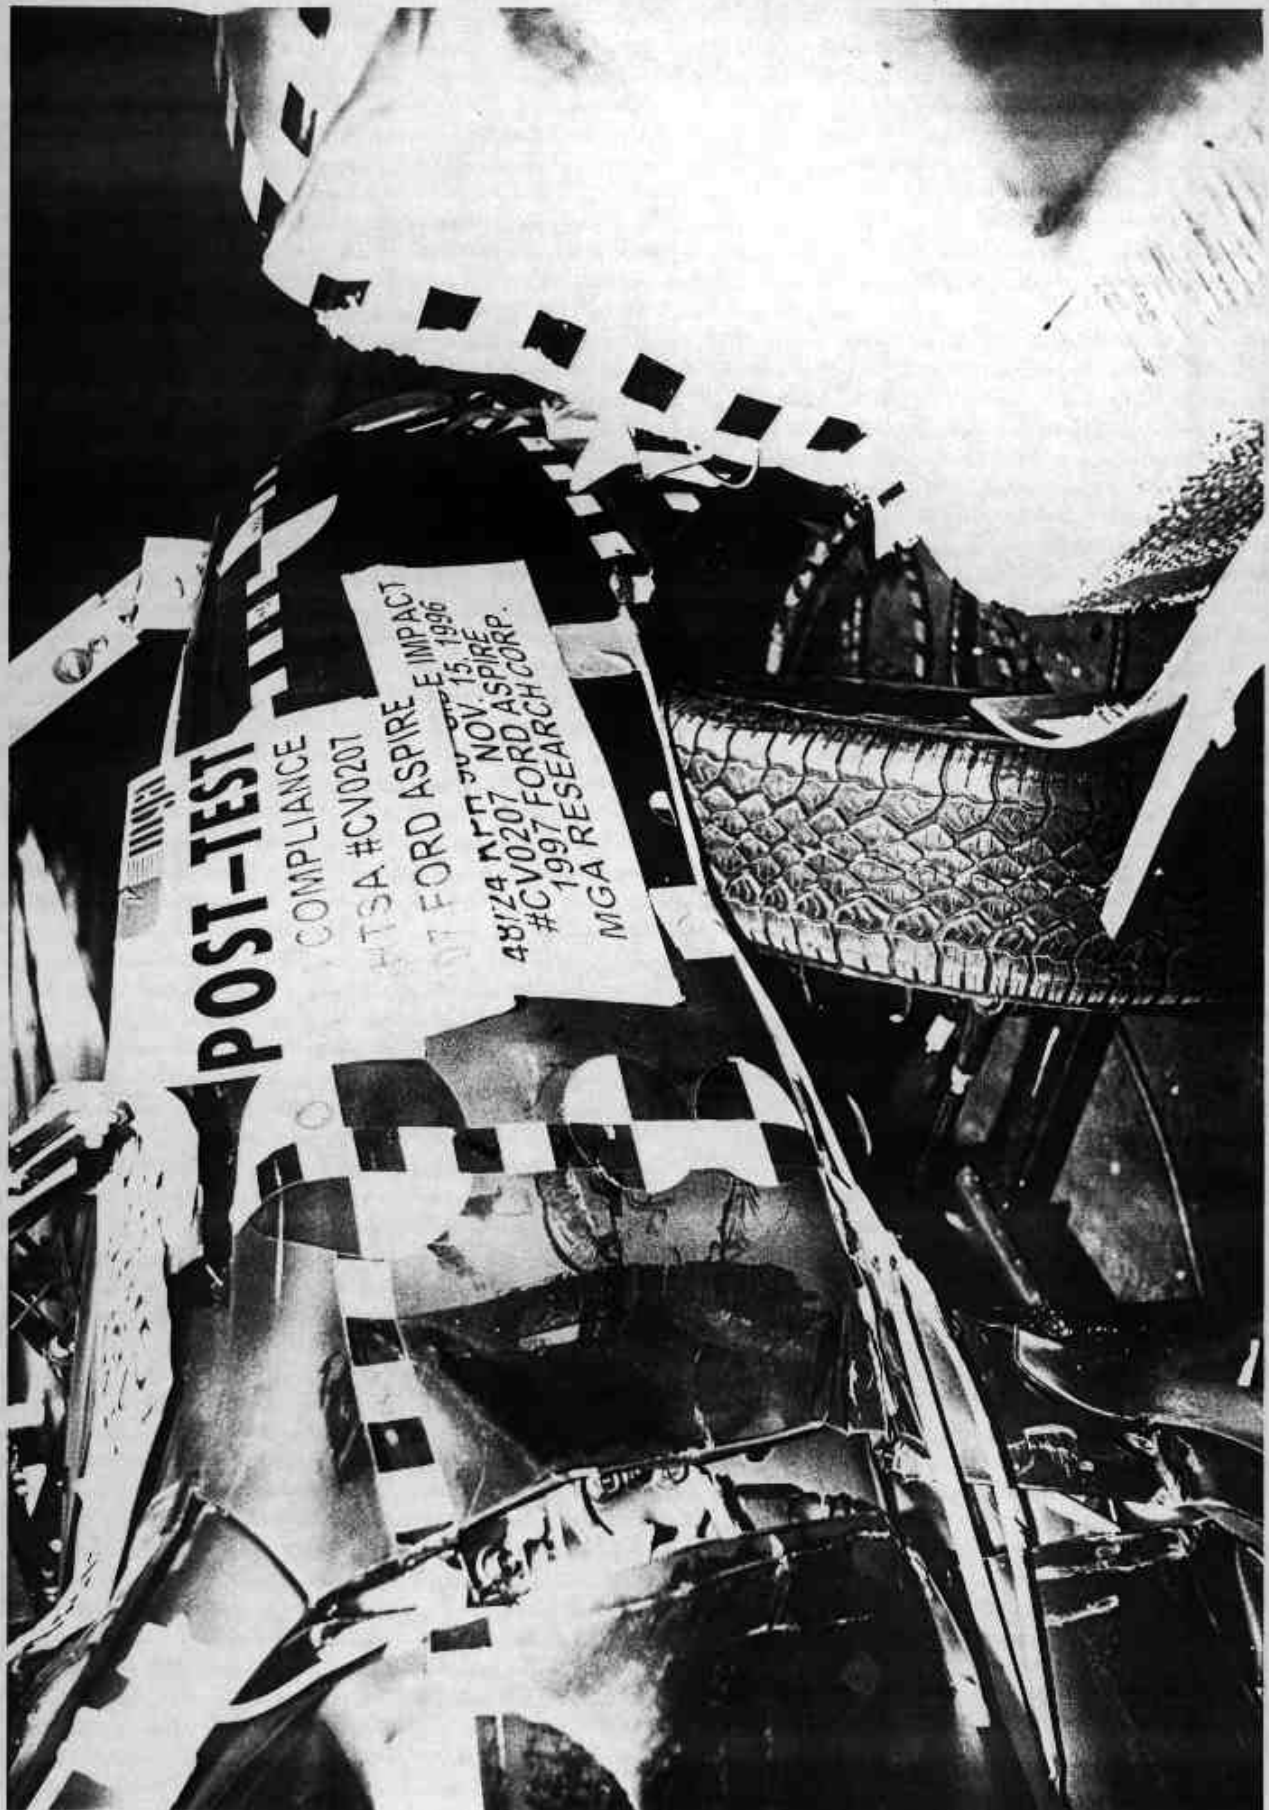
Photo No. A-40 - Post-Test Right Front Impact Point on Vehicle

MDB DISTANCE FROM TARGET IMPACT POINT:

Horizontal: 5 mm rearward      Vertical: 13 mm high
