NEW CAR ASSESSMENT PROGRAM  
SIDE IMPACT TESTING  
PASSENGER CARS

1997 SUBARU LEGACY AWD  
4-DOOR SEDAN

NHTSA NO: MV5500

FINAL REPORT

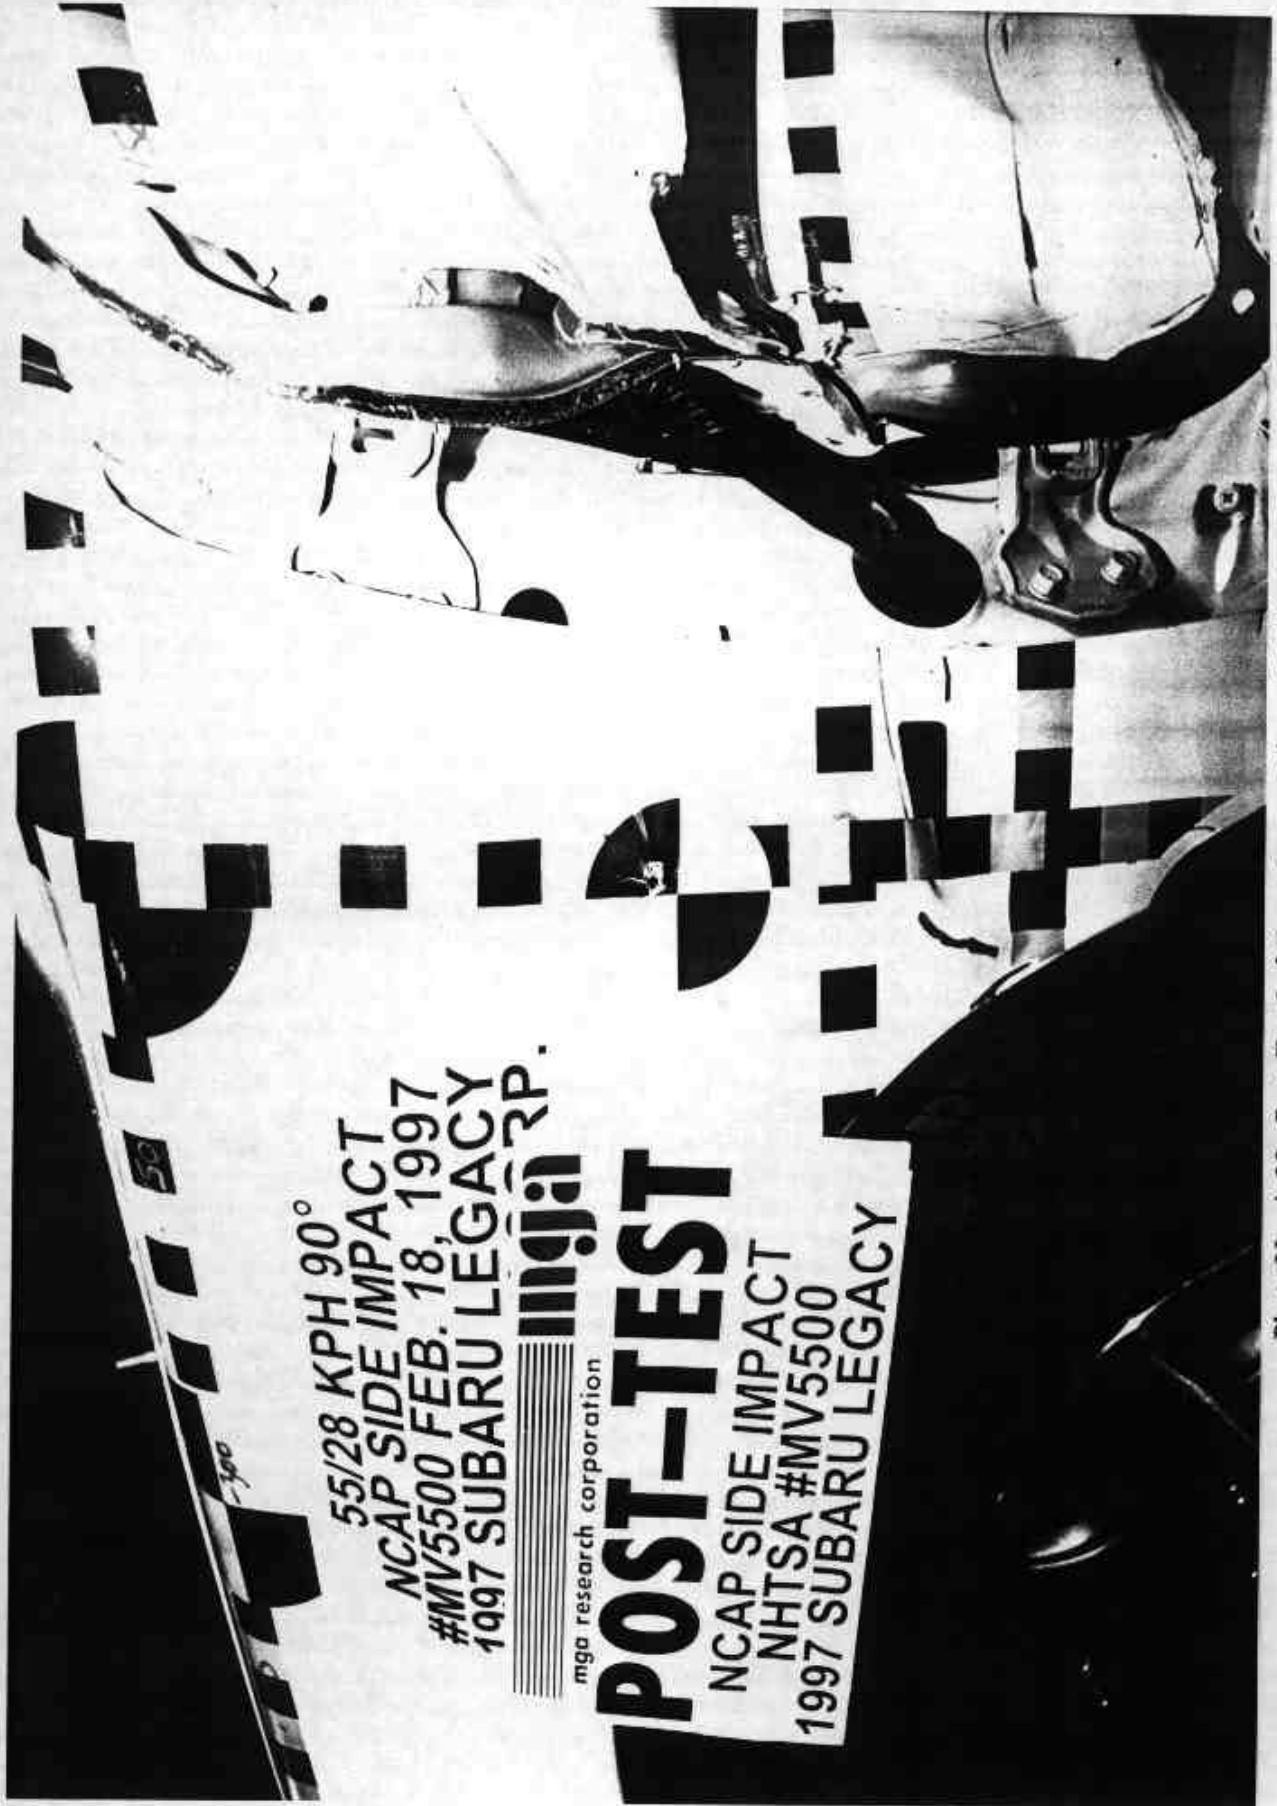
Photo No. A-39 - Post-Test Left Front Impact Point on Vehicle

Horizontal: 7 mm rearward      Vertical: 8 mm high
