NEW CAR ASSESSMENT PROGRAM
SIDE IMPACT TESTING
PASSENGER CARS

1997 MAZDA 626
4-DOOR SEDAN
NHTSA NO: MV5400

FINAL REPORT

1. Report No. 214D-MGA-97-14		2. Government Accession No.		3. Recipient's Catalog No.																									
4. Title and Subtitle New Car Assessment Program Side Impact Test of a 1997 Mazda 626 4-Door Sedan NHTSA No. MV5400			5. Report Date February 25, 1997																										
			6. Performing Organization Code MGA																										
7. Author(s) Gary Strassburg, Project Engineer			8. Performing Organization Report No. MGA-DOT-214-0																										
9. Performing Organization Name and Address MGA Research Corporation 5000 Warren Road Burlington, WI 53105			10. Work Unit No.																										
			11. Contract or Grant No. DTNH22-93-C-02047																										
12. Sponsoring Agency Name and Address U.S. Department of Transportation National Highway Traffic Safety Administration Office of Crashworthiness Standards 400 Seventh St., S.W. Washington, D.C. 20590			13. Type of Report and Period Covered Final Test Report January 30, 1997 to February 25, 1997																										
			14. Sponsoring Agency Code NPS-10

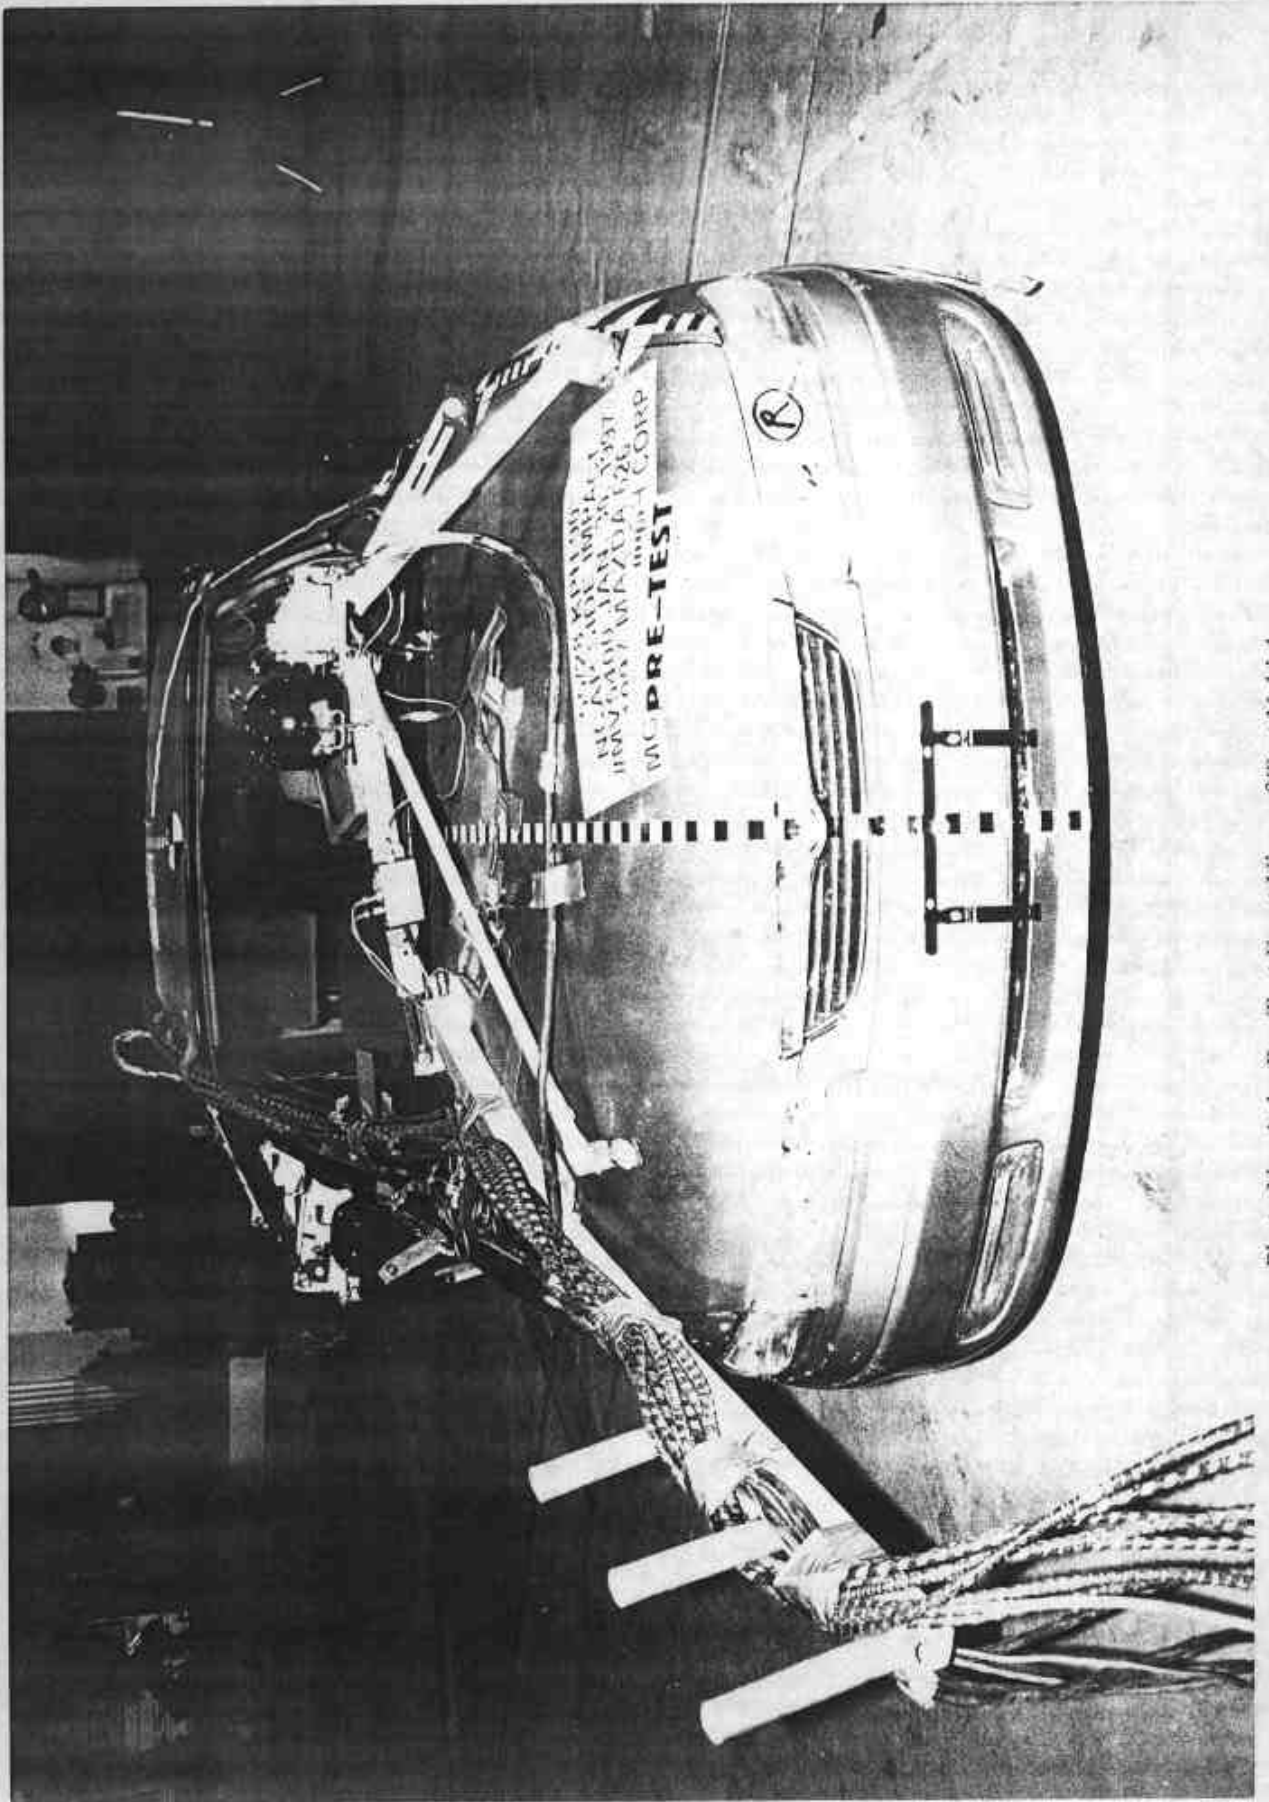
Photo No. A-1 - Pre-Test Front View of Test Vehicle

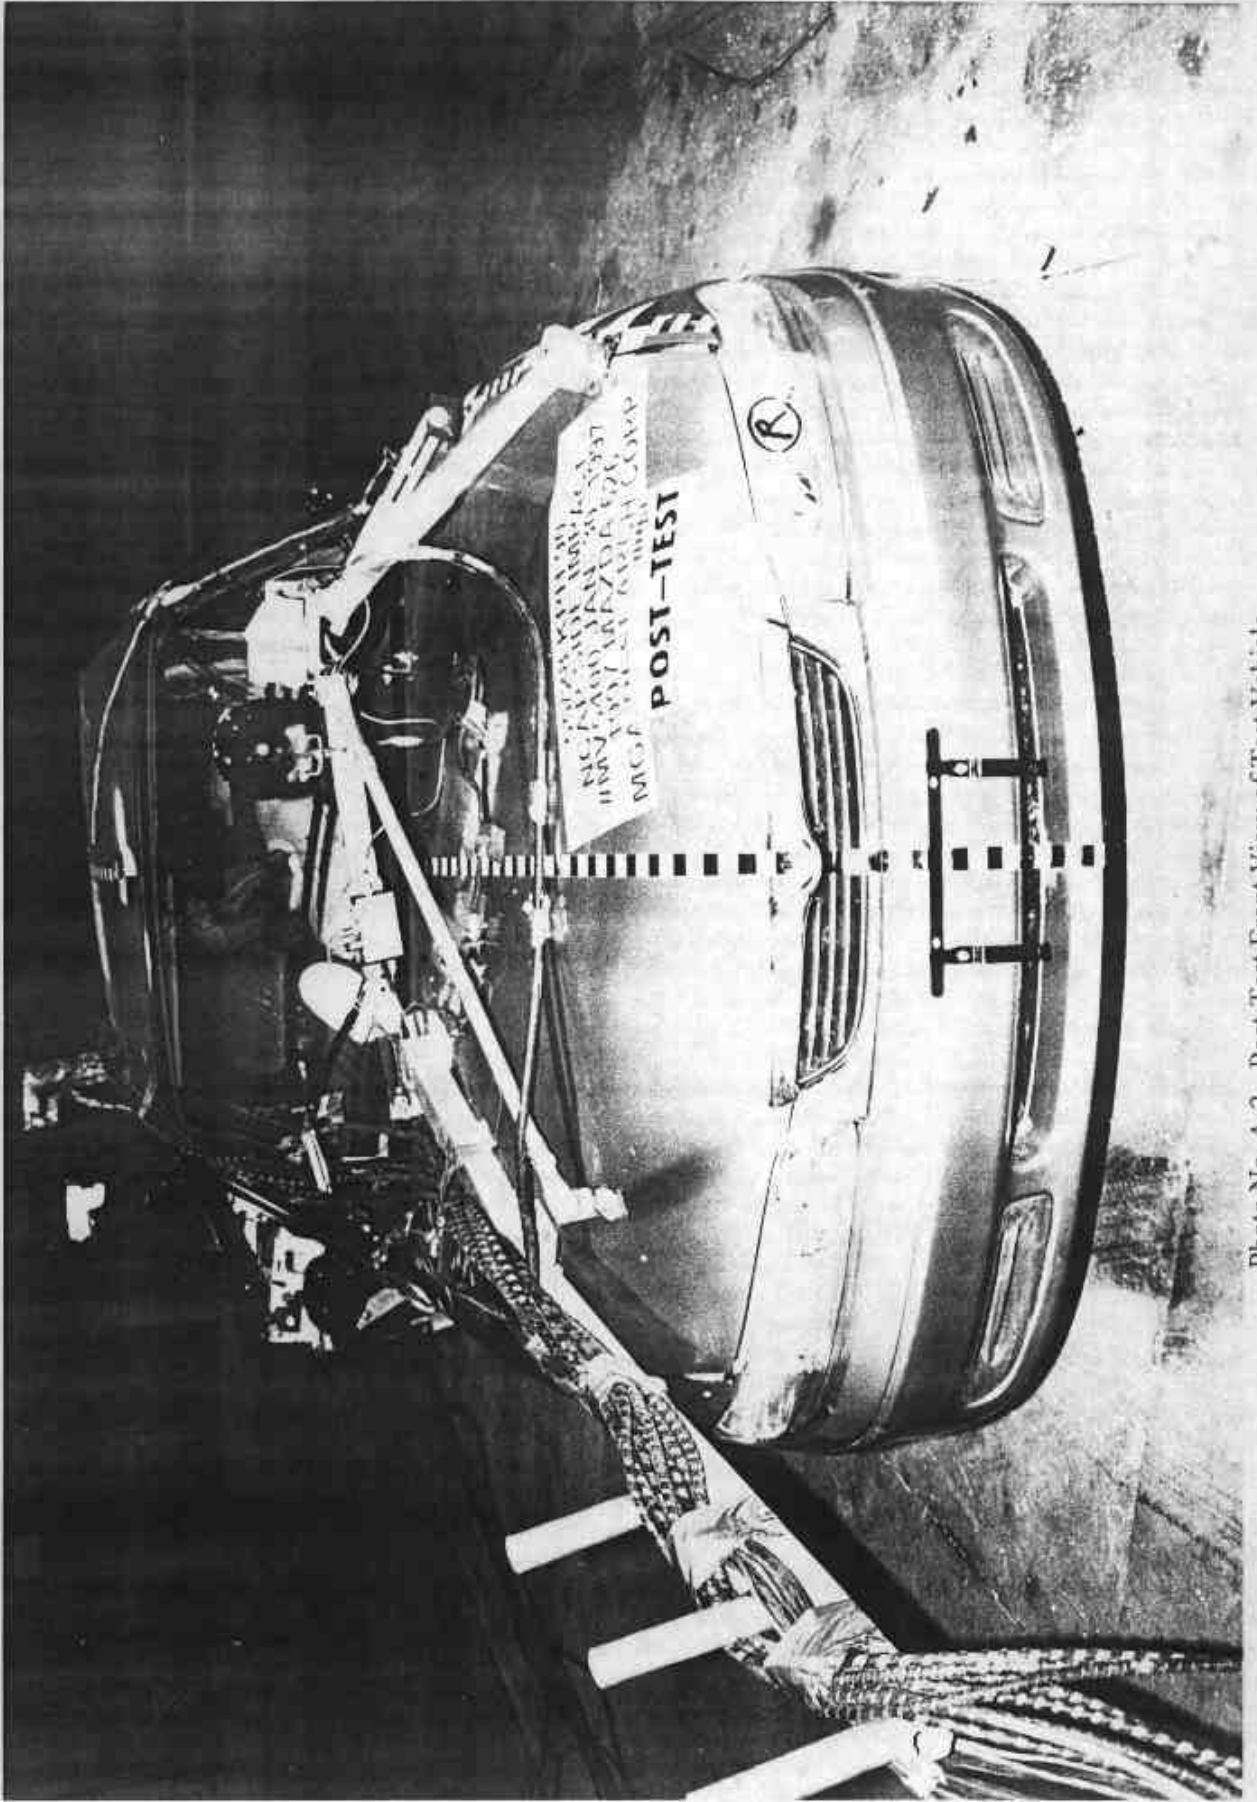
Photo No. A-2 - Post-Test Front View of Test Vehicle

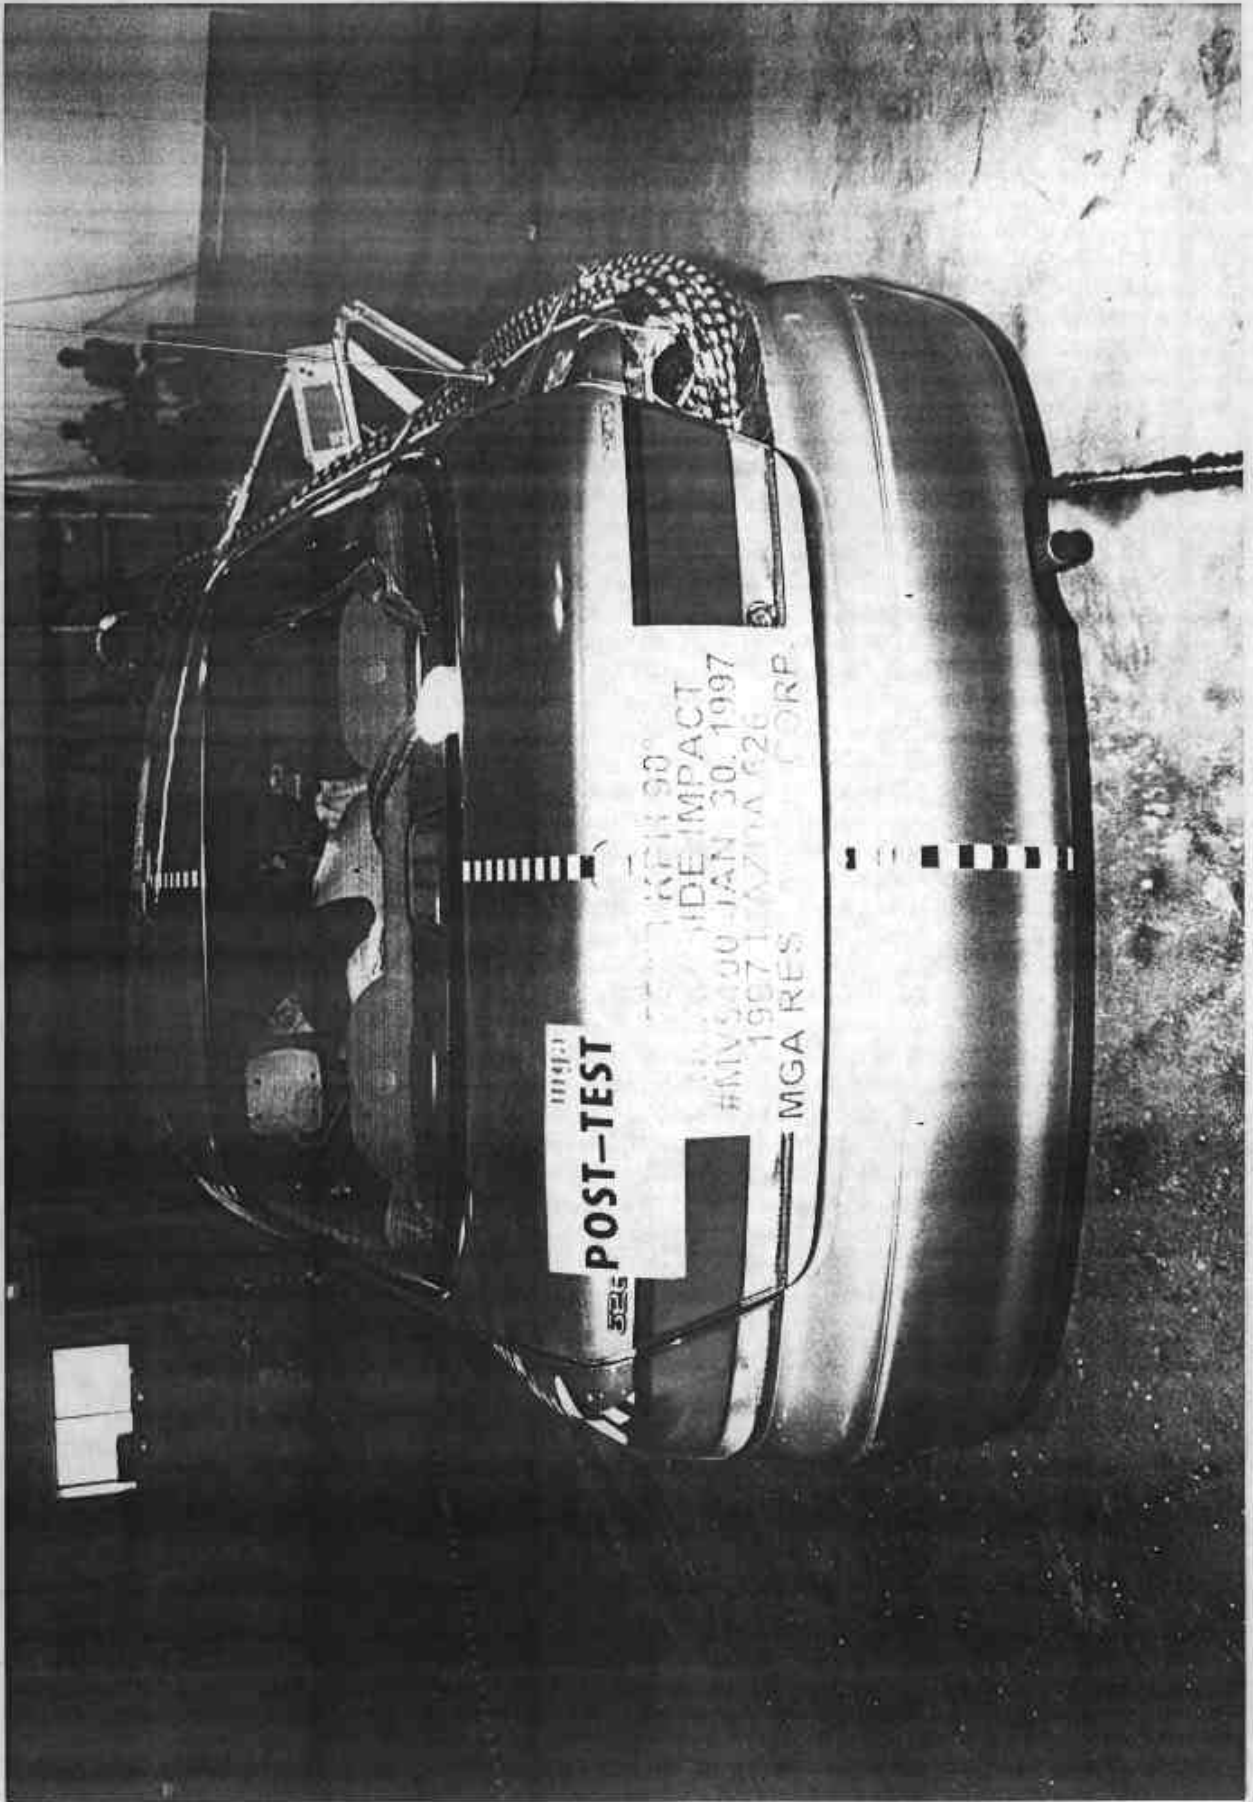
Photo No. A-4 - Post-Test Rear View of Test Vehicle

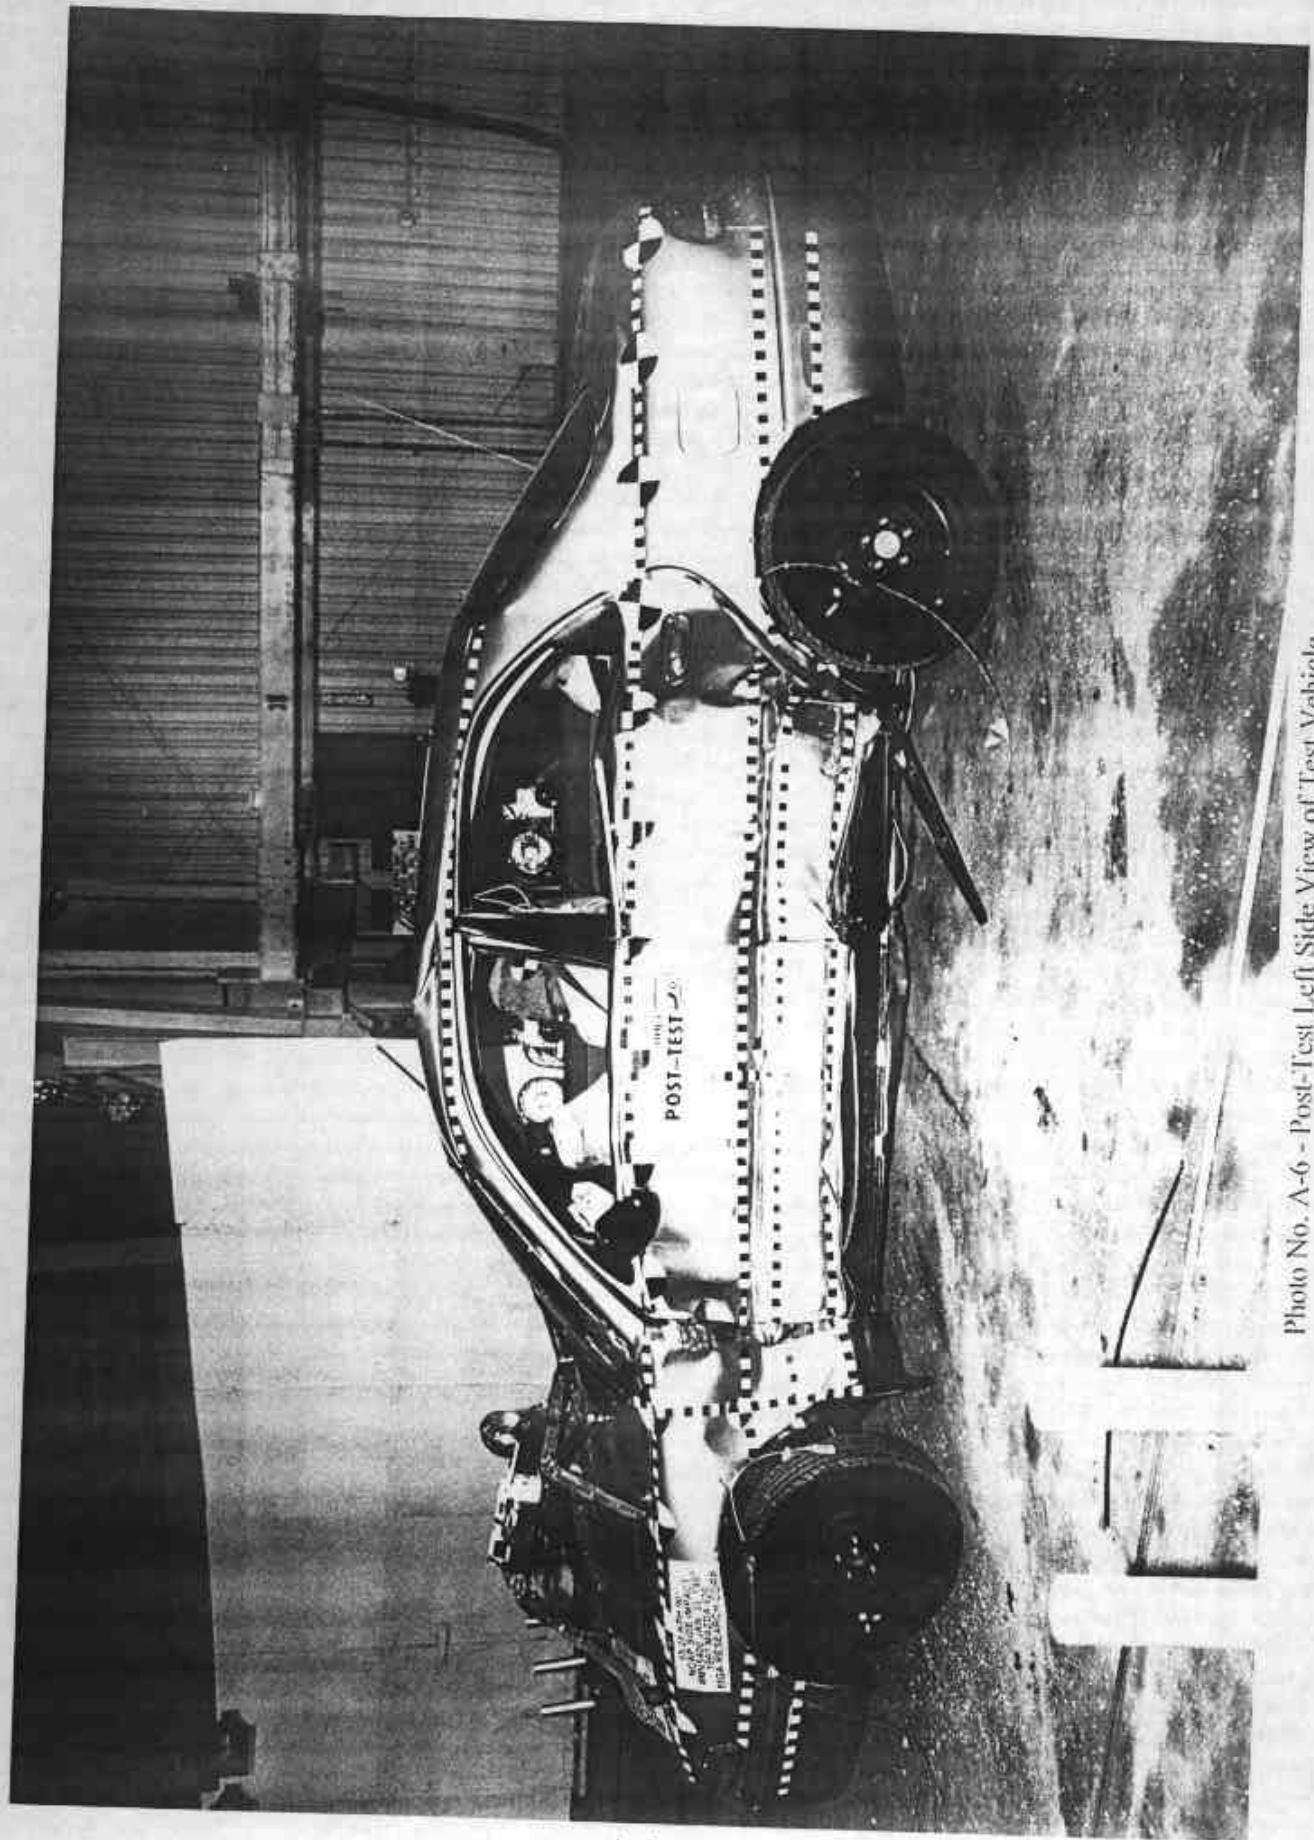
Photo No. A-6 - Post-Test Left Side View of Test Vehicle

MAXIMUM EXTERIOR STATIC CRUSH:

1. LEVEL 1 (294 mm above ground) = 356 mm

2. LEVEL 2 (457 mm above ground) = 465 mm

3. LEVEL 3 (594 mm above ground) = 390 mm

4. LEVEL 4 (885 mm above ground) = 315 mm

5. LEVEL 5 (1312 mm above ground) = 128 mm

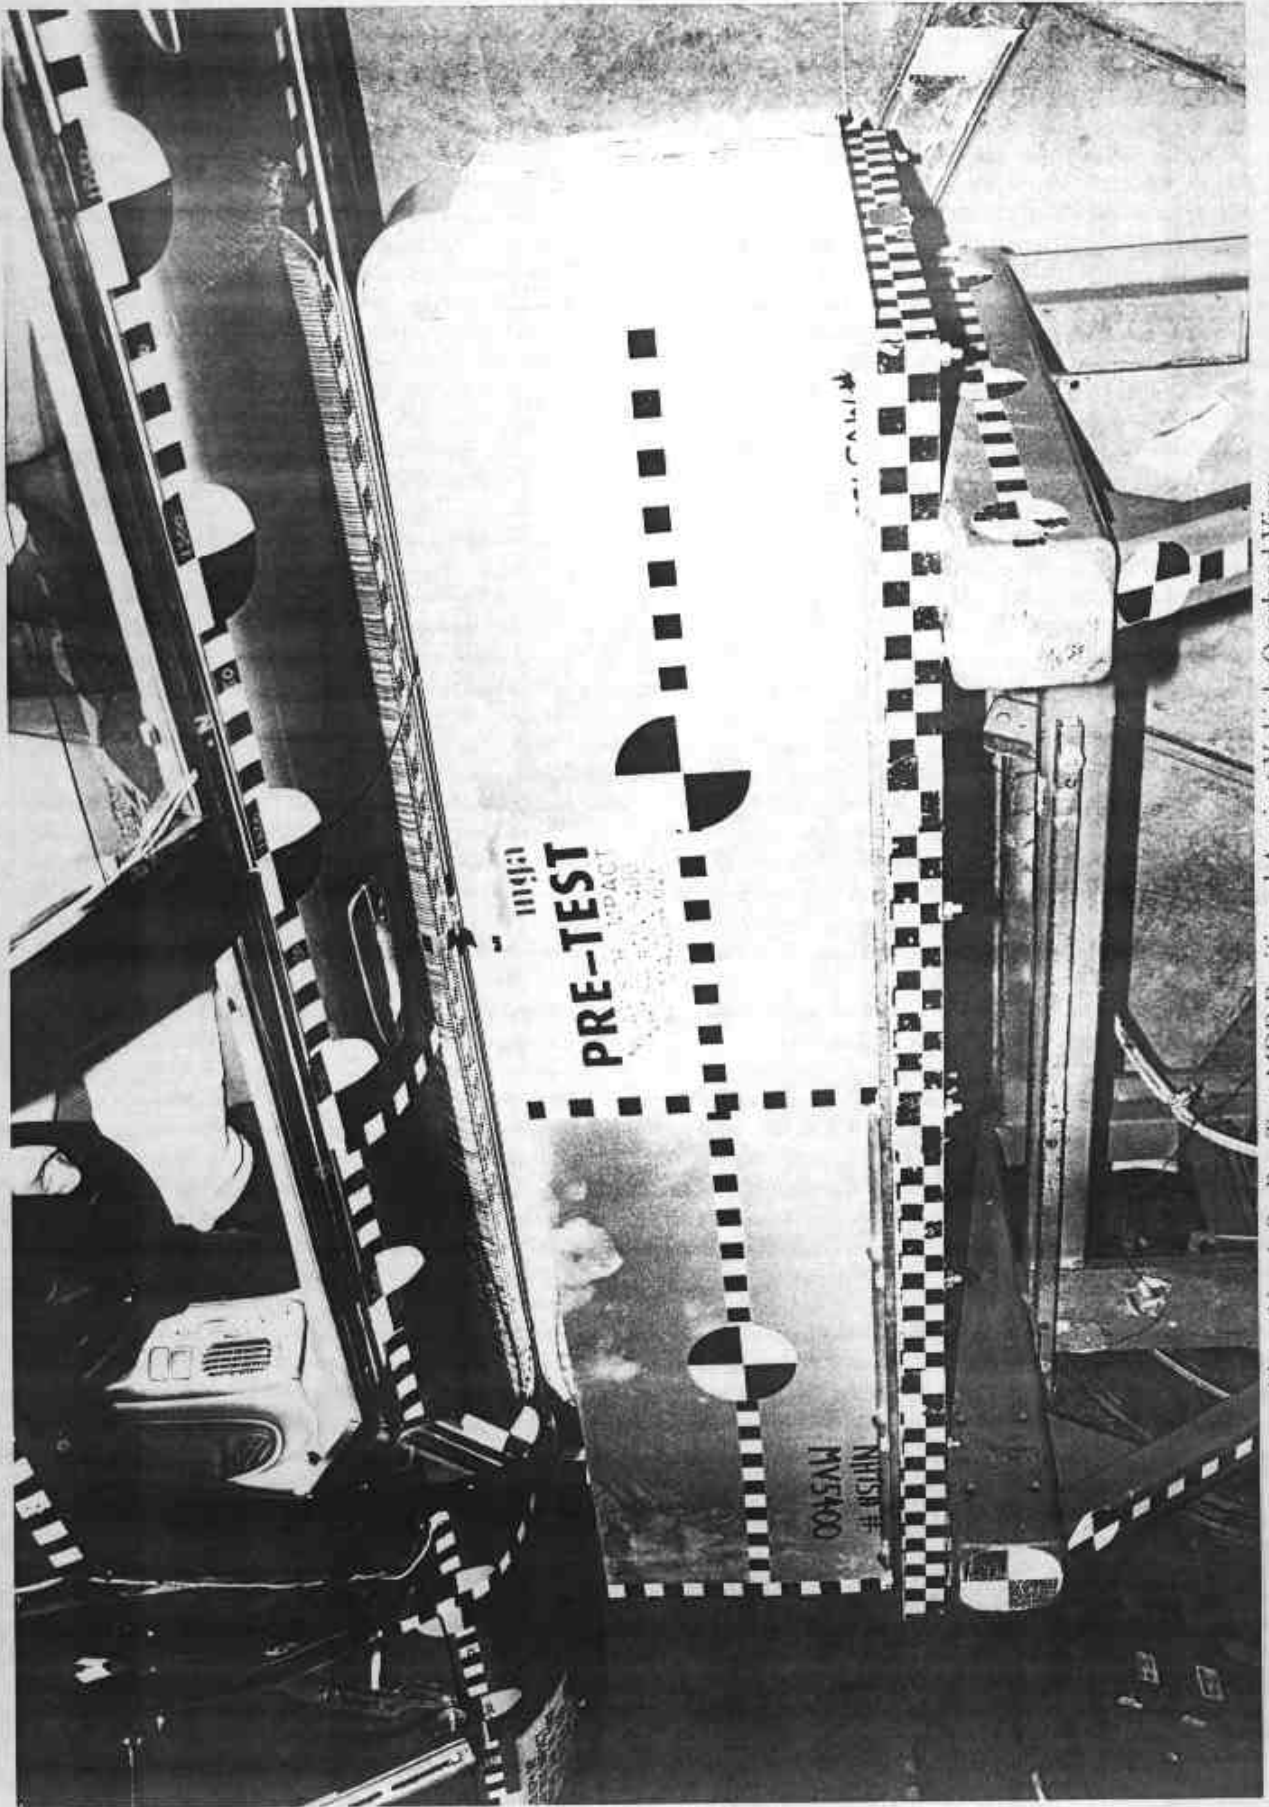
Photo No. A-9 - Pre-Test MDB Positioned Against Vehicle Overhead View

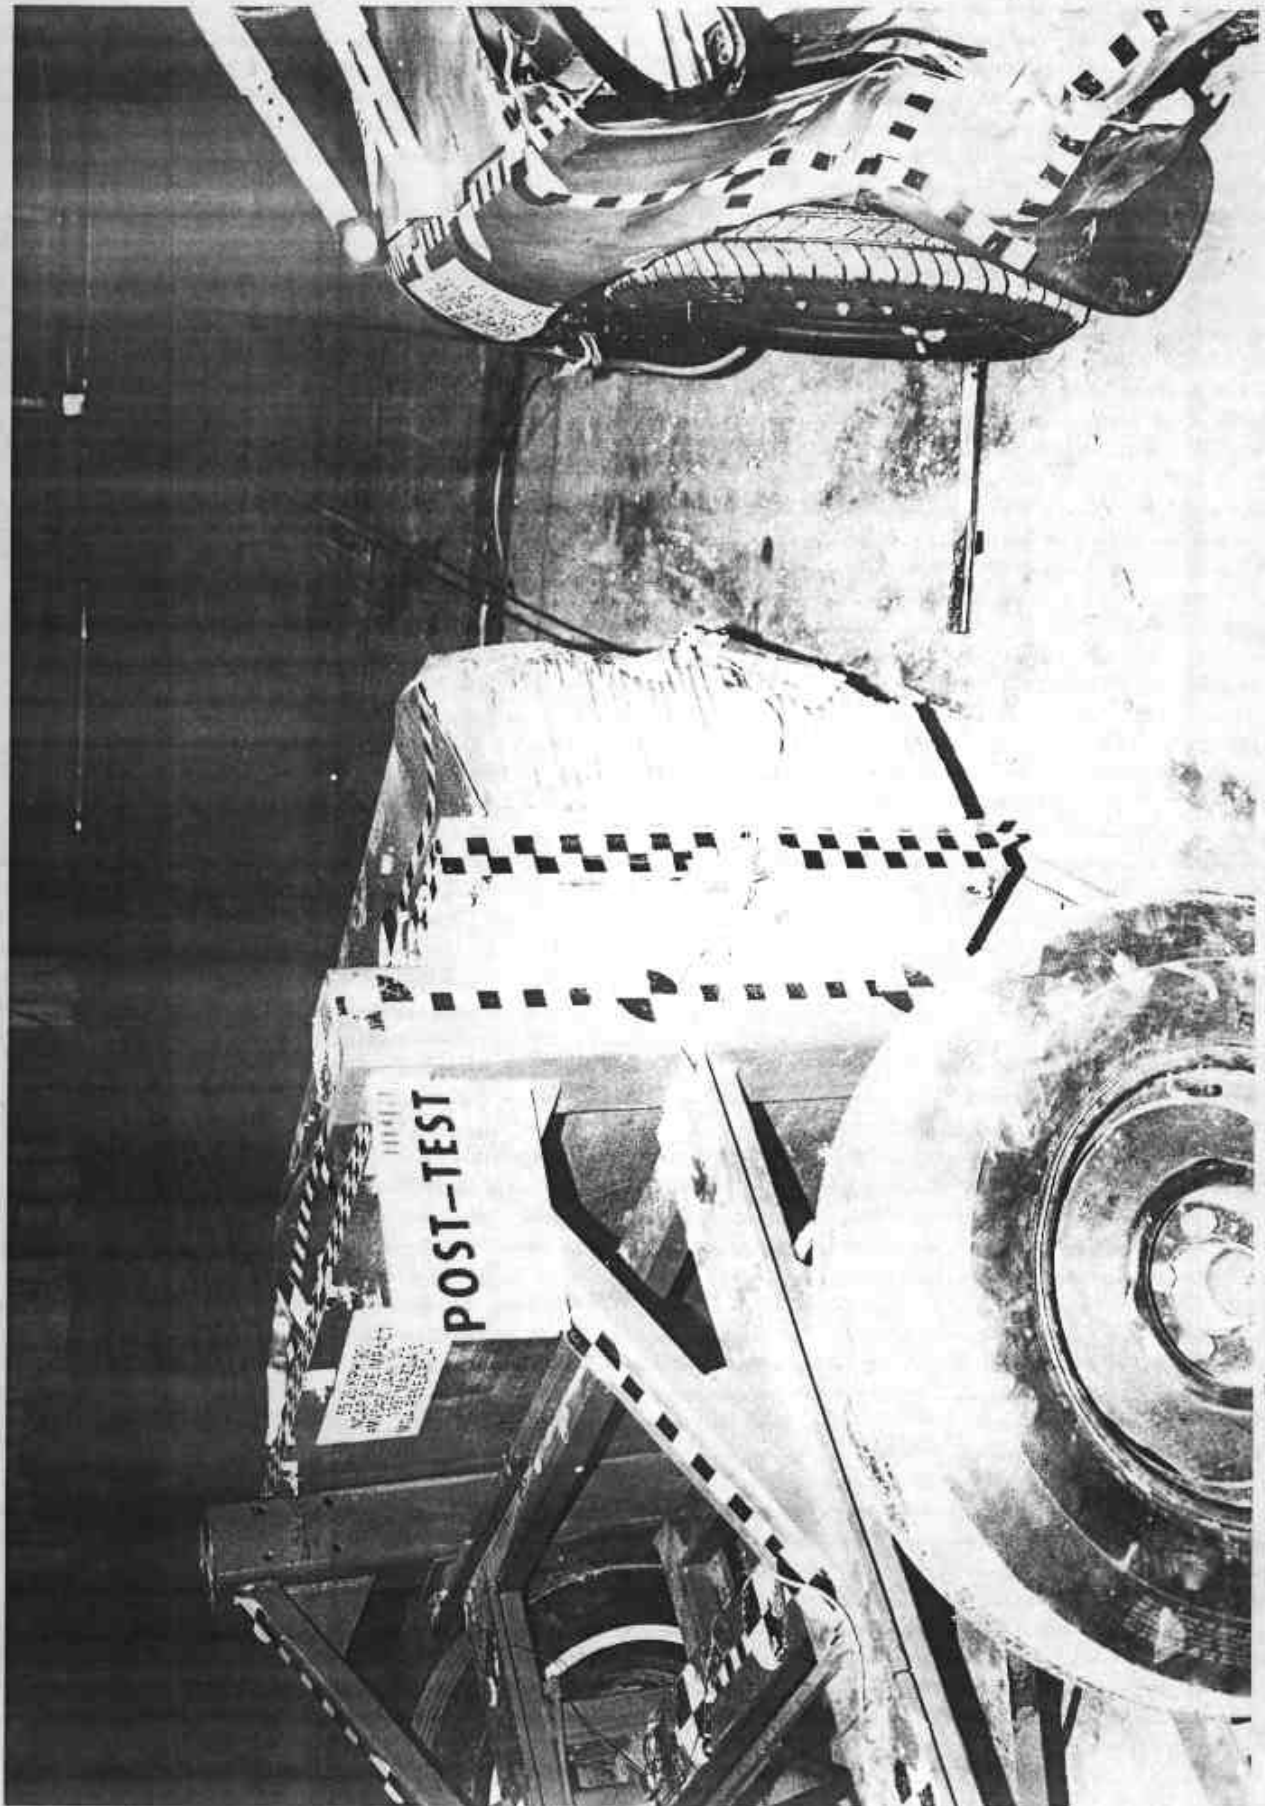
Photo No. A-10 - Post-Test MDB Positioned Against Vehicle (right side)

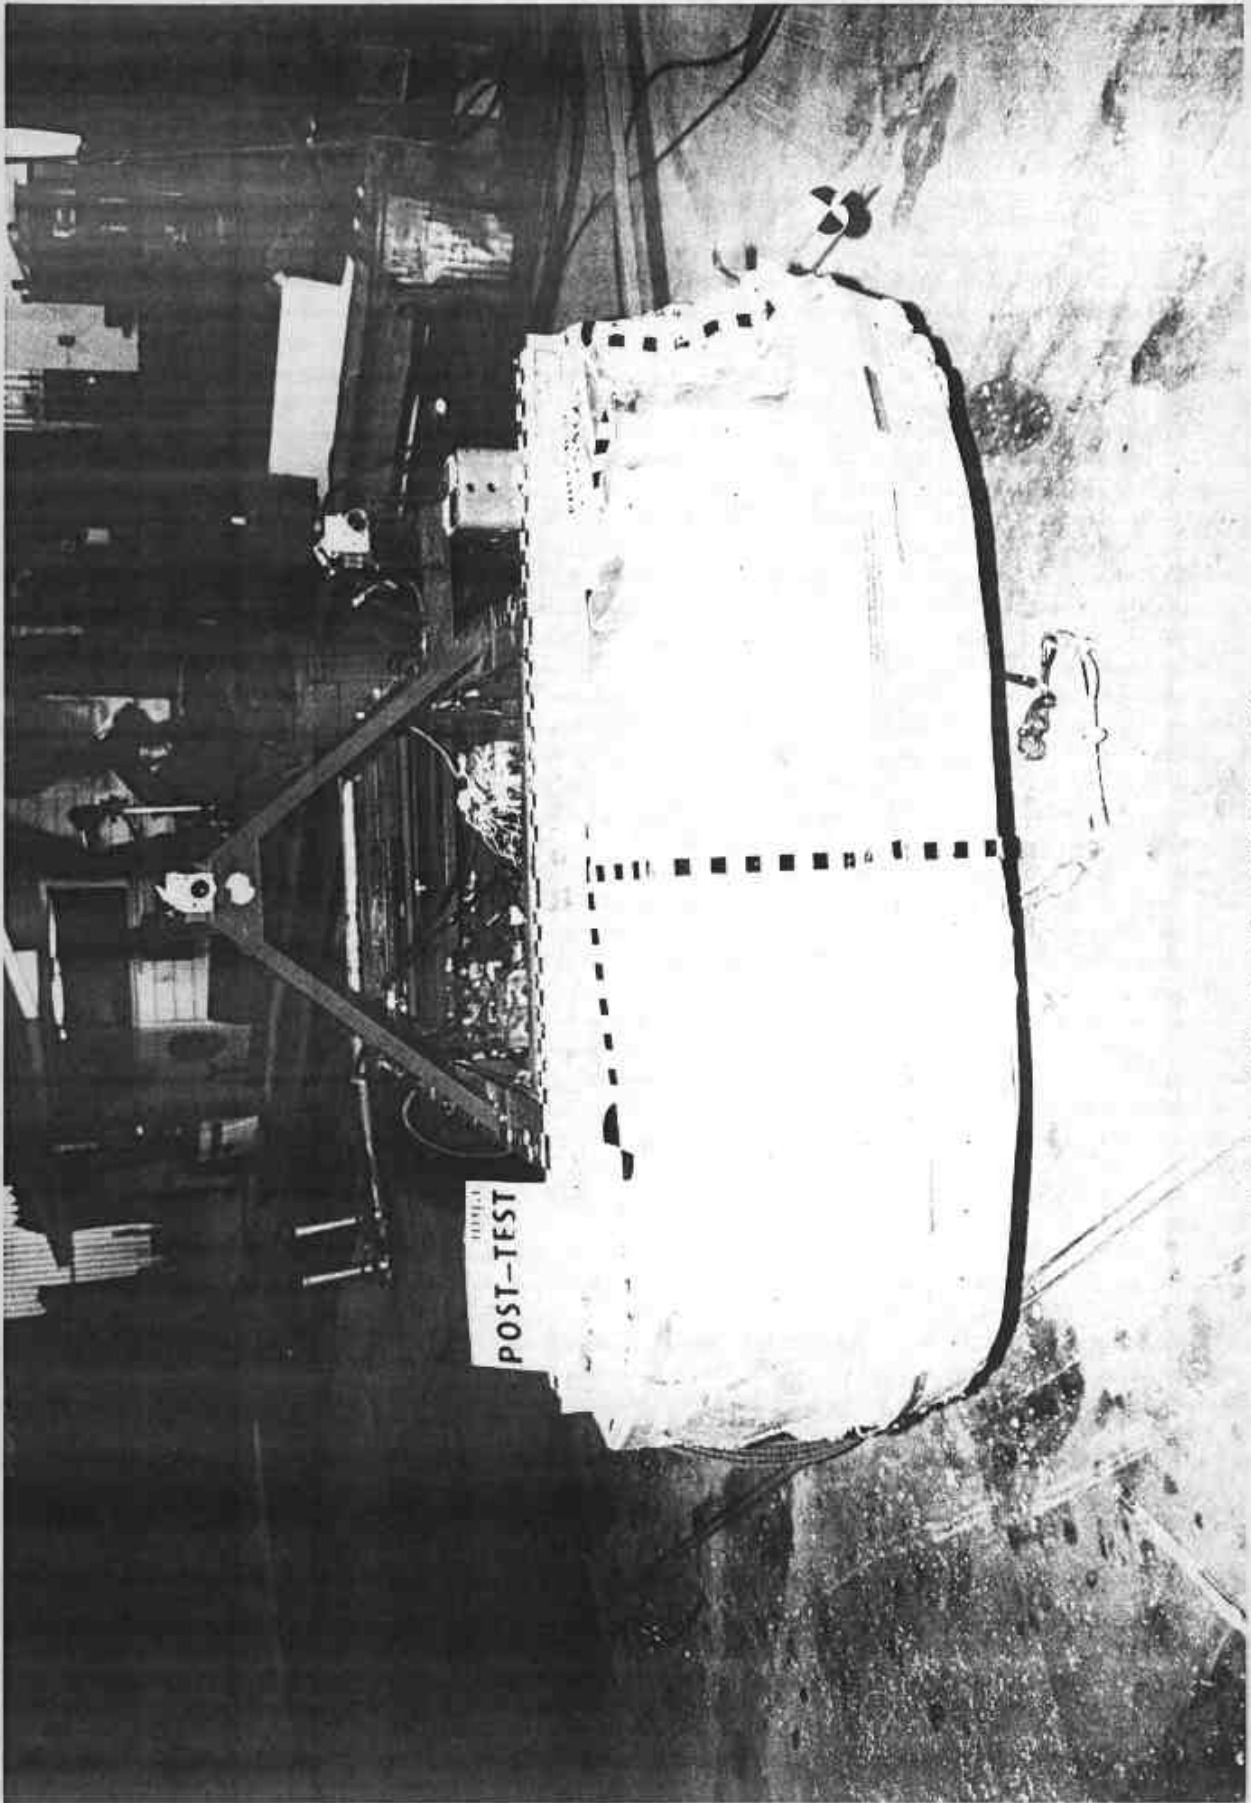
Photo No. A-14 - Post-Test MDB Front View

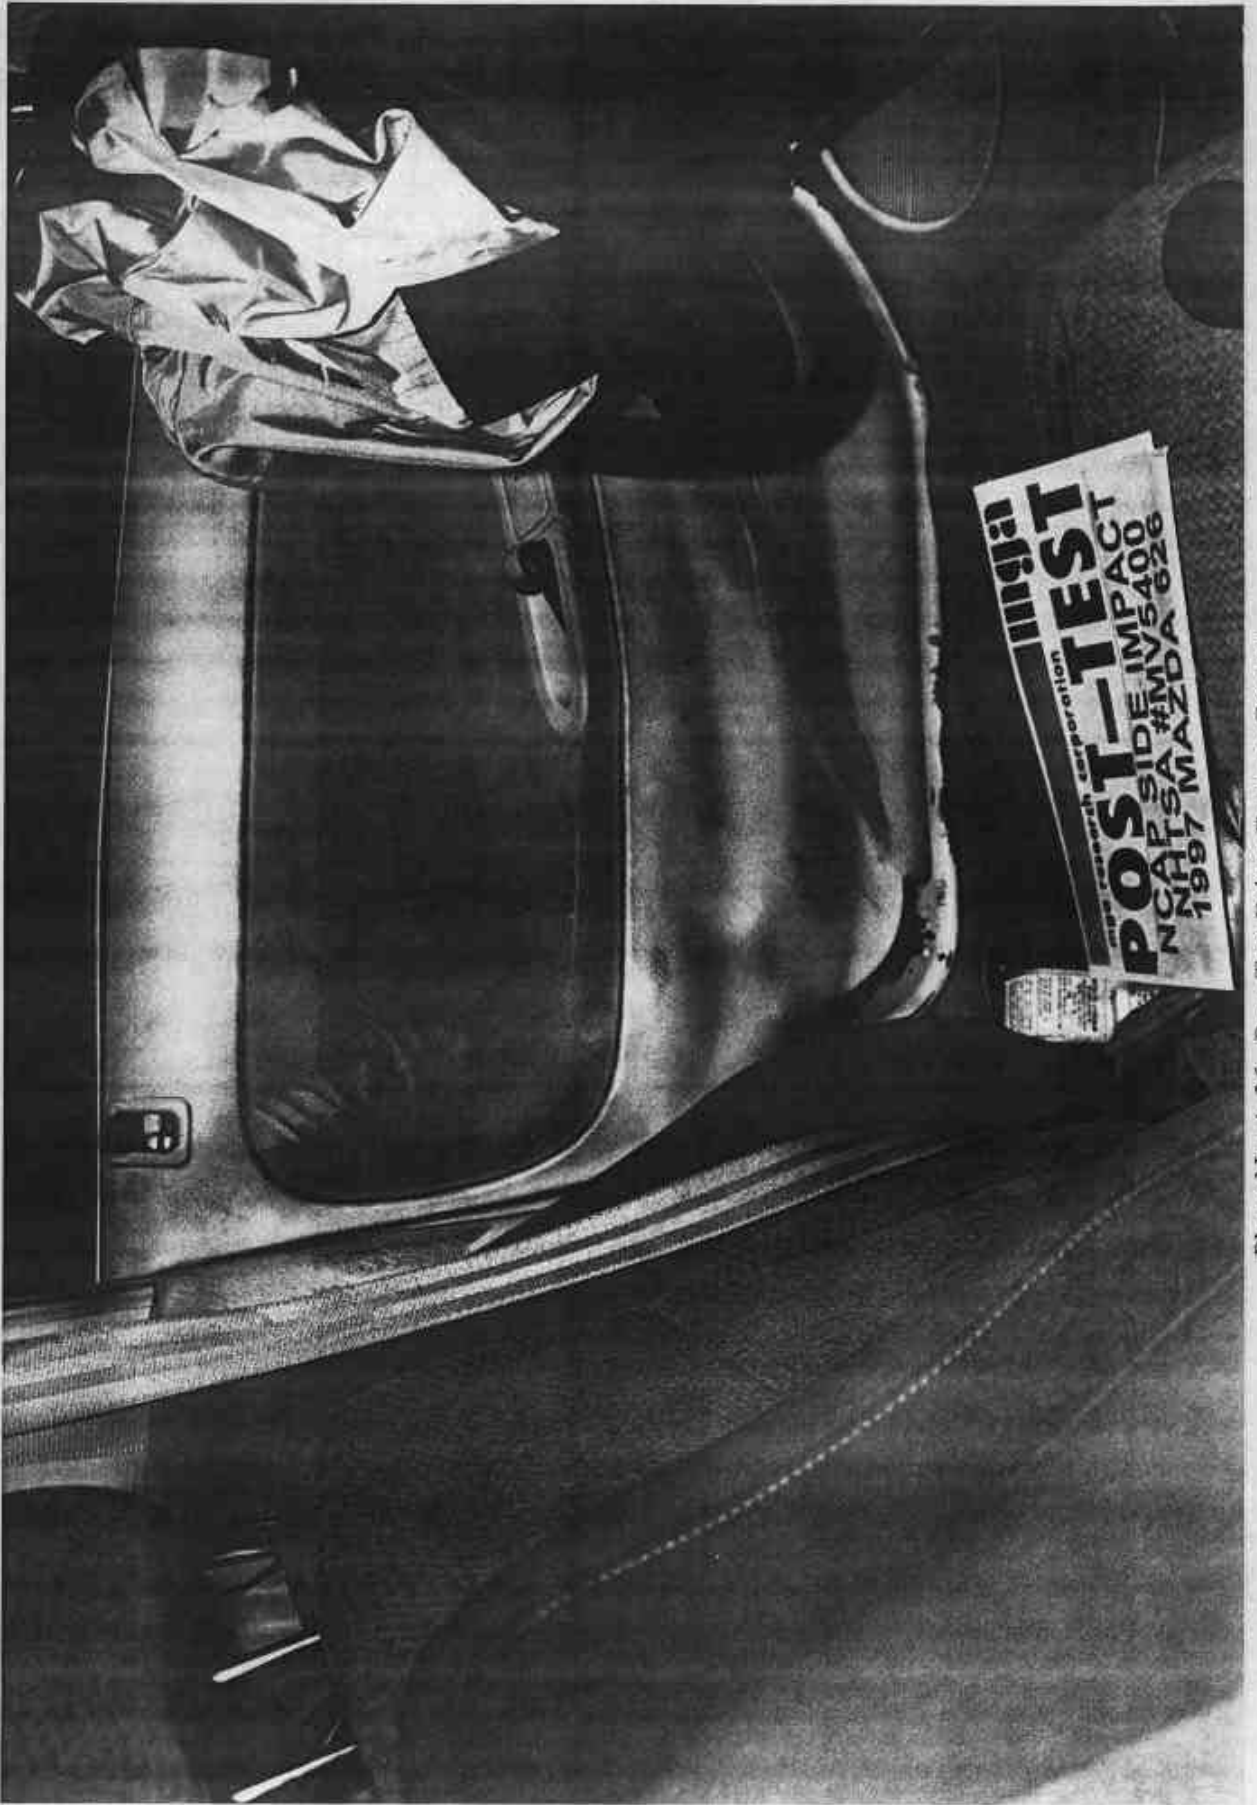
Photo No. A-26 - Post-Test Driver Dummy Contact

<u>LEFT FRONT SID</u>	<u>LEFT REAR SID</u>
Head	<u>airbag</u>	<u>to C-post</u>
Arm	<u>to door</u>	<u>to door and armrest</u>
Pelvis	<u>to door and armrest</u>	<u>to door and armrest</u>
Left Knee	<u>to door</u>	<u>to door</u>
Right Knee	<u>to left knee</u>	<u>to left knee</u>

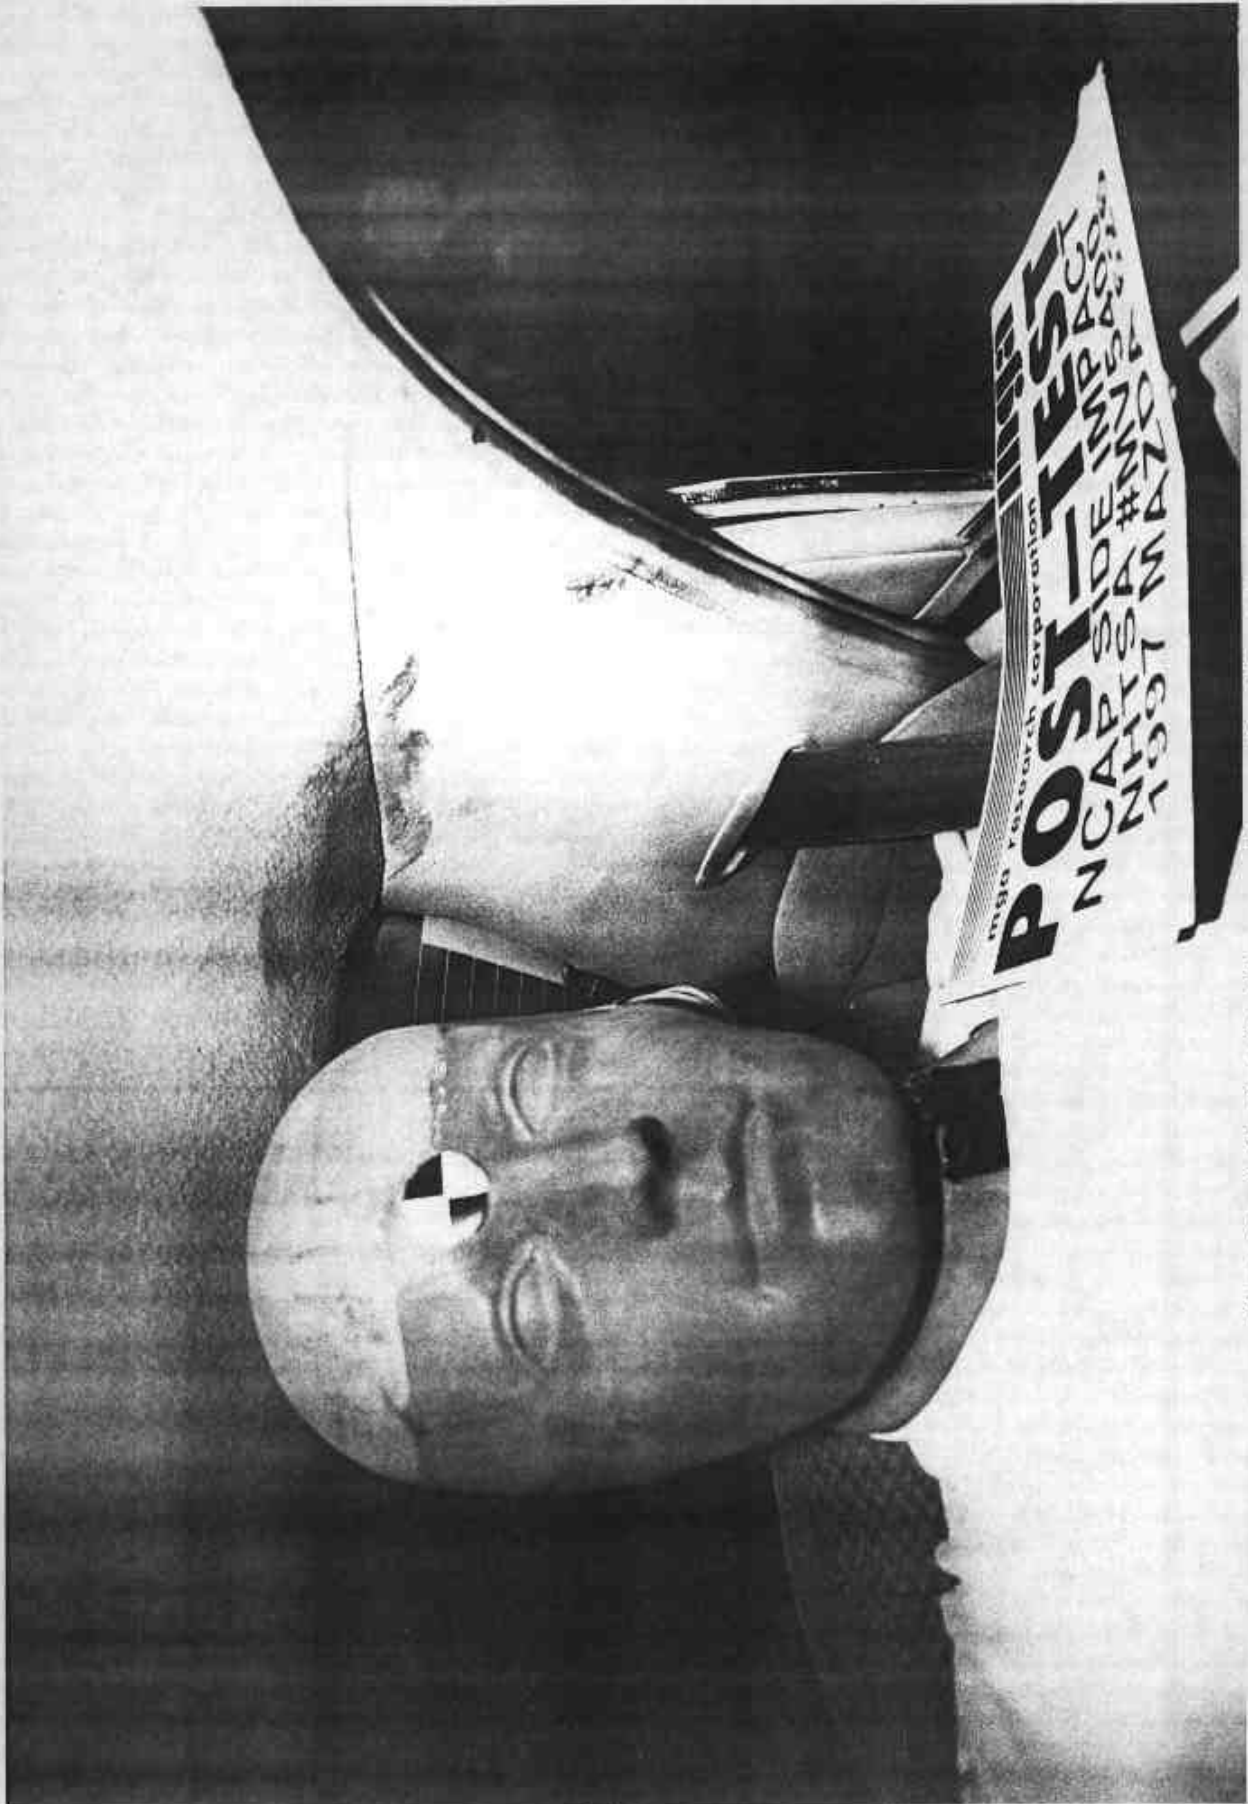
Photo No. A-35 - Post-Test Passenger Dummy Head Contact
