NEW CAR ASSESSMENT PROGRAM
SIDE IMPACT TESTING
PASSENGER CARS

1997 MAZDA 626
4-DOOR SEDAN
NHTSA NO: MV5400

FINAL REPORT

1. Report No. 214D-MGA-97-14		2. Government Accession No.		3. Recipient's Catalog No.																									
4. Title and Subtitle New Car Assessment Program Side Impact Test of a 1997 Mazda 626 4-Door Sedan NHTSA No. MV5400			5. Report Date February 25, 1997																										
			6. Performing Organization Code MGA																										
7. Author(s) Gary Strassburg, Project Engineer			8. Performing Organization Report No. MGA-DOT-214-0																										
9. Performing Organization Name and Address MGA Research Corporation 5000 Warren Road Burlington, WI 53105			10. Work Unit No.																										
			11. Contract or Grant No. DTNH22-93-C-02047																										
12. Sponsoring Agency Name and Address U.S. Department of Transportation National Highway Traffic Safety Administration Office of Crashworthiness Standards 400 Seventh St., S.W. Washington, D.C. 20590			13. Type of Report and Period Covered Final Test Report January 30, 1997 to February 25, 1997																										
			14. Sponsoring Agency Code NPS-10

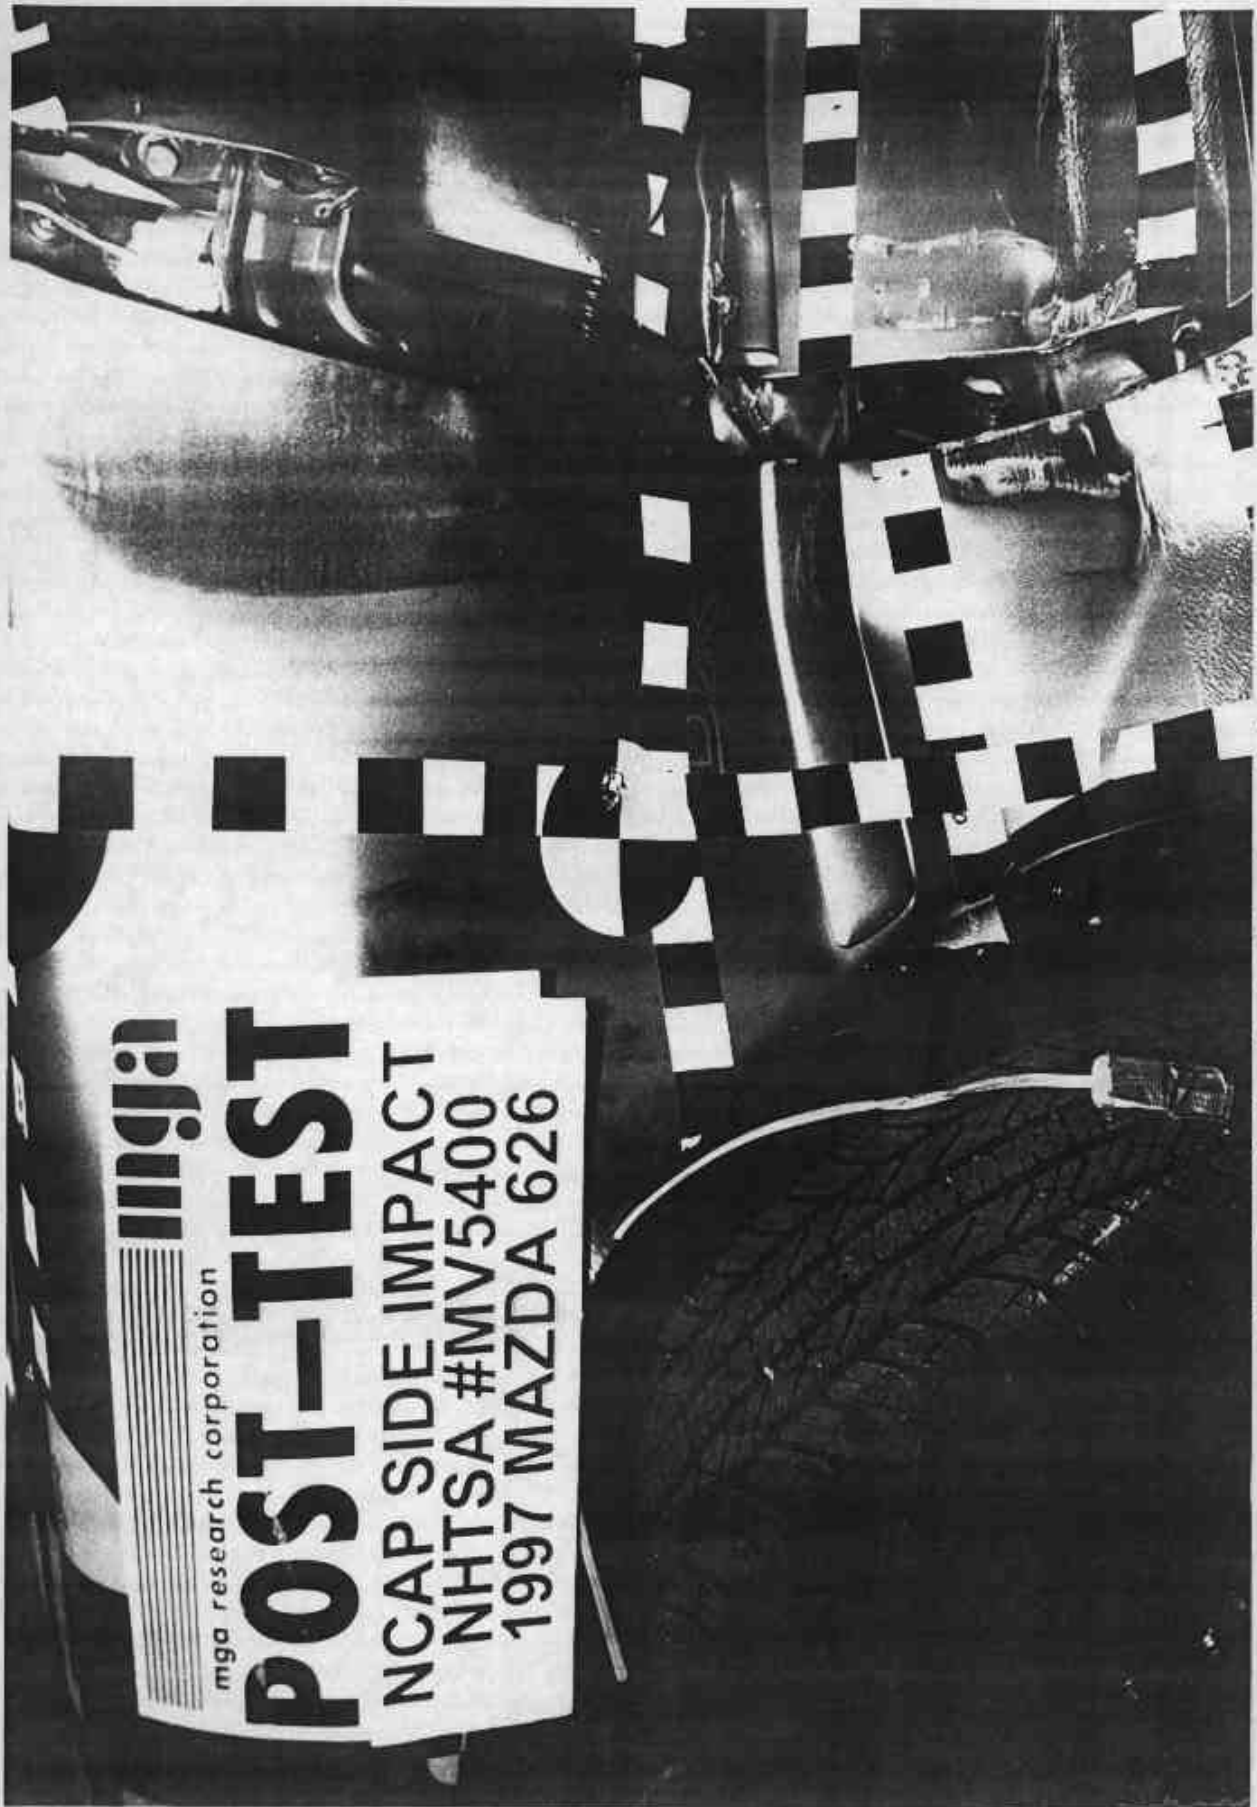
Photo No. A-37 - Post-Test Left Front Impact Point on Vehicle

MDB DISTANCE FROM TARGET IMPACT POINT:

Horizontal: 15 mm rearward Vertical: 6 mm high

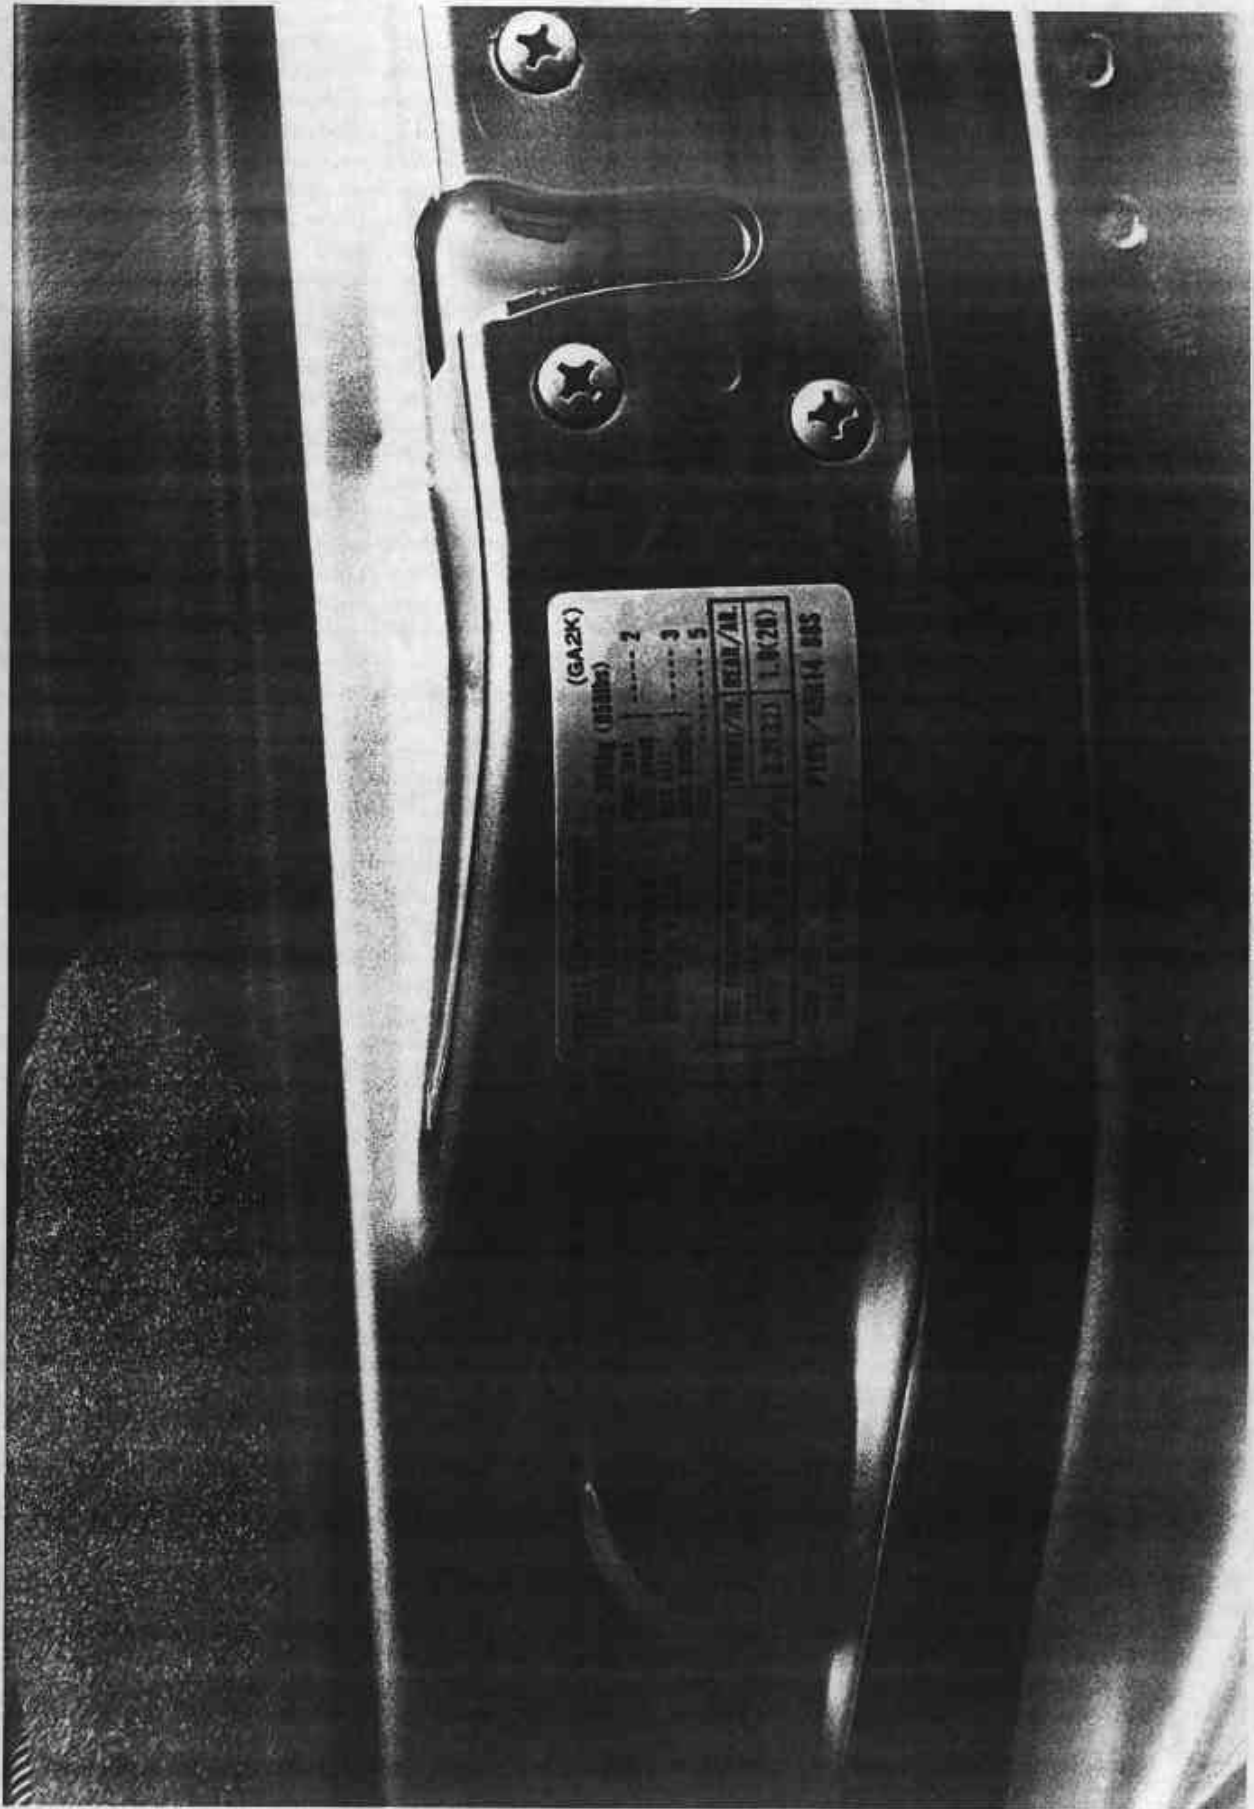
Photo No. A-40 - Tire Placard

DATA FROM TIRE PLACARD:

Tire Pressure (at capacity): 32 Psi FRONT

26 Psi REAR

Recommended Tire Size: P195/65/R14
