NEW CAR ASSESSMENT PROGRAM  
SIDE IMPACT TESTING  
PASSENGER CARS

1997 CHEVROLET LUMINA  
4-DOOR SEDAN  
NHTSA NO: MV0114

MGA PROVING GROUNDS  
5000 WARREN ROAD  
BURLINGTON, WI 53105

FINAL REPORT

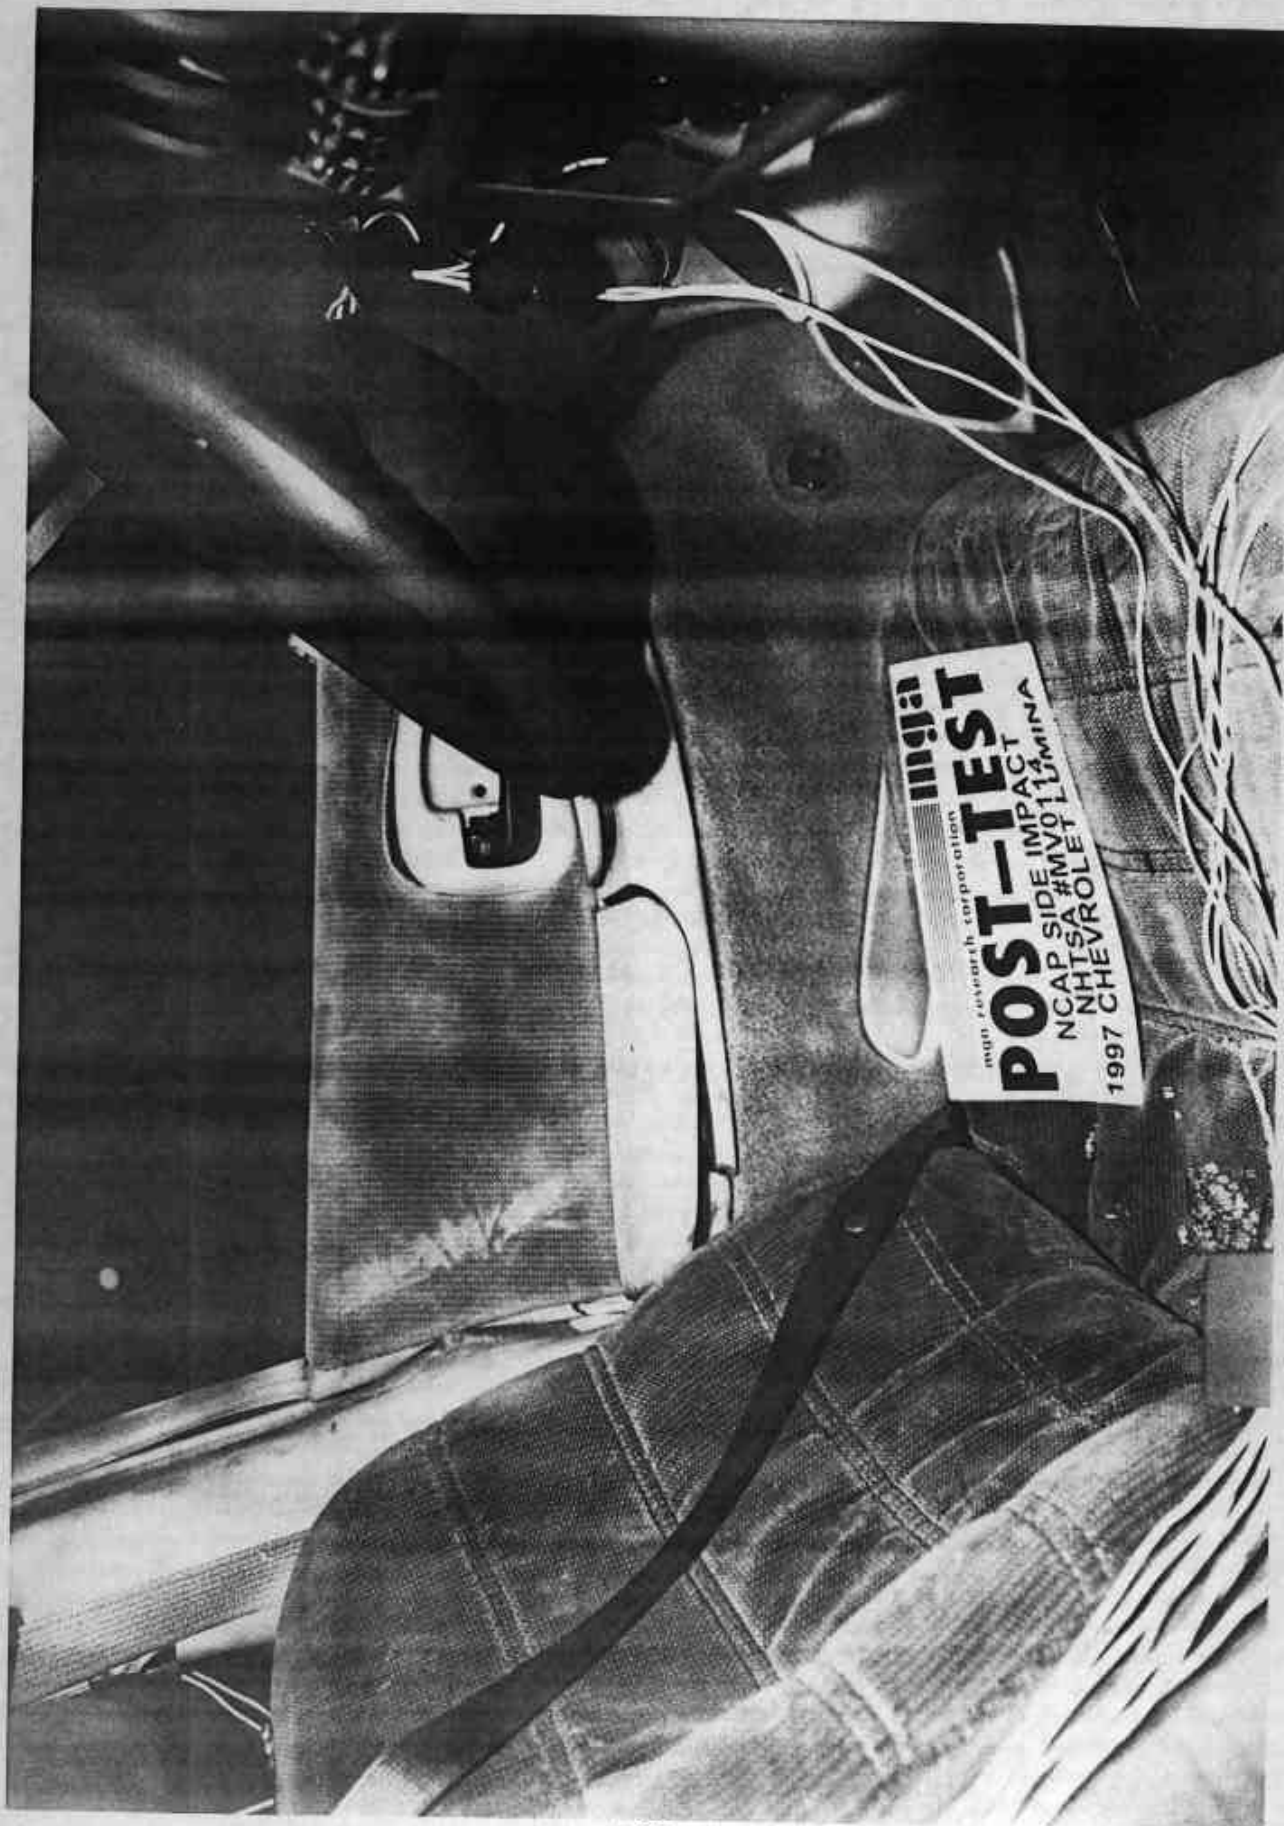
Photo No. A-29 - Post-Test Driver Dummy Contact

VISIBLE DUMMY CONTACT POINTS:

| | <u>LEFT FRONT SID</u> | <u>LEFT REAR SID</u> |
|---|---|---|
| Head | <u>to left shoulder</u> | <u>to C-post</u> |
| Arm | <u>to door panel</u> | <u>to door panel</u> |
| Pelvis | <u>to armrest</u> | <u>to armrest</u> |
| Left Knee | <u>to door panel</u> | <u>to door panel</u> |

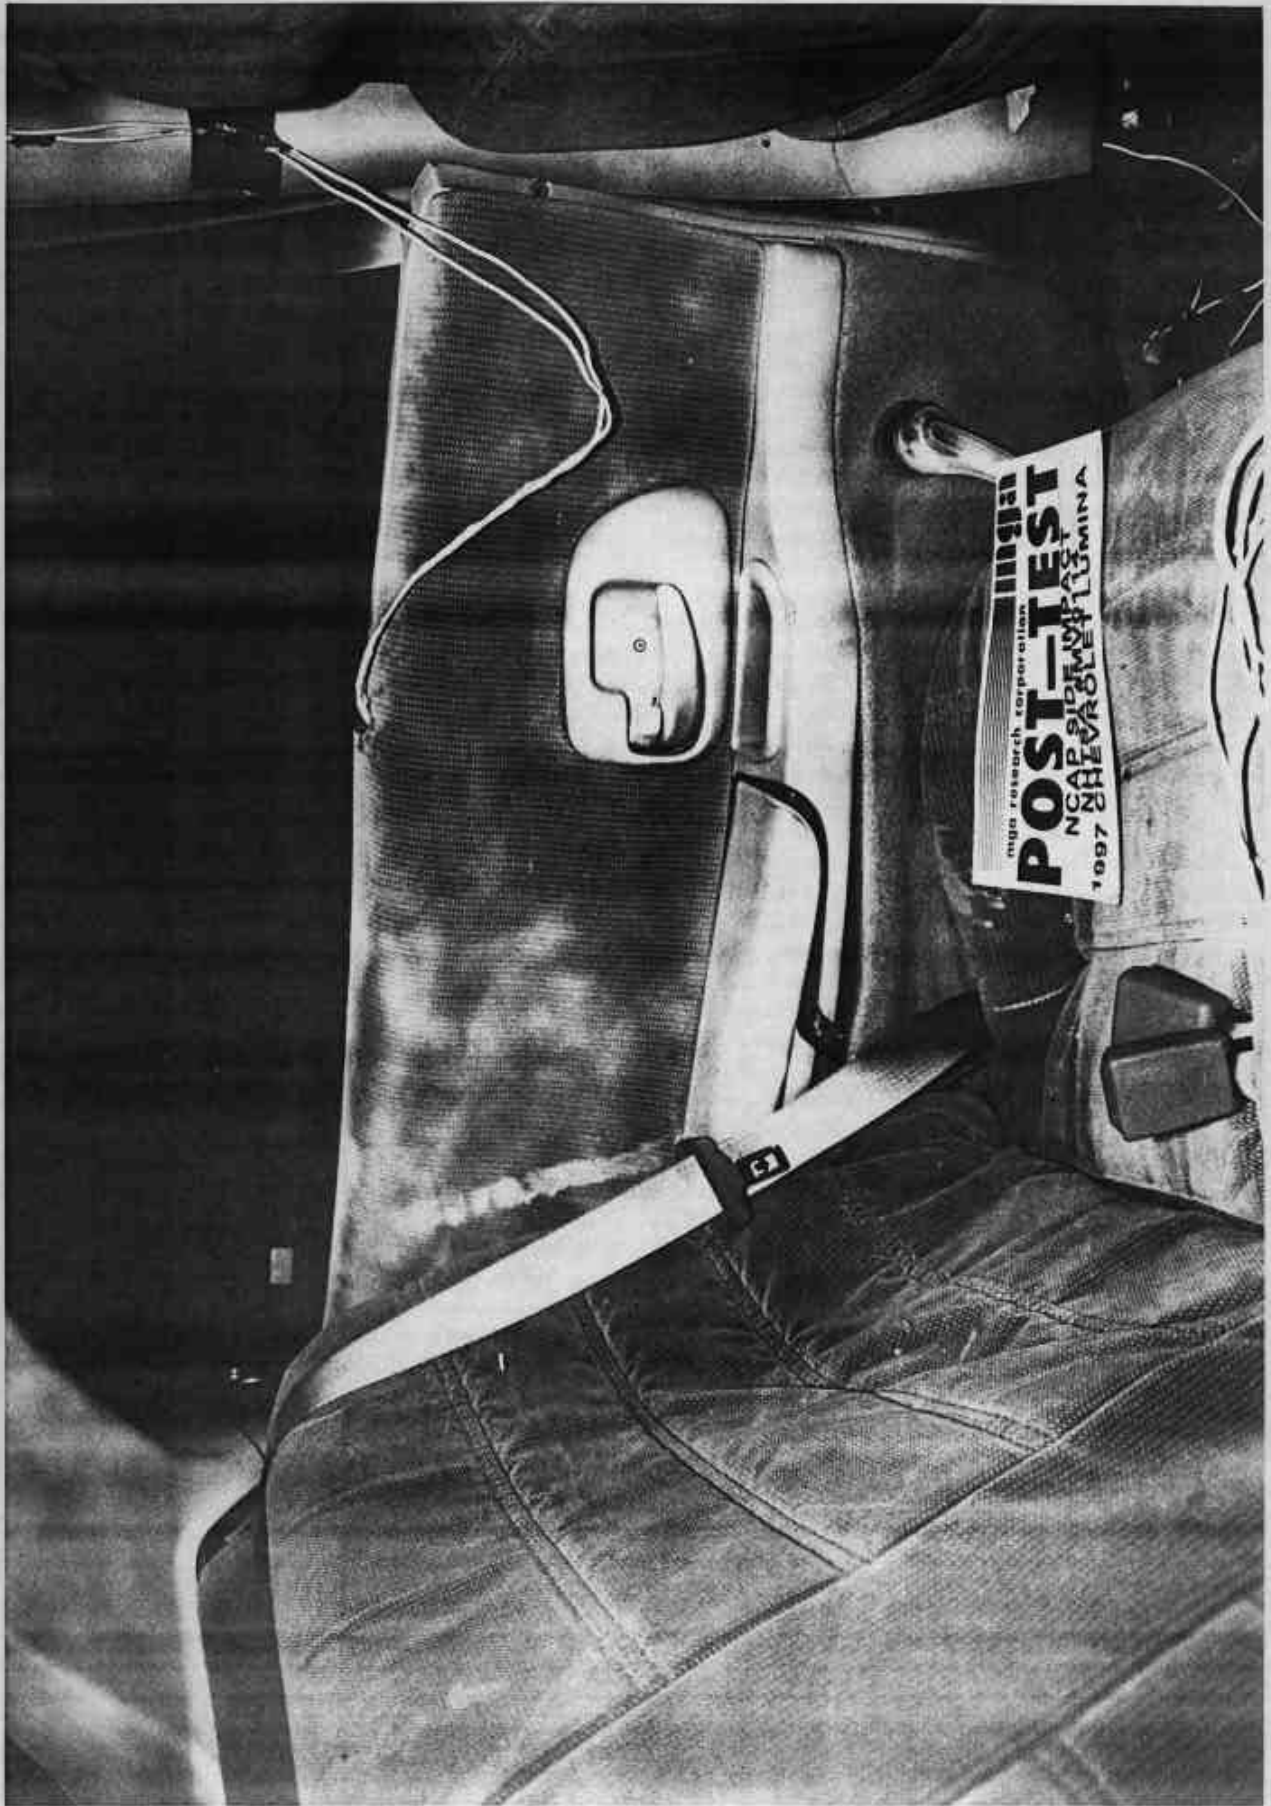
Photo No. A-37 - Post-Test Passenger Dummy Contact

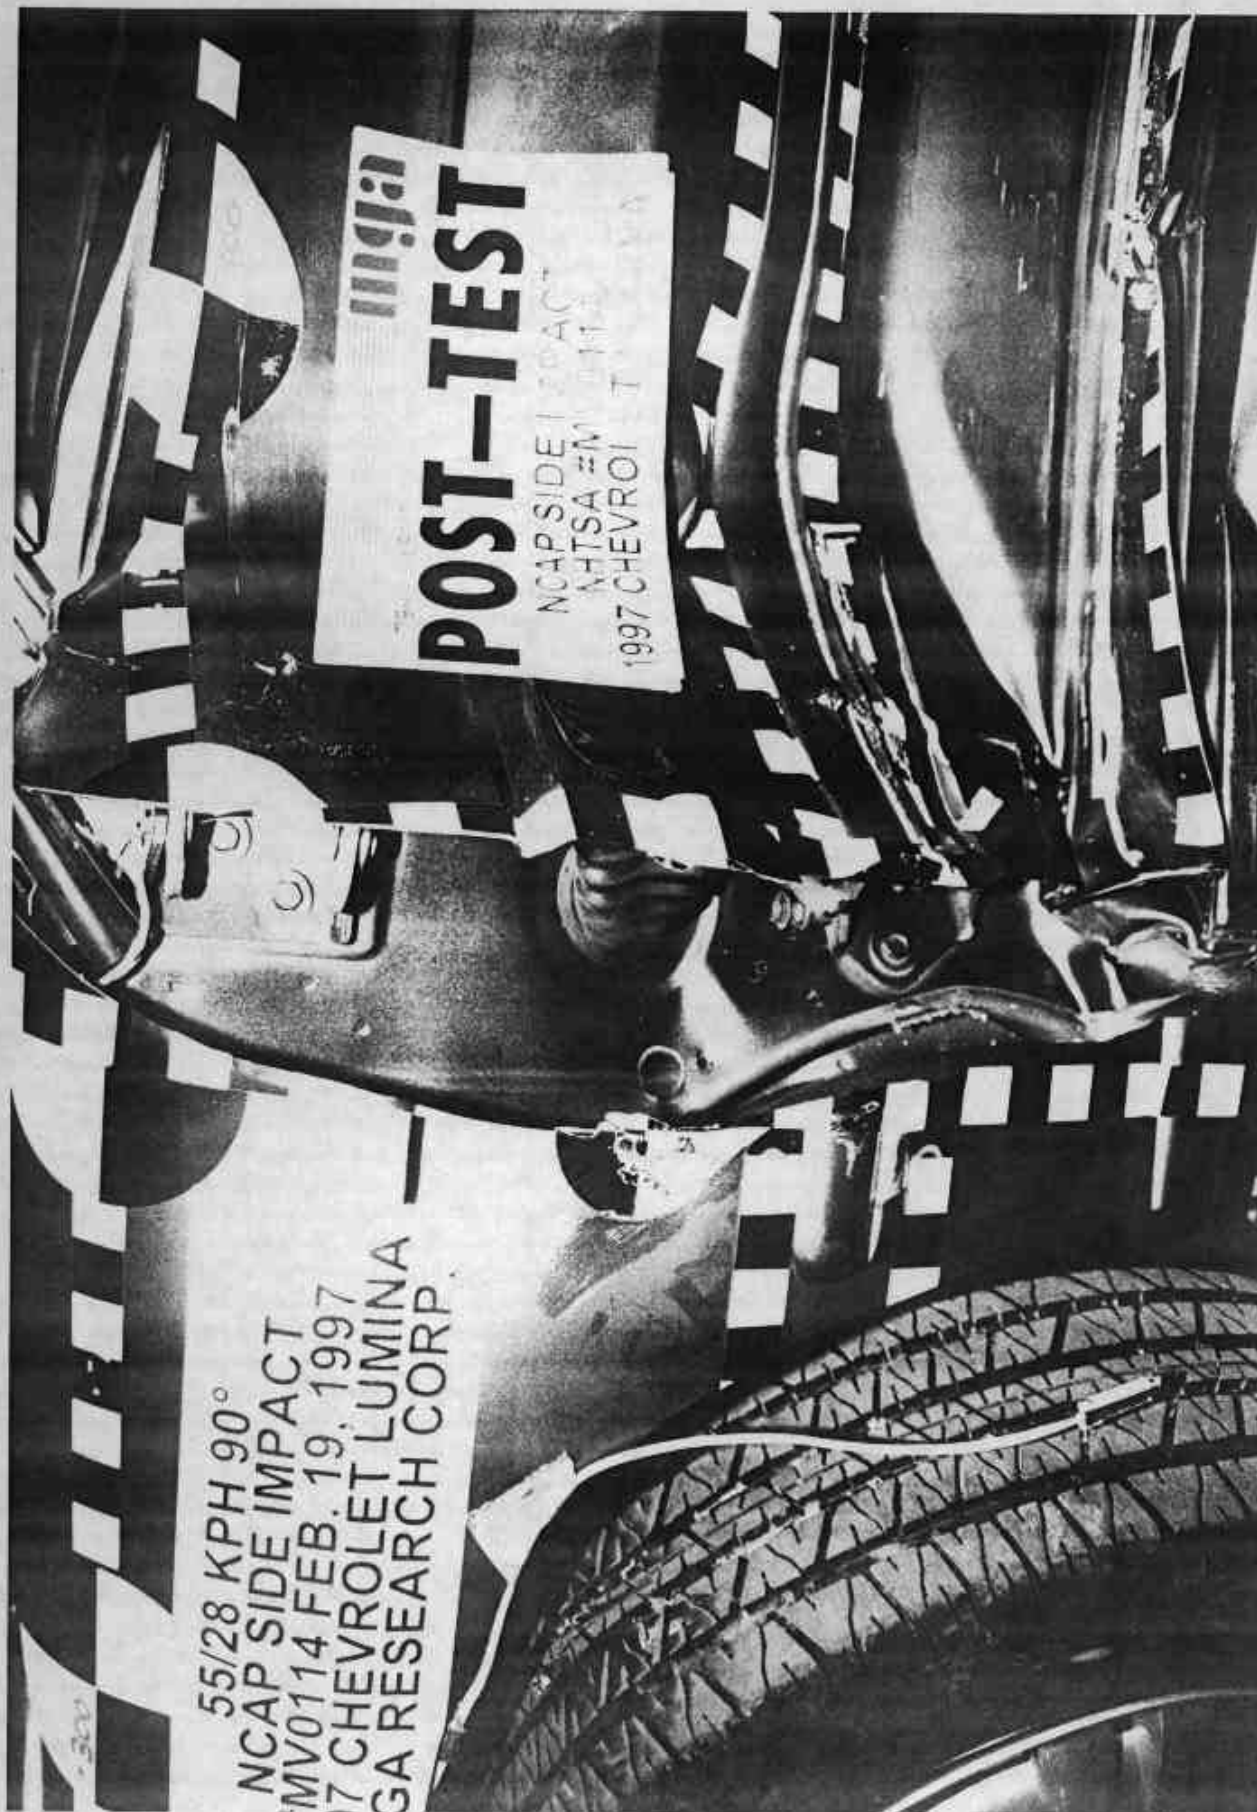
Photo No. A-40 - Post-Test Left Front Impact Point on Vehicle

MDB DISTANCE FROM TARGET IMPACT POINT:

Horizontal: 7 mm forward      Vertical: 0 mm
