NEW CAR ASSESSMENT PROGRAM  
SIDE IMPACT TESTING  
PASSENGER CARS

1997 HYUNDAI SONATA  
4-DOOR  
NHTSA NO: MV0500

FINAL REPORT

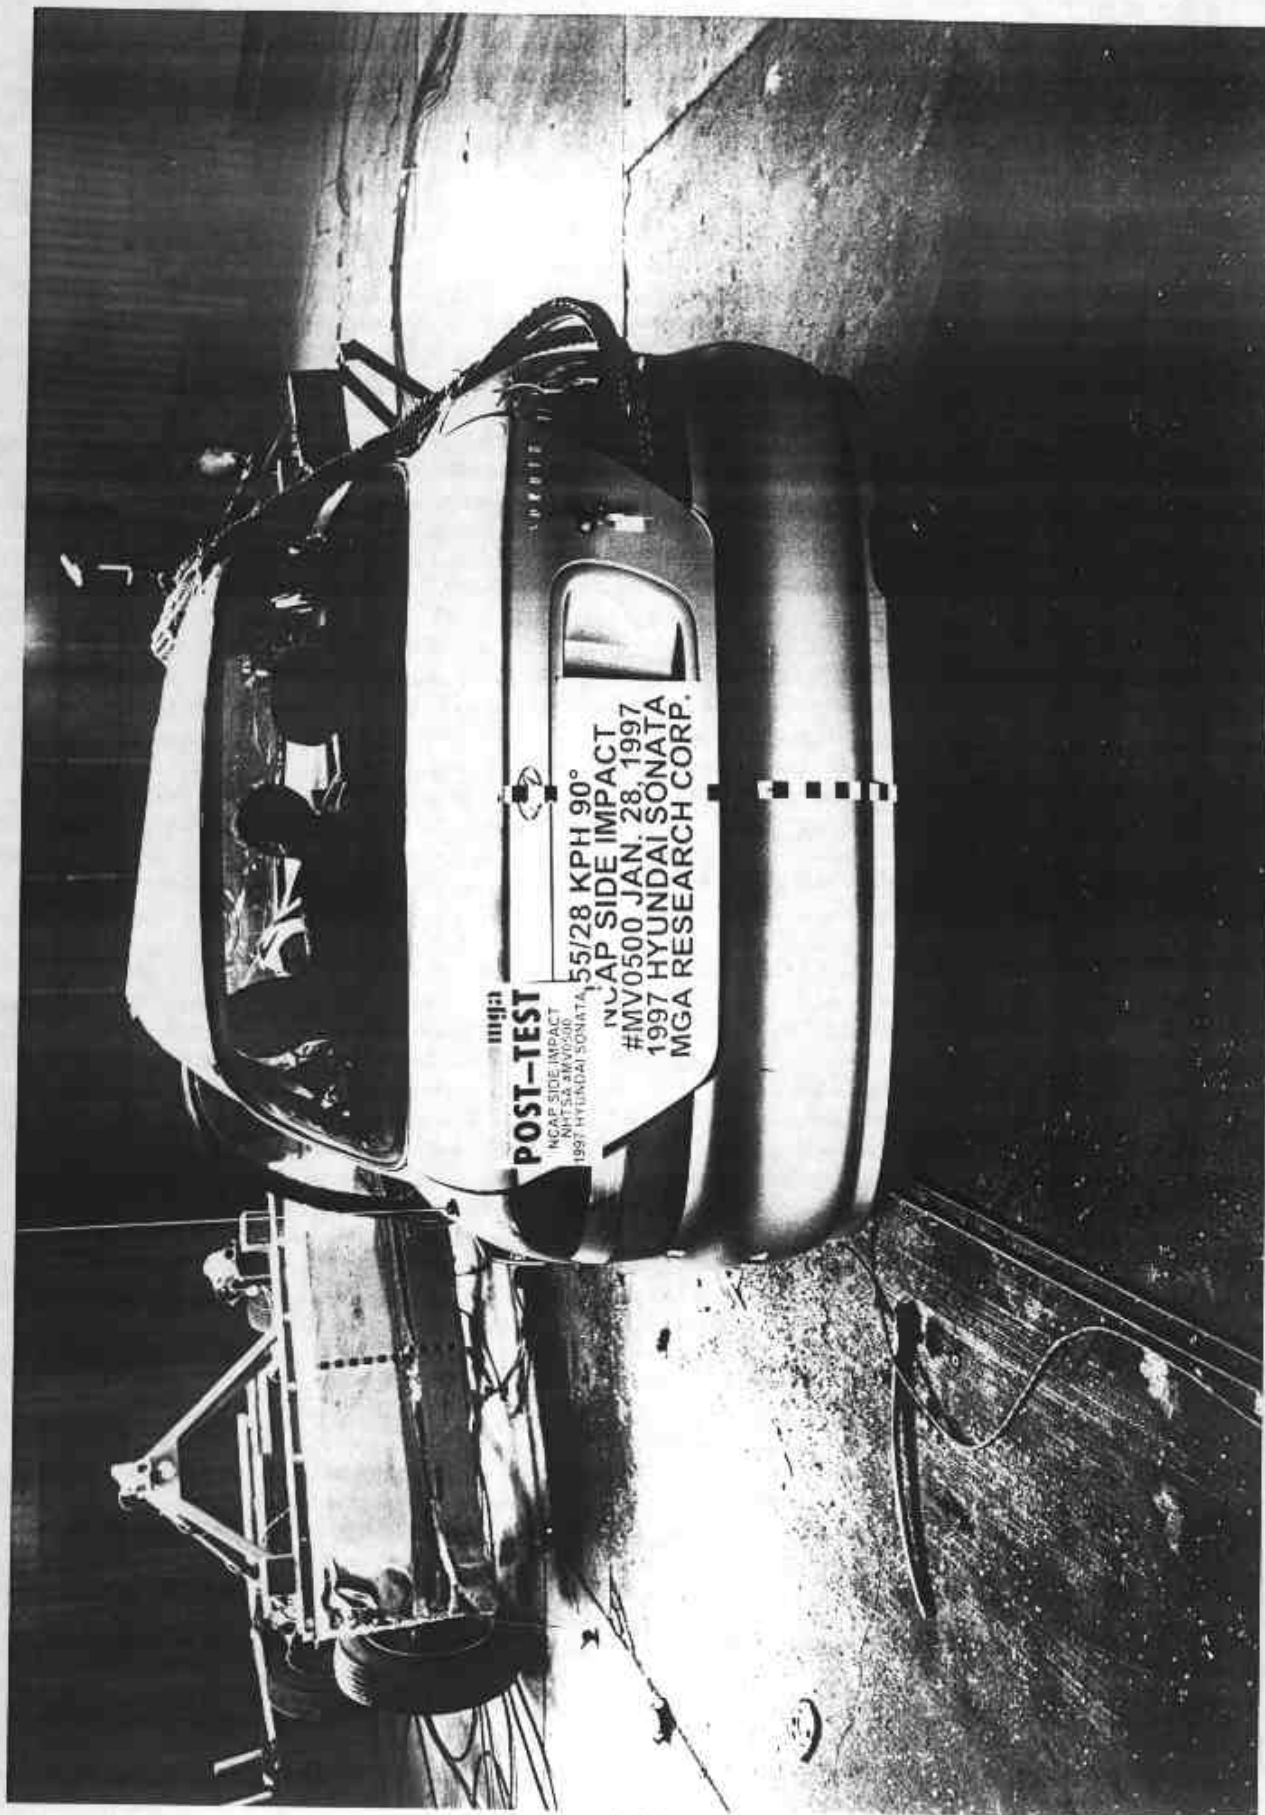
Photo No. A-3 - Post-Test Rear View of Test Vehicle

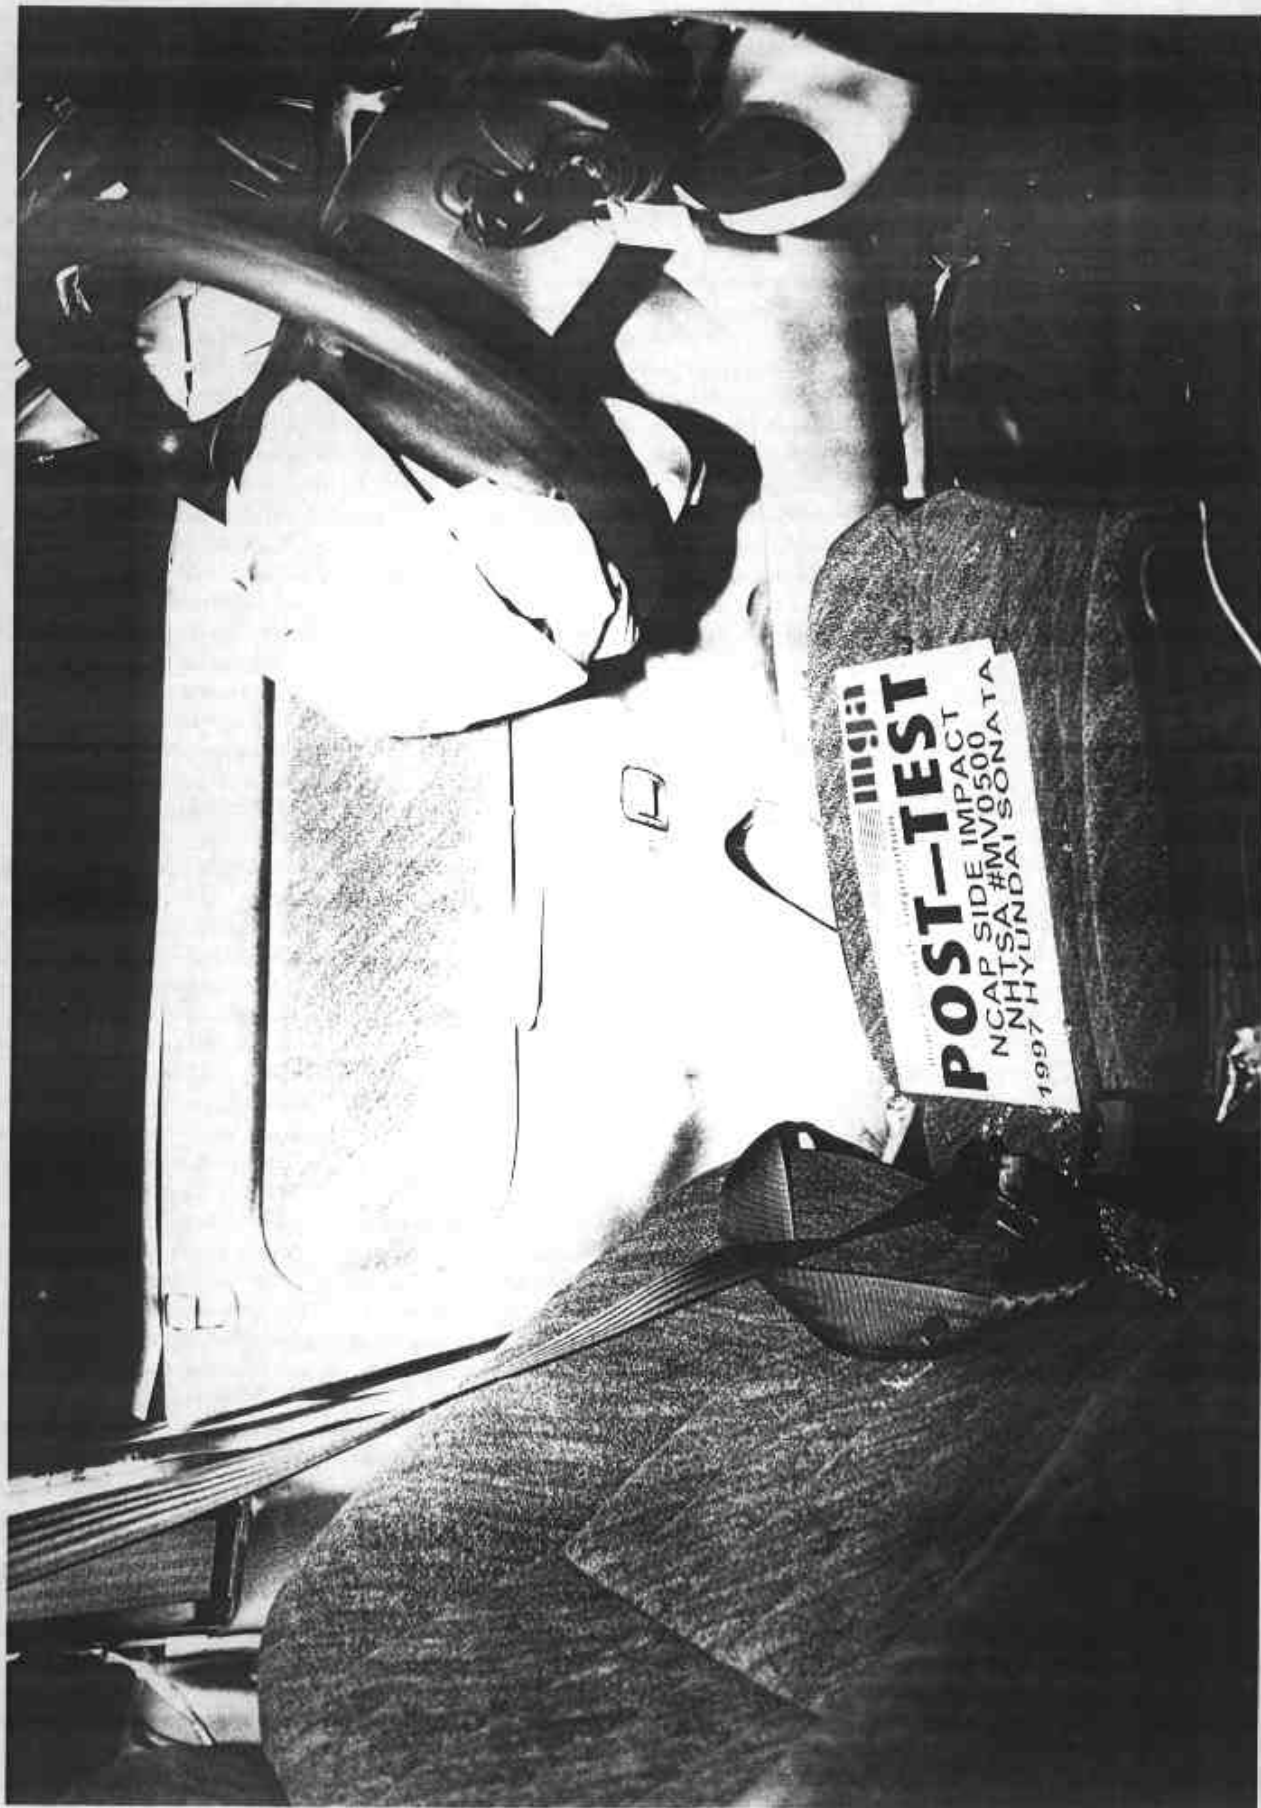
Photo No. A-27 - Post-Test Driver Dummy Contact

VISIBLE DUMMY CONTACT POINTS:

| | <u>LEFT FRONT SID</u> | <u>LEFT REAR SID</u> |
|---|---|---|
| Head | <u>to D-ring</u> | <u>to C-Post</u> |
| Arm | <u>to door</u> | <u>to door</u> |
| Pelvis | <u>to door</u> | <u>to door</u> |

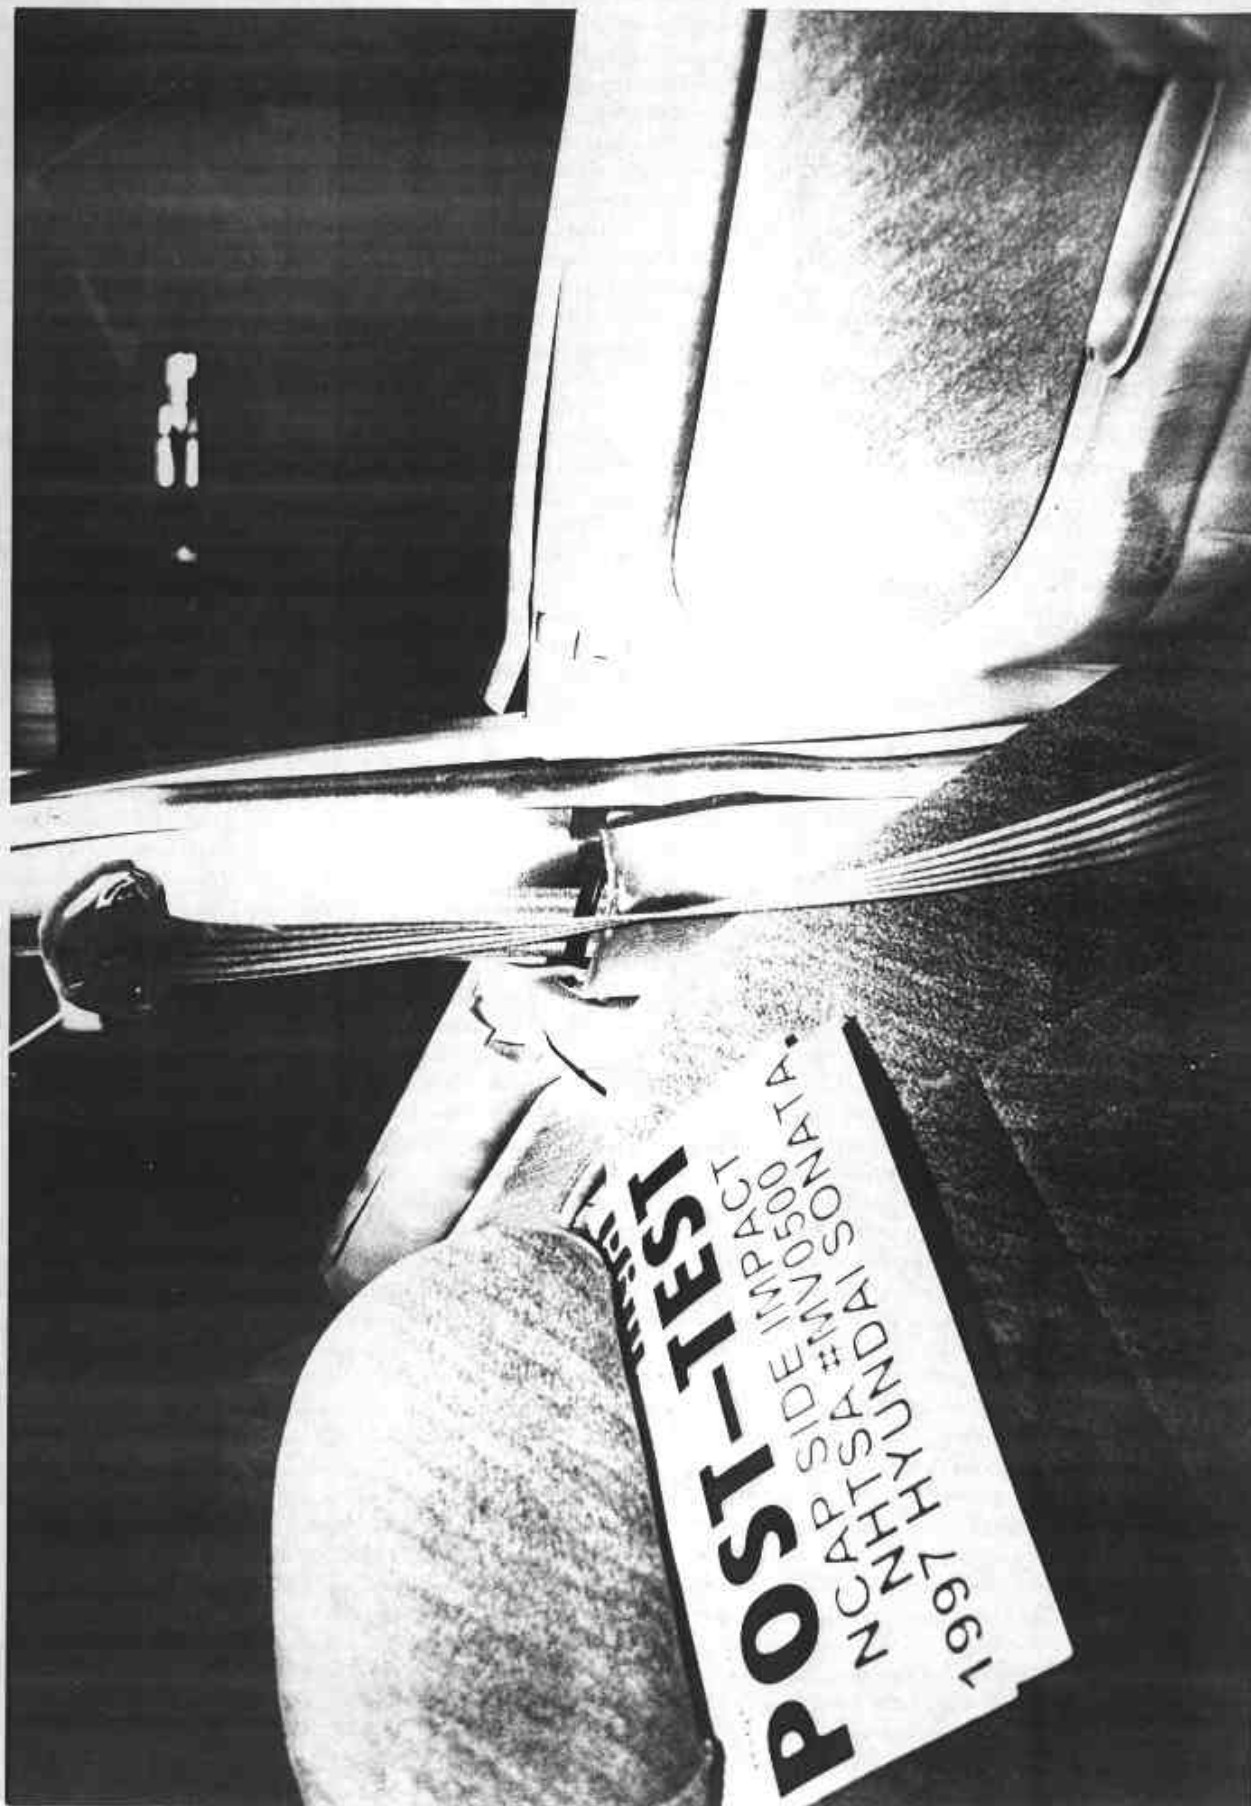
Photo No. A-28 - Post-Test Driver Dummy Head Contact

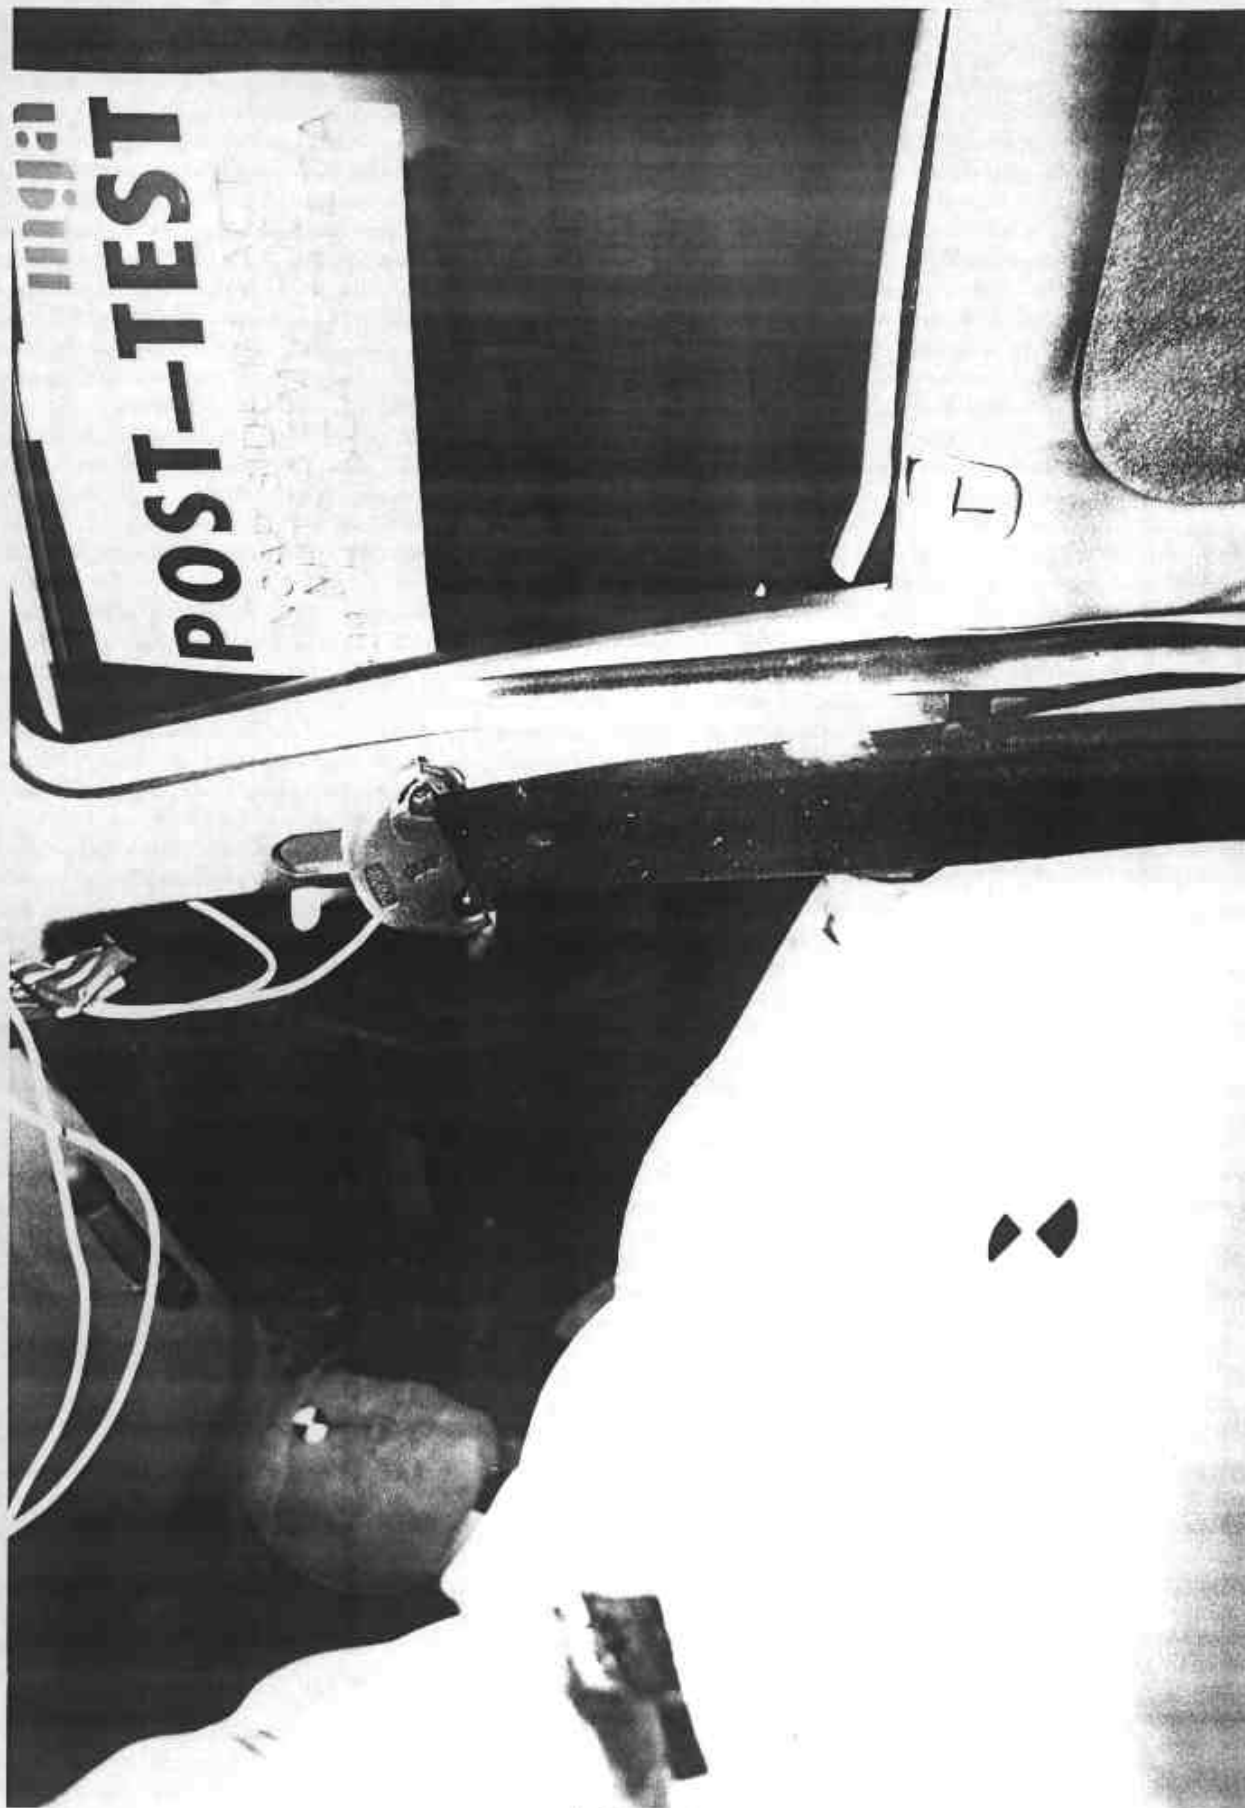
Photo No. A-29 - Post-Test Driver Dummy Head Contact

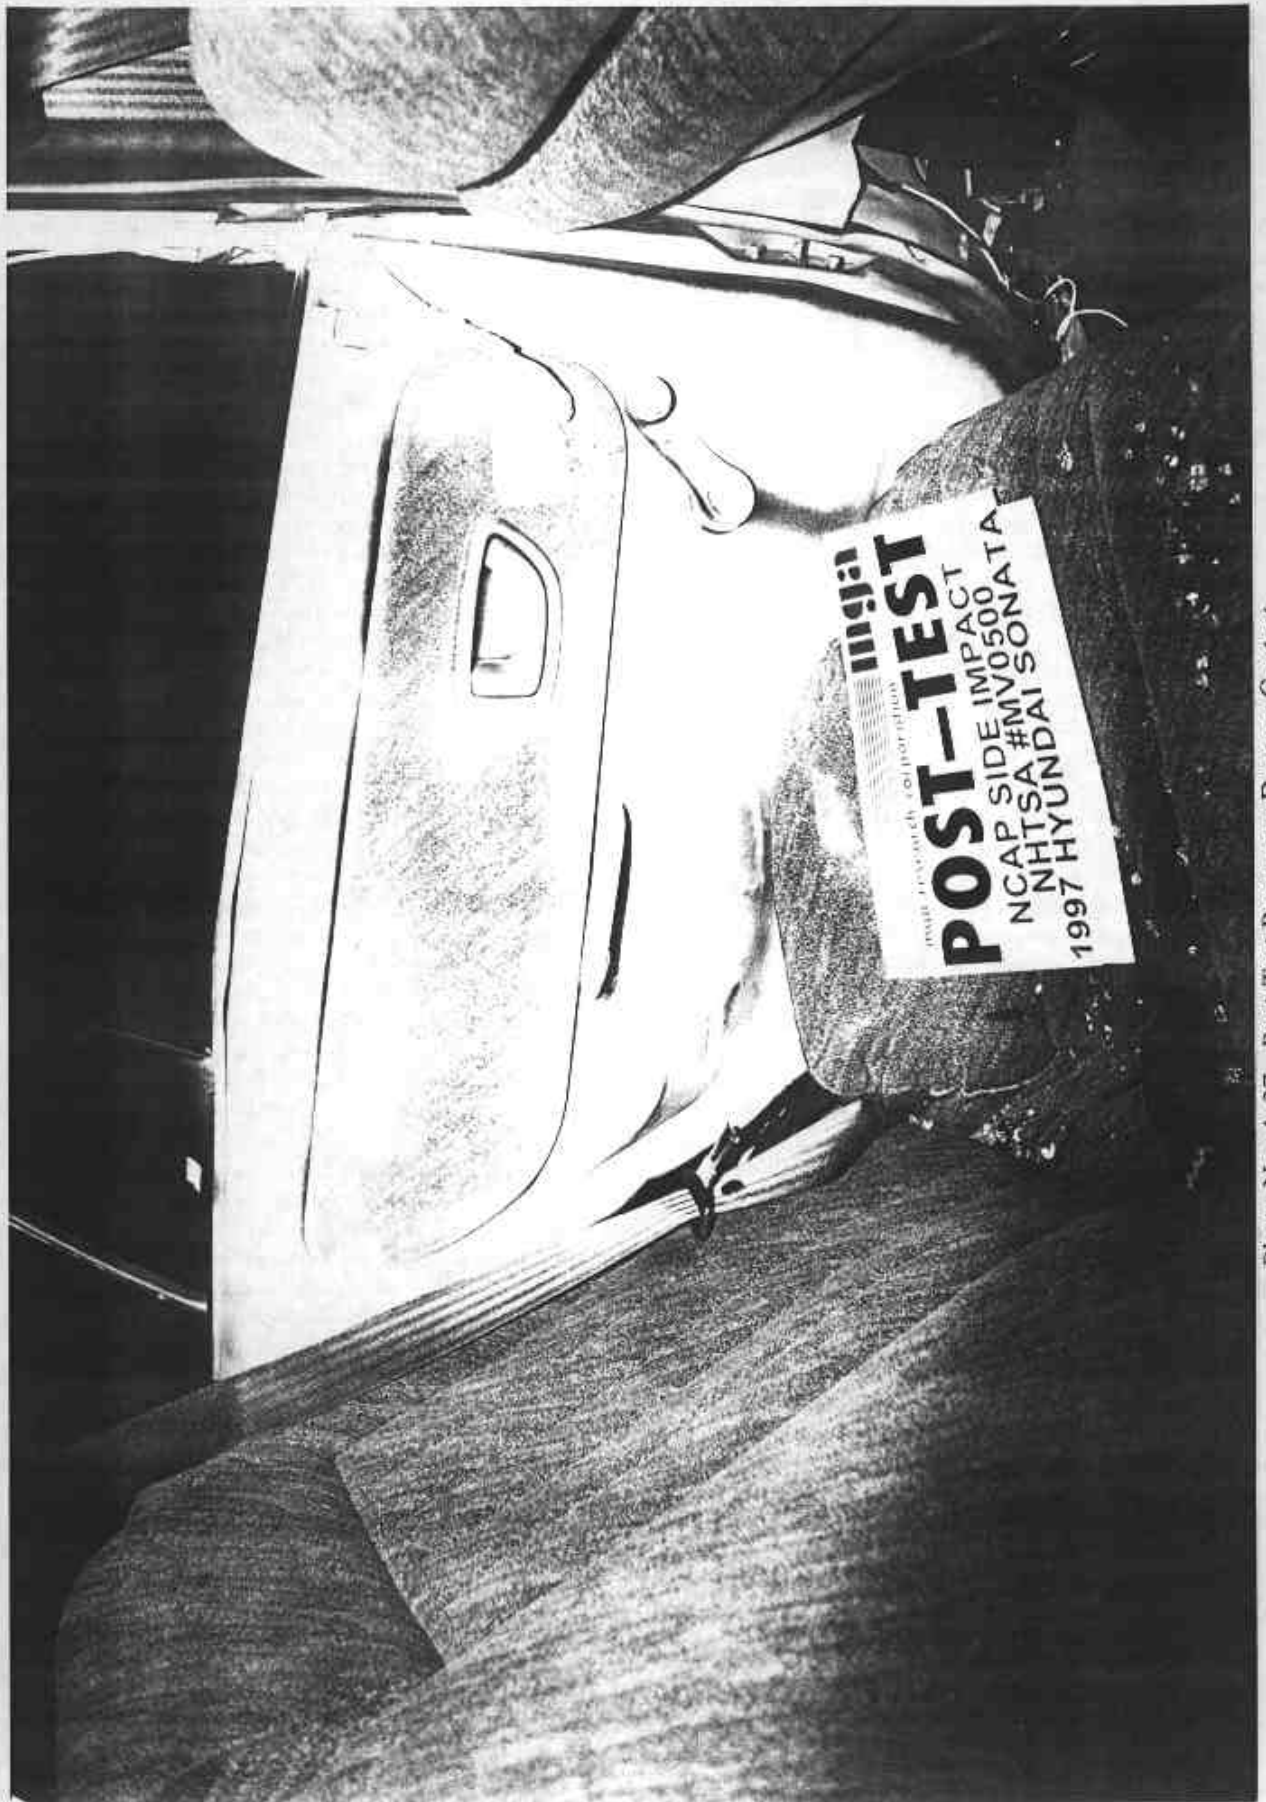
Photo No. A-37 - Post-Test Passenger Dummy Contact

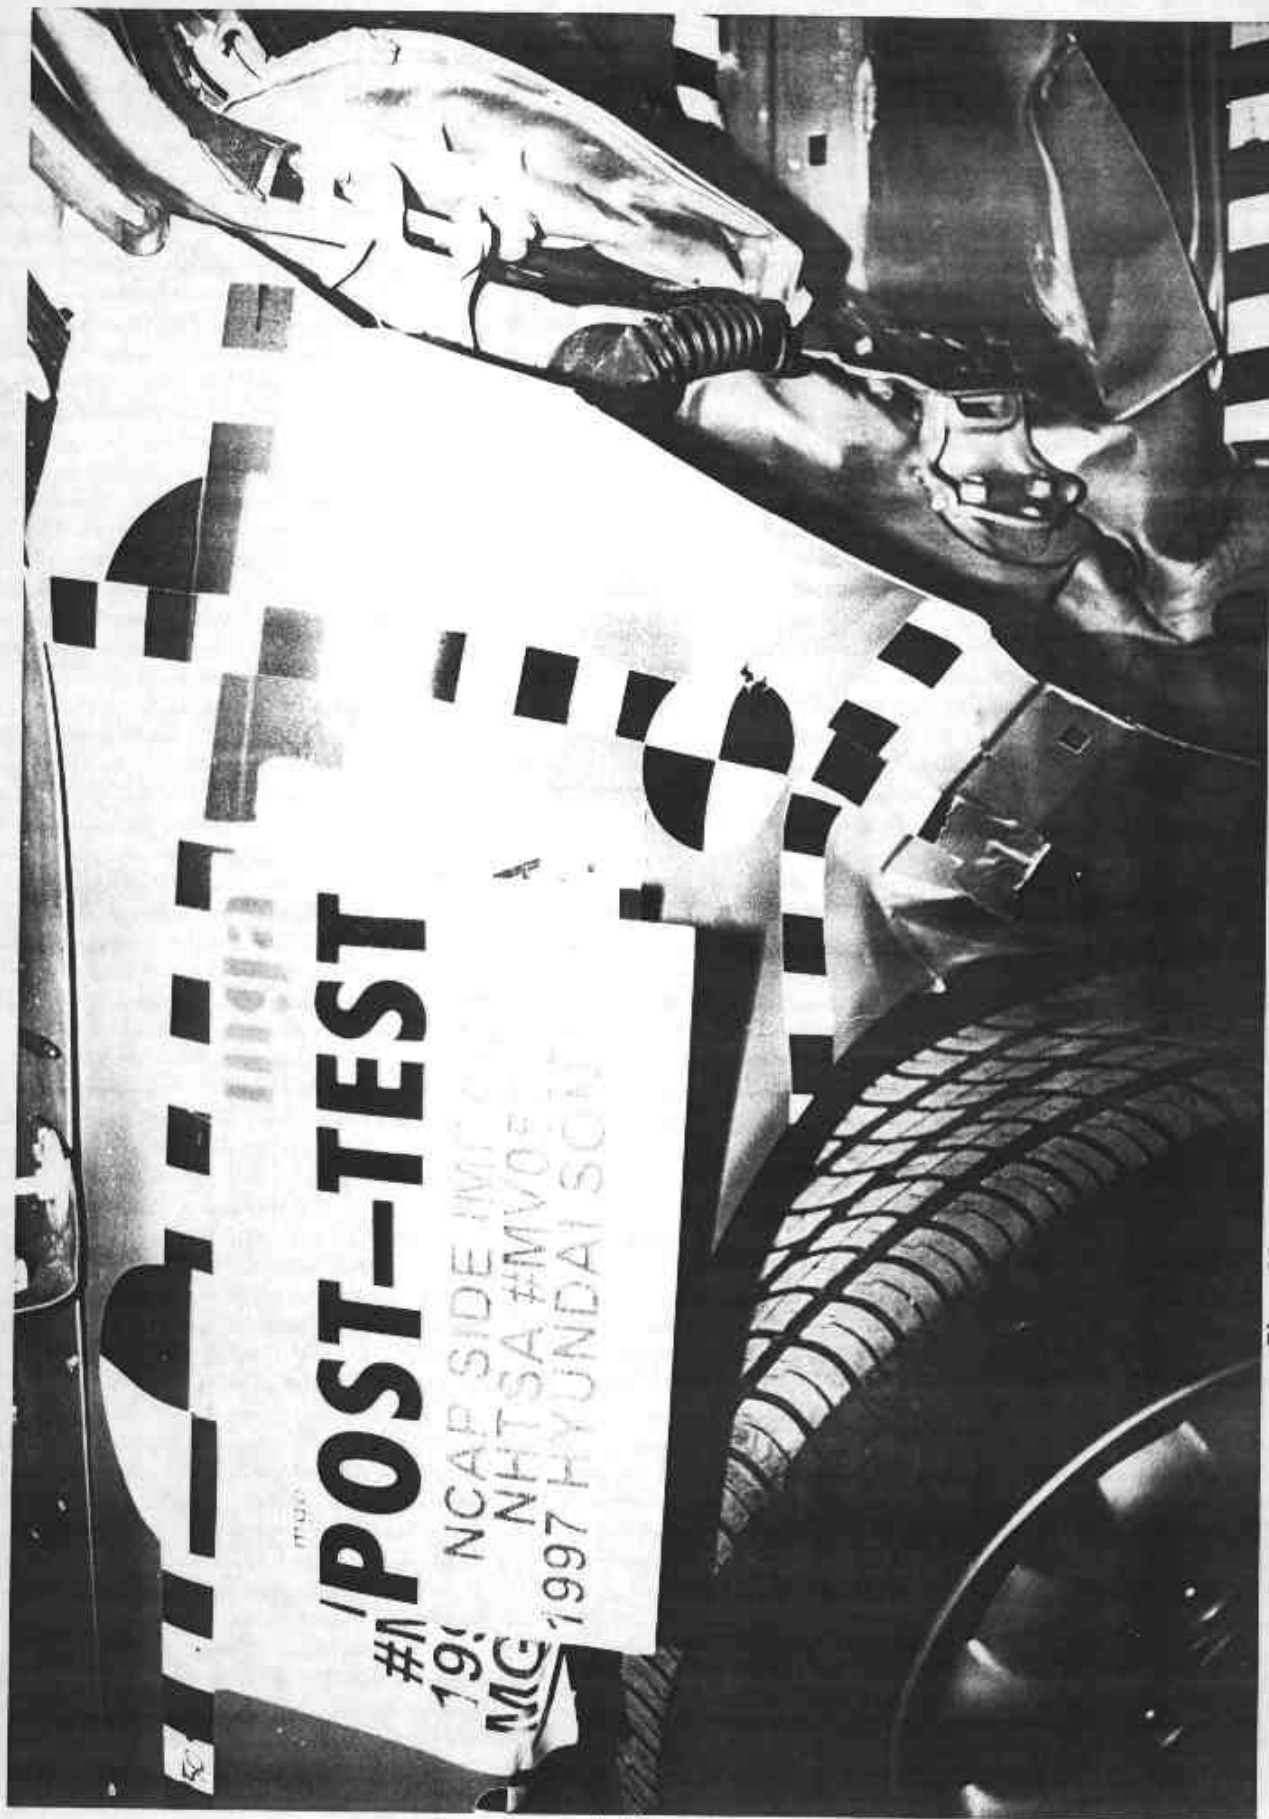
Photo No. A-40 - Post-Test Left Front Impact Point on Vehicle

Impact Point is 410 mm rearward of front axle centerline

Horizontal: 35 mm rearward      Vertical: 3 mm low
